Expertise

Protocol number: 46069260  
Order No. / Reference: 26474408  
Inspection date: 18 Jun 2026

Manufacturer: Volkswagen

Model: Tiguan Allspace 2.0 TDI SCR DSG Life

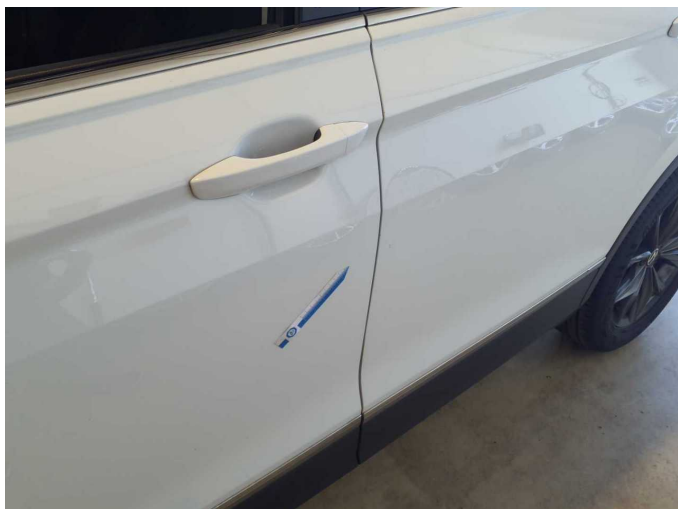
| No. | Component group | Description |
|---|---|---|
| 1 | Door - front left side | Door - dent(s) - Smooth repair work |

**Damage 1:** Door - front left side: Door - dent(s) - Smooth repair work

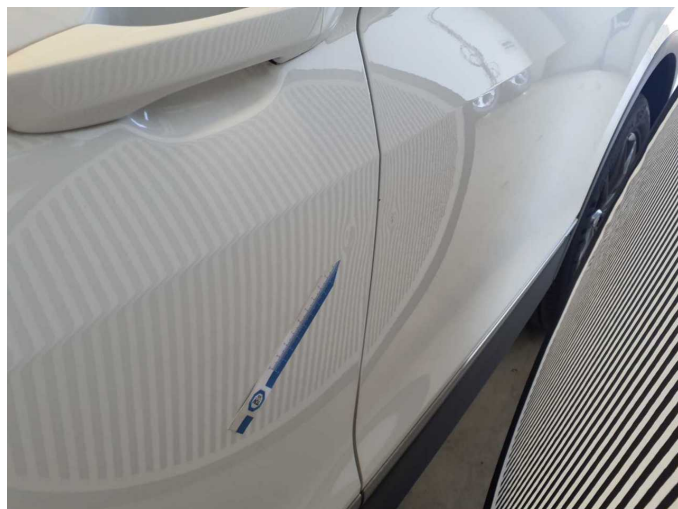
**Damage 1:** Door - front left side: Door - dent(s) - Smooth repair work

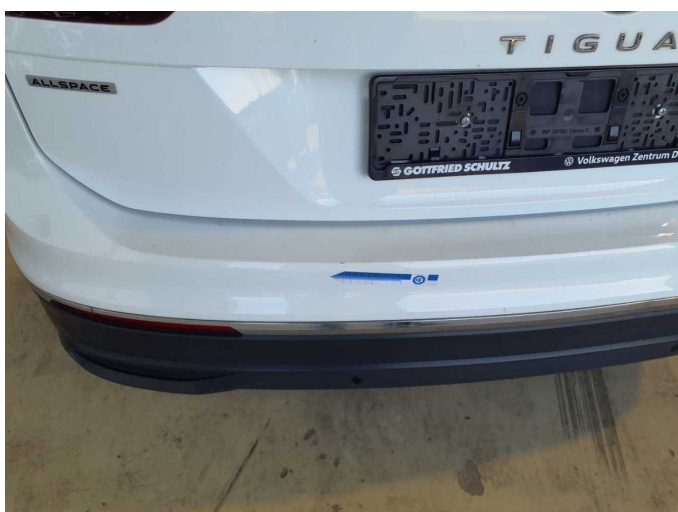
| No. | Component group | Description |
|---|---|---|
| 2 | Rear bumper | Rear bumper - Scratch(es) - Smart repair |

**Damage 2:** Rear bumper: Rear bumper - Scratch(es) - Smart repair

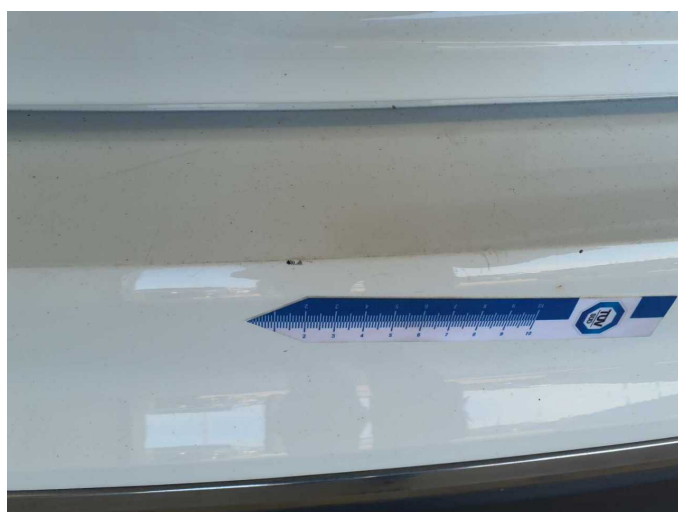
**Damage 2:** Rear bumper: Rear bumper - Scratch(es) - Smart repair

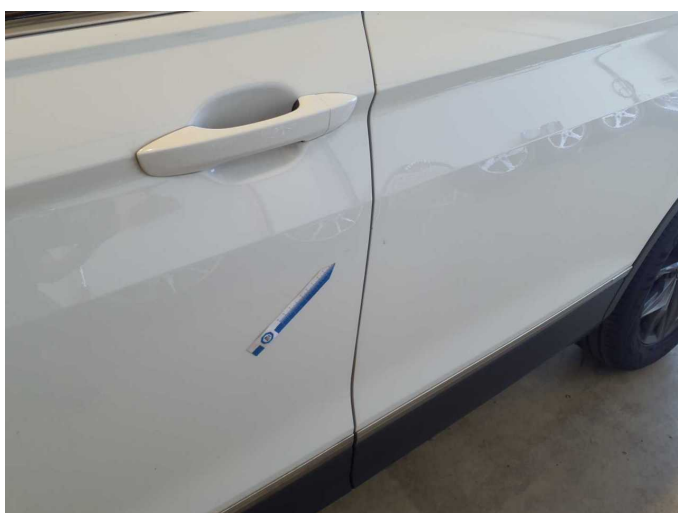
| No. | Component group | Description |
|---|---|---|
| 3 | Door - rear left side | Door - Scratch(es) - Smart repair |

**Damage 3:** Door - rear left side: Door - Scratch(es) - Smart repair

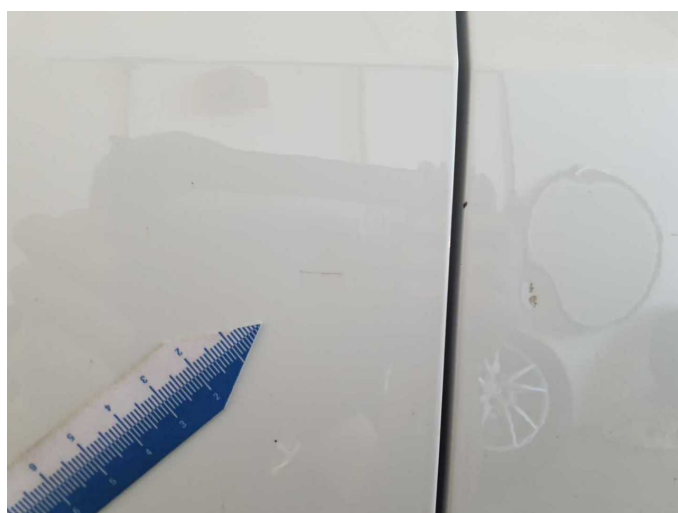
**Damage 3:** Door - rear left side: Door - Scratch(es) - Smart repair

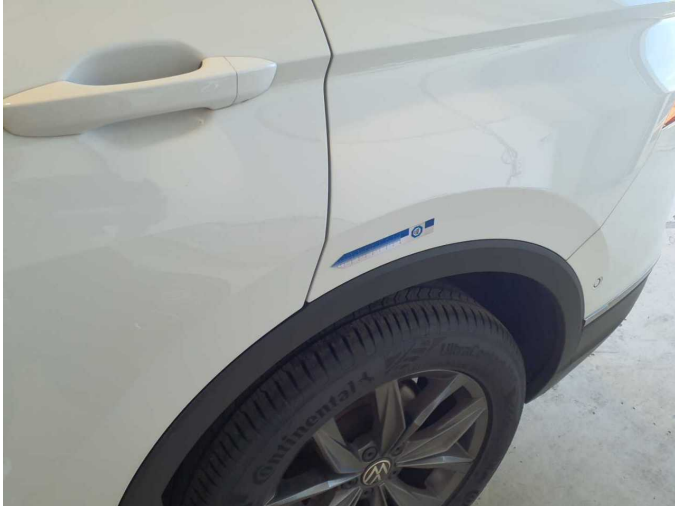
| No. | Component group | Description |
|---|---|---|
| 4 | Side panel - rear left side | Side panel - Scratch(es) - Smart repair |

**Damage 4:** Side panel - rear left side: Side panel - Scratch(es) - Smart repair

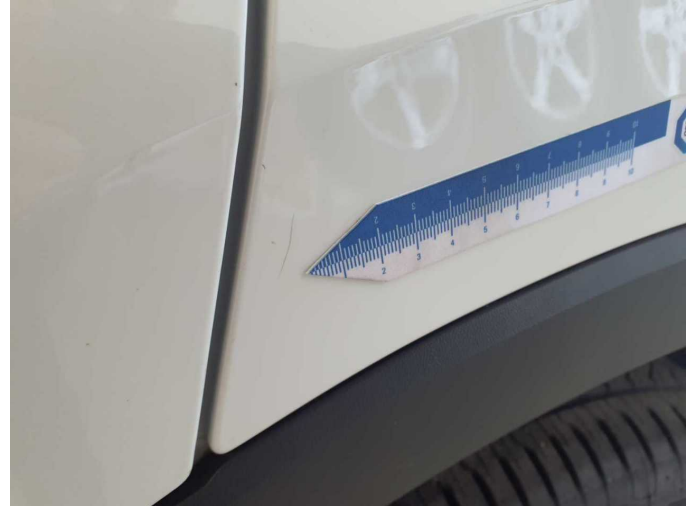
**Damage 4:** Side panel - rear left side: Side panel - Scratch(es) - Smart repair

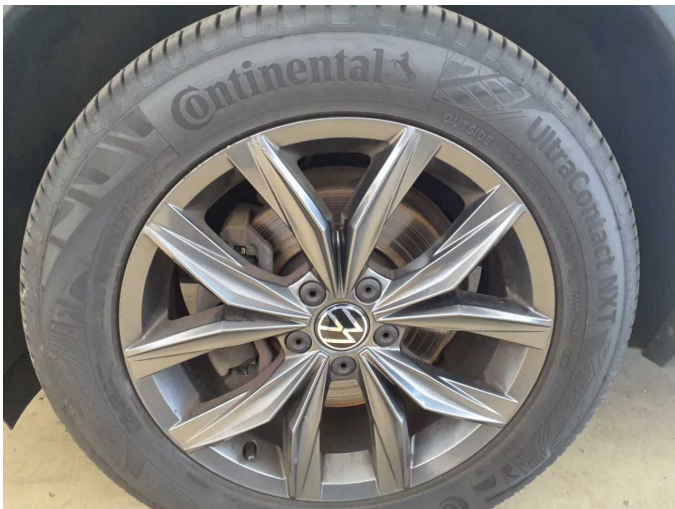
| No. | Component group | Description |
|---|---|---|
| 5 | Wheel / tyres | Alloy rim - front left side - Scratched - Loss in value |

**Damage 5:** Wheel / tyres: Alloy rim - front left side - Scratched - Loss in value

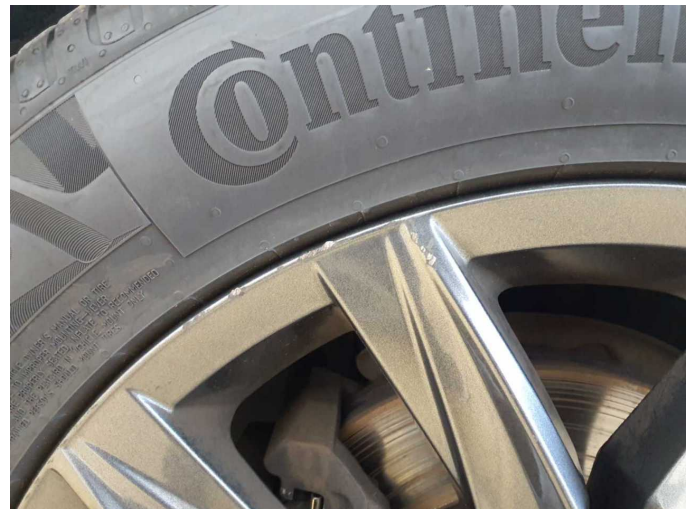
**Damage 5:** Wheel / tyres: Alloy rim - front left side - Scratched - Loss in value

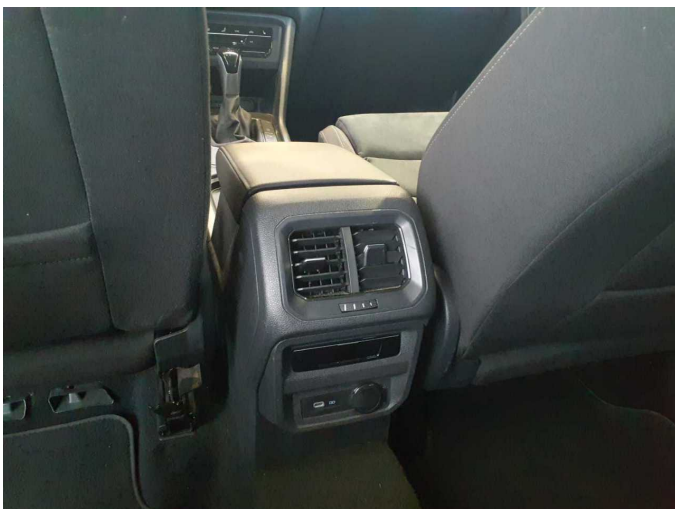
| No. | Component group | Description |
|---|---|---|
| 6 | Instrument panel | Air nozzle - centre - Damaged - Replace |

**Damage 6:** Instrument panel: Air nozzle - centre - Damaged - Replace

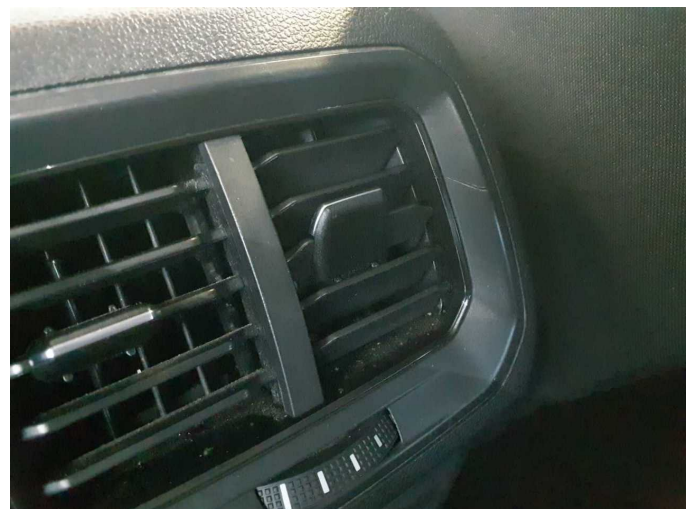
**Damage 6:** Instrument panel: Air nozzle - centre - Damaged - Replace

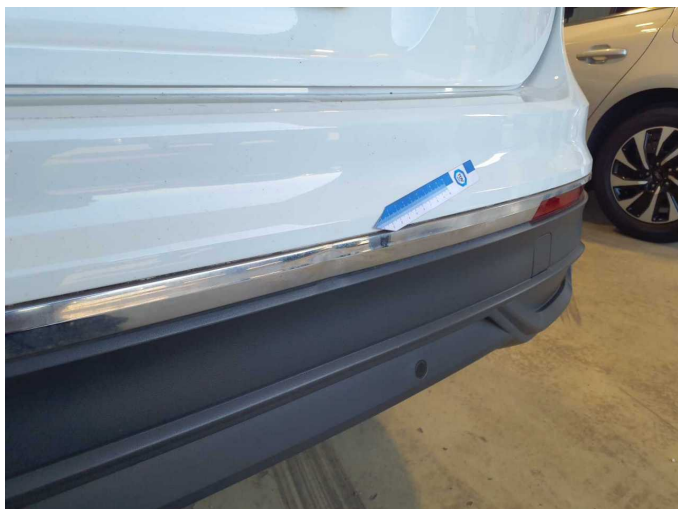
| No. | Component group | Description |
|---|---|---|
| 7 | Trim / covers | Brightware / decorative strip (Stoßfänger hinten) - dent(s) - Replace |

**Damage 7:** Trim / covers: Brightware / decorative strip (Stoßfänger hinten) - dent(s) - Replace

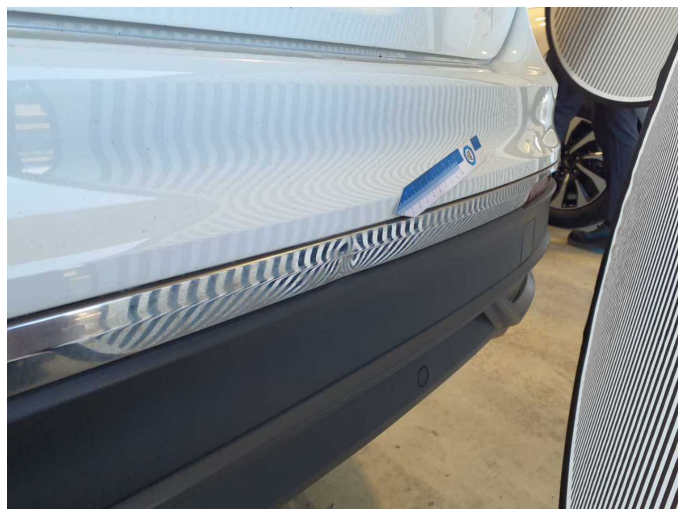
**Damage 7:** Trim / covers: Brightware / decorative strip (Stoßfänger hinten) - dent(s) - Replace

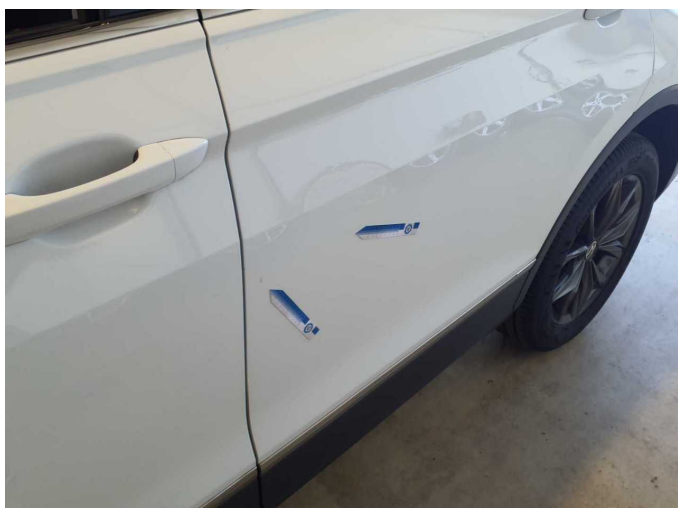
| No. | Component group | Description |
|---|---|---|
| 8 | Door - rear left side | Door - Dent / paintcoat damage - Repair and paint |

**Damage 8:** Door - rear left side: Door - Dent / paintcoat damage - Repair and paint

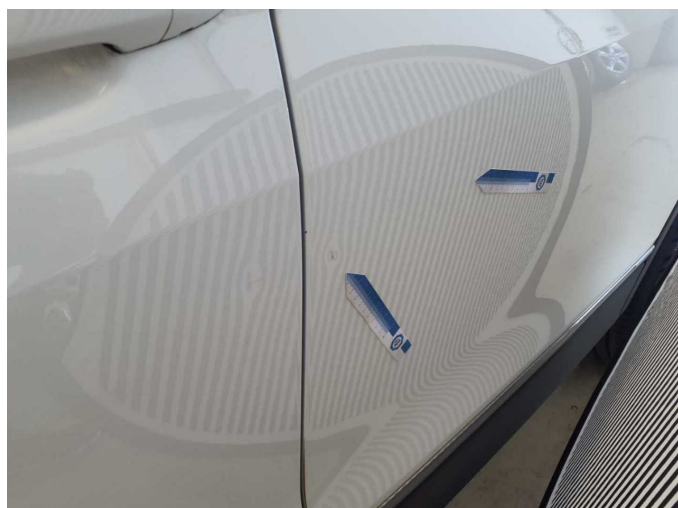
**Damage 8:** Door - rear left side: Door - Dent / paintcoat damage - Repair and paint

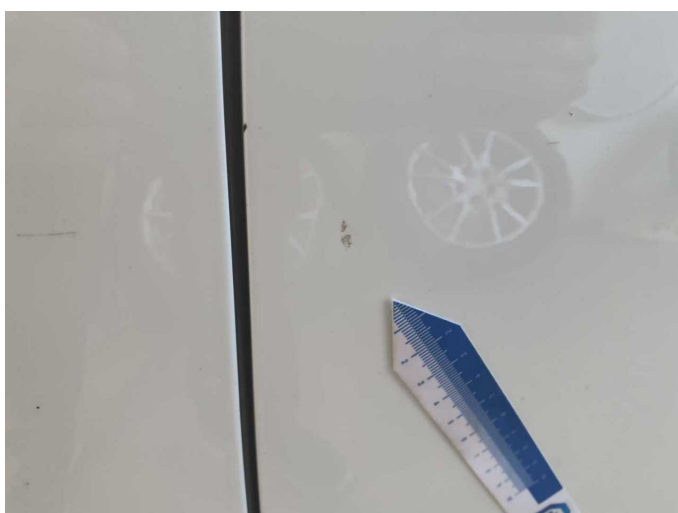
**Damage 8:** Door - rear left side: Door - Dent / paintcoat damage - Repair and paint

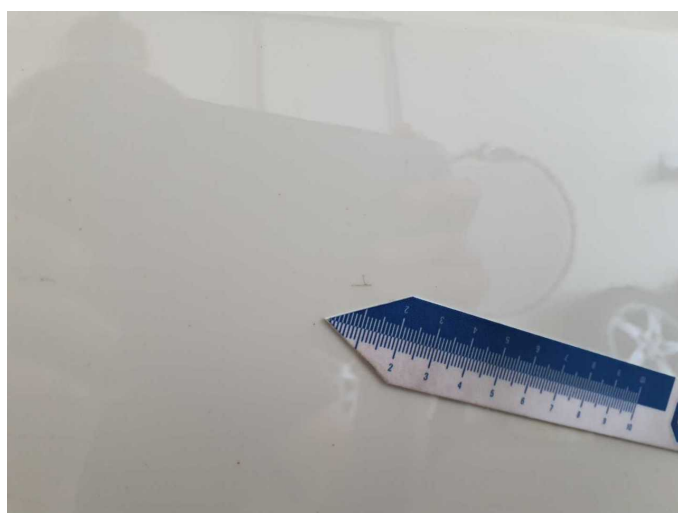
**Damage 8:** Door - rear left side: Door - Dent / paintcoat damage - Repair and paint

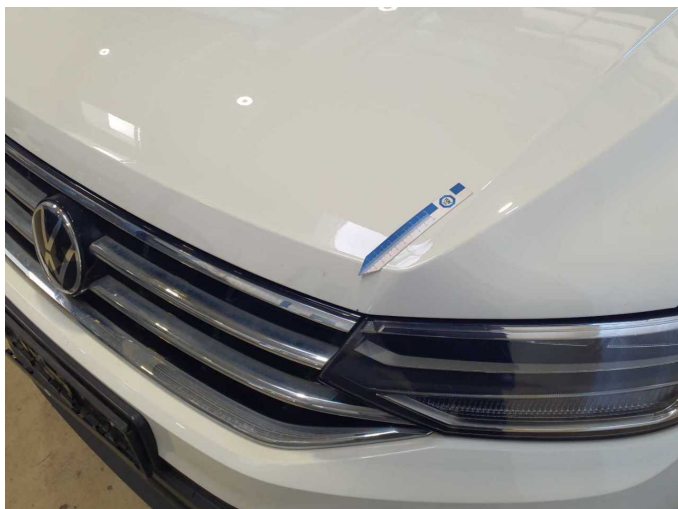
| No. | Component group | Description |
|---|---|---|
| 9 | Bonnet | Bonnet (Korrosion) - Dent / paintcoat damage - Repair and paint |

**Damage 9:** Bonnet: Bonnet (Korrosion) - Dent / paintcoat damage - Repair and paint

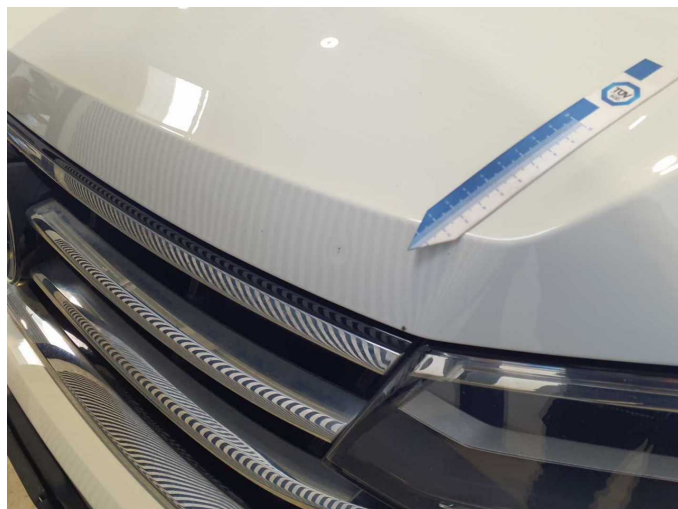
**Damage 9:** Bonnet: Bonnet (Korrosion) - Dent / paintcoat damage - Repair and paint

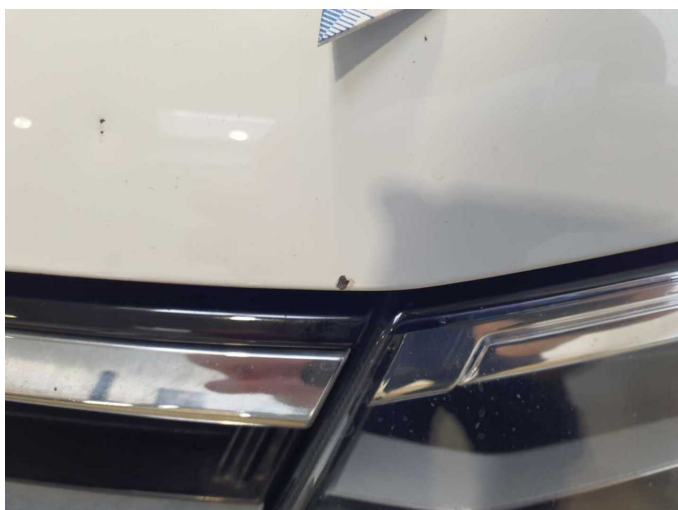
**Damage 9:** Bonnet: Bonnet (Korrosion) - Dent / paintcoat damage - Repair and paint

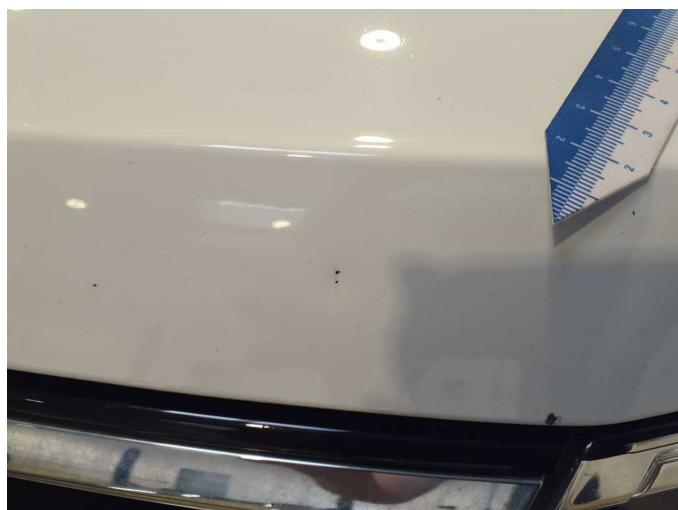
**Damage 9:** Bonnet: Bonnet (Korrosion) - Dent / paintcoat damage - Repair and paint
