## Expertise

Protocol number: 45980554  
Order No. / Reference: 26453619  
Inspection date: 11 Jun 2026

Manufacturer: Volkswagen

Model: Golf Variant 2.0 TDI SCR DSG Life

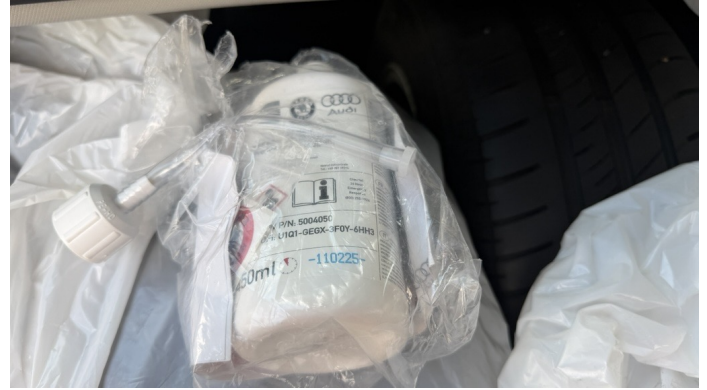
Damage 1: Equipment: Tirefit filler - Expired - Replace

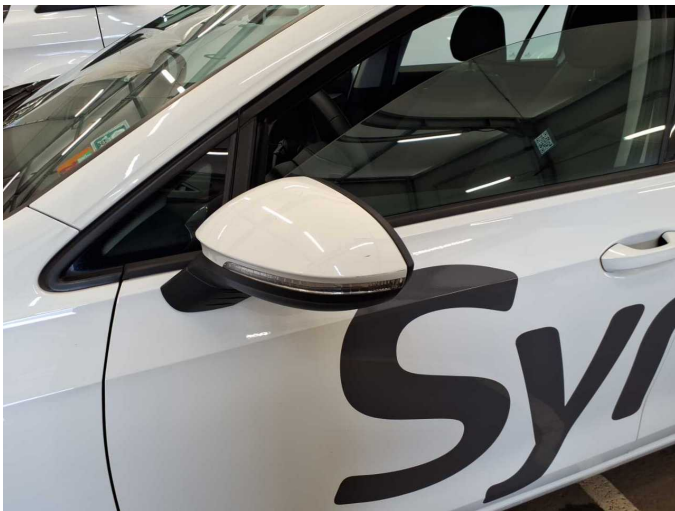
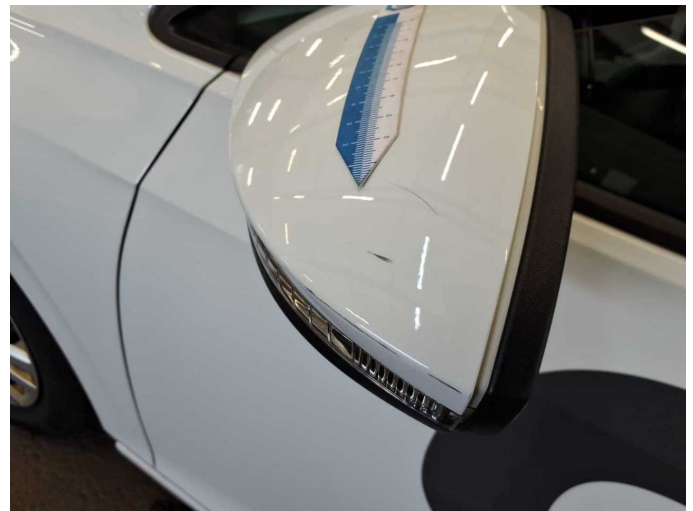
Damage 2: Wing mirror - left side: Cap - Scratch(es) - Smart repair

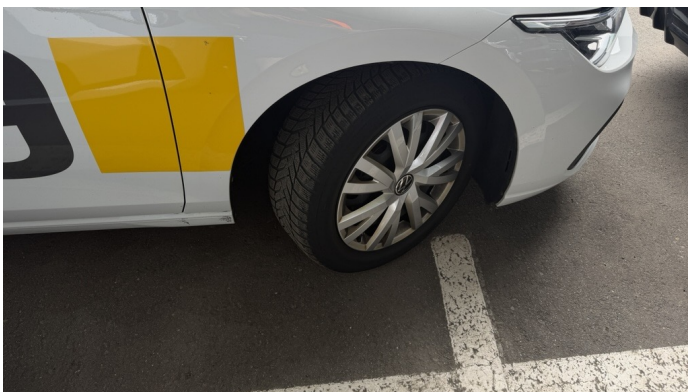
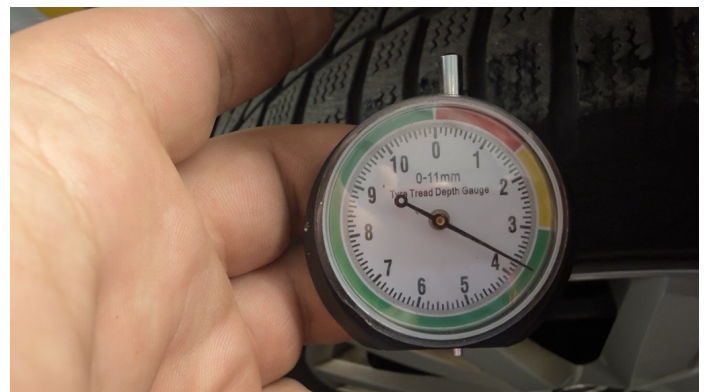
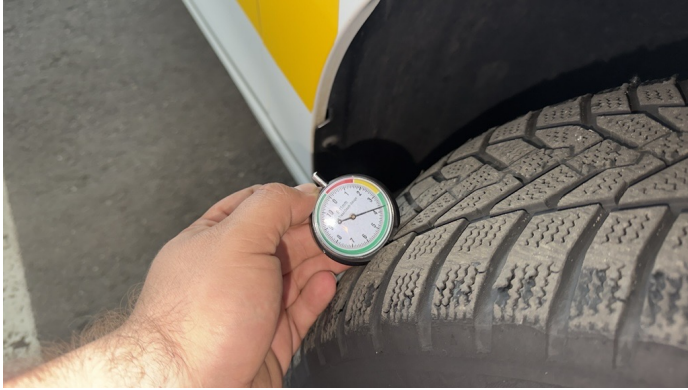
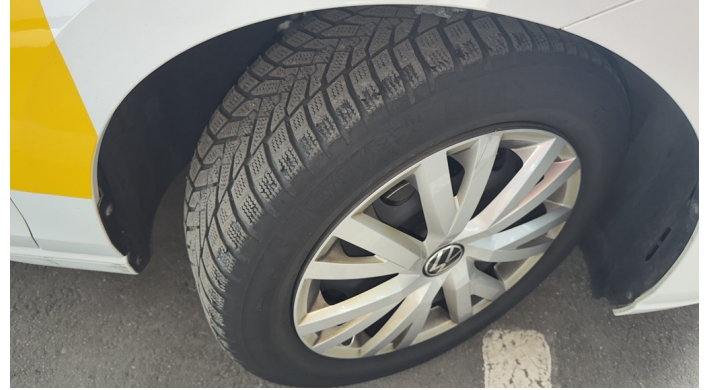
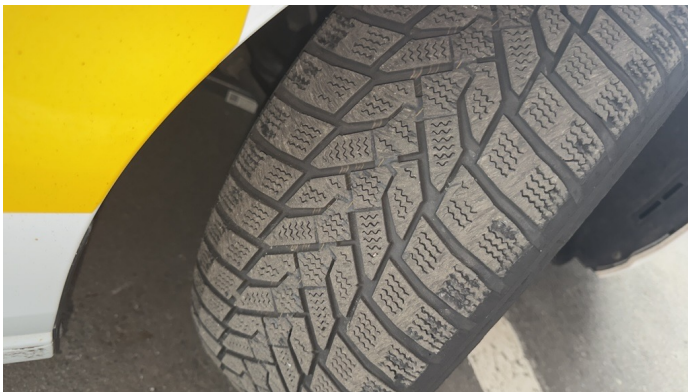
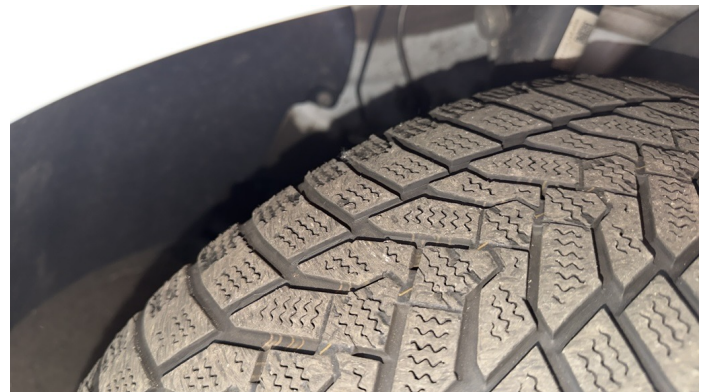
Damage 3: Wheel / tyres: Tyre - front right side (Profiltiefe 3mm + Ausbrüche in der Lauffläche) - Does not meet the leasing specifications - Replace

**Damage 3:** Wheel / tyres: Tyre - front right side (Profiltiefe 3mm + Ausbrüche in der Lauffläche) - Does not meet the leasing specifications - Replace

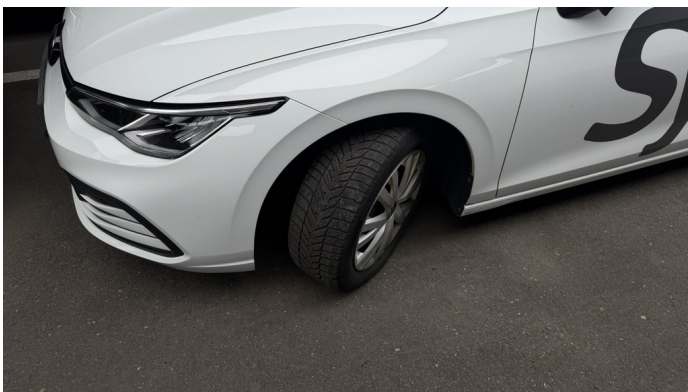
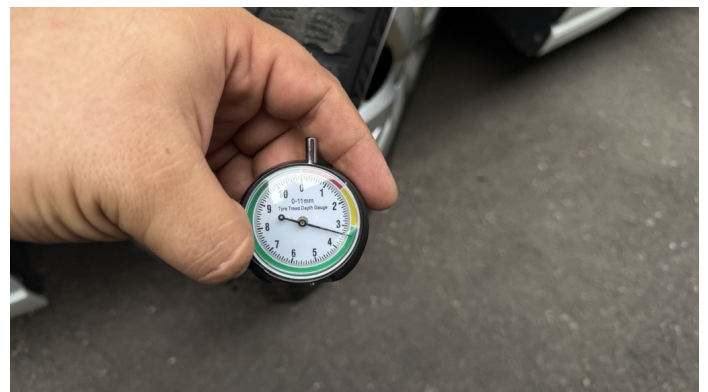
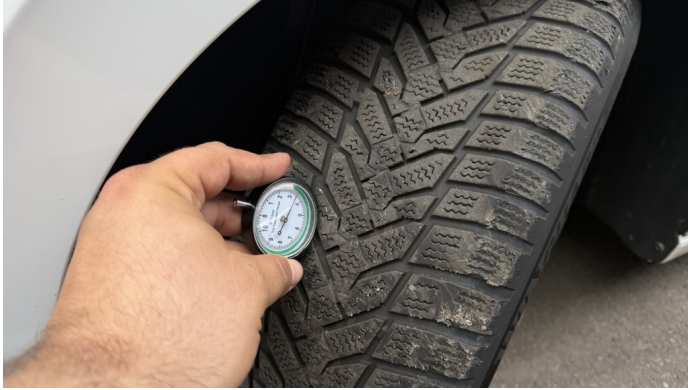
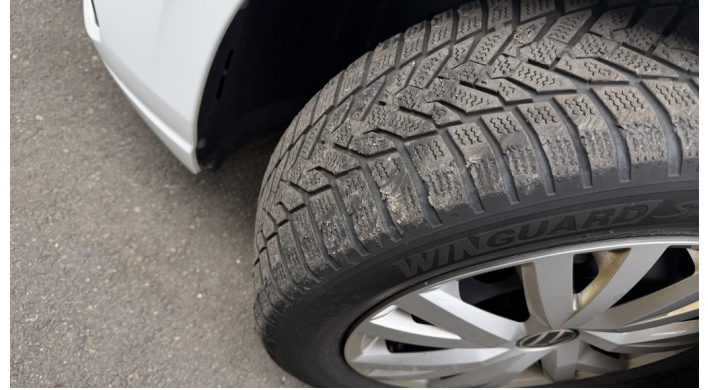
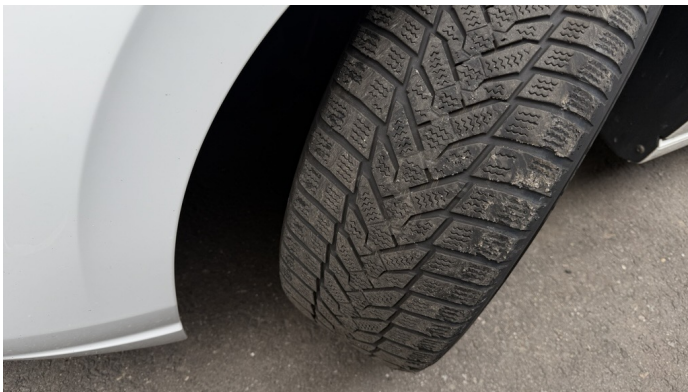
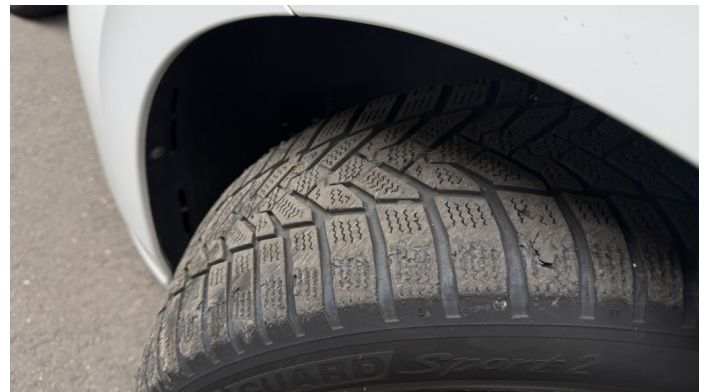
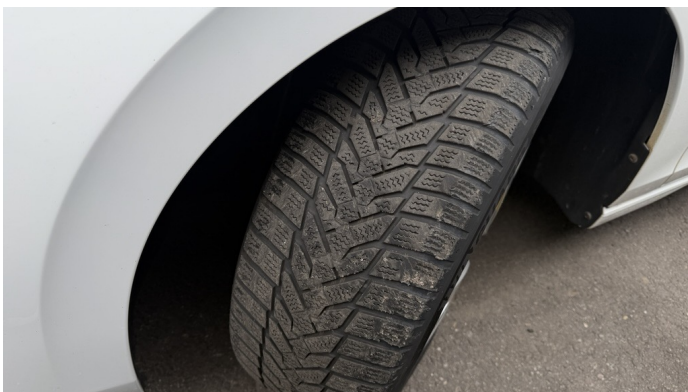
**Damage 4:** Wheel / tyres: Tyre - front left side (Profiltiefe 3mm + Ausbrüche in der Lauffläche) - Does not meet the leasing specifications - Replace

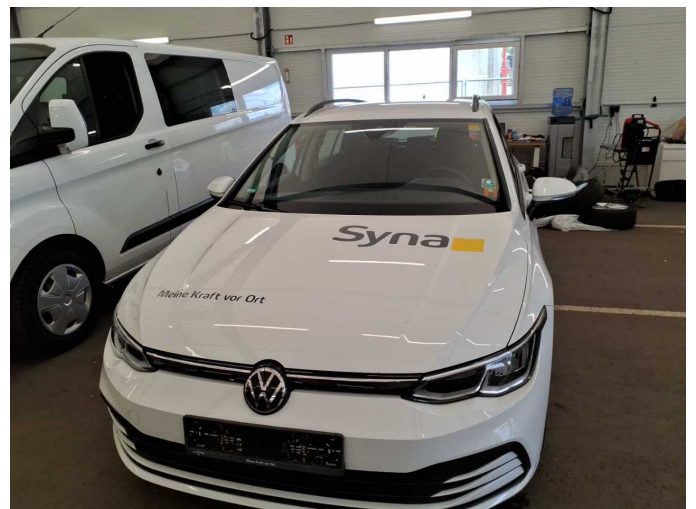
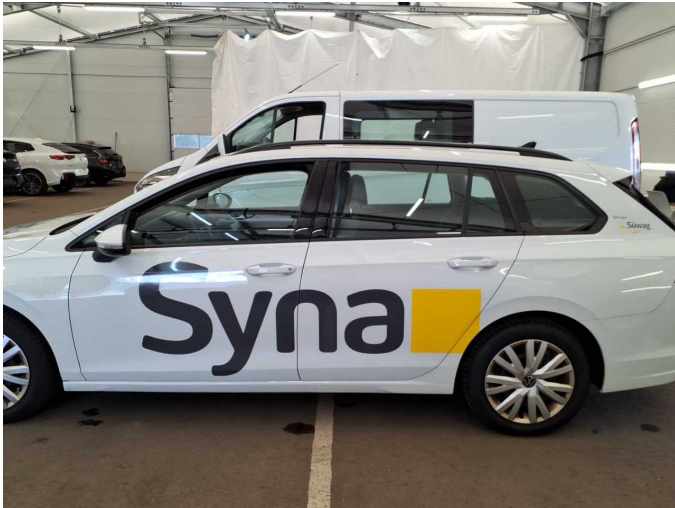
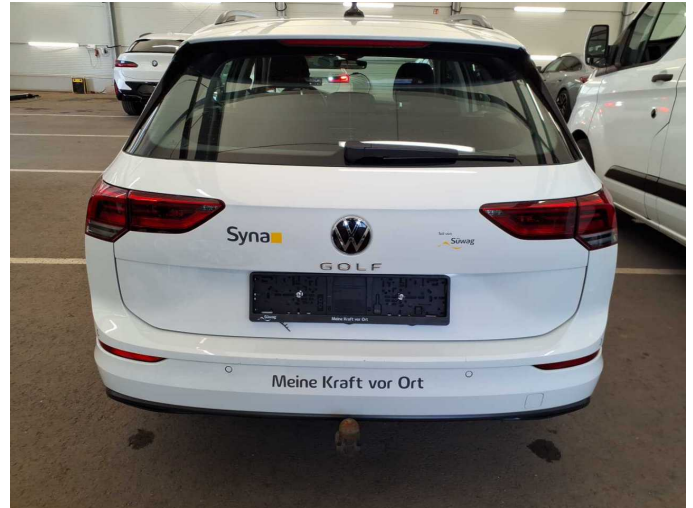
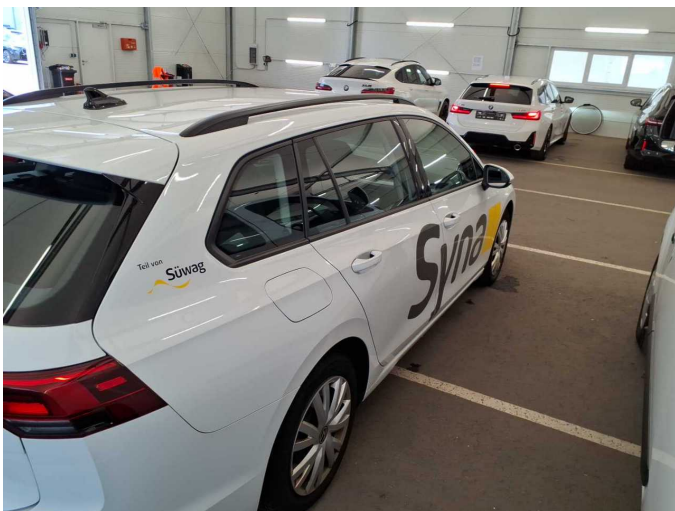
**Damage 5:** Body: Body - Glued / labelled - De-glue / neutralise

Damage 5: Body: Body - Glued / labelled - De-glude / neutralise

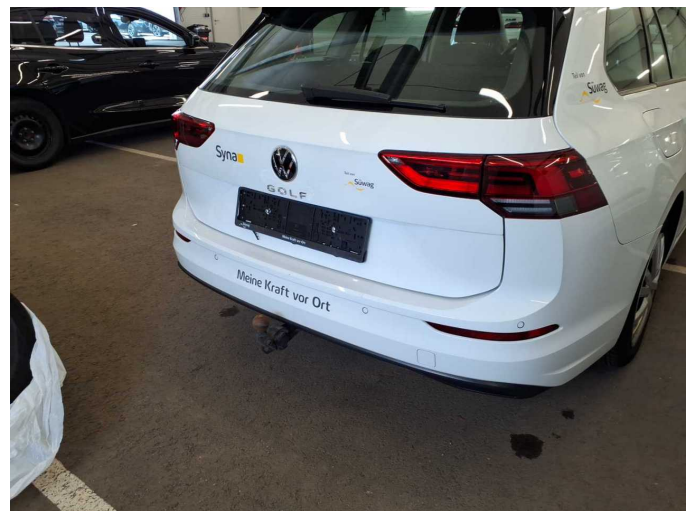
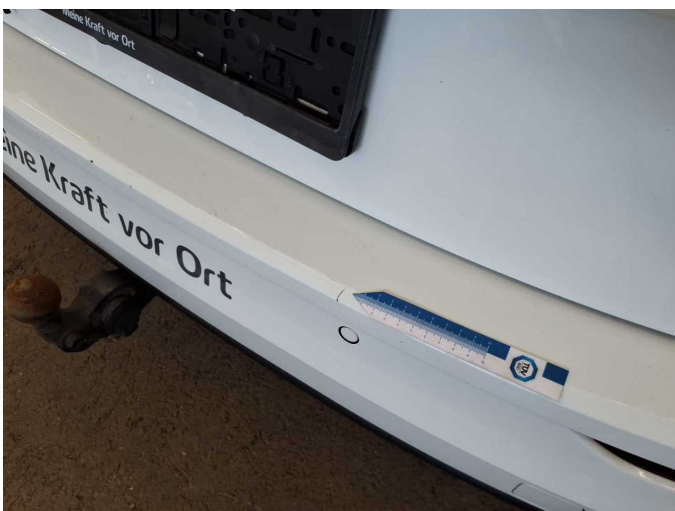
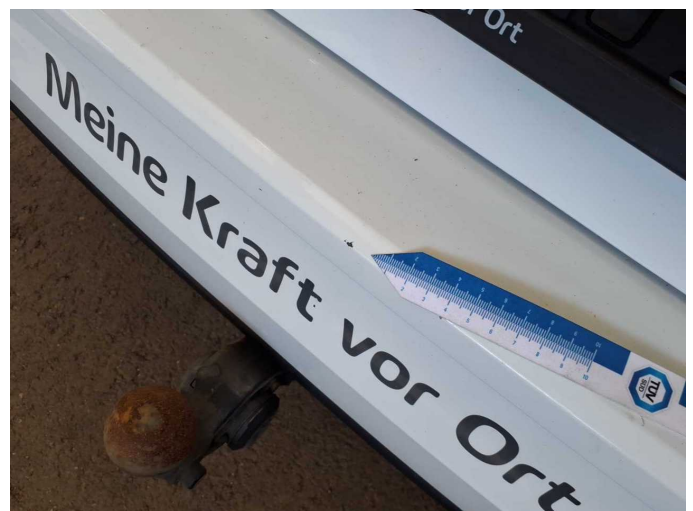
Damage 6: Rear bumper: Rear bumper - Scratched - Paint

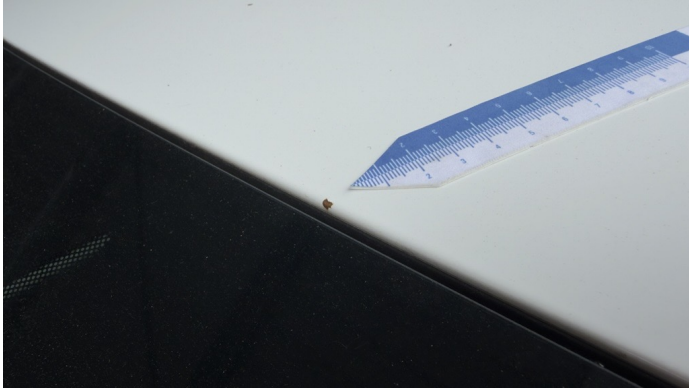
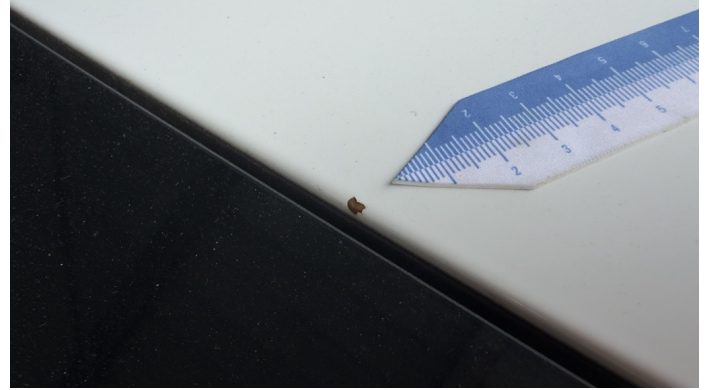
**Damage 7:** Roof: Roof (Dachkante, Steinschlag mit Korrosionsbeginn) - Corrosion - Repair and paint

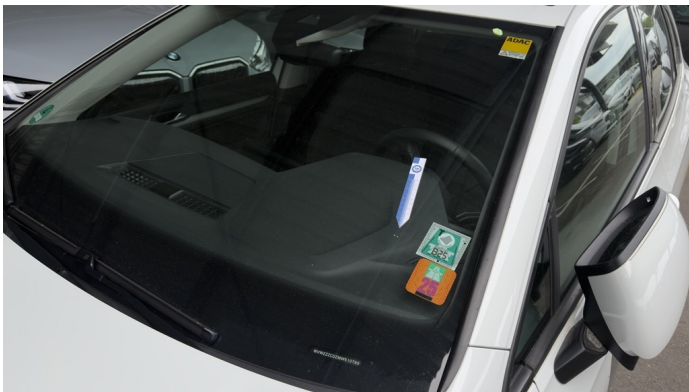
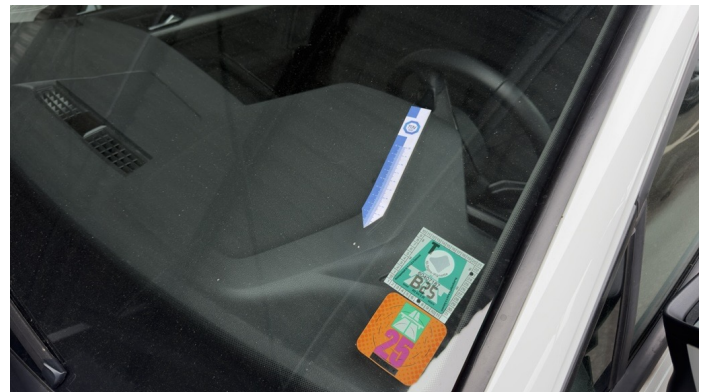
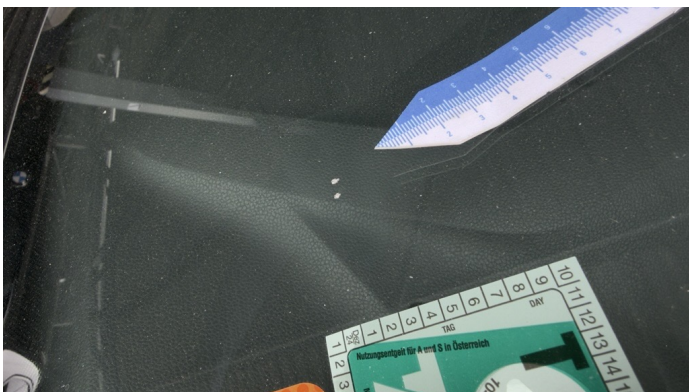
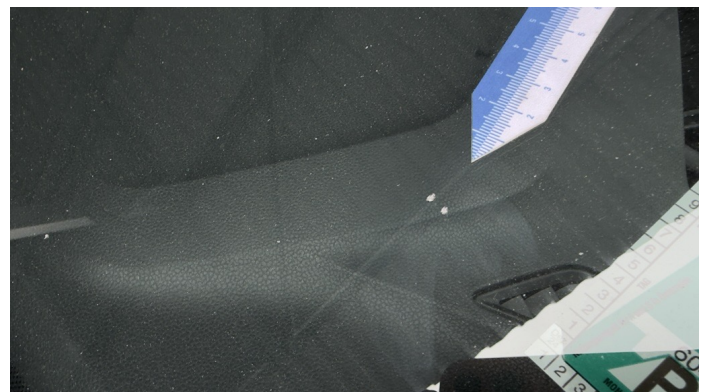
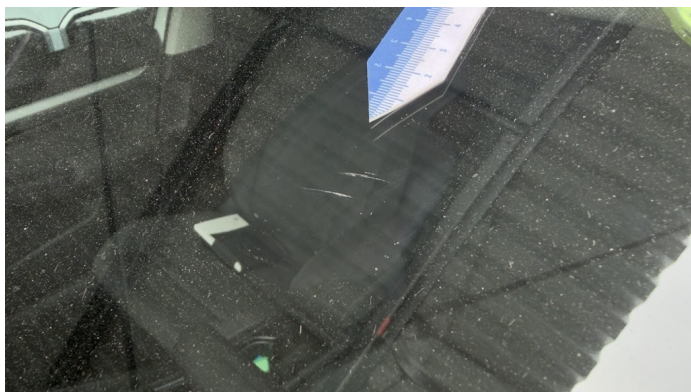
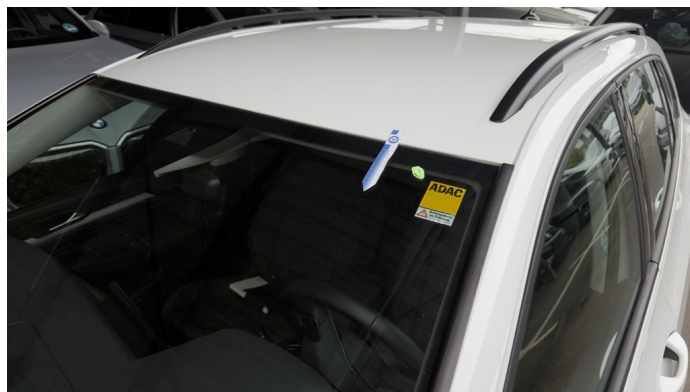
**Damage 8:** Vehicle glazing: Windscreen (Steinschläge im Fahrersichtfeld & Kratzer) - Stone chips - Replace
