Expertise

Protocol number: 45487502
Order No. / Reference: 26284126
Inspection date: 15 May 2026

Model: Caddy Cargo 2.0 TDI BMT

VIN: WV1ZZZSKZNX031554

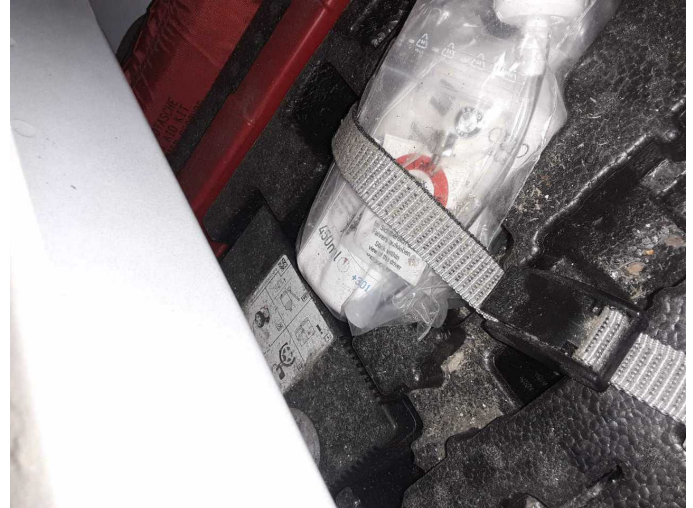
Damage 1: Equipment: Tirefit filler - Expired - Replace

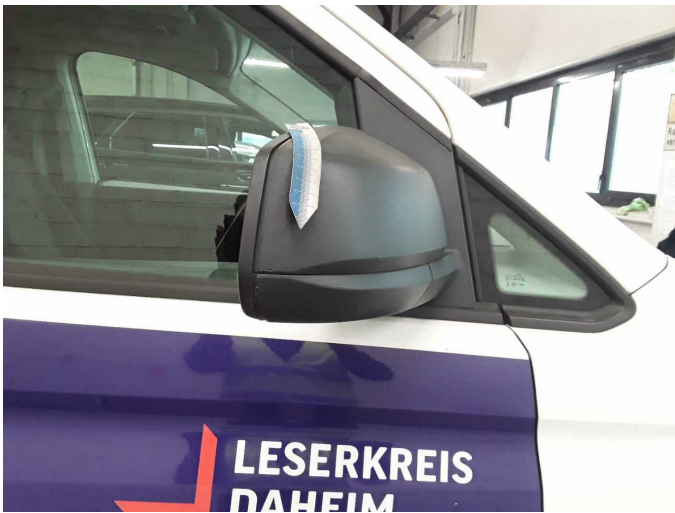
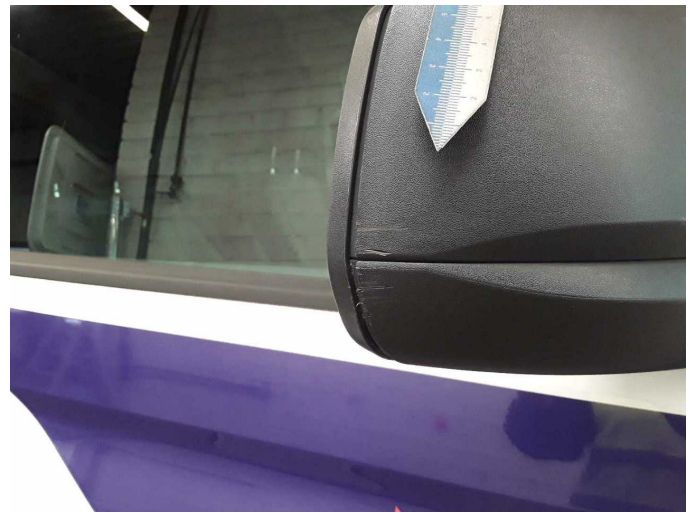
Damage 2: Wing mirror - right side: Cap - Scratched - Smart repair

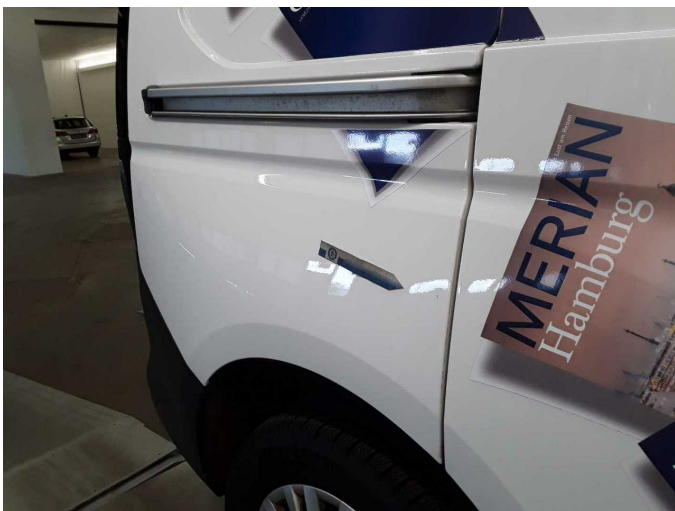
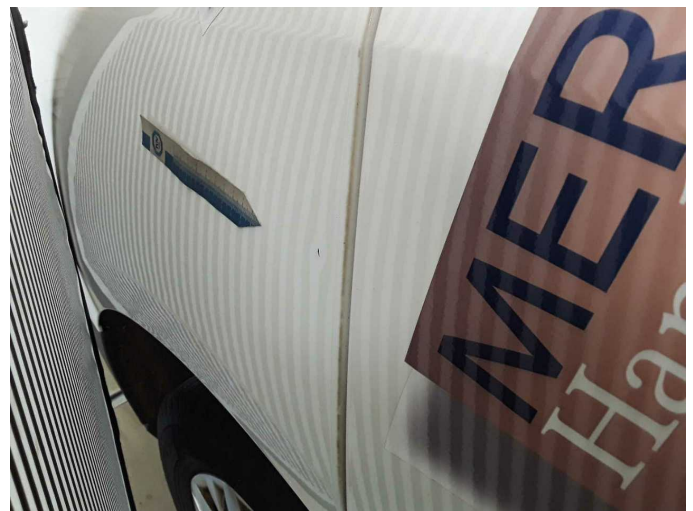
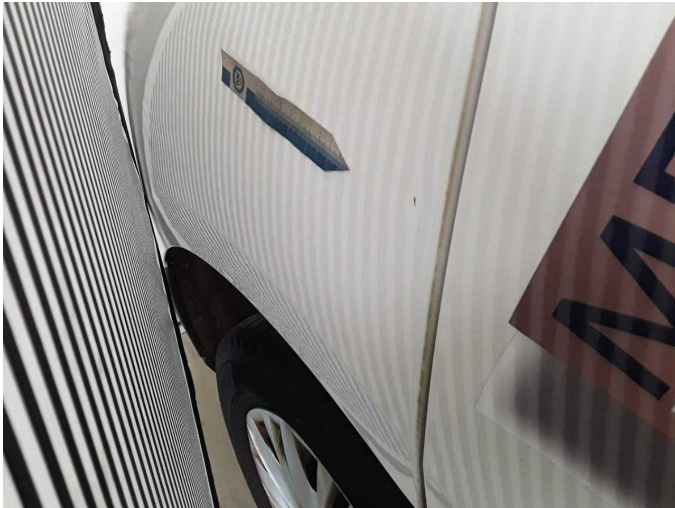
Damage 3: Side panel - rear right side: Side panel - Dent / paintcoat damage - Smart repair

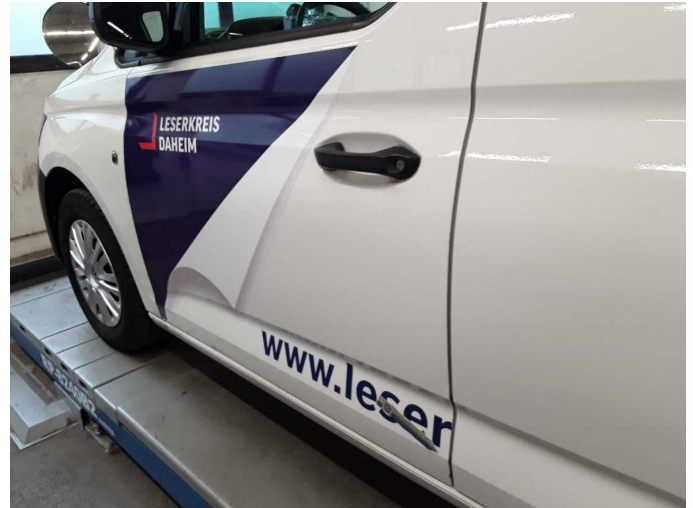
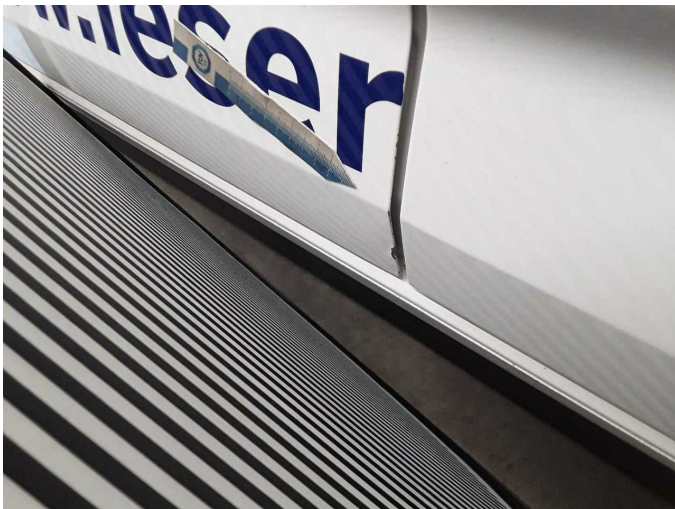
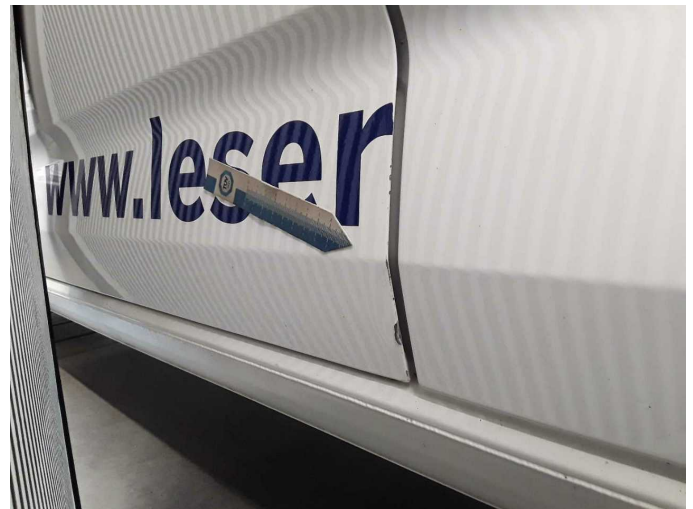
Damage 4: Door - front left side: Door - Dent / paintcoat damage - Smart repair

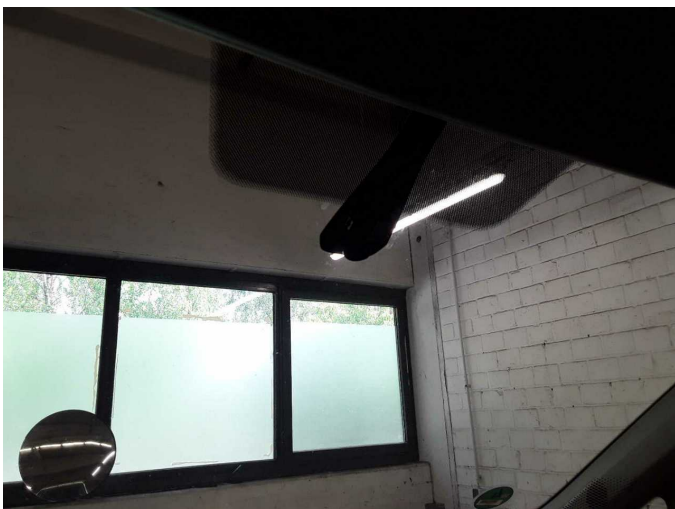
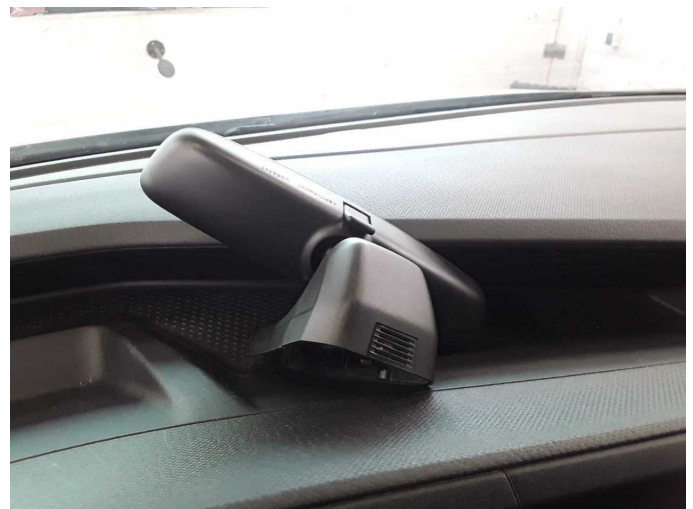
Damage 5: Instrument panel: Interior mirror - Damaged - Replace

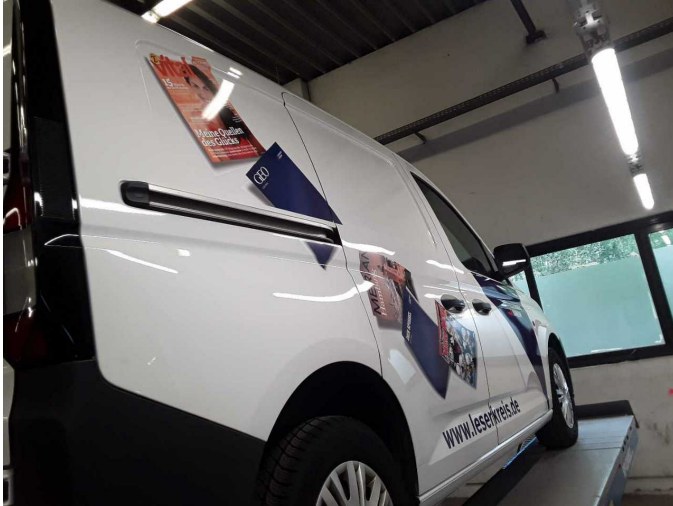
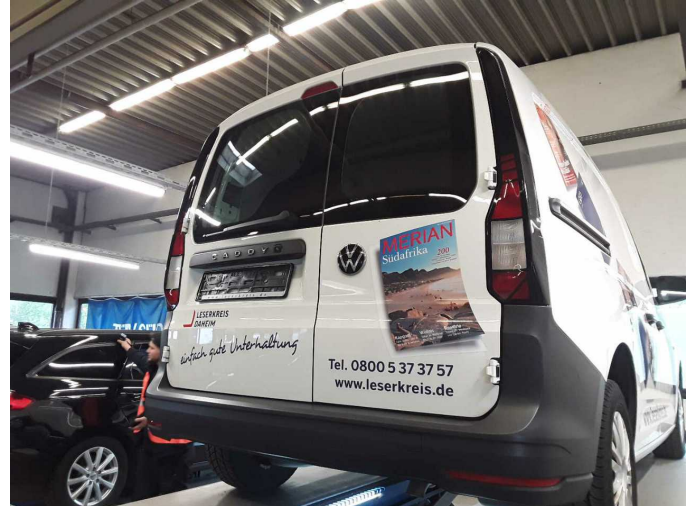
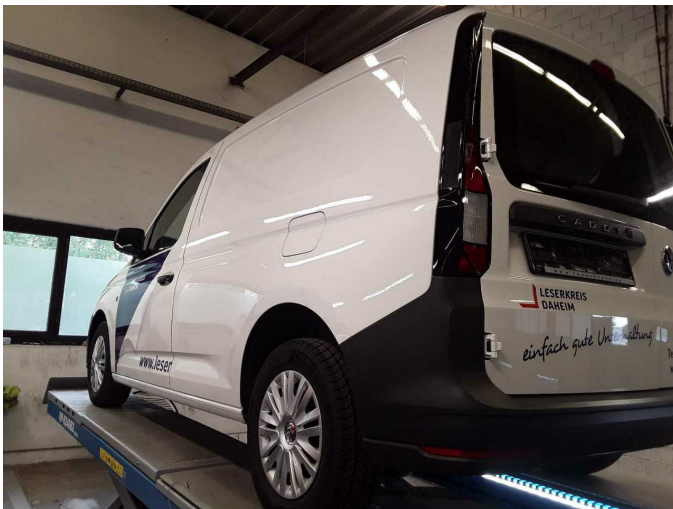
Damage 6: Body: Body - Glued / labelled - De-glue / neutralise

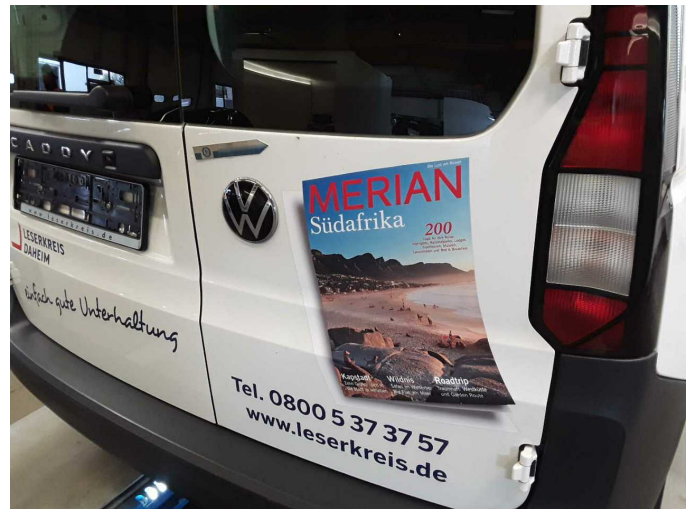
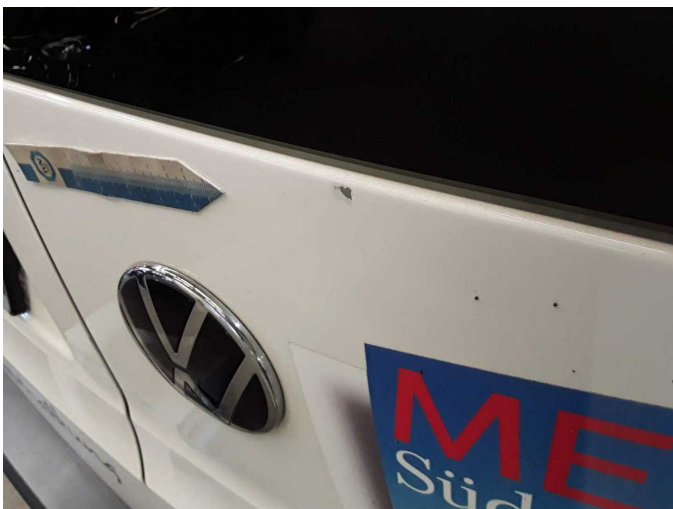
Damage 7: Boot lid / rear door: Rear door - right side - Scratch(es) - Paint

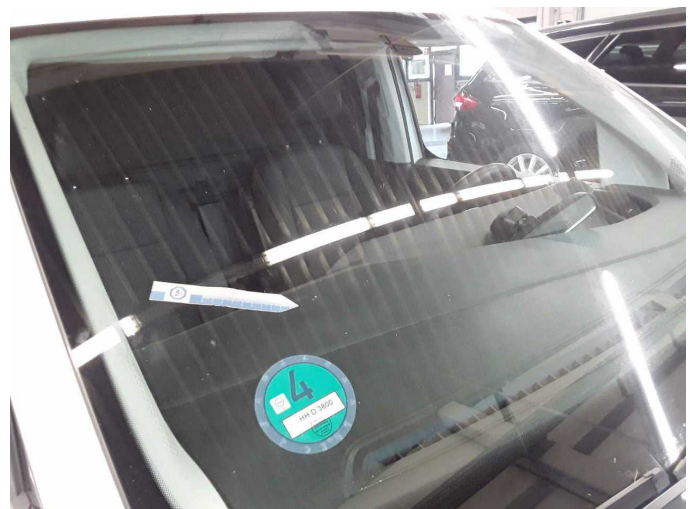
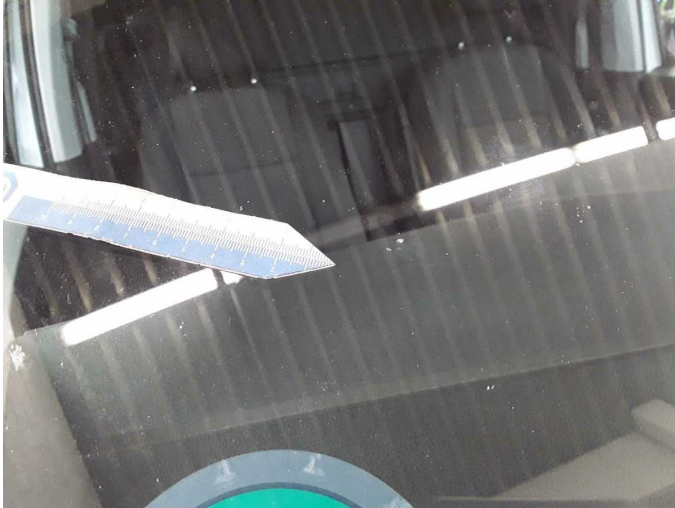
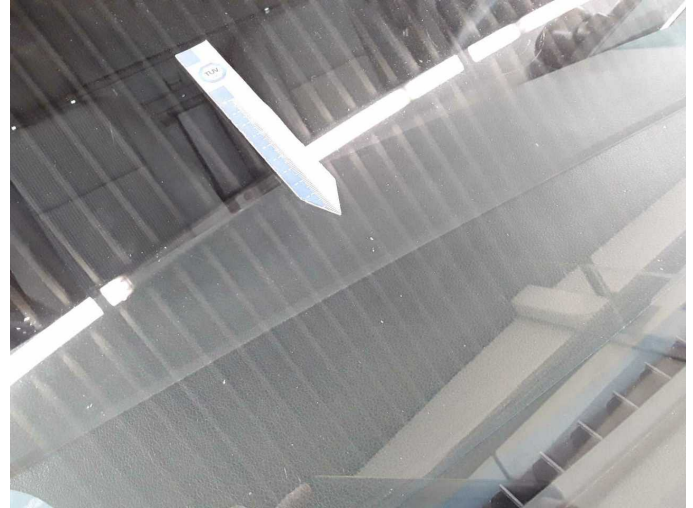
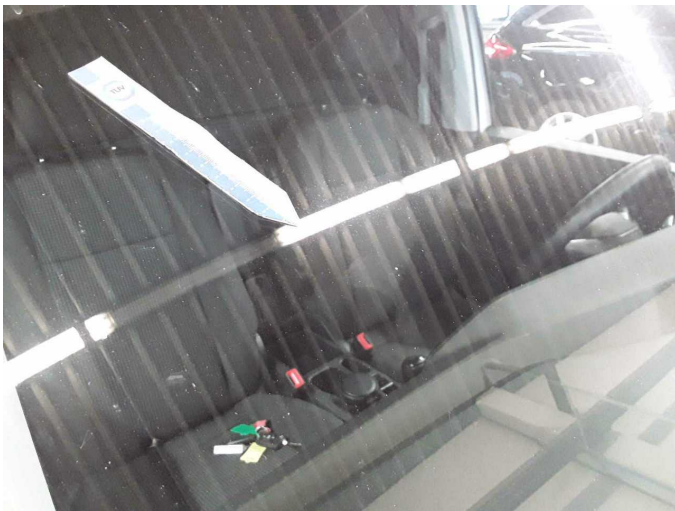
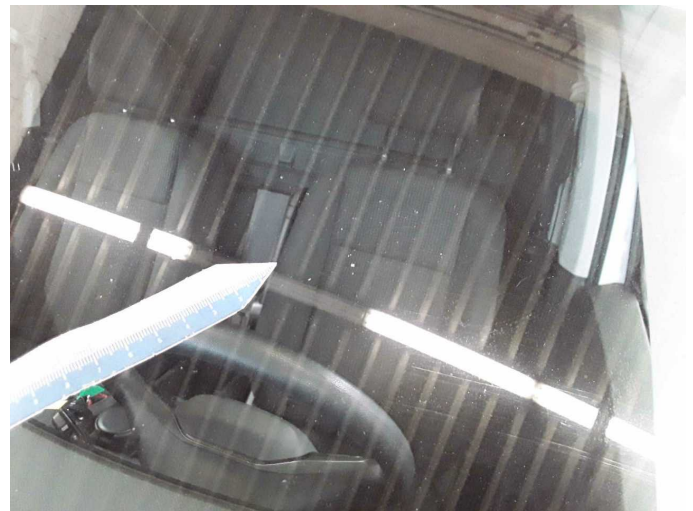
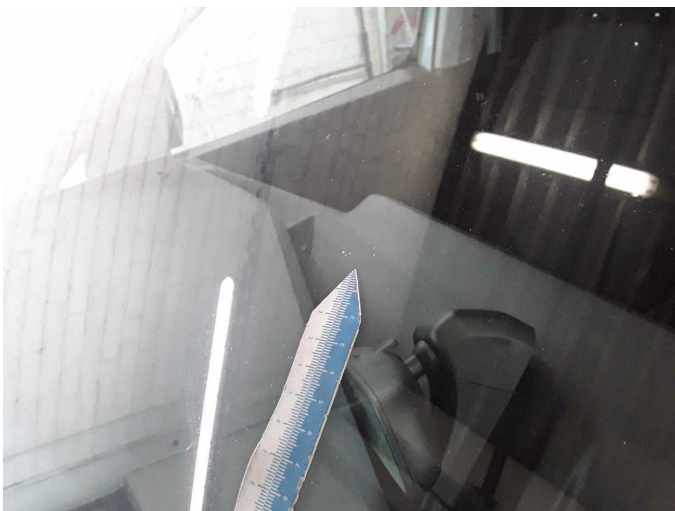
Damage 8: Vehicle glazing: Windscreen (Vermehrte steinschläge) - Stone chips - Replace

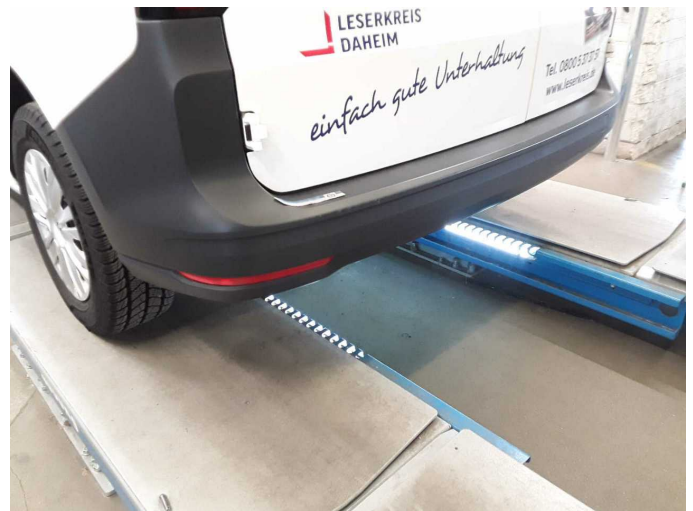
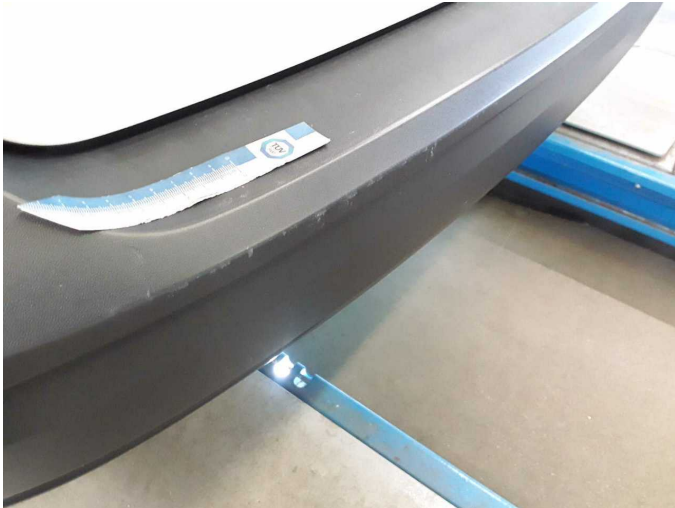
Wear and tear 1: Rear bumper: Rear bumper (unpainted) - Scratch(es) - No deduction

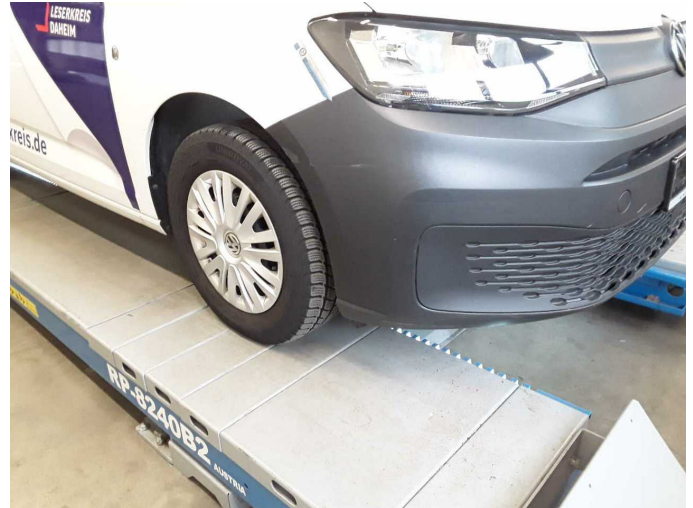
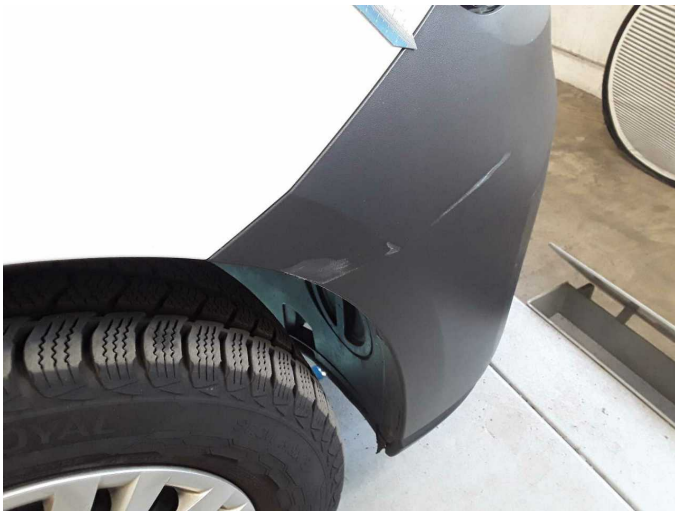
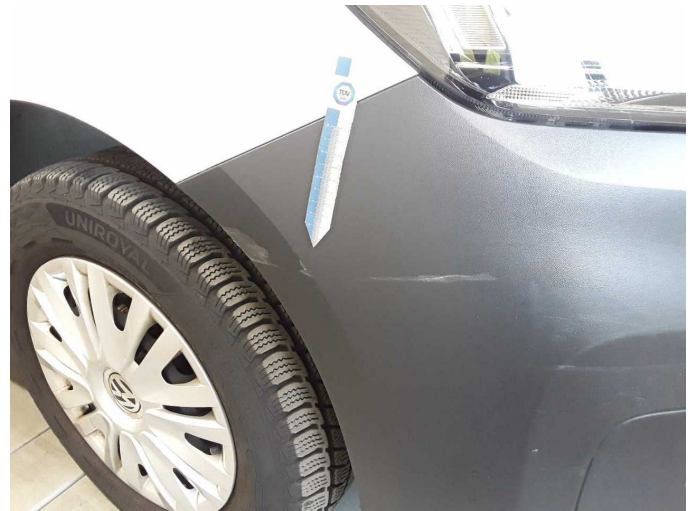
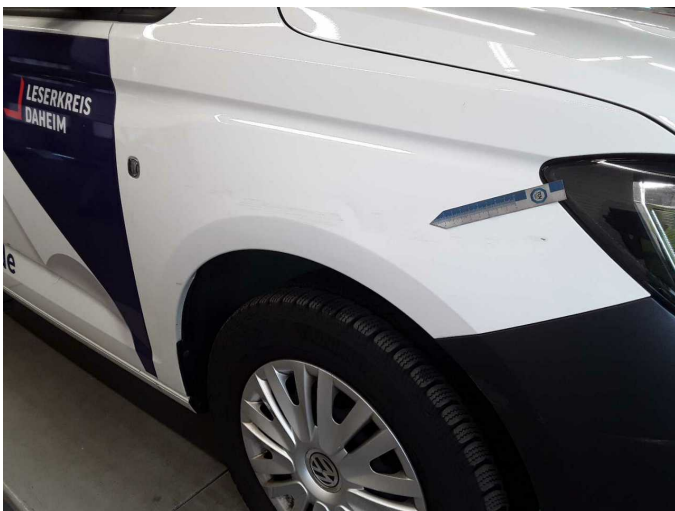
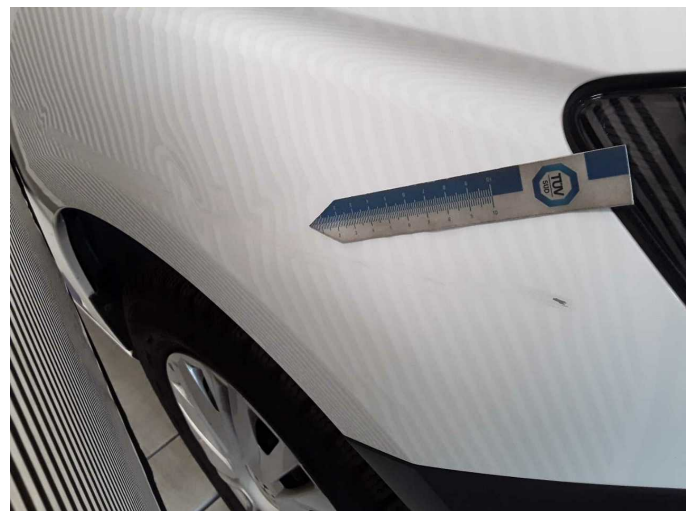
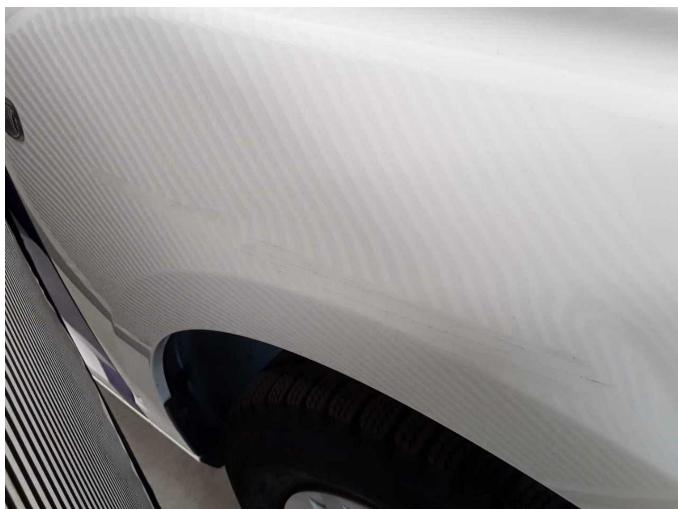
Accident 1: Front, Side right

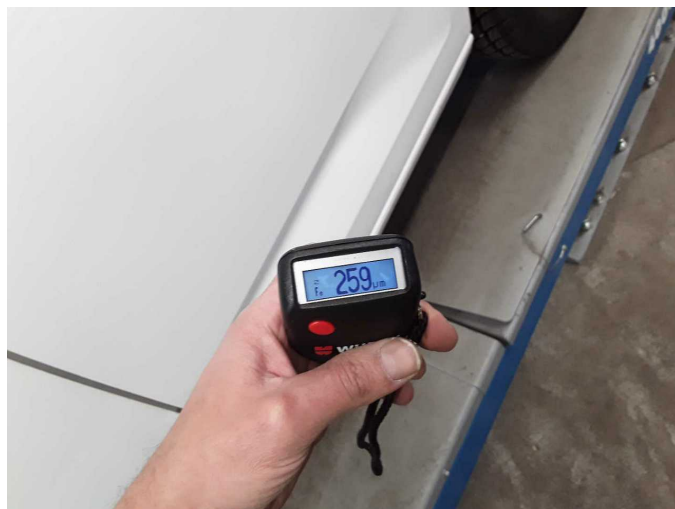
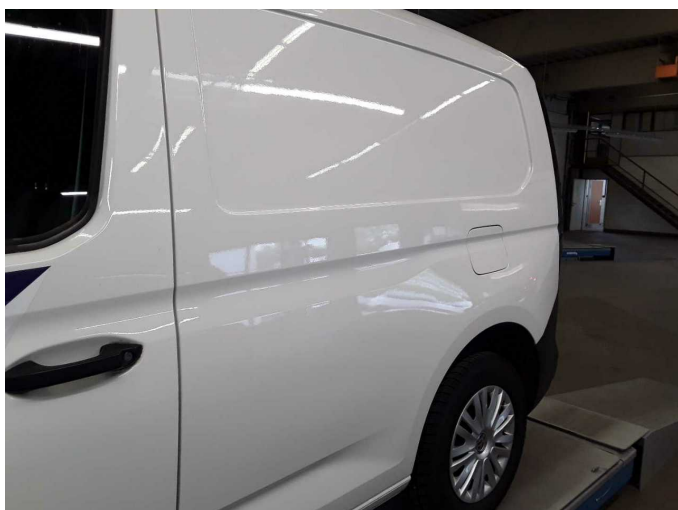
No.	Repainting
1	Side panel - rear left side, Professionally carried out, Invoice of repair done Non-existent

Side panel - rear left side	259 μm
-----------------------------	-------------------

Repainting 1: Side panel - rear left side
