## Expertise

Protocol number: 46071922  
Order No. / Reference: 26472453  
Inspection date: 22 Jun 2026

Manufacturer: Ford

Model: Transit Custom 340 L2H1 LKW VA Trend

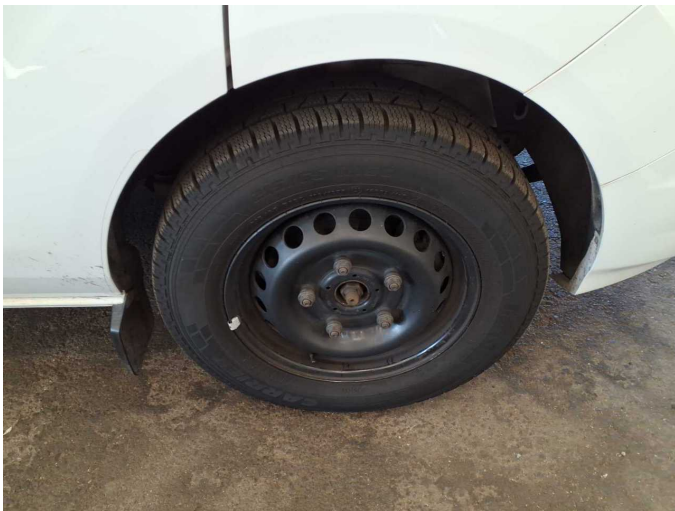
Damage 1: Wheel / tyres: Wheel cover - front right side - Missing - Replace

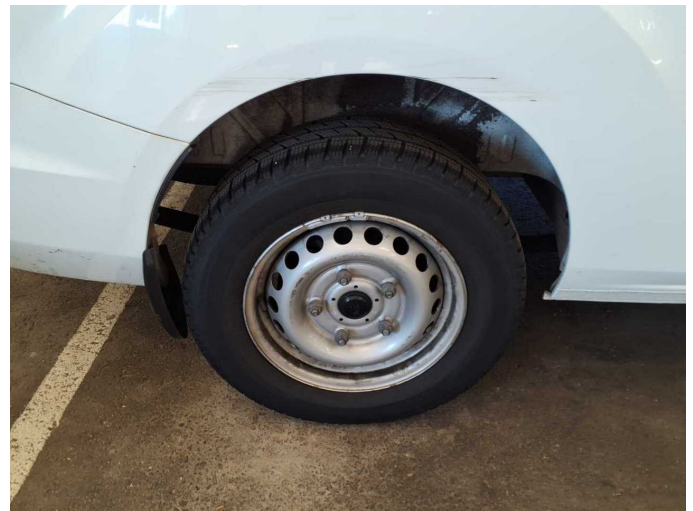
Damage 2: Wheel / tyres: Wheel cover - rear right side - Missing - Replace

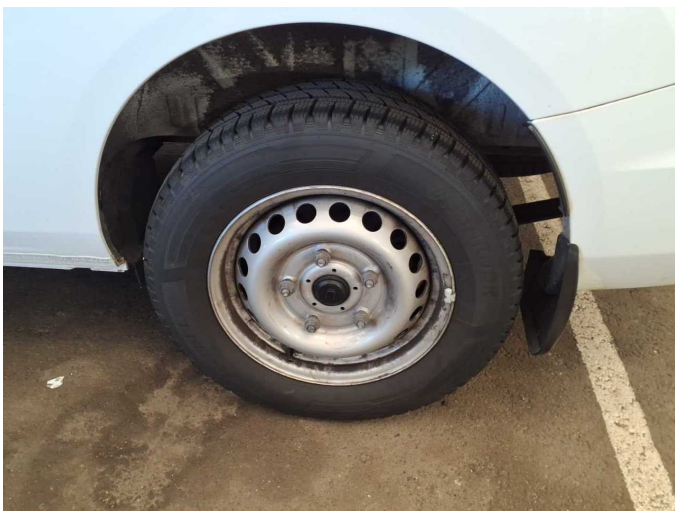
Damage 3: Wheel / tyres: Wheel cover - rear left side - Missing - Replace

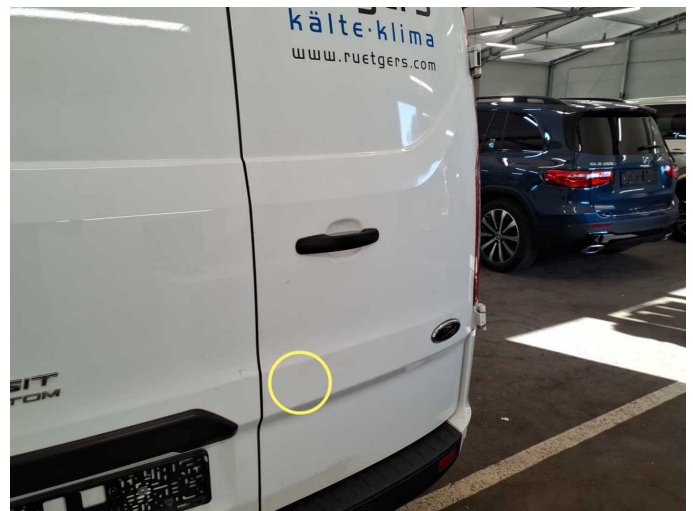
Damage 4: Boot lid / rear door: Rear door - right side - dent(s) - Smooth repair work

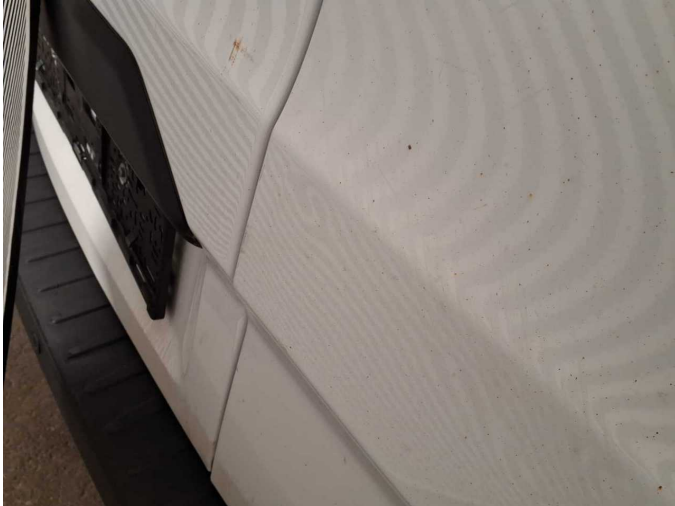
**Damage 4:** Boot lid / rear door: Rear door - right side - dent(s) - Smooth repair work

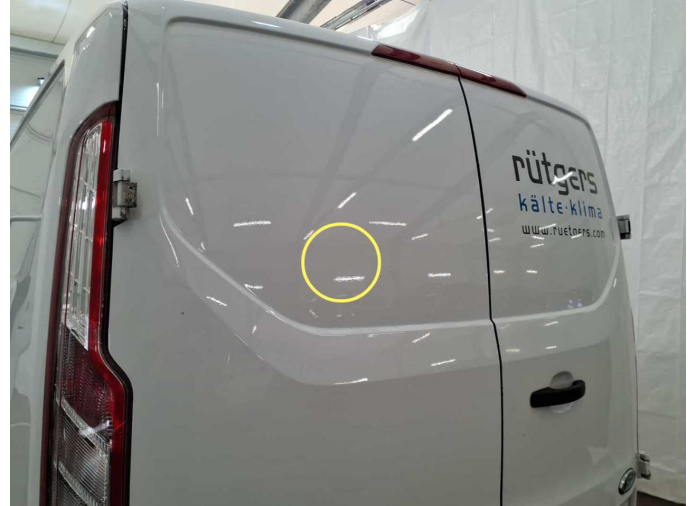
**Damage 5:** Boot lid / rear door: Rear door - left side - dent(s) - Smooth repair work

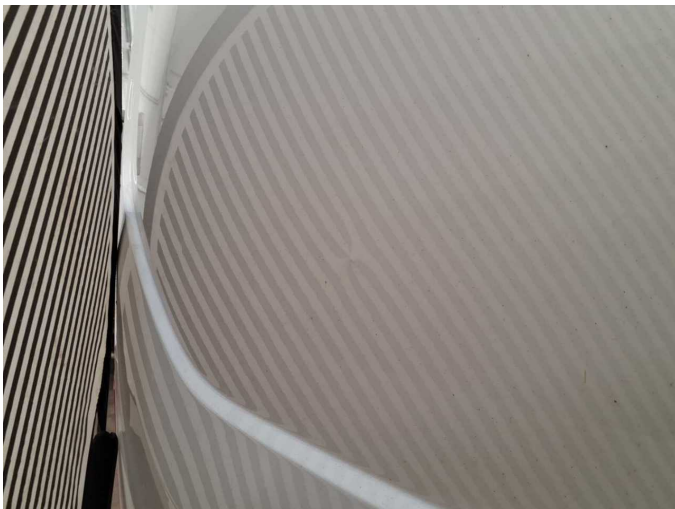
**Damage 5:** Boot lid / rear door: Rear door - left side - dent(s) - Smooth repair work

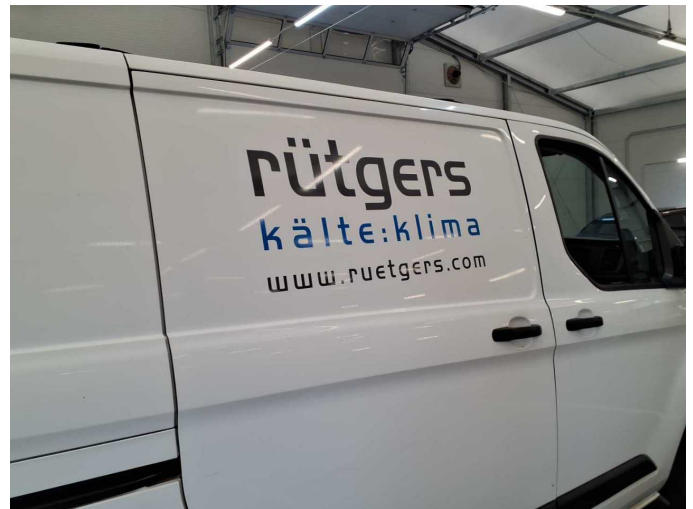
**Damage 6:** Body: Body - Glued / labelled - De-glue / neutralise

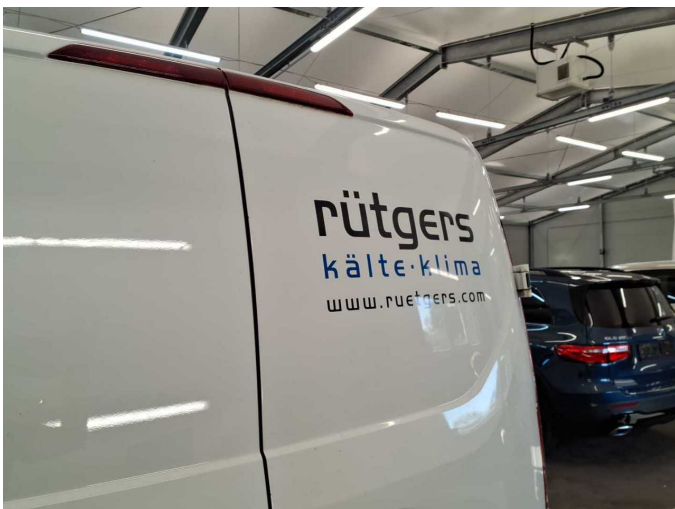
**Damage 6:** Body: Body - Glued / labelled - De-glue / neutralise

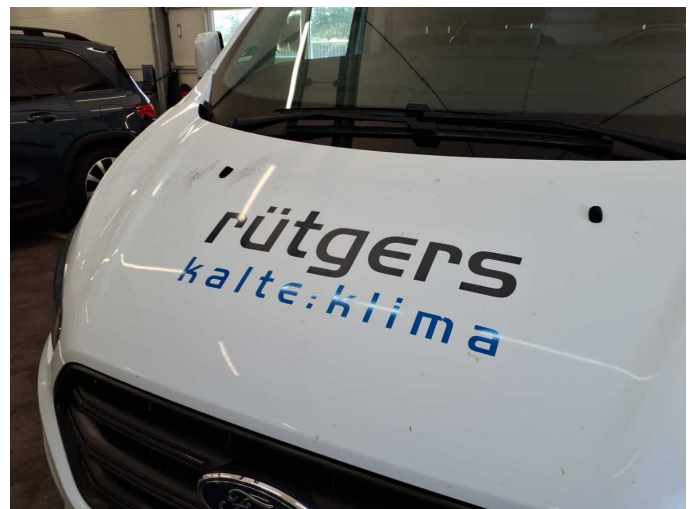
**Damage 6:** Body: Body - Glued / labelled - De-glue / neutralise

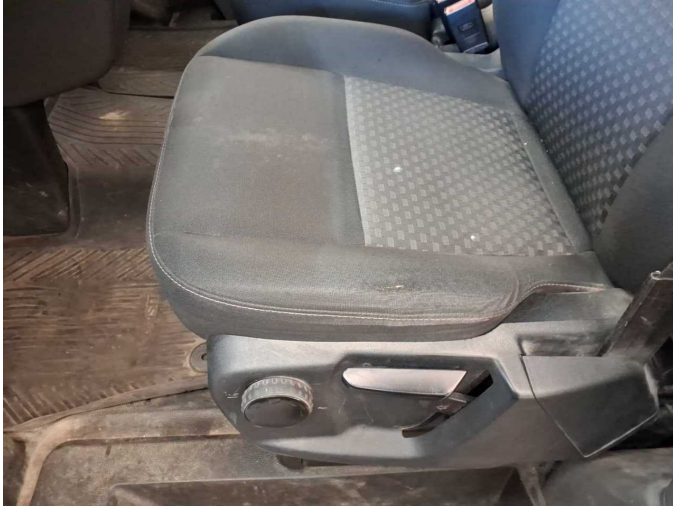
**Damage 7:** Seat - front: Seat cover - left side - Abrasion - Loss in value

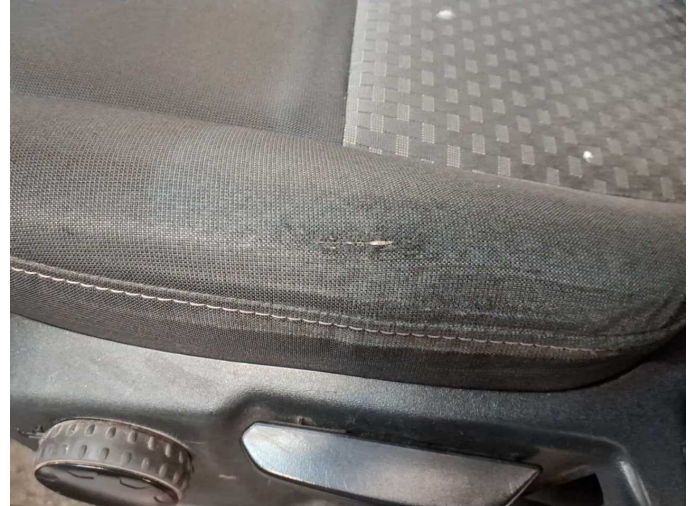
**Damage 7:** Seat - front: Seat cover - left side - Abrasion - Loss in value

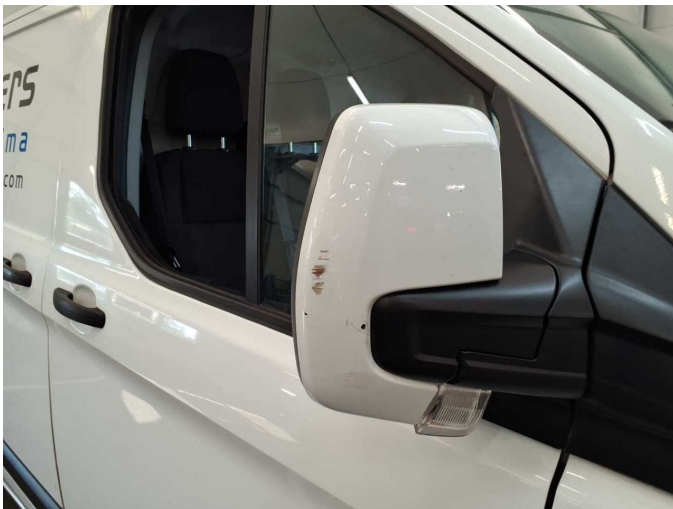
**Damage 8:** Wing mirror - right side: Cap - Scratch(es) - Paint

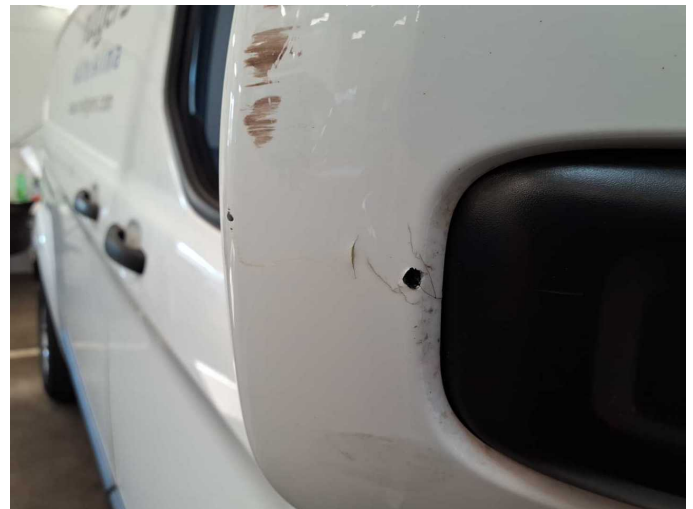
**Damage 8:** Wing mirror - right side: Cap - Scratch(es) - Paint

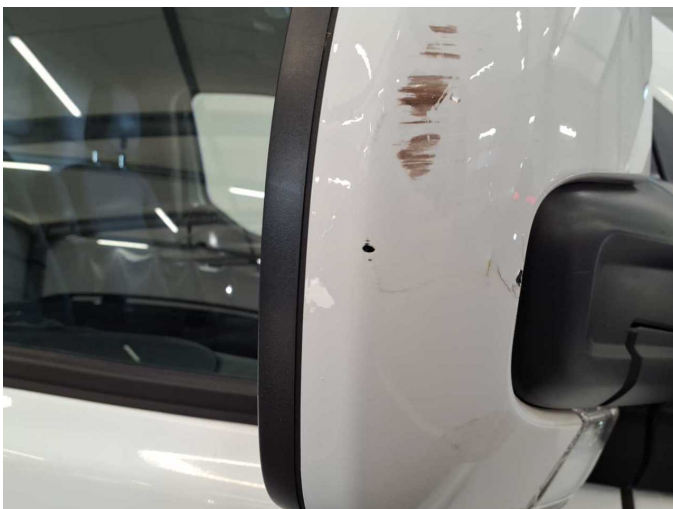
**Damage 8:** Wing mirror - right side: Cap - Scratch(es) - Paint

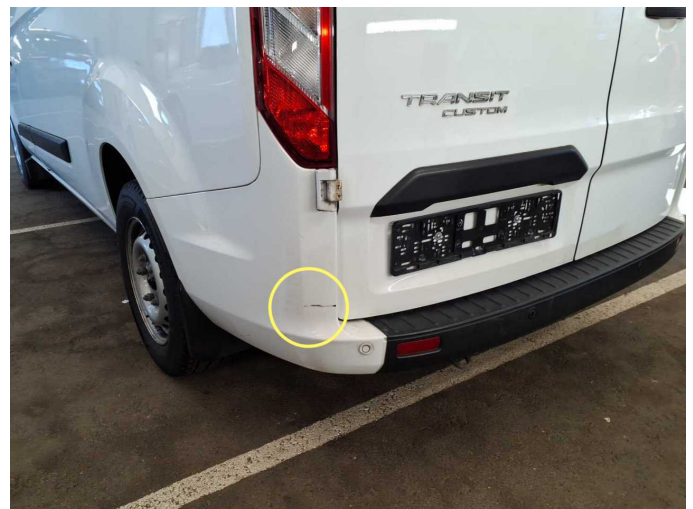
**Damage 9:** Rear bumper: Rear bumper - Scratch(es) - Paint

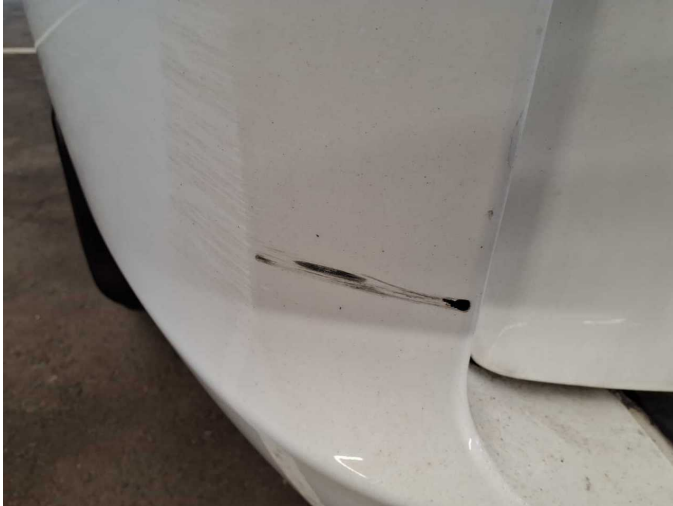
**Damage 9:** Rear bumper: Rear bumper - Scratch(es) - Paint

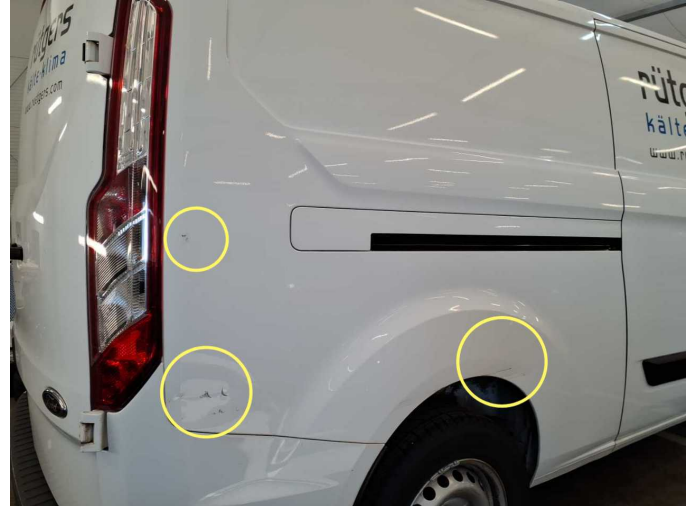
**Damage 10:** Side panel - rear right side: Side panel - Dent / paintcoat damage - Repair and paint

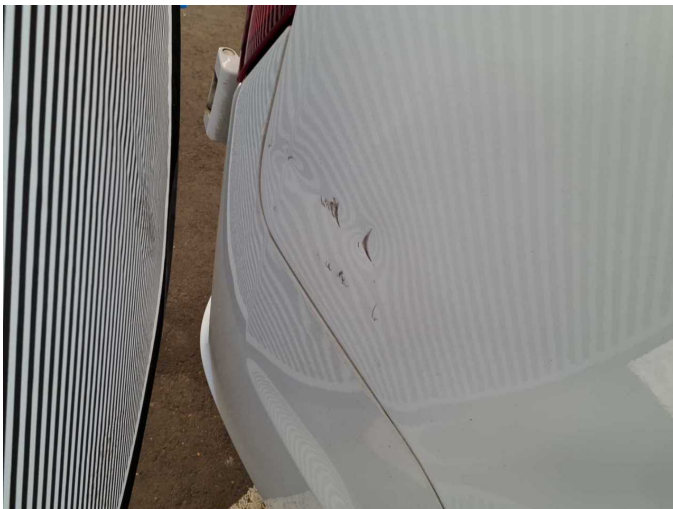
**Damage 10:** Side panel - rear right side: Side panel - Dent / paintcoat damage - Repair and paint

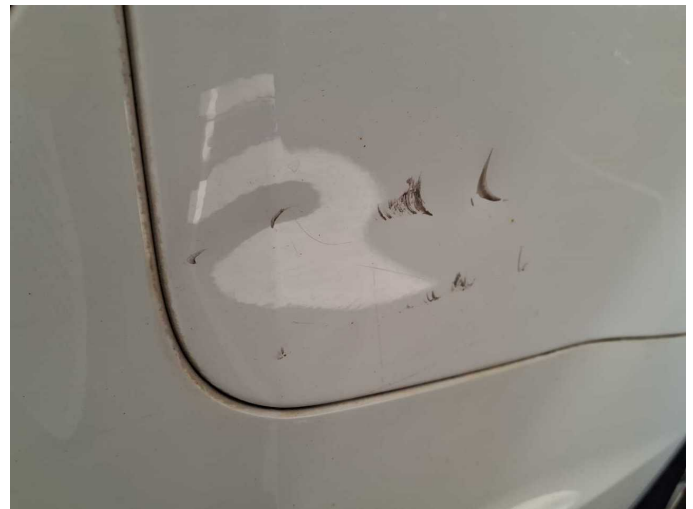
**Damage 10:** Side panel - rear right side: Side panel - Dent / paintcoat damage - Repair and paint

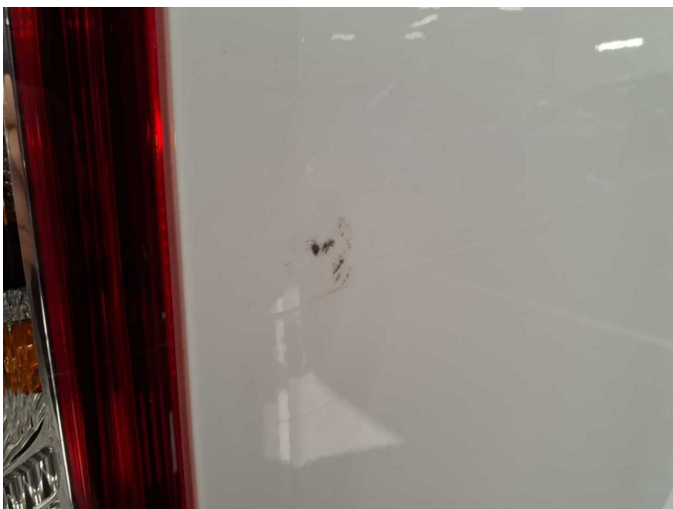
**Damage 10:** Side panel - rear right side: Side panel - Dent / paintcoat damage - Repair and paint

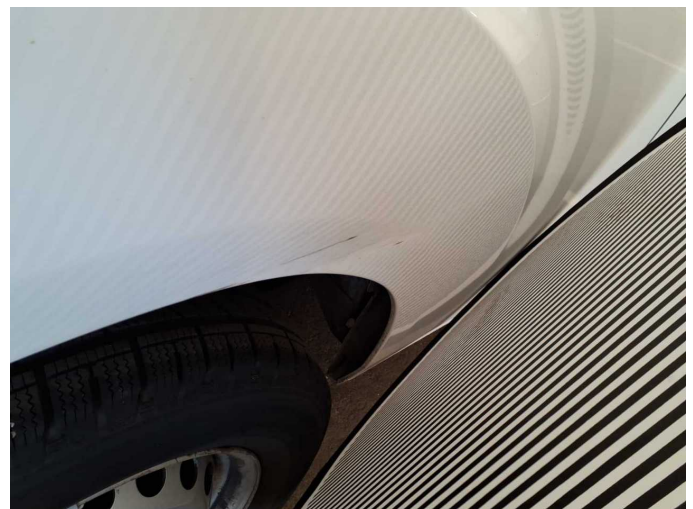
**Damage 10:** Side panel - rear right side: Side panel - Dent / paintcoat damage - Repair and paint

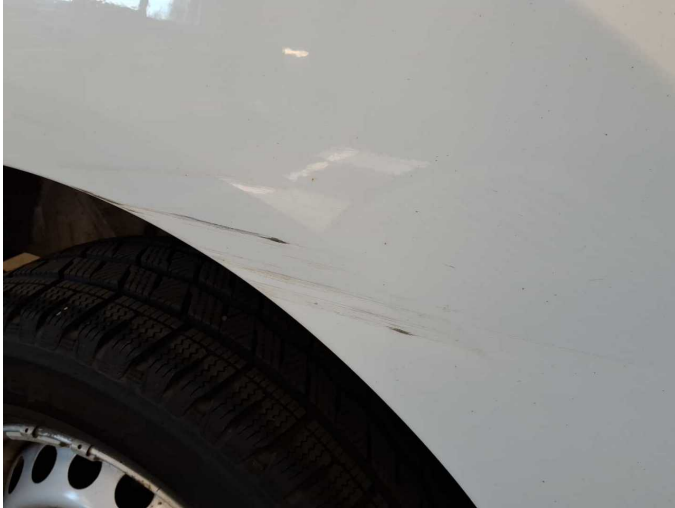
**Damage 10:** Side panel - rear right side: Side panel - Dent / paintcoat damage - Repair and paint

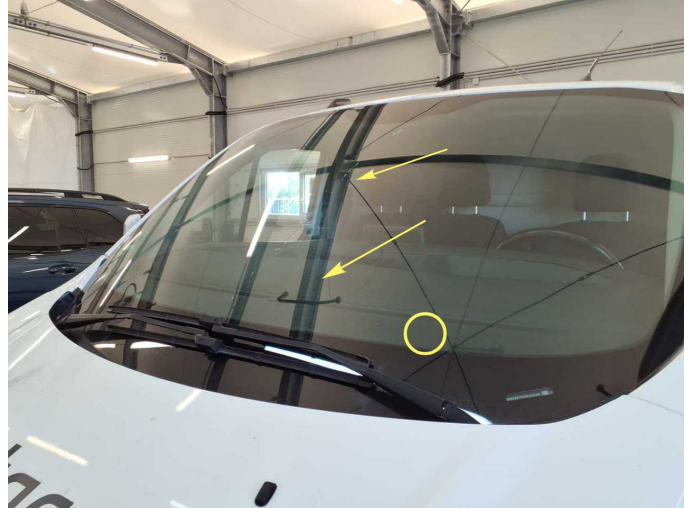
**Damage 11:** Vehicle glazing: Windscreen - Broken / torn - Replace

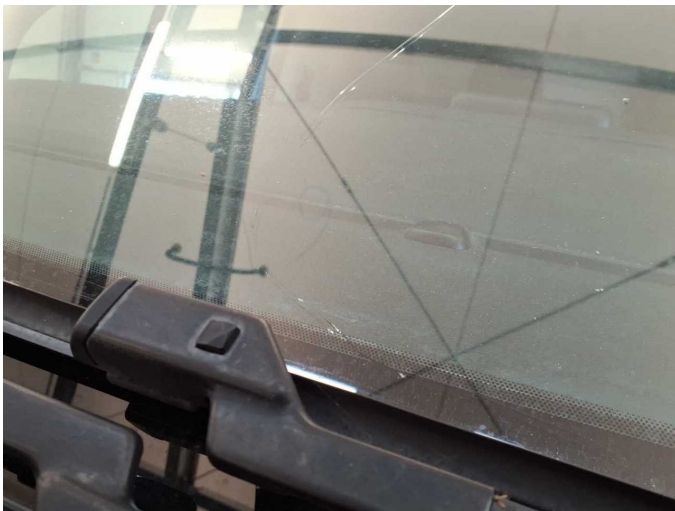
**Damage 11:** Vehicle glazing: Windscreen - Broken / torn - Replace

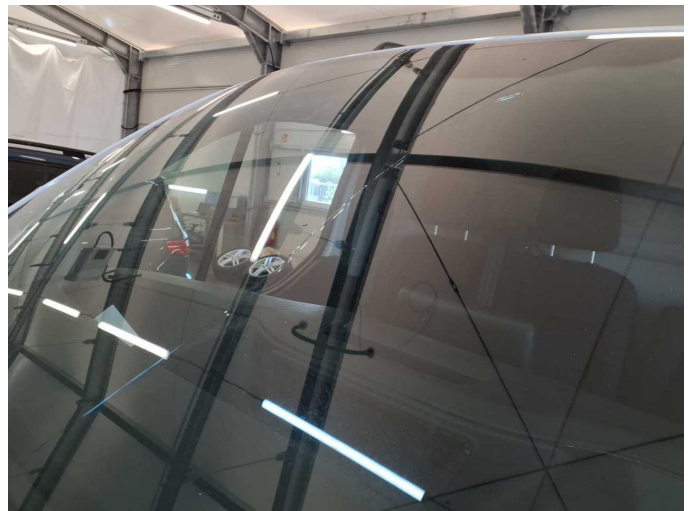
**Damage 11:** Vehicle glazing: Windscreen - Broken / torn - Replace

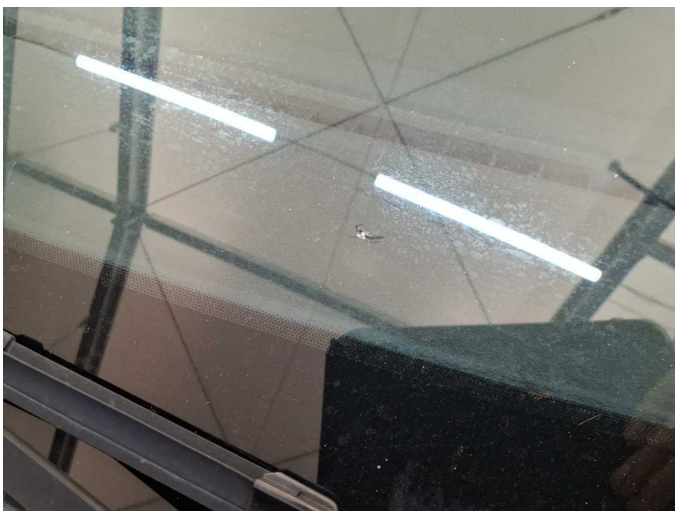
**Damage 11:** Vehicle glazing: Windscreen - Broken / torn - Replace

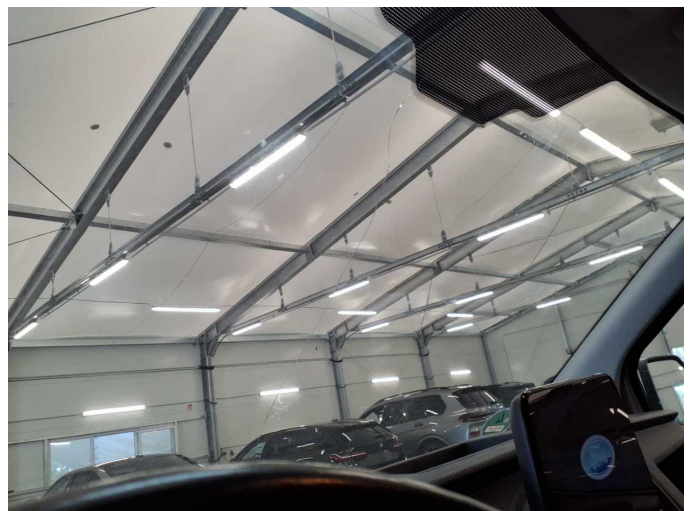
**Damage 11:** Vehicle glazing: Windscreen - Broken / torn - Replace

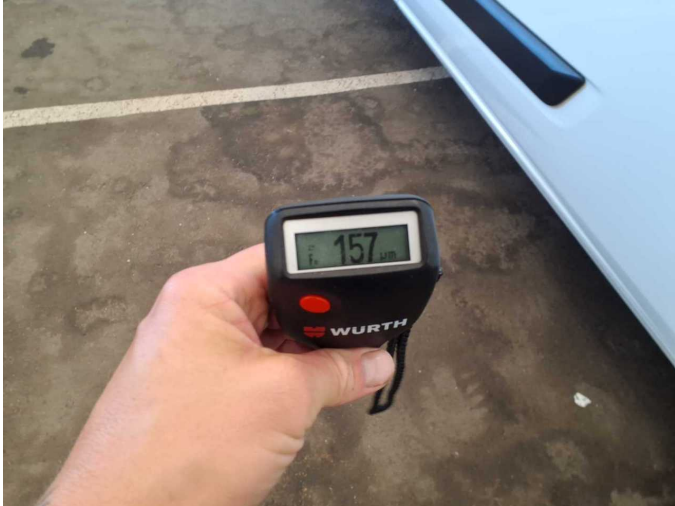
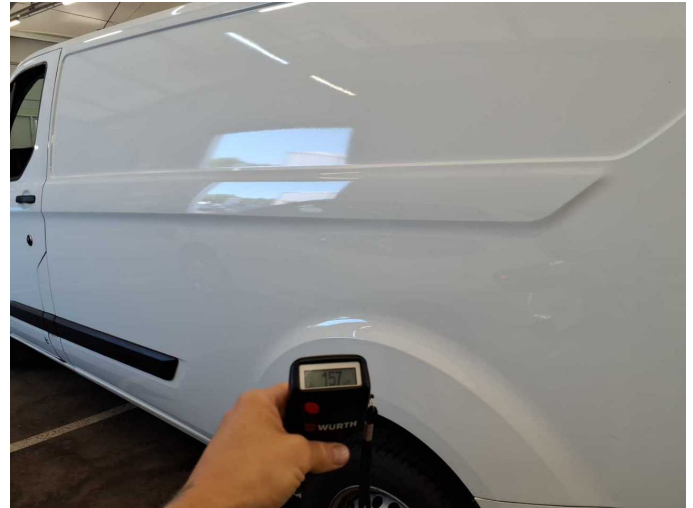
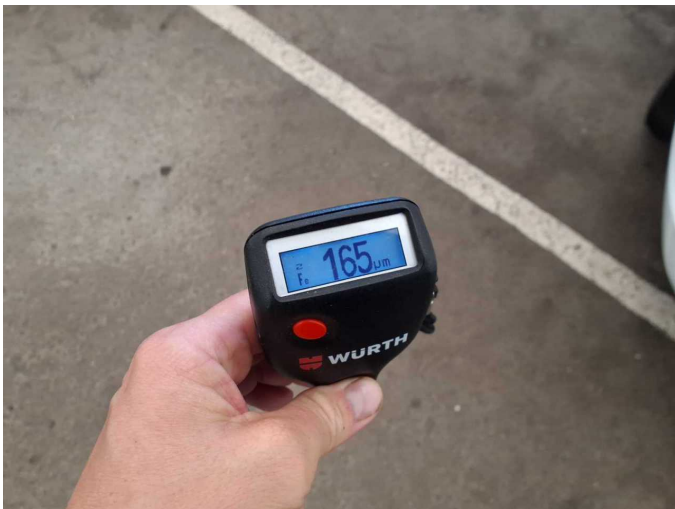
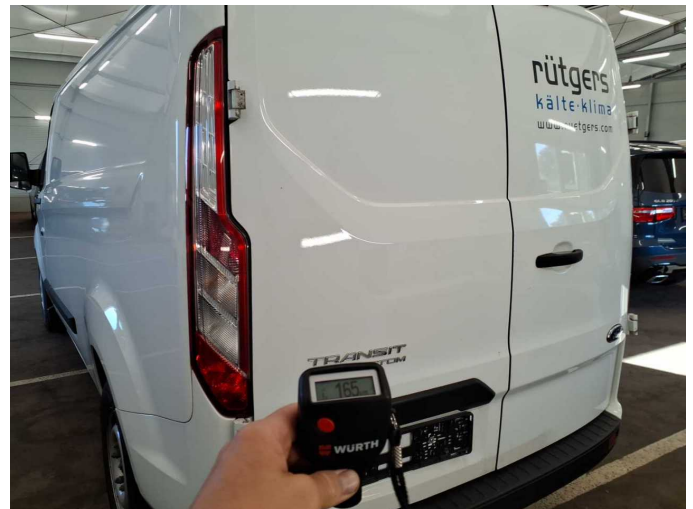
No.	Repainting
1	Boot lid / rear door, Side panel - rear left side, Professionally carried out, Invoice of repair done Non-existent

Boot lid / rear door	165 µm	Side panel - rear left side	157 µm
----------------------	--------	-----------------------------	--------

Repainting 1: Boot lid / rear door, Side panel - rear left side
