Expertise

Protocol number: 46151837
Order No. / Reference: 26495093
Inspection date: 24 Jun 2026

Model: Focus Turnier 1.5 EcoBlue Start-Stopp-System Aut.
COOL&CONNECT

VIN: WF0PXXGCHPNR10955

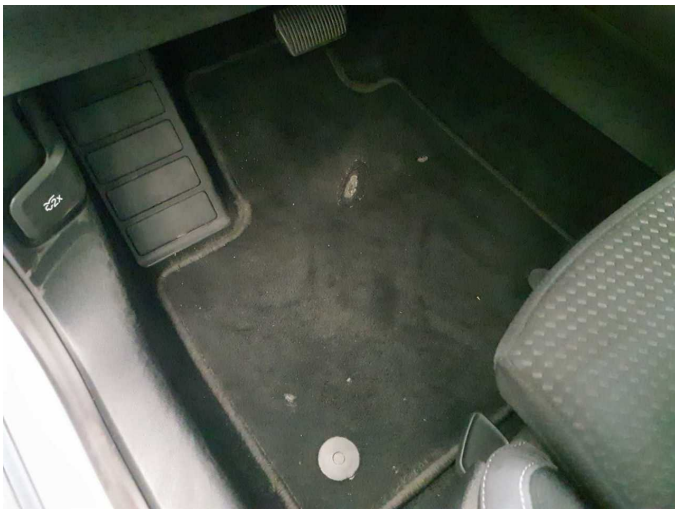
Damage 1: Trim / covers: Floor mats - Holes - Replace

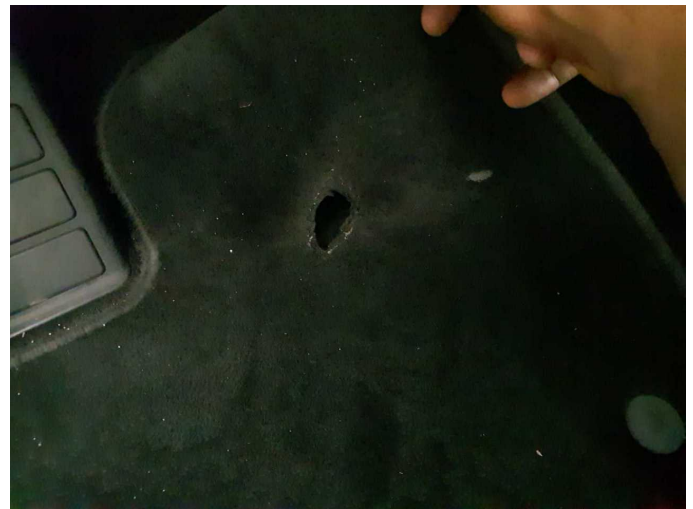
Damage 1: Trim / covers: Floor mats - Holes - Replace

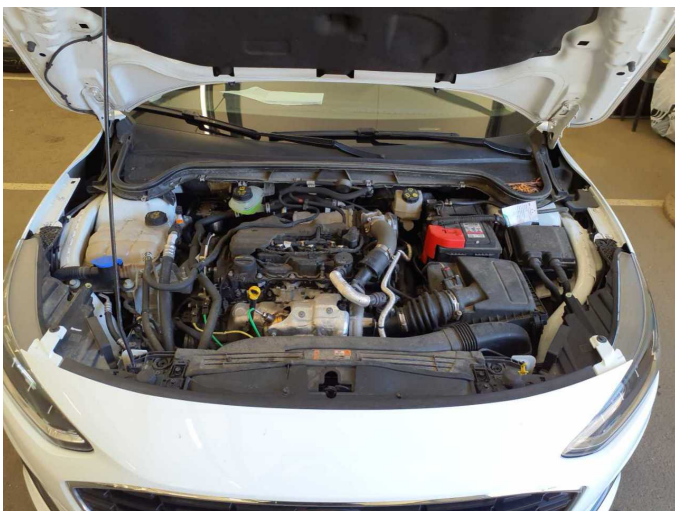
Damage 2: Engine: Engine cover - Damage caused by marten / rodent - Replace

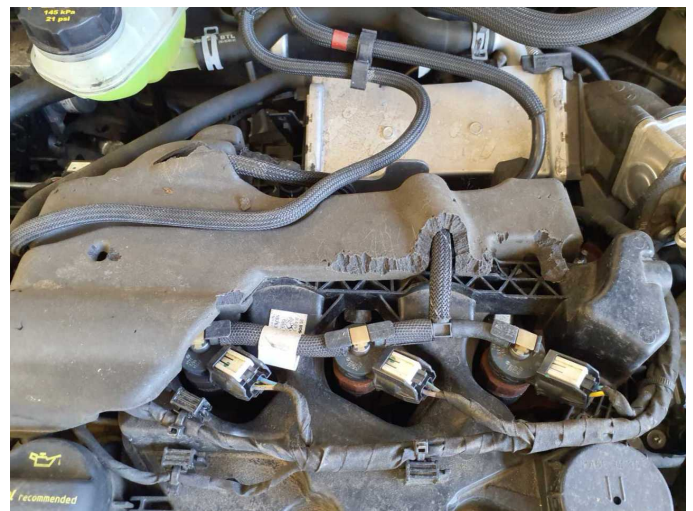
Damage 2: Engine: Engine cover - Damage caused by marten / rodent - Replace

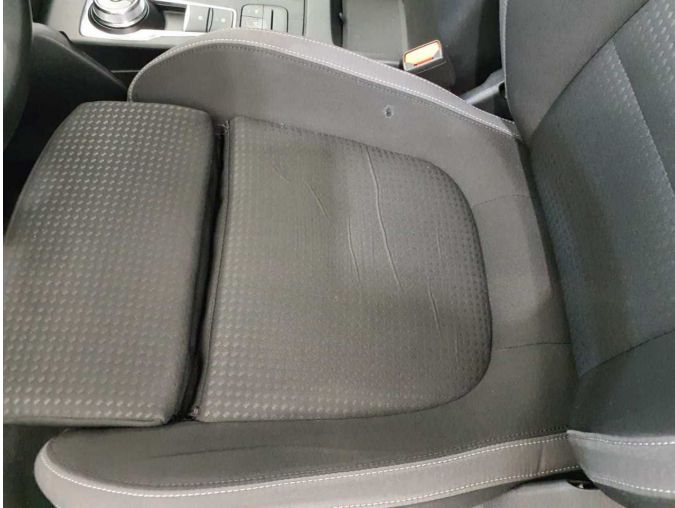
Damage 3: Seat - front: Seat cover - left side - Burn hole (cigarettes) - Smart repair

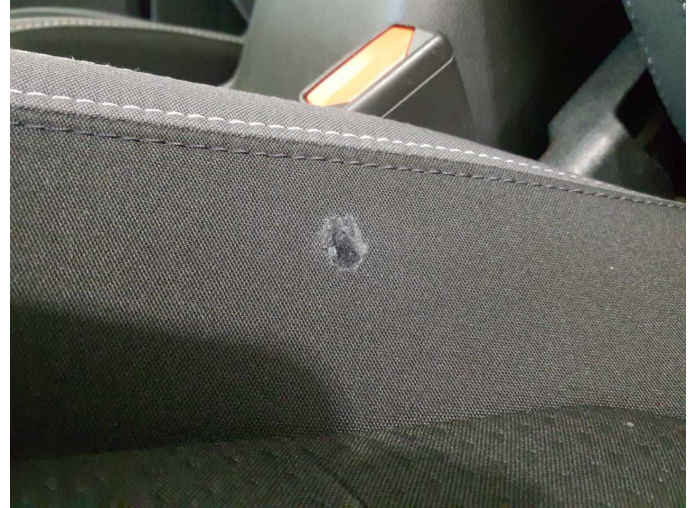
Damage 3: Seat - front: Seat cover - left side - Burn hole (cigarettes) - Smart repair

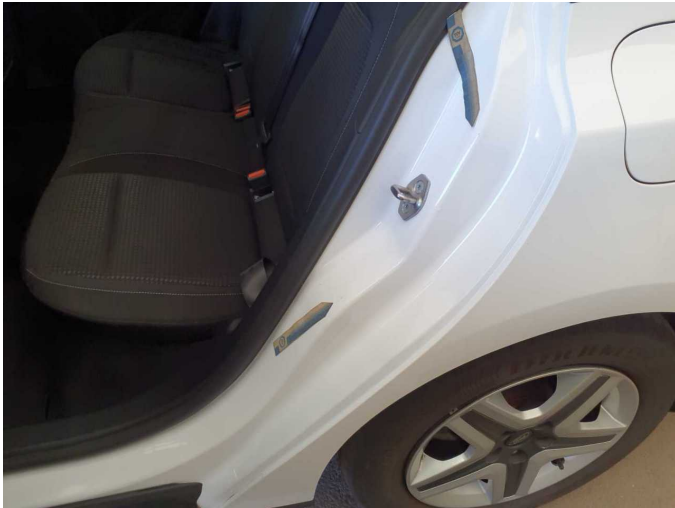
Damage 4: Side panel - rear left side: Sill - Dent / paintcoat damage - Smart repair

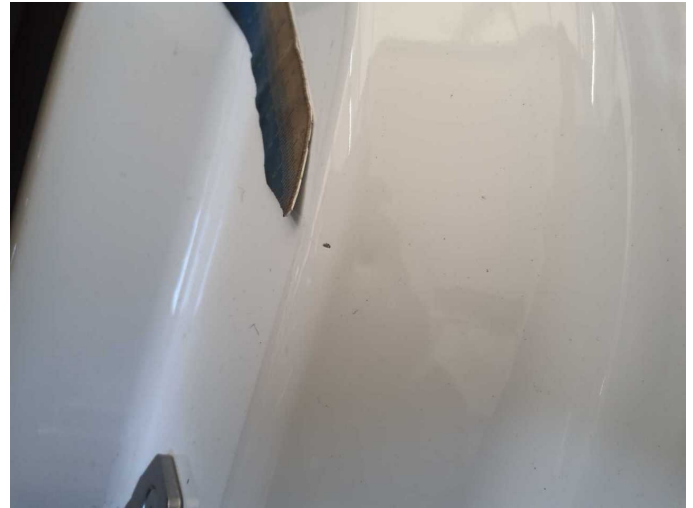
Damage 4: Side panel - rear left side: Sill - Dent / paintcoat damage - Smart repair

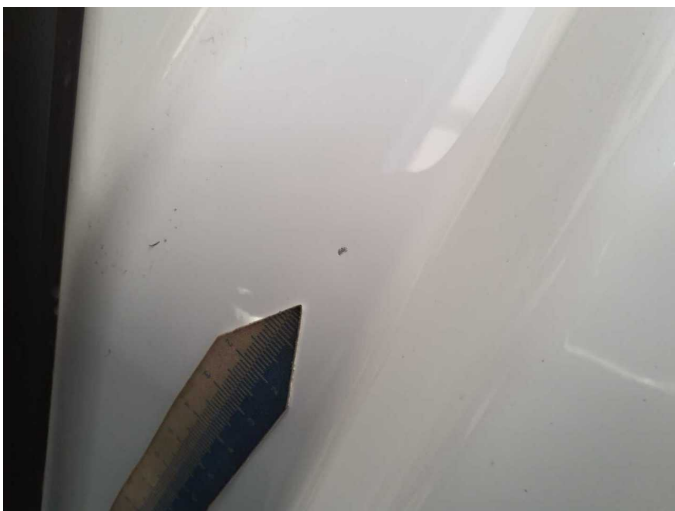
Damage 4: Side panel - rear left side: Sill - Dent / paintcoat damage - Smart repair

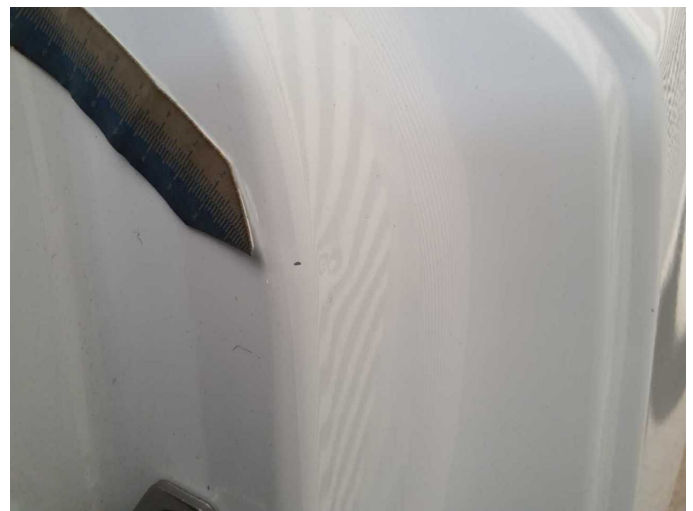
Damage 4: Side panel - rear left side: Sill - Dent / paintcoat damage - Smart repair

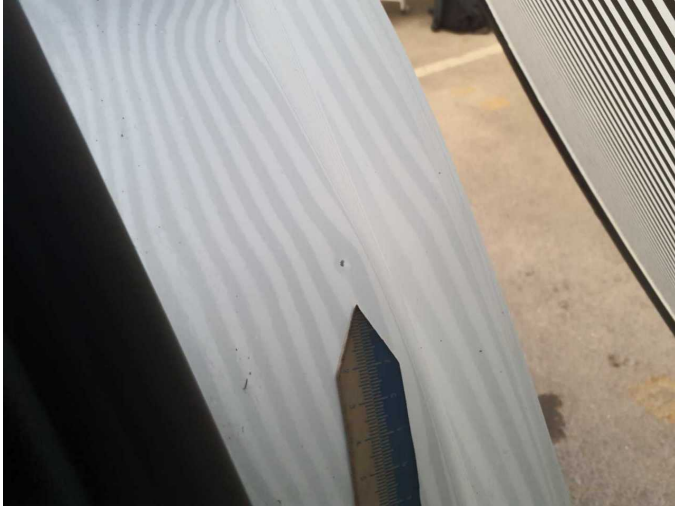
Damage 4: Side panel - rear left side: Sill - Dent / paintcoat damage - Smart repair

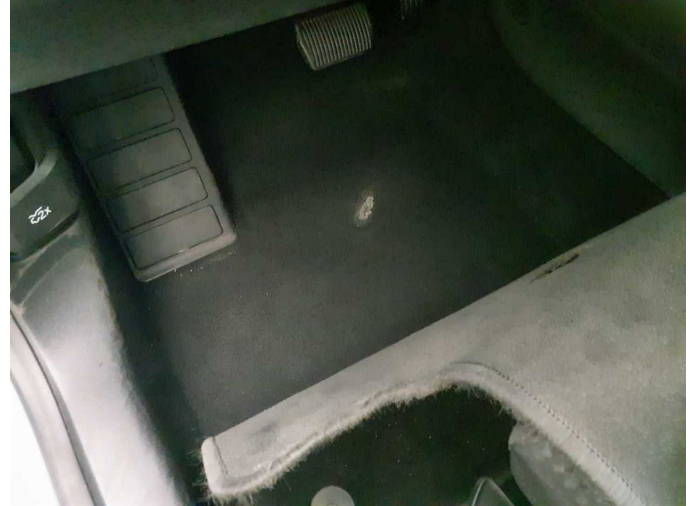
Damage 6: Trim / covers: Carpet - front left side - Holes - Loss in value

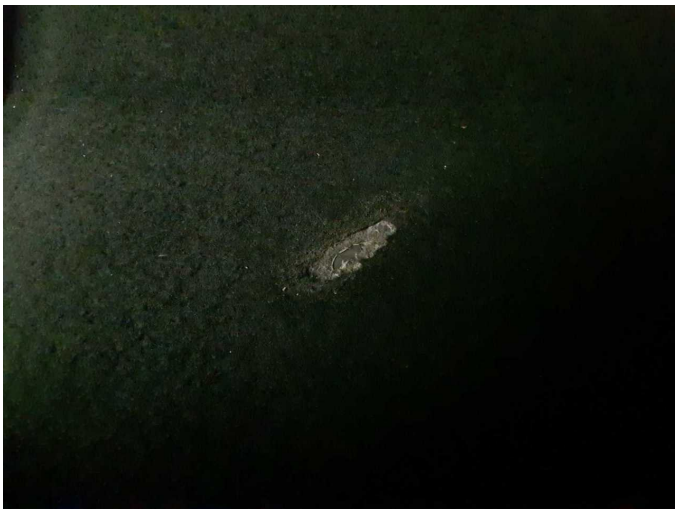
Damage 6: Trim / covers: Carpet - front left side - Holes - Loss in value

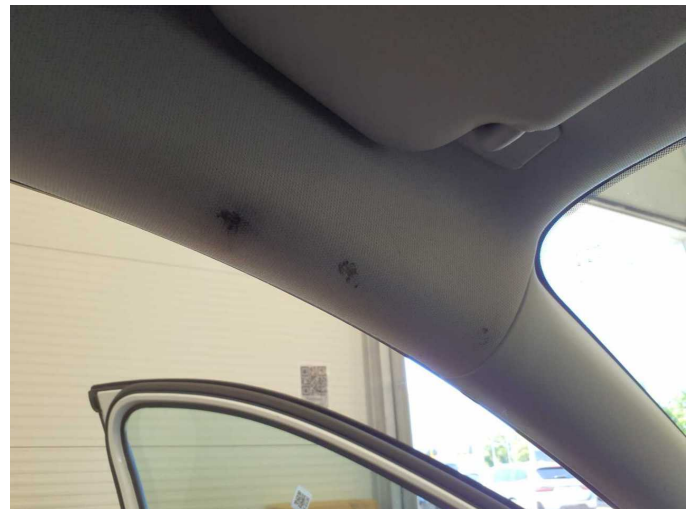
Damage 7: Trim / covers: Roof lining - Holes - Loss in value

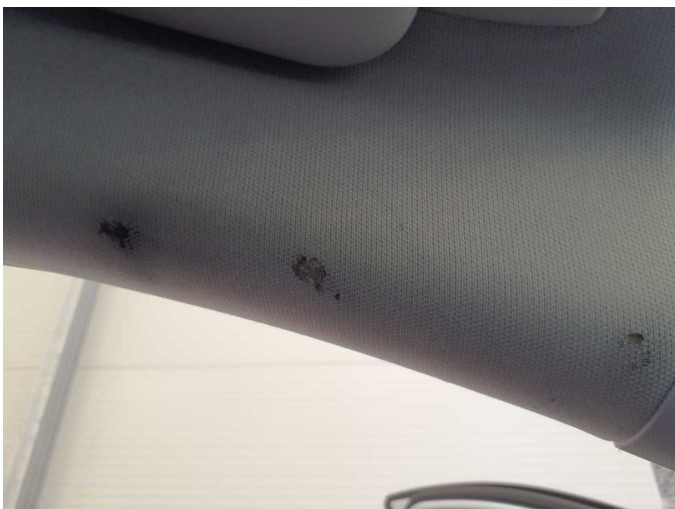
Damage 7: Trim / covers: Roof lining - Holes - Loss in value

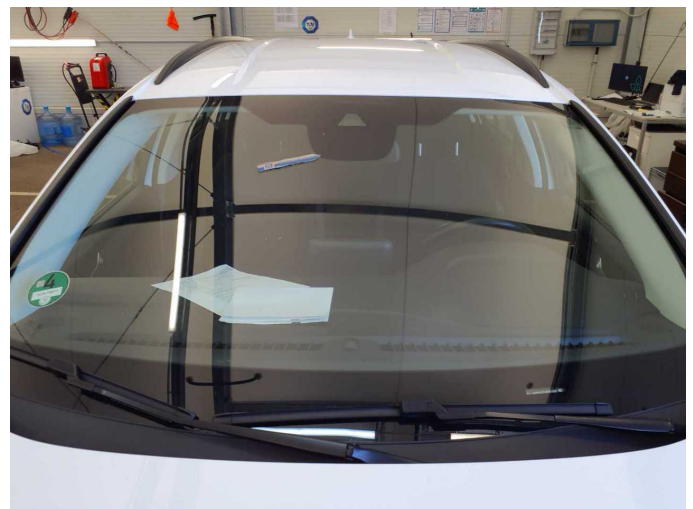
Damage 8: Vehicle glazing: Windscreen with lane departure assistant - Broken / torn - Replace

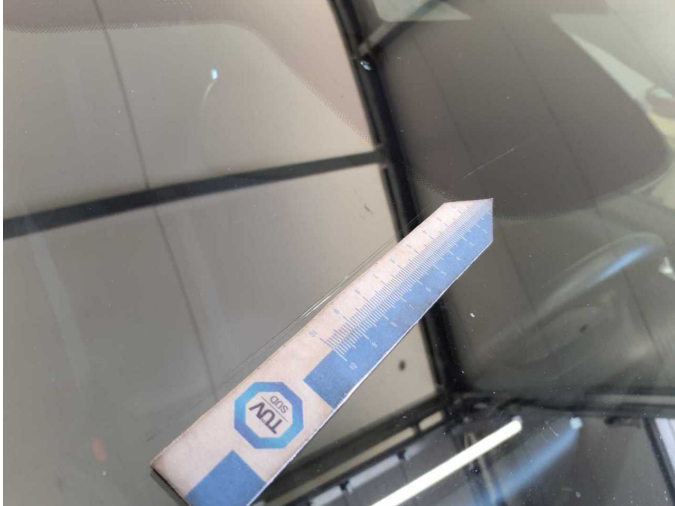
Damage 8: Vehicle glazing: Windscreen with lane departure assistant - Broken / torn - Replace

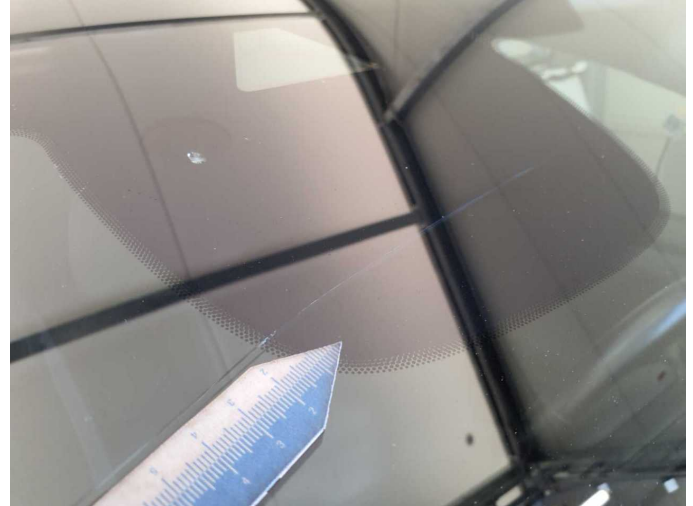
Damage 8: Vehicle glazing: Windscreen with lane departure assistant - Broken / torn - Replace

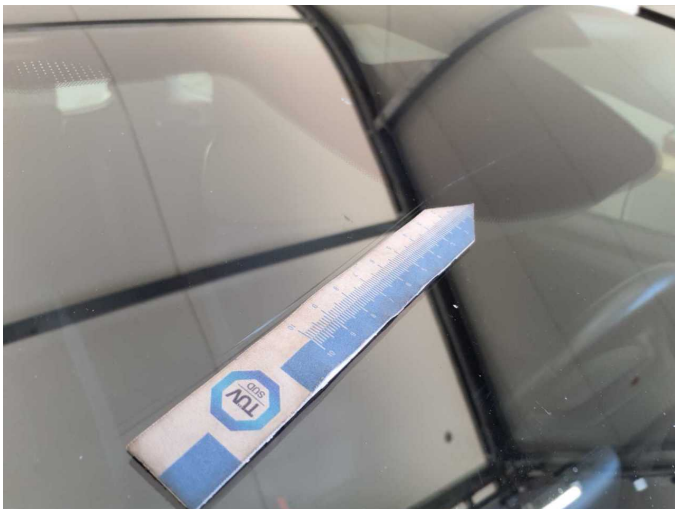
Damage 8: Vehicle glazing: Windscreen with lane departure assistant - Broken / torn - Replace

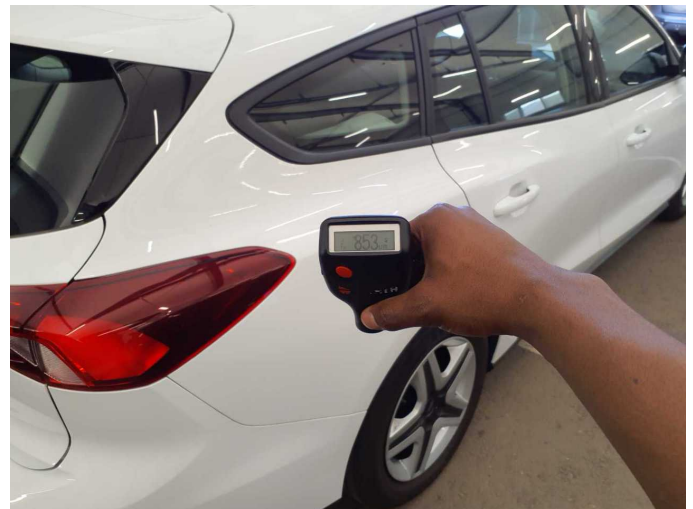
No.	Repainting
1	Side panel - rear right side, Professionally carried out, Invoice of repair done Non-existent

Side panel - rear right side	853 µm
------------------------------	--------

Repainting 1: Side panel - rear right side

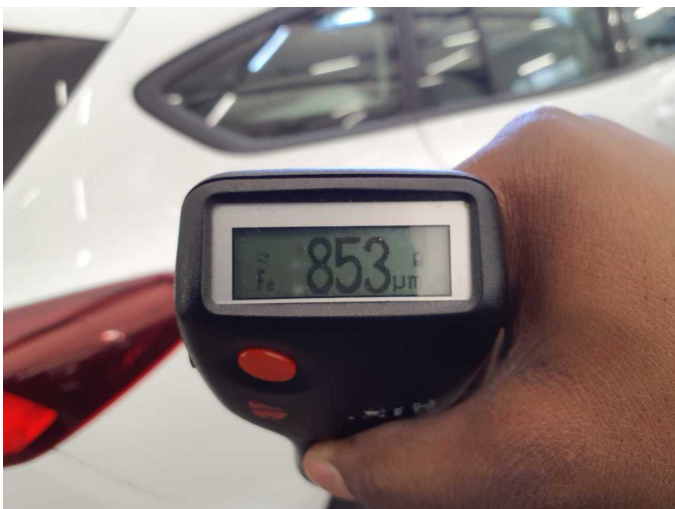
Repainting 1: Side panel - rear right side
