Expertise

Protocol number: 45524925
Order No. / Reference: 26380221
Inspection date: 11 May 2026

Model: Kodiaq 2.0 TDI 4x4 DSG Sportline

VIN: TMBLN9NSXN8008144

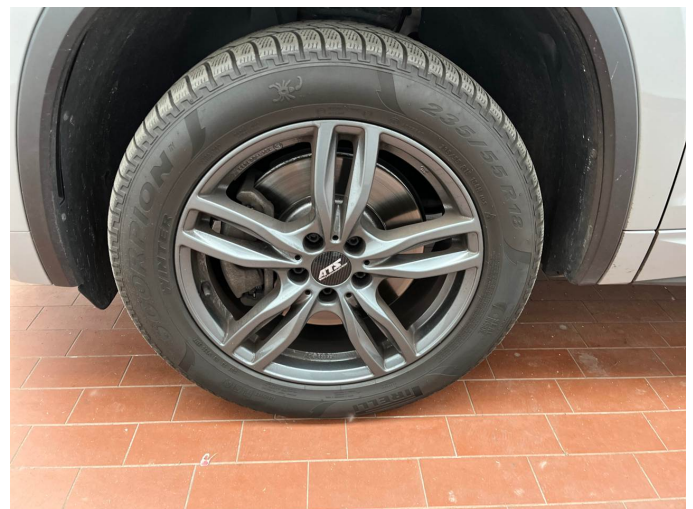
Figure 12: Mounted tyres

#	Tyre size	Type of tyre	Manufacturer	Tread depth
1)	235/55 R18 104H	Winter tires (with run-flat tires) on Light alloy	Pirelli	3mm / 3mm
2)	235/55 R18 104H	Winter tires (with run-flat tires) on Light alloy	Pirelli	5mm / 5mm

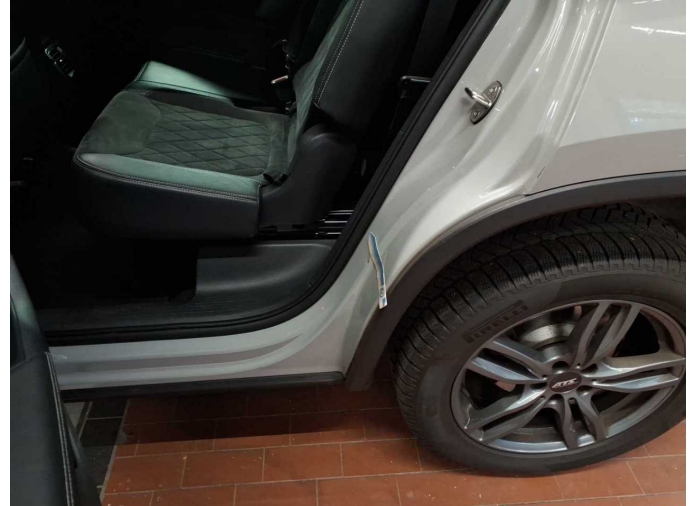
Damage 1: Side panel - rear left side: Sill - Dent / paintcoat damage - Smart repair

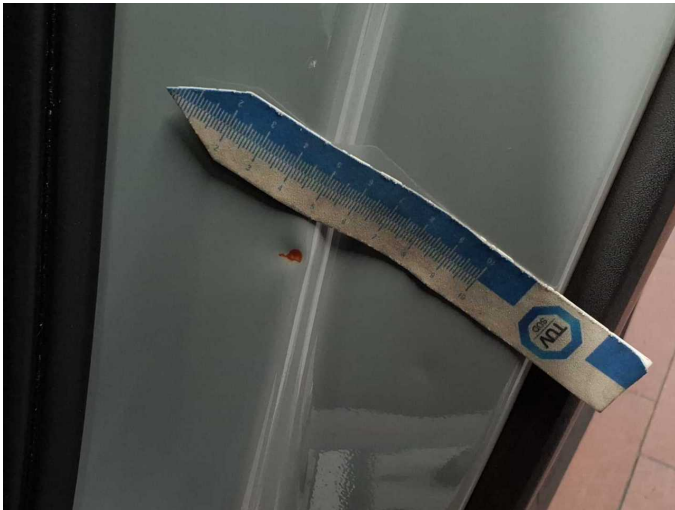
Damage 1: Side panel - rear left side: Sill - Dent / paintcoat damage - Smart repair

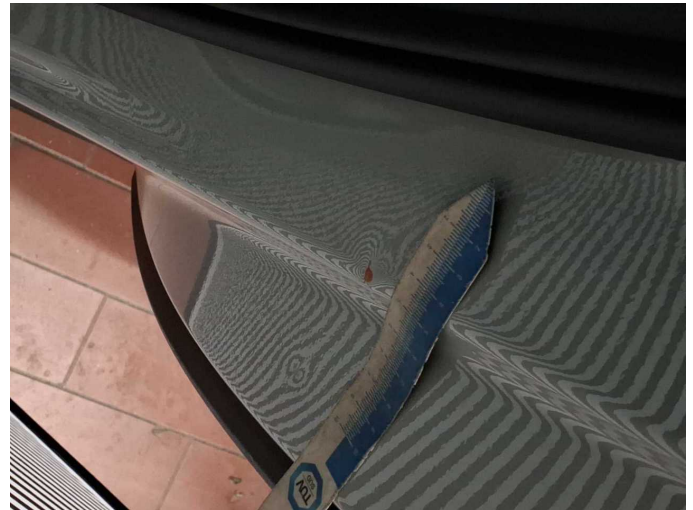
Damage 1: Side panel - rear left side: Sill - Dent / paintcoat damage - Smart repair

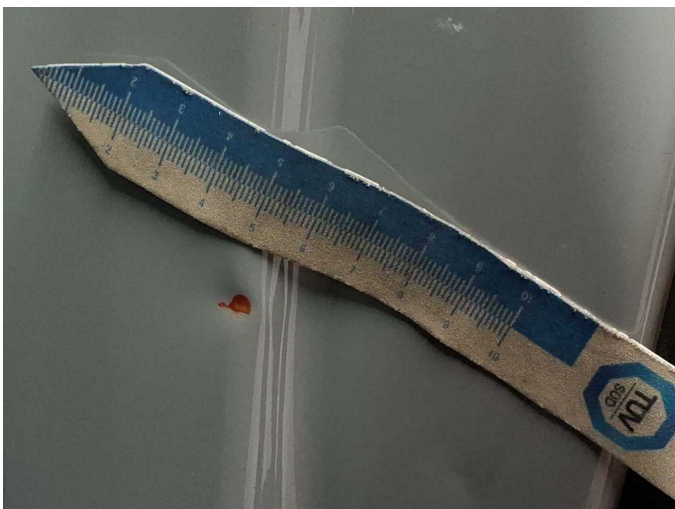
Damage 1: Side panel - rear left side: Sill - Dent / paintcoat damage - Smart repair

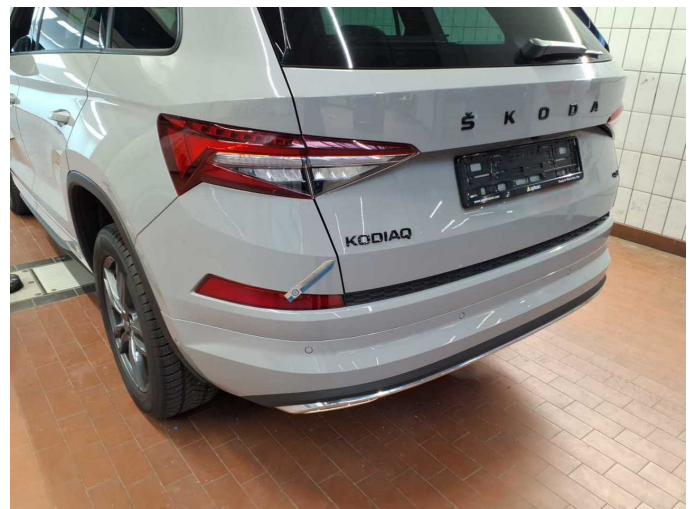
Damage 2: Rear bumper: Rear bumper - Scratch(es) - Paint

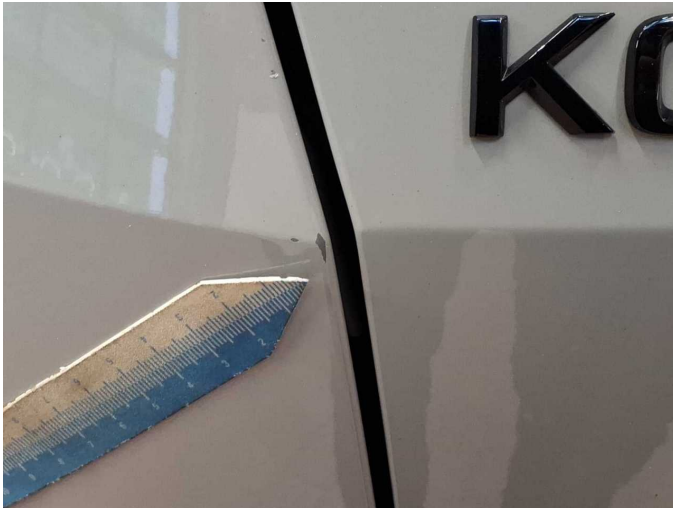
Damage 2: Rear bumper: Rear bumper - Scratch(es) - Paint

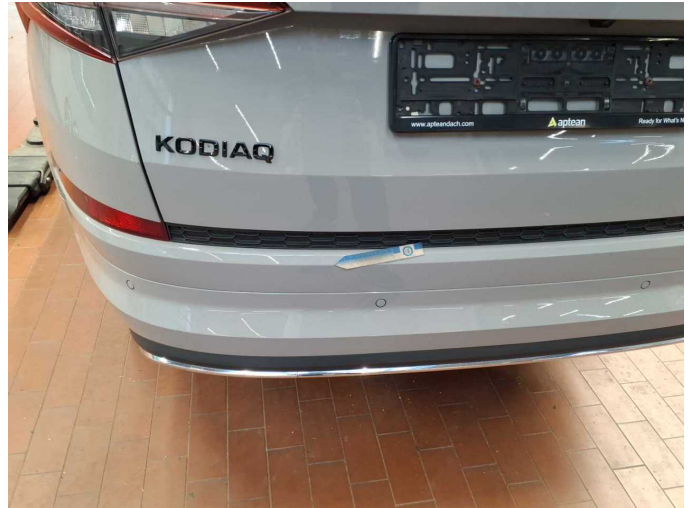
Damage 2: Rear bumper: Rear bumper - Scratch(es) - Paint

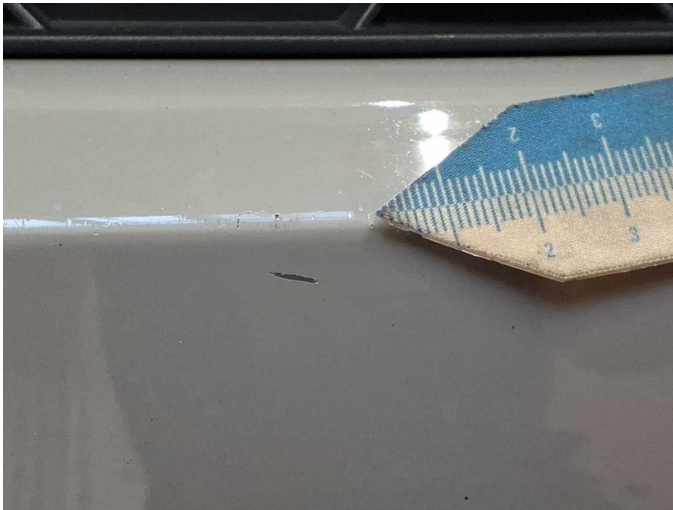
Damage 2: Rear bumper: Rear bumper - Scratch(es) - Paint

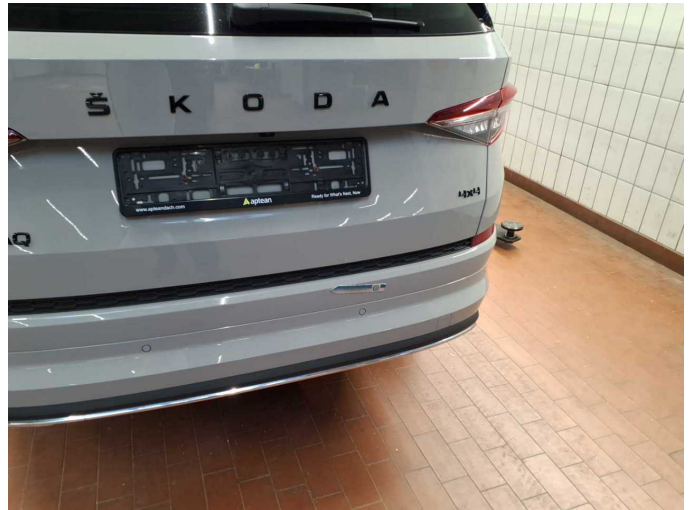
Damage 2: Rear bumper: Rear bumper - Scratch(es) - Paint

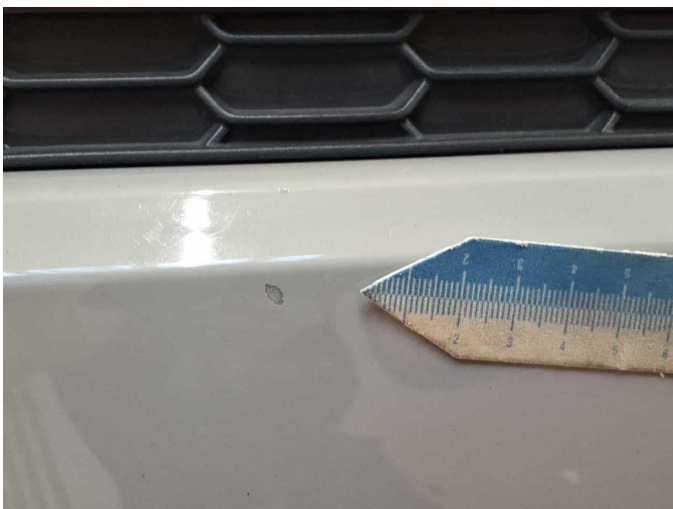
Damage 2: Rear bumper: Rear bumper - Scratch(es) - Paint

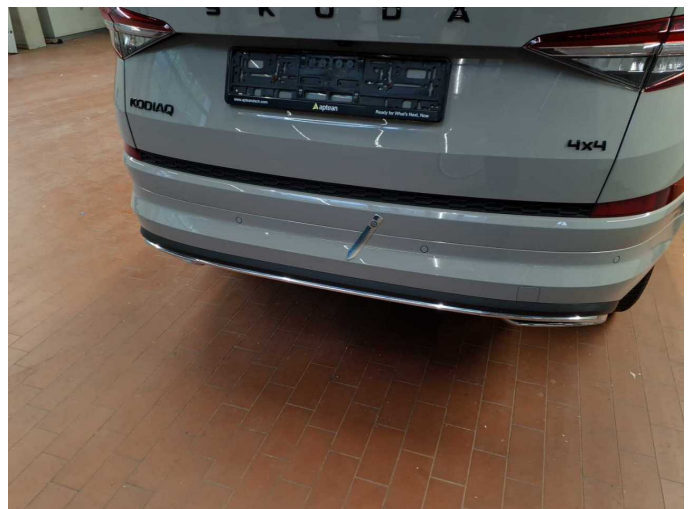
Damage 3: Rear bumper: Spoiler - Dent / paintcoat damage - Repair and paint

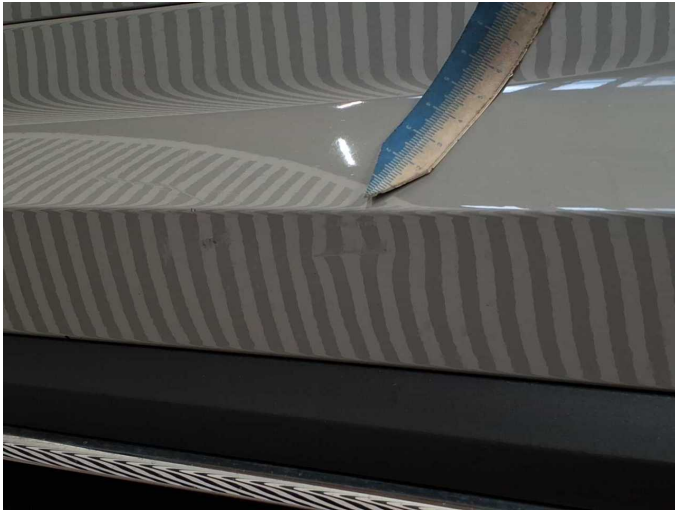
Damage 3: Rear bumper: Spoiler - Dent / paintcoat damage - Repair and paint

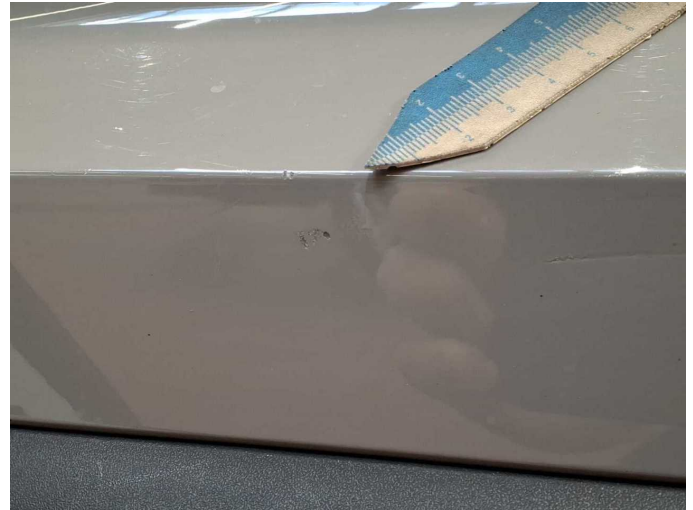
Damage 3: Rear bumper: Spoiler - Dent / paintcoat damage - Repair and paint

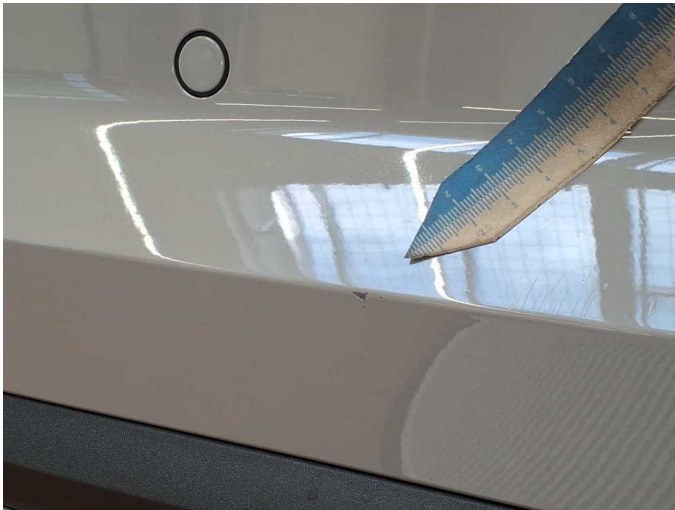
Damage 3: Rear bumper: Spoiler - Dent / paintcoat damage - Repair and paint

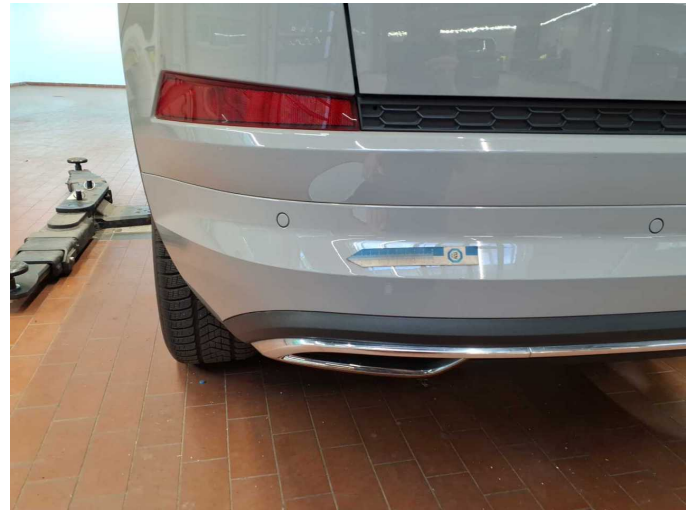
Damage 3: Rear bumper: Spoiler - Dent / paintcoat damage - Repair and paint

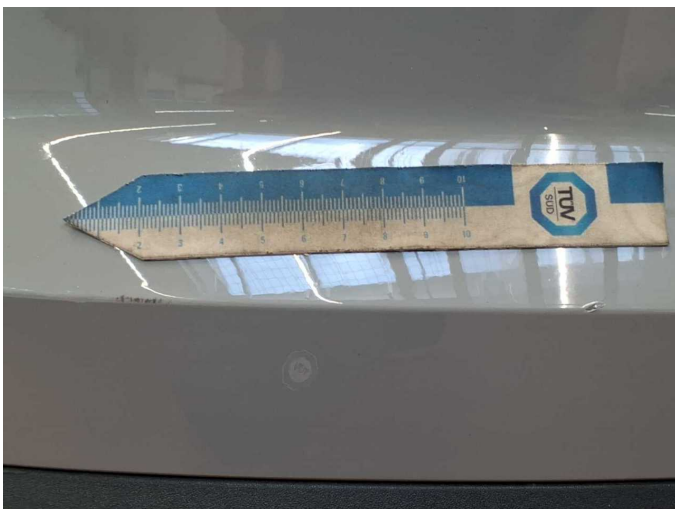
Damage 3: Rear bumper: Spoiler - Dent / paintcoat damage - Repair and paint

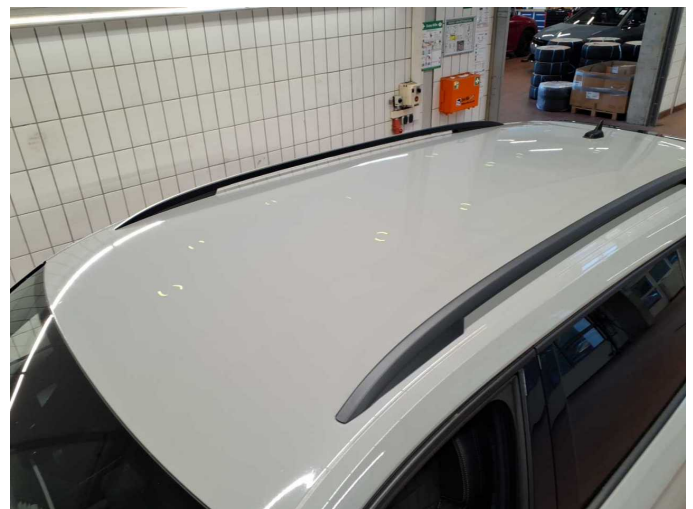
Damage 4: Roof: Roof - Damage by hail - repair according to calculation

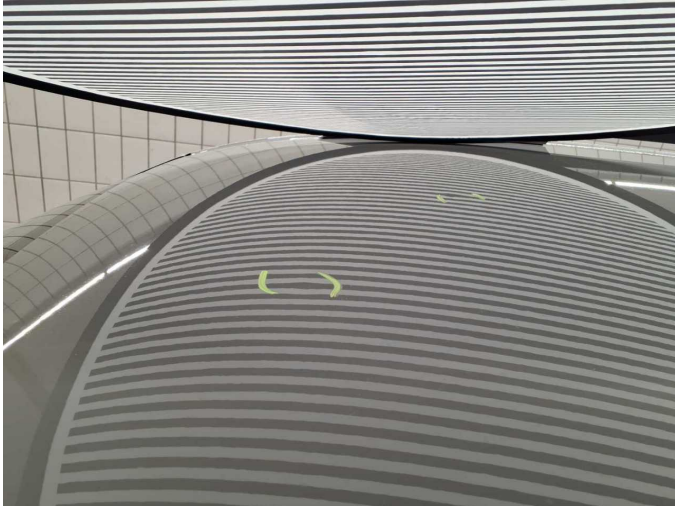
Damage 4: Roof: Roof - Damage by hail - repair according to calculation

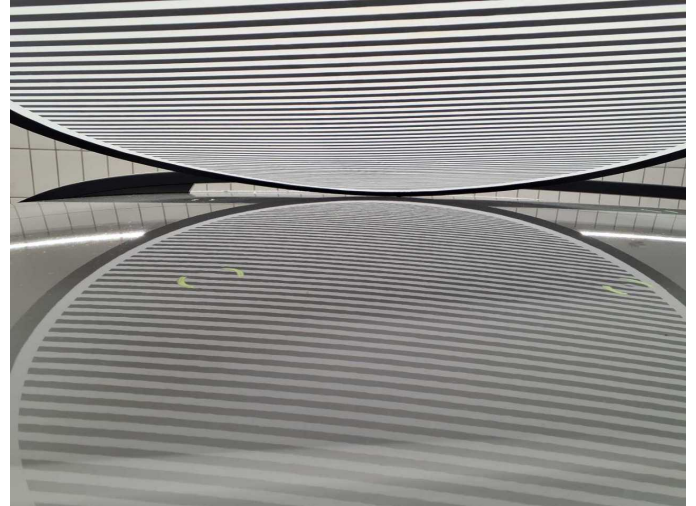
Damage 4: Roof: Roof - Damage by hail - repair according to calculation

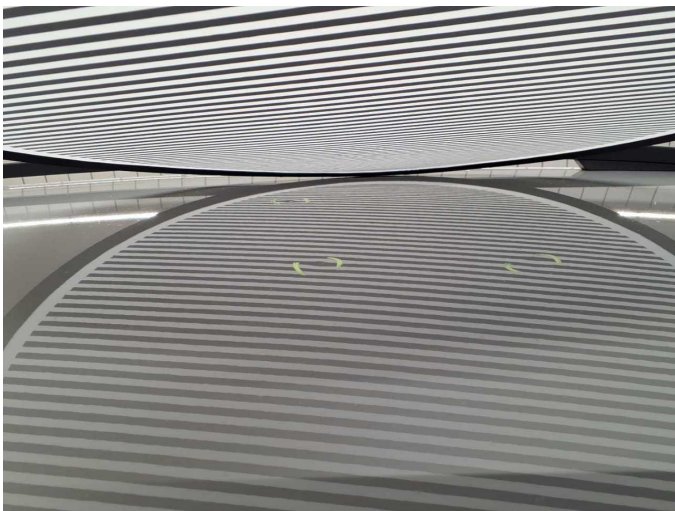
Damage 4: Roof: Roof - Damage by hail - repair according to calculation

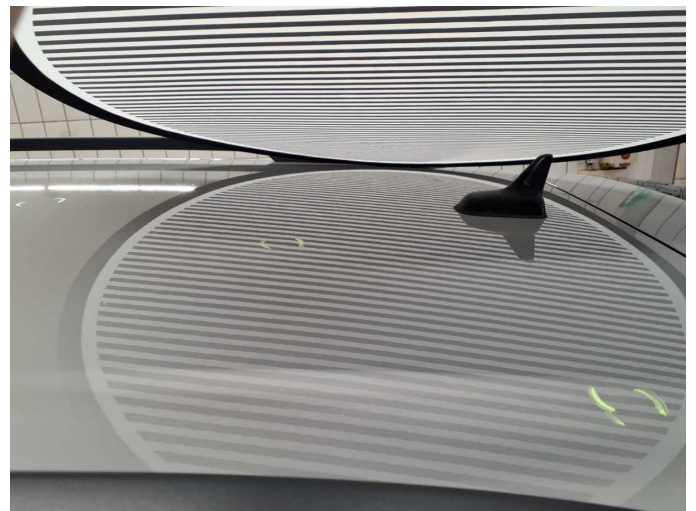
Damage 4: Roof: Roof - Damage by hail - repair according to calculation

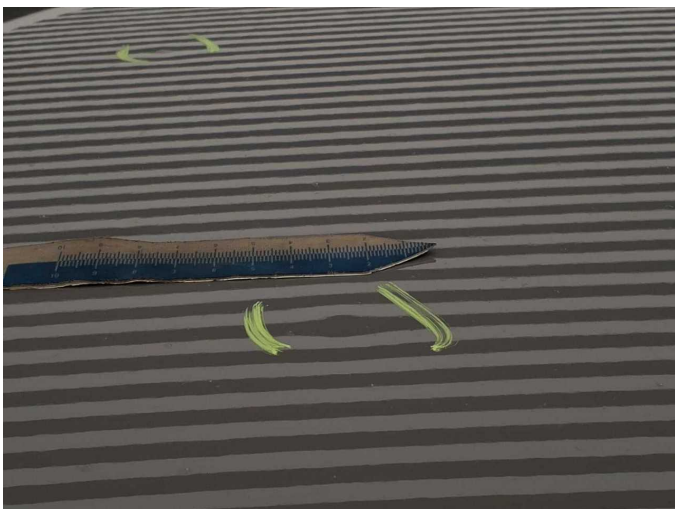
Damage 4: Roof: Roof - Damage by hail - repair according to calculation

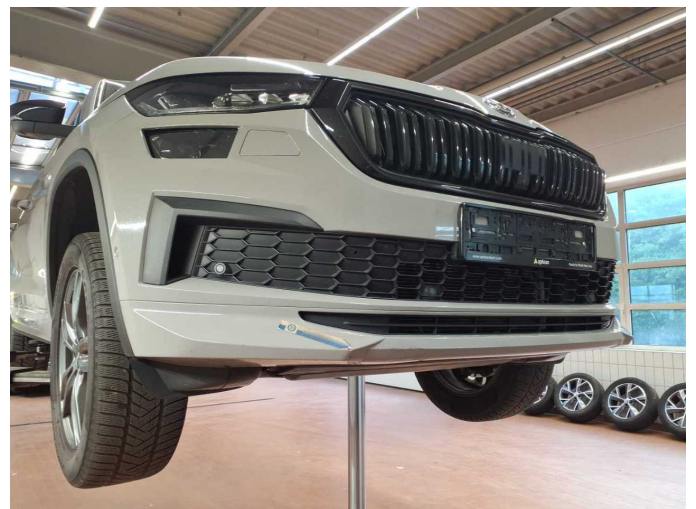
Damage 5: Front bumper: Spoiler - Scratched - Replace

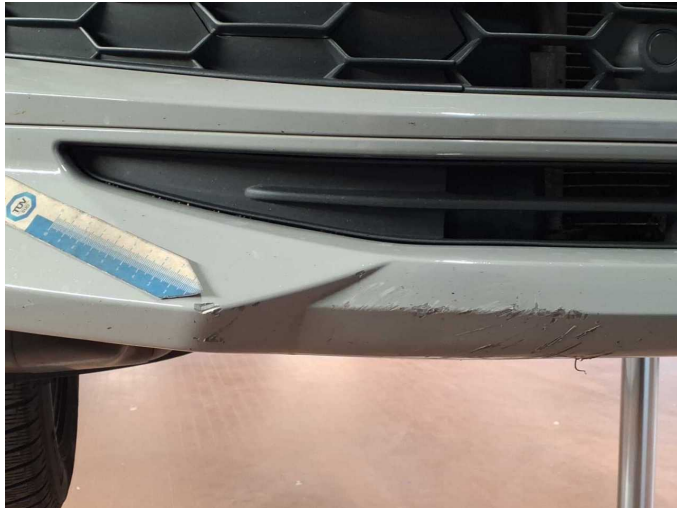
Damage 5: Front bumper: Spoiler - Scratched - Replace

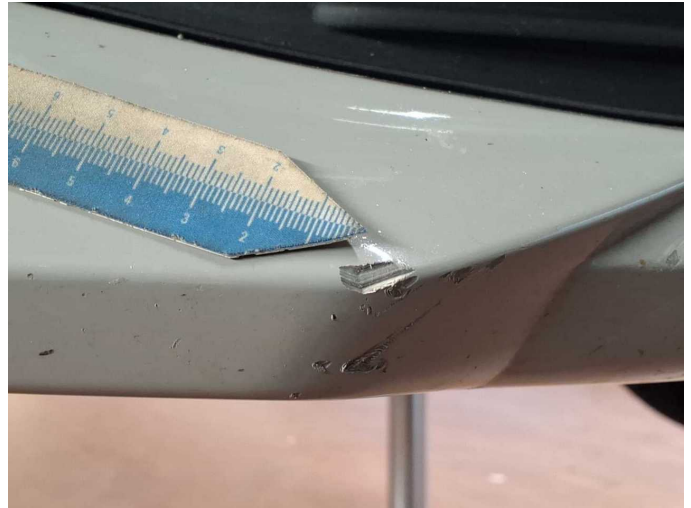
Damage 5: Front bumper: Spoiler - Scratched - Replace

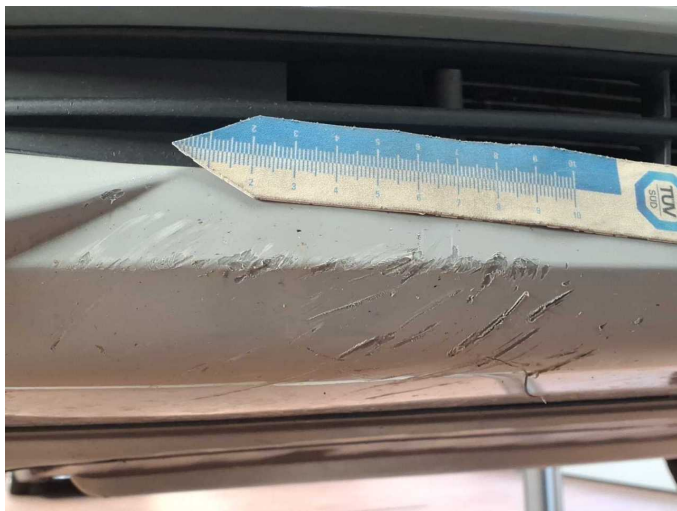
Damage 5: Front bumper: Spoiler - Scratched - Replace

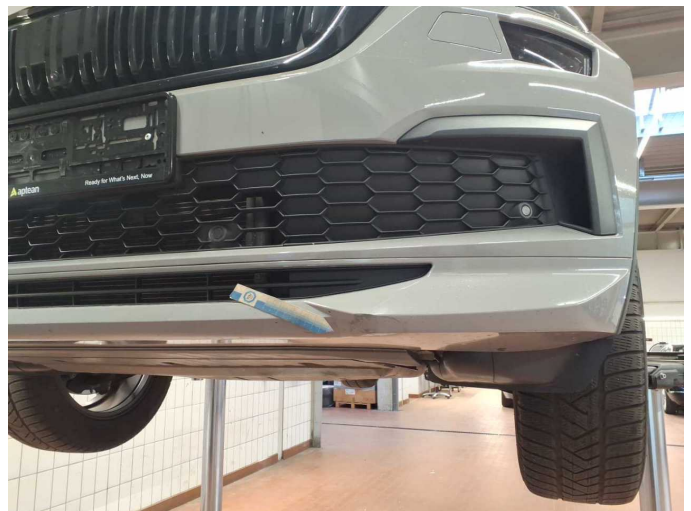
Damage 5: Front bumper: Spoiler - Scratched - Replace

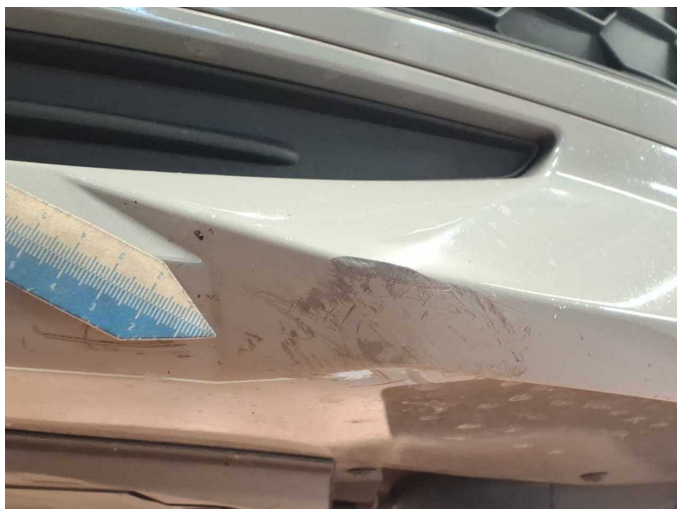
Damage 5: Front bumper: Spoiler - Scratched - Replace

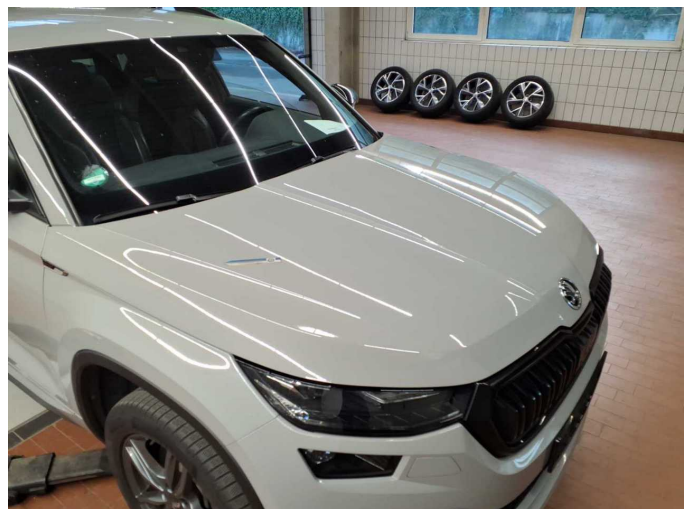
Wear and tear 3: Bonnet: Bonnet - dent(s) - No deduction

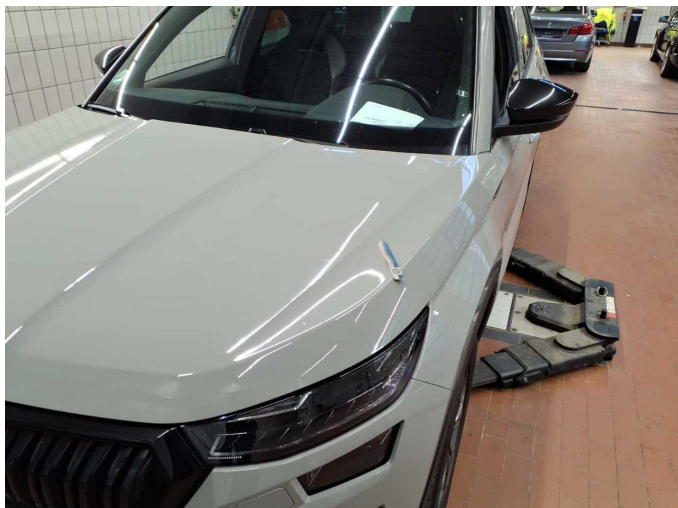
Wear and tear 3: Bonnet: Bonnet - dent(s) - No deduction

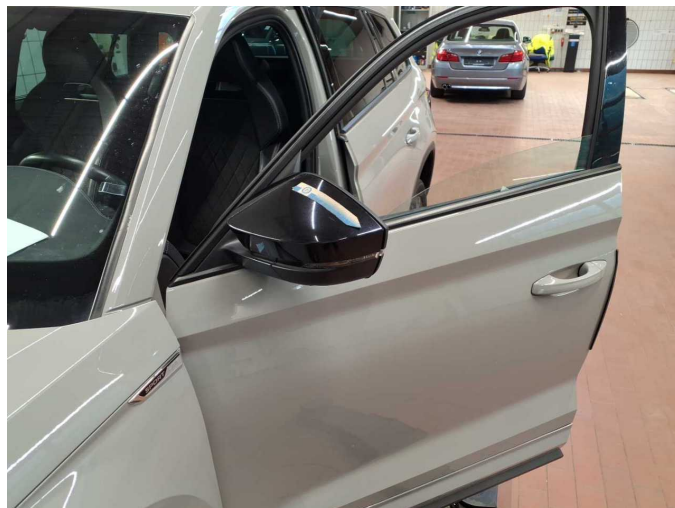
Wear and tear 6: Wing mirror - left side: Cap - Scratch(es) - No deduction

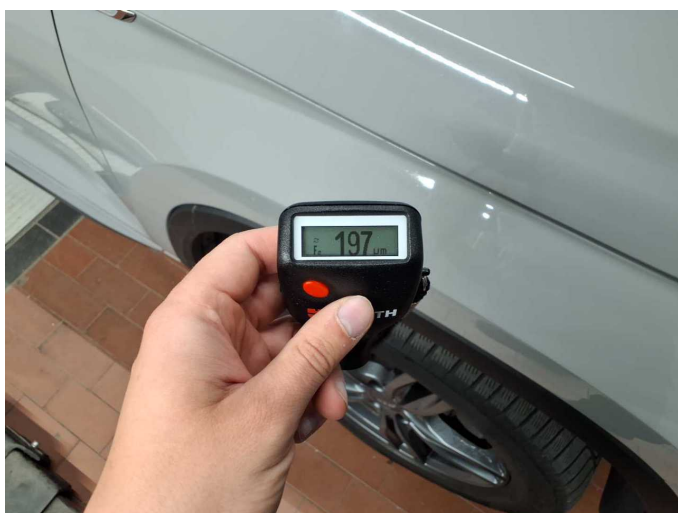
1 Mudguard - right side, Professionally carried out, Invoice of repair done Non-existent

Mudguard - right side 197 µm |

Repainting 1: Mudguard - right side
