Expertise

Protocol number: 46220707  
Order No. / Reference: 26550262  
Inspection date: 26 Jun 2026

Manufacturer: Skoda  
VIN: TMBJJ7NX1NY014417

Model: Octavia Combi 2.0 TDI Ambition

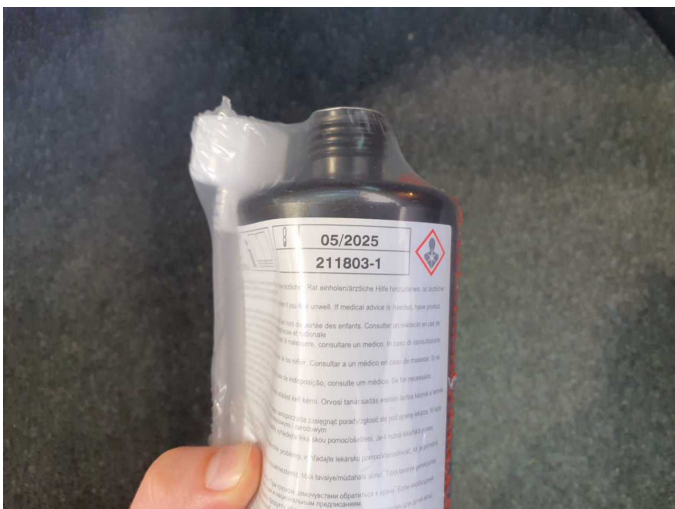
| No. | Component group | Description |
|---|---|---|
| 1 | Equipment | Tirefit filler - Expired - Replace |

Damage 1: Equipment: Tirefit filler - Expired - Replace

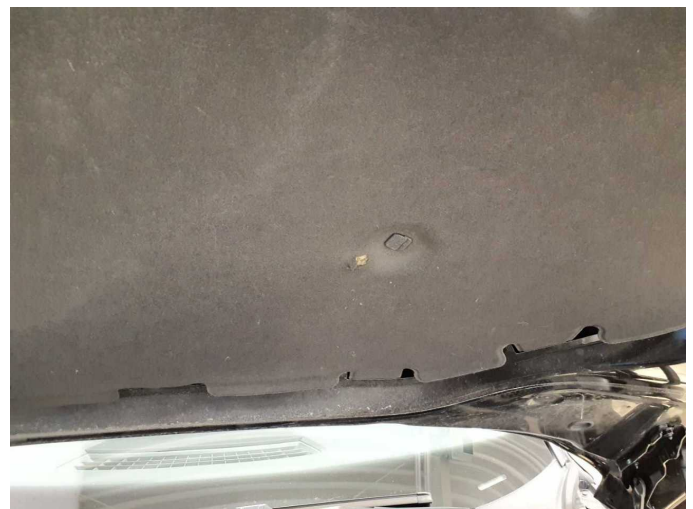
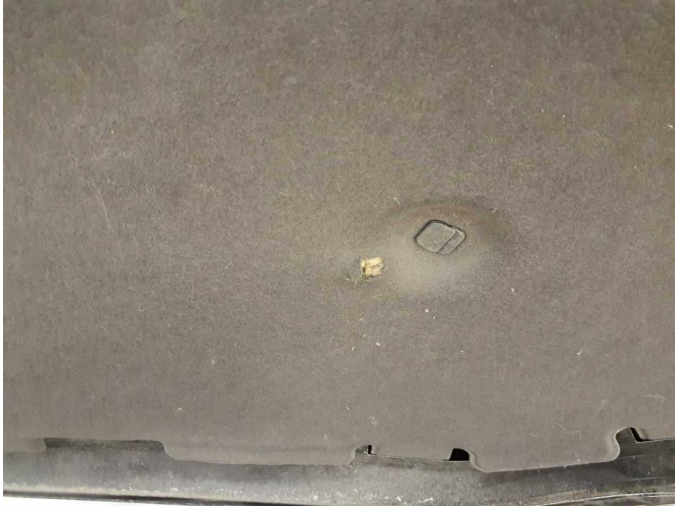
| No. | Component group | Description |
|---|---|---|
| 2 | Bonnet | Insulation lining - Broken / torn - Replace |

Damage 2: Bonnet: Insulation lining - Broken / torn - Replace

**Damage 2:** Bonnet: Insulation lining - Broken / torn - Replace

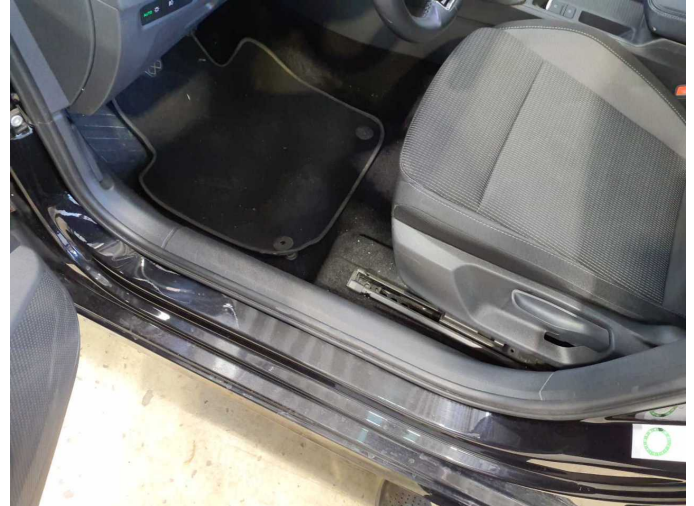
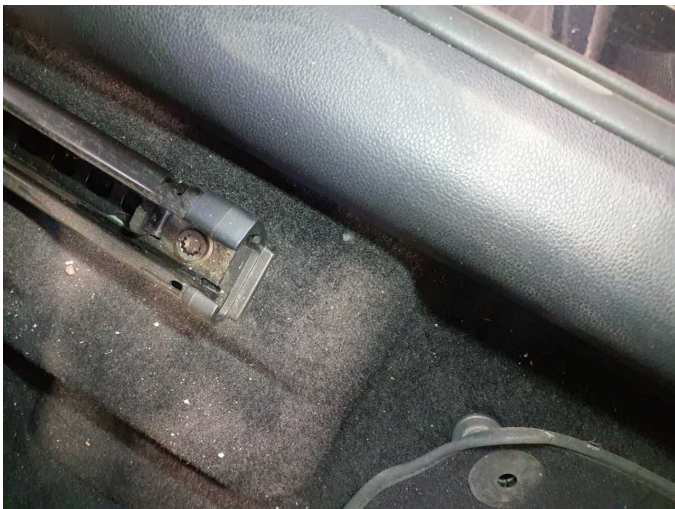
| No. | Component group | Description |
|---|---|---|
| 3 | Trim / covers | Carpet - front left side - Burn hole (cigarettes) - Smart repair |

**Damage 3:** Trim / covers: Carpet - front left side - Burn hole (cigarettes) - Smart repair

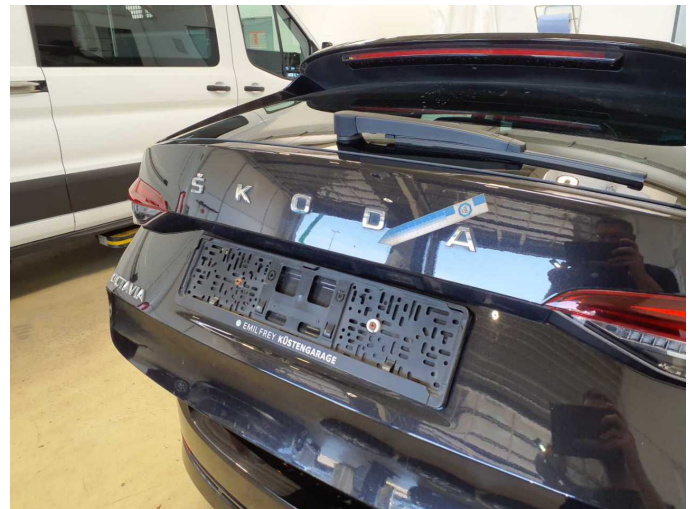
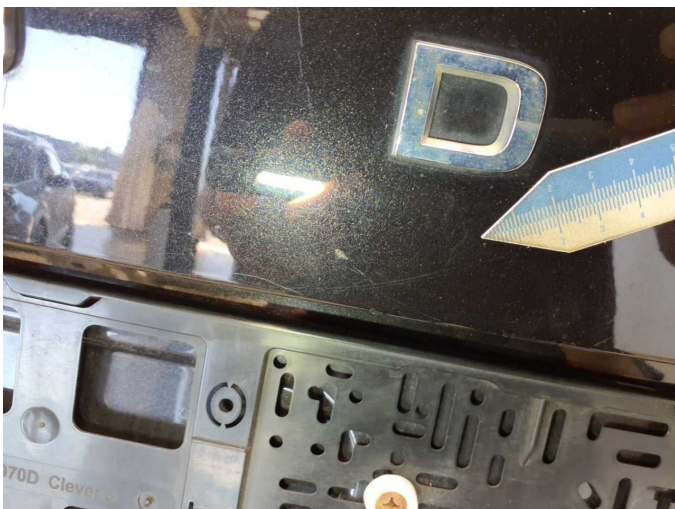
| No. | Component group | Description |
|---|---|---|
| 4 | Boot lid / rear door | Boot lid - Scratch(es) - Smart repair |

**Damage 4:** Boot lid / rear door: Boot lid - Scratch(es) - Smart repair

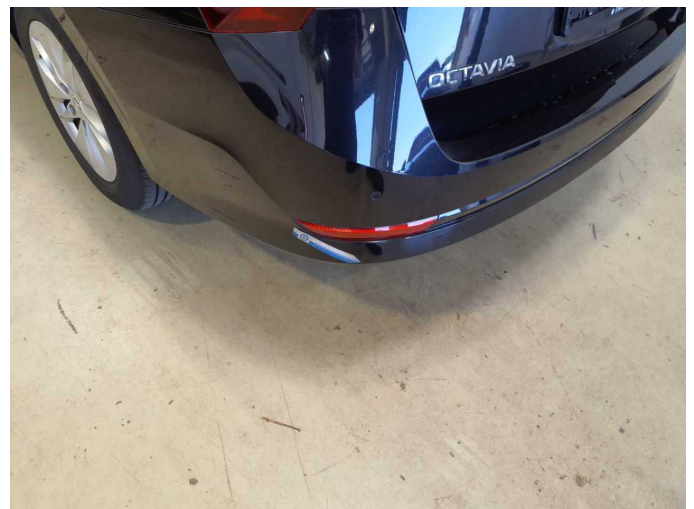
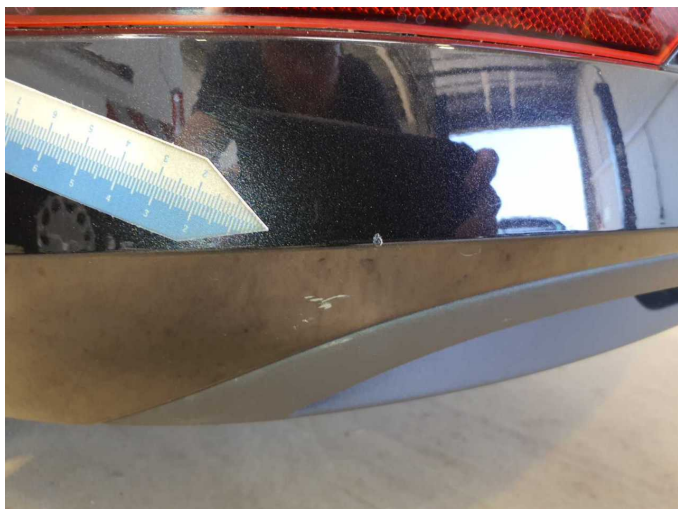
| No. | Component group | Description |
|---|---|---|
| 5 | Rear bumper | Rear bumper - Scratch(es) - Smart repair |

**Damage 5:** Rear bumper: Rear bumper - Scratch(es) - Smart repair

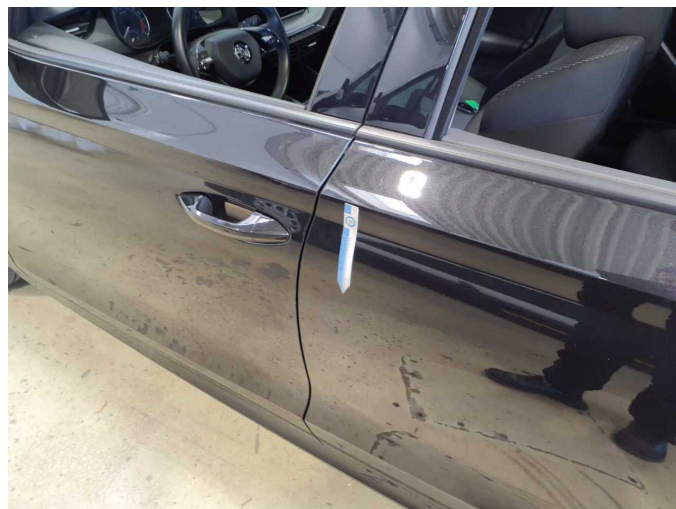
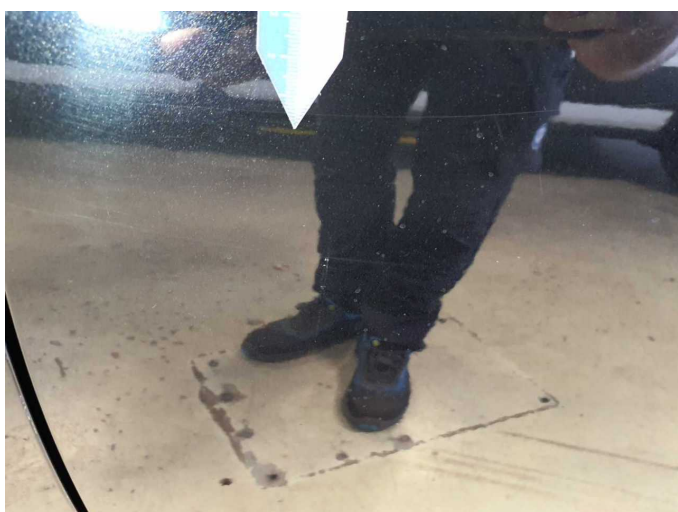
| No. | Component group | Description |
|---|---|---|
| 6 | Door - rear left side | Door - Scratch(es) - Smart repair |

**Damage 6:** Door - rear left side: Door - Scratch(es) - Smart repair

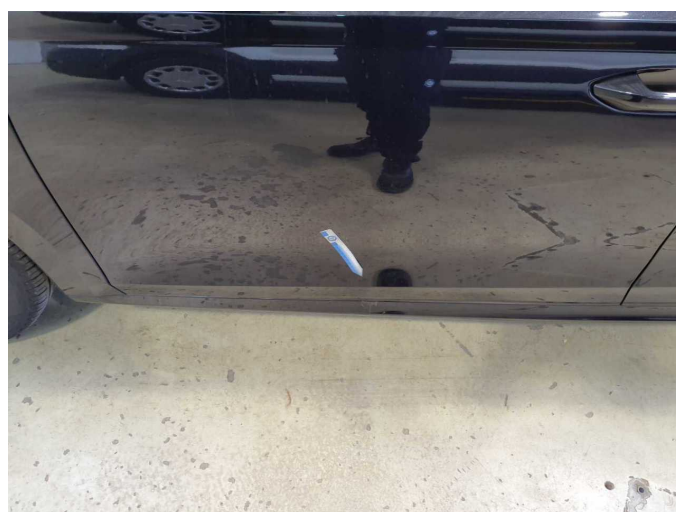
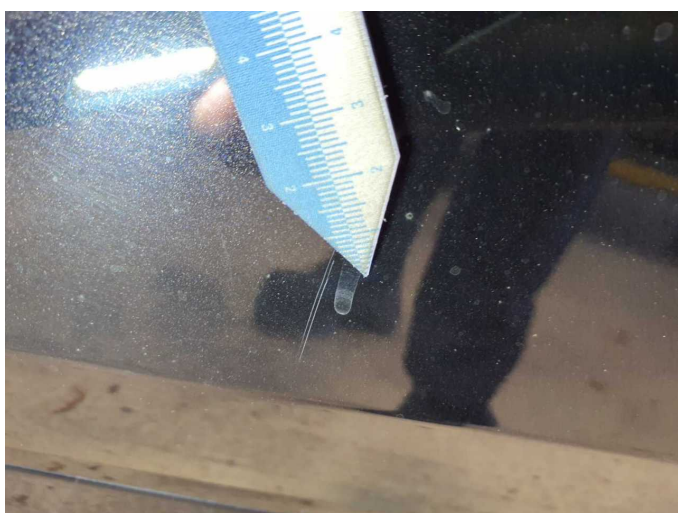
| No. | Component group | Description |
|---|---|---|
| 7 | Door - front left side | Door - Scratch(es) - Smart repair |

**Damage 7:** Door - front left side: Door - Scratch(es) - Smart repair

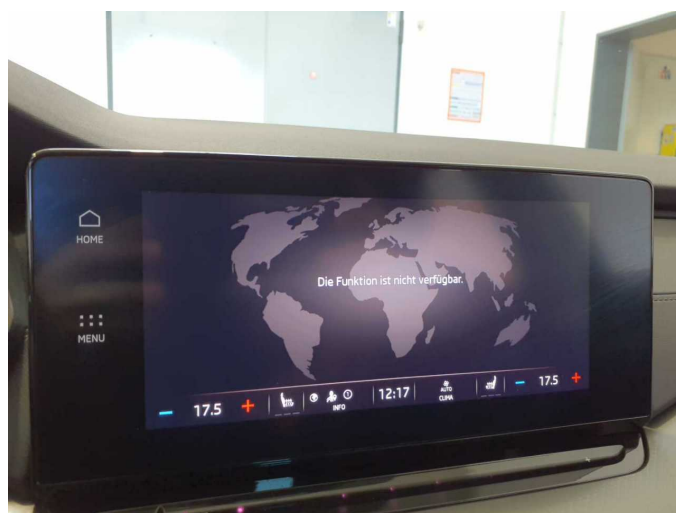
| No. | Component group | Description |
|---|---|---|
| 8 | Multimedia system | Navigation system - Functional / admissibility - Perform diagnosis |

**Damage 8:** Multimedia system: Navigation system - Functional / admissibility - Perform diagnosis

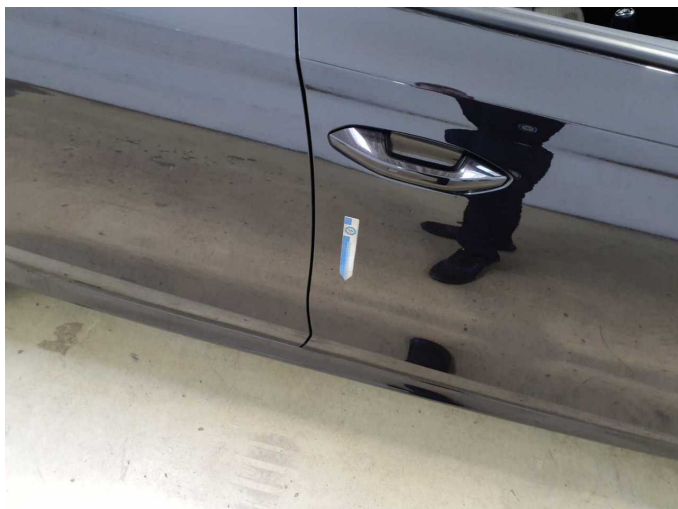
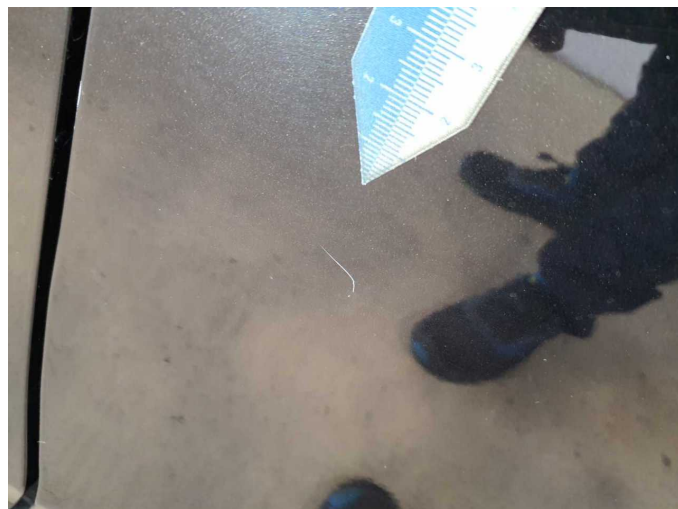
| No. | Component group | Description |
|---|---|---|
| 9 | Door - front right side | Door - Scratch(es) - Loss in value |

**Damage 9:** Door - front right side: Door - Scratch(es) - Loss in value

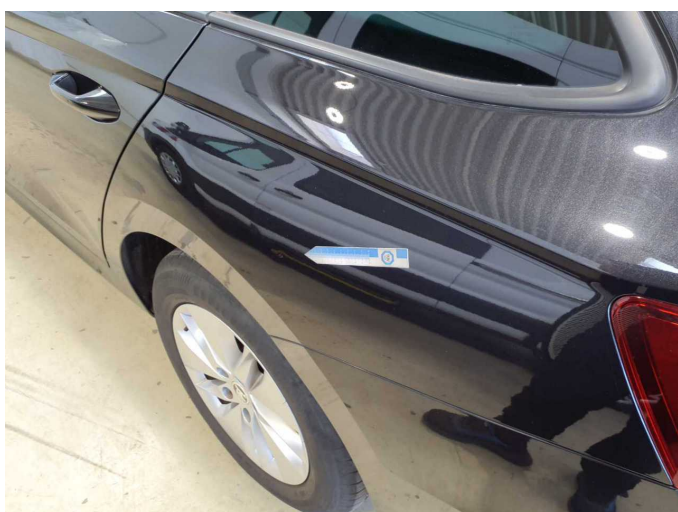
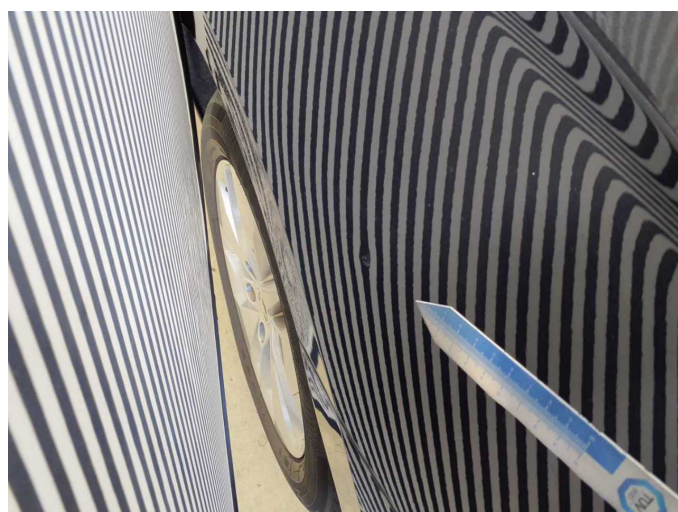
| No. | Component group | Description |
|---|---|---|
| 10 | Side panel - rear left side | Side panel - Dent / paintcoat damage - Smart repair |

**Damage 10:** Side panel - rear left side: Side panel - Dent / paintcoat damage - Smart repair

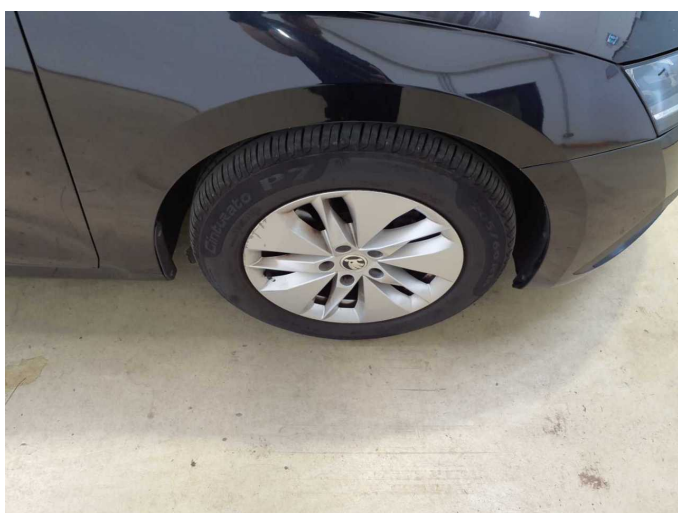
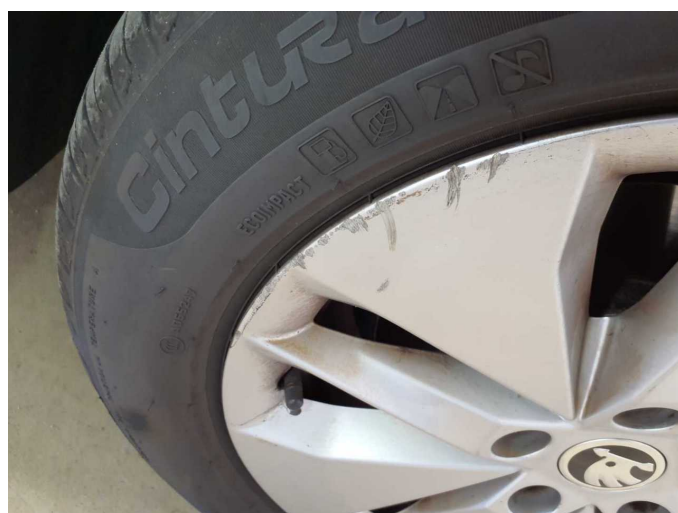
| No. | Component group | Description |
|---|---|---|
| 11 | Wheel / tyres | Alloy rim - front right side - Scratch(es) - Replace |

**Damage 11:** Wheel / tyres: Alloy rim - front right side - Scratch(es) - Replace

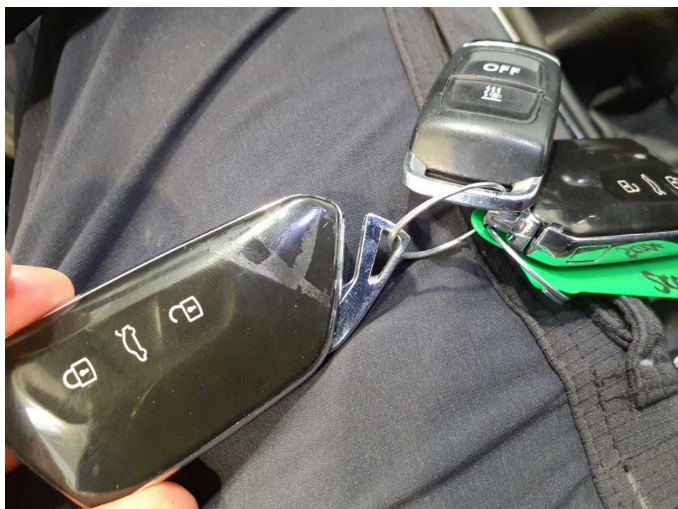
| No. | Component group | Description |
|---|---|---|
| 12 | Equipment | Vehicle key - Broken / torn - Replace |

**Damage 12:** Equipment: Vehicle key - Broken / torn - Replace

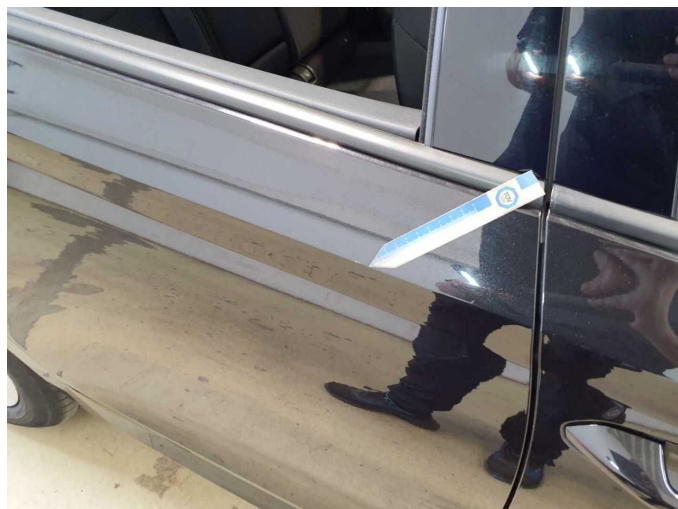
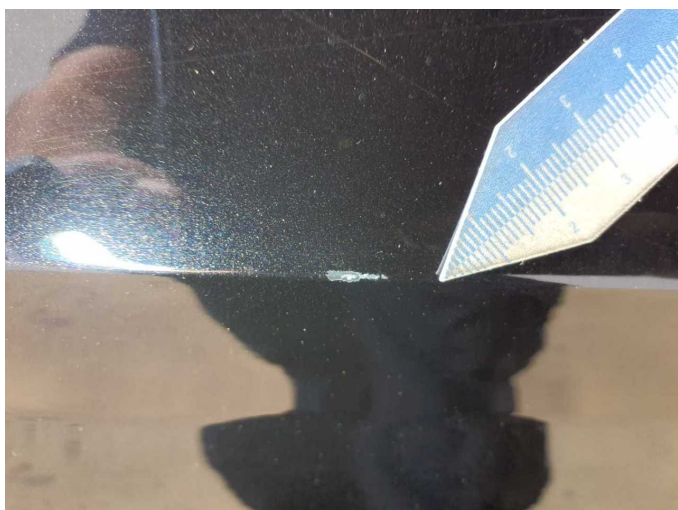
| No. | Component group | Description |
|---|---|---|
| 13 | Door - rear right side | Door - Scratch(es) - Paint |

**Damage 13:** Door - rear right side: Door - Scratch(es) - Paint

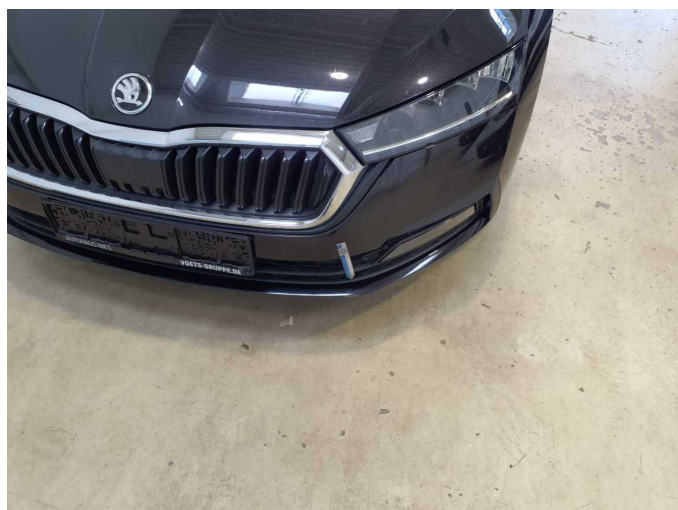
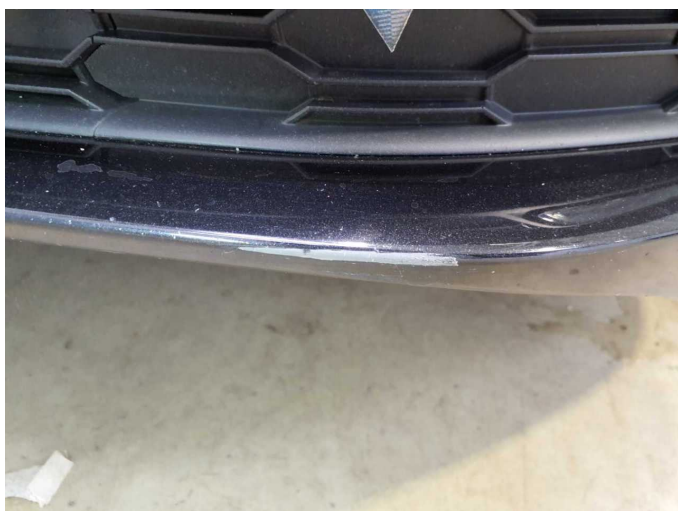
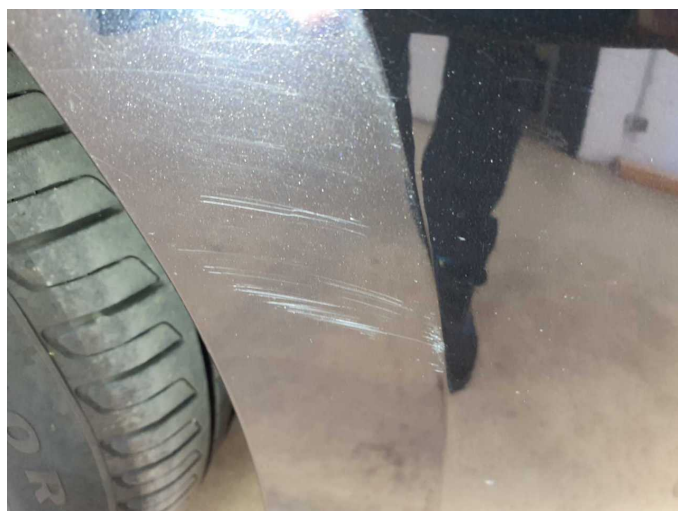
| No. | Component group | Description |
|---|---|---|
| 14 | Front bumper | Front bumper - Scratch(es) - Paint |

**Damage 14:** Front bumper: Front bumper - Scratch(es) - Paint

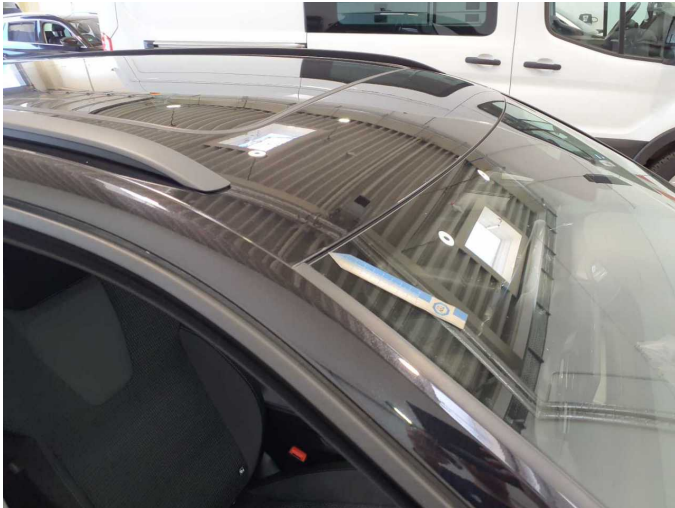
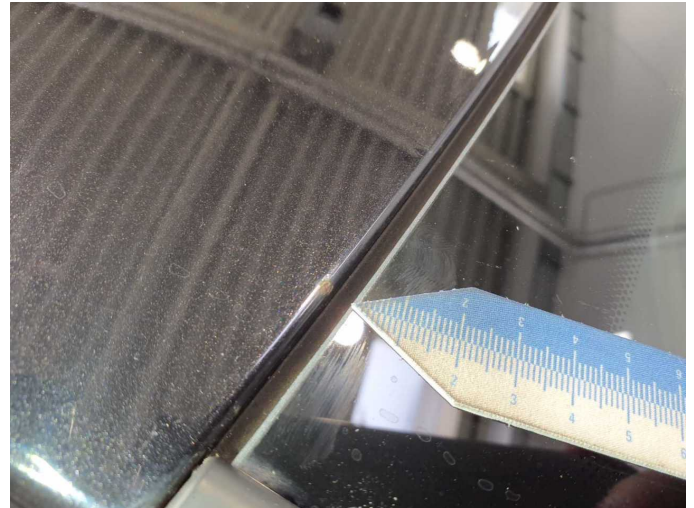
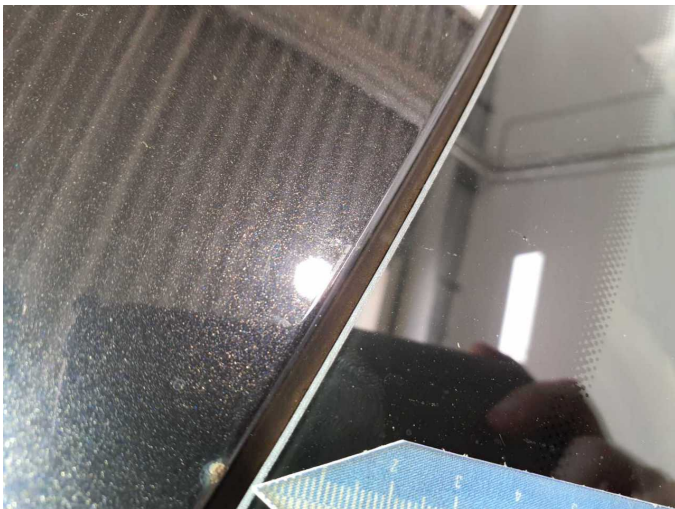
| No. | Component group | Description |
|---|---|---|
| 15 | Roof | Roof - Scratch(es) - Repair and paint |

**Damage 15:** Roof: Roof - Scratch(es) - Repair and paint
