Expertise

Protocol number: 46167146
Order No. / Reference: 26509866
Inspection date: 25 Jun 2026

Manufacturer: Nissan

Model: Leaf 62 kWh e+ N-Connecta

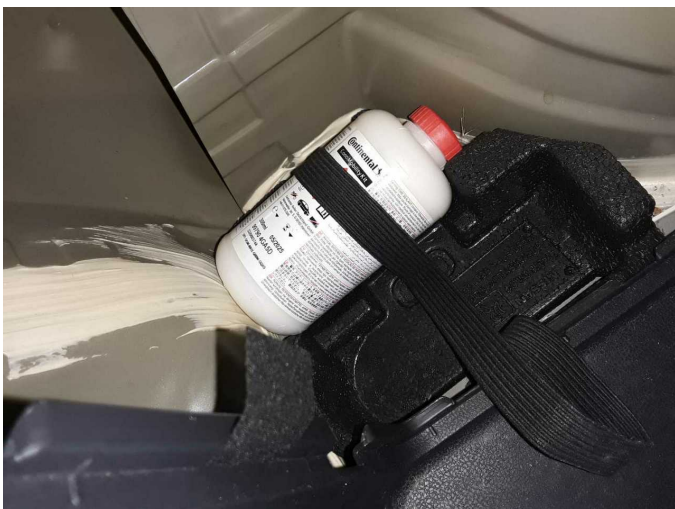
Damage 1: Equipment: Tirefit filler - Due - Replace

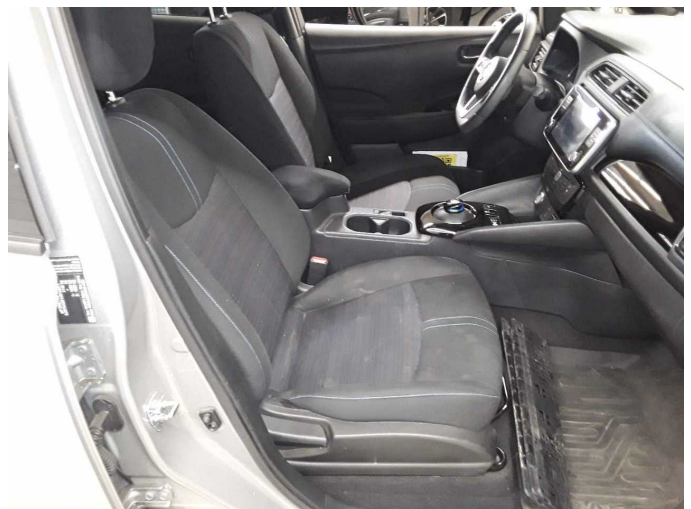
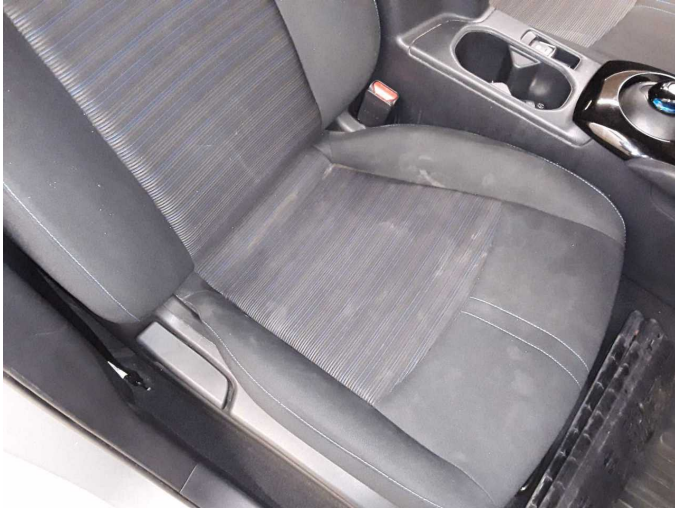
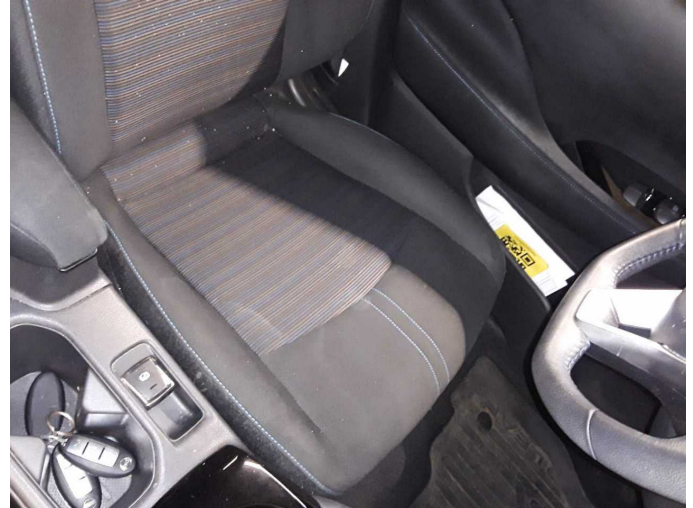
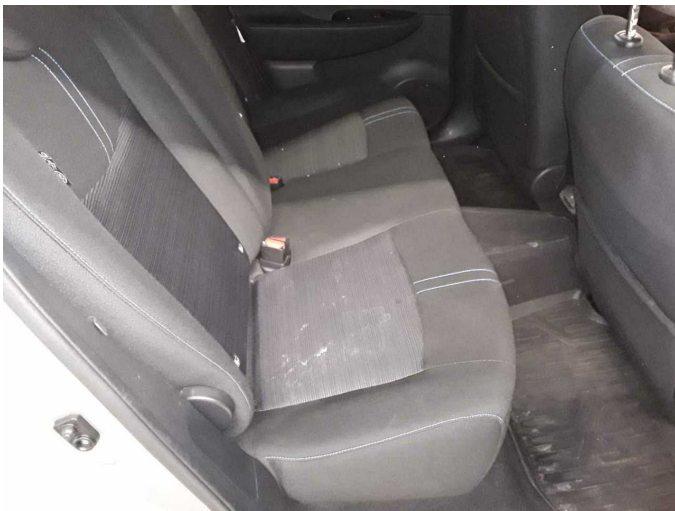
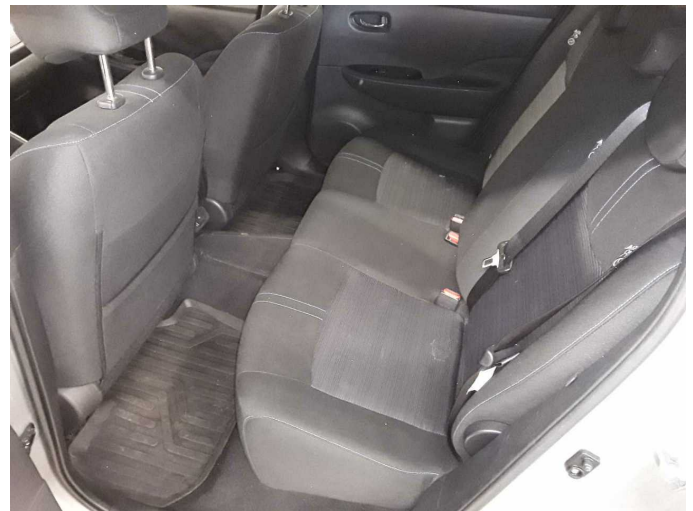
Damage 2: Seat - front: Seat cover - right side (Sitze) - Soiled - Clean

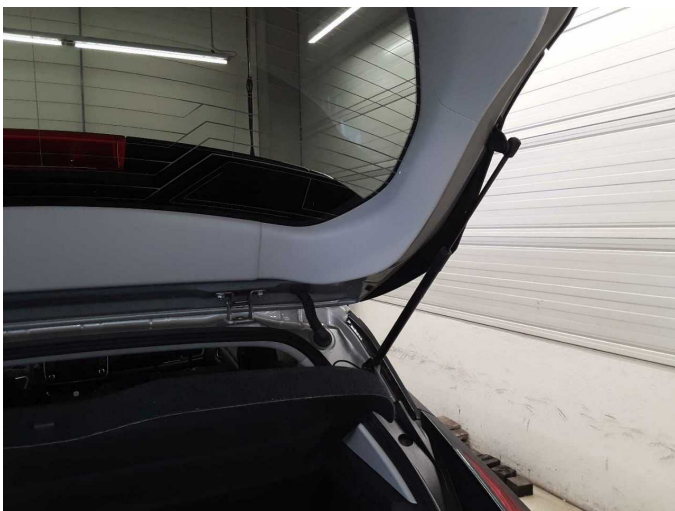
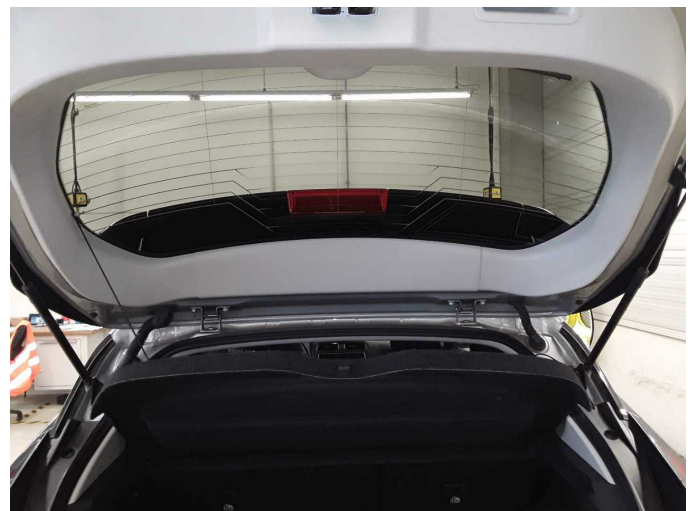
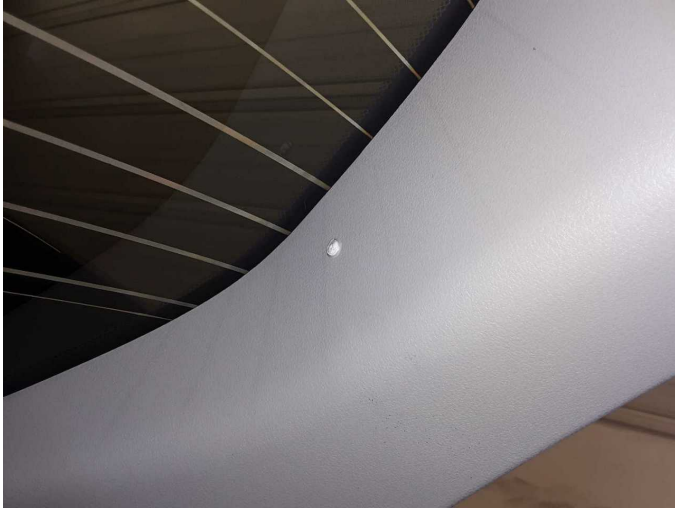
Damage 3: Boot lid / rear door: Trim standard - upper (Rechts mit Halter) - Broken / torn - Replace

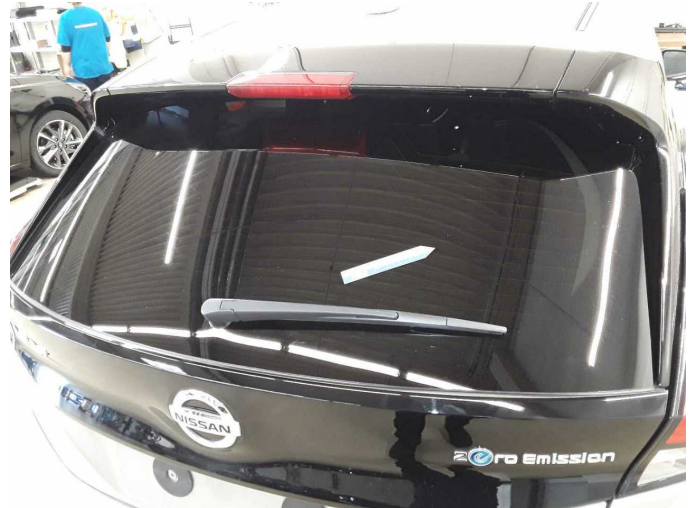
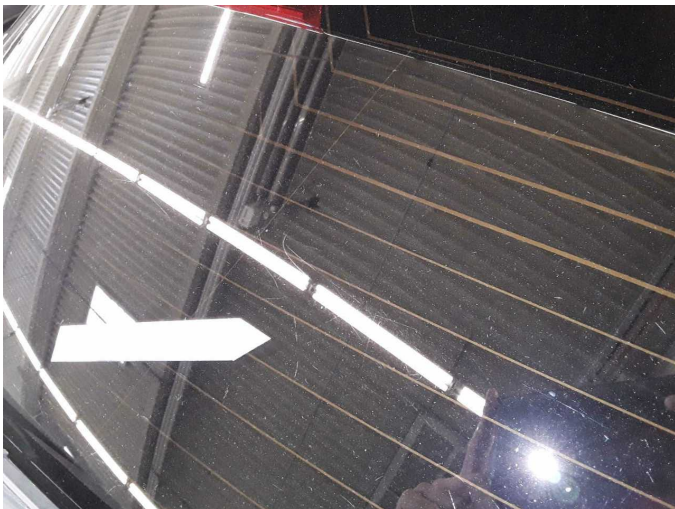
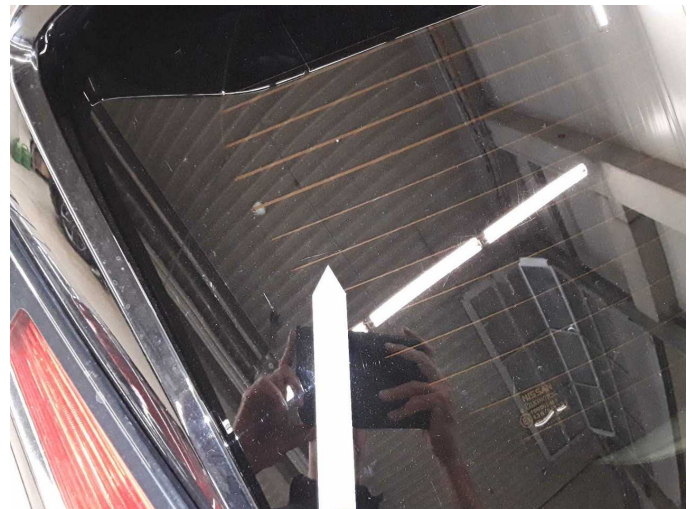
Damage 4: Vehicle glazing: Rear window - Scratch(es) - Loss in value

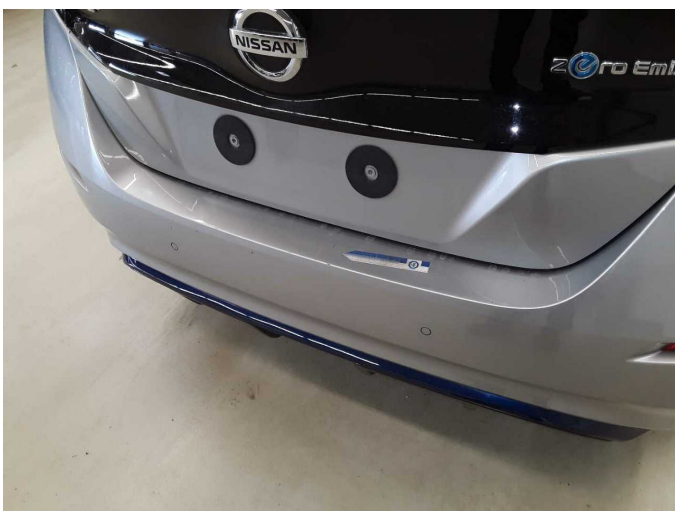
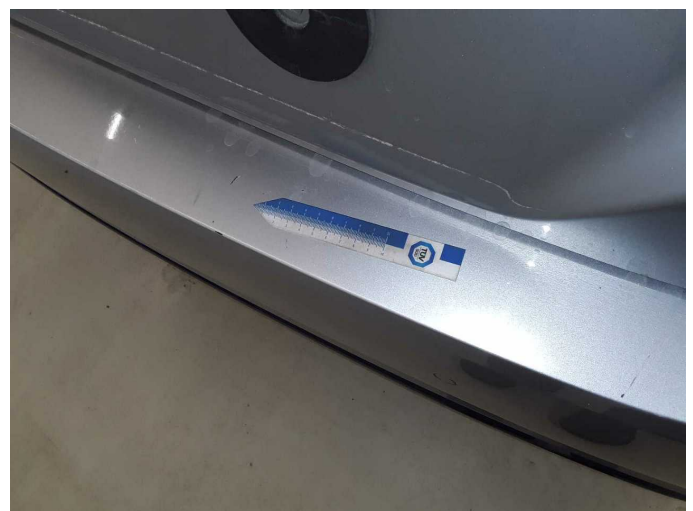
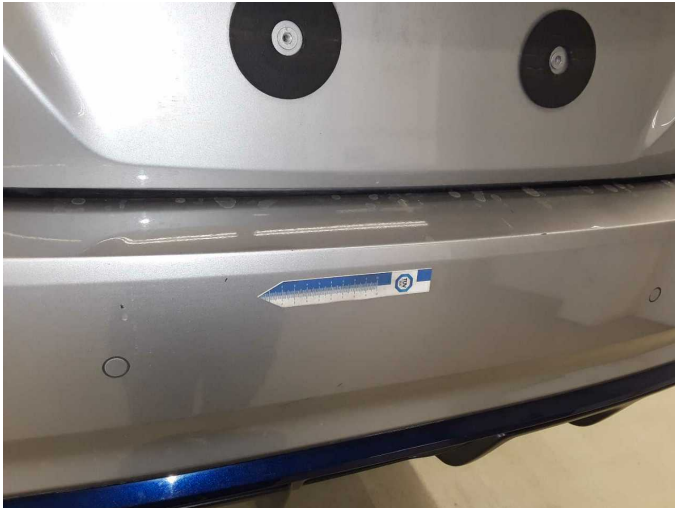
Damage 5: Rear bumper: Rear bumper - Scratch(es) - Smart repair

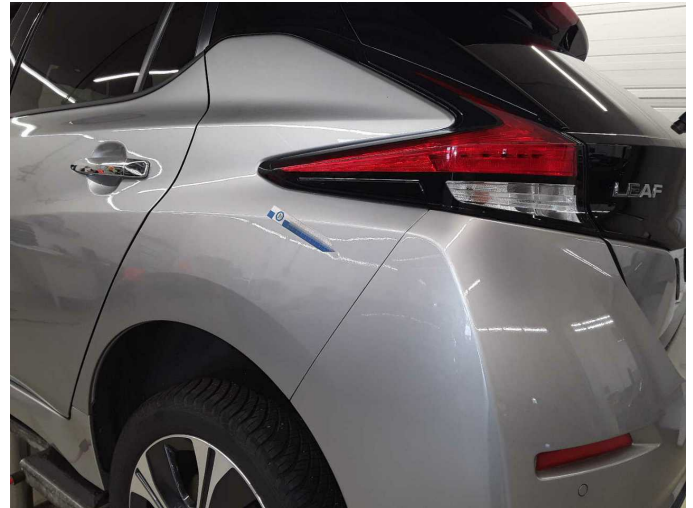
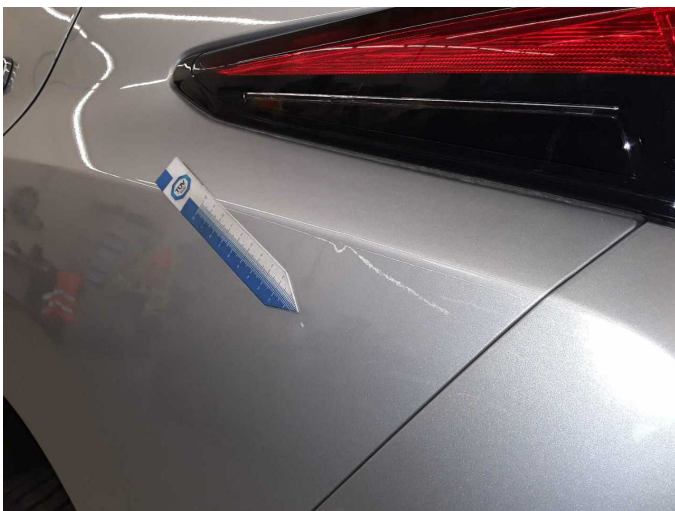
Damage 6: Side panel - rear left side: Side panel - Dent / paintcoat damage - Smart repair

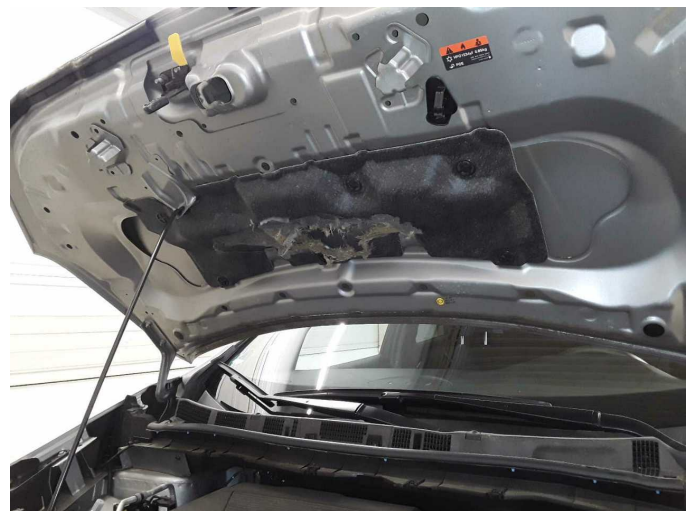
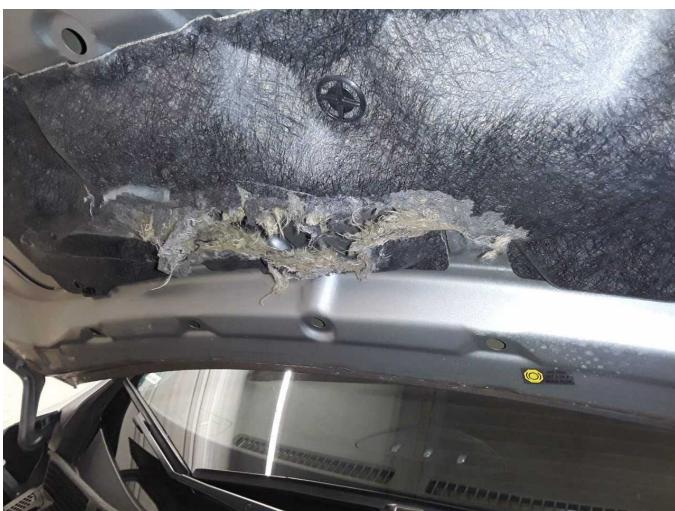
Damage 7: Bonnet: Insulation lining - Broken / torn - Replace

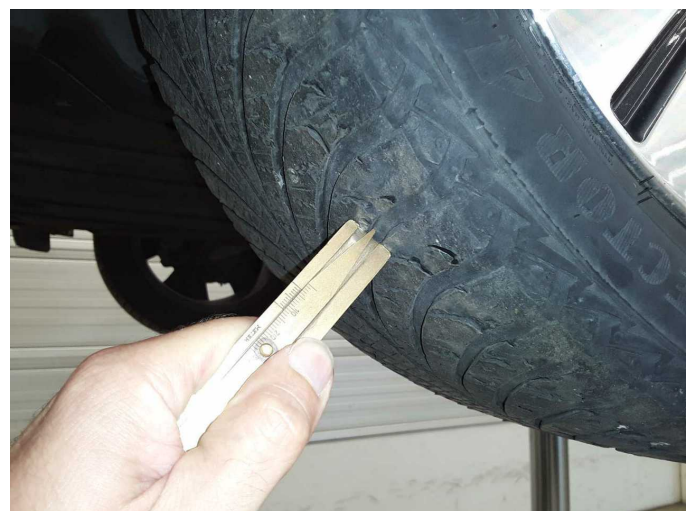
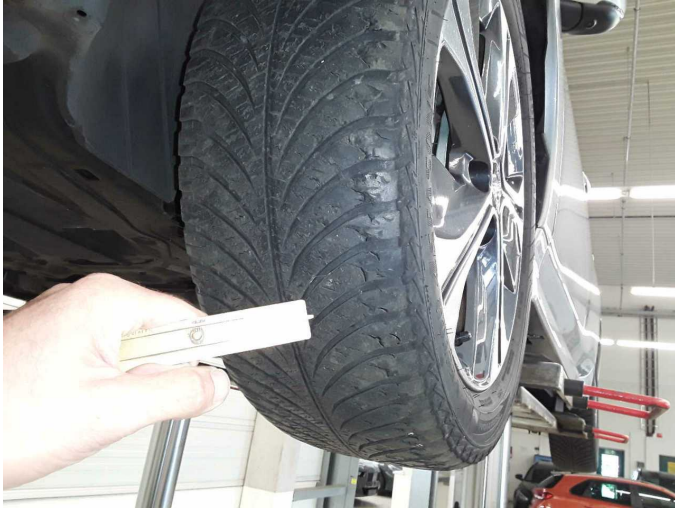
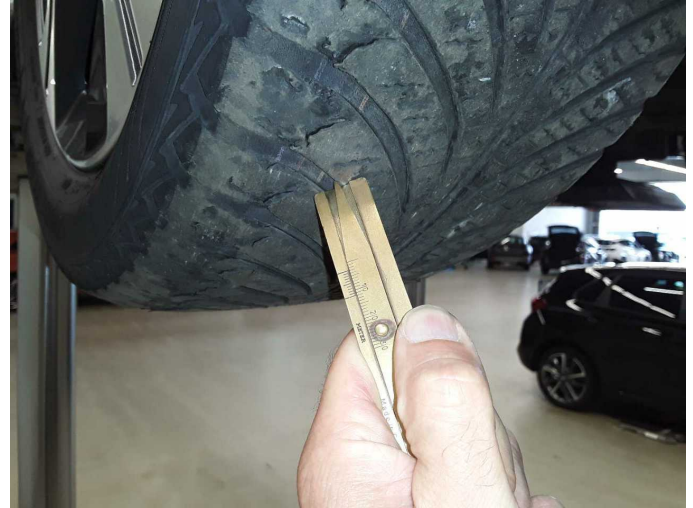
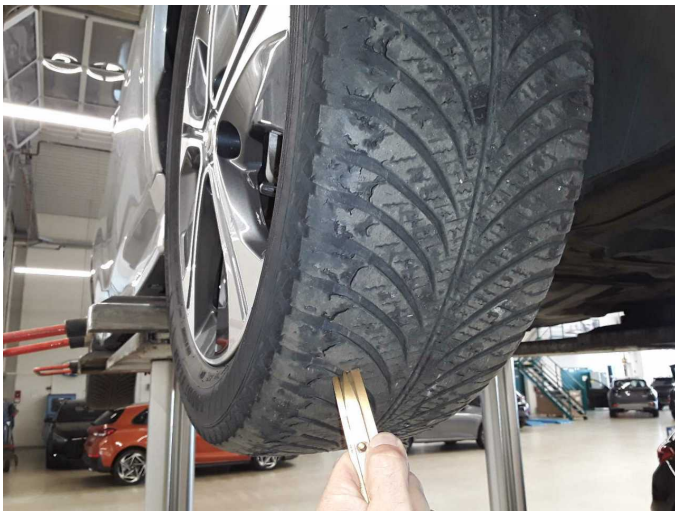
Damage 8: Wheel / tyres: Tyre - front - Does not meet the leasing specifications - Replace

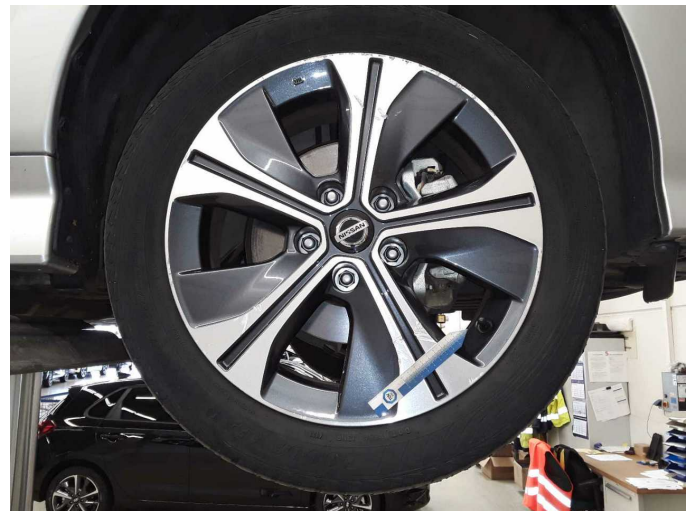
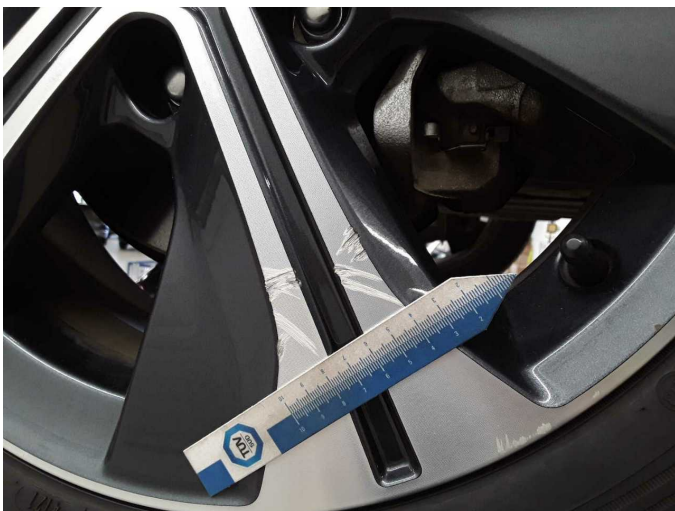
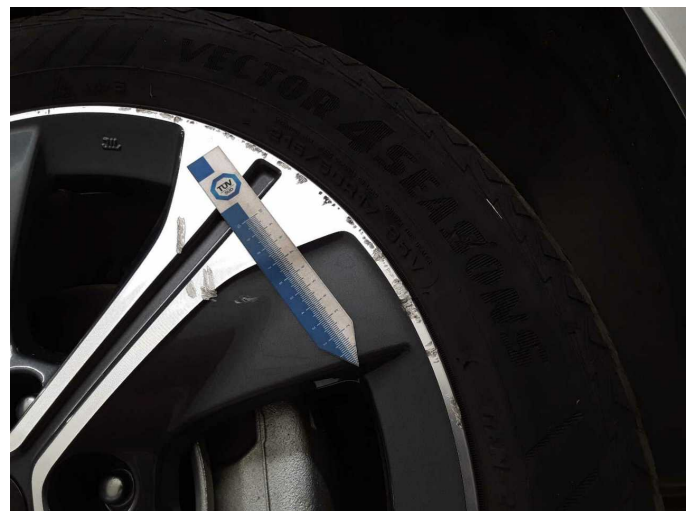
Damage 9: Wheel / tyres: Alloy rim - front right side - Scratched - Replace

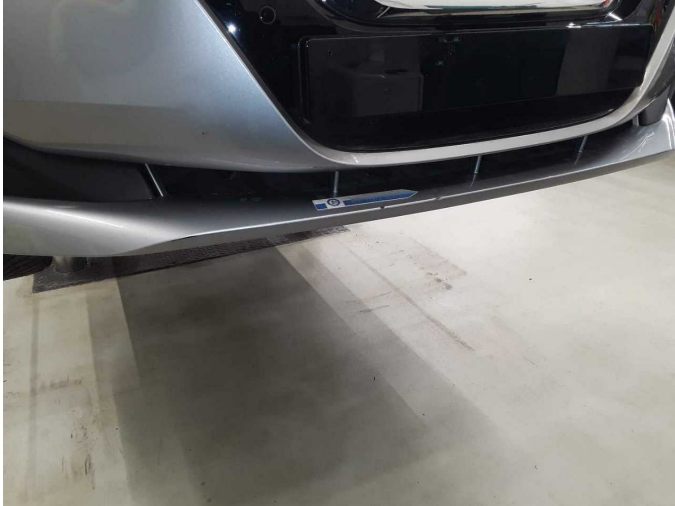
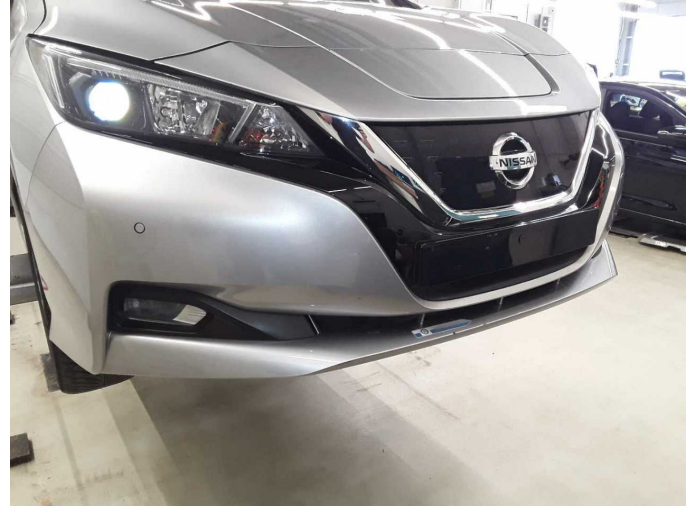
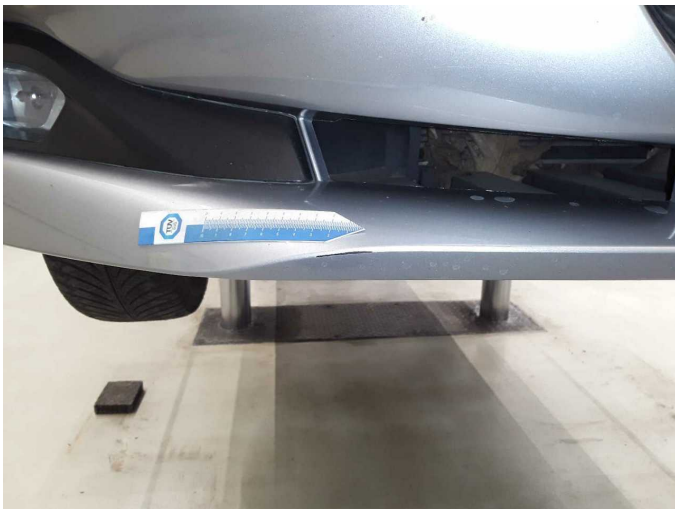
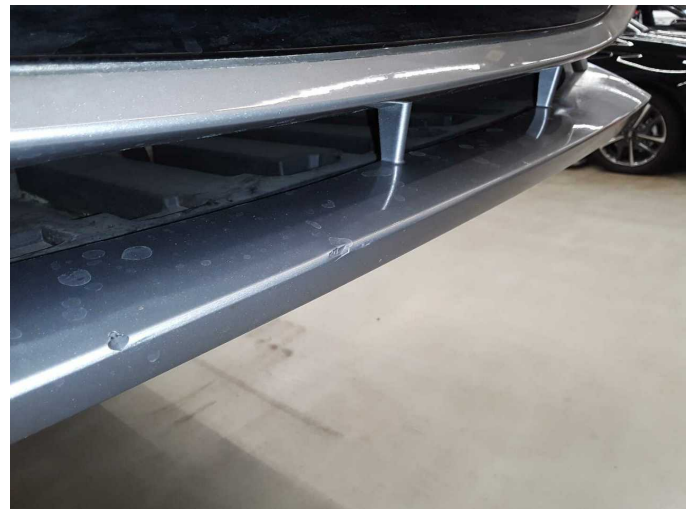
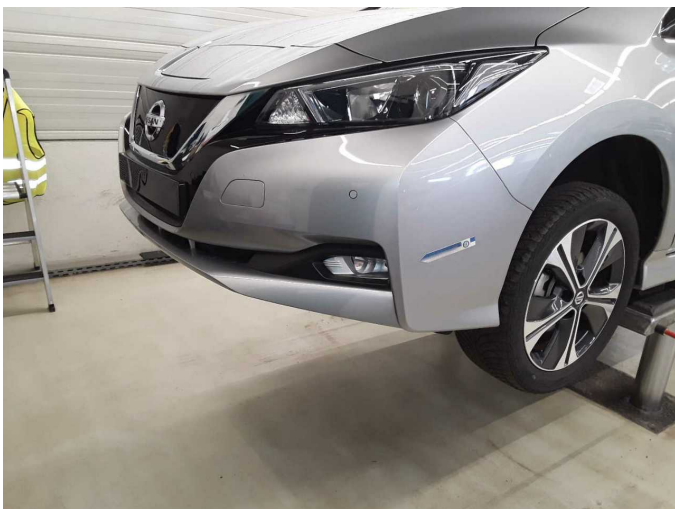
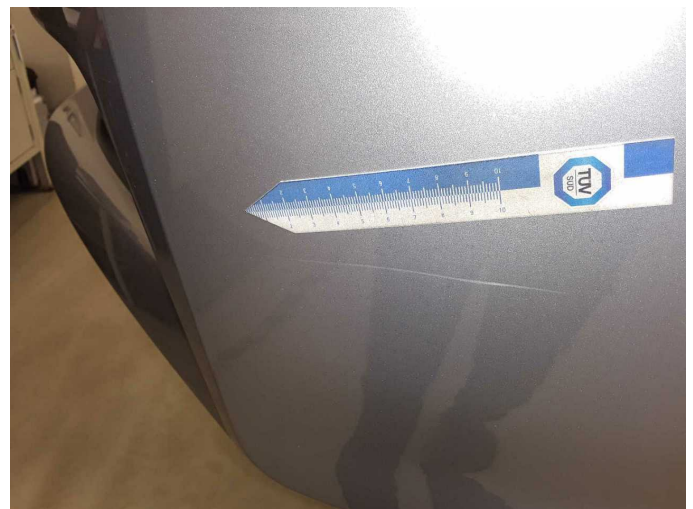
Damage 10: Front bumper: Front bumper - Scratched - Repair and paint

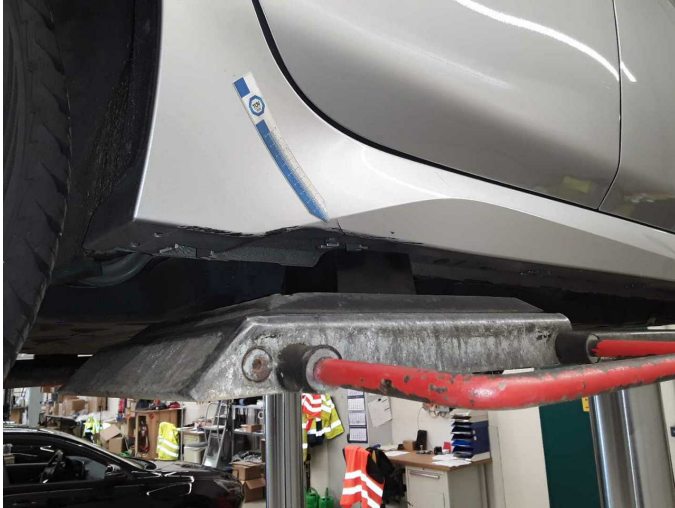
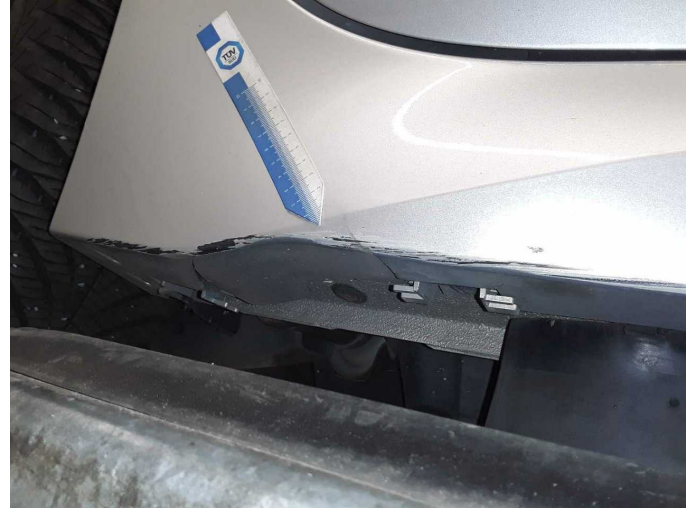
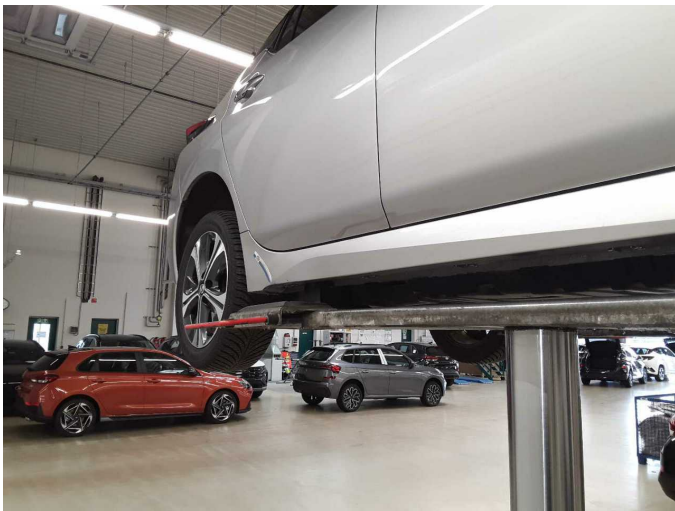
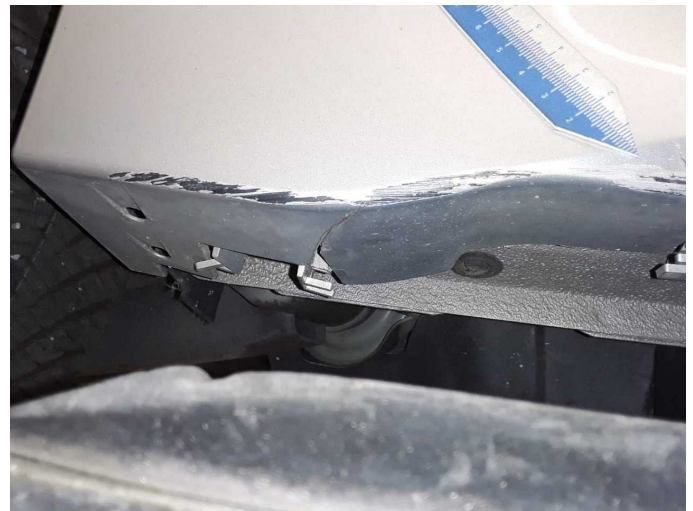
Damage 11: Sill - right side: Trim - Broken / torn - Replace

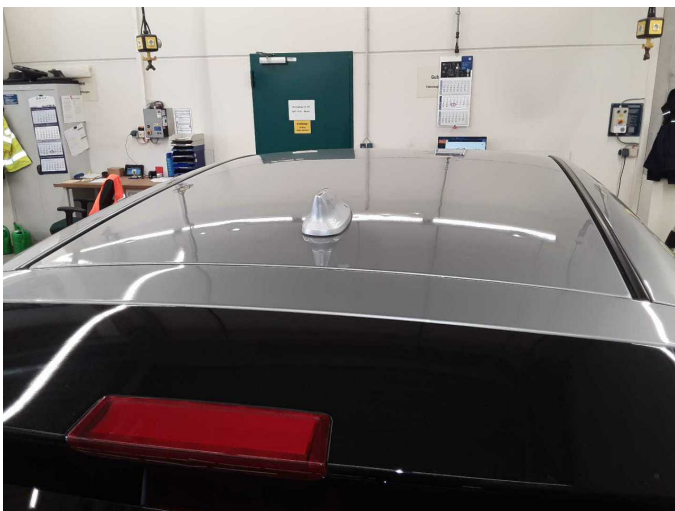
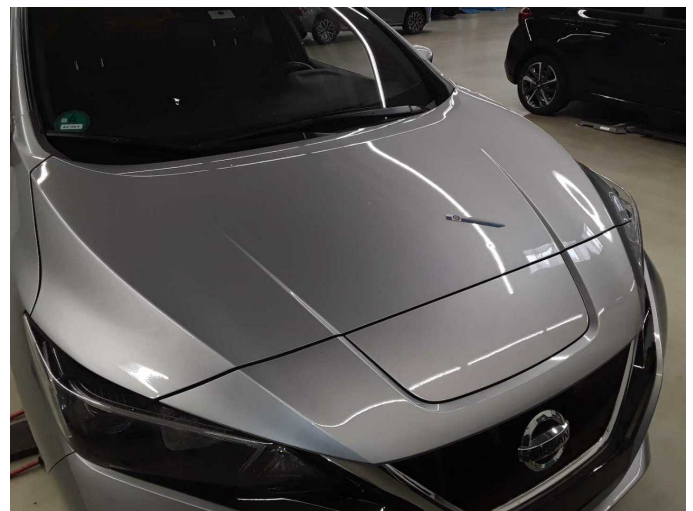
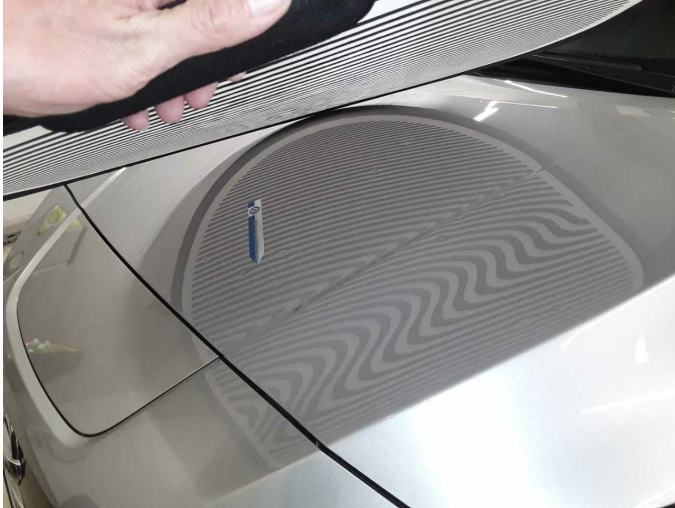
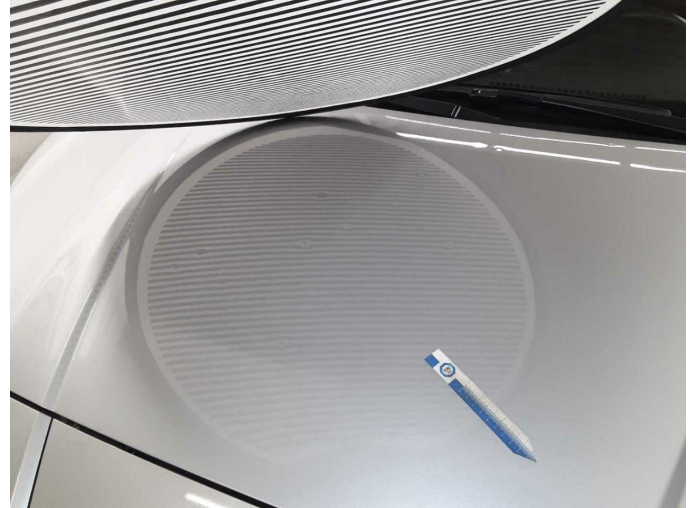
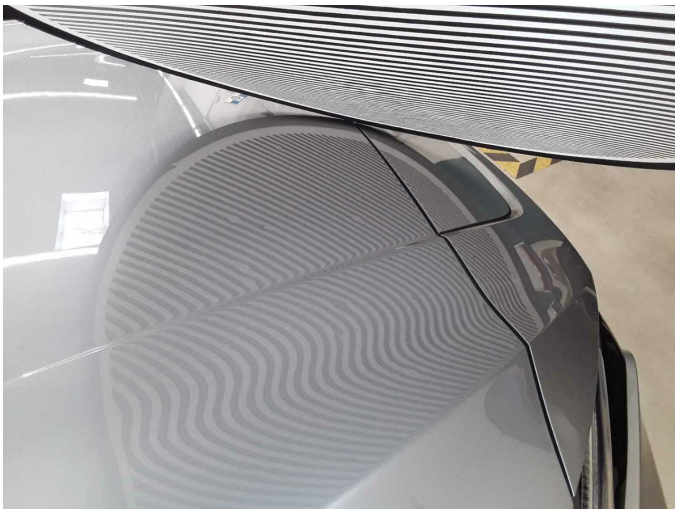
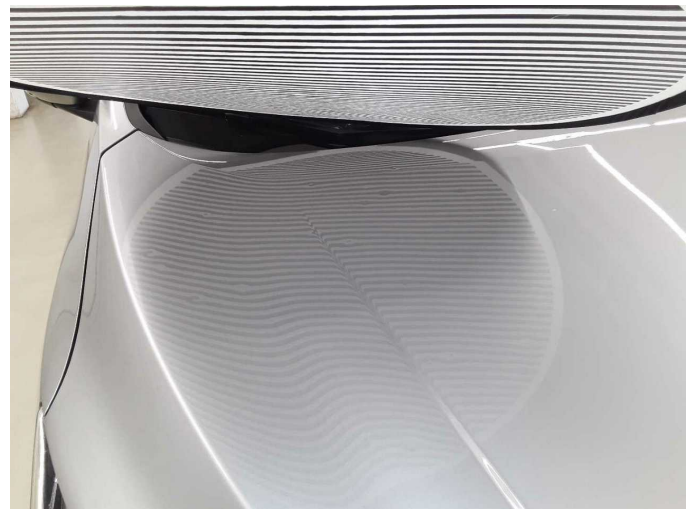
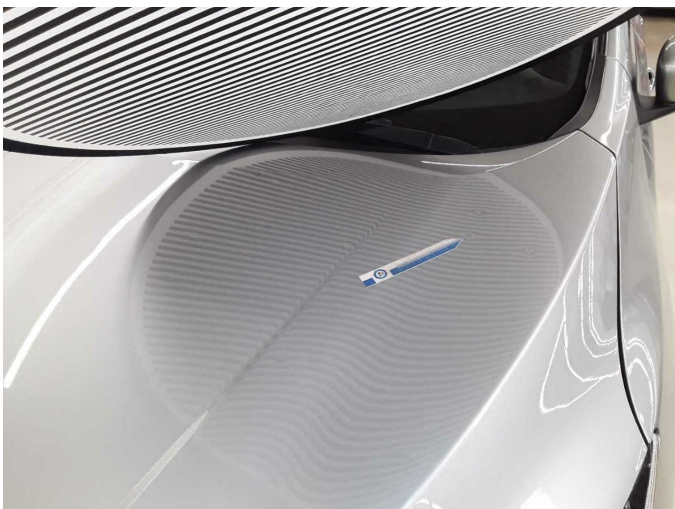
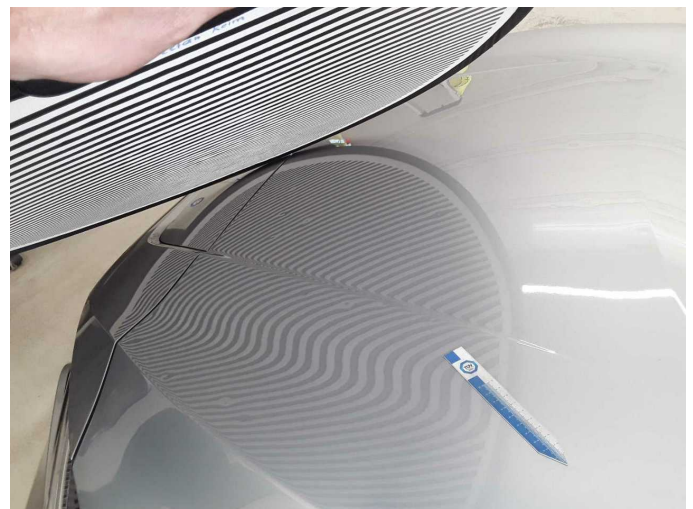
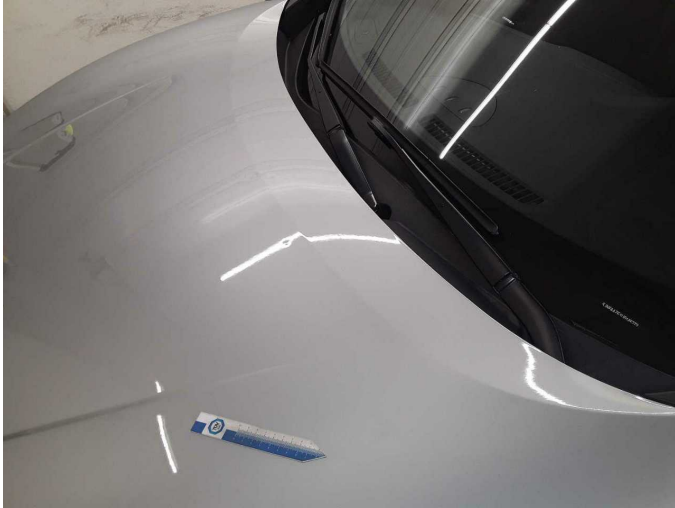
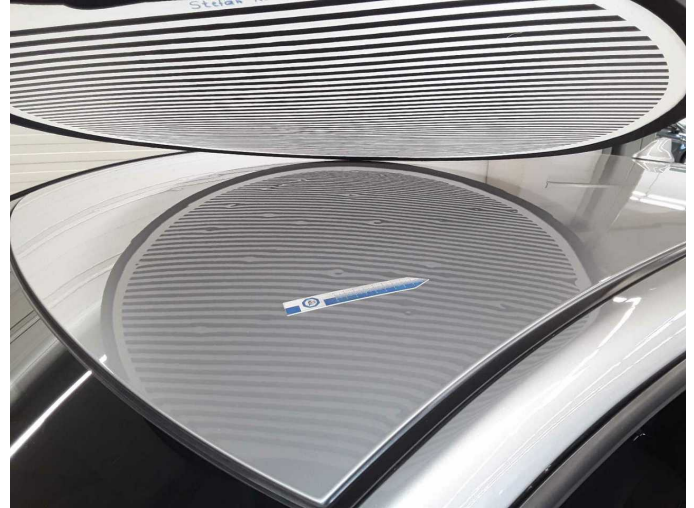
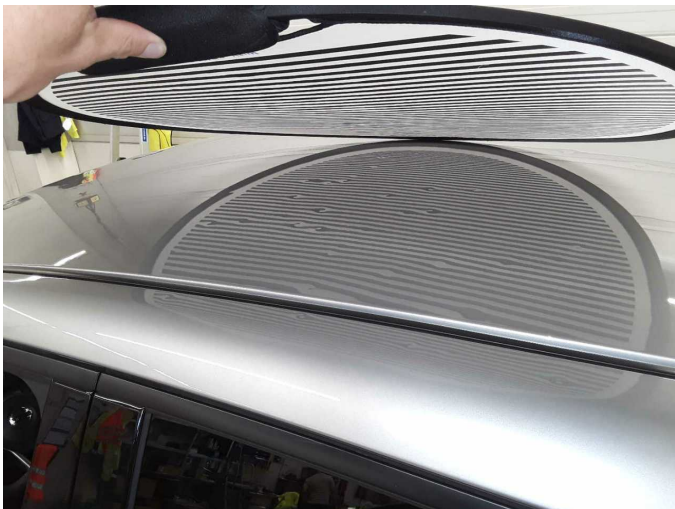
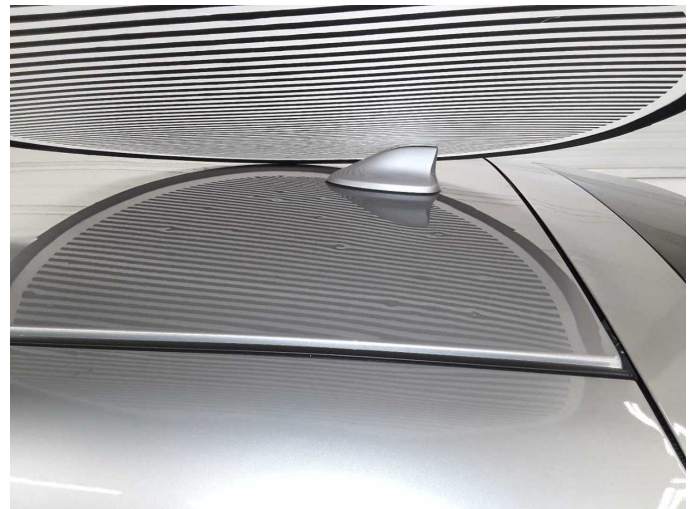
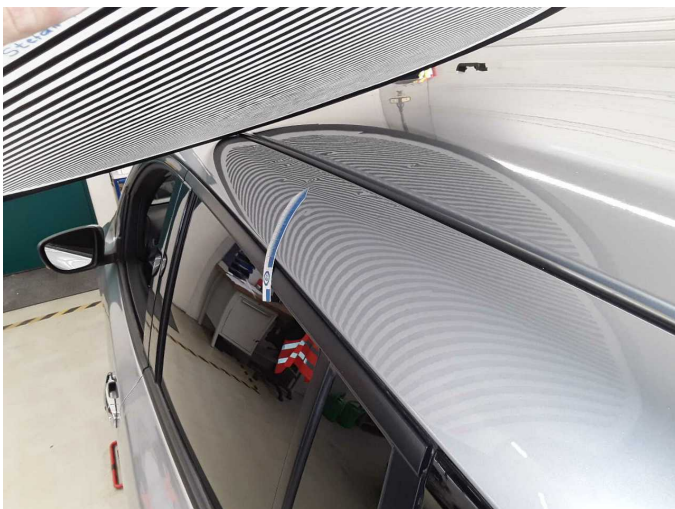
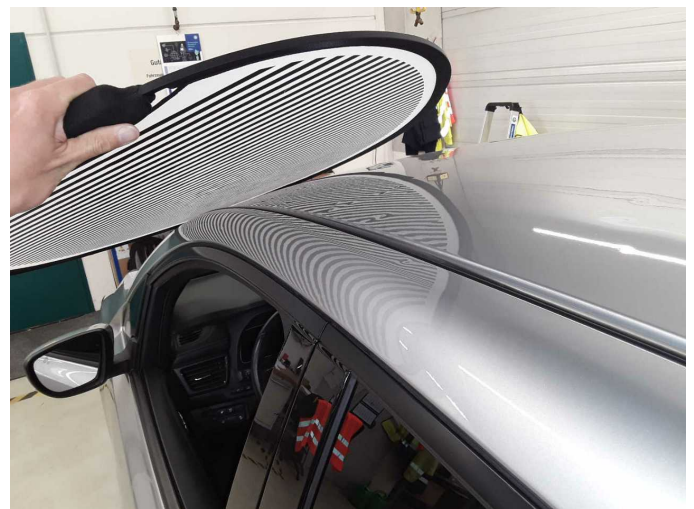
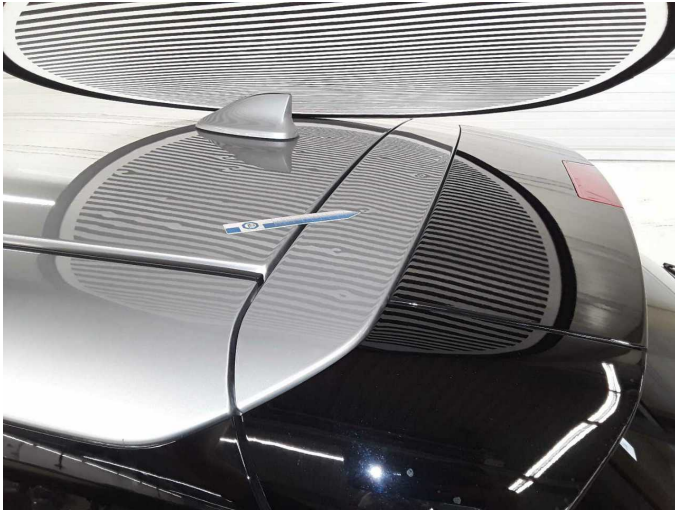
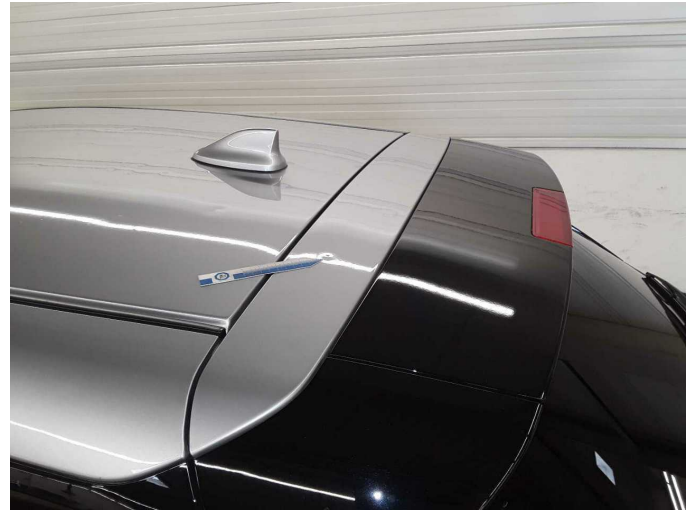
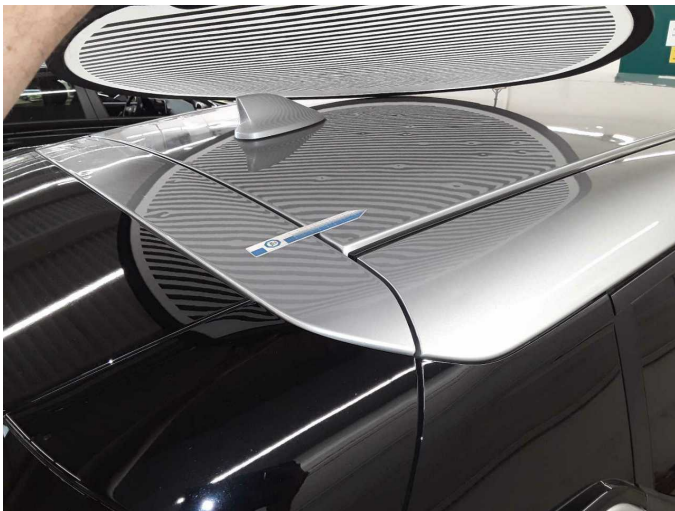
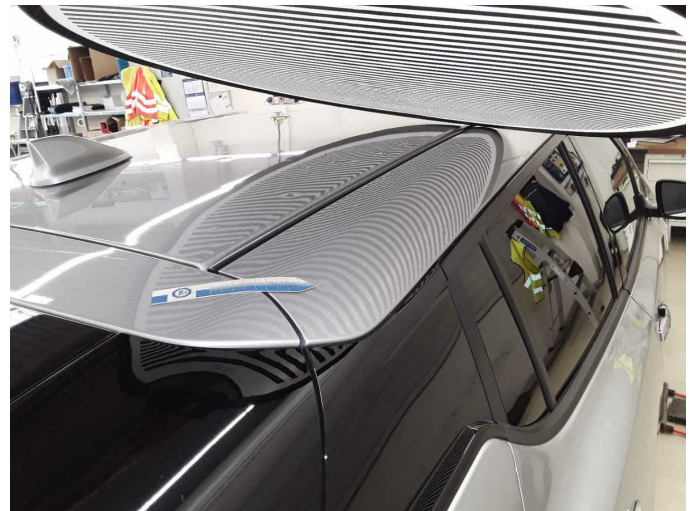
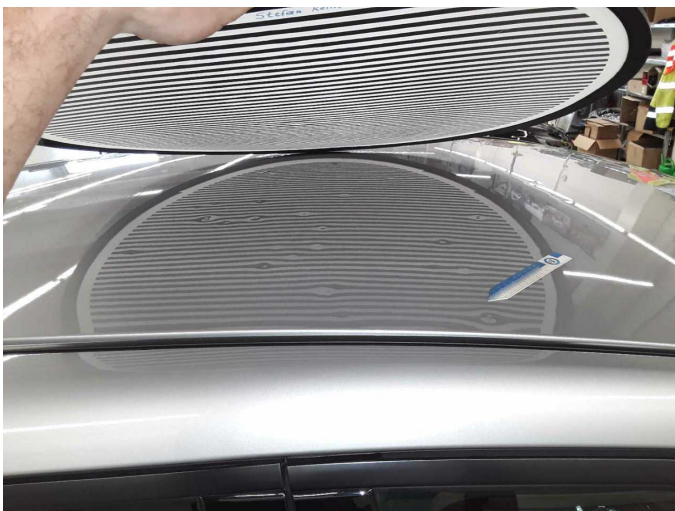
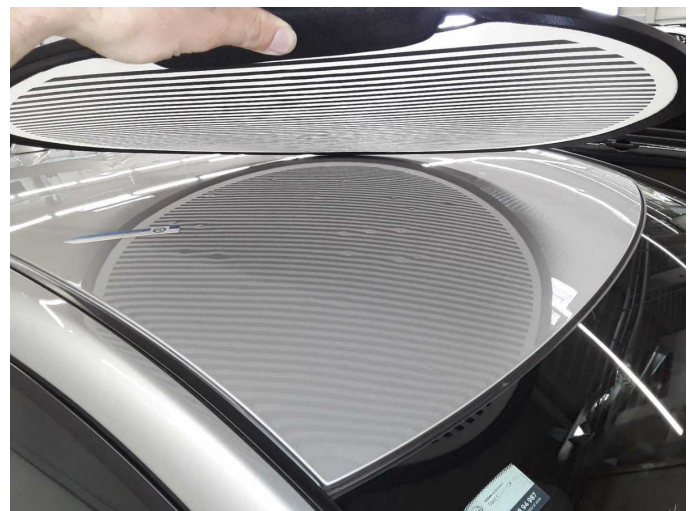
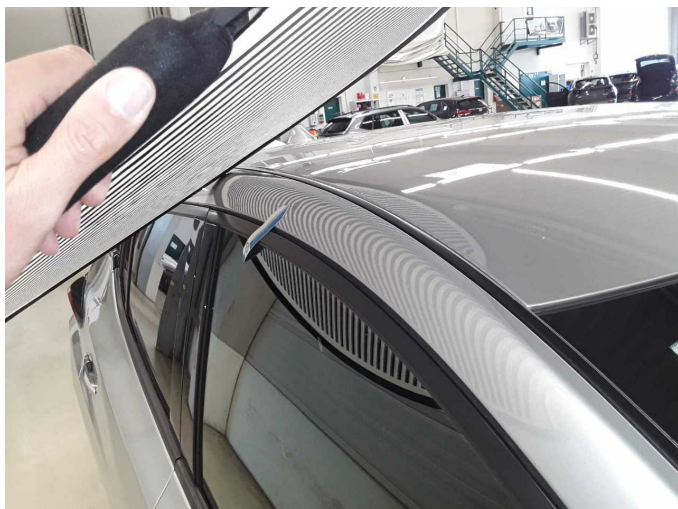
Damage 12: Body: Body (Hagelschaden) - dent(s) - Repair

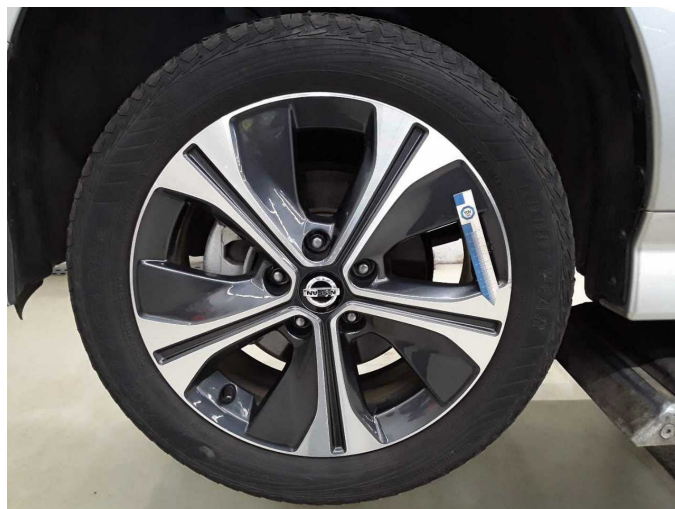
Wear and tear 1: Wheel / tyres: Alloy rim - front left side - Scratch(es) - No deduction
