Expertise

Protocol number: 46363508
Order No. / Reference: 26505209
Inspection date: 6 Jul 2026

Manufacturer: Volkswagen

Model: Multivan 2,0 TDI SCR KÜ Life

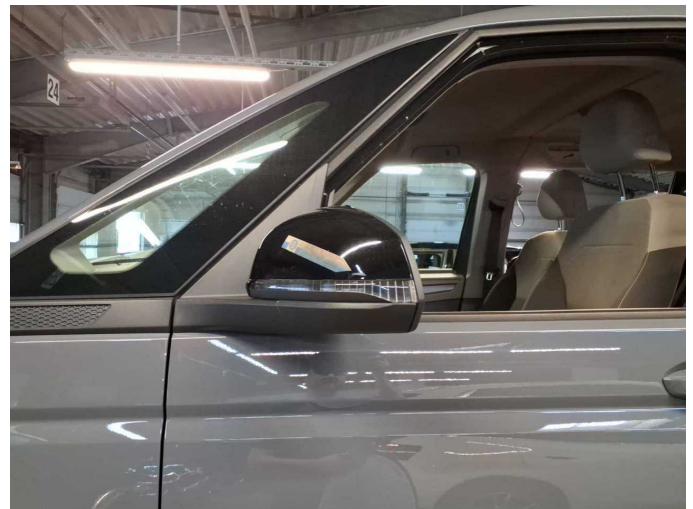
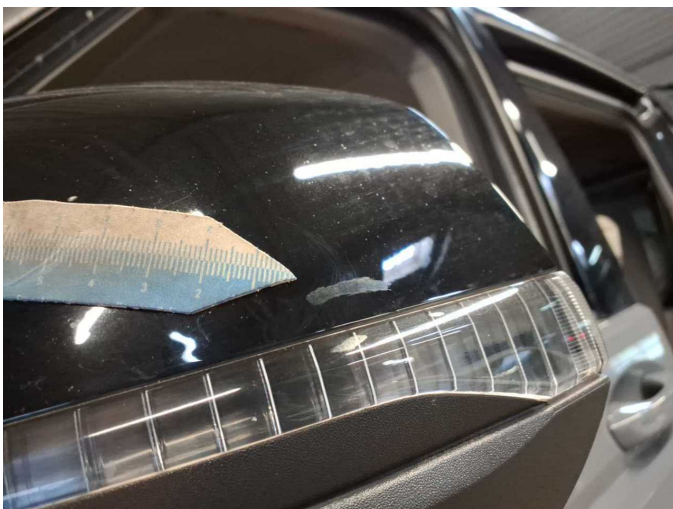
Damage 1: Wing mirror - left side: Cap - Scratch(es) - Smart repair

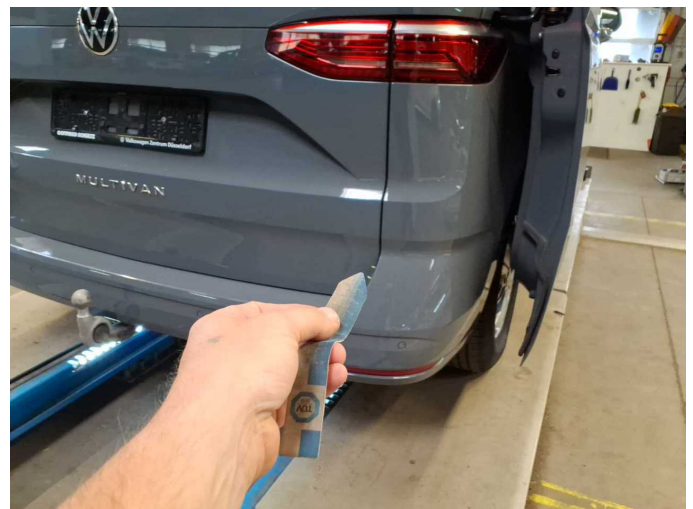
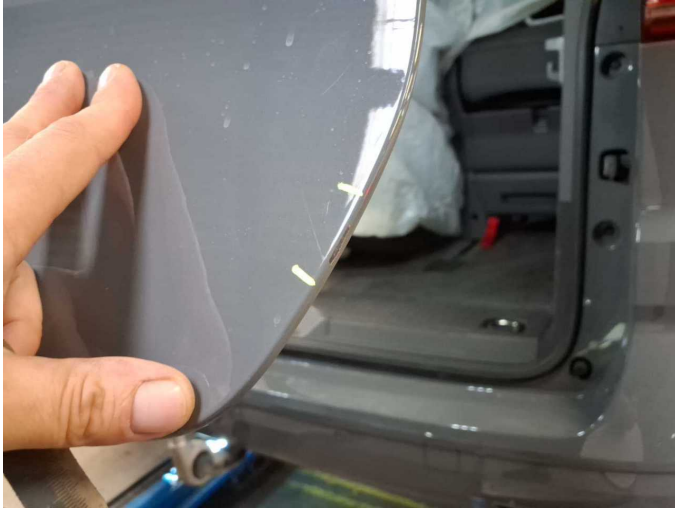
Damage 2: Boot lid / rear door: Boot lid - Scratch(es) - Smart repair

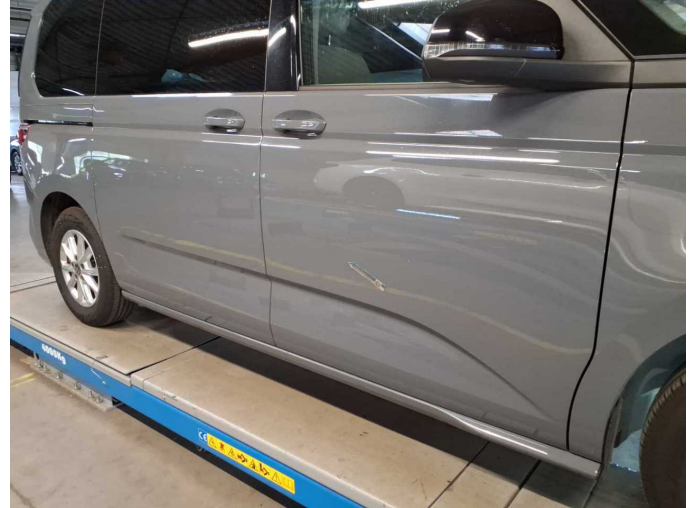
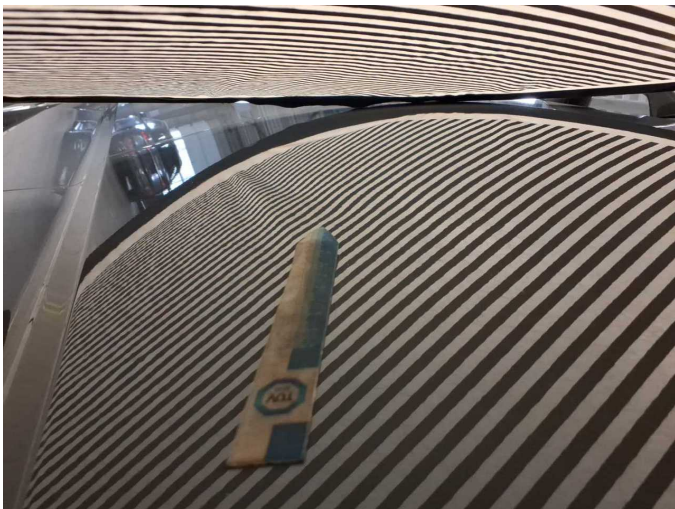
Damage 3: Door - front right side: Door - dent(s) - Smooth repair work

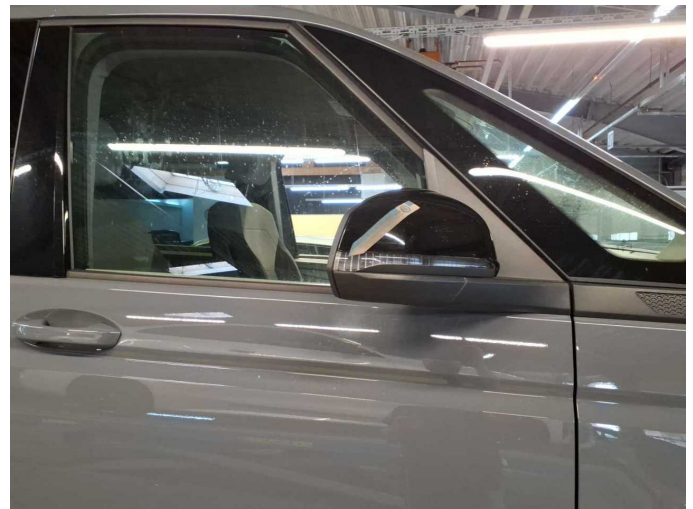
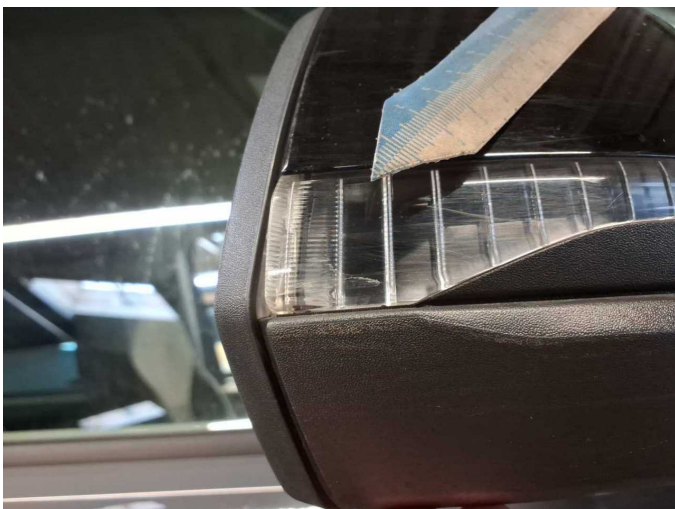
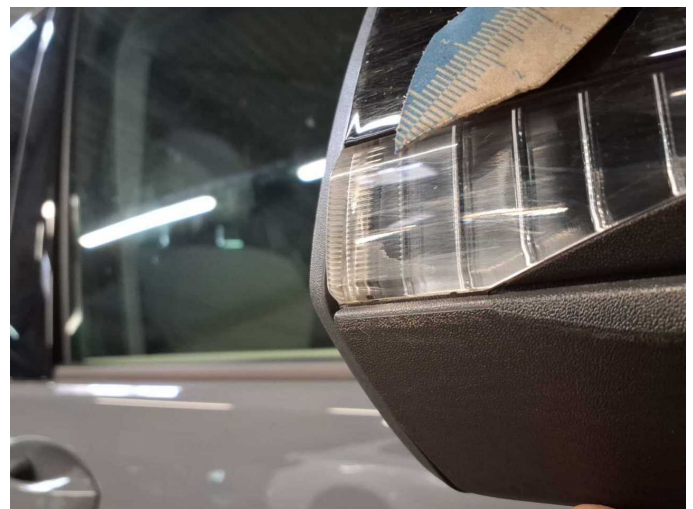
Damage 4: Indicator - front: Mirror - right side - Scratch(es) - Replace

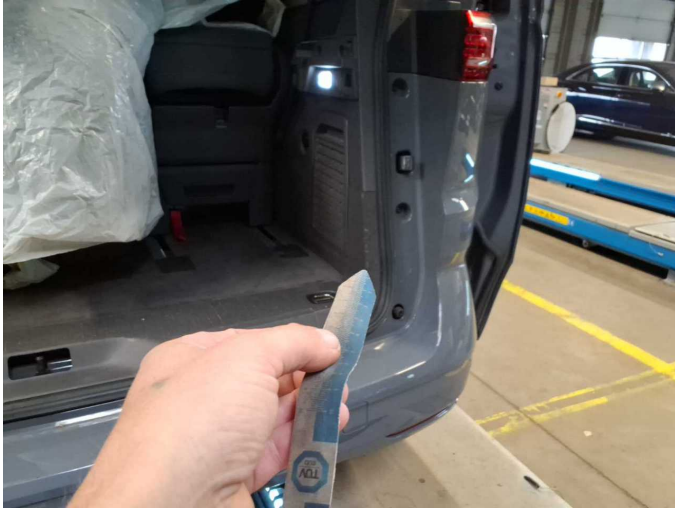
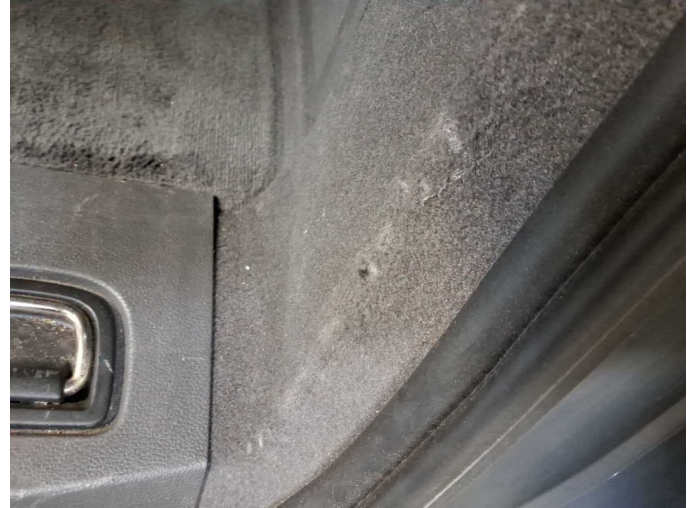
Damage 5: Side panel - rear right side: Interior trim (Stoff) - Broken / torn - Smart repair

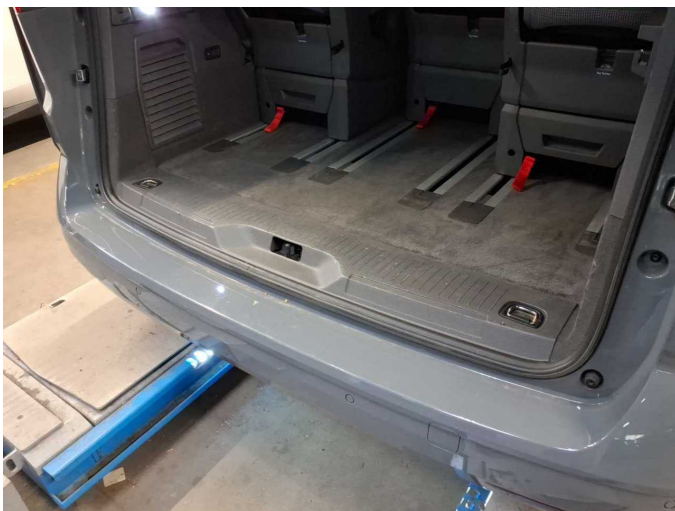
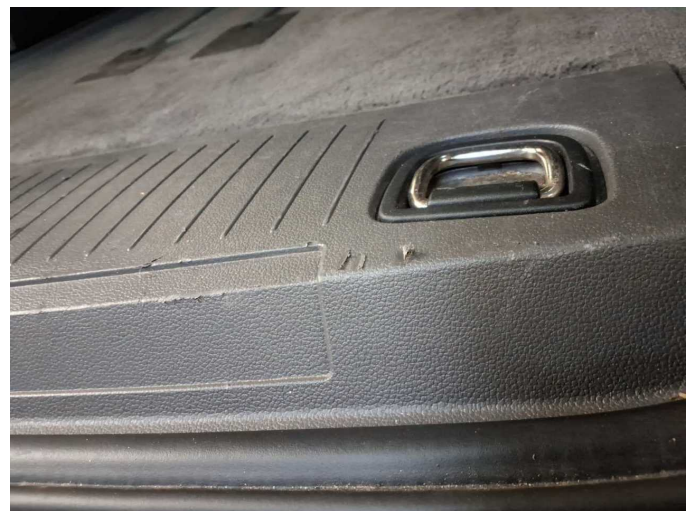
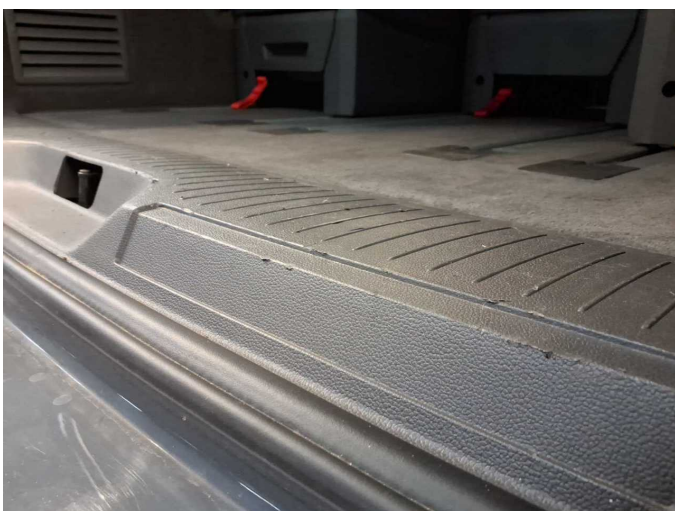
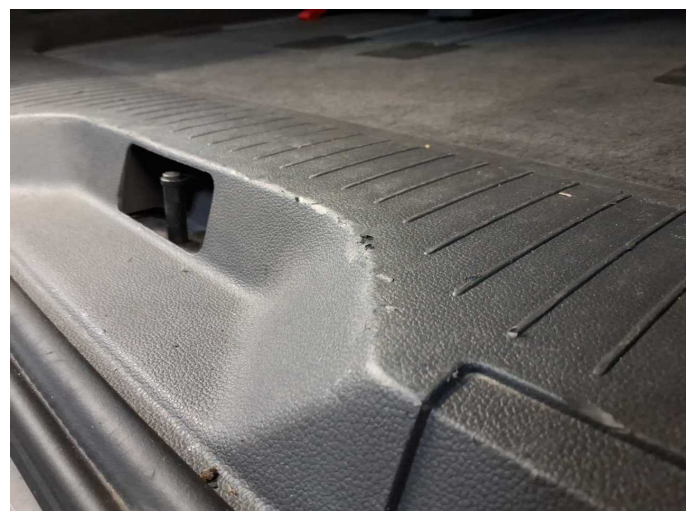
Damage 6: Trim / covers: Boot sill cover (Materialabtrag) - Scratched - Replace

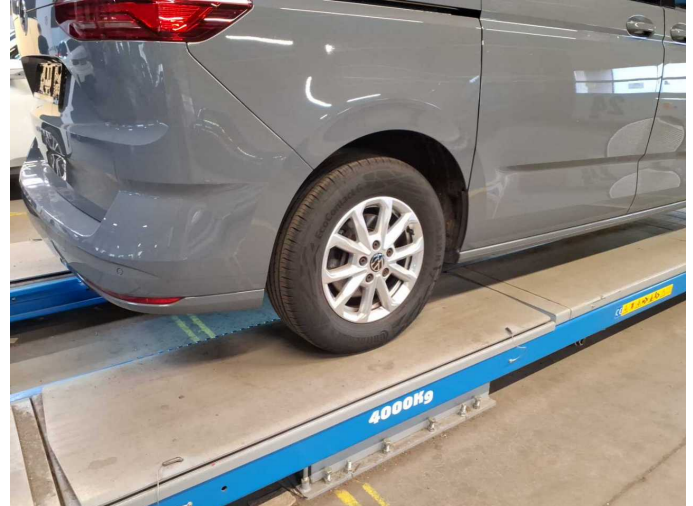
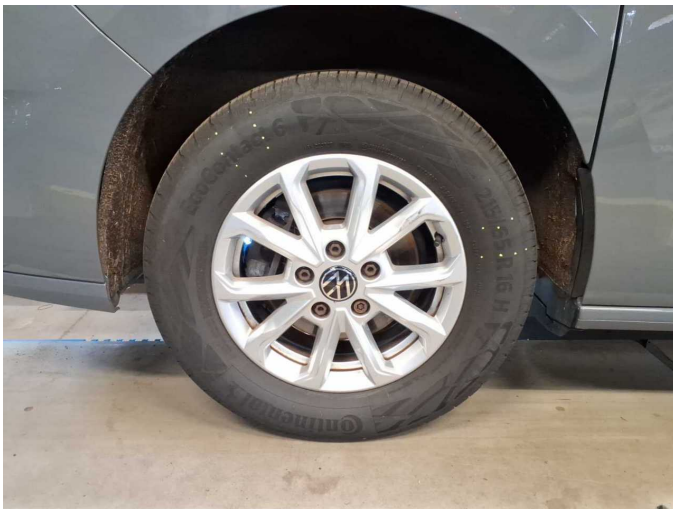
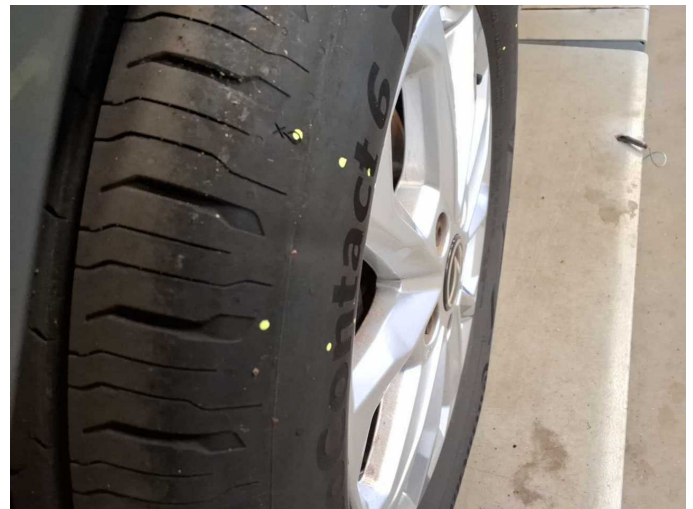
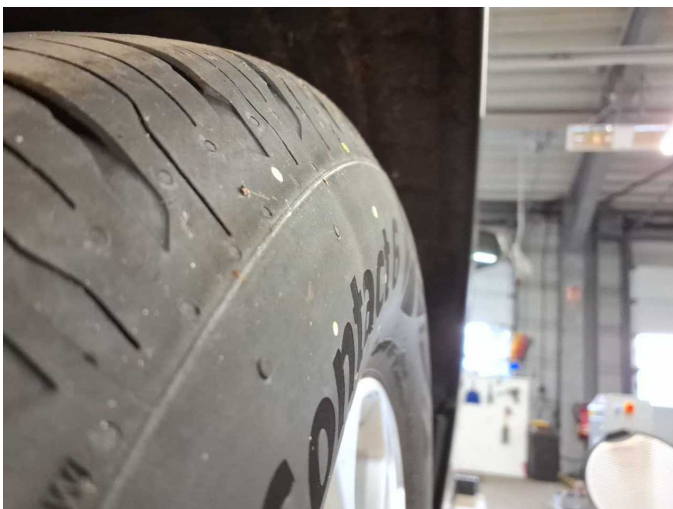
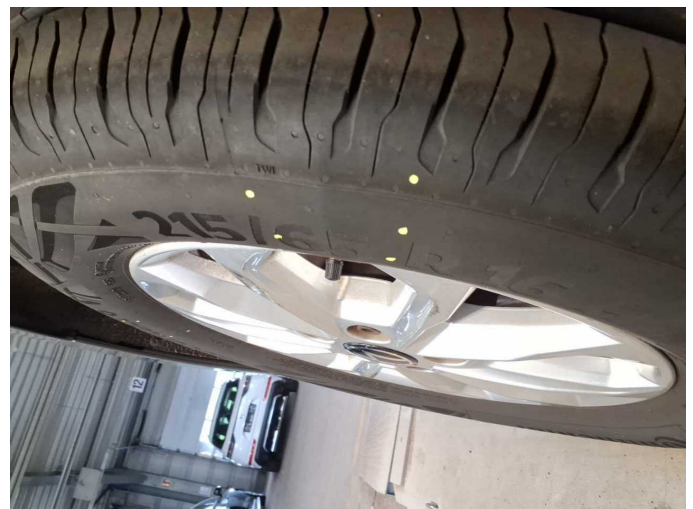
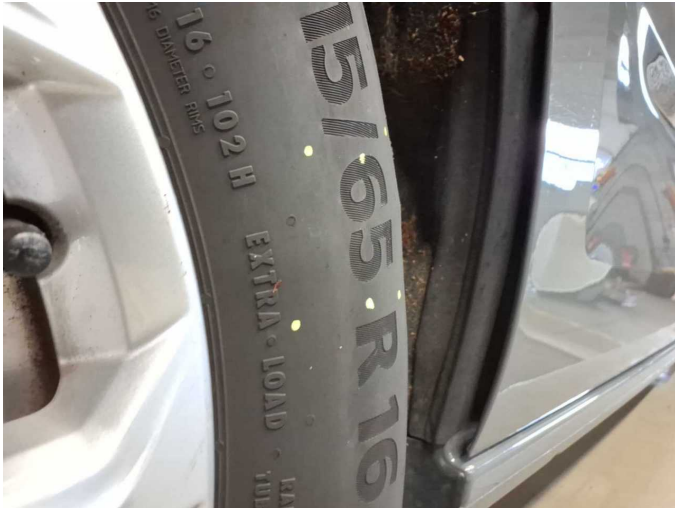
Damage 7: Wheel / tyres: Tyre - rear right side (nicht fahrbereit) - Deformed - Replace

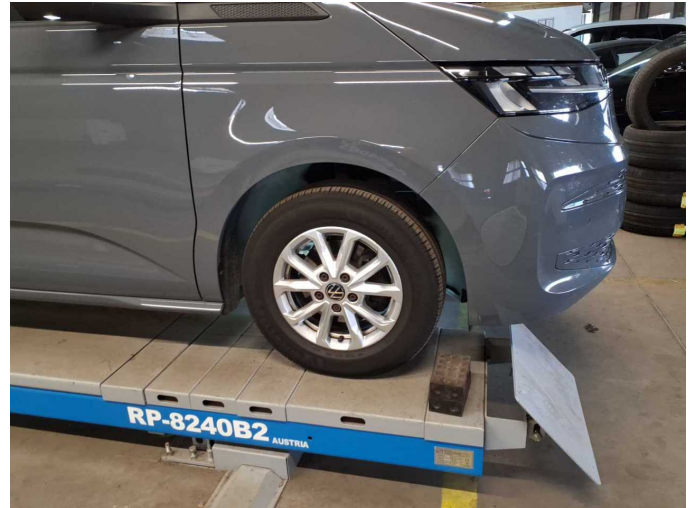
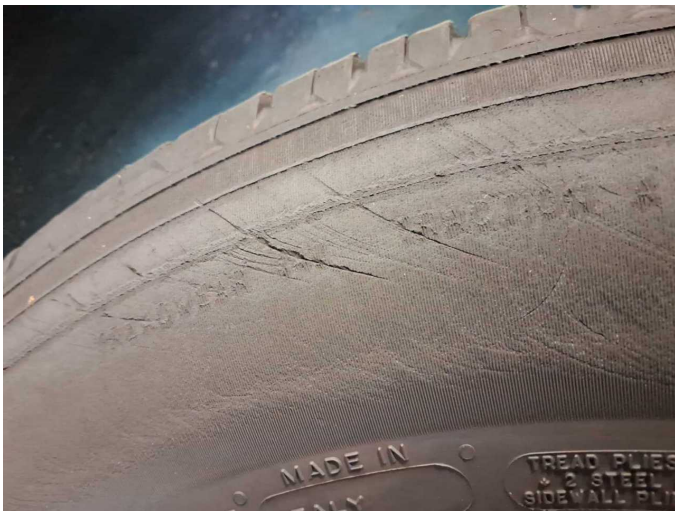
Damage 8: Wheel / tyres: Tyre - front right side (Flanke, nicht fahrbereit) - Damaged - Replace

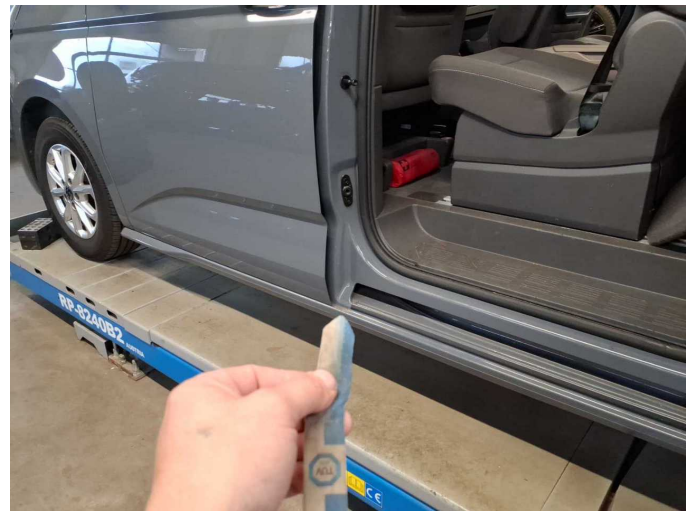
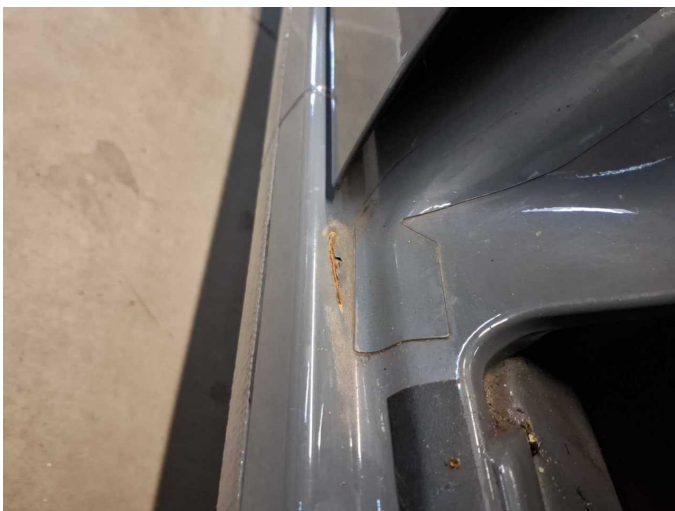
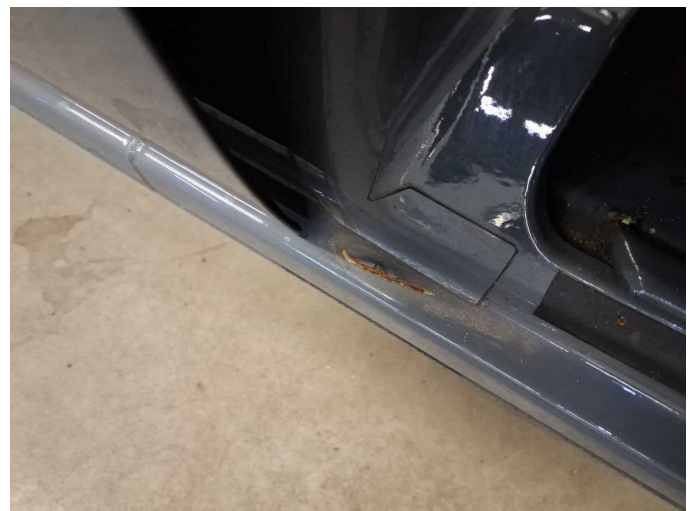
Damage 9: Sill - left side: Sill - Scratch(es) - Smart repair

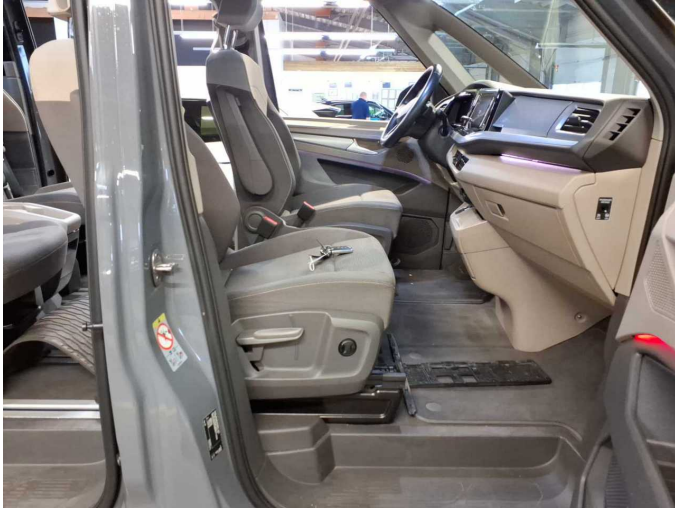
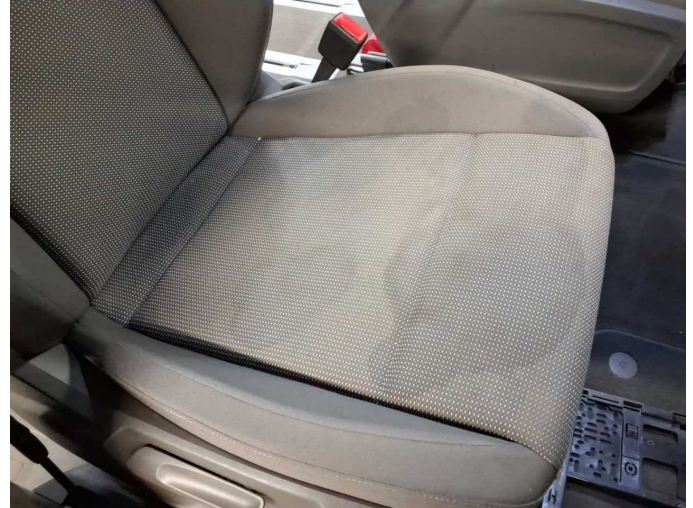
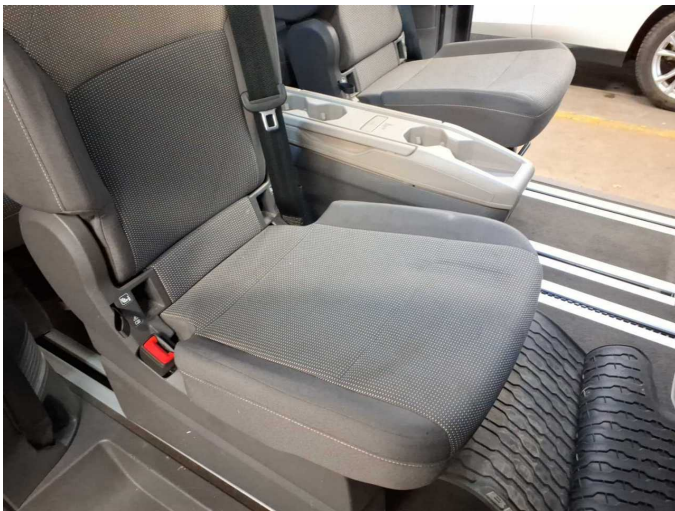
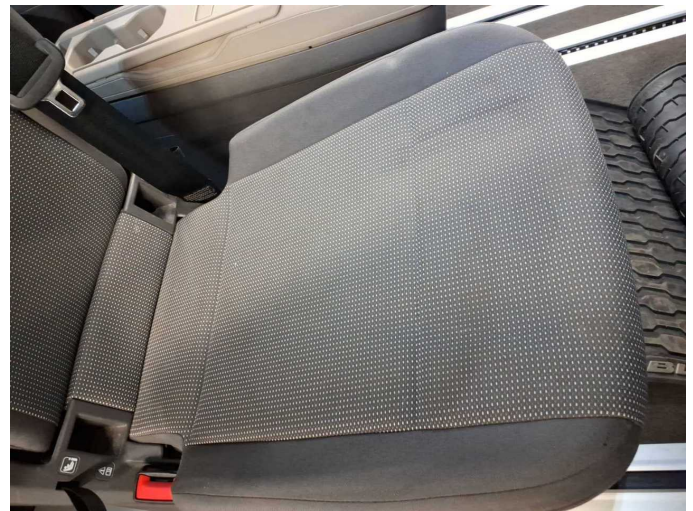
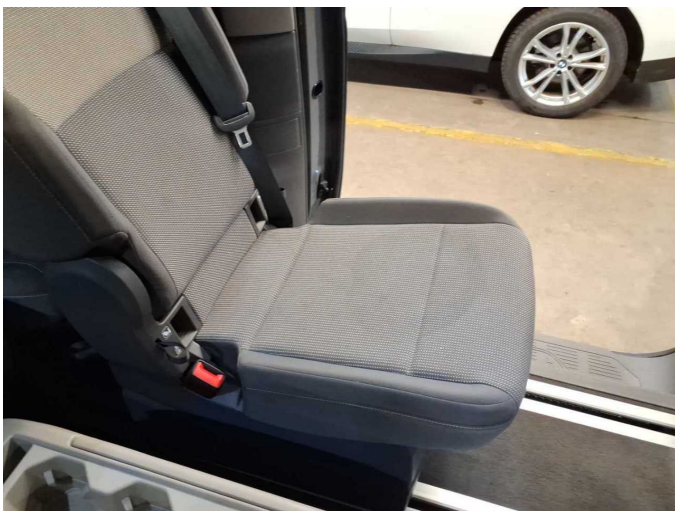
Damage 10: Interior: Interior (Flecken) - Soiled - Clean

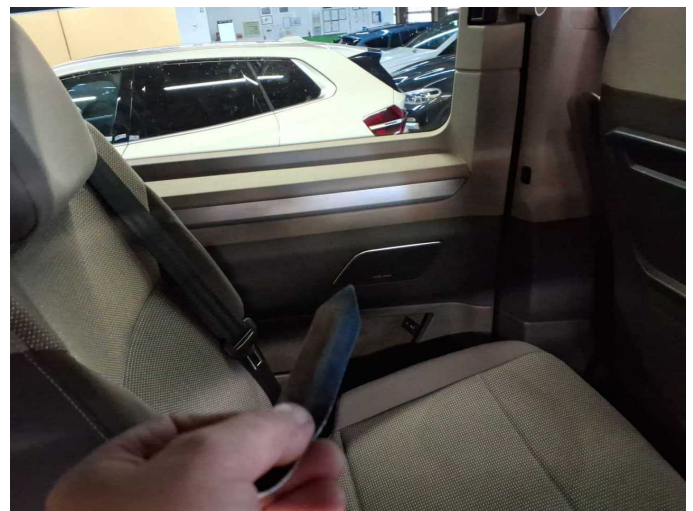
Damage 11: Door - rear left side: Speaker cover - Deformed - Loss in value

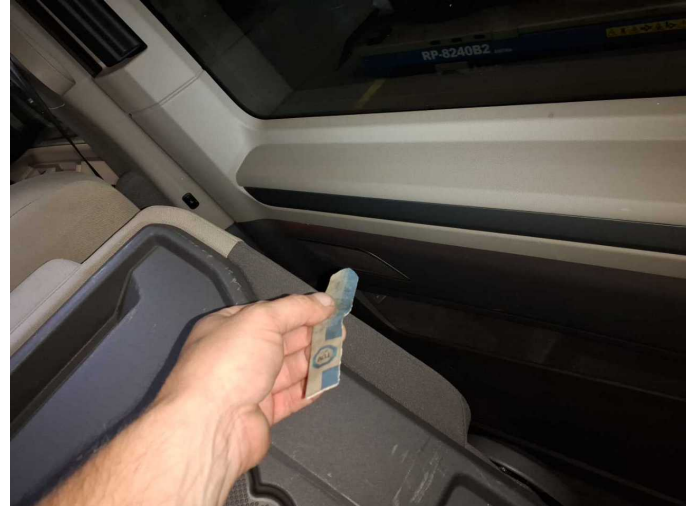
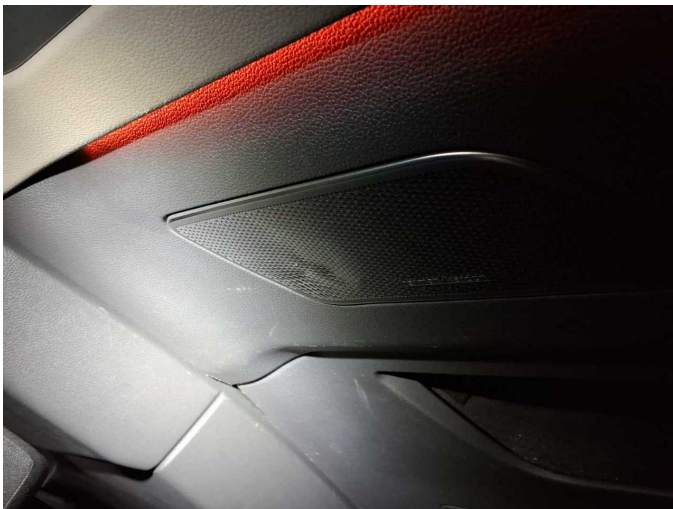
Damage 12: Door - rear right side: Speaker cover - Deformed - Loss in value

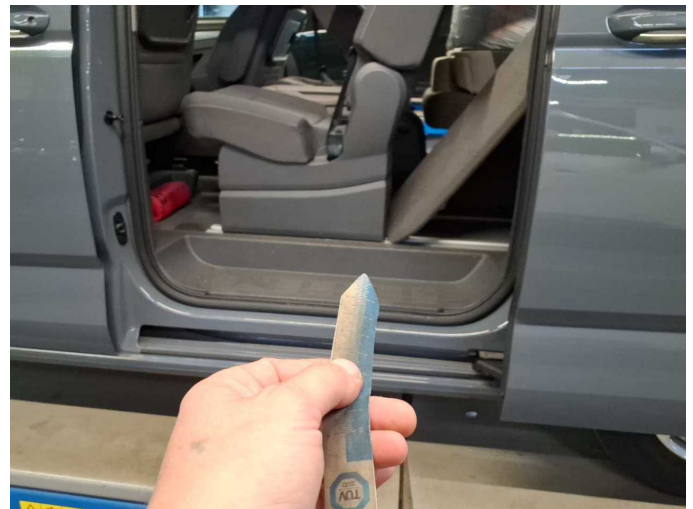
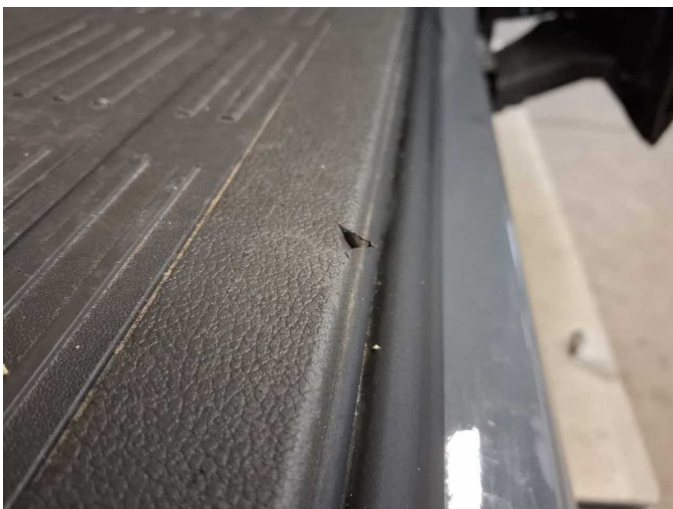
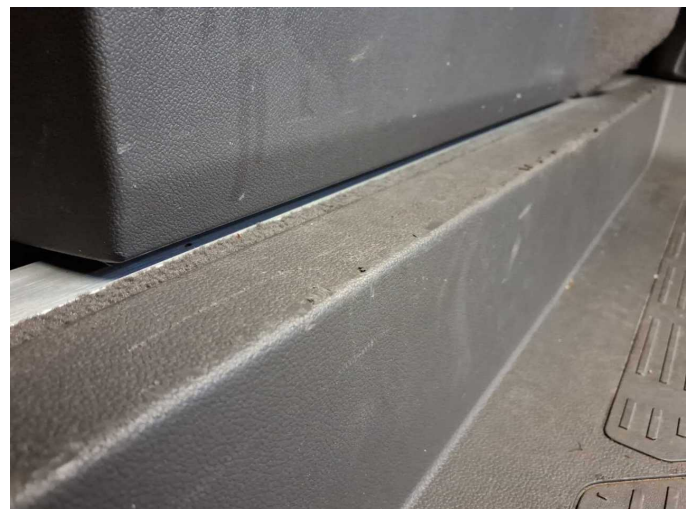
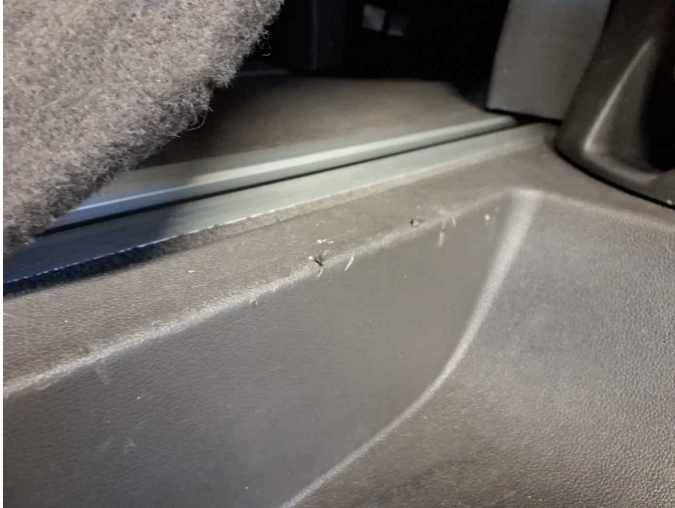
Damage 13: Trim / covers: Entrance sliding door - left side (Trittbrett links Materialabtrag) - Scratched - Replace

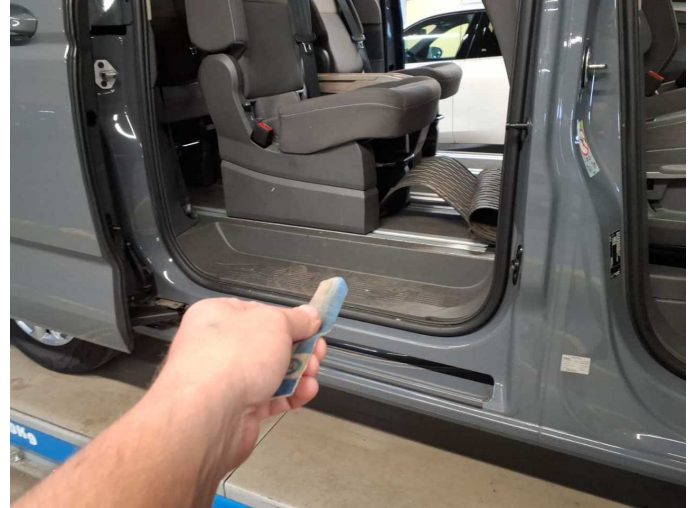
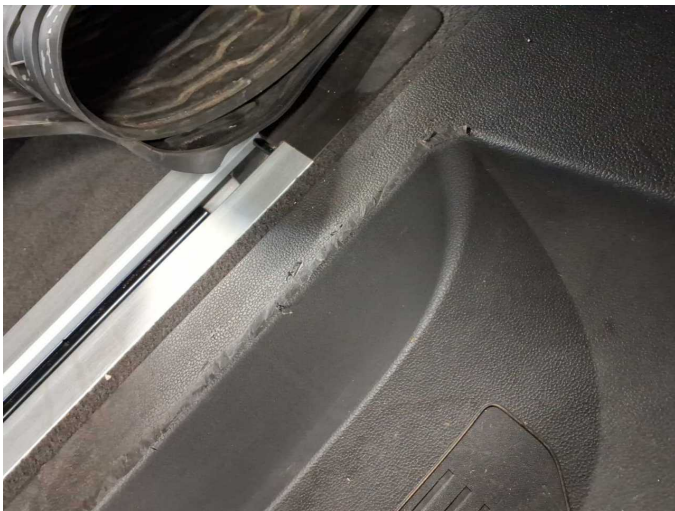
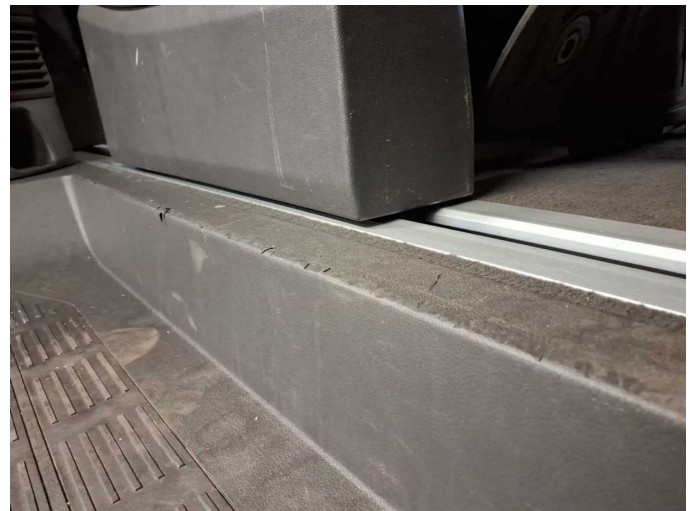
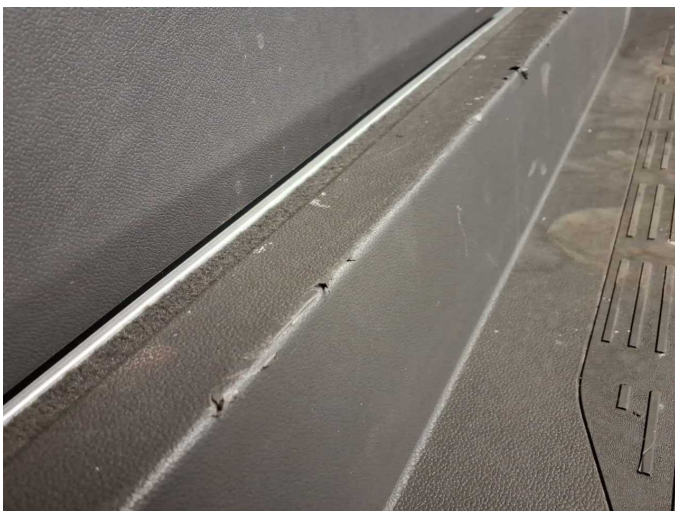
Damage 14: Trim / covers: Entrance sliding door - right side (Trittbrett rechts Materialabtrag) - Scratched - Replace

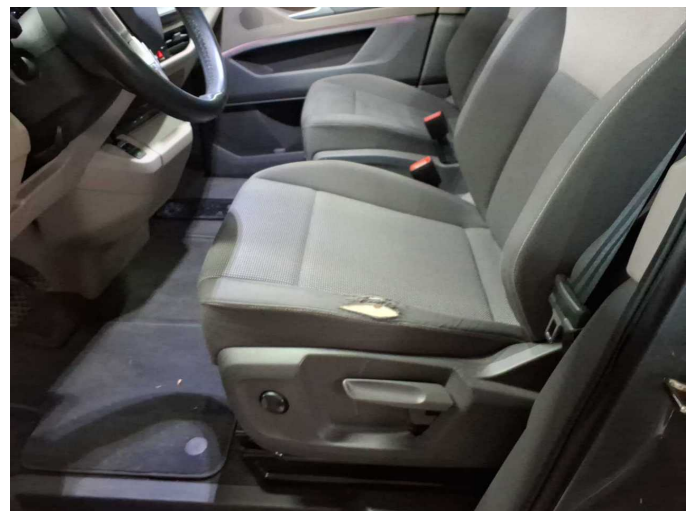
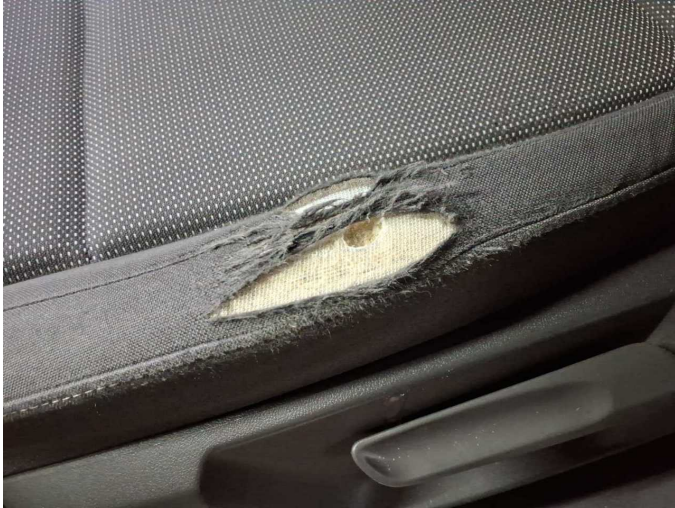
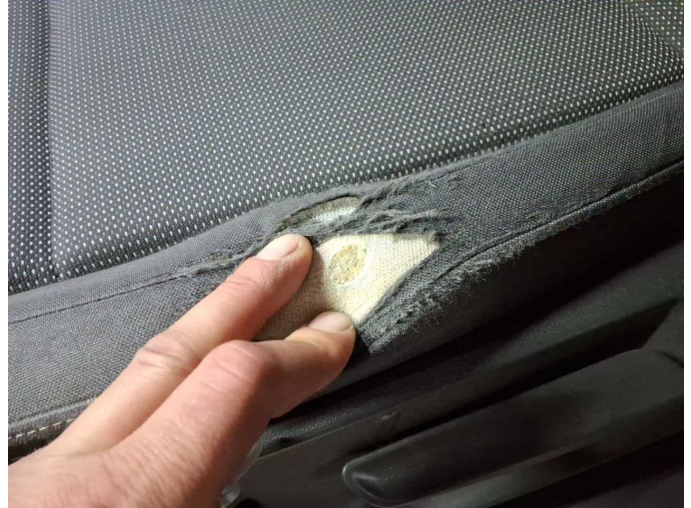
Damage 15: Seat - front: Seat cover - left side (+ Polster) - Broken / torn - Replace

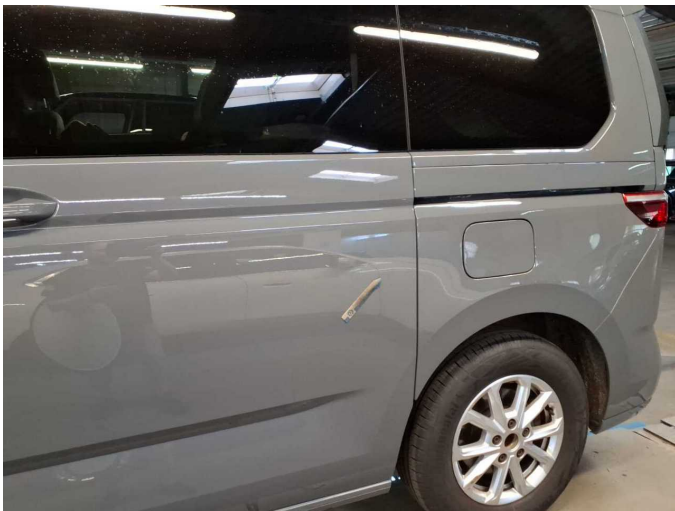
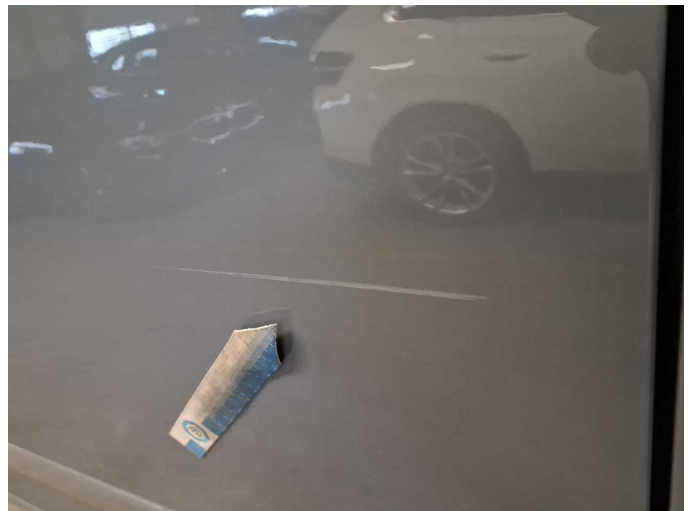
Damage 16: Sliding door - left side: Sliding door with glass panel - Scratch(es) - Paint

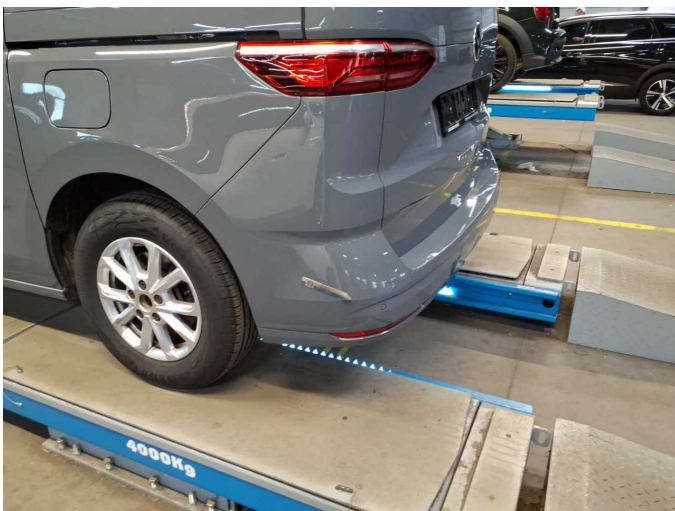
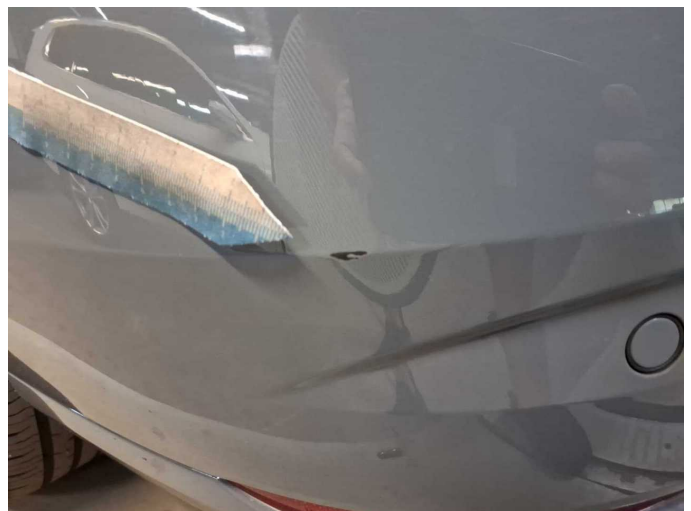
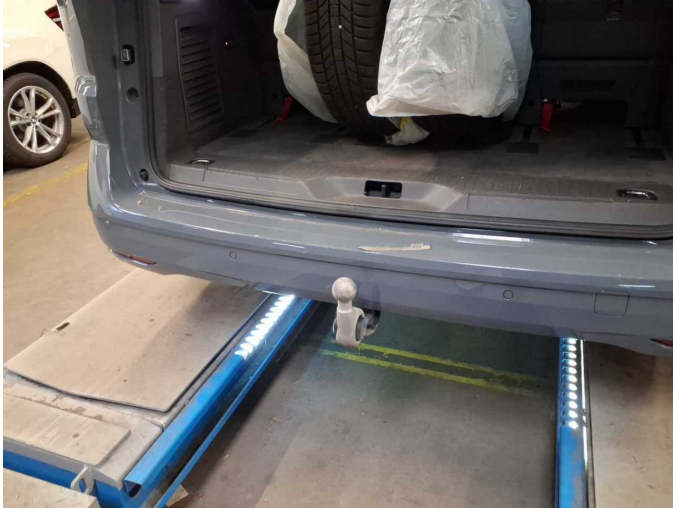
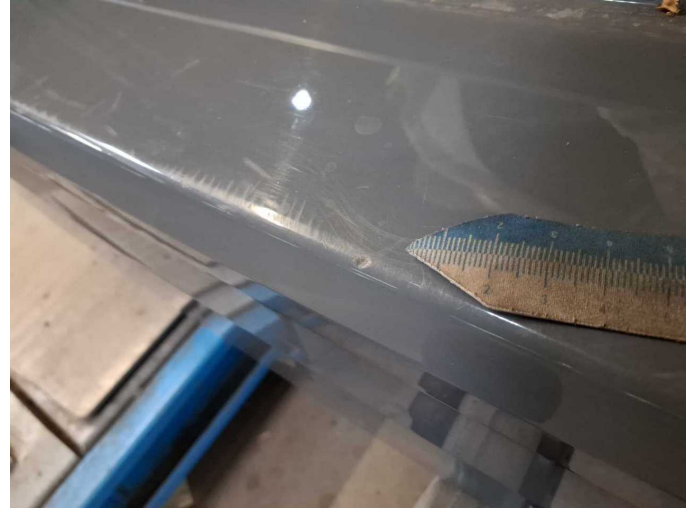
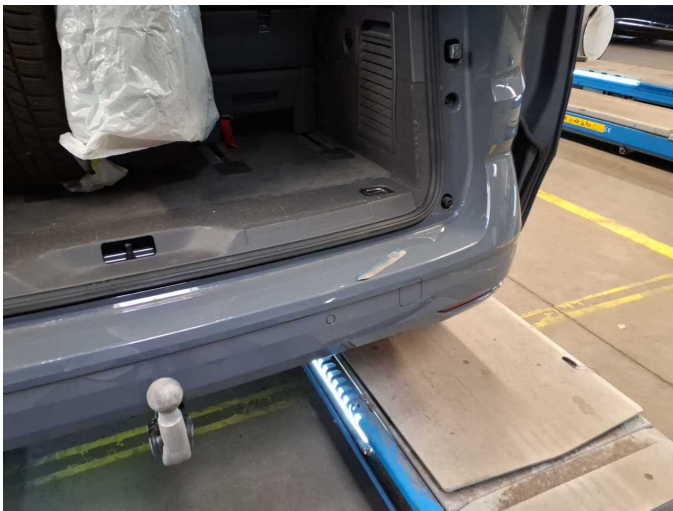
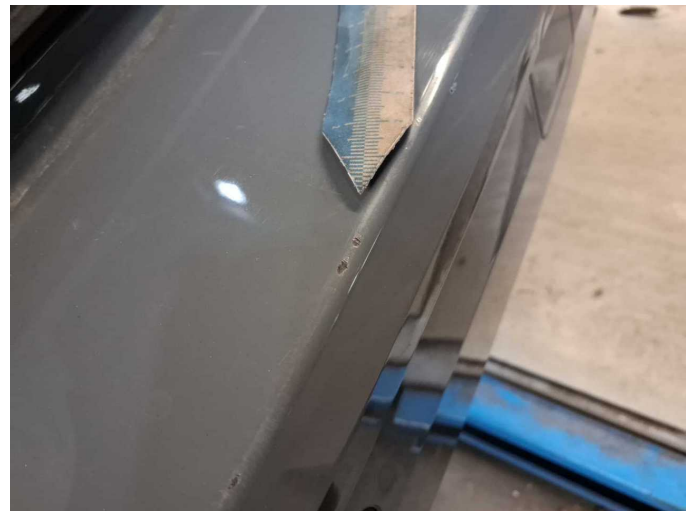
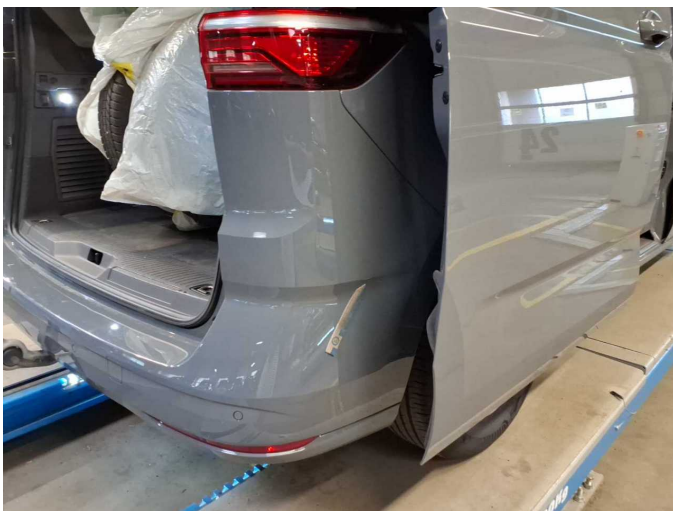
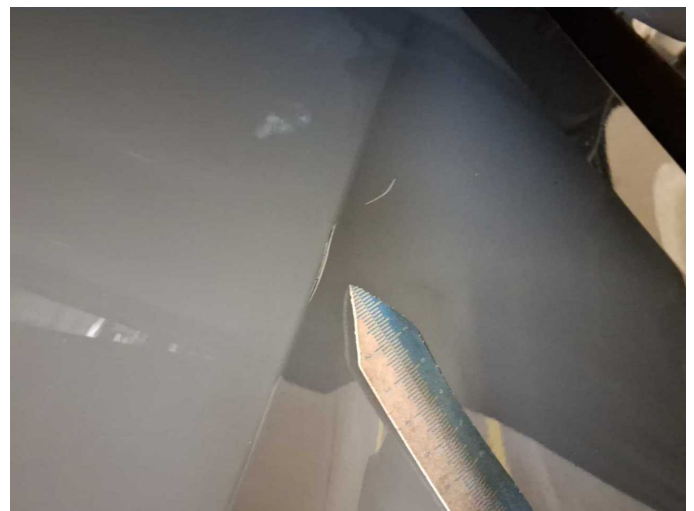
Damage 17: Rear bumper: Rear bumper - Scratched - Paint

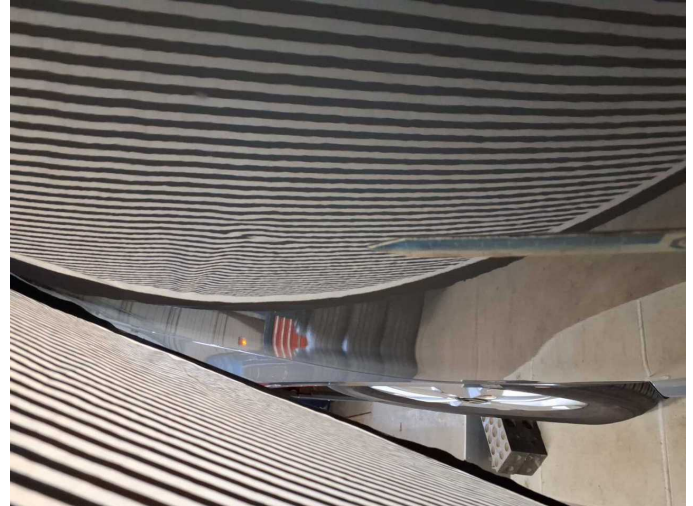
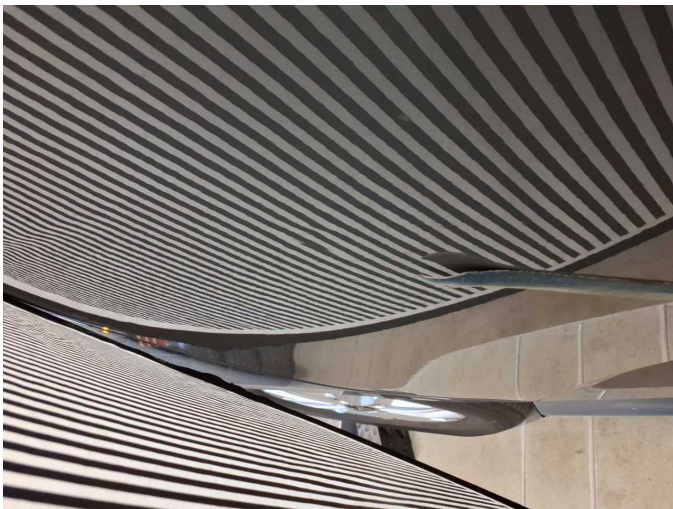
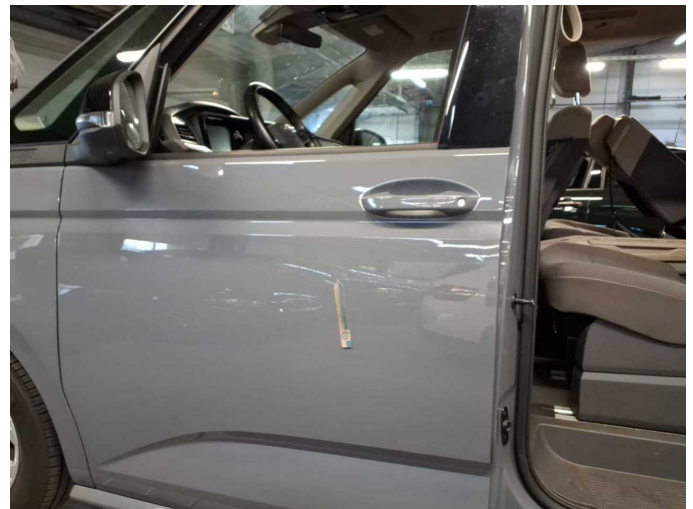
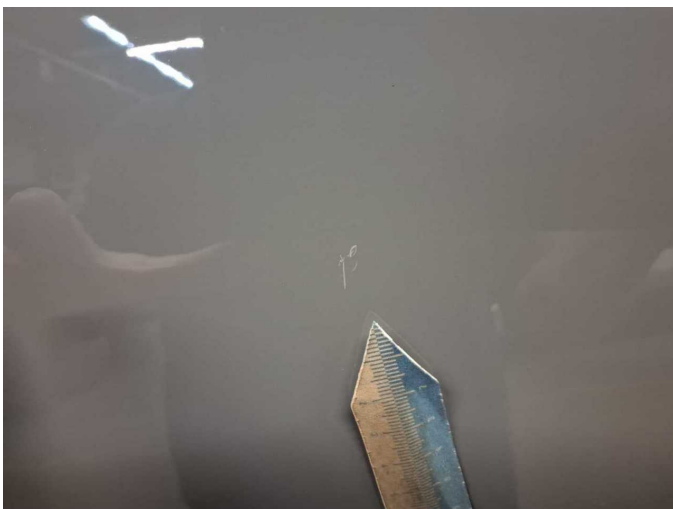
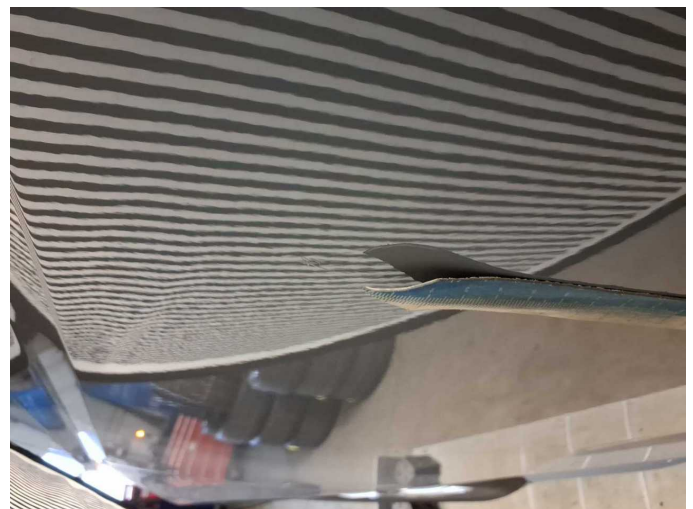
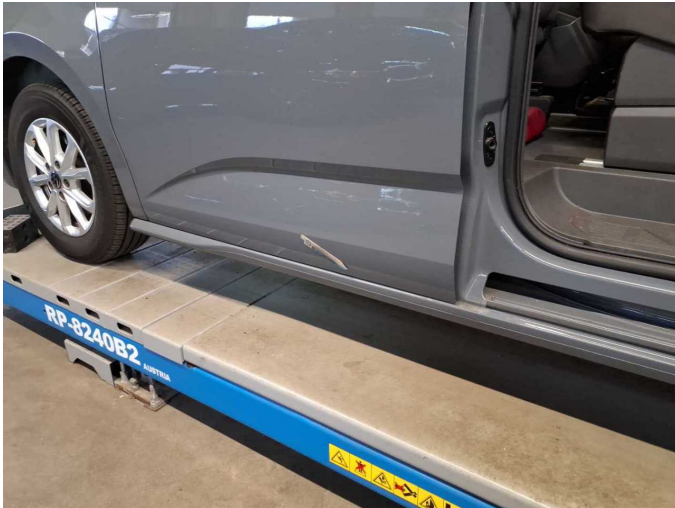
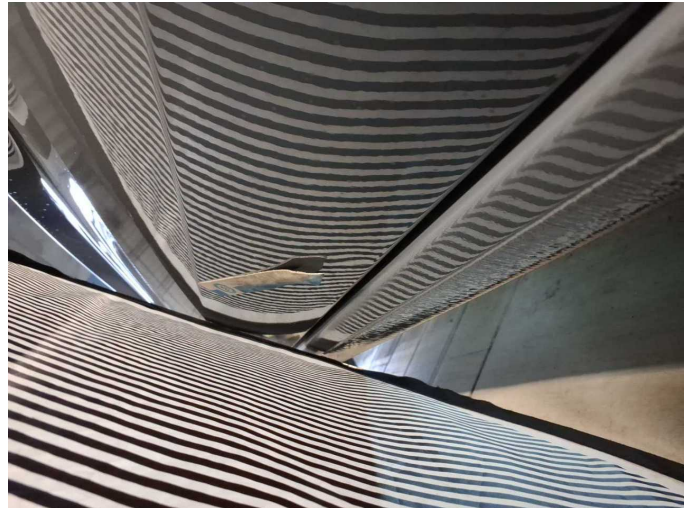
Damage 18: Door - front left side: Door - Dent / paintcoat damage - Repair and paint
