Expertise

Protocol number: 46363508
Order No. / Reference: 26505209
Inspection date: 6 Jul 2026

Manufacturer: Volkswagen

Model: Multivan 2,0 TDI SCR KÜ Life

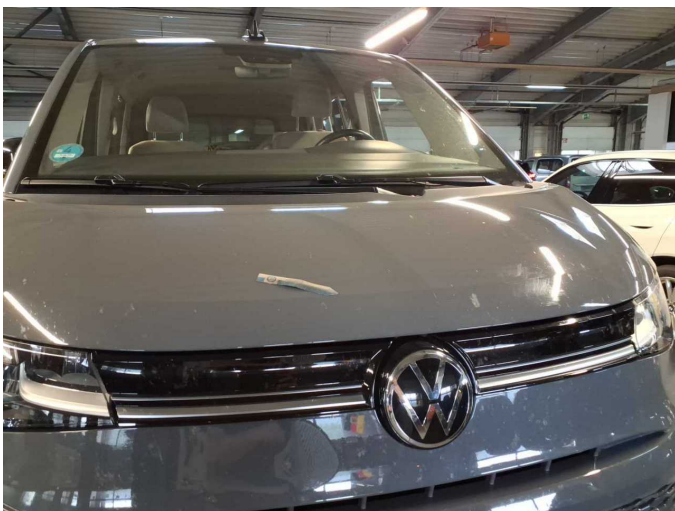
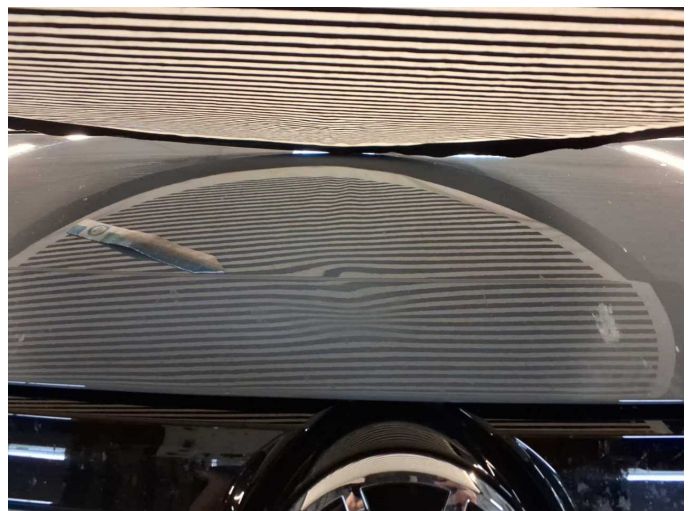
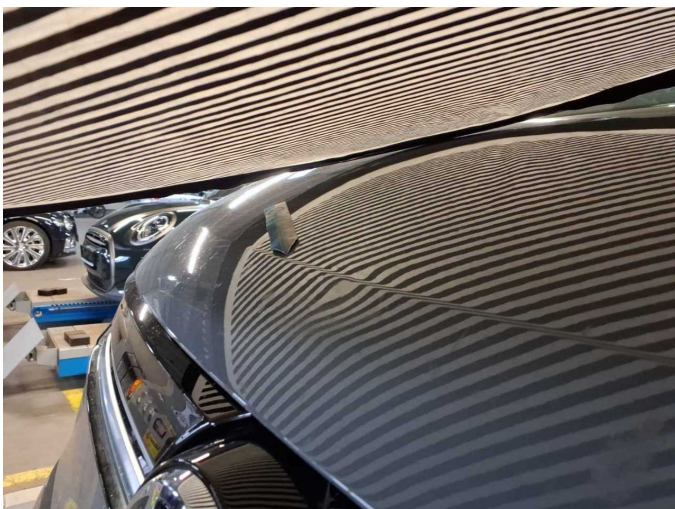
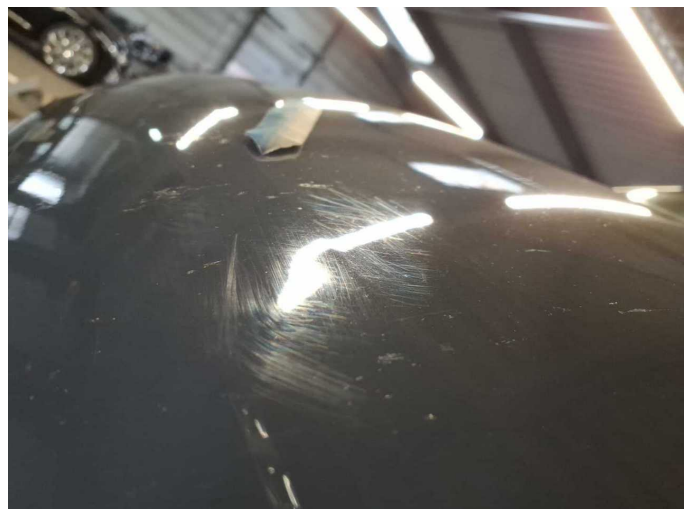
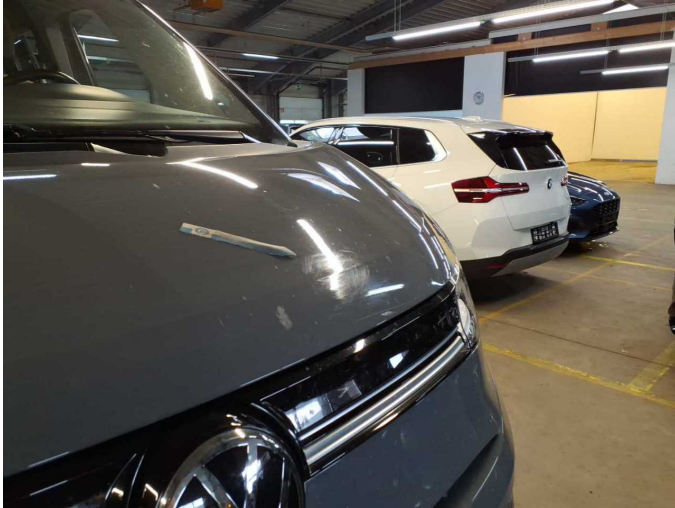
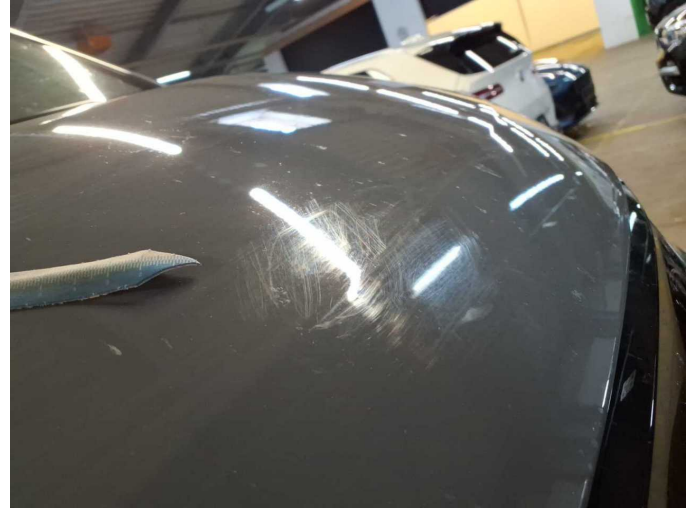
Damage 19: Bonnet: Bonnet - Dent / paintcoat damage - Repair and paint

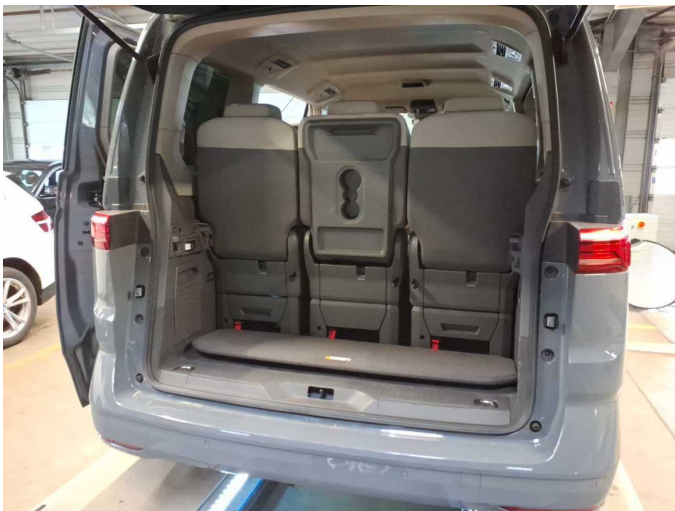
Missing part 1: Interior: Separation net - Missing - Replace

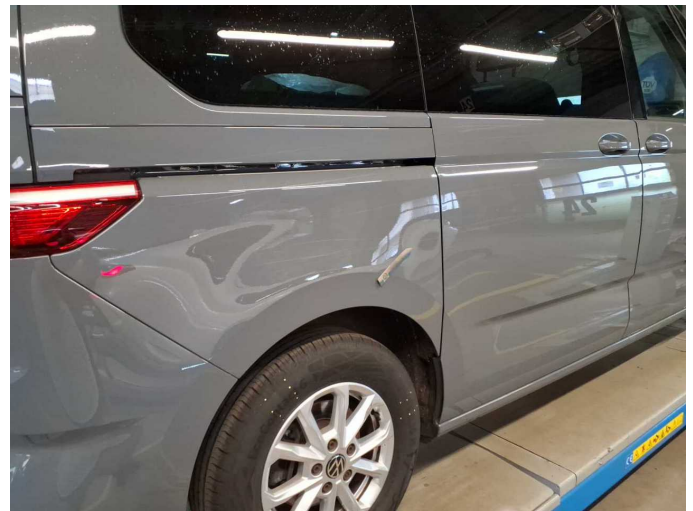
Accident 1: Side right
