Expertise

Protocol number: 44498411
Order number / reference: 26093325
Inspection date: 16 Mar 2026

Manufacturer: Opel

Model: Movano 2.3 D L2H2 2WD VA S&S

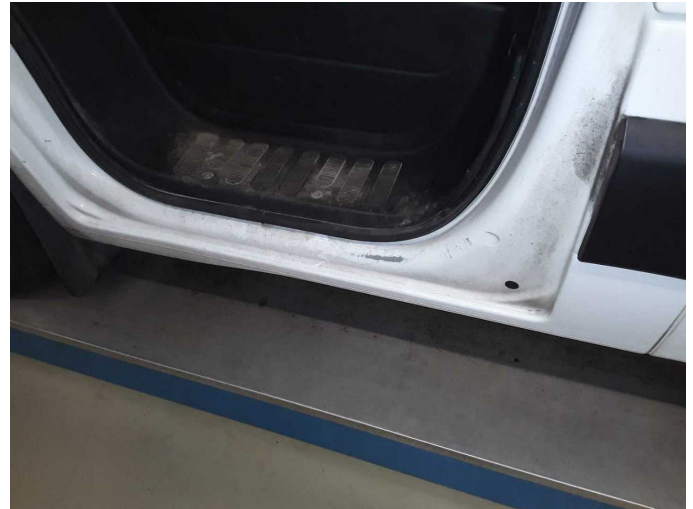
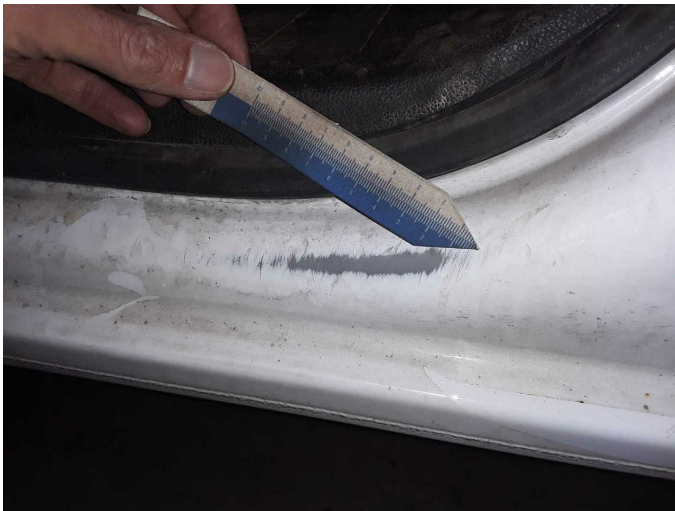
No.	Component group	Description
1	Sill - left side	Sill - Scratch(es) - Smart repair
2	Wheel / tyres	Tyre - front - Does not meet the leasing specifications - Replace
3	Braking system	Brake discs and pads - rear - Corrosion - Replace
4	Braking system	Brake discs and brake pads - front - Corrosion - Replace

Damage 1: Sill - left side: Sill - Scratch(es) - Smart repair

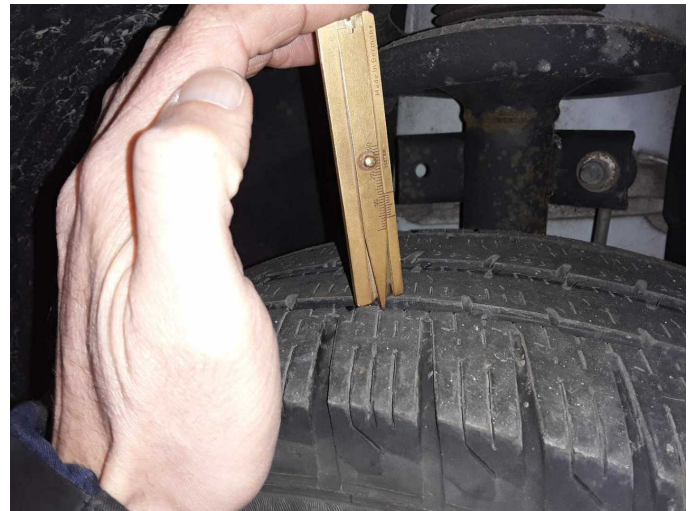
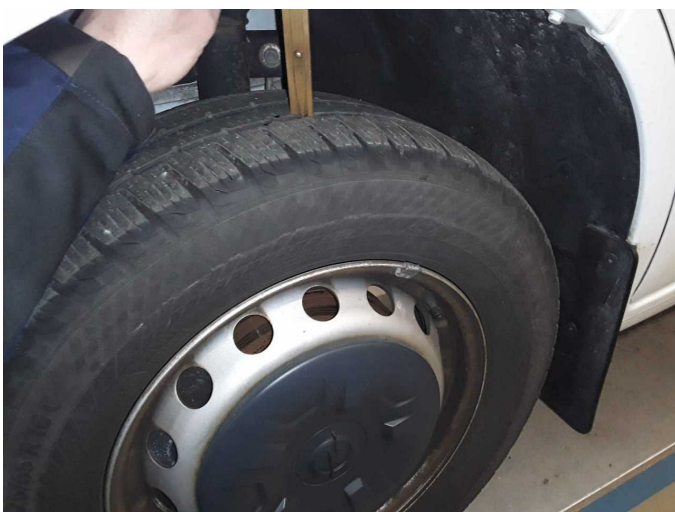
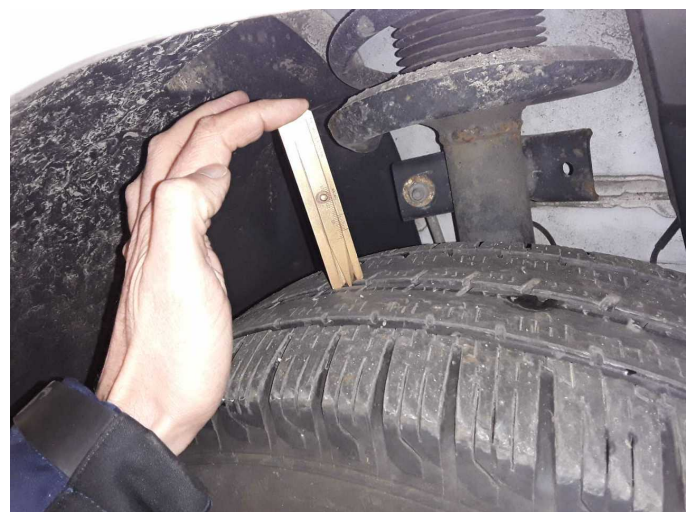
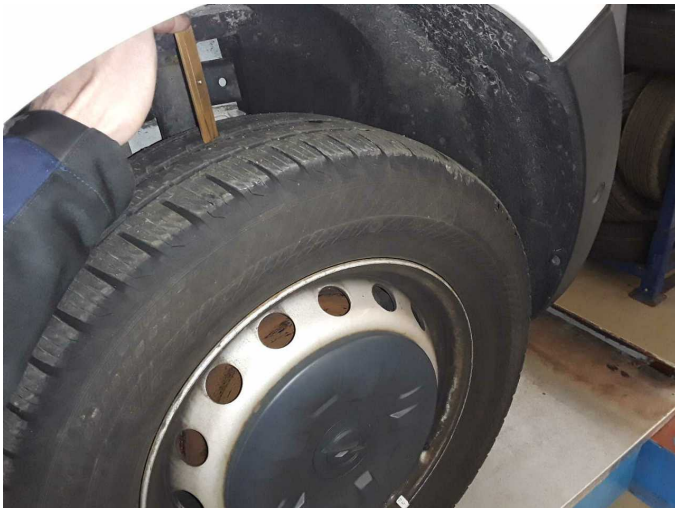
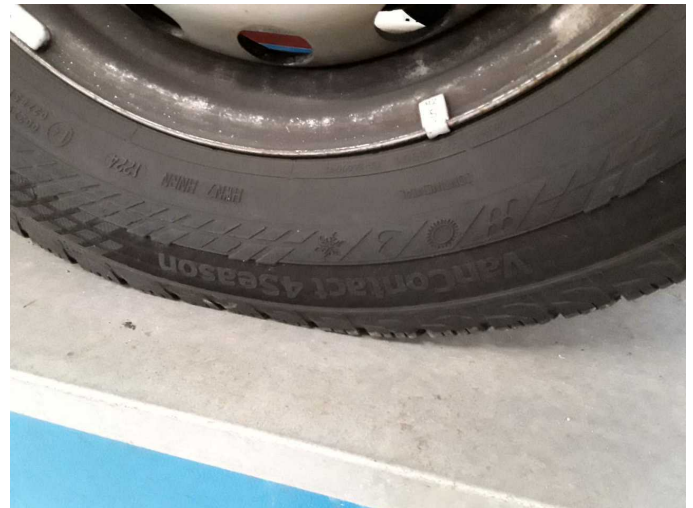
Damage 2: Wheel / tyres: Tyre - front - Does not meet the leasing specifications - Replace

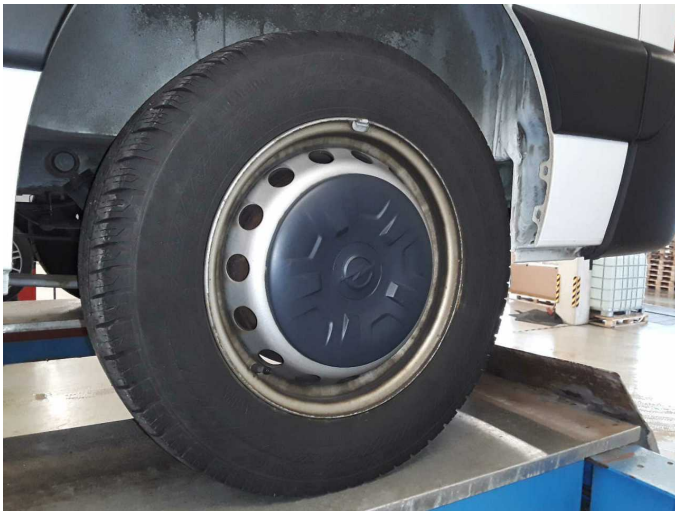
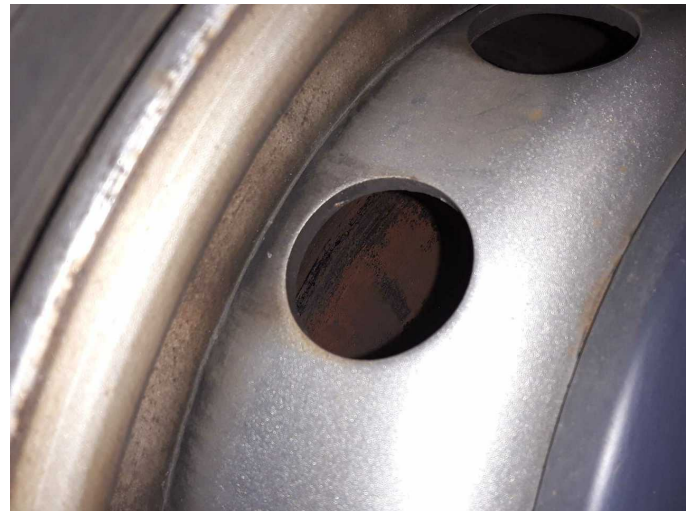
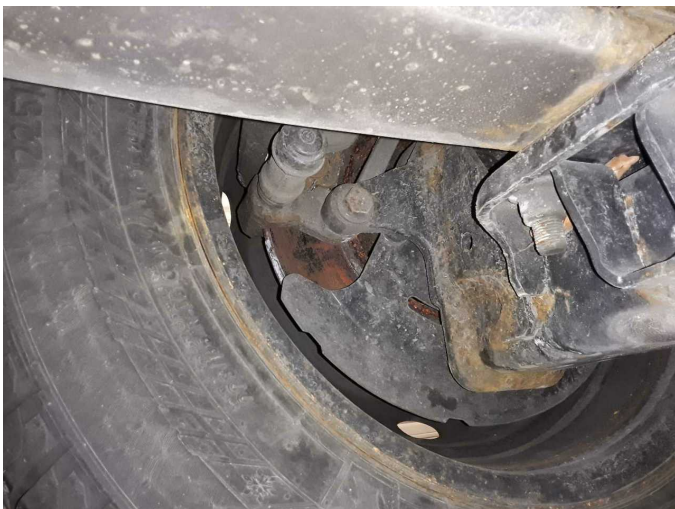
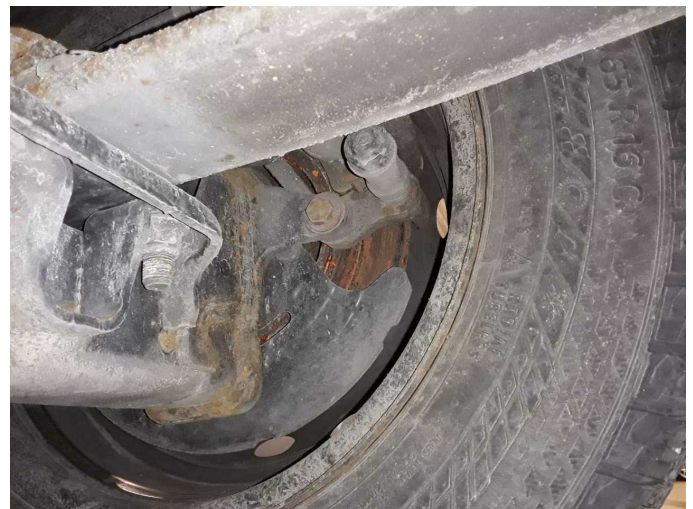
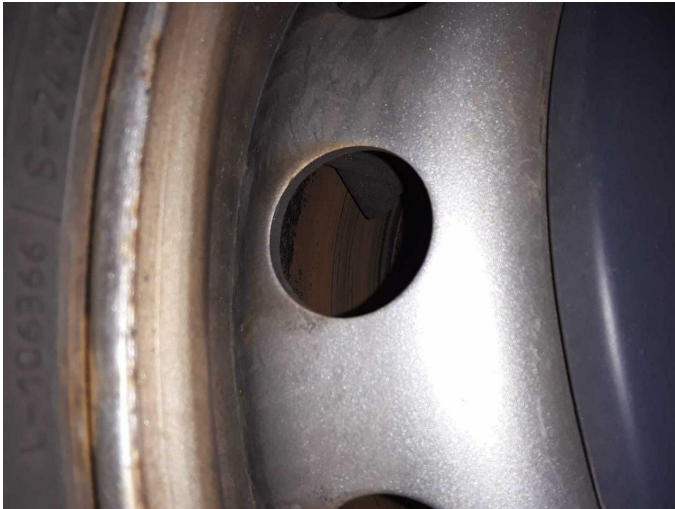
Damage 3: Braking system: Brake discs and pads - rear - Corrosion - Replace

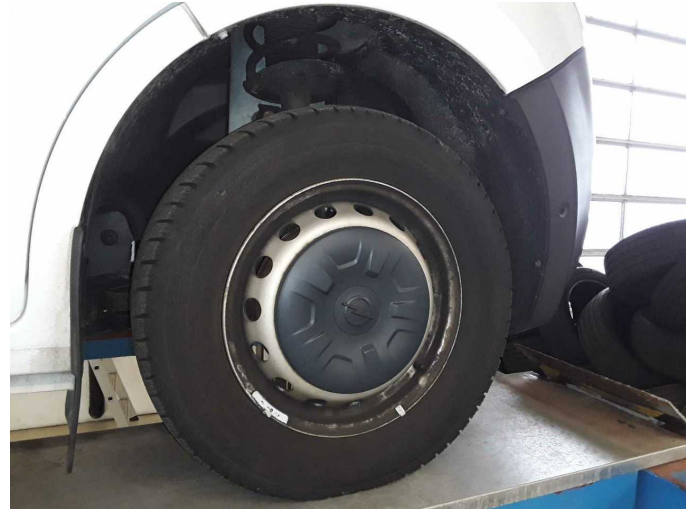
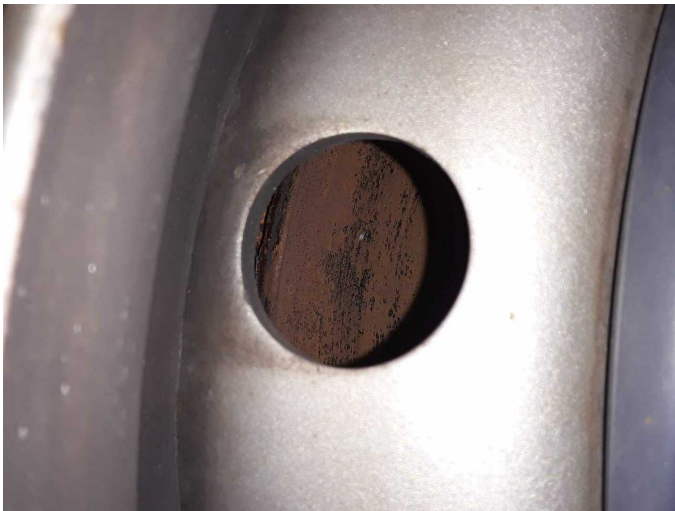
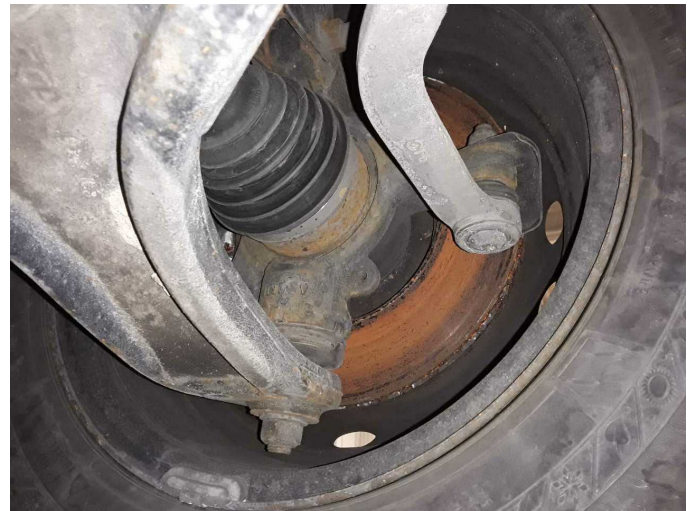
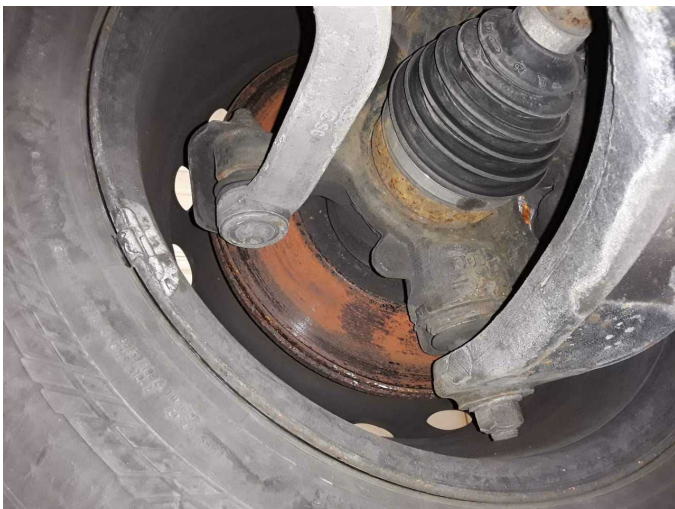
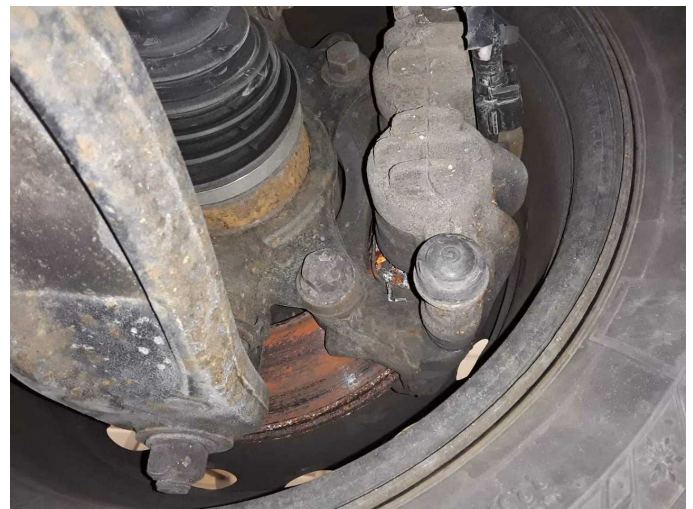
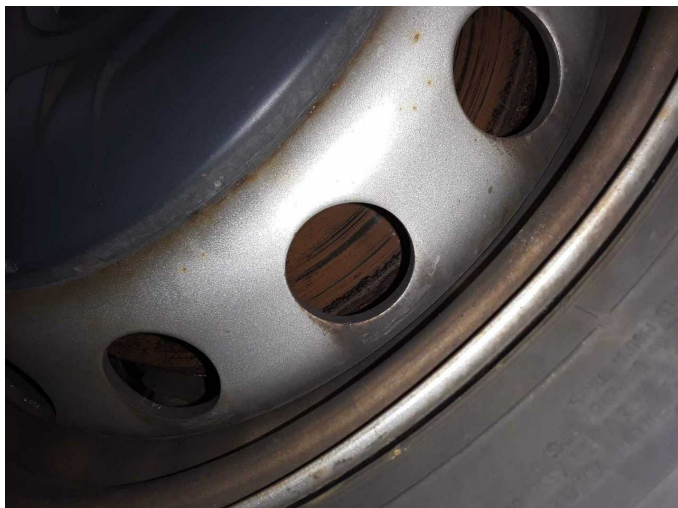
Damage 4: Braking system: Brake discs and brake pads - front - Corrosion - Replace

Damage 4: Braking system: Brake discs and brake pads - front -
Corrosion - Replace
