Expertise

Protocol number: 45967817
Order No. / Reference: 26503458
Inspection date: 16 Jun 2026

Model: 316 CDI Sprinter Standard HA 7G-Tronic Plus

VIN: W1V9076331P267206

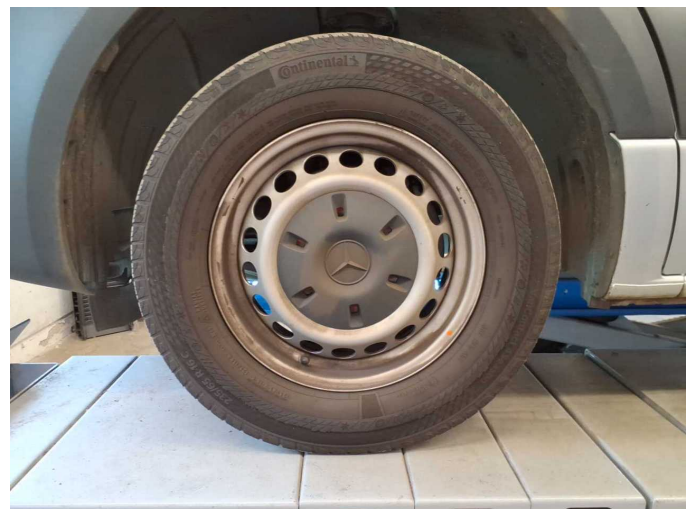
Figure 12: Mounted tyres

#	Tyre size	Type of tyre	Manufacturer	Tread depth
1)	235/65 R16 121R	All-season tyres on Steel rim with wheel cover	Continental	4mm / 4mm
2)	235/65 R16 121R	All-season tyres on Steel rim with wheel cover	Continental	6mm / 6mm

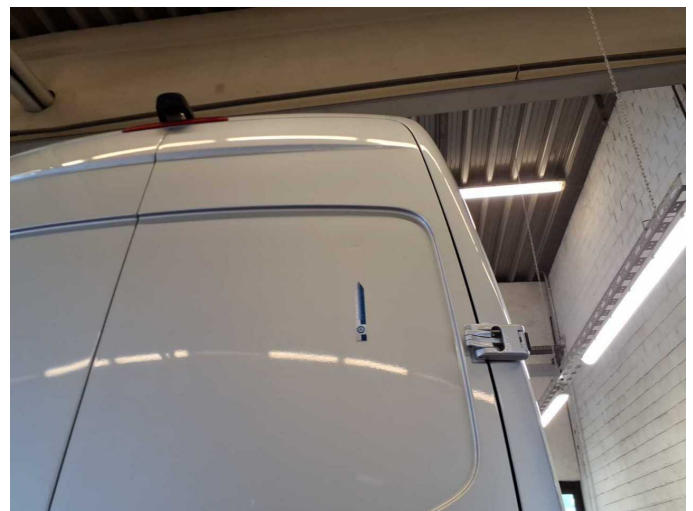
Damage 1: Boot lid / rear door: Rear door - right side - dent(s) - Smooth repair work

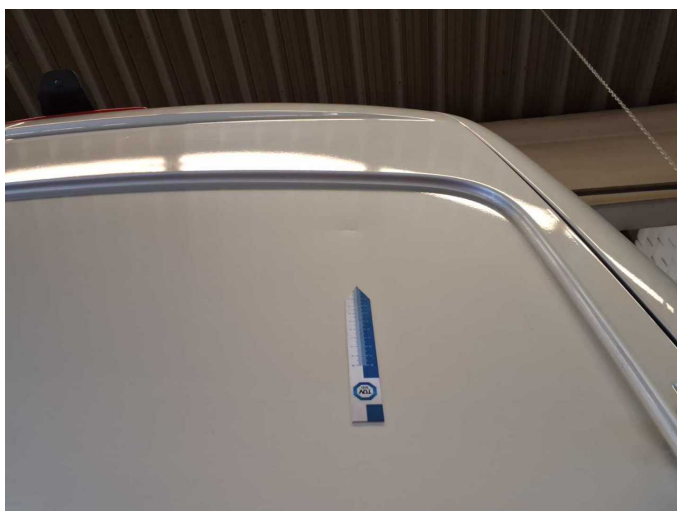
Damage 1: Boot lid / rear door: Rear door - right side - dent(s) - Smooth repair work

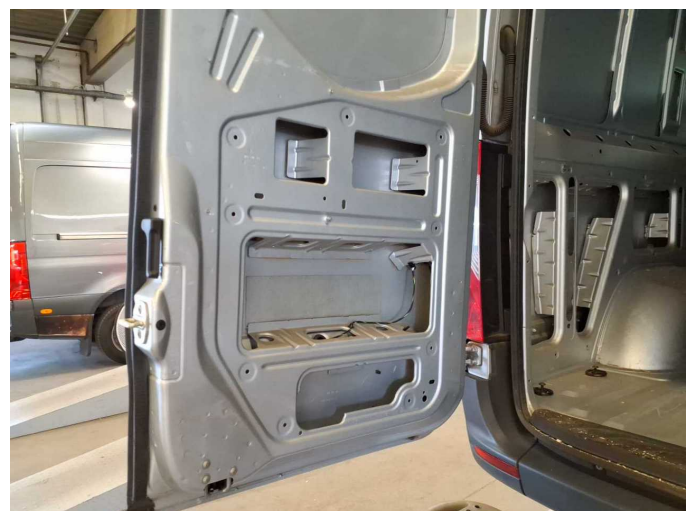
Damage 2: Trim / covers: Boot lid - interior trim (Links + Rechts) - Missing - Replace

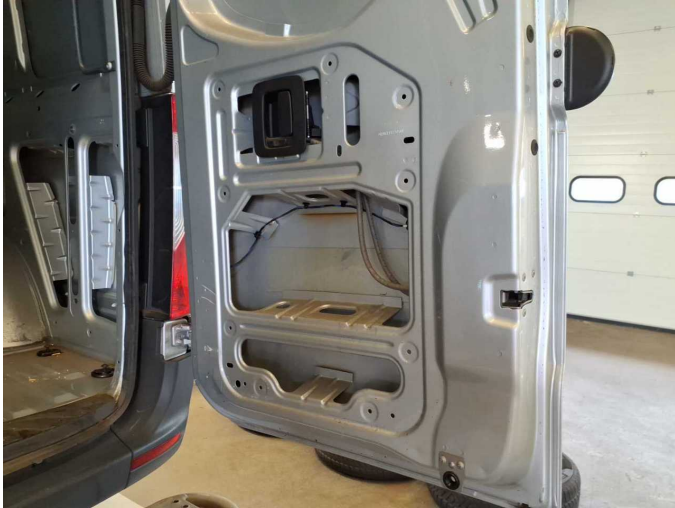
Damage 2: Trim / covers: Boot lid - interior trim (Links + Rechts) - Missing - Replace

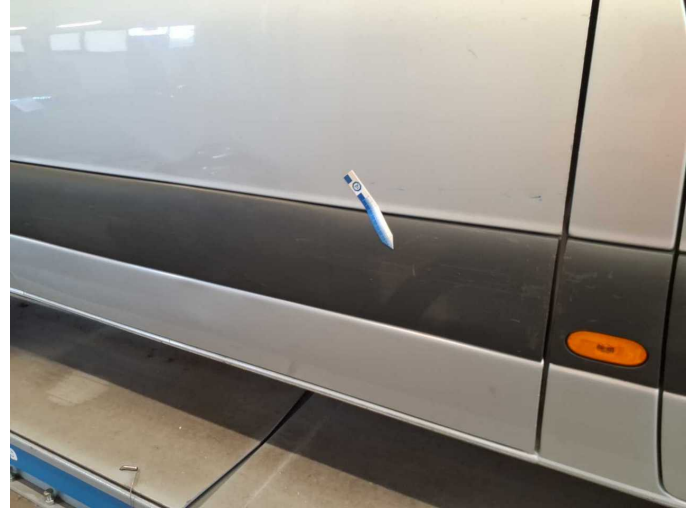
Damage 3: Door - rear right side: Brightware - lower - Scratch(es) - Replace

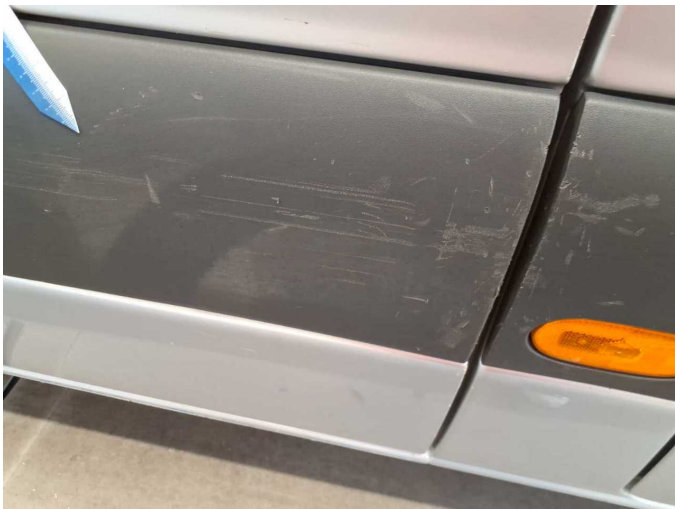
Damage 3: Door - rear right side: Brightware - lower - Scratch(es) - Replace

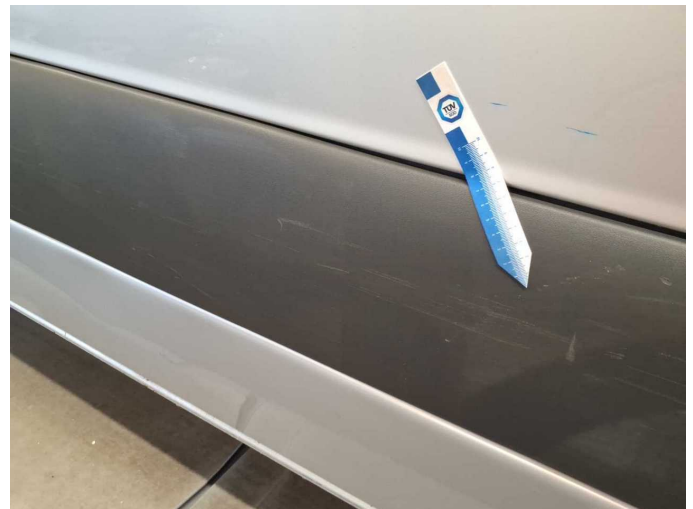
Damage 3: Door - rear right side: Brightware - lower - Scratch(es) - Replace

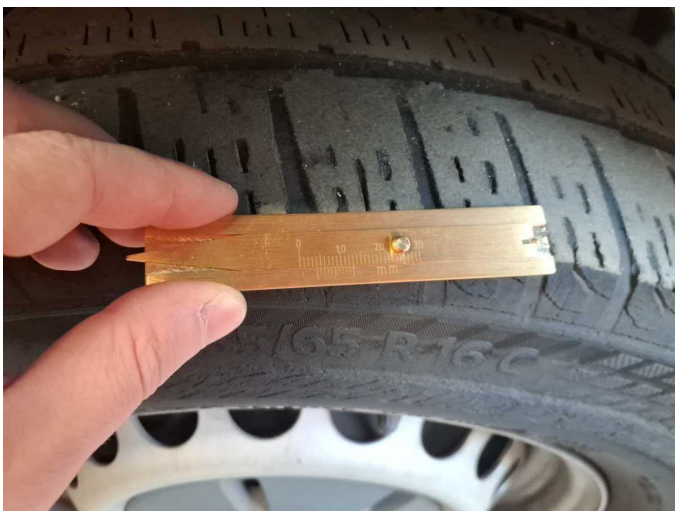
Damage 4: Wheel / tyres: Tyre - front (4mm) - Does not meet the leasing specifications - Replace

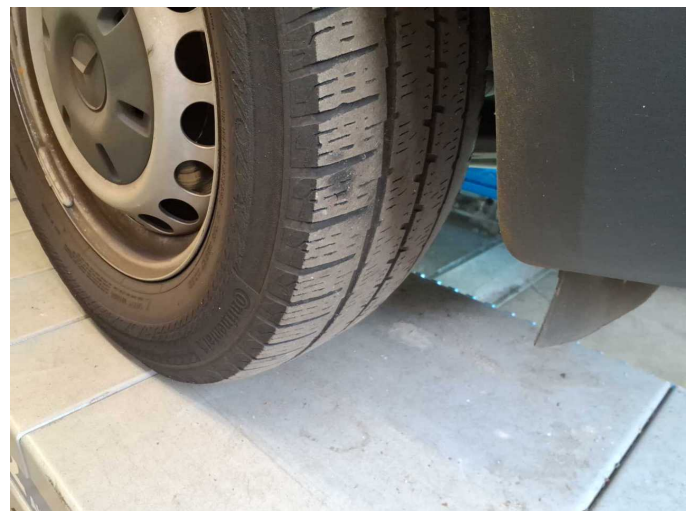
Damage 4: Wheel / tyres: Tyre - front (4mm) - Does not meet the leasing specifications - Replace

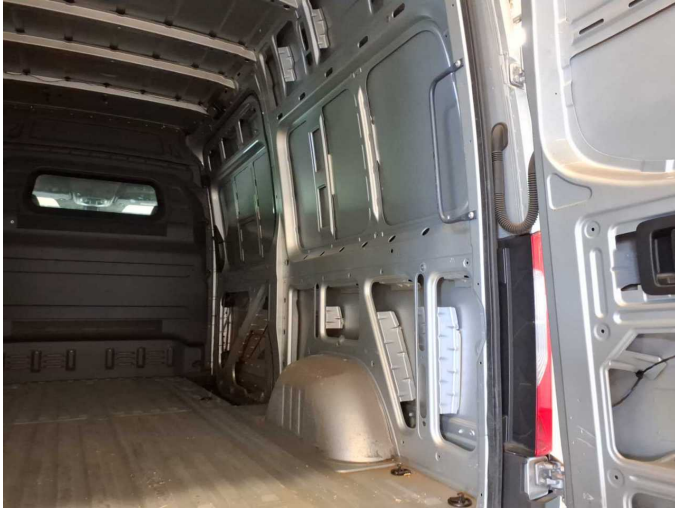
Damage 5: Trim / covers: Boot lining (Unterteile fehlen komplett) - Missing - Replace

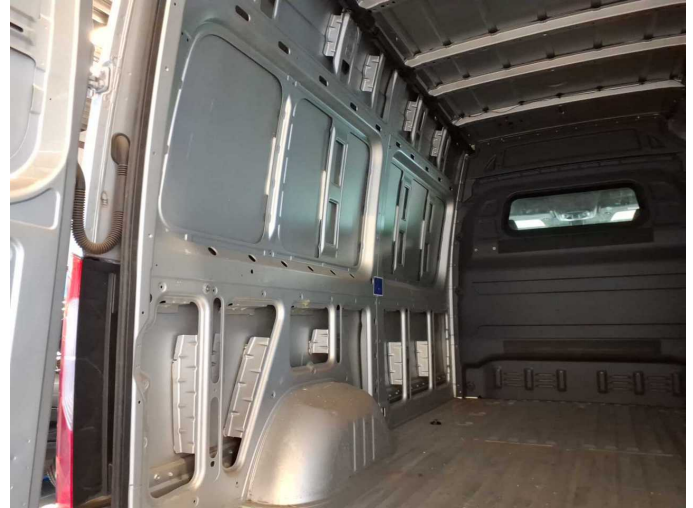
Damage 5: Trim / covers: Boot lining (Unterteile fehlen komplett) - Missing - Replace

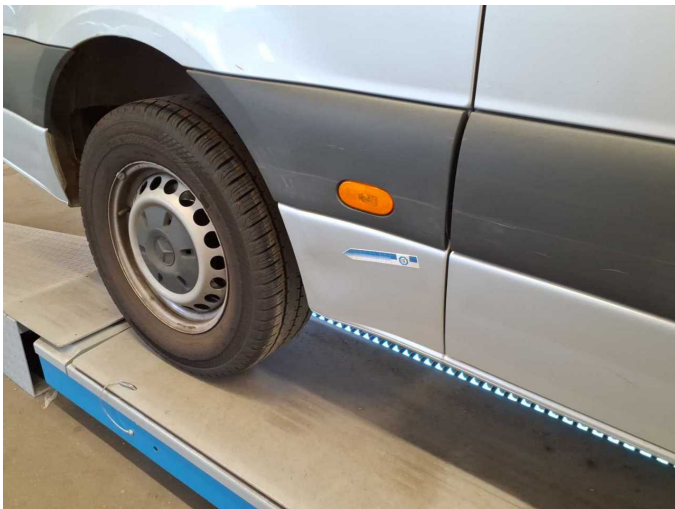
Damage 6: Side panel - rear right side: Side panel - Deformed - Repair and paint

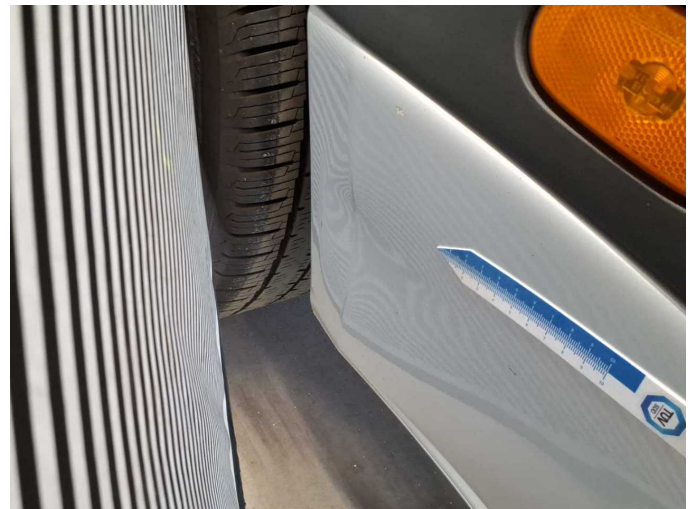
Damage 6: Side panel - rear right side: Side panel - Deformed - Repair and paint

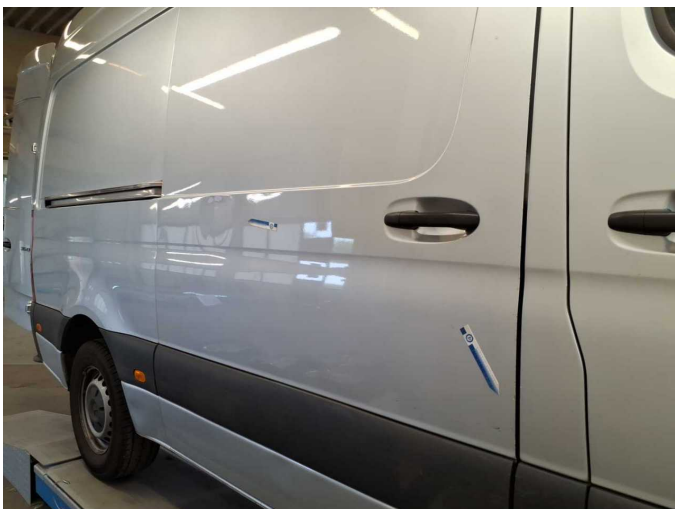
Damage 7: Sliding door, right: Sliding door - Dent / paintcoat damage - Repair and paint

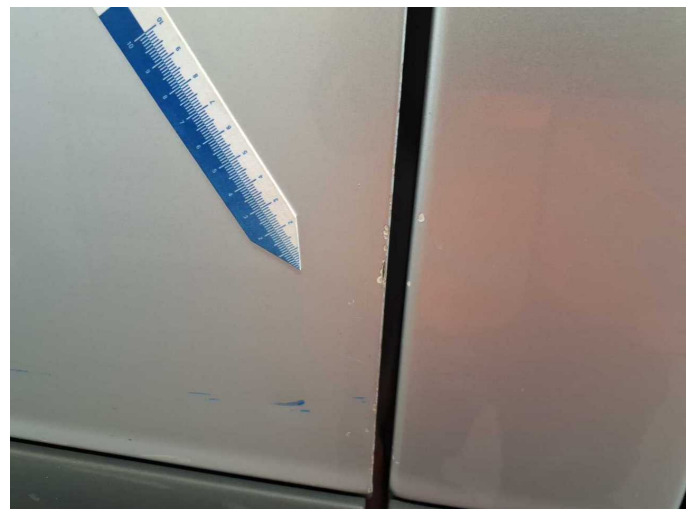
Damage 7: Sliding door, right: Sliding door - Dent / paintcoat damage - Repair and paint

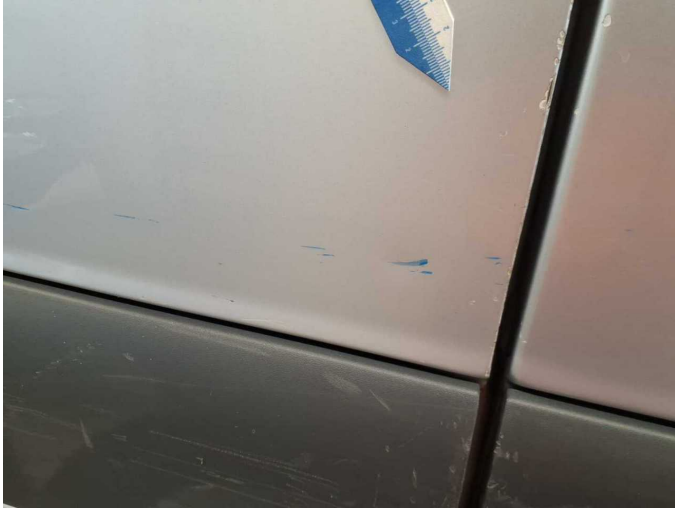
Damage 7: Sliding door, right: Sliding door - Dent / paintcoat damage - Repair and paint

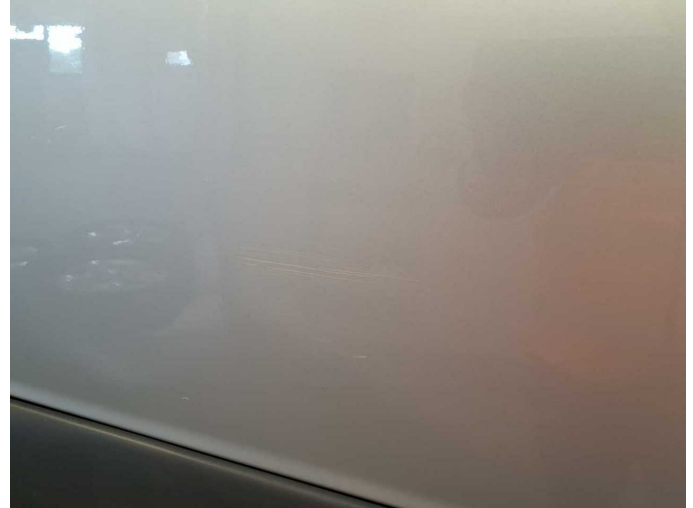
Damage 7: Sliding door, right: Sliding door - Dent / paintcoat damage - Repair and paint

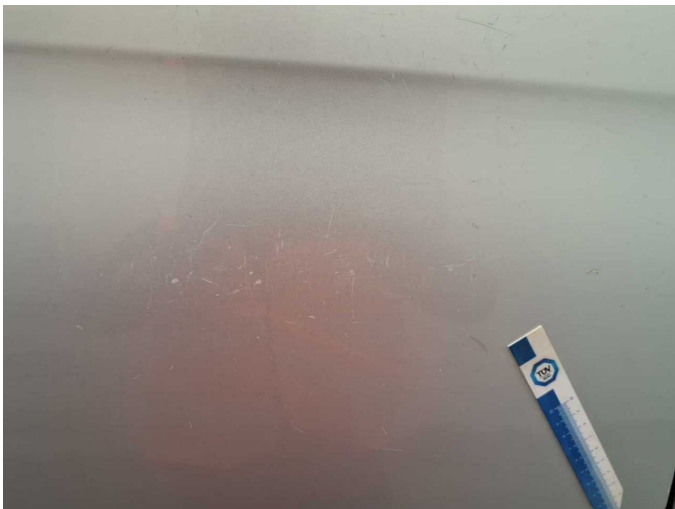
Damage 7: Sliding door, right: Sliding door - Dent / paintcoat damage - Repair and paint

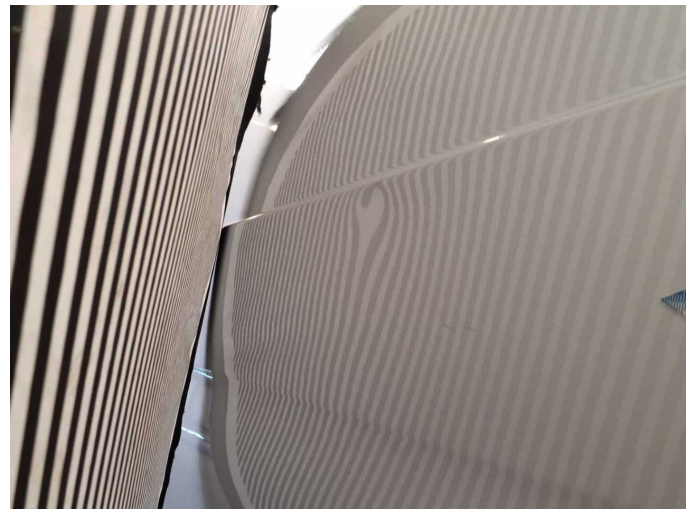
Damage 7: Sliding door, right: Sliding door - Dent / paintcoat damage - Repair and paint

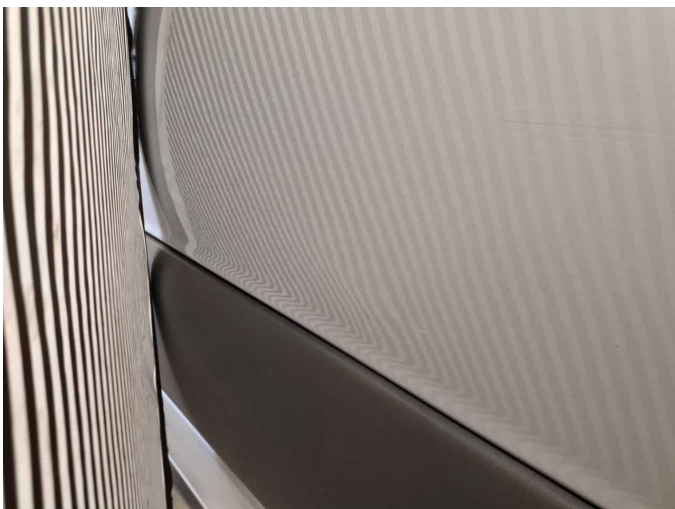
Damage 7: Sliding door, right: Sliding door - Dent / paintcoat damage - Repair and paint
