Expertise

Protocol number: 46474177  
Order No. / Reference: 26699646  
Inspection date: 10 Jul 2026

Manufacturer: Ford

Model: Transit Courier S&S Trend

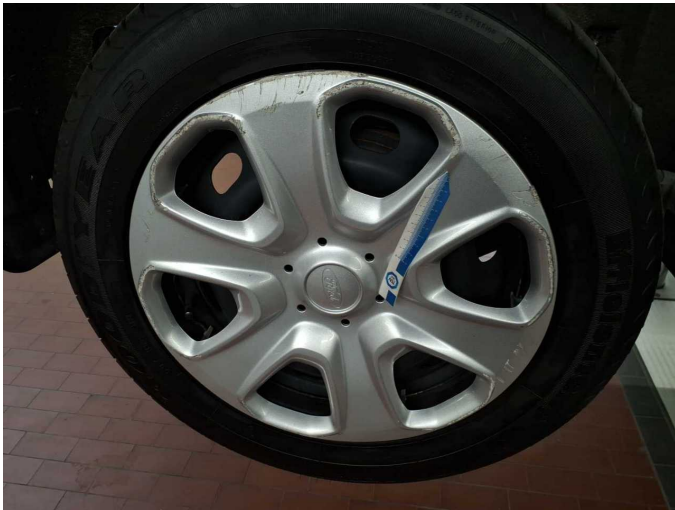
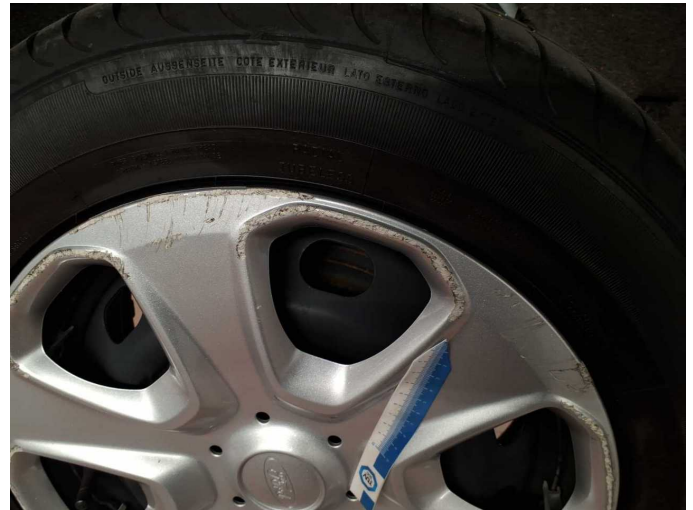
| No. | Component group | Description |
|---|---|---|
| 1 | Wheel / tyres | Wheel cover - rear right side - Scratched - Replace |

**Damage 1:** Wheel / tyres: Wheel cover - rear right side - Scratched - Replace

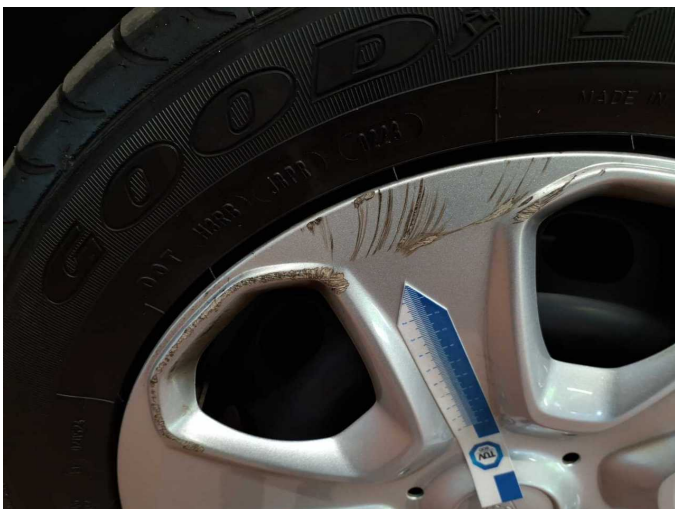
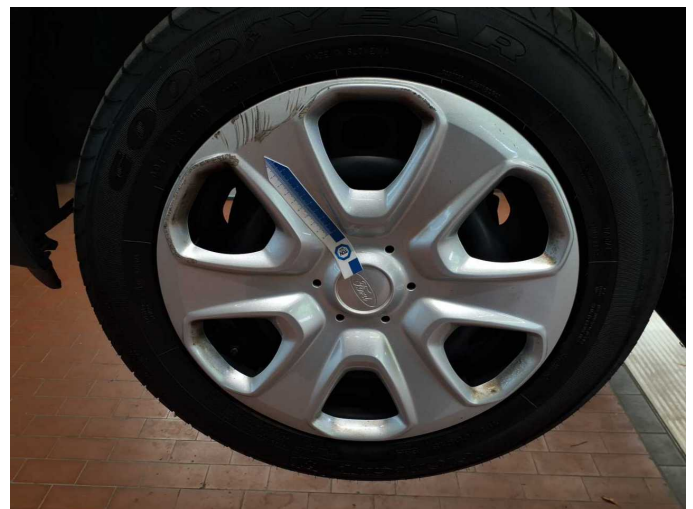
| No. | Component group | Description |
|---|---|---|
| 2 | Wheel / tyres | Wheel cover - front left side - Scratch(es) - Replace |

**Damage 2:** Wheel / tyres: Wheel cover - front left side - Scratch(es) - Replace

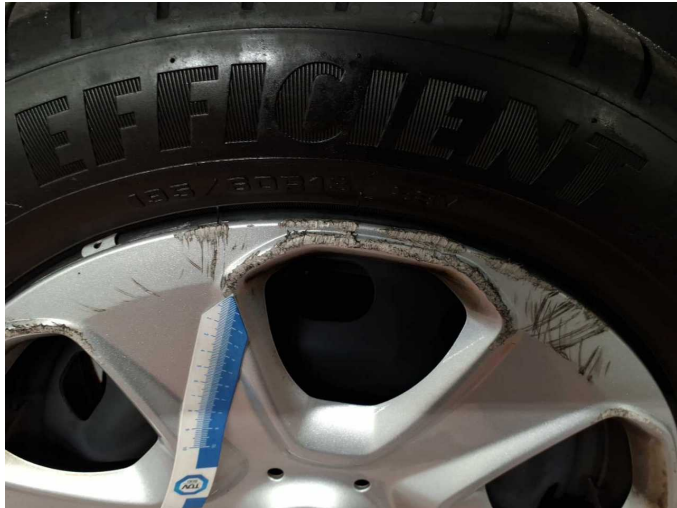
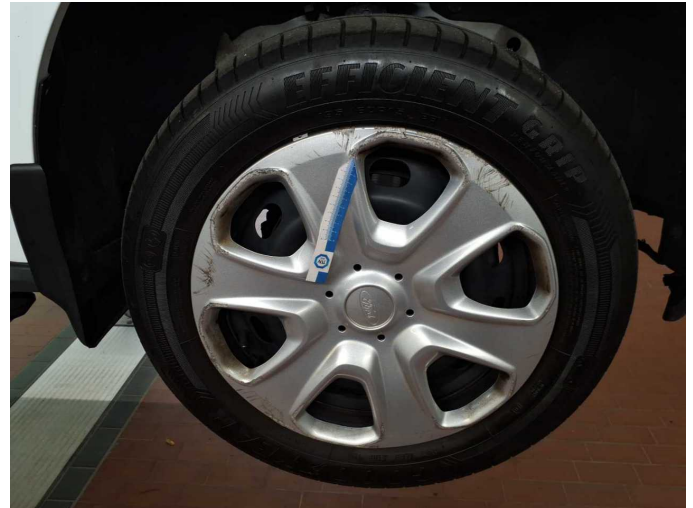
| No. | Component group | Description |
|---|---|---|
| 3 | Wheel / tyres | Wheel cover - front right side - Scratched - Replace |

**Damage 3:** Wheel / tyres: Wheel cover - front right side - Scratched - Replace

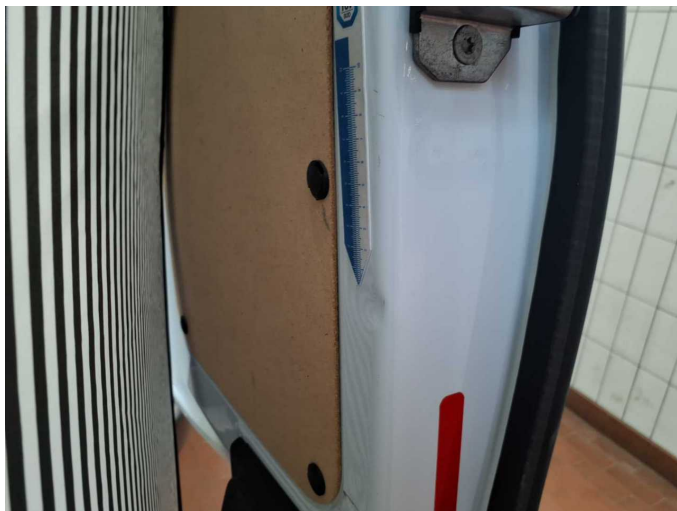
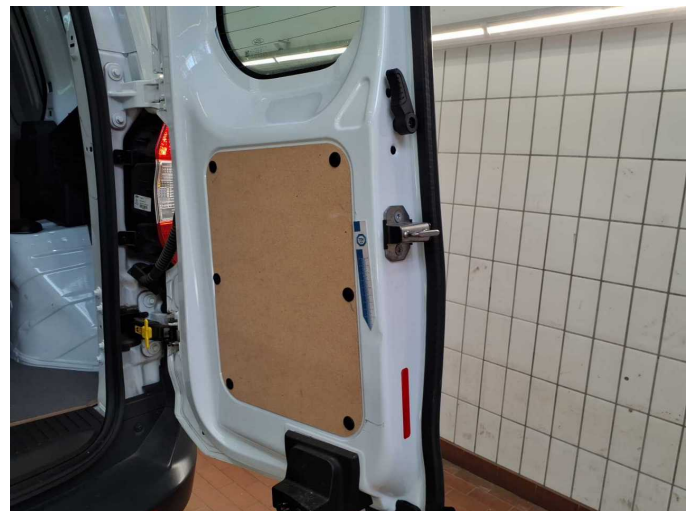
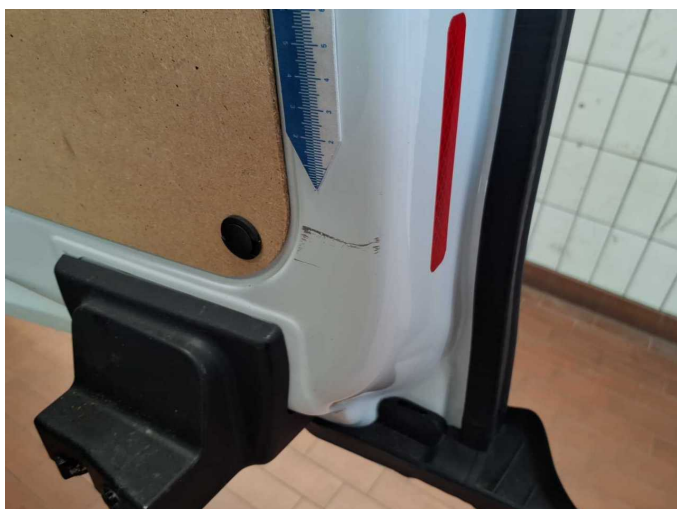
| No. | Component group | Description |
|---|---|---|
| 4 | Boot lid / rear door | Rear door - right side - Dent / paintcoat damage - Smart repair |

**Damage 4:** Boot lid / rear door: Rear door - right side - Dent / paintcoat damage - Smart repair

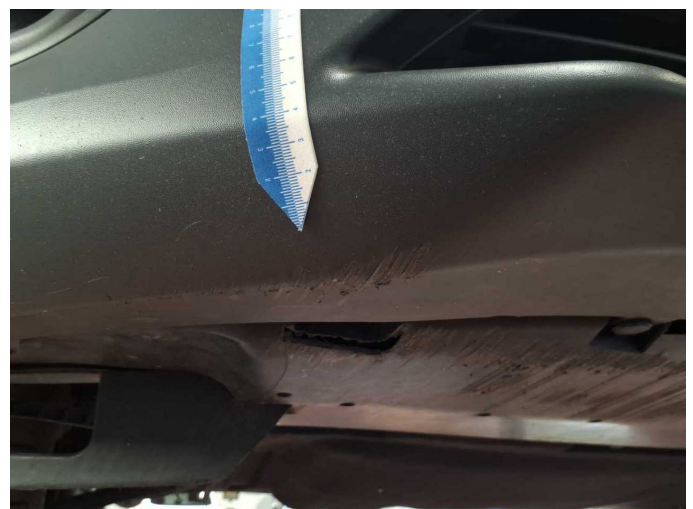
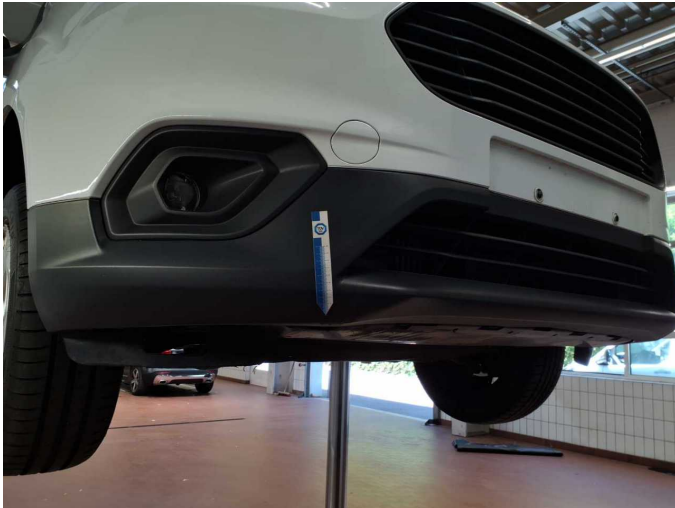
| No. | Component group | Description |
|---|---|---|
| 5 | Front bumper | Spoiler - Scratch(es) - Loss in value |

**Damage 5:** Front bumper: Spoiler - Scratch(es) - Loss in value

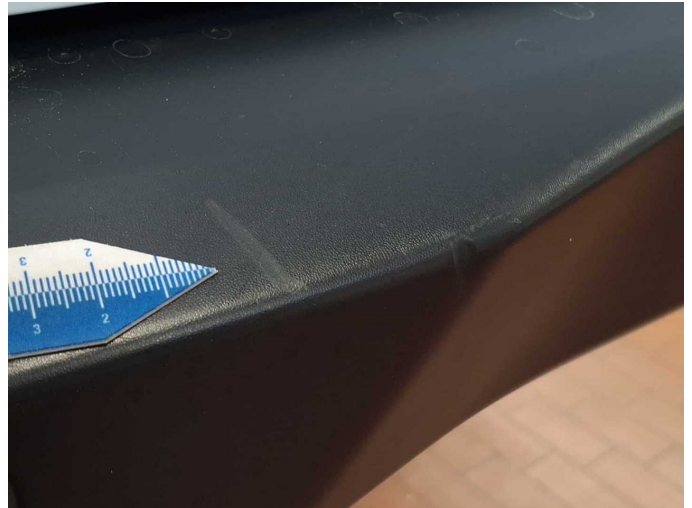
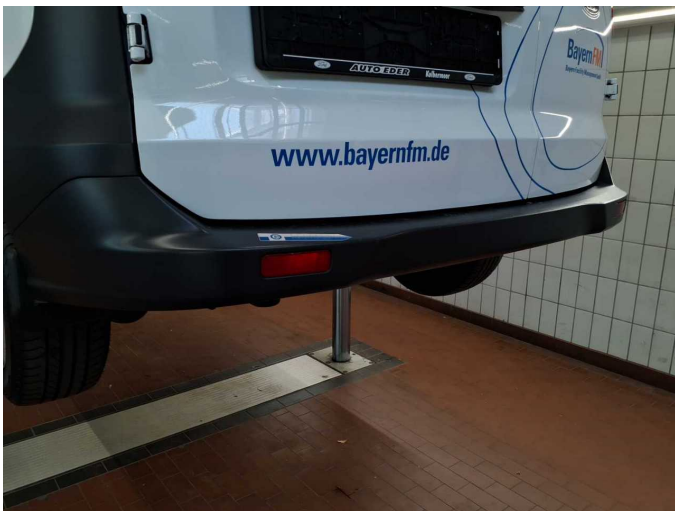
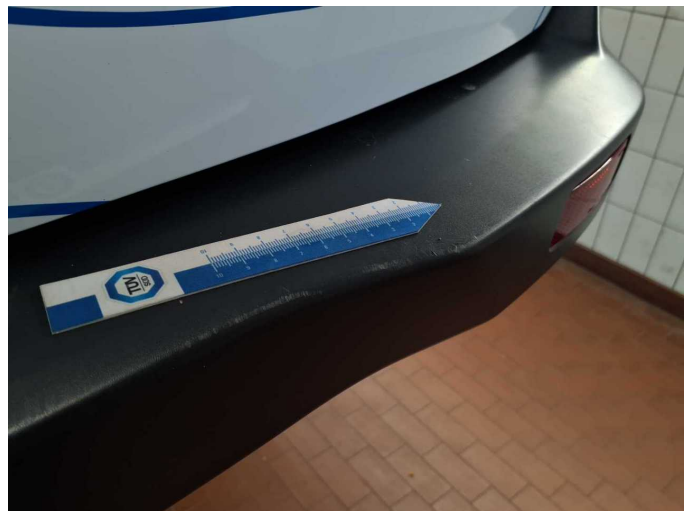
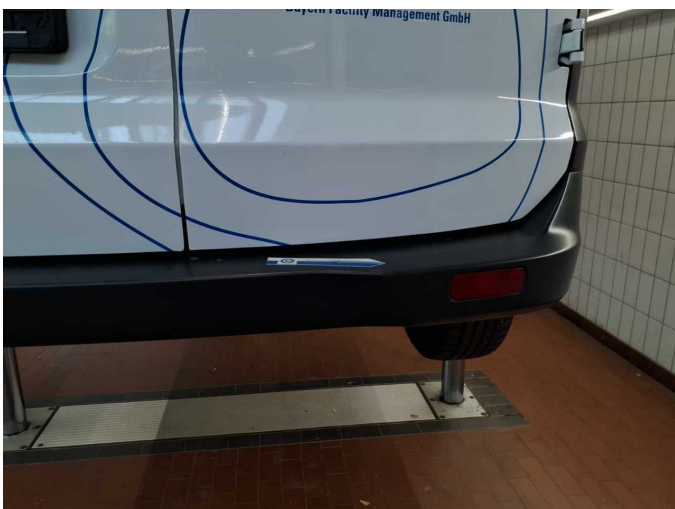
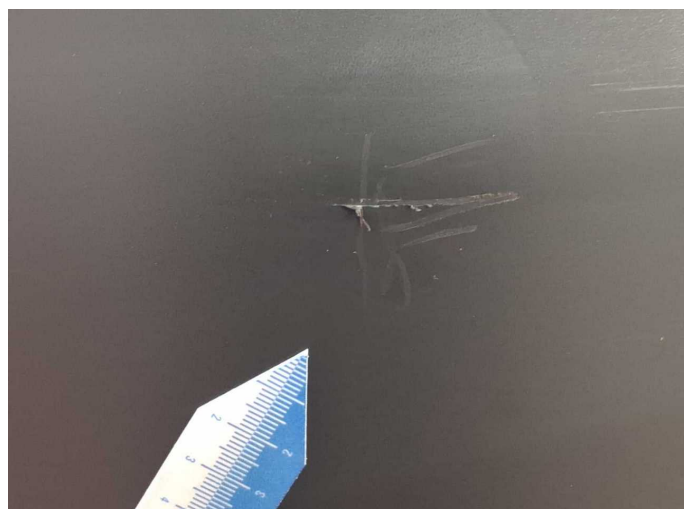
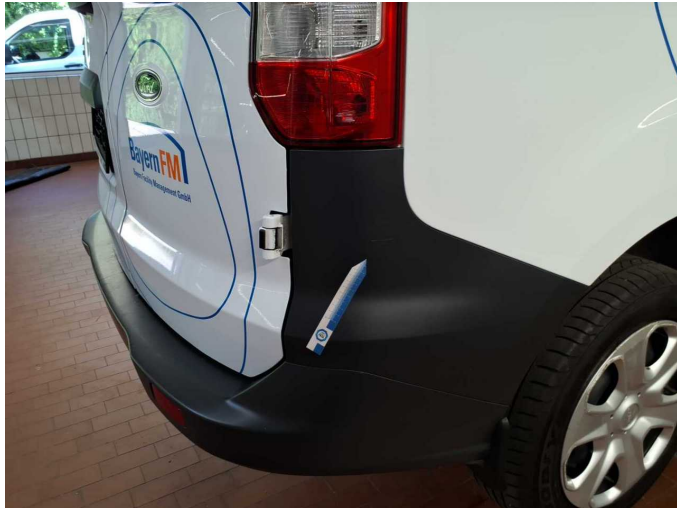
| No. | Component group | Description |
|---|---|---|
| 6 | Rear bumper | Rear bumper - Scratch(es) - Replace |

**Damage 6:** Rear bumper: Rear bumper - Scratch(es) - Replace

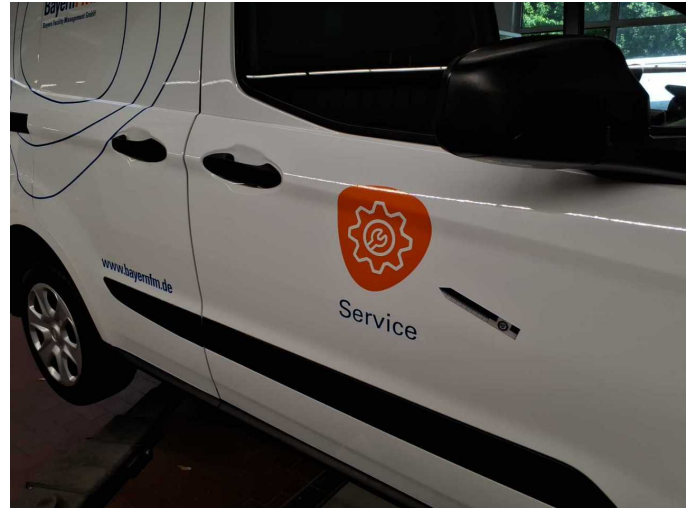
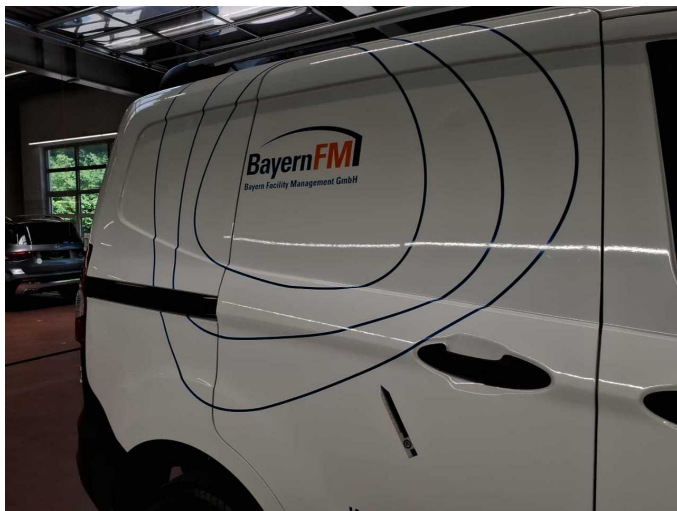
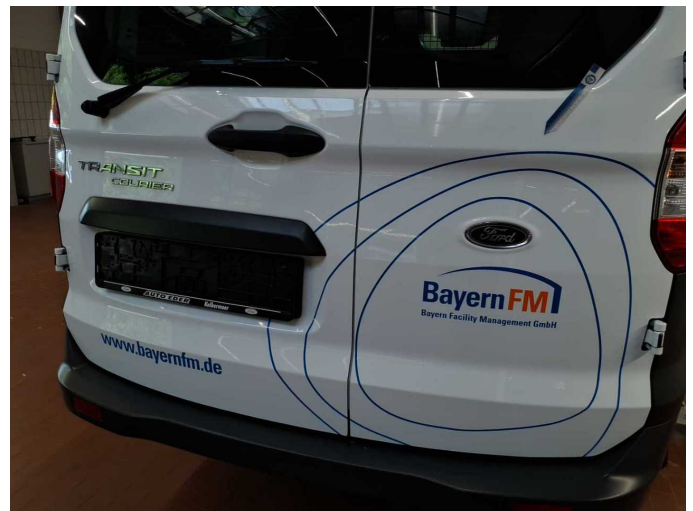
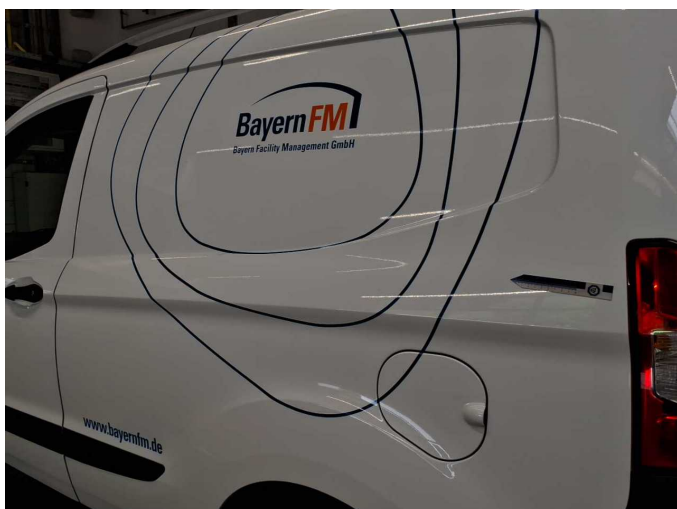
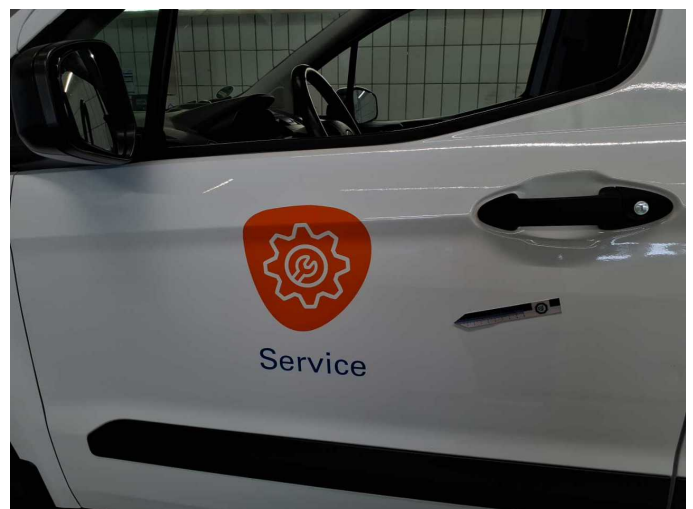
| No. | Component group | Description |
|---|---|---|
| 7 | Body | Body - Glued / labelled - De-glue / neutralise |

**Damage 7:** Body: Body - Glued / labelled - De-glue / neutralise

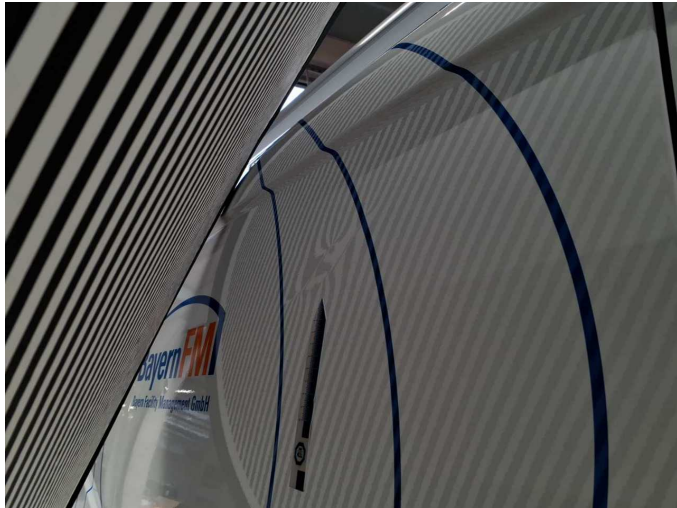
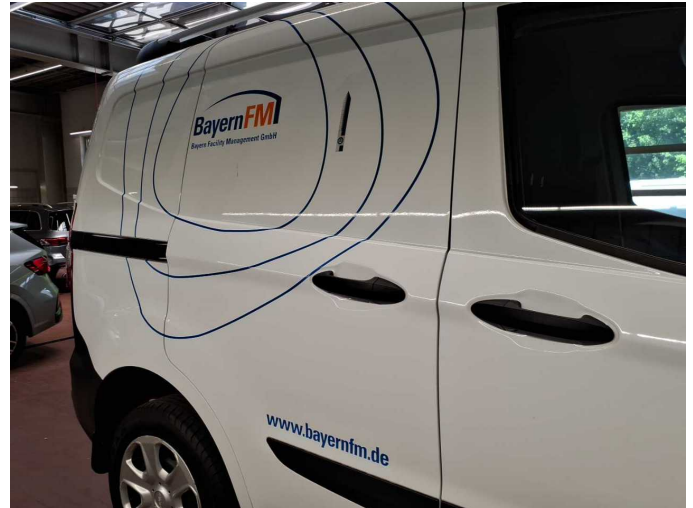
| No. | Component group | Description |
|---|---|---|
| 8 | Sliding door, right | Sliding door - dent(s) - Repair and paint |

**Damage 8:** Sliding door, right: Sliding door - dent(s) - Repair and paint

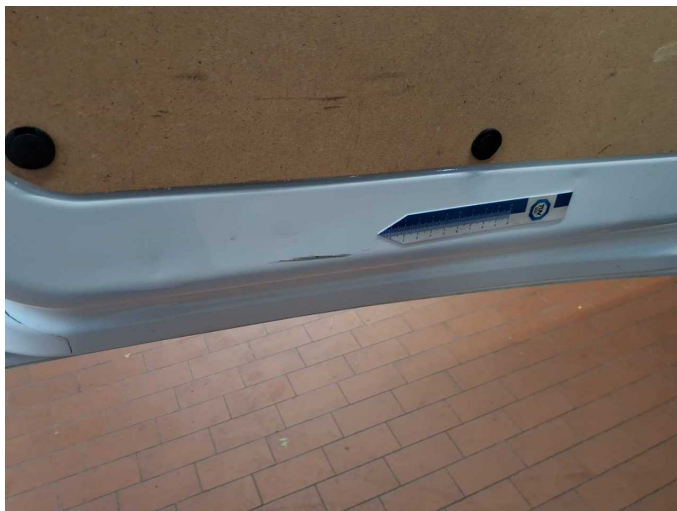
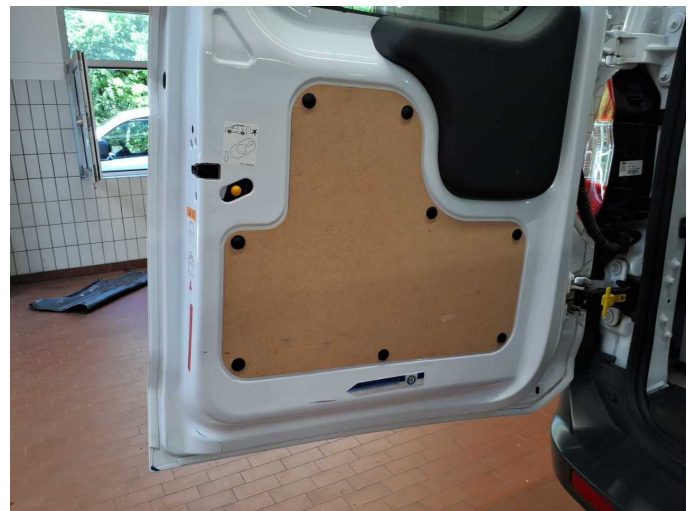
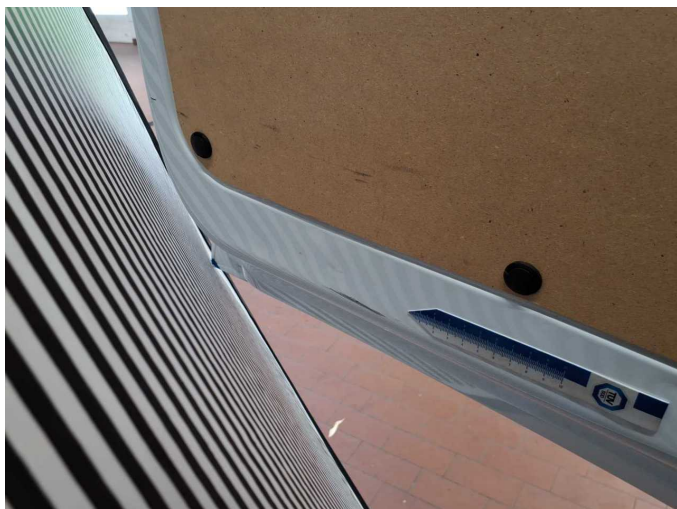
| No. | Component group | Description |
|---|---|---|
| 2 | Boot lid / rear door | Rear door - left side - Dent / paintcoat damage - No deduction |

**Wear and tear 2:** Boot lid / rear door: Rear door - left side - Dent / paintcoat damage - No deduction
