Expertise

Protocol number: 46355117
Order No. / Reference: 26612056
Inspection date: 7 Jul 2026

Manufacturer: Mercedes-Benz

Model: CLA 180 Shooting Brake 7G-DCT Progressive

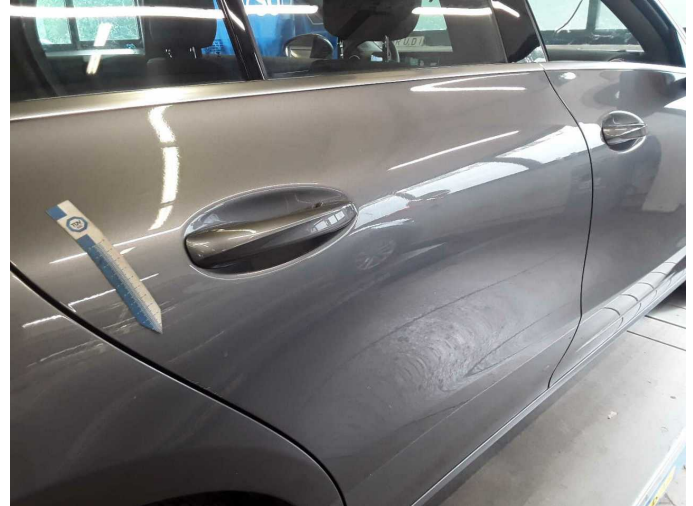
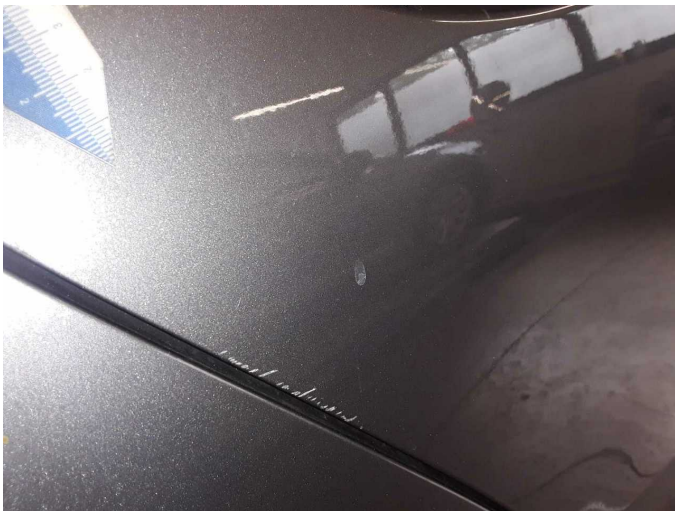
No.	Component group	Description
1	Door - rear right side	Door - Scratch(es) - Smart repair
2	Wheel / tyres	Alloy rim - front right side - Scratch(es) - Loss in value
3	Wheel / tyres	Alloy rim - front left side - Scratch(es) - Loss in value
4	Misc.	Inspection / maintenance - Due - Perform
5	Front bumper	Front bumper - Scratched - Paint

Damage 1: Door - rear right side: Door - Scratch(es) - Smart repair

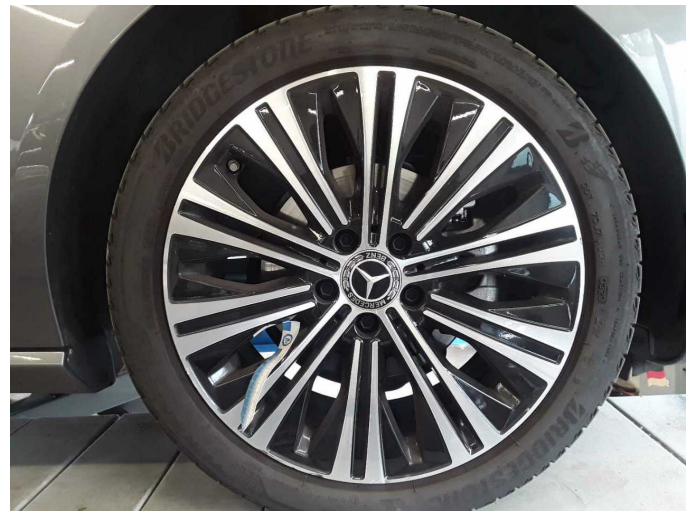
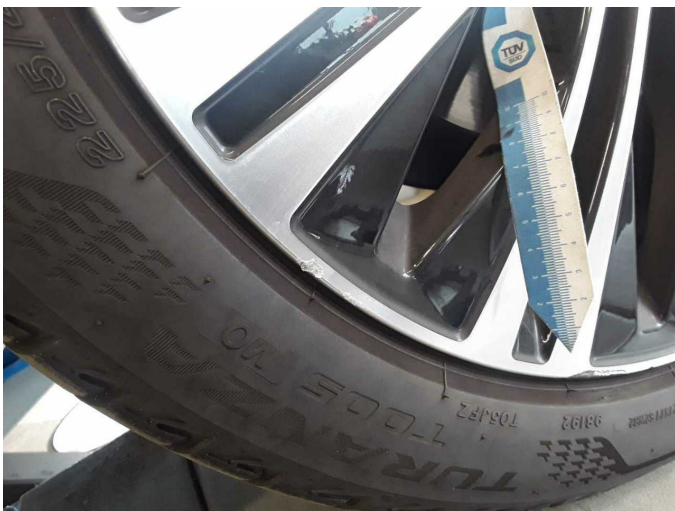
Damage 2: Wheel / tyres: Alloy rim - front right side - Scratch(es) - Loss in value

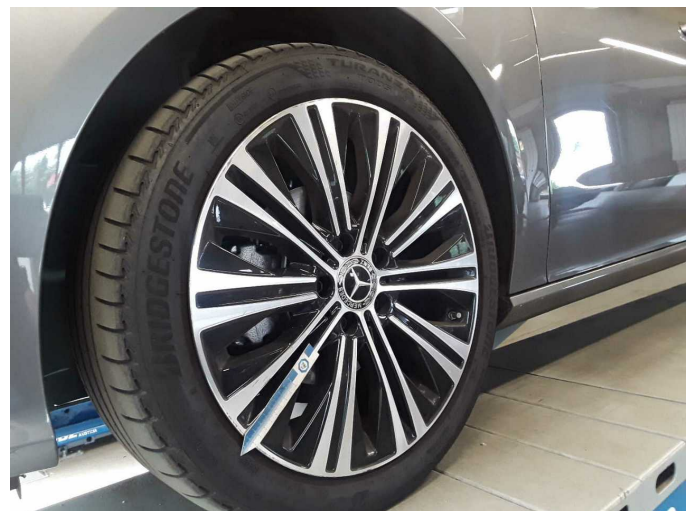
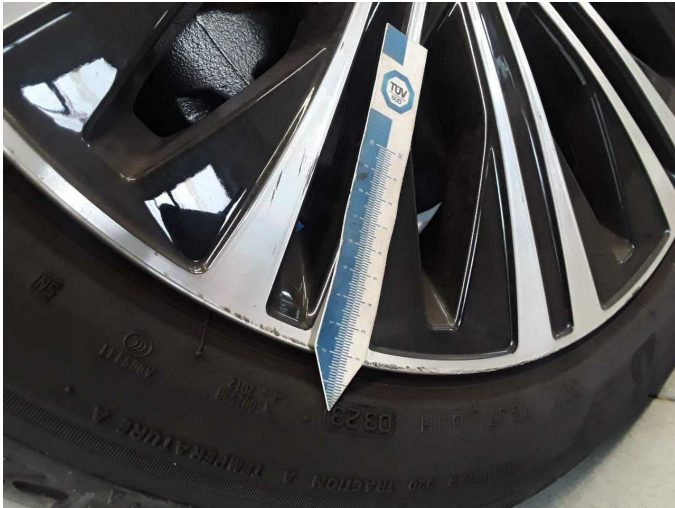
Damage 3: Wheel / tyres: Alloy rim - front left side - Scratch(es) - Loss in value

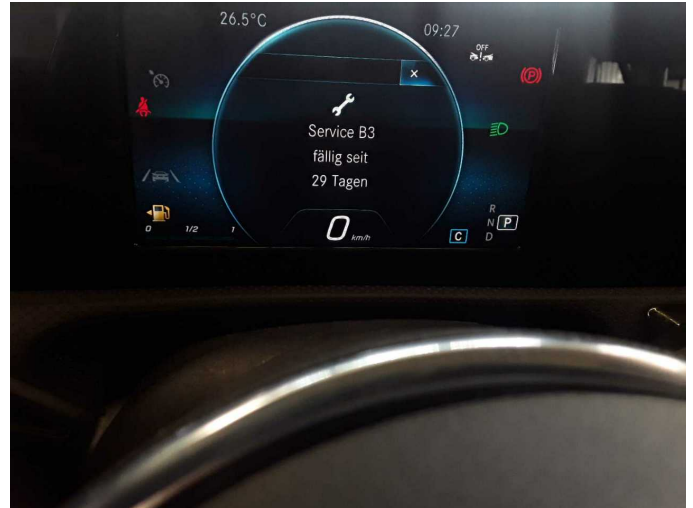
Damage 4: Misc.: Inspection / maintenance - Due - Perform

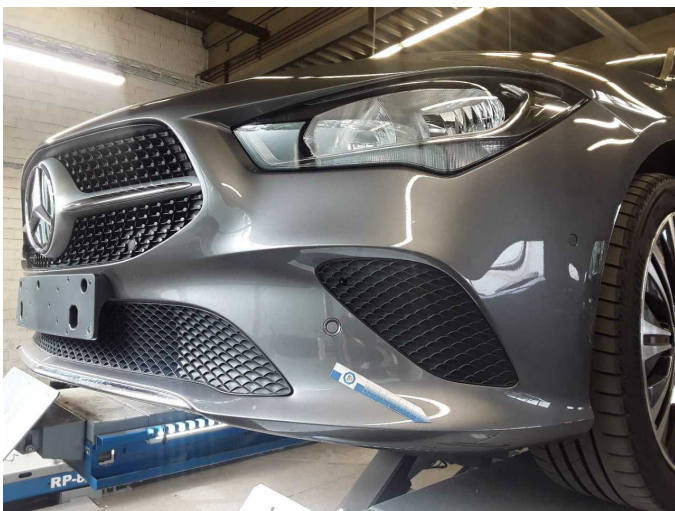
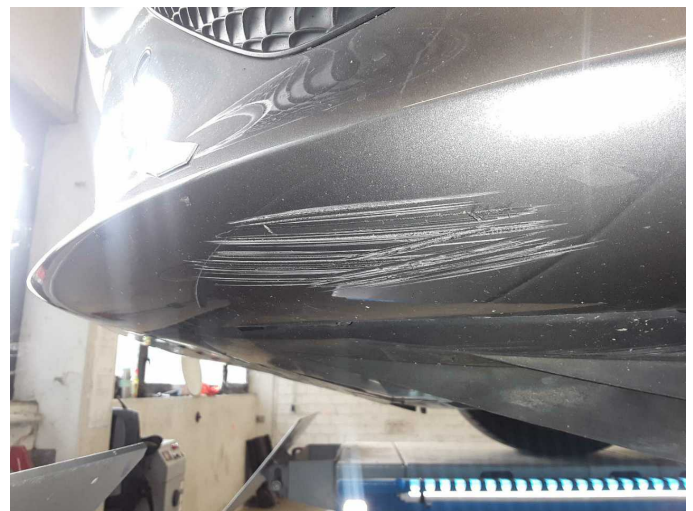
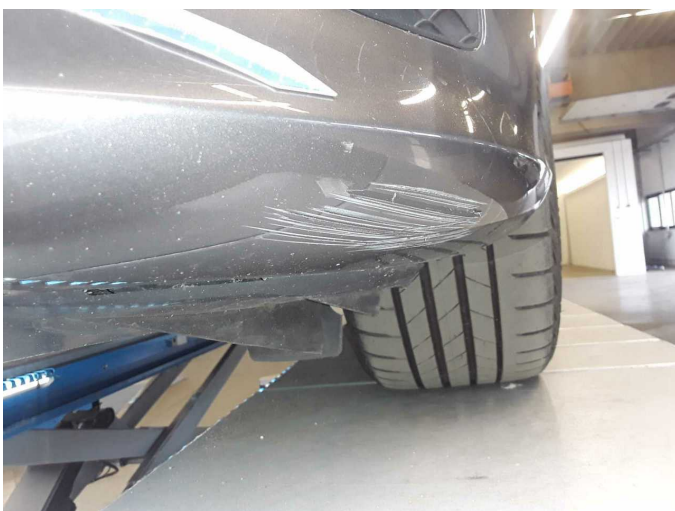
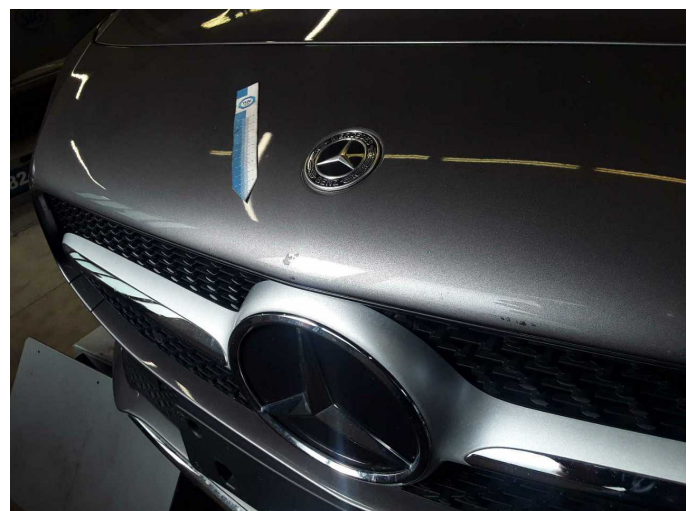
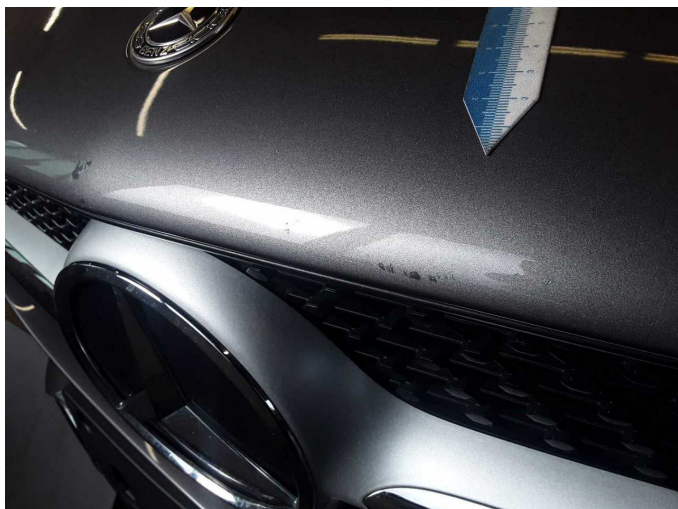
Damage 5: Front bumper: Front bumper - Scratched - Paint
