# FORD KUGA

| Vinnumber: | WF0FXXWPMFL59967 | Versionname: | 1.5 EcoBlue 88kW Aut. ST-Line X |

## Limited Technical Inspection

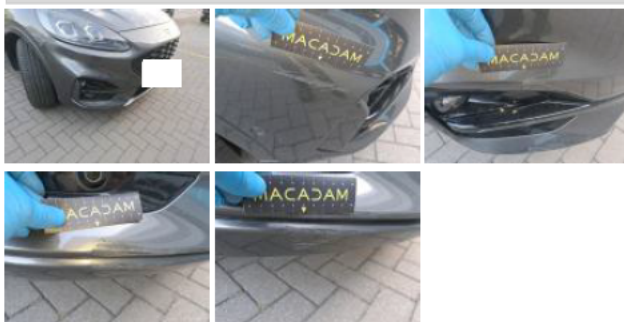
| Bumper F, Dent(s) and scratch(es), Repair and paint (complete) | 385,64 |

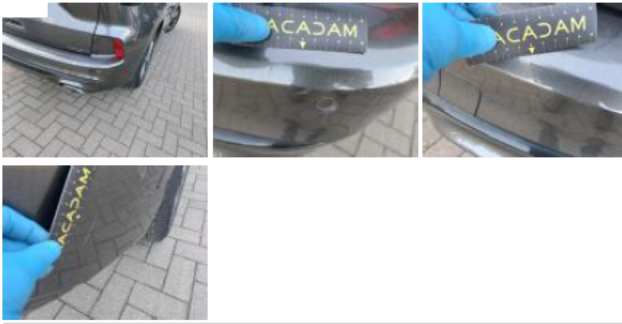
Bumper R, Dent(s) and scratch(es), Repair and paint (complete)

385,64

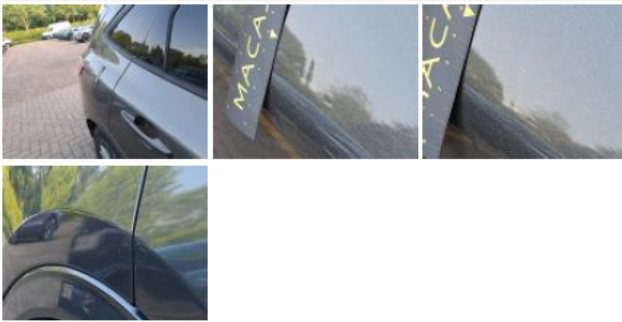
Wing RR, Bad repair, Repair and paint (complete)

517,89
