Expertise

Protocol number: 46058504  
Order No. / Reference: 26308073  
Inspection date: 20 Jun 2026

Manufacturer: Opel

Model: Astra Sports Tourer 1.2 Turbo Automatik GS

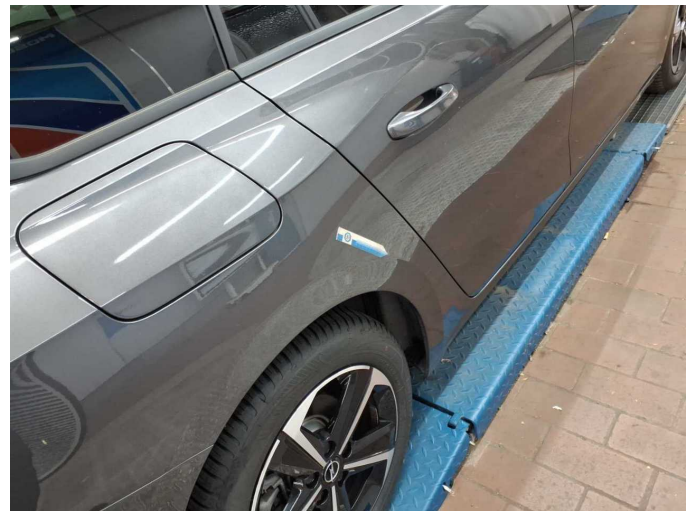
| No. | Component group | Description |
|---|---|---|
| 1 | Side panel - rear right side | Side panel - dent(s) - Smooth repair work |

**Damage 1:** Side panel - rear right side: Side panel - dent(s) - Smooth repair work

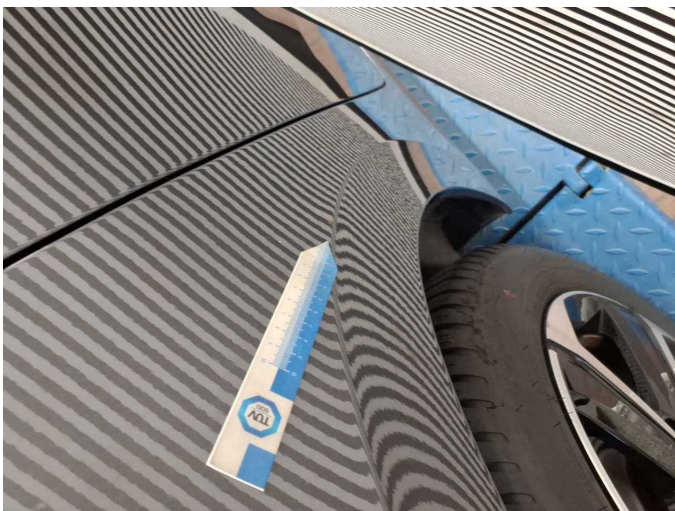
**Damage 1:** Side panel - rear right side: Side panel - dent(s) - Smooth repair work

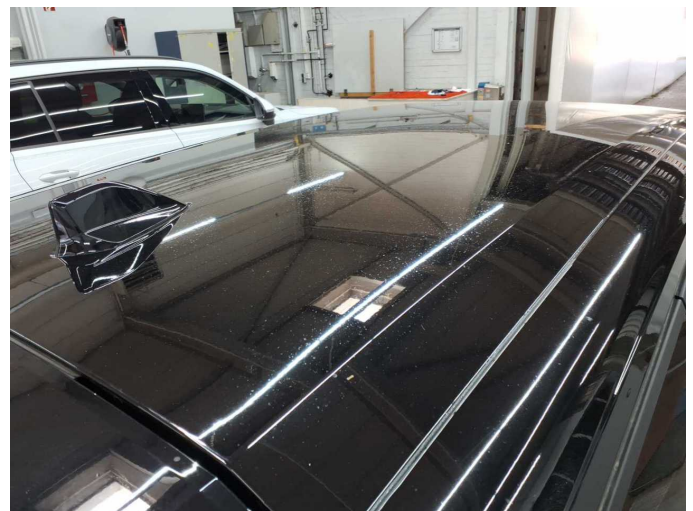
| No. | Component group | Description |
|---|---|---|
| 2 | Roof | Roof (Anhaftung Harz-Mehrkosten möglich) - Paint defect - Conditioning |

**Damage 2:** Roof: Roof (Anhaftung Harz-Mehrkosten möglich) - Paint defect - Conditioning

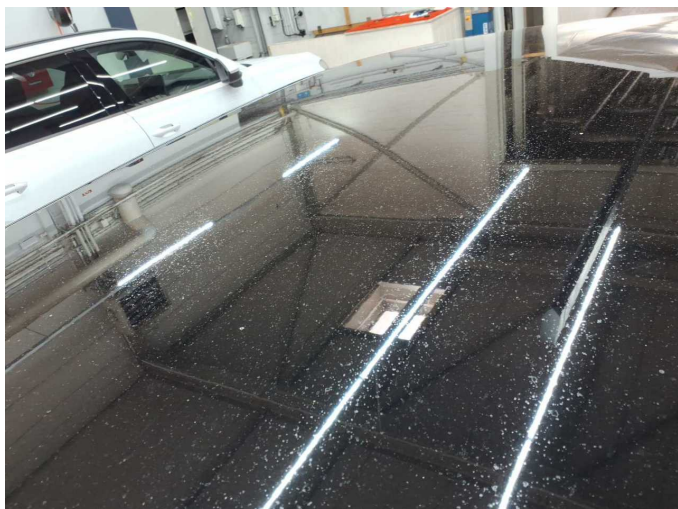
**Damage 2:** Roof: Roof (Anhaftung Harz-Mehrkosten möglich) - Paint defect - Conditioning

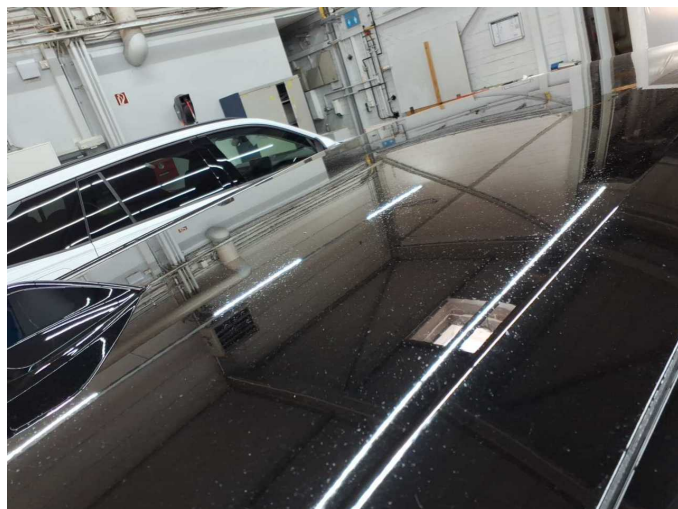
**Damage 2:** Roof: Roof (Anhaftung Harz-Mehrkosten möglich) - Paint defect - Conditioning

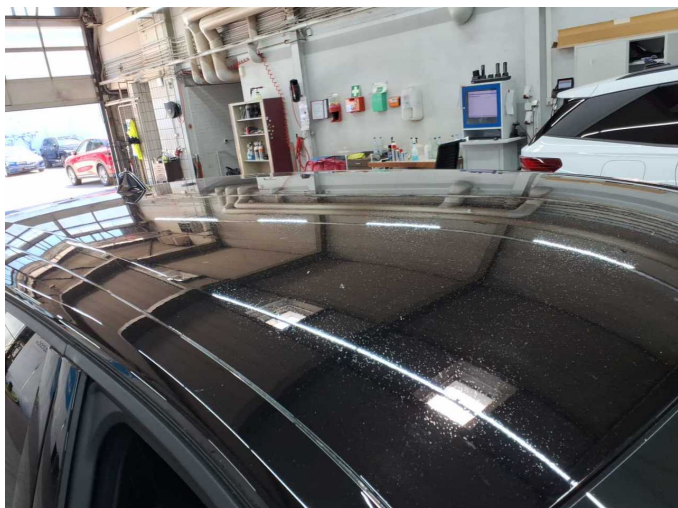
**Damage 2:** Roof: Roof (Anhaftung Harz-Mehrkosten möglich) - Paint defect - Conditioning

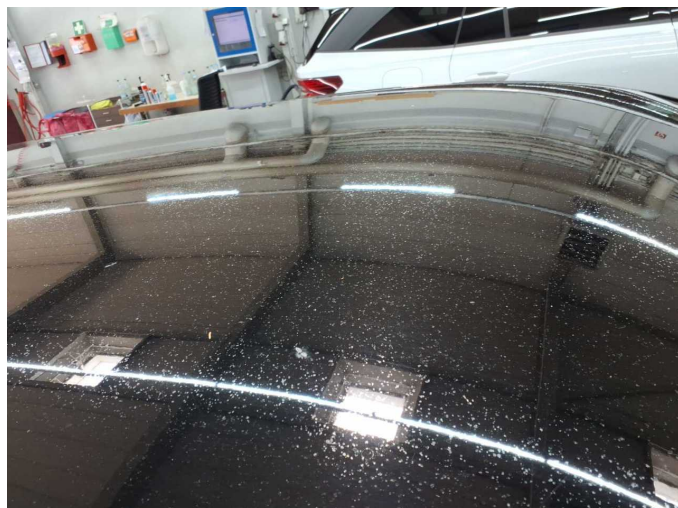
**Damage 2:** Roof: Roof (Anhaftung Harz-Mehrkosten möglich) - Paint defect - Conditioning

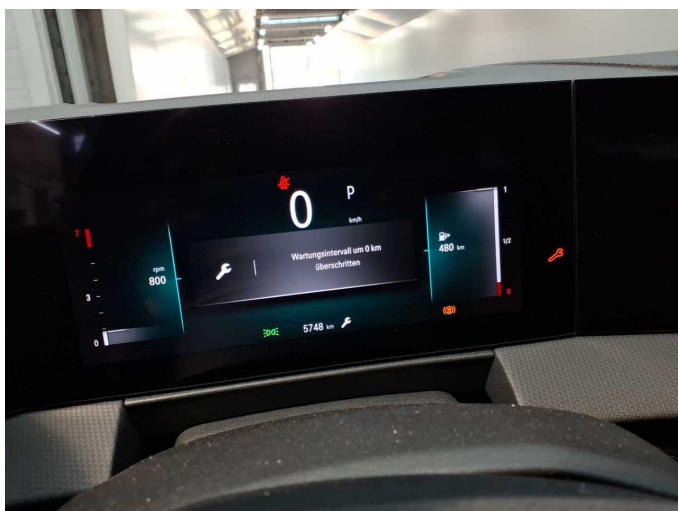
| No. | Component group | Description |
|---|---|---|
| 3 | Misc. | Inspection / maintenance - Due - Replace |

**Damage 3:** Misc.: Inspection / maintenance - Due - Replace
