## Expertise

Protocol number: 45538256  
Order No. / Reference: 26352043  
Inspection date: 11 May 2026

Manufacturer: Ford

Model: Focus Turnier 2.0 EcoBlue Start-Stopp-System Aut.  
COOL&CONNECT

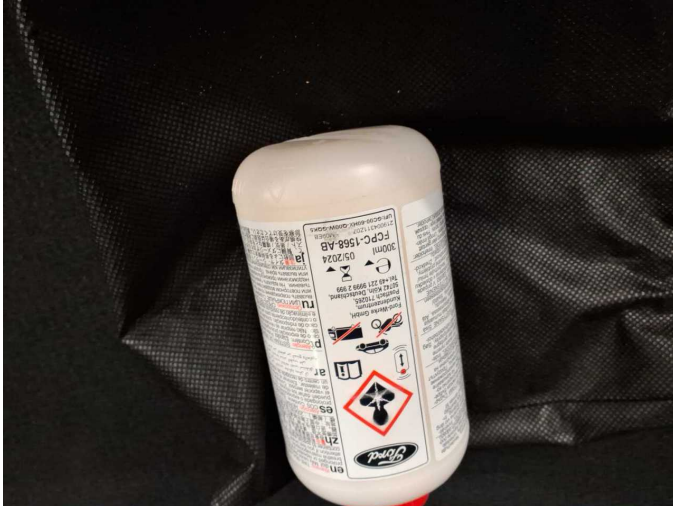
**Damage 3:** Equipment: Tirefit filler - Expired - Replace

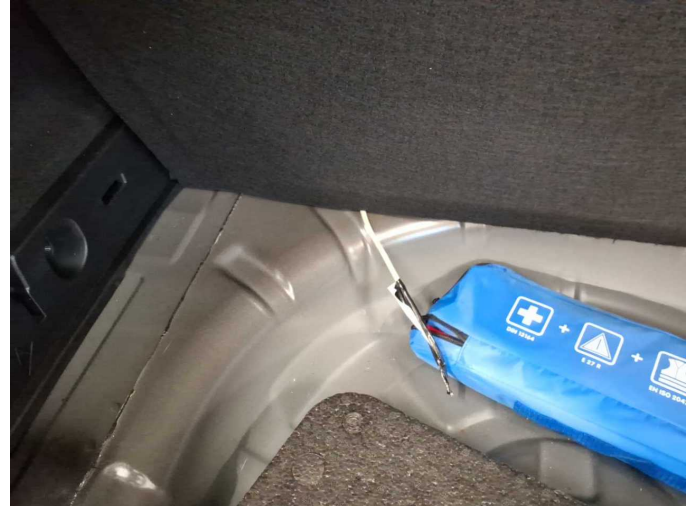
**Damage 4:** Electrical system: Cable strand (Kabelführung von Frontbereich in Laderaum) - Differs from the original configuration - Un-/install

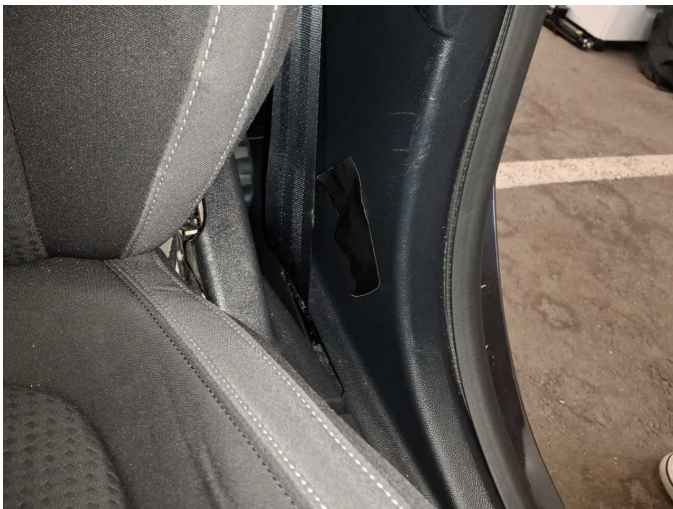
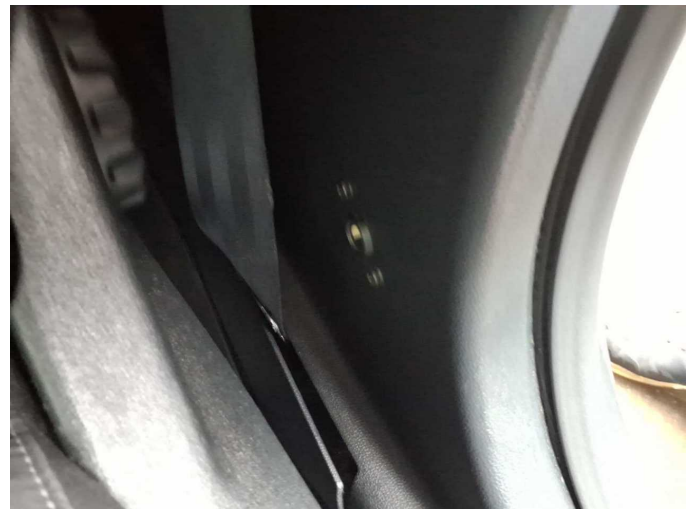
**Damage 5:** Trim / covers: B-pillar - trim - interior, left side (Fehlbohrungen) - Damaged - Replace

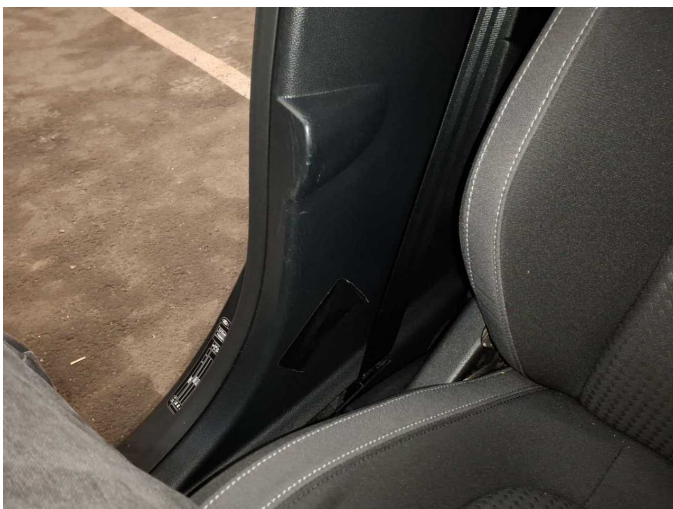
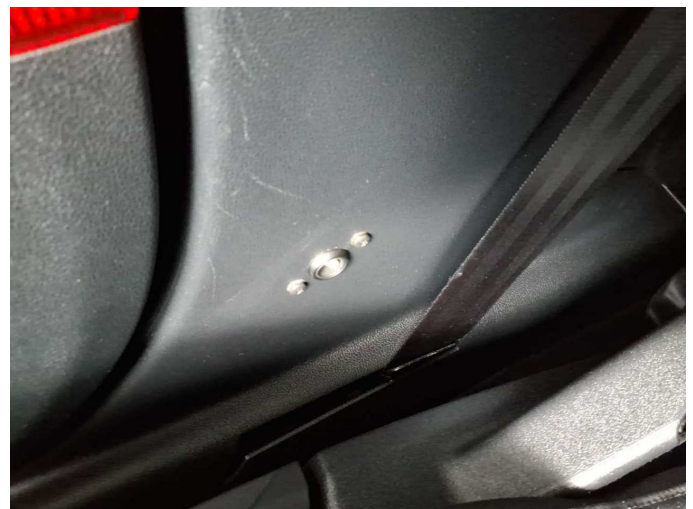
**Damage 6:** Trim / covers: B-pillar - trim - interior, right side (Fehlbohrungen) - Damaged - Replace

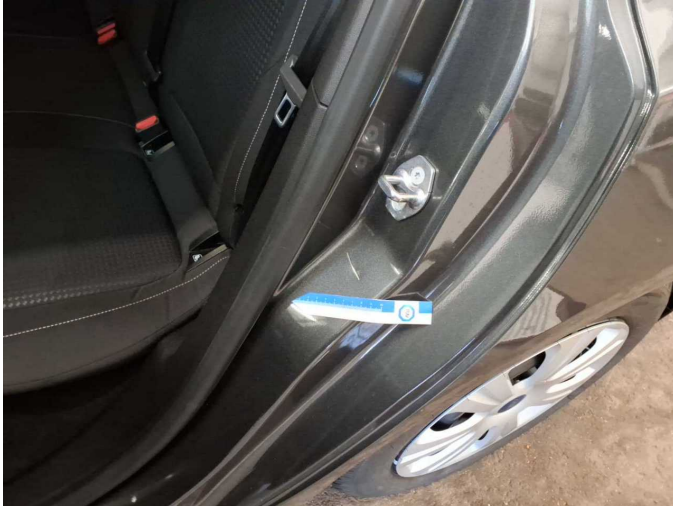
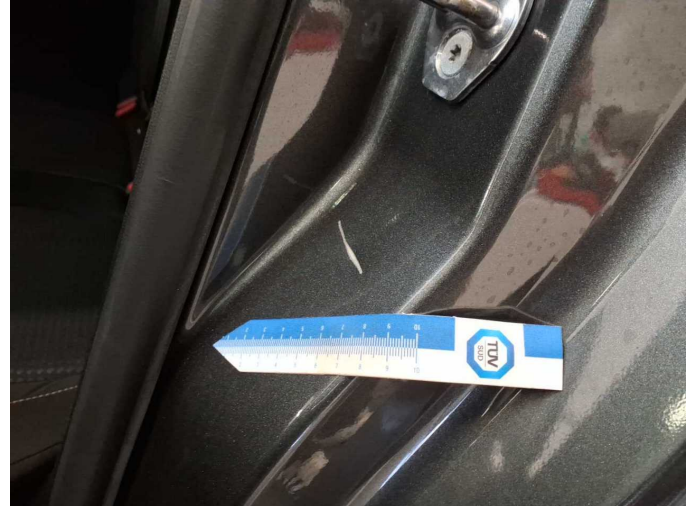
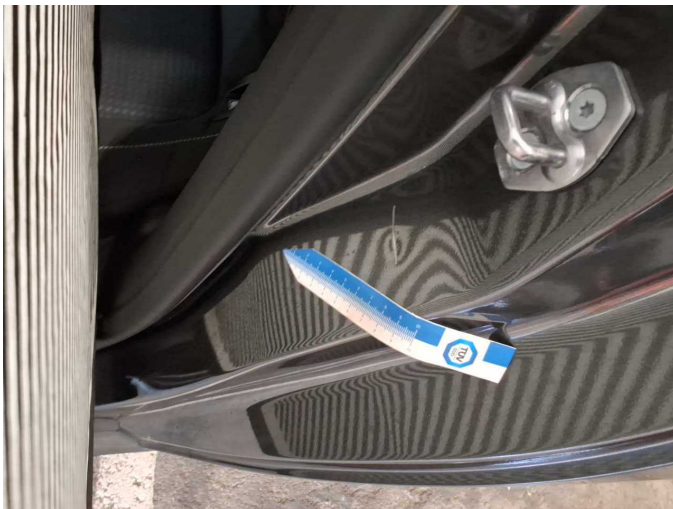
**Damage 7:** Side panel - rear left side: Sill - Dent / paintcoat damage - Smart repair

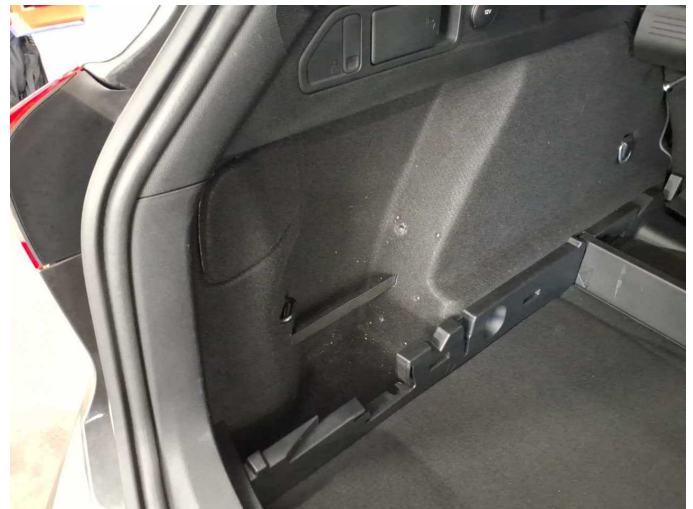
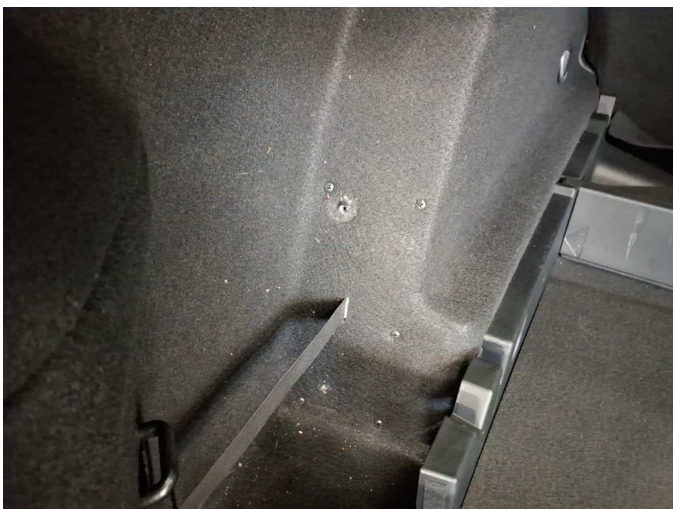
**Damage 8:** Trim / covers: Cargo area - lining -left side (Fehlbohrungen) - Damaged - Replace

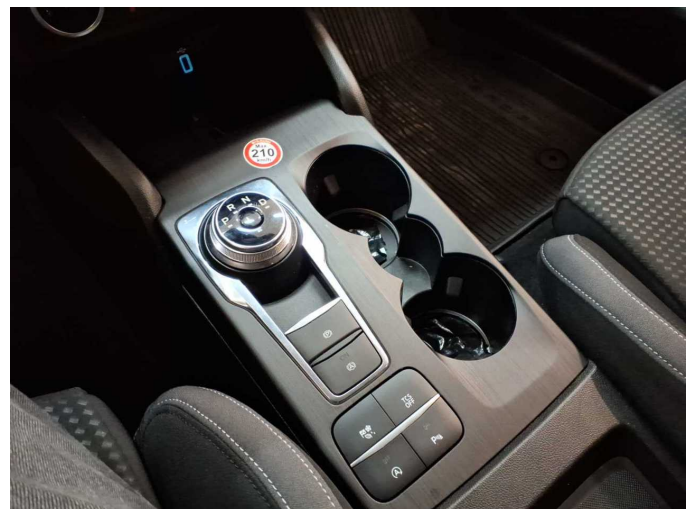
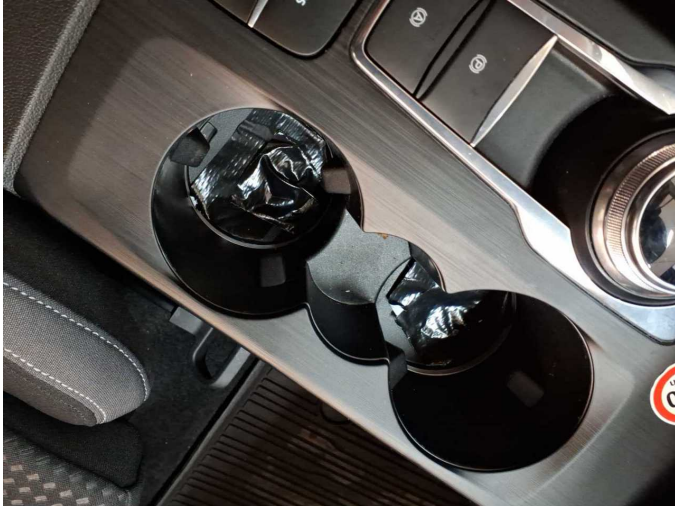
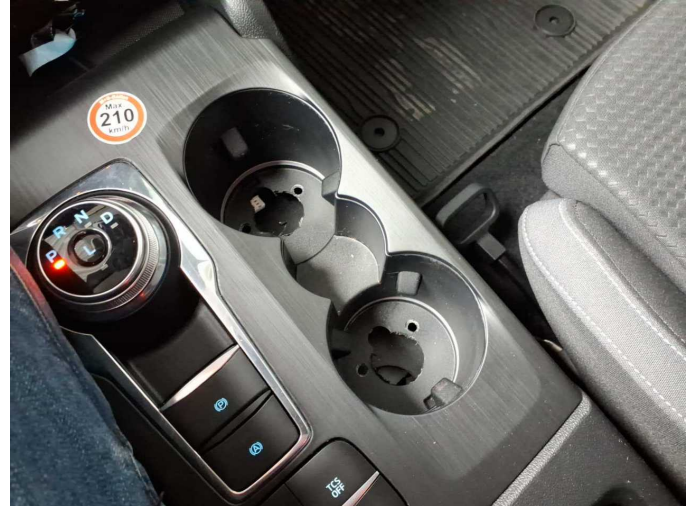
**Damage 9:** Instrument panel: Centre console - front (Getränkehalter, Fehlbohrungen) - Damaged - Replace

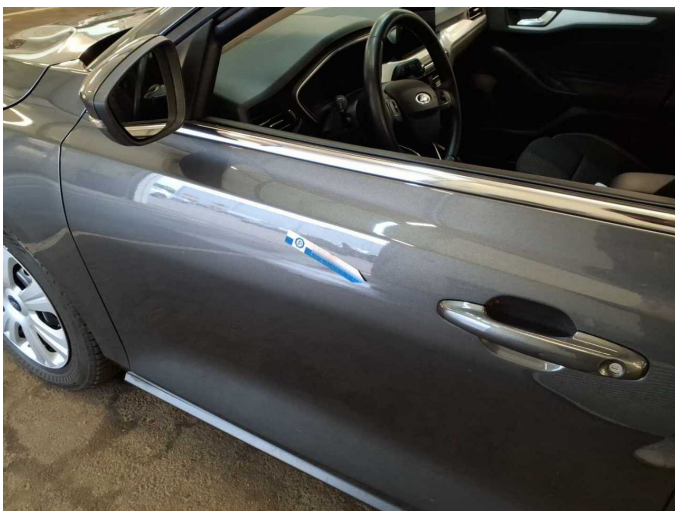
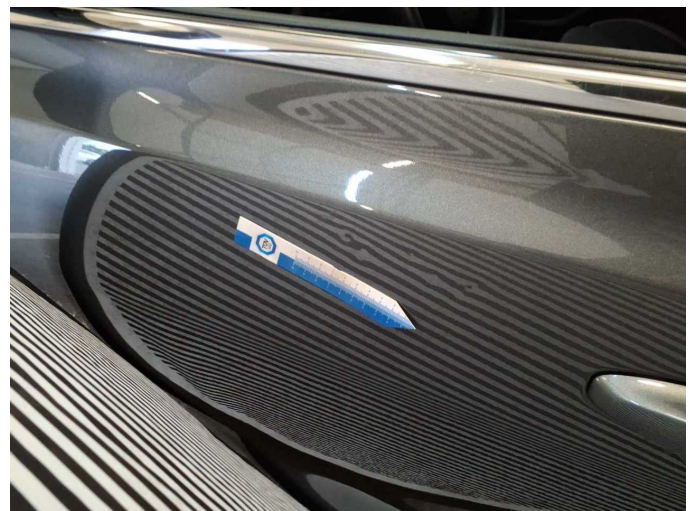
**Damage 10:** Door - front left side: Door - dent(s) - Smooth repair work

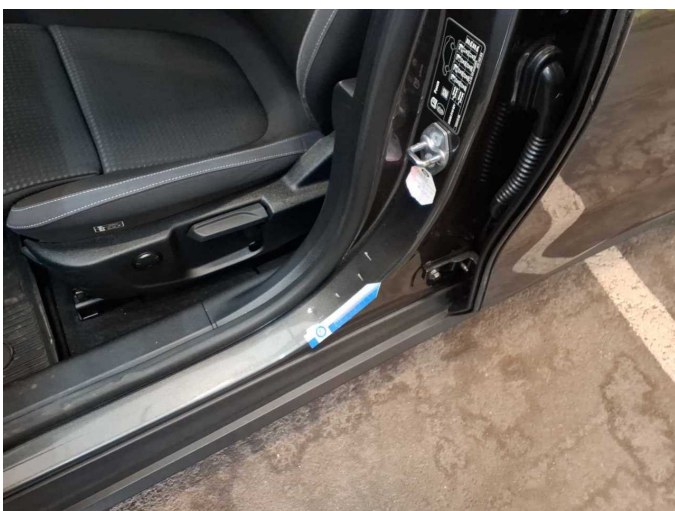
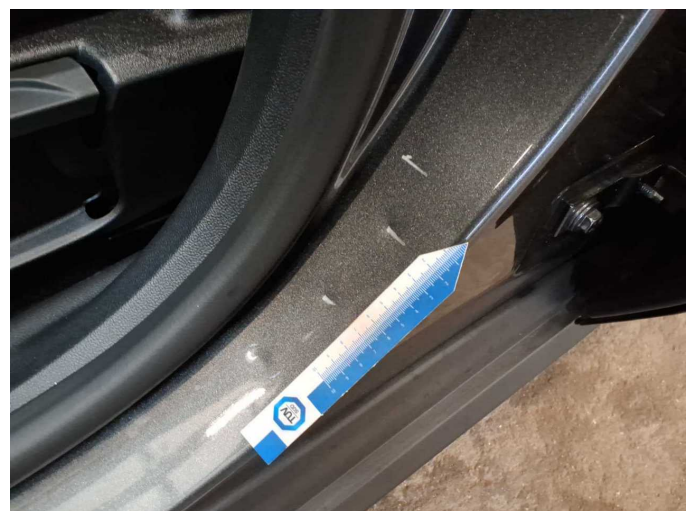
**Damage 11:** Sill - left side: Sill - Scratched - Smart repair

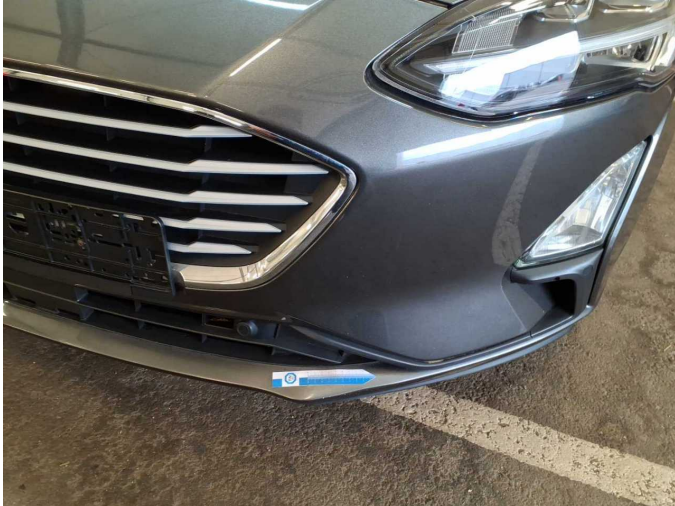
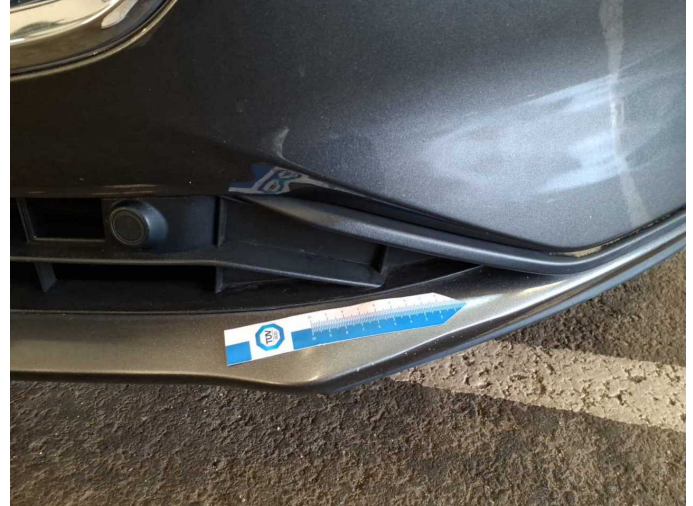
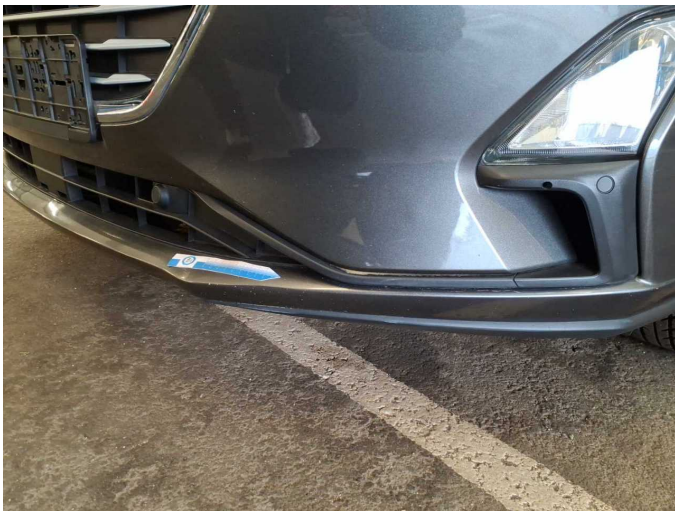
1 Bumper front, Unprofessionally carried out

**Damage 12:** Front bumper: Front bumper (Farbabweichung) - Unprofessionally repaired - Repair and paint

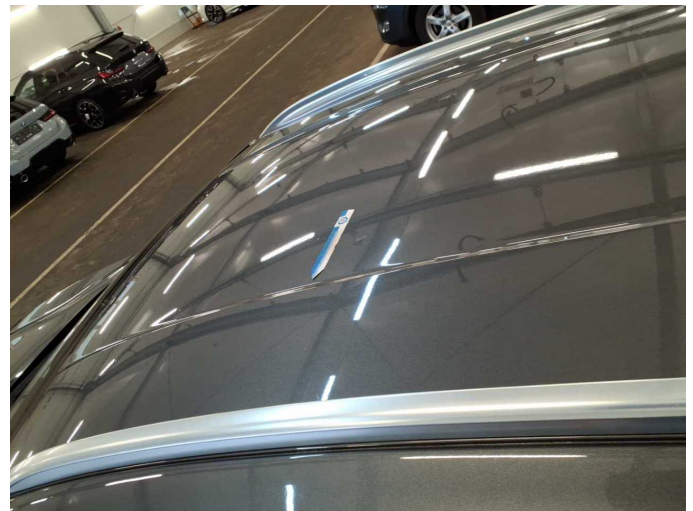
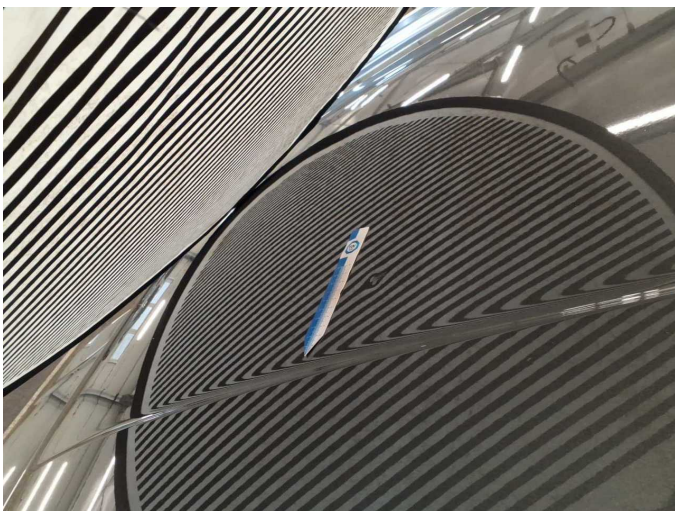
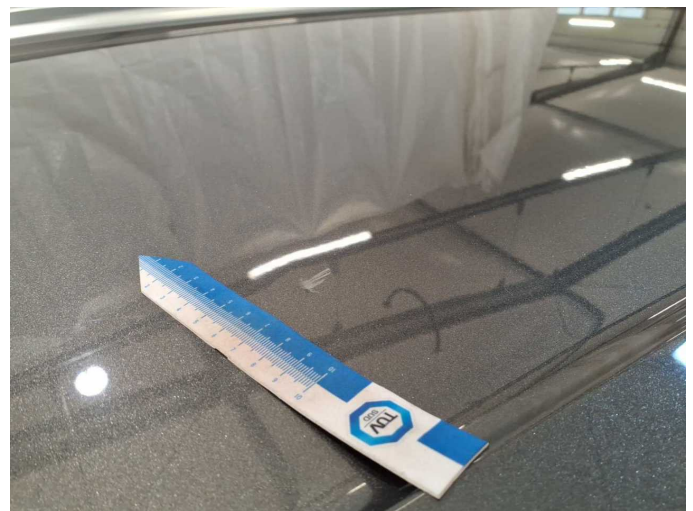
13	Roof	Roof - Dent / paintcoat damage - Repair and paint

**Damage 13:** Roof: Roof - Dent / paintcoat damage - Repair and paint

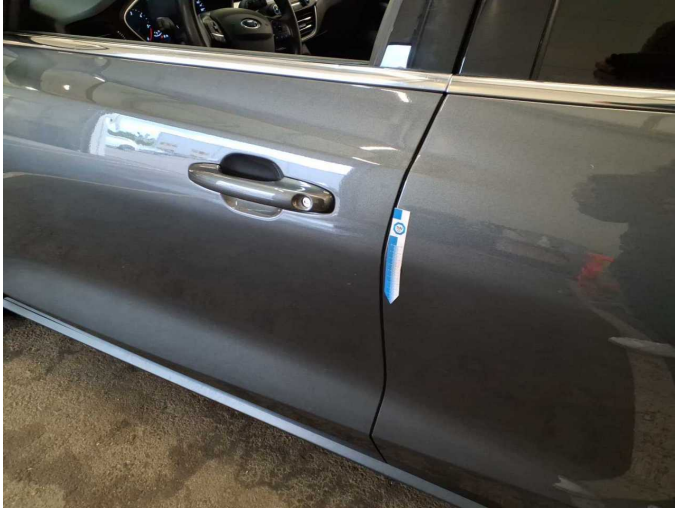
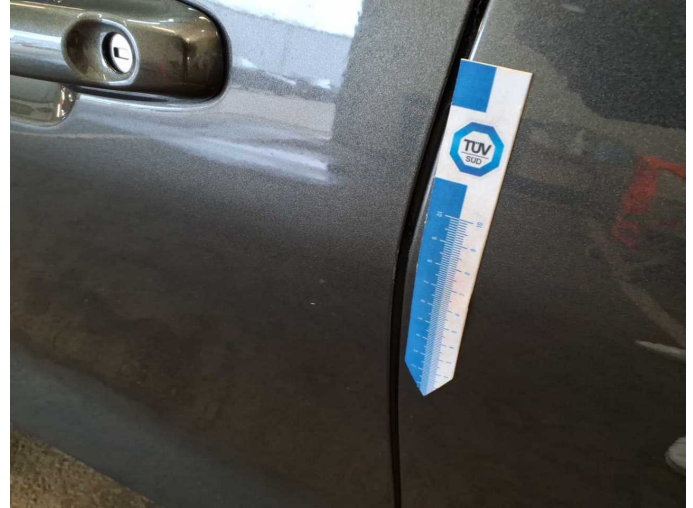
**Wear and tear 1:** Door - front left side: Door - Scratch(es) - No deduction

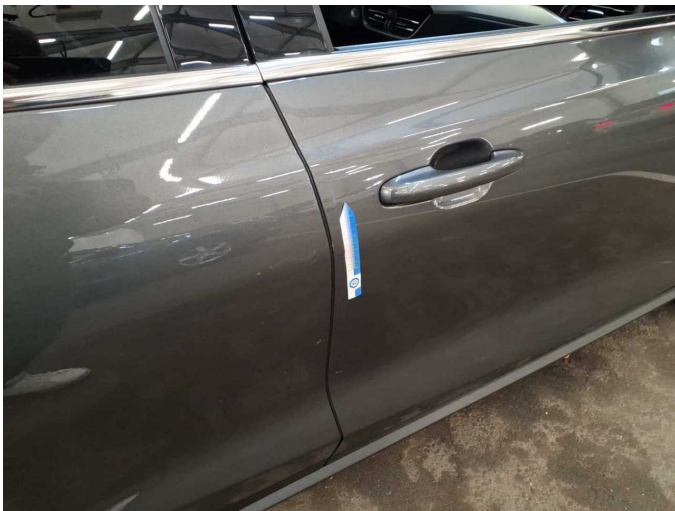
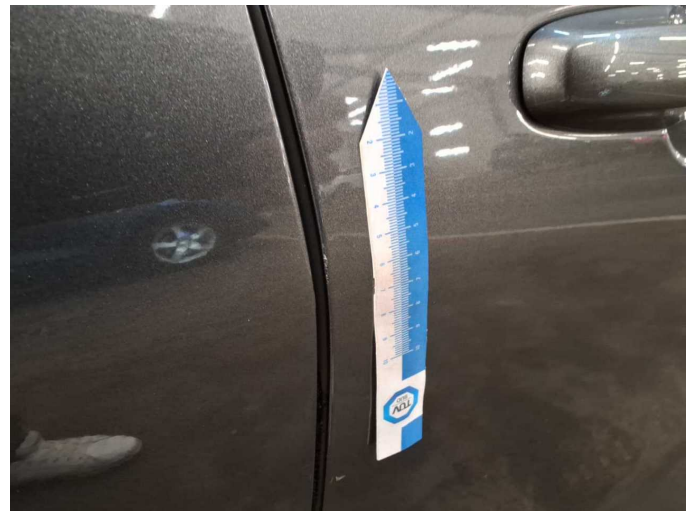
**Wear and tear 2:** Door - front right side: Door - Scratch(es) - No deduction

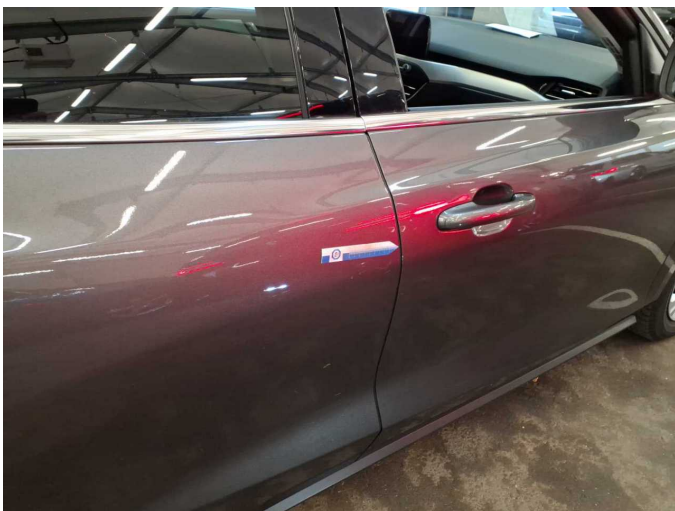
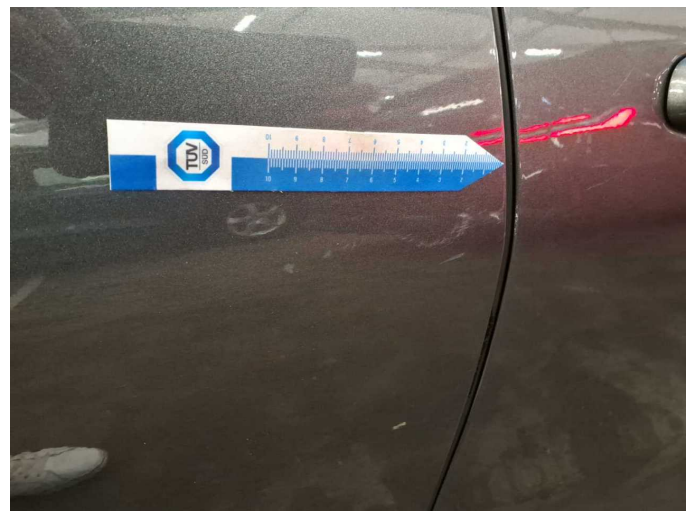
**Wear and tear 3:** Door - rear right side: Door - Scratch(es) - No deduction

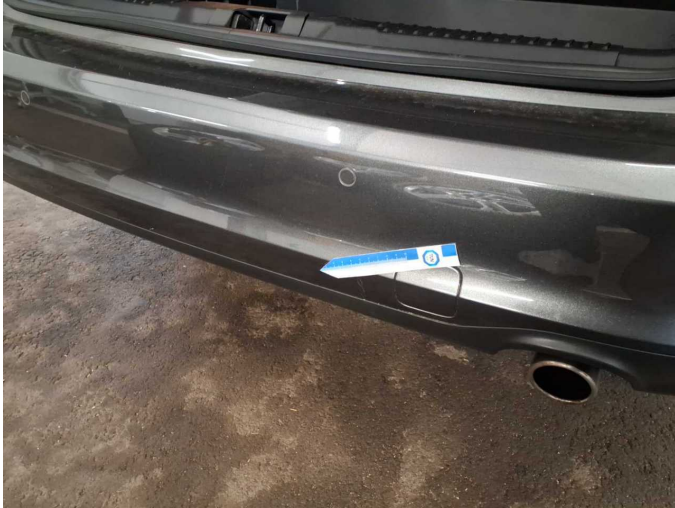
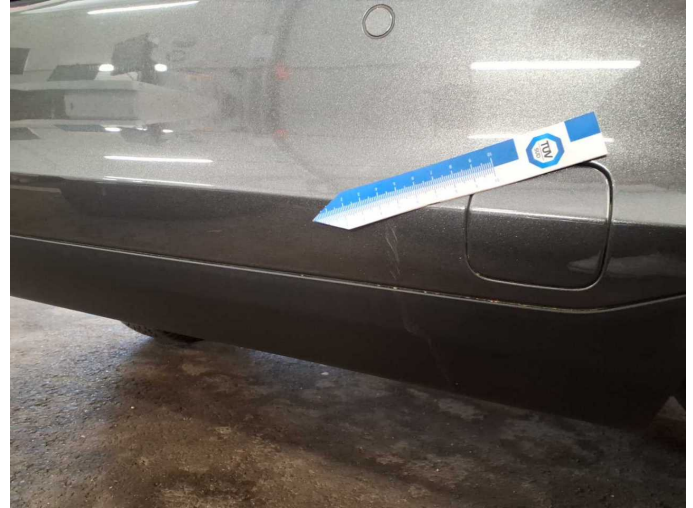
**Wear and tear 4:** Rear bumper: Rear bumper - Scratch(es) - No deduction

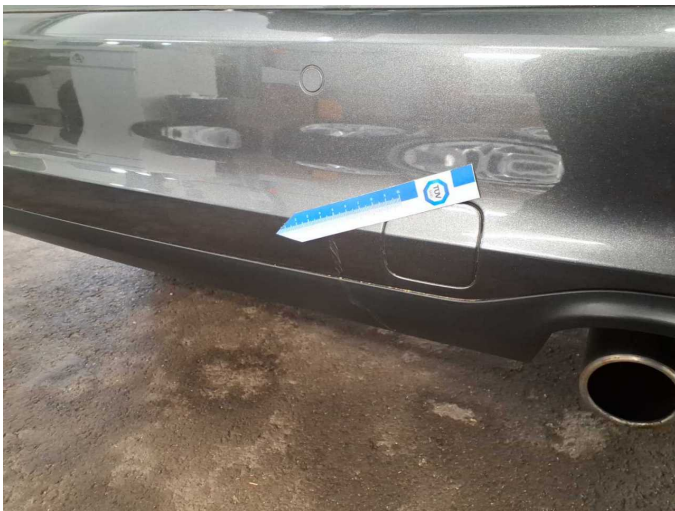
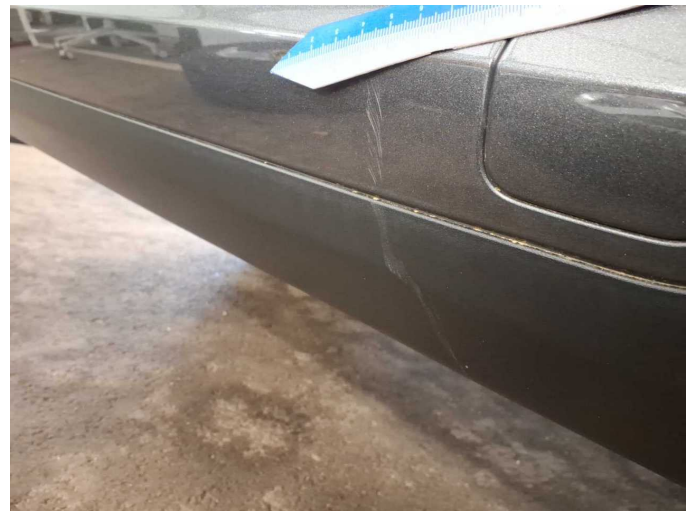
**Wear and tear 5:** Rear bumper: Spoiler - Scratch(es) - No deduction

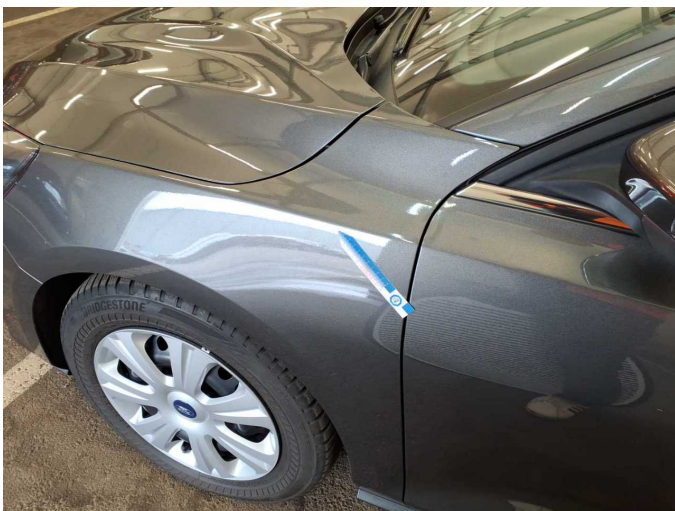
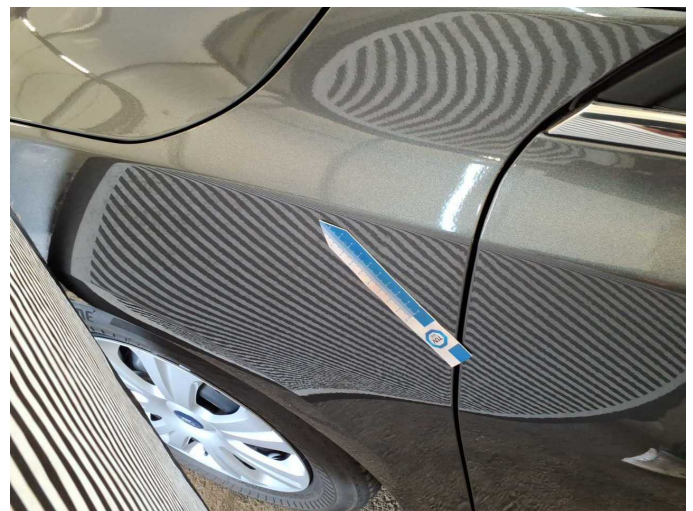
**Wear and tear 6:** Mudguard - left side: Mudguard - left side - dent(s) - No deduction

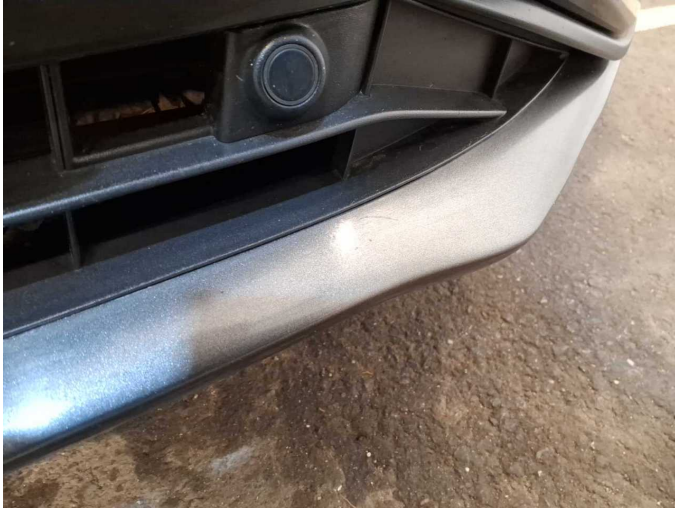
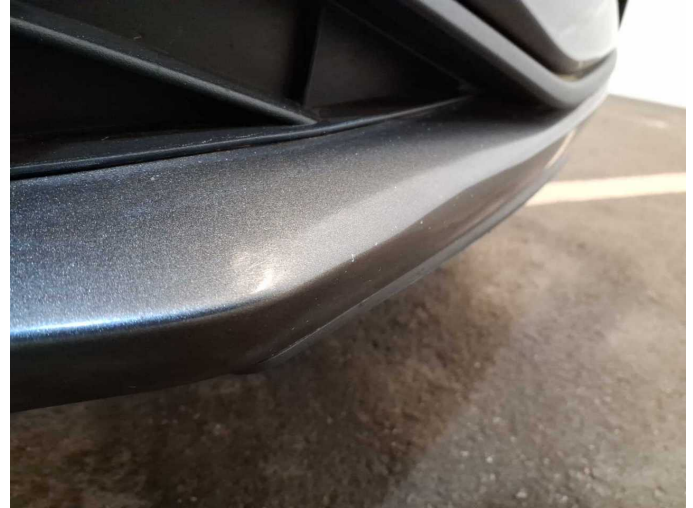
**Repainting 1:** Bumper front
