## Expertise

Protocol number: 45975398  
Order No. / Reference: 26410626  
Inspection date: 15 Jun 2026

Manufacturer: Ford

Model: Transit Connect 210 L2 S&S Trend

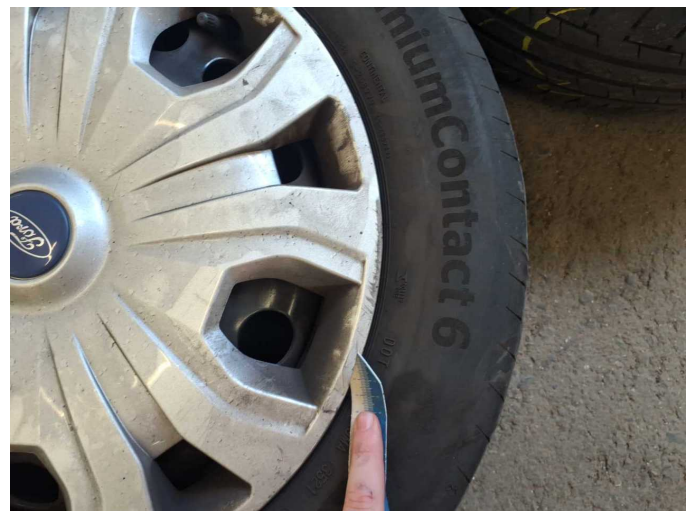
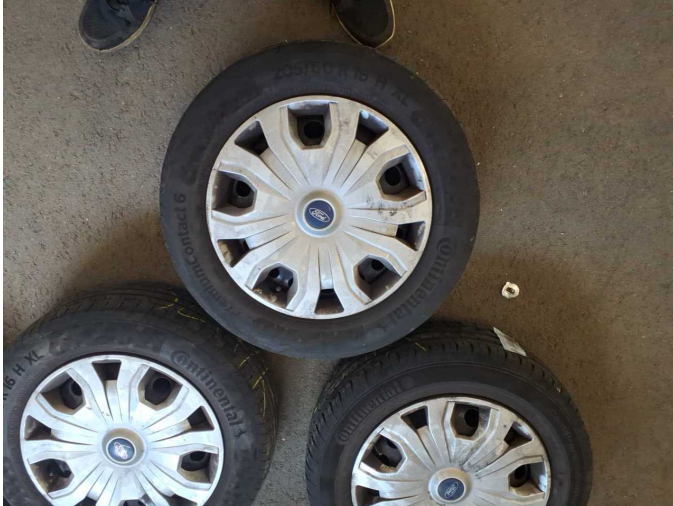
Damage 1: 2nd wheel set: 1 wheel cover - Scratch(es) - Replace

**Damage 1:** 2nd wheel set: 1 wheel cover - Scratch(es) - Replace

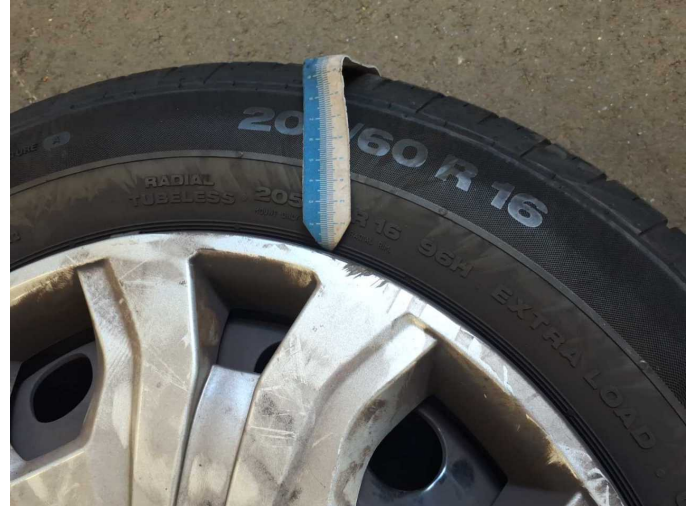
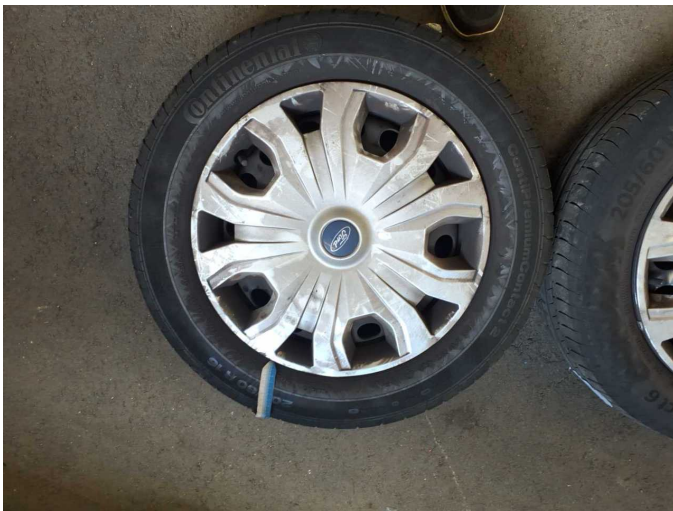
**Damage 2:** 2nd wheel set: 1 wheel cover - Scratch(es) - Replace

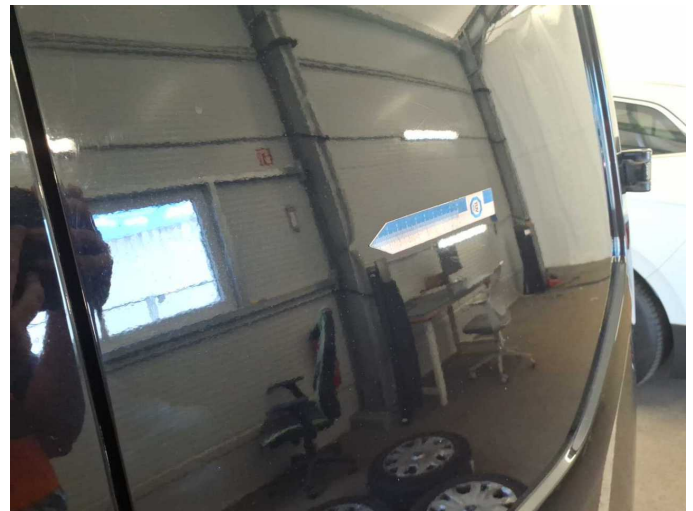
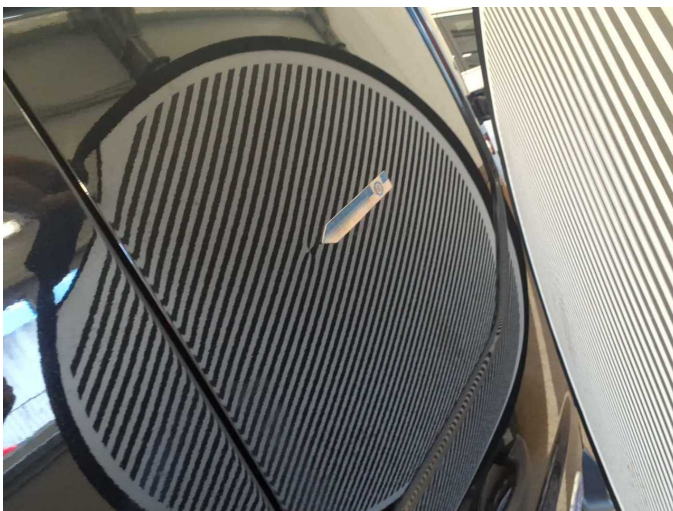
**Damage 3:** Boot lid / rear door: Rear door - right side - dent(s) - Smooth repair work

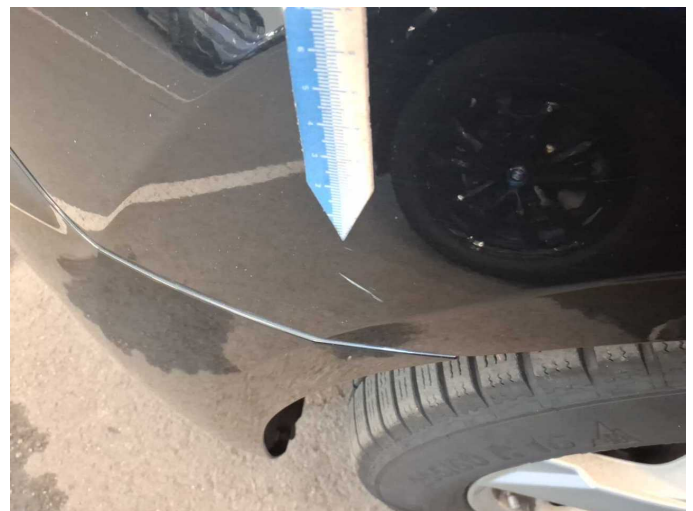
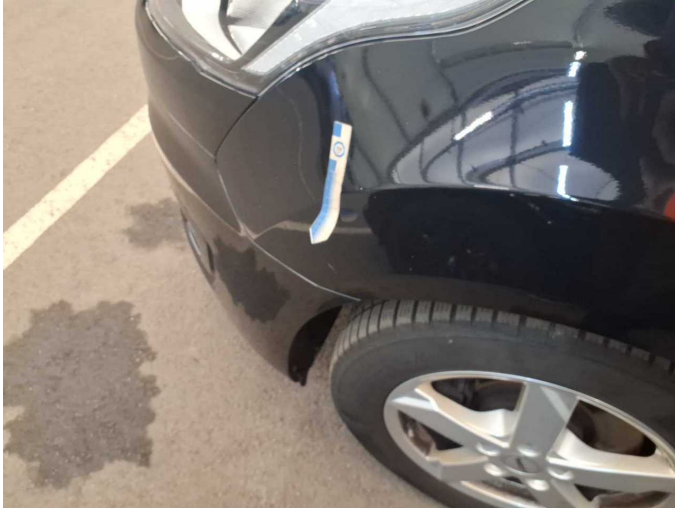
**Damage 4:** Mudguard - left side: Mudguard - left side - Scratch(es) - Smart repair

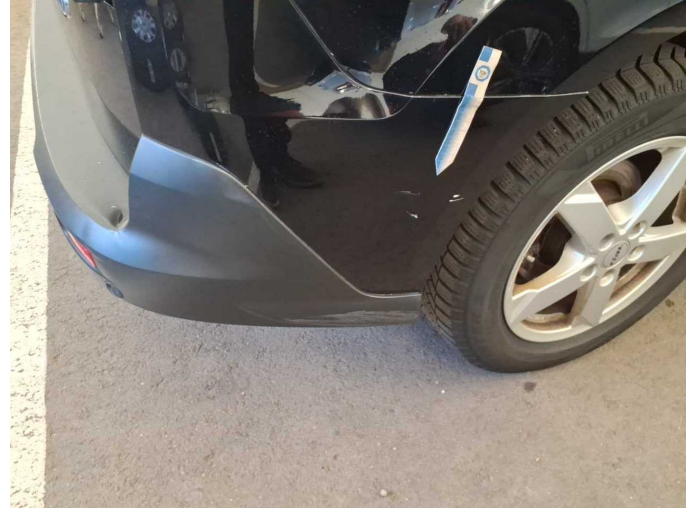
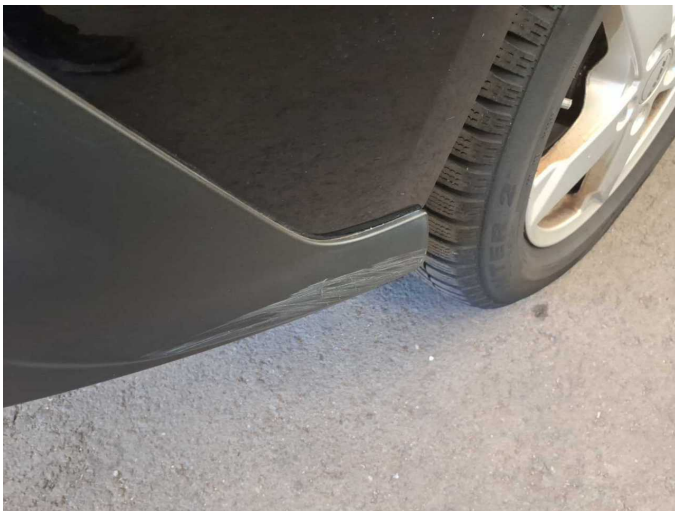
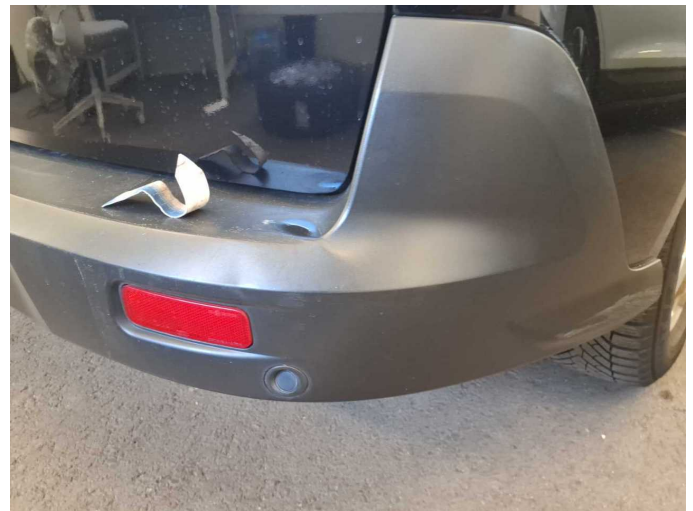
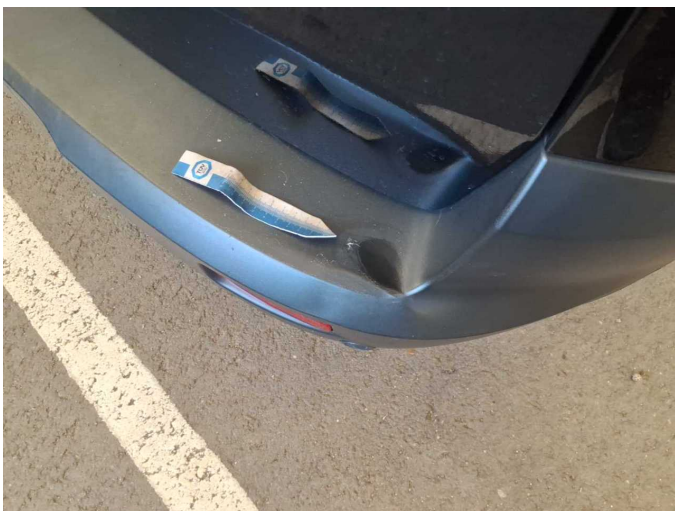
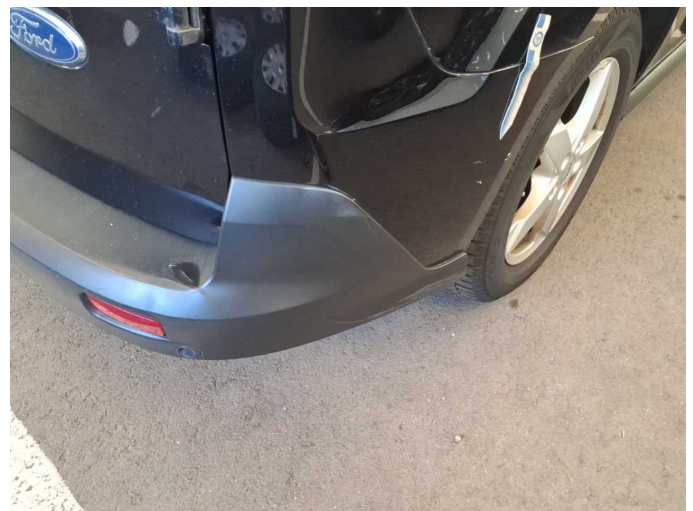
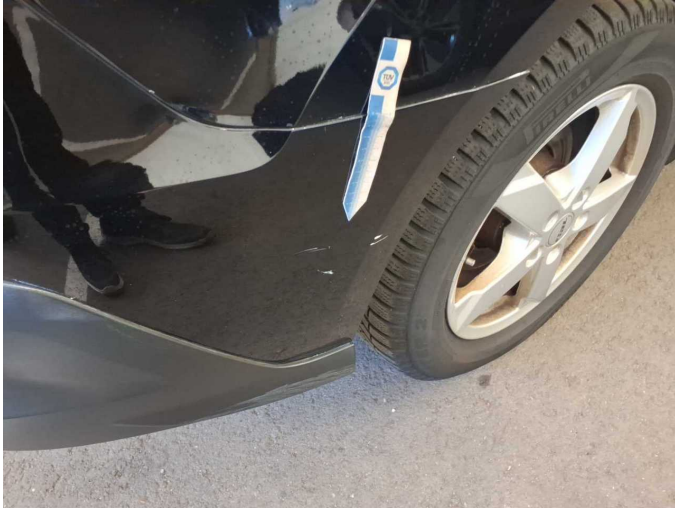
**Damage 5:** Rear bumper: Rear bumper - Damaged - Replace
