Expertise

Protocol number: 46090354  
Order No. / Reference: 26434655  
Inspection date: 22 Jun 2026

Manufacturer: Skoda  
VIN: TMBJU8NXXPY098155

Model: Octavia Combi 2.0 TSI DSG RS

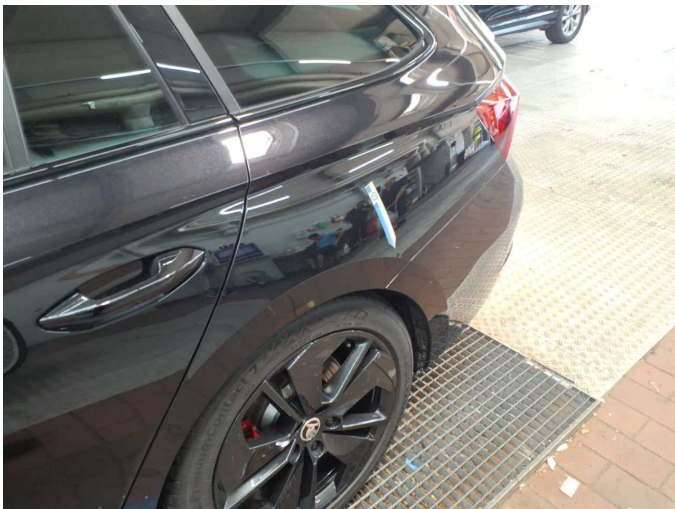
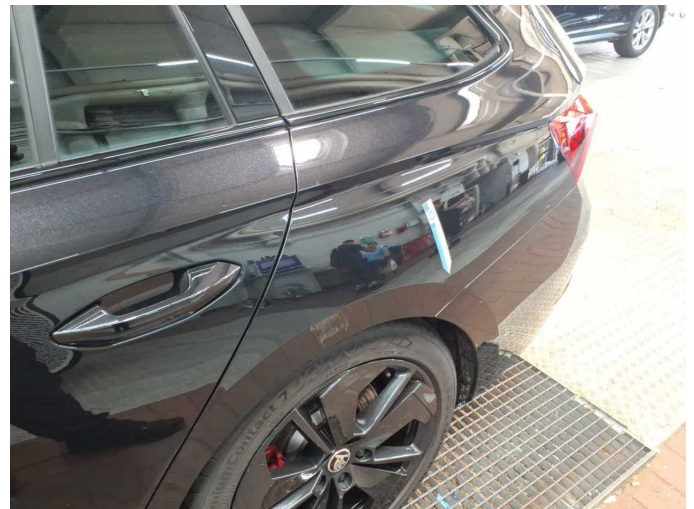
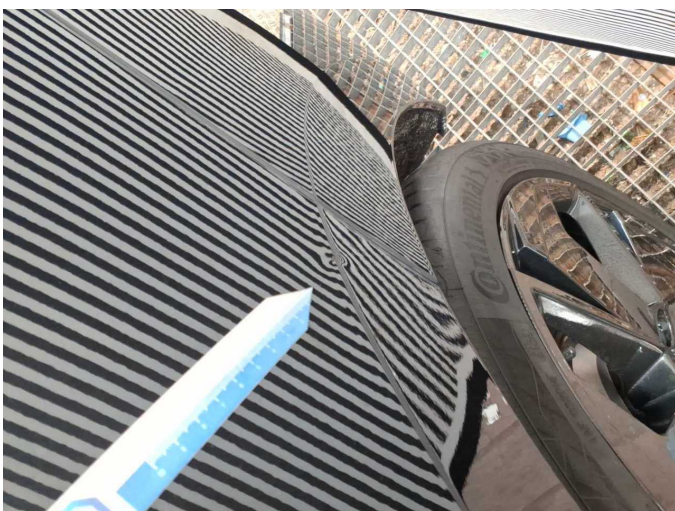
| No. | Component group | Description |
|---|---|---|
| 1 | Side panel - rear left side | Side panel - dent(s) - Smooth repair work |

**Damage 1:** Side panel - rear left side: Side panel - dent(s) - Smooth repair work

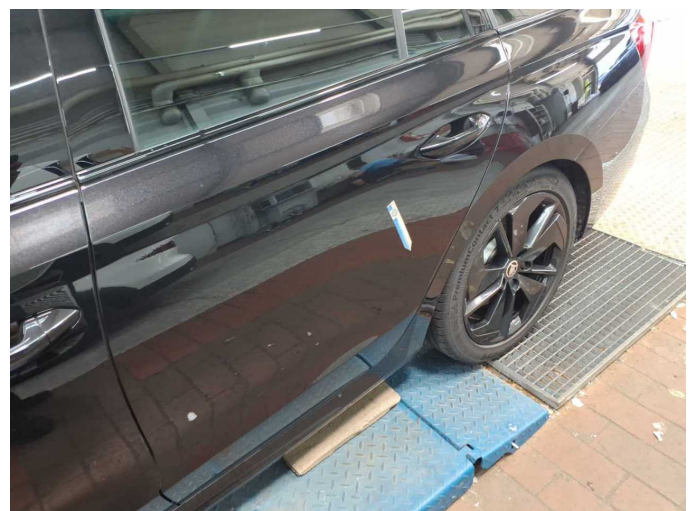
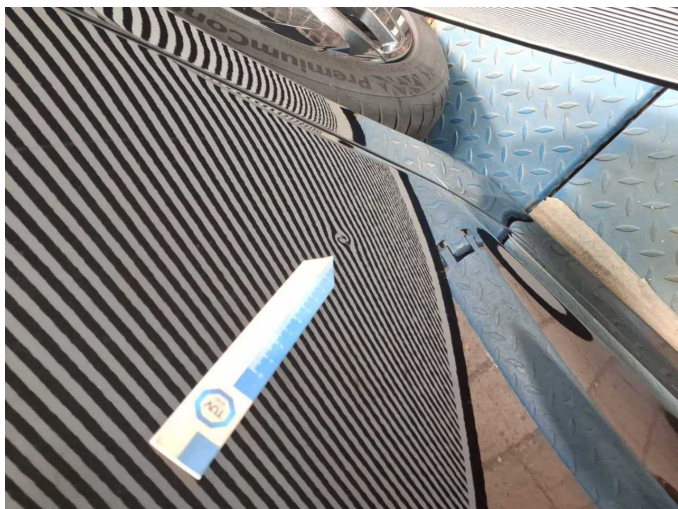
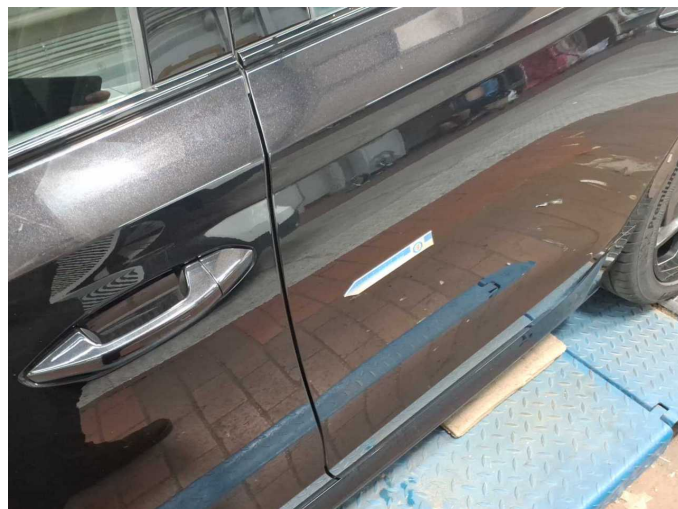
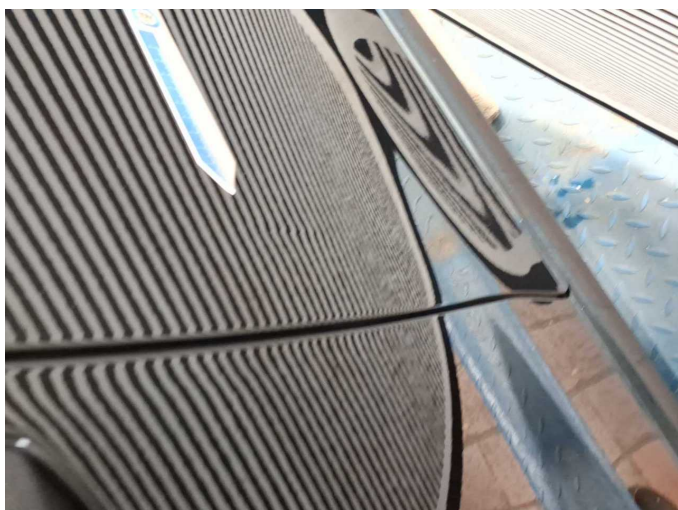
| No. | Component group | Description |
|---|---|---|
| 3 | Door - rear left side | Door - Dent / paintcoat damage - Smart repair |

**Damage 3:** Door - rear left side: Door - Dent / paintcoat damage - Smart repair

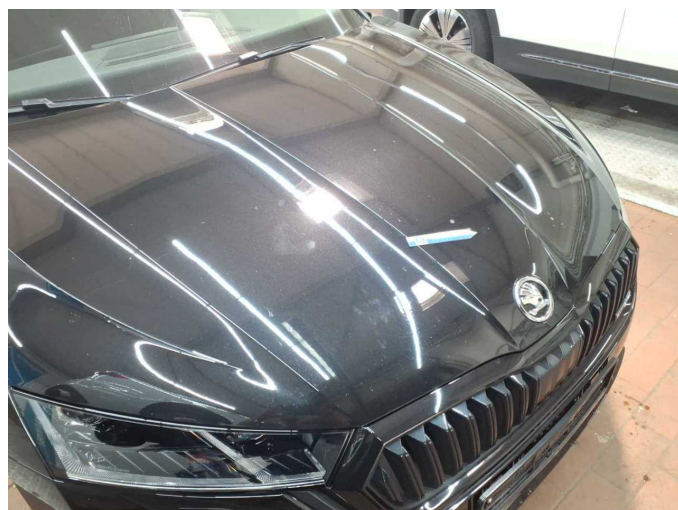
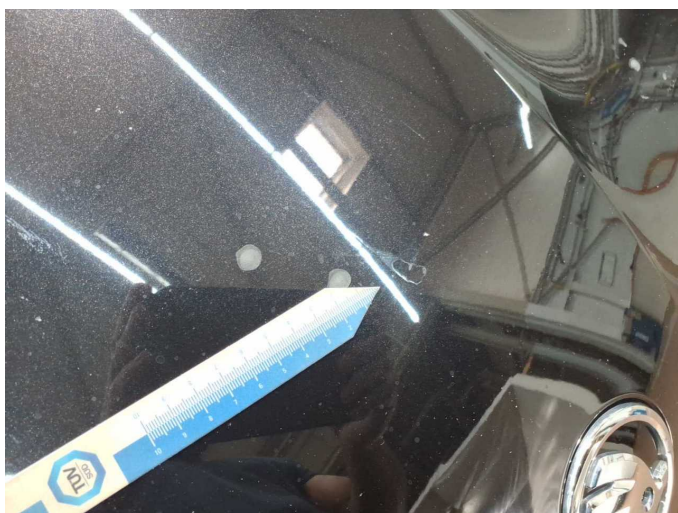
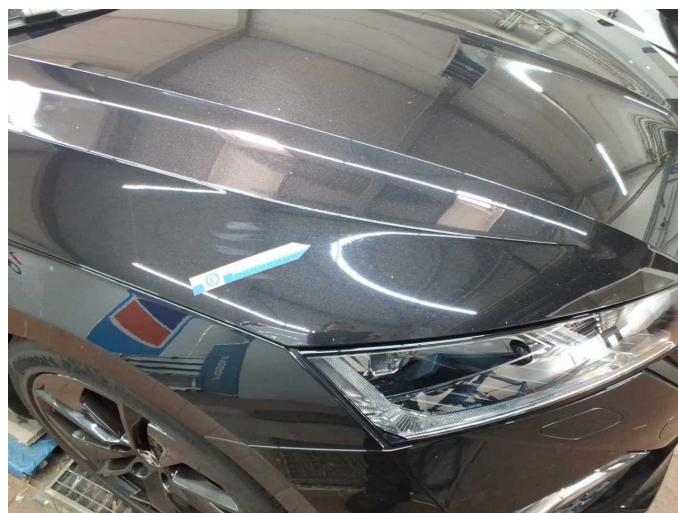
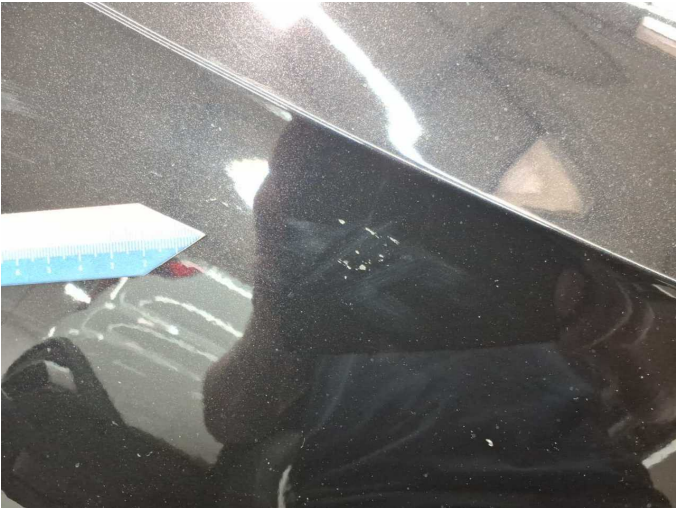
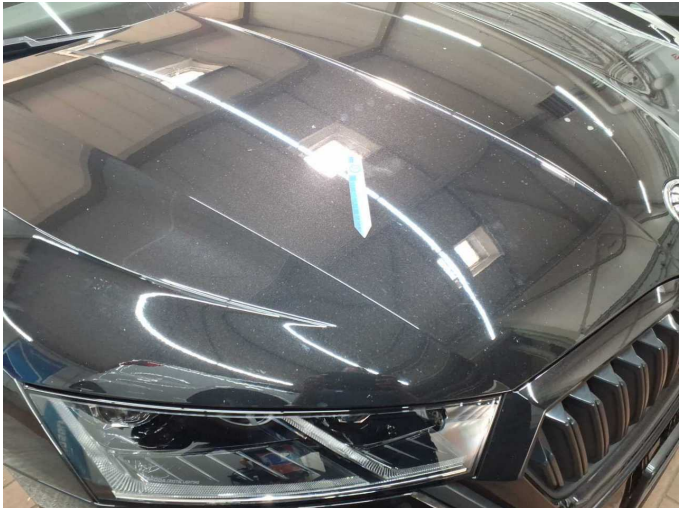
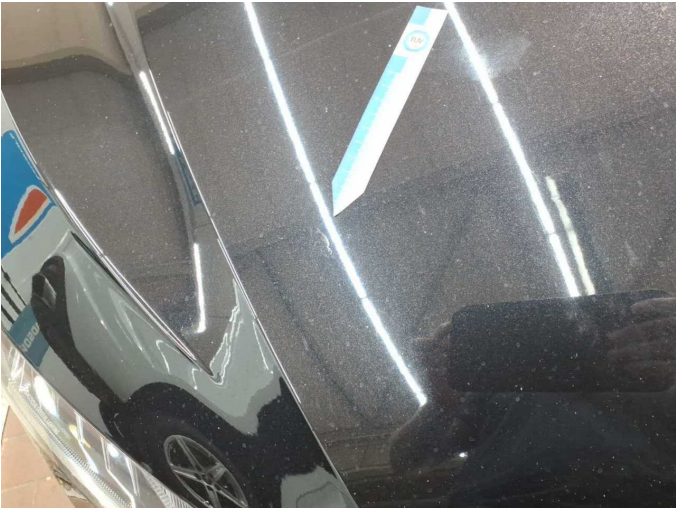
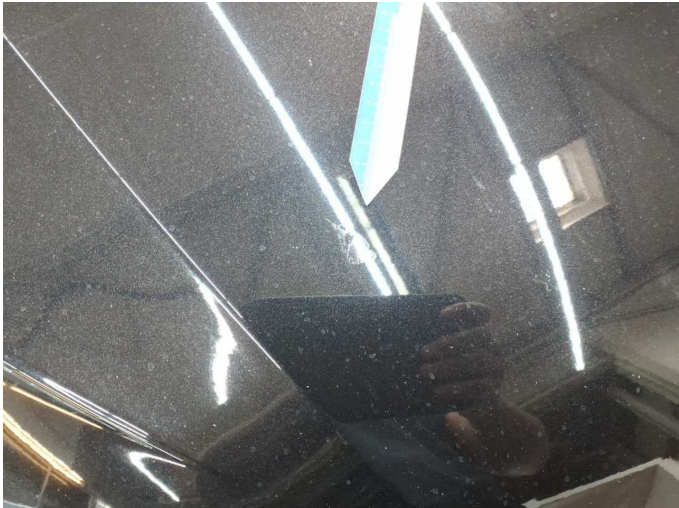
| No. | Component group | Description |
|---|---|---|
| 4 | Bonnet | Bonnet (Und kratzer) - Paint defect - Paint |

**Damage 4:** Bonnet: Bonnet (Und kratzer) - Paint defect - Paint

Damage 4: Bonnet: Bonnet (Und kratzer) - Paint defect - Paint

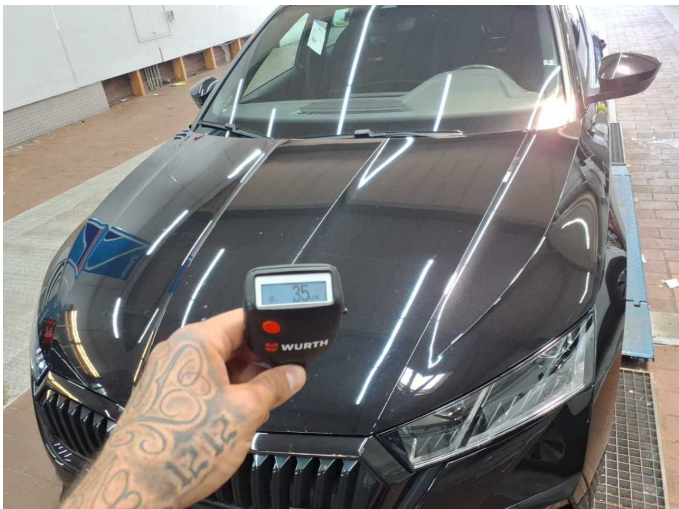
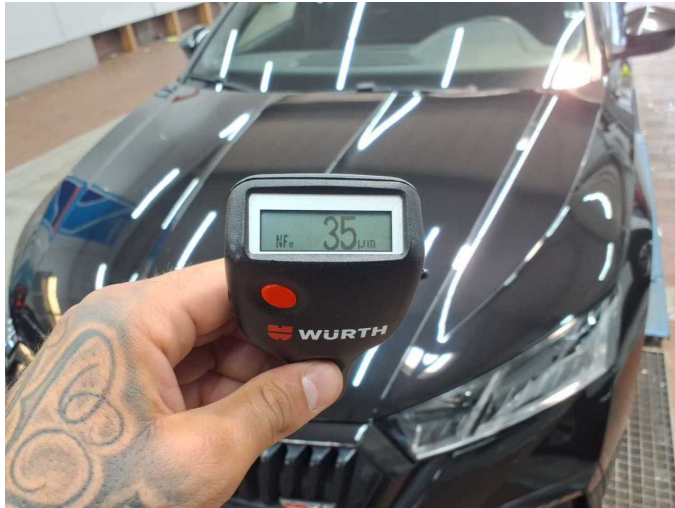
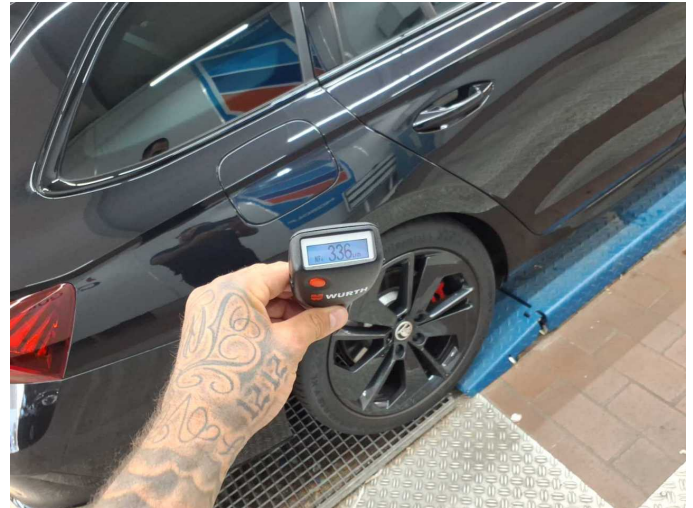
1 Front, Provided by user / customer

Previous damage 1: Front

**Previous damage 1: Front**

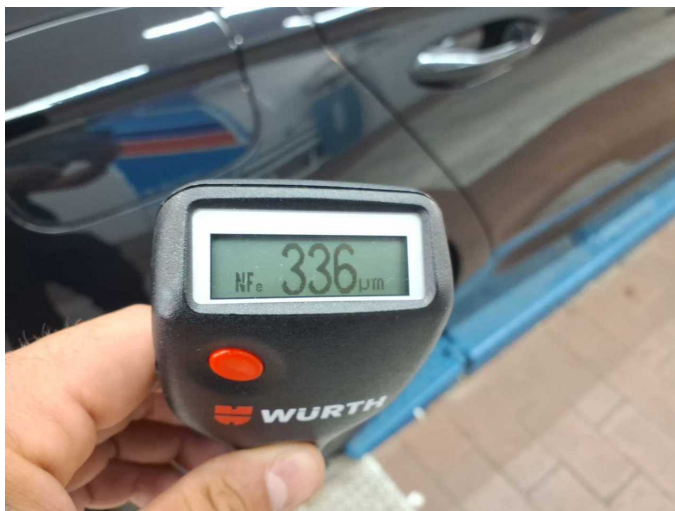
1 Side panel - rear right side, Professionally carried out, Invoice of repair done Non-existent

**Repainting 1: Side panel - rear right side**

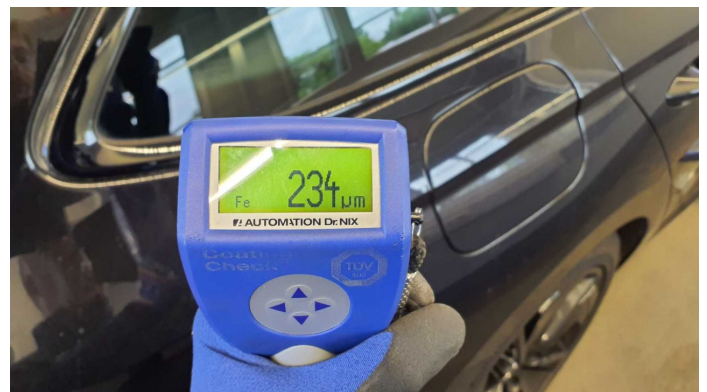
Side panel - rear right side 336 µm

**Side panel - rear right side: 336 µm**
