Expertise

Protocol number: 45306790
Order No. / Reference: 26292688
Inspection date: 4 May 2026

Model: 317 CDI Sprinter Standard HA 9G-TRONIC PRO

VIN: W1V3KBFZ1TP862043

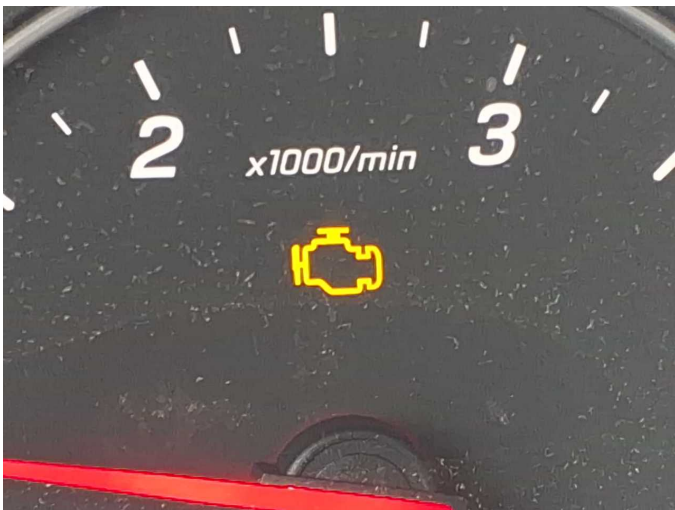
Documents submitted	At the time of the inspection, the vehicle registration certificate Part 2 (title) was available, but the vehicle registration certificate Part 1 (document) was not. (Copy)
VIN comparison	The vehicle identification number (VIN) was read from the vehicle and its conformity with the submitted documents was confirmed by the undersigned during the inspection.
Inspection	The inspection conditions were sufficient for the assessment of the vehicle. No lifting equipment or pit was available for inspecting the vehicle. Therefore, inspection of the vehicle's underside was only possible to a limited extent.
Test drive	No test drive/shunting maneuver was carried out during the inspection of the vehicle.
Engine function test	An engine test run was performed, problem has been detected This is due to the following reason.: Motorkontrollleuchte aktiv, Fehlerursache nicht genauer identifizierbar

Damage 1: Instrument panel: Indicator light (Motorkontrollleuchte) - on - Perform diagnosis

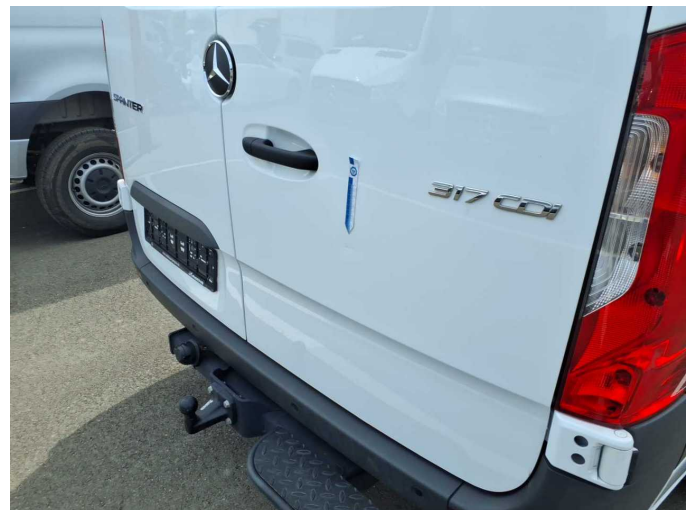
Damage 2: Boot lid / rear door: Rear door - right side - Dent / paintcoat damage - Paint

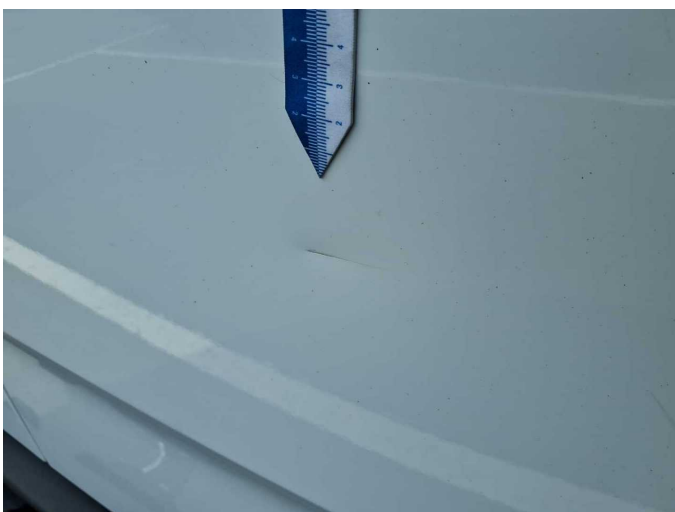
Damage 2: Boot lid / rear door: Rear door - right side - Dent / paintcoat damage - Paint

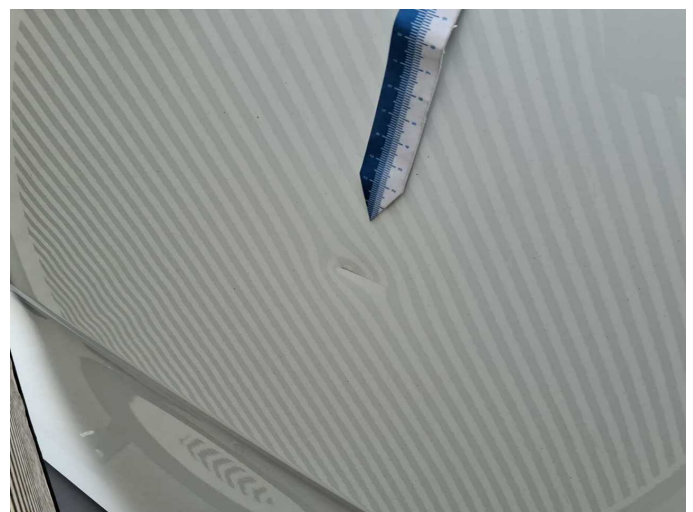
Damage 2: Boot lid / rear door: Rear door - right side - Dent / paintcoat damage - Paint

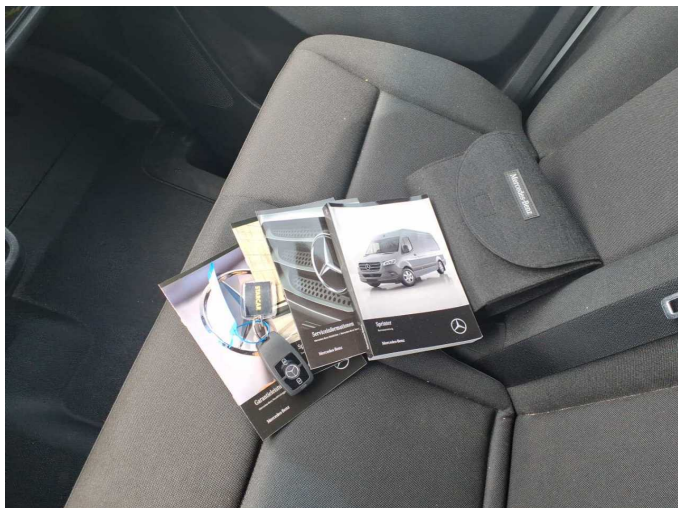
Missing part 1: Equipment: Vehicle key - Missing - Replace
