## Expertise

Protocol number: 46315956  
Order No. / Reference: 26511517  
Inspection date: 3 Jul 2026

Manufacturer: Opel

Model: Astra Sports Tourer 1.5 D Automatik Elegance

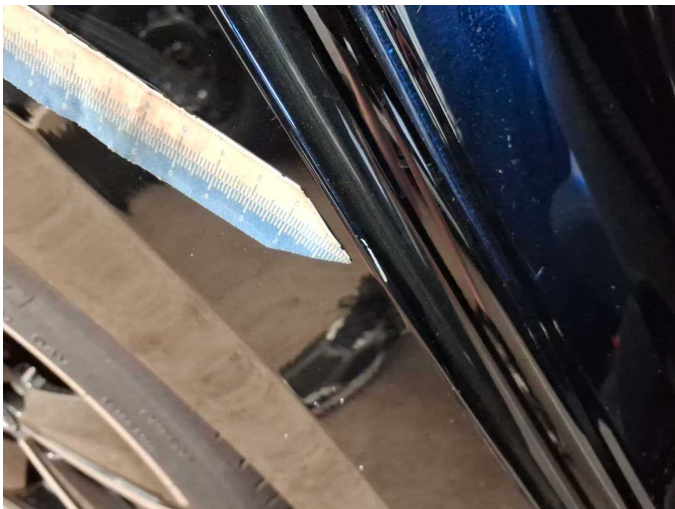
Damage 1: Side panel - rear right side: Sill - Scratch(es) - Smart repair

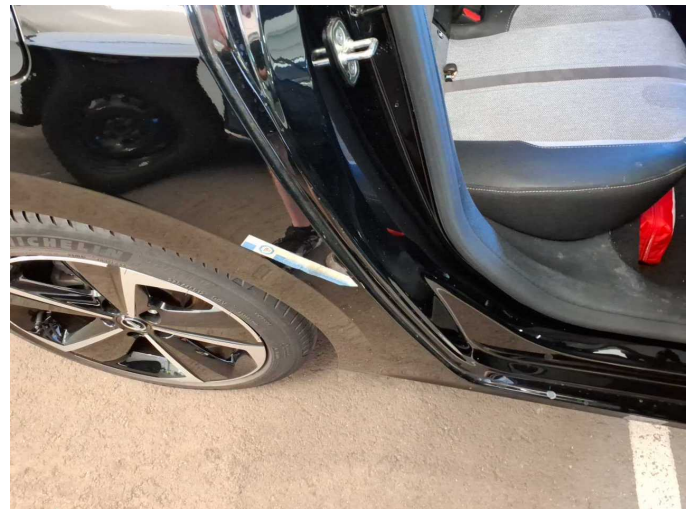
Damage 1: Side panel - rear right side: Sill - Scratch(es) - Smart repair

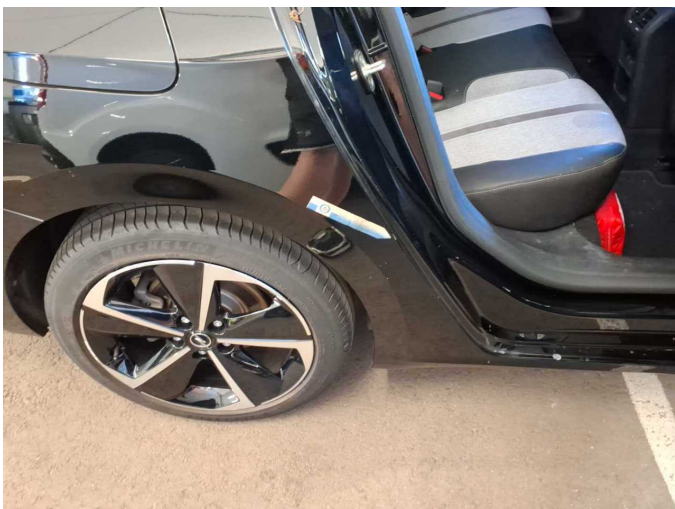
Damage 1: Side panel - rear right side: Sill - Scratch(es) - Smart repair

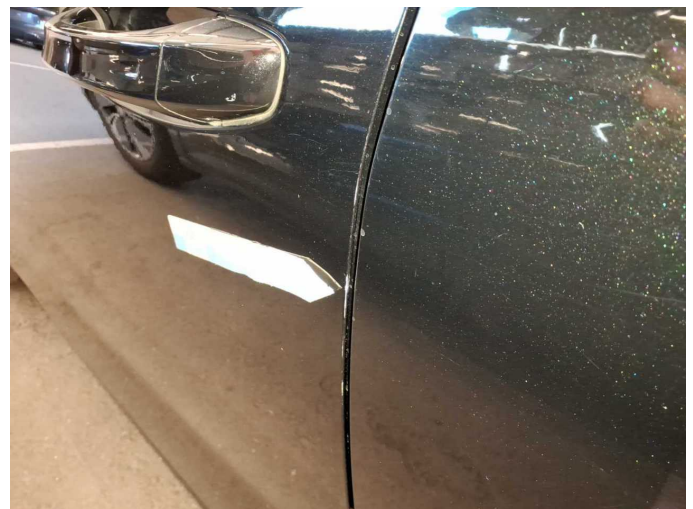
Damage 2: Door - front left side: Door edge - Scratch(es) - Smart repair

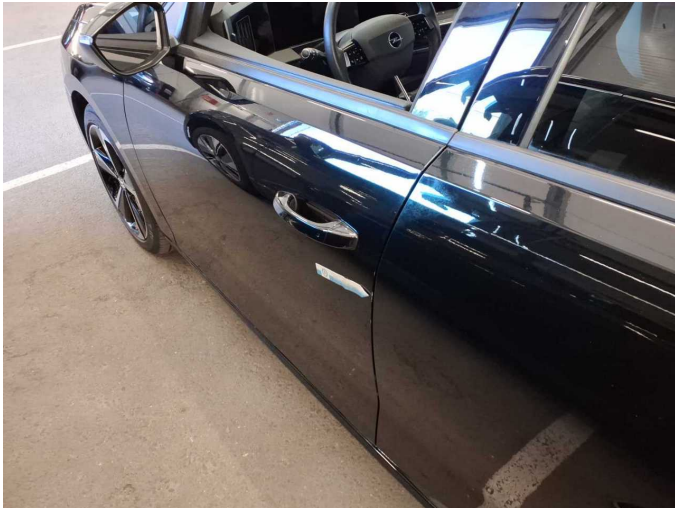
**Damage 2:** Door - front left side: Door edge - Scratch(es) - Smart repair

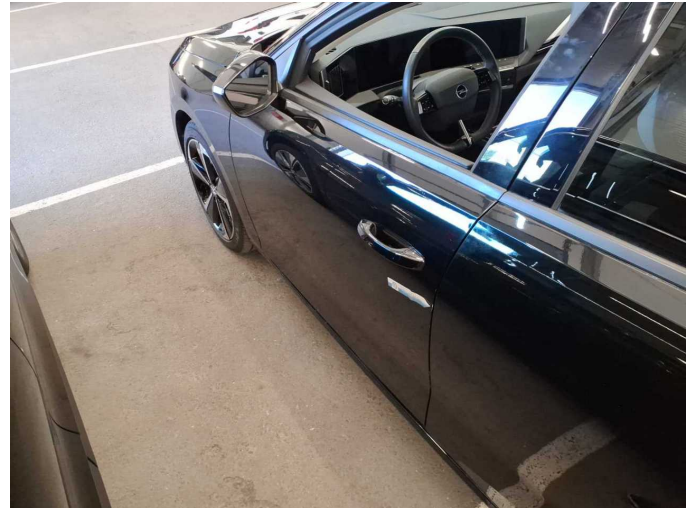
**Damage 2:** Door - front left side: Door edge - Scratch(es) - Smart repair

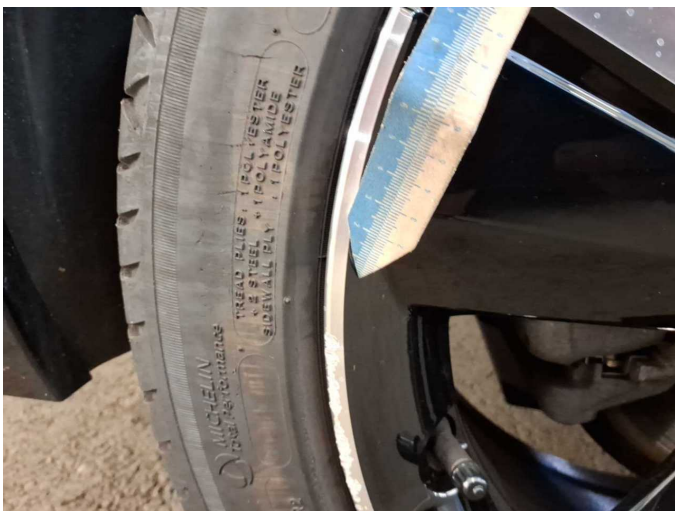
**Damage 3:** Wheel / tyres: Alloy rim - rear right side - Scratch(es) - Loss in value

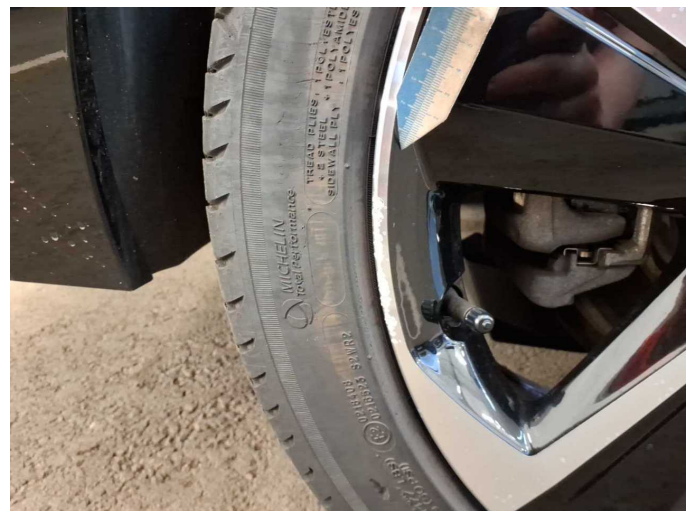
**Damage 3:** Wheel / tyres: Alloy rim - rear right side - Scratch(es) - Loss in value

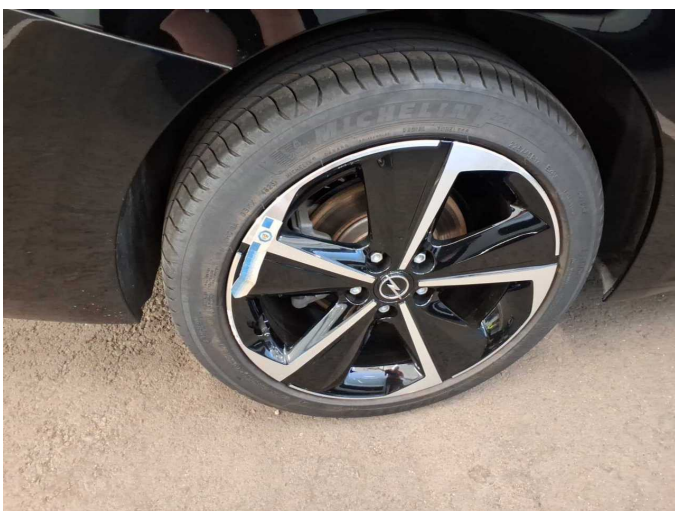
**Damage 3:** Wheel / tyres: Alloy rim - rear right side - Scratch(es) - Loss in value

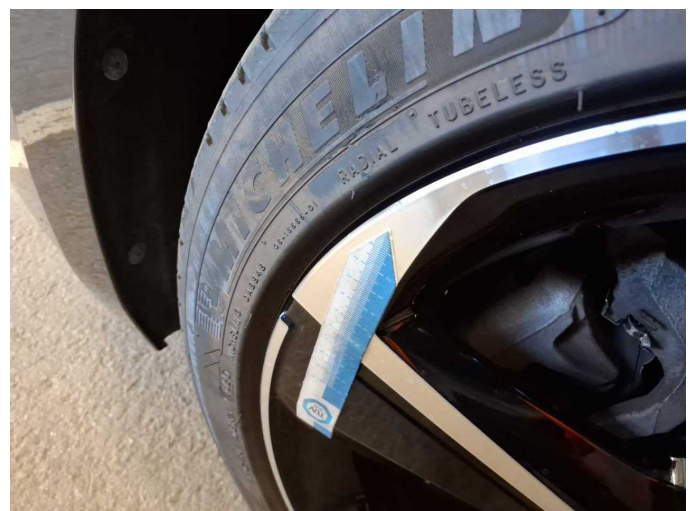
**Damage 4:** Wheel / tyres: Alloy rim - front left side - Scratch(es) - Loss in value

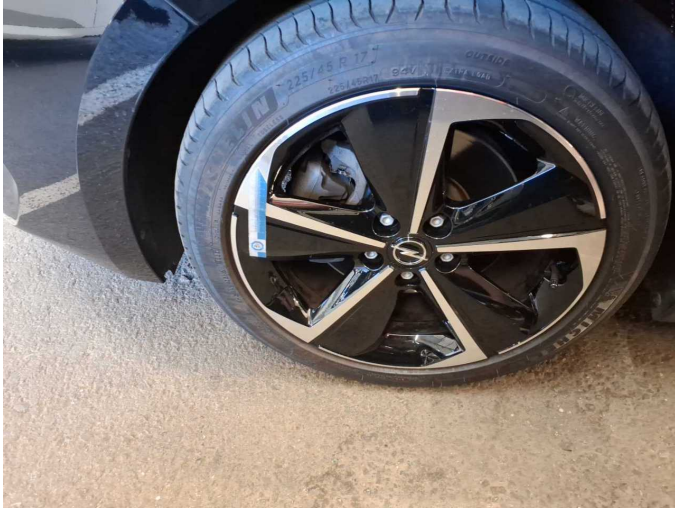
**Damage 4:** Wheel / tyres: Alloy rim - front left side - Scratch(es) - Loss in value

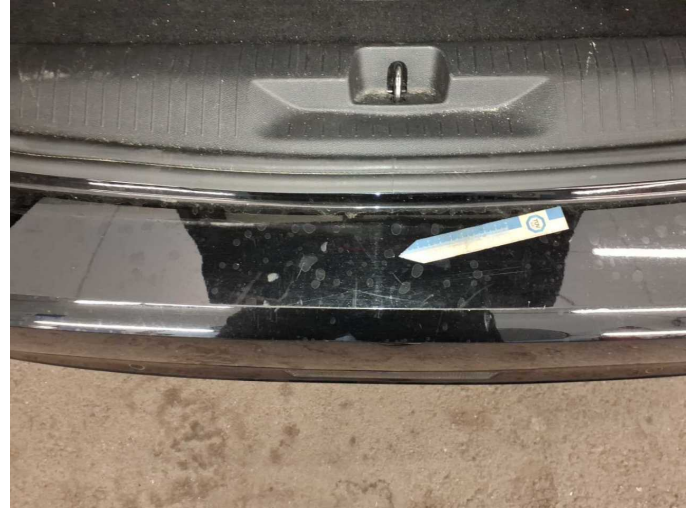
**Damage 5:** Rear bumper: Rear bumper - Scratched - Paint

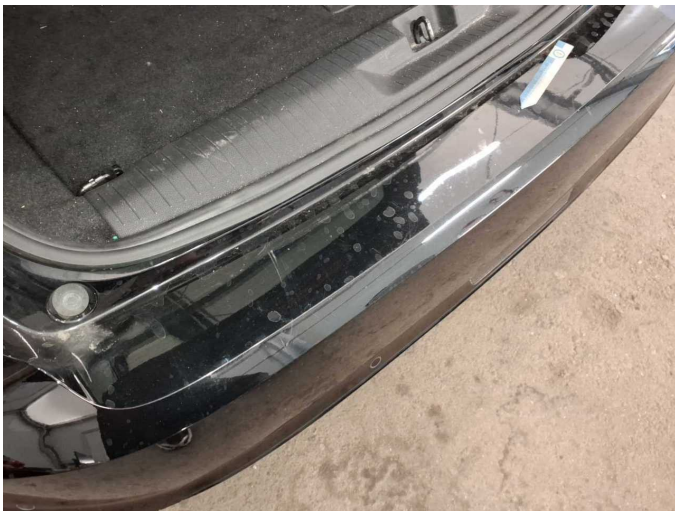
**Damage 5:** Rear bumper: Rear bumper - Scratched - Paint

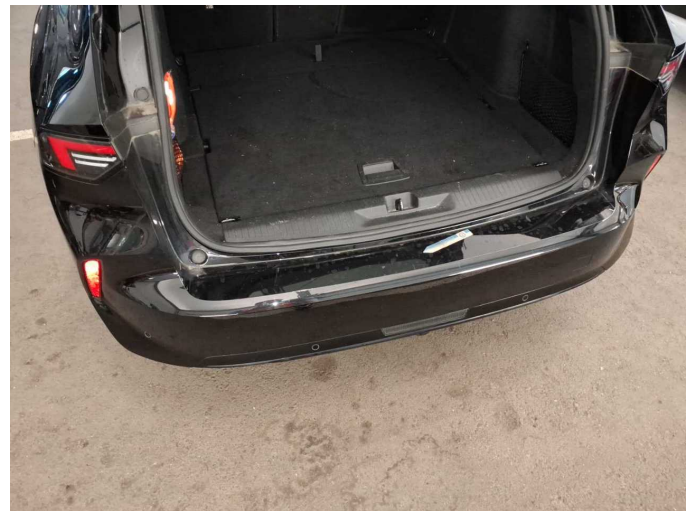
**Damage 5:** Rear bumper: Rear bumper - Scratched - Paint

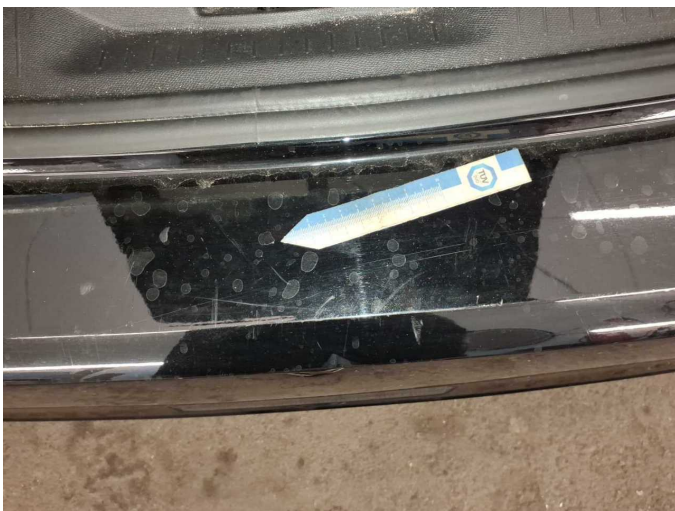
**Damage 5:** Rear bumper: Rear bumper - Scratched - Paint

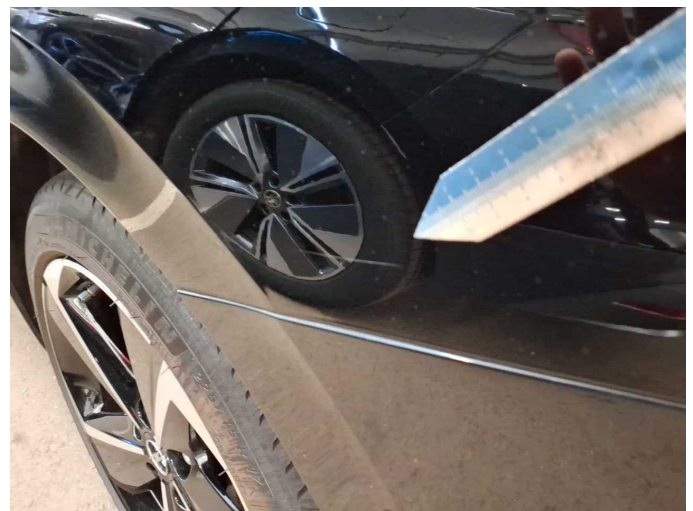
**Damage 6:** Side panel - rear left side: Side panel - Scratch(es) - Paint

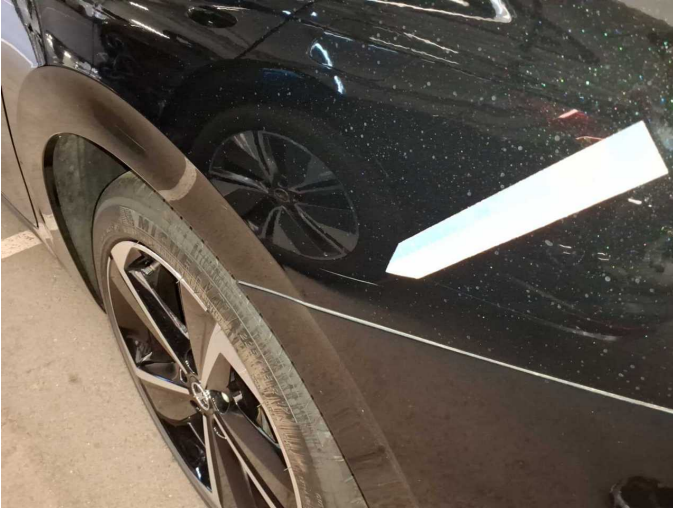
**Damage 6:** Side panel - rear left side: Side panel - Scratch(es) - Paint

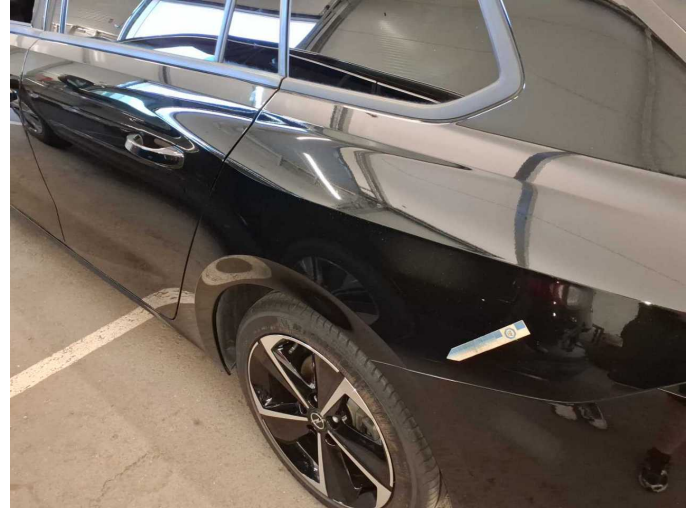
**Damage 6:** Side panel - rear left side: Side panel - Scratch(es) - Paint

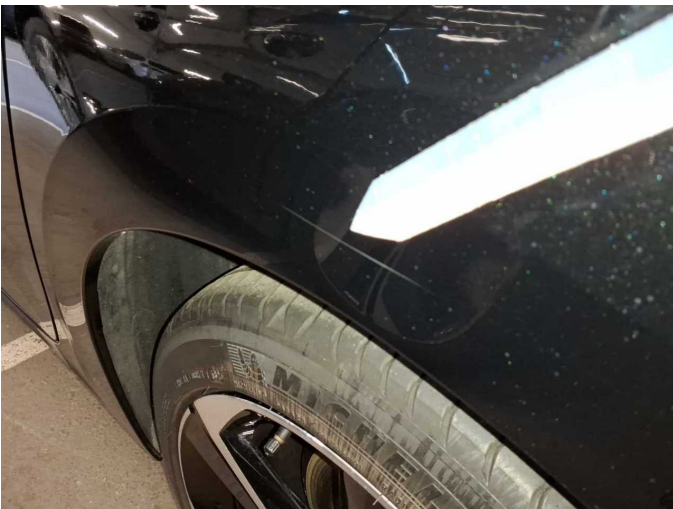
**Damage 6:** Side panel - rear left side: Side panel - Scratch(es) - Paint

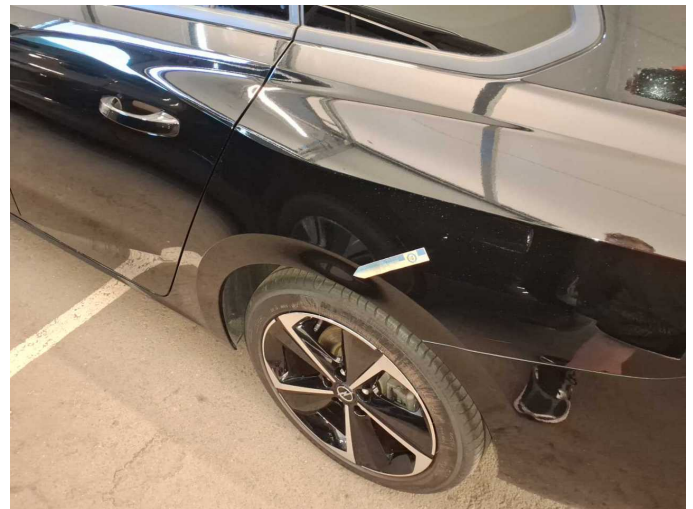
**Damage 6:** Side panel - rear left side: Side panel - Scratch(es) - Paint
