Expertise

Protocol number: 46489002  
Order No. / Reference: 26535270  
Inspection date: 14 Jul 2026

Manufacturer: Opel

Model: Vivaro 1.5 D L

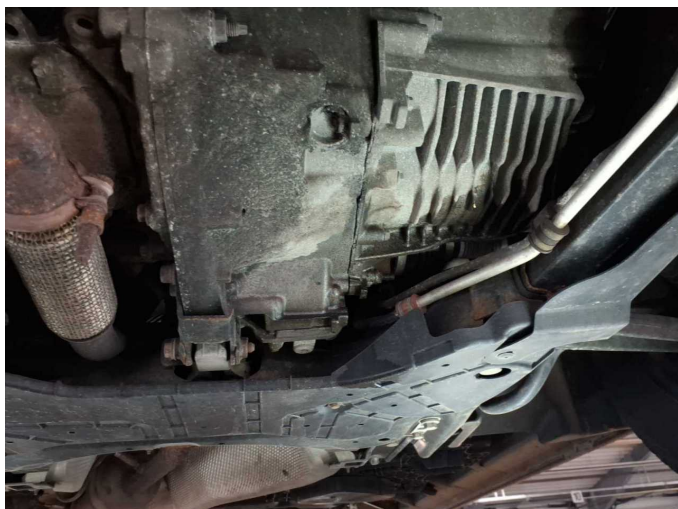
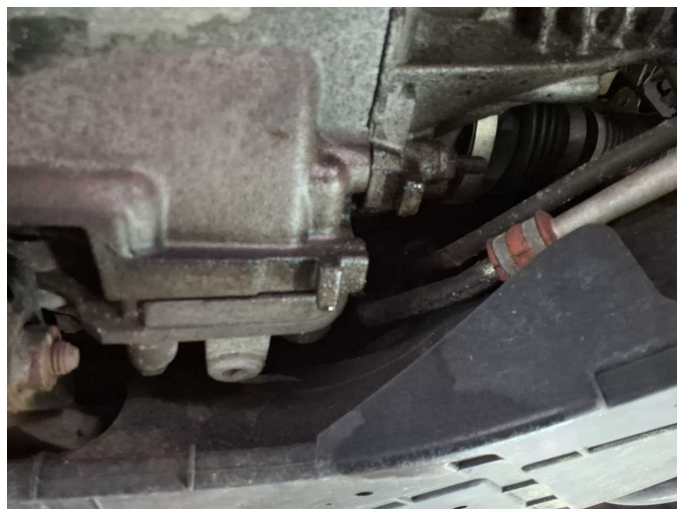
| No. | Component group | Description |
|---|---|---|
| 1 | Gearbox | Gearbox - Leaking - Perform diagnosis |

**Damage 1:** Gearbox: Gearbox - Leaking - Perform diagnosis

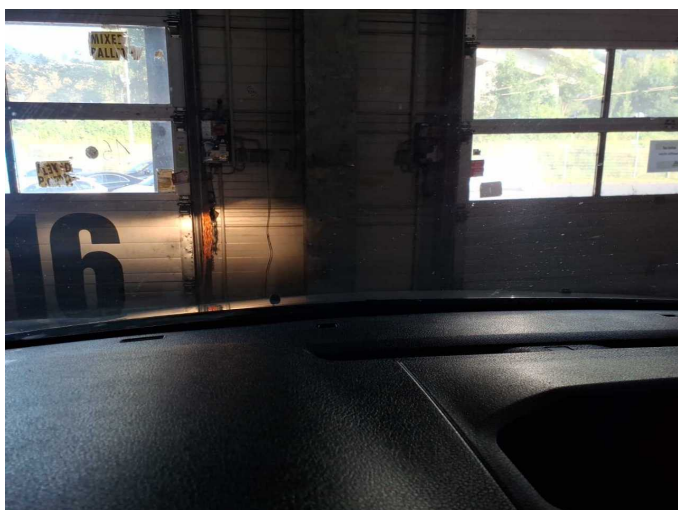
| No. | Component group | Description |
|---|---|---|
| 2 | Headlight | Headlight - right side (Leuchtmittel defekt) - Defective - Perform diagnosis |

**Damage 2:** Headlight: Headlight - right side (Leuchtmittel defekt) - Defective - Perform diagnosis

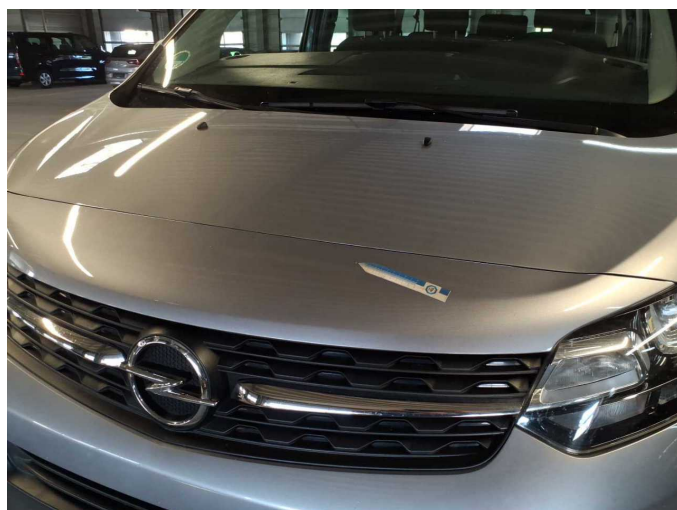
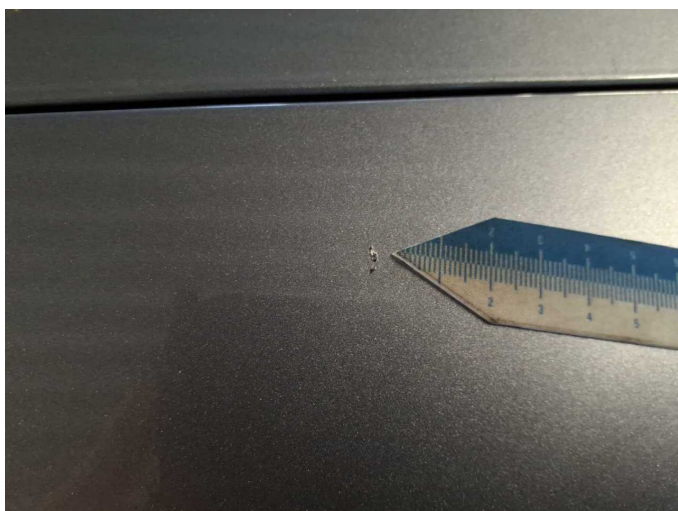
| No. | Component group | Description |
|---|---|---|
| 3 | Bonnet | Radiator grille - Stone chips - Smart repair |

**Damage 3:** Bonnet: Radiator grille - Stone chips - Smart repair

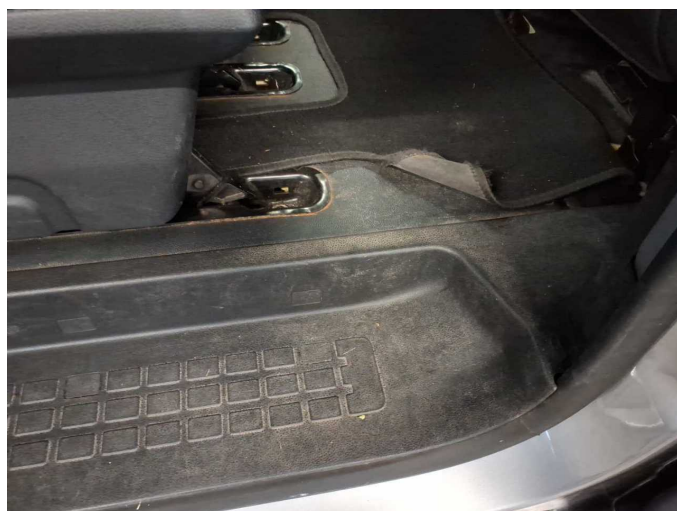
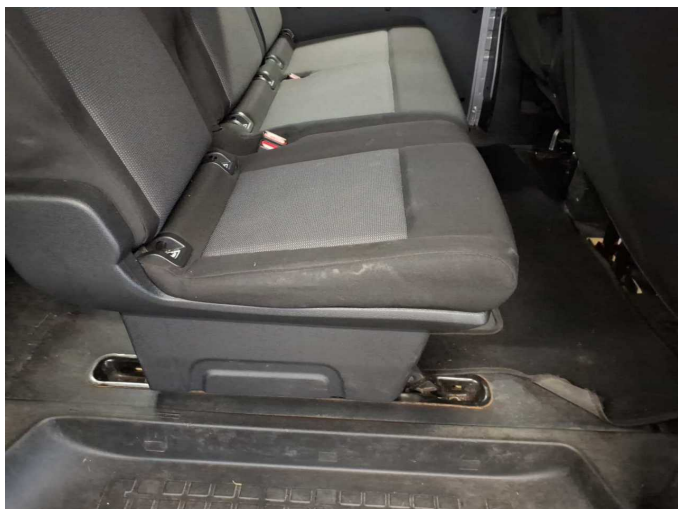
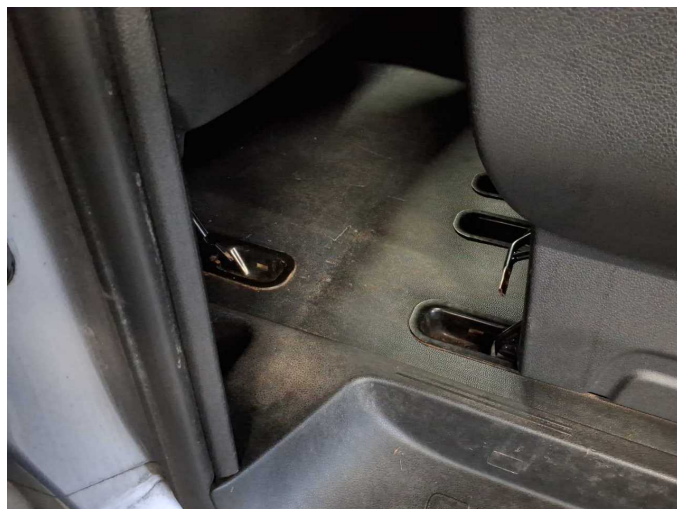
| No. | Component group | Description |
|---|---|---|
| 4 | Interior | Interior - Soiled - Clean |

**Damage 4:** Interior: Interior - Soiled - Clean

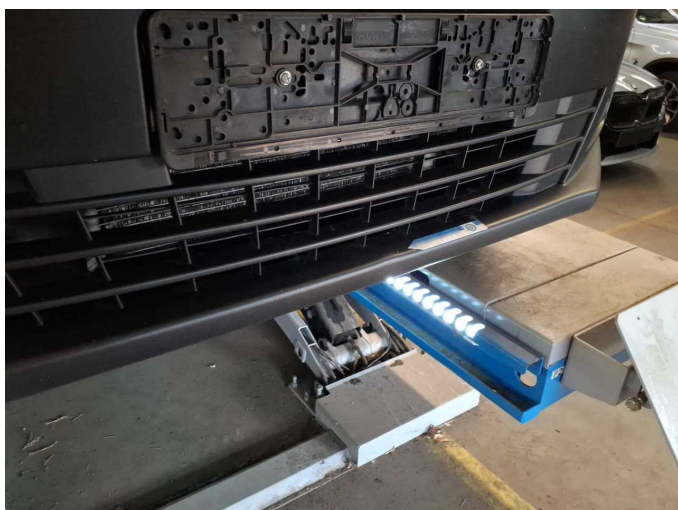
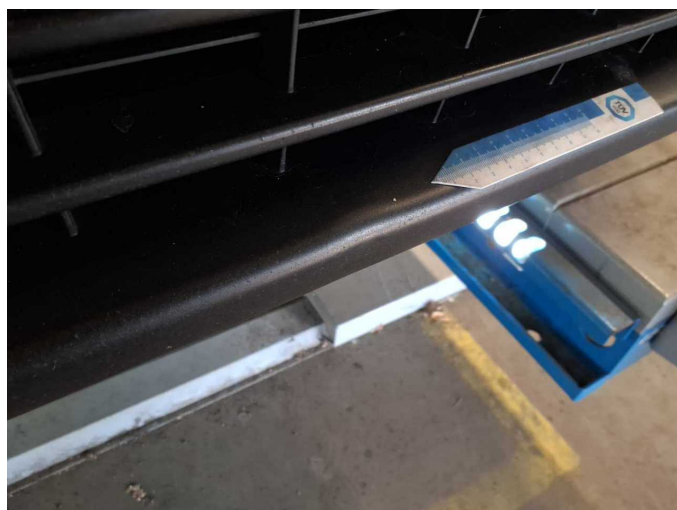
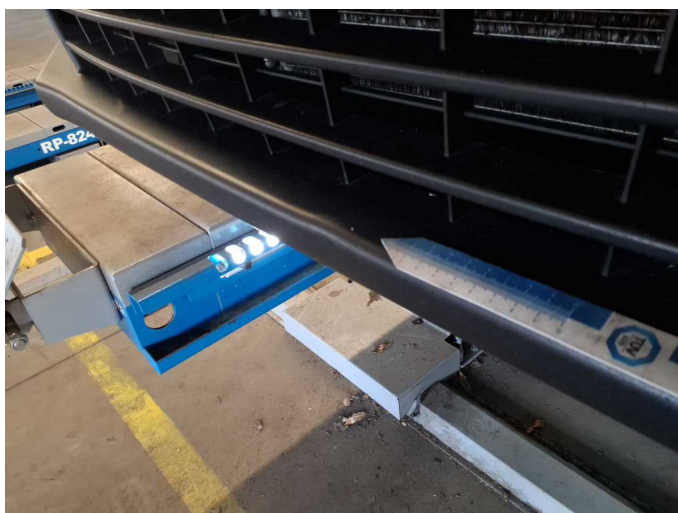
| No. | Component group | Description |
|---|---|---|
| 5 | Front bumper | Front bumper (unpainted) - Damaged - Smart repair |

**Damage 5:** Front bumper: Front bumper (unpainted) - Damaged - Smart repair

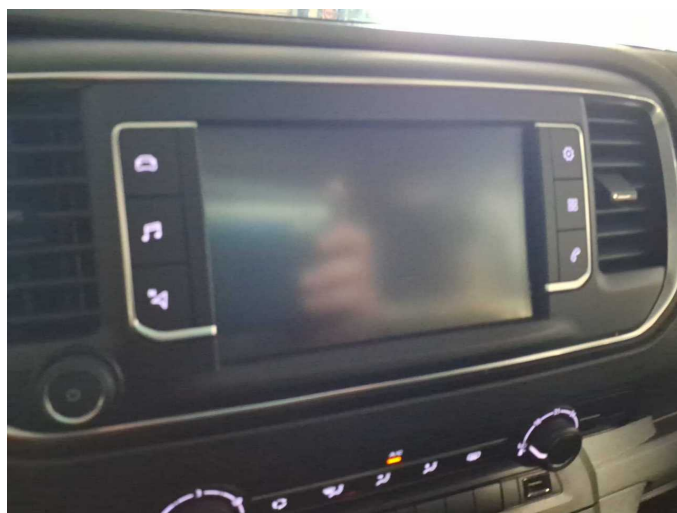
| No. | Component group | Description |
|---|---|---|
| 6 | Multimedia system | Radio - Non-operational - Perform diagnosis |

**Damage 6:** Multimedia system: Radio - Non-operational - Perform diagnosis

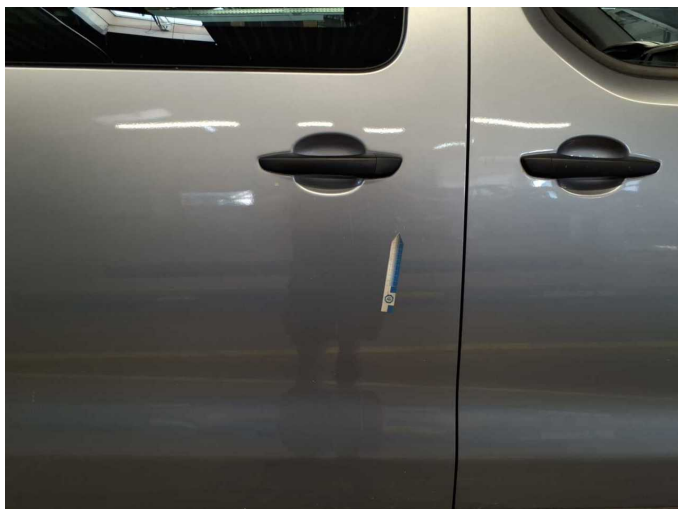
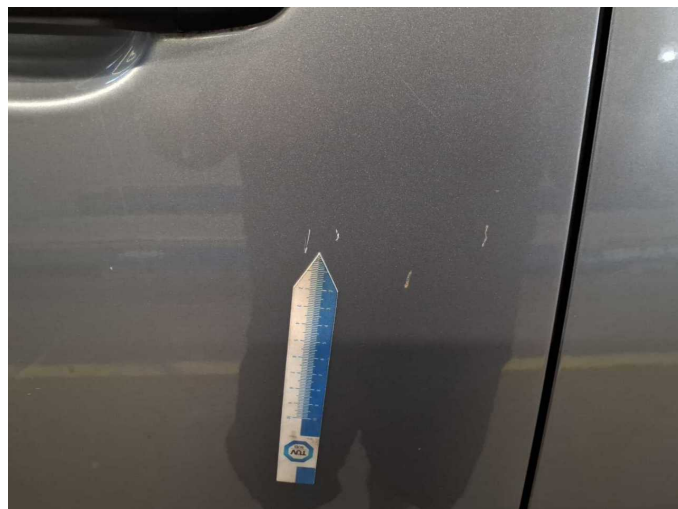
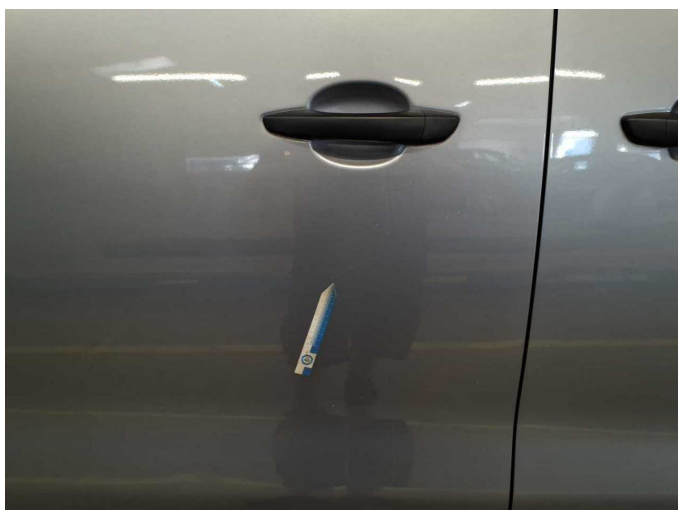
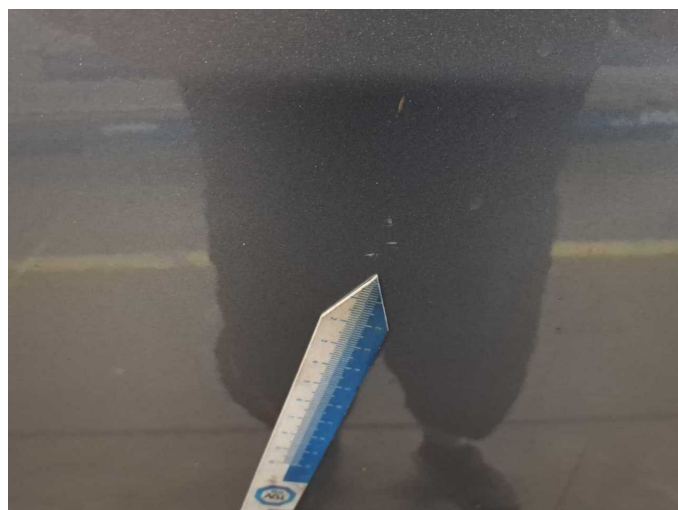
| No. | Component group | Description |
|---|---|---|
| 7 | Sliding door, right | Sliding door - Scratched - Smart repair |

**Damage 7:** Sliding door, right: Sliding door - Scratched - Smart repair

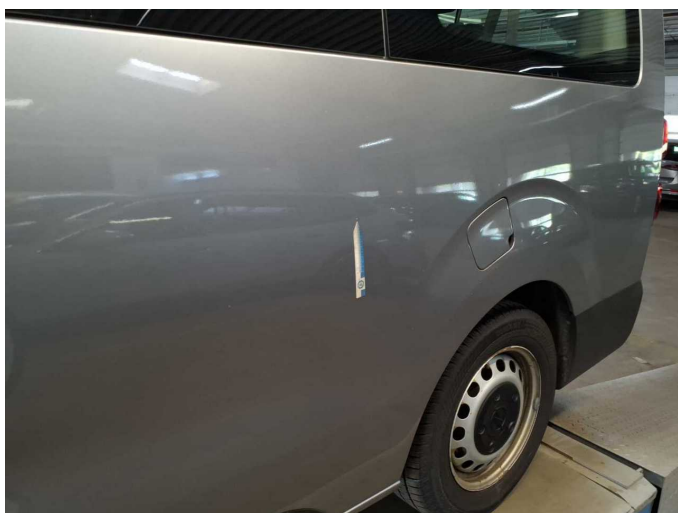
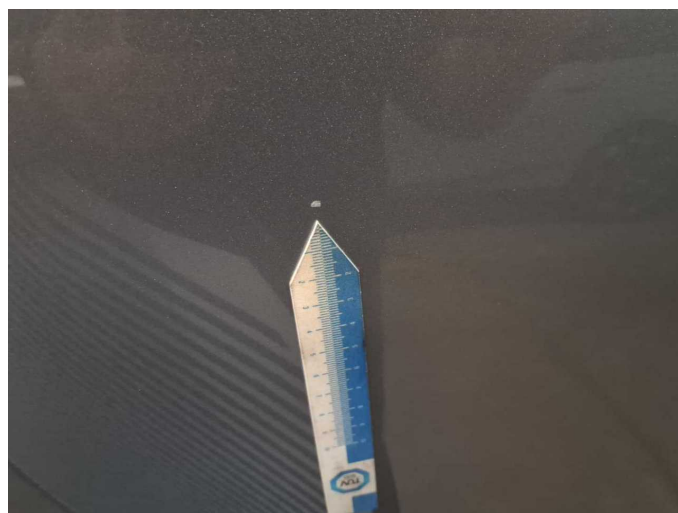
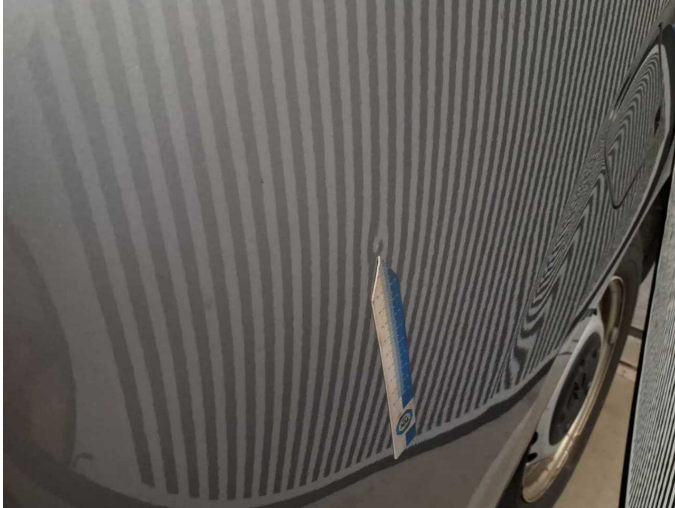
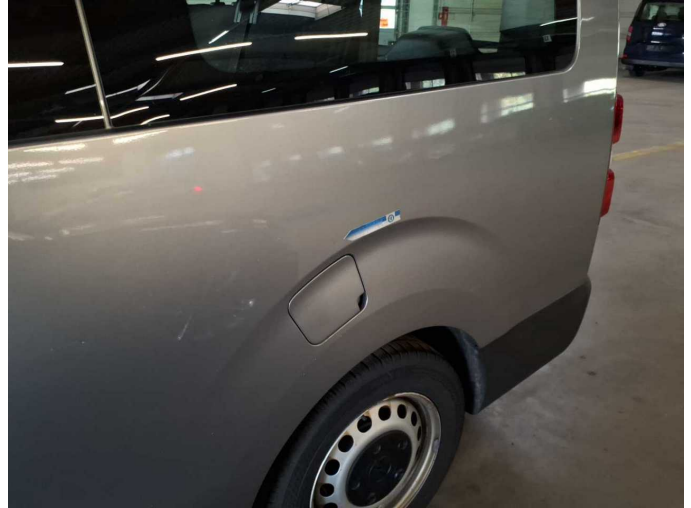
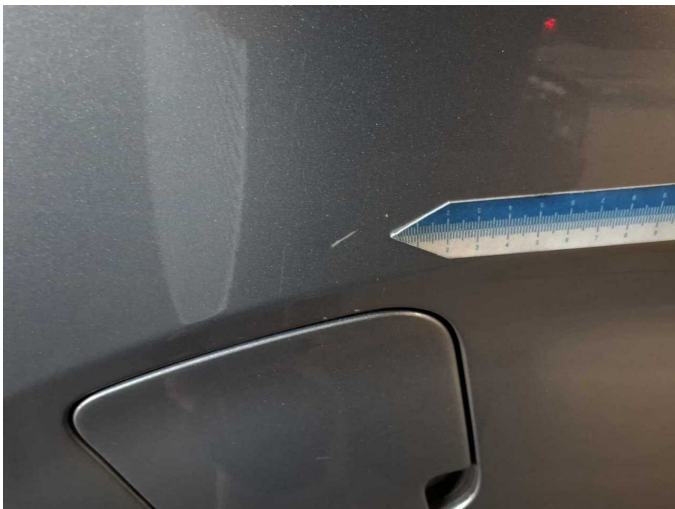
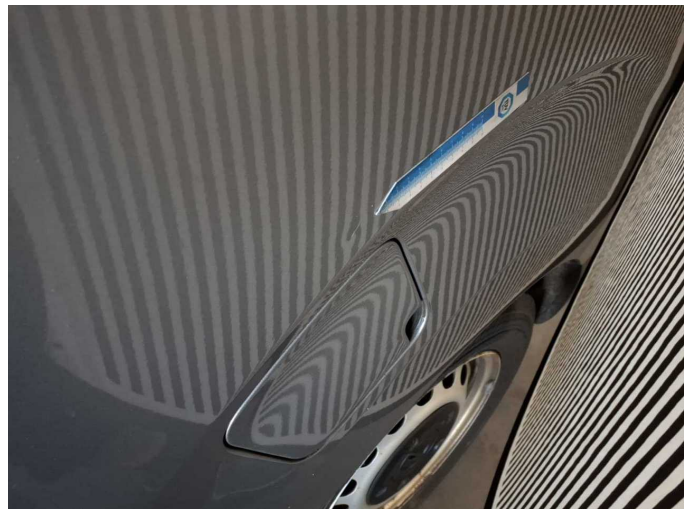
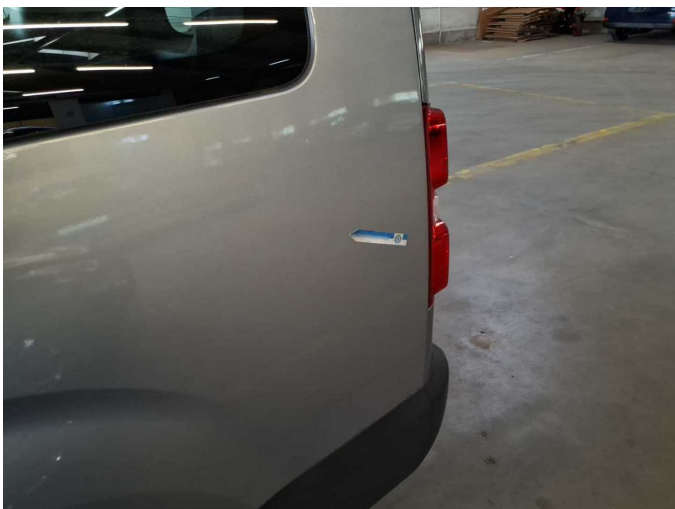
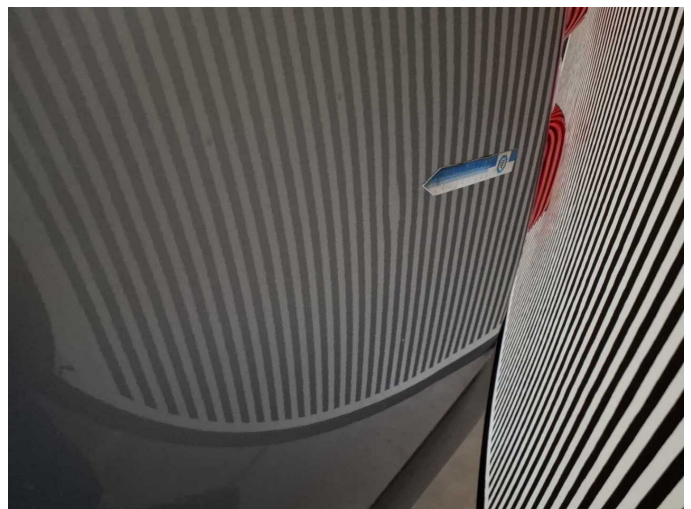
| No. | Component group | Description |
|---|---|---|
| 8 | Side panel - rear left side | Side panel - Dent / paintcoat damage - Smart repair |

**Damage 8:** Side panel - rear left side: Side panel - Dent / paintcoat damage - Smart repair

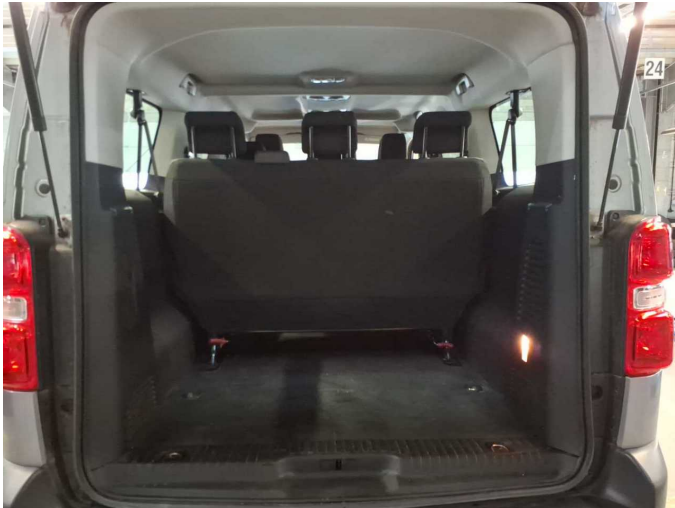
**Missing part 1:** Equipment: Tirefit complete - Missing - Replace

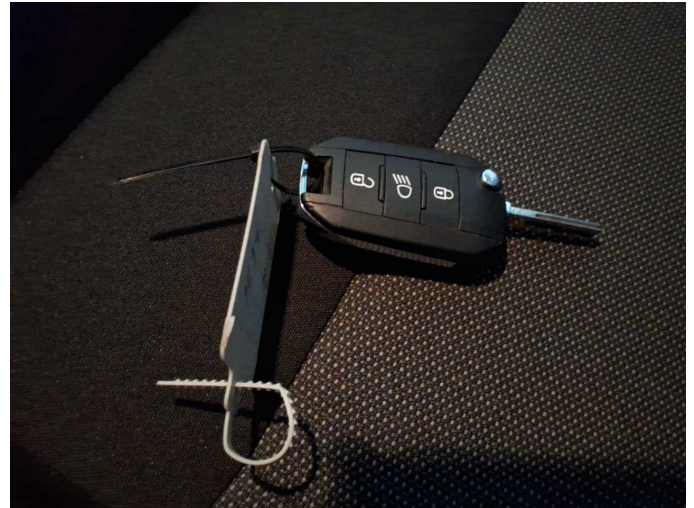
**Missing part 2:** Equipment: Vehicle key - Missing - Replace

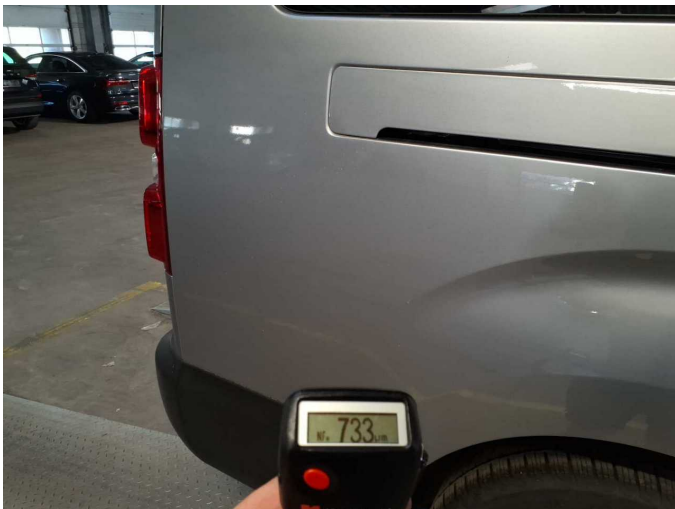
Side panel - rear right side 733 µm |

**Repainting 1:** Side panel - rear right side
