Expertise

Protocol number: 46045407
Order No. / Reference: 26015178-1
Inspection date: 13 Apr 2026

Model: TGE 3.140 4x2F (03V) 3,5T SB

VIN: WMA03VUY5S9001926

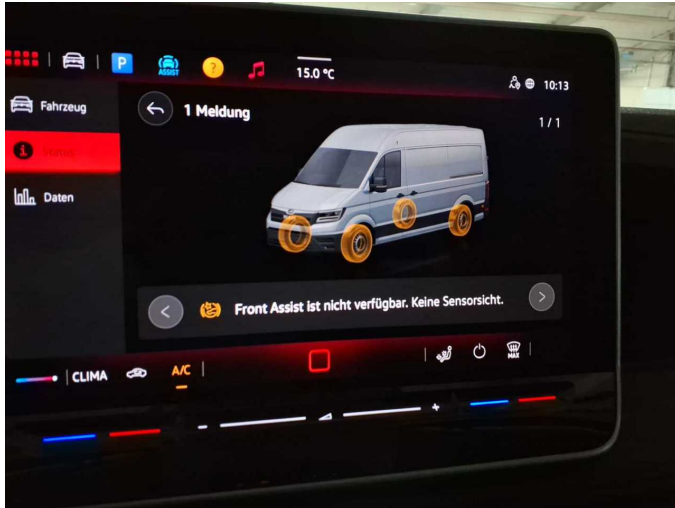
No.	Component group	Description
1	Instrument panel	Indicator light (Front Assist) - on - Perform diagnosis
2	Mudguard - left side	Mudguard - left side - Dent / paintcoat damage - Smart repair
3	Body	Body - Glued / labelled - De-glue / neutralise

Damage 1: Instrument panel: Indicator light (Front Assist) - on - Perform diagnosis

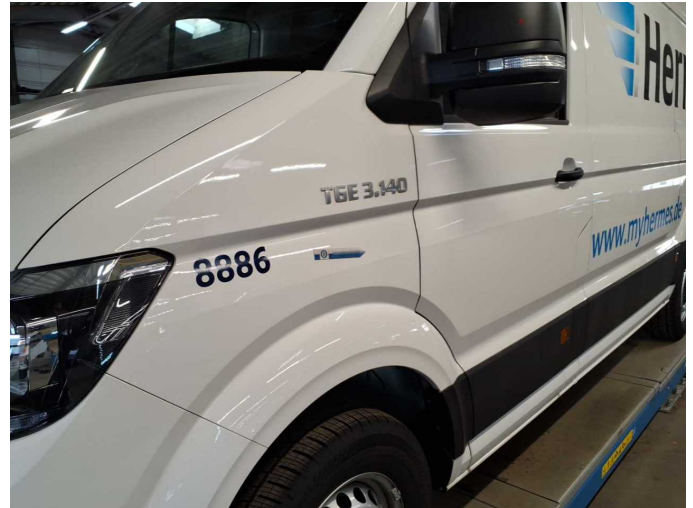
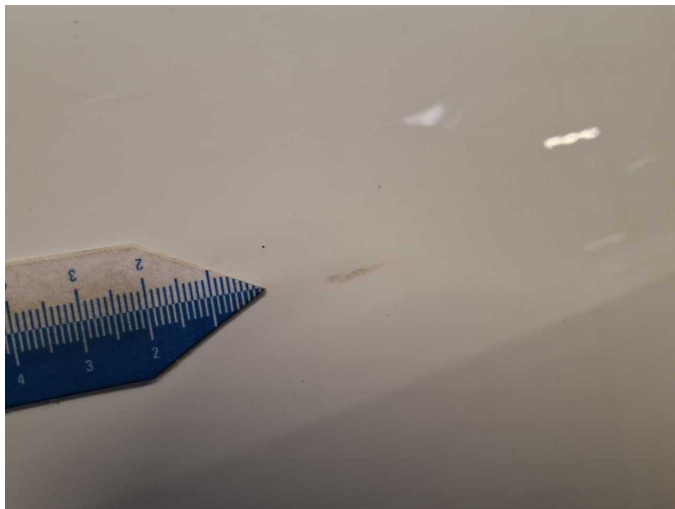
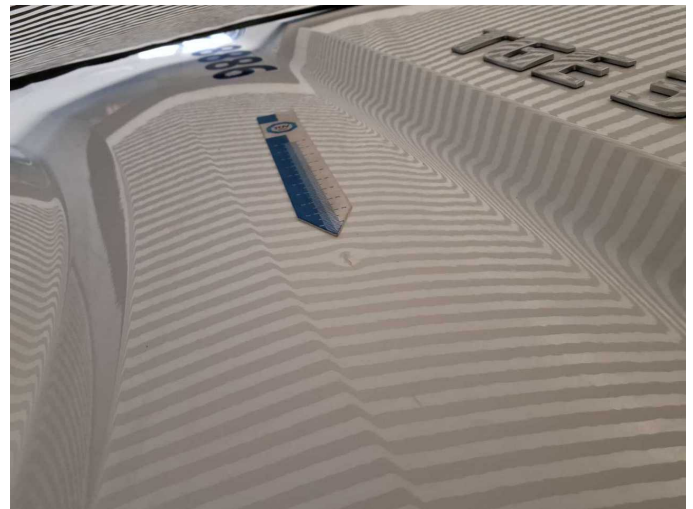
Damage 2: Mudguard - left side: Mudguard - left side - Dent / paintcoat damage - Smart repair

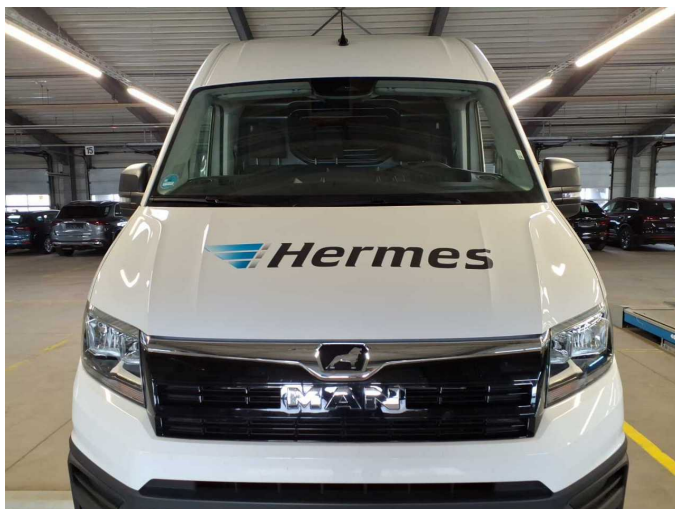
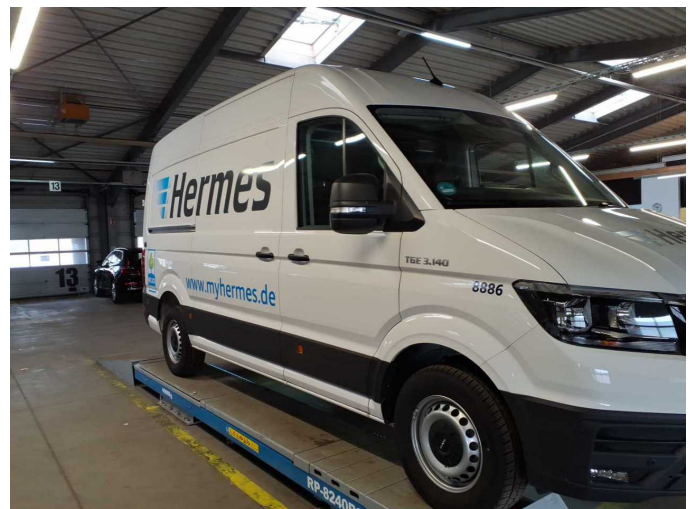
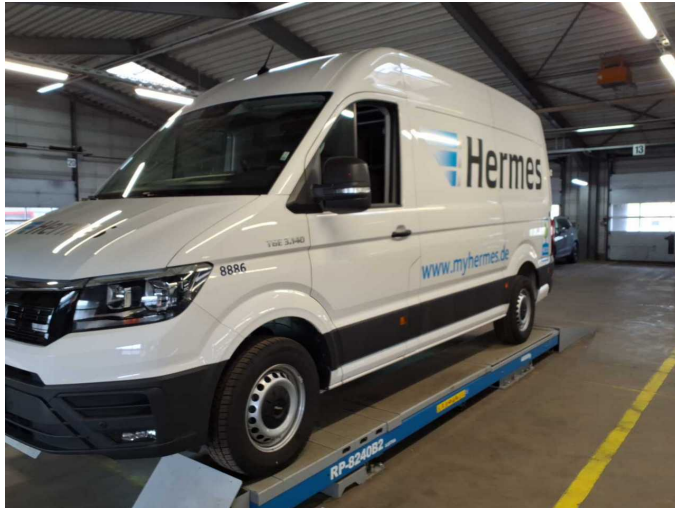
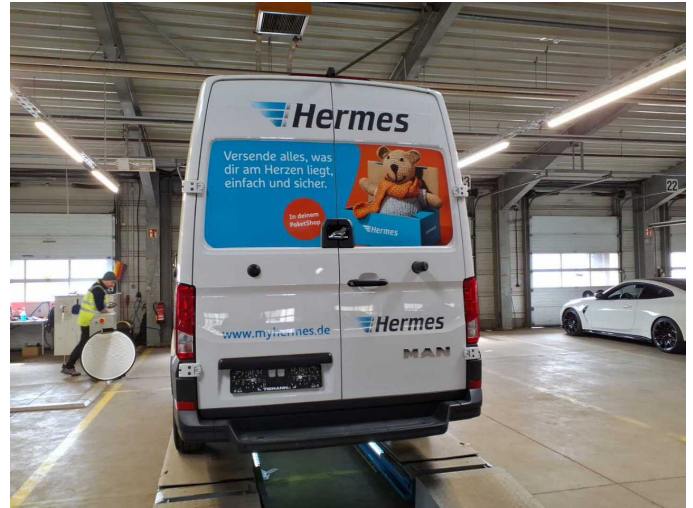
Damage 3: Body: Body - Glued / labelled - De-glug / neutralise

Damage 3: Body: Body - Glued / labelled - De-glue / neutralise
