APPRAISAL REPORT

| Make: | PEUGEOT |
| Model / version: | 308 SW |

Appraisal report | 2CVF311

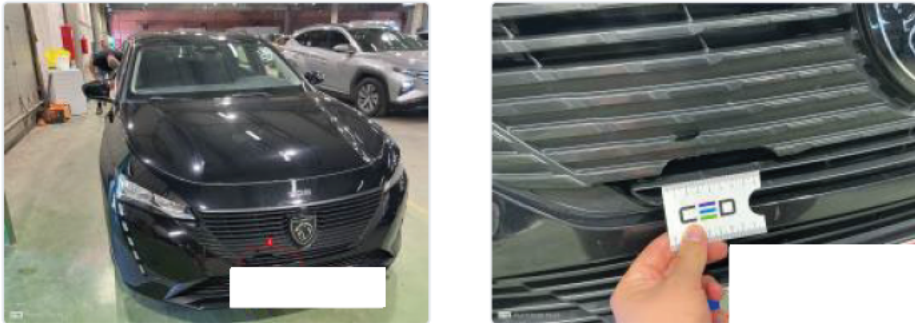
| # | Location | Damage type |
|---|---|---|
| 2 | Grill | Broken |

2 - Grill - Broken

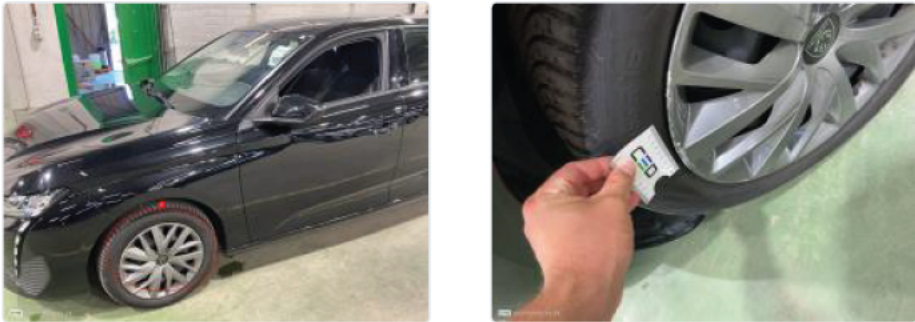
| # | Location | Damage type |
|---|---|---|
| 3 | Wheel cover FL | Scratch(es) |

3 - Wheel cover FL - Scratch(es)

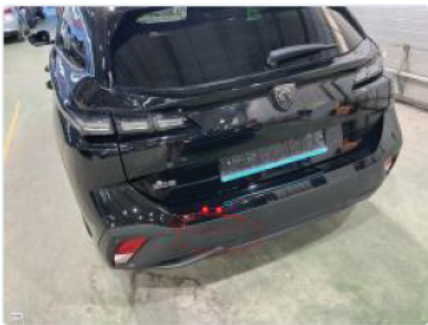
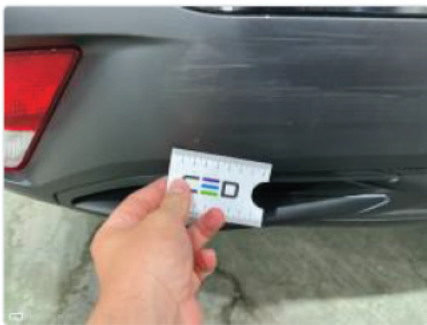
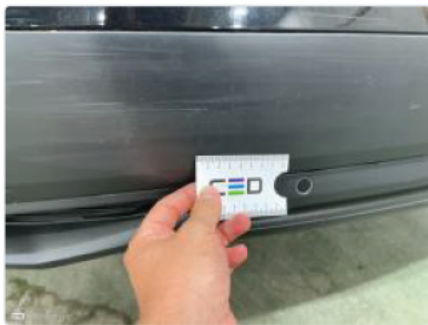
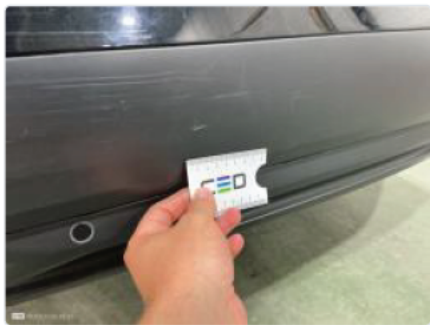
| # | Location | Damage type |
|---|---|---|
| 5 | Bumper moulding R | Scratch(es) |

5 - Bumper moulding R - Scratch(es)

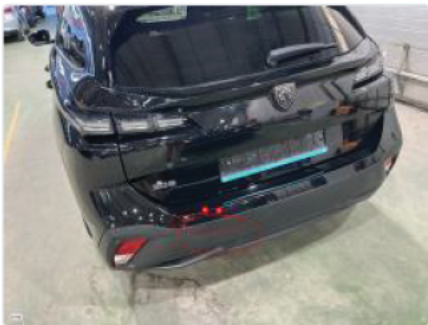
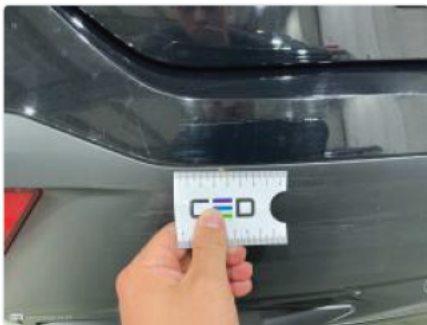
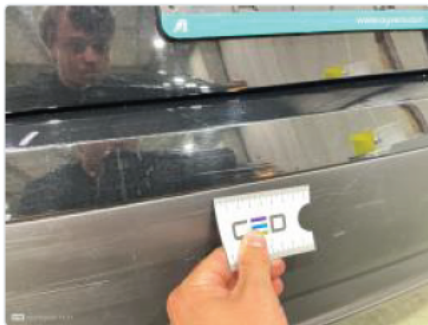
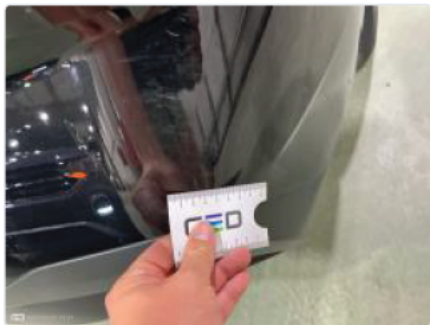
| # | Location | Damage type |
|---|---|---|
| 6 | Bumper R | Scratch(es) |

6 - Bumper R - Scratch(es)

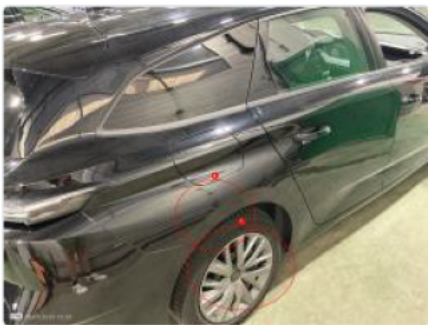
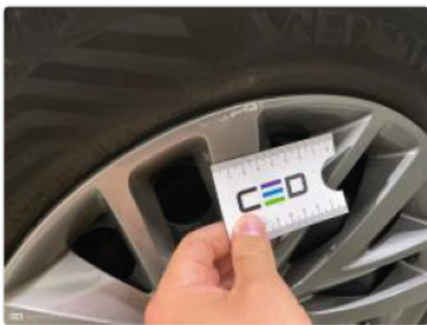
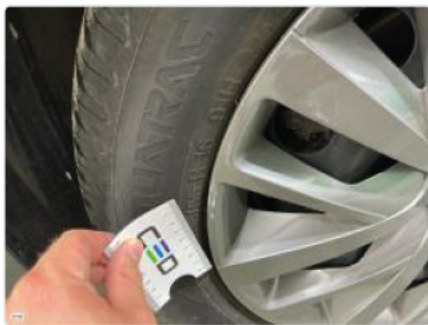
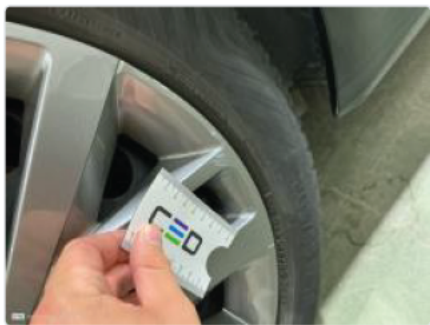
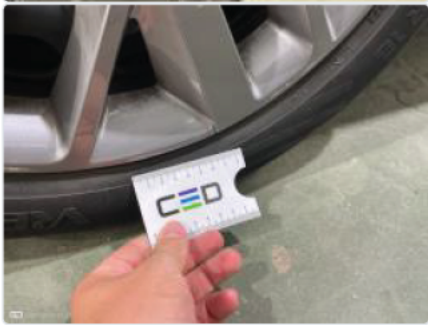
| # | Location | Damage type |
|---|---|---|
| 7 | Wheel cover RR | Scratch(es) |

7 - Wheel cover RR - Scratch(es)

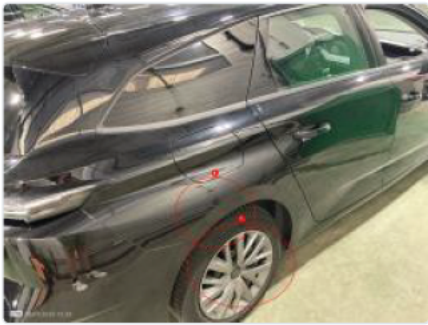
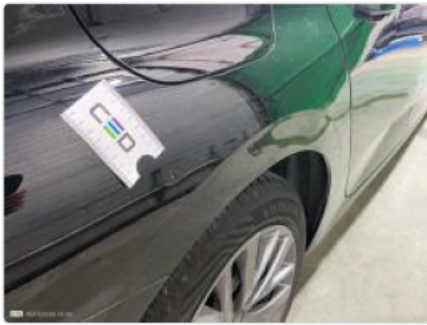
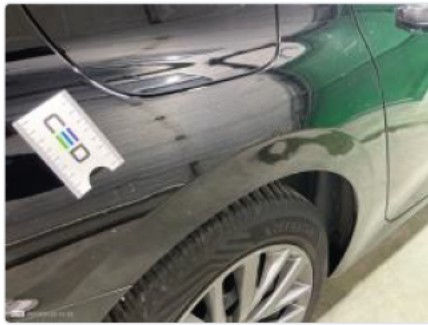
| # | Location | Damage type |
|---|---|---|
| 8 | Wing RR | Dent(s) and scratch(es) |

8 - Wing RR - Dent(s) and scratch(es)

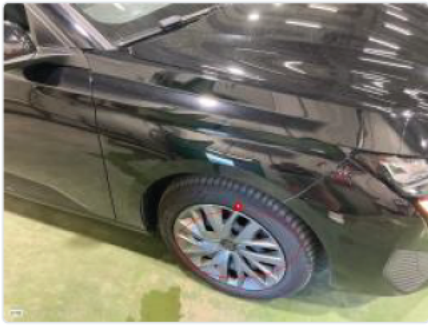
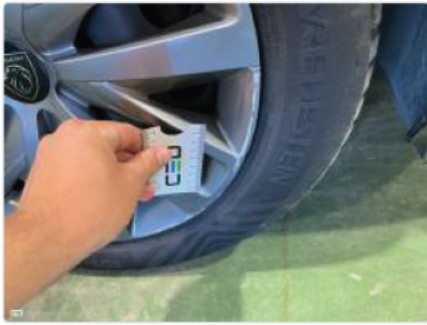
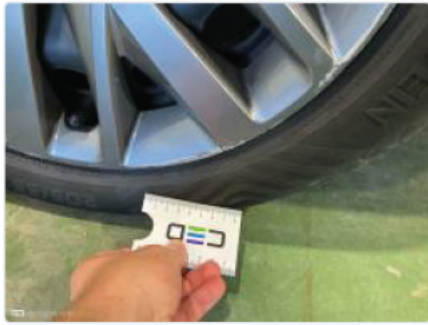
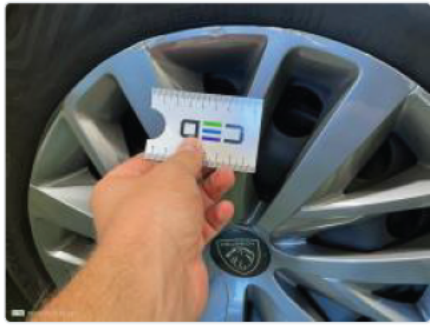
| # | Location | Damage type |
|---|---|---|
| 9 | Wheel cover FR | Scratch(es) |

9 - Wheel cover FR - Scratch(es)

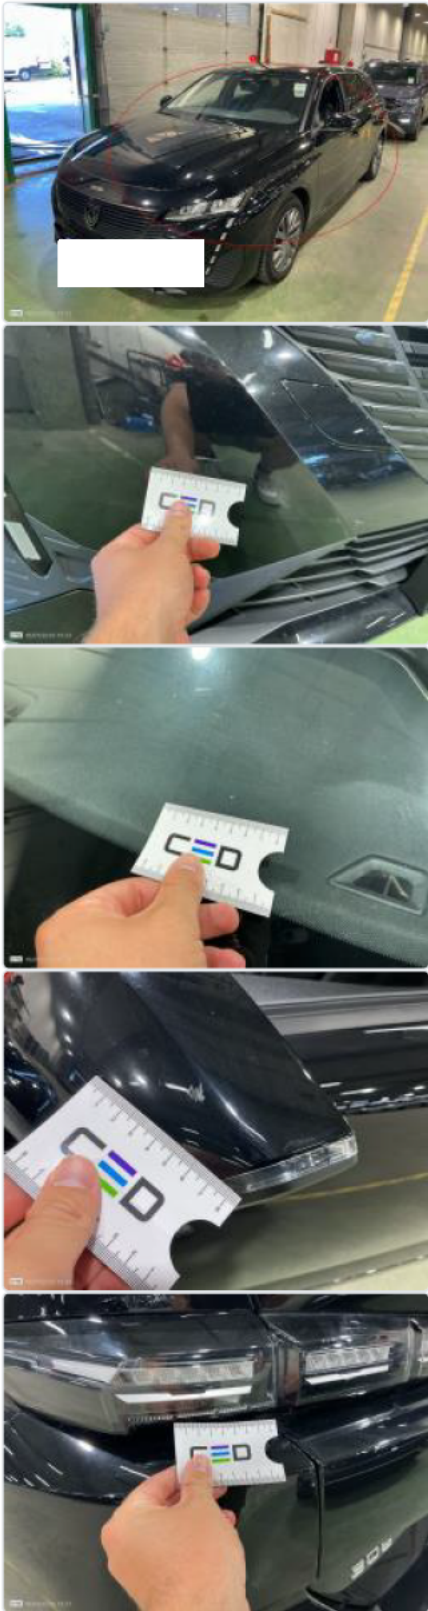
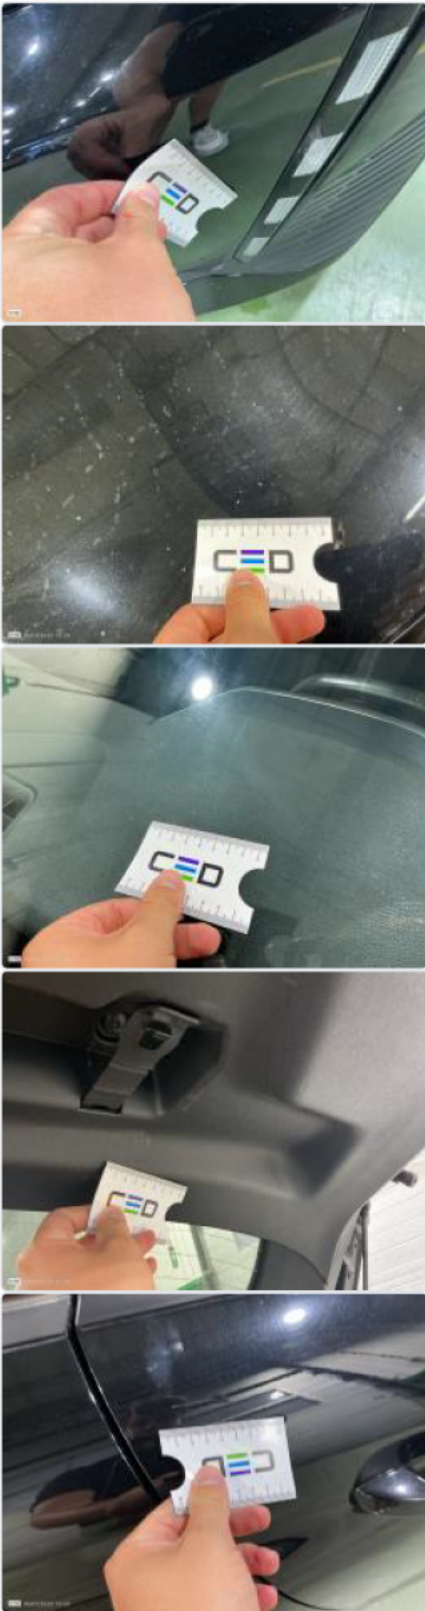
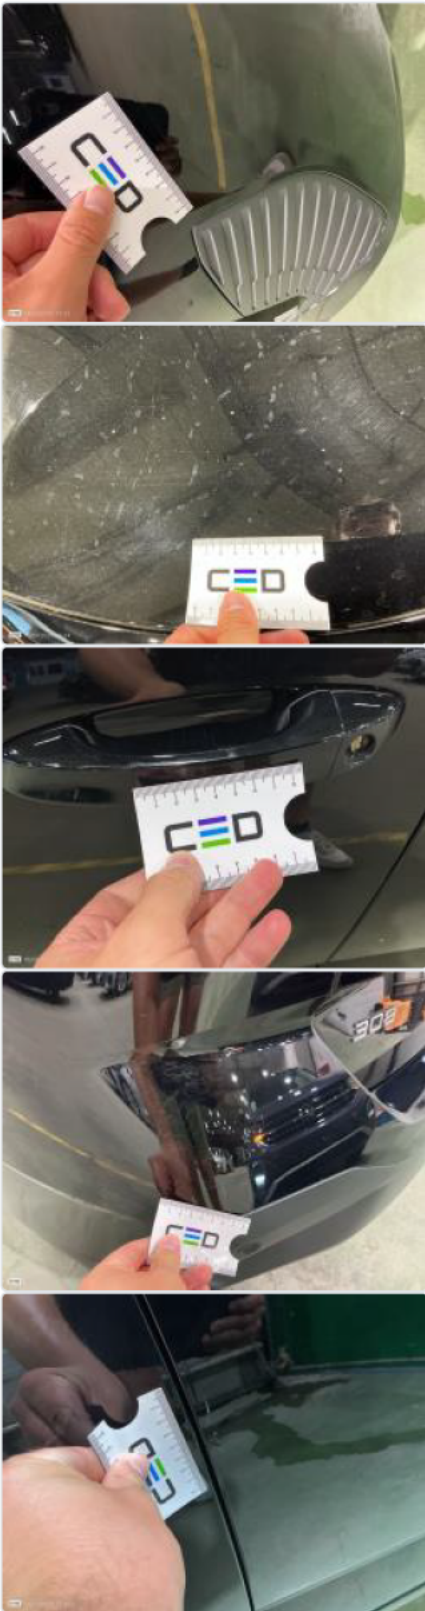
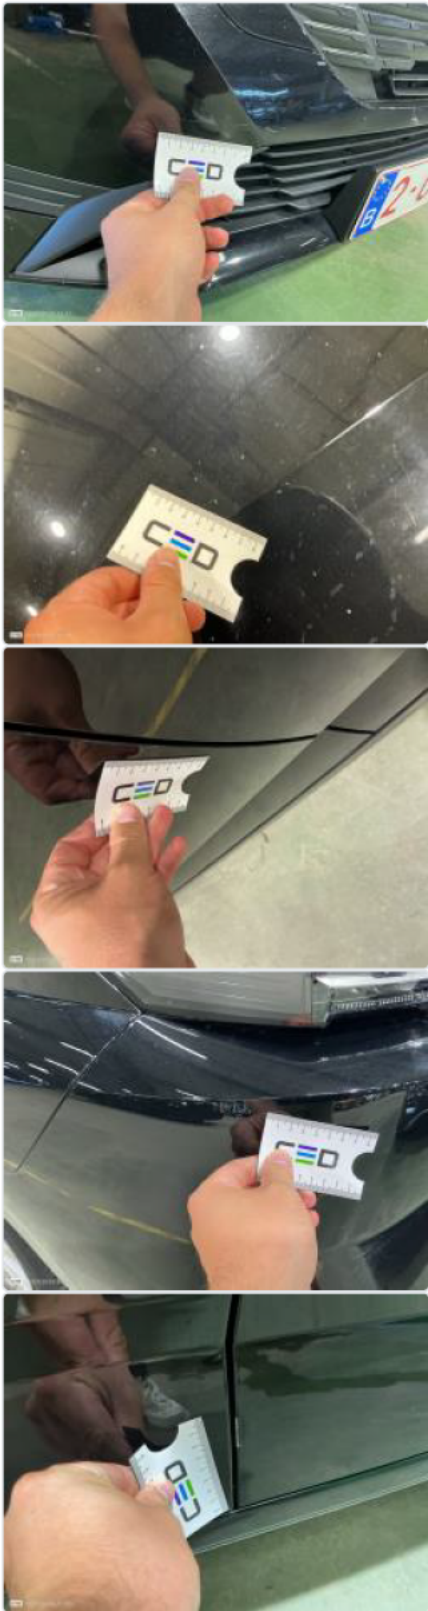
| # | Location | Damage type | Renta® | Repaired | Already invoiced |
|---|---|---|---|---|---|
| 1 | Bodywork | Damaged | ✓ | ✗ | ✗ |

1 - Bodywork - Damaged - Renta®
