Expertise

Protocol number: 46607068  
Order No. / Reference: 26715380  
Inspection date: 20 Jul 2026

Manufacturer: Opel

Model: Astra Sports Tourer 1.5 D Automatik Ultimate

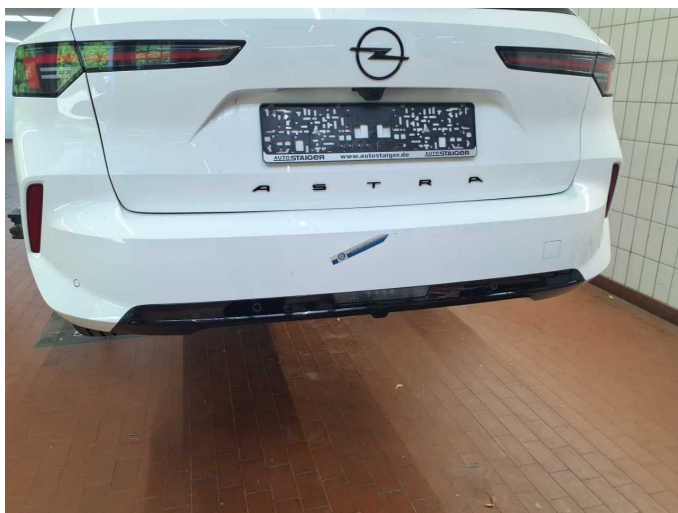
| No. | Component group | Description |
|---|---|---|
| 1 | Rear bumper | Rear bumper - Scratch(es) - Smart repair |

**Damage 1:** Rear bumper: Rear bumper - Scratch(es) - Smart repair

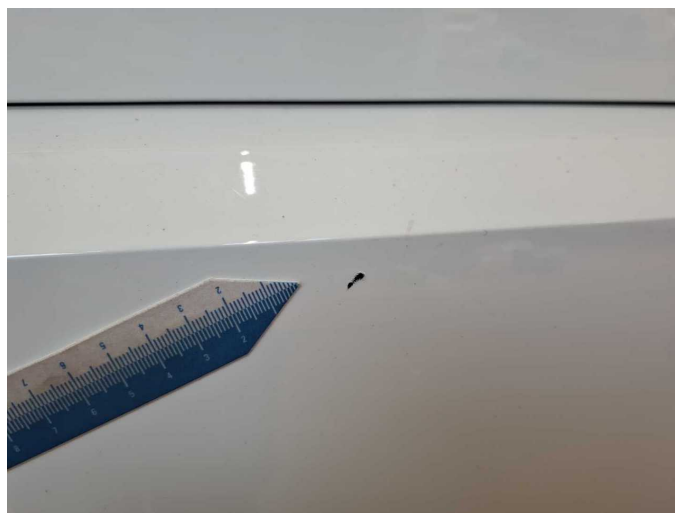
**Damage 1:** Rear bumper: Rear bumper - Scratch(es) - Smart repair

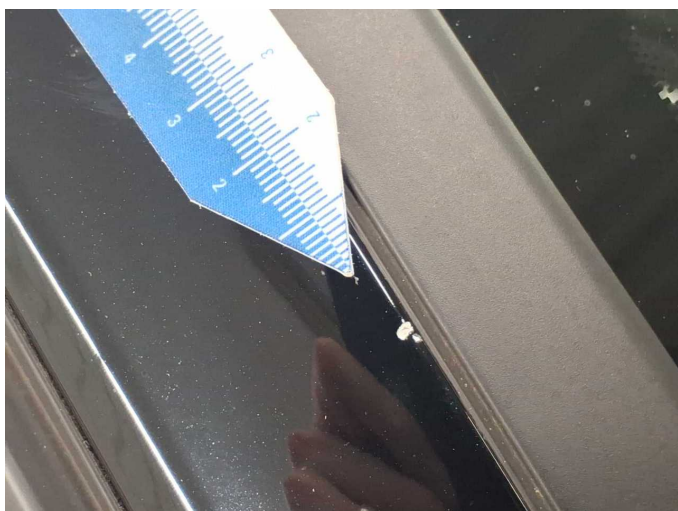
| No. | Component group | Description |
|---|---|---|
| 2 | Roof | Roof rail - right side - Stone chips - Smart repair |

**Damage 2:** Roof: Roof rail - right side - Stone chips - Smart repair

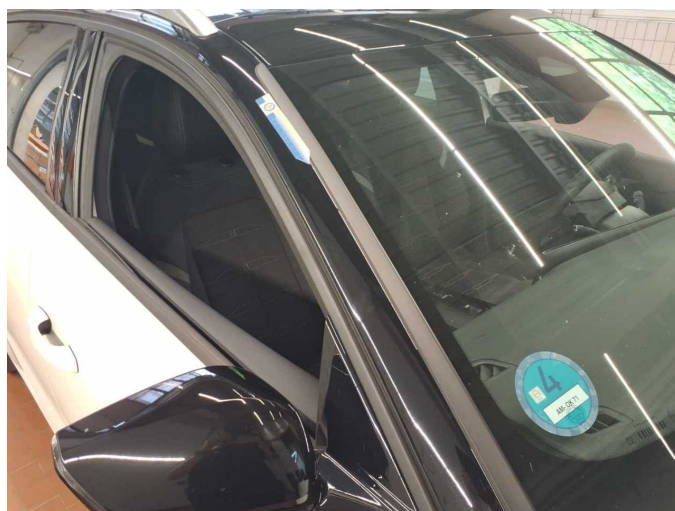
**Damage 2:** Roof: Roof rail - right side - Stone chips - Smart repair

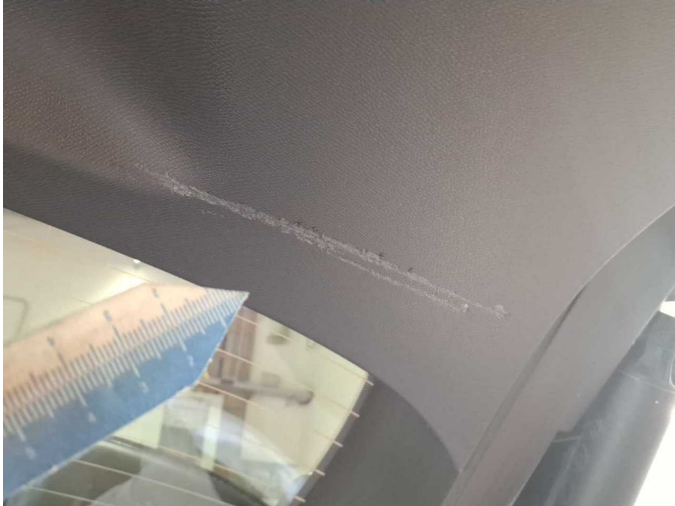
| No. | Component group | Description |
|---|---|---|
| 3 | Trim / covers | Boot lid - interior trim - Scratch(es) - Replace |

**Damage 3:** Trim / covers: Boot lid - interior trim - Scratch(es) - Replace

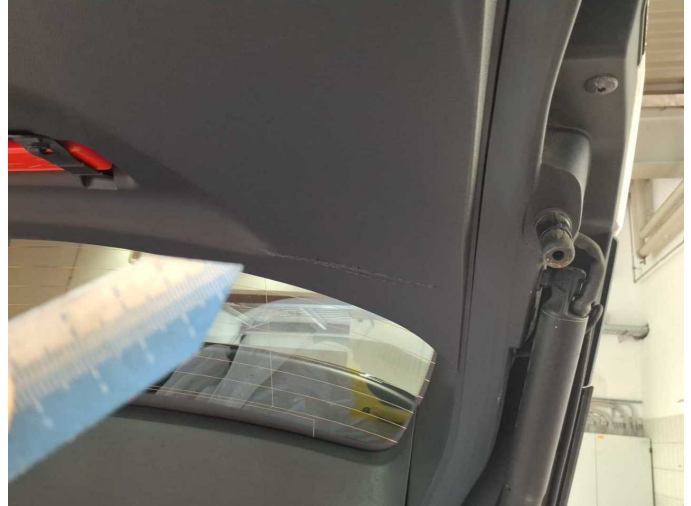
**Damage 3:** Trim / covers: Boot lid - interior trim - Scratch(es) - Replace

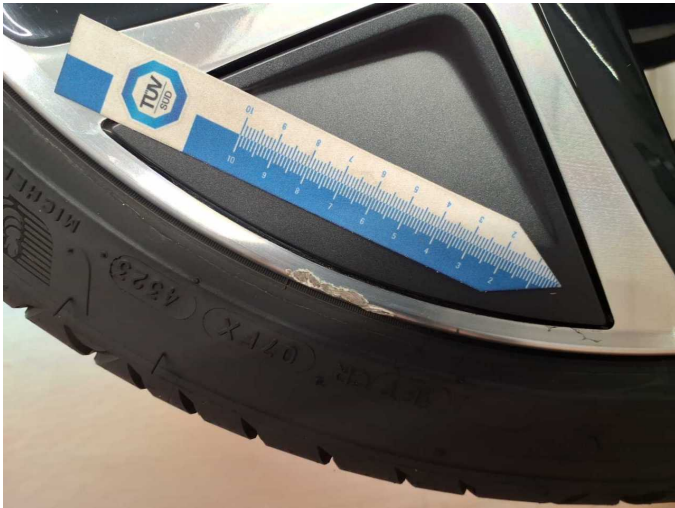
| No. | Component group | Description |
|---|---|---|
| 4 | Wheel / tyres | Alloy rim - rear right side - Scratched - Replace |

**Damage 4:** Wheel / tyres: Alloy rim - rear right side - Scratched - Replace

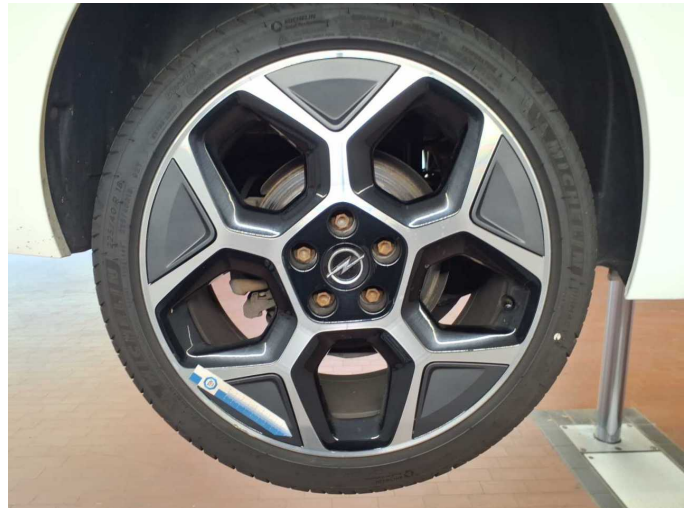
**Damage 4:** Wheel / tyres: Alloy rim - rear right side - Scratched - Replace

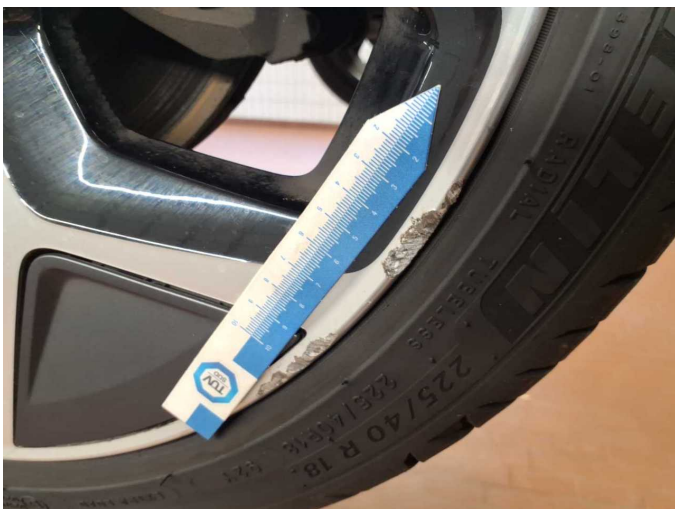
| No. | Component group | Description |
|---|---|---|
| 5 | Wheel / tyres | Alloy rim - front right side (+Radblende) - Scratched - Replace |

**Damage 5:** Wheel / tyres: Alloy rim - front right side (+Radblende) - Scratched - Replace

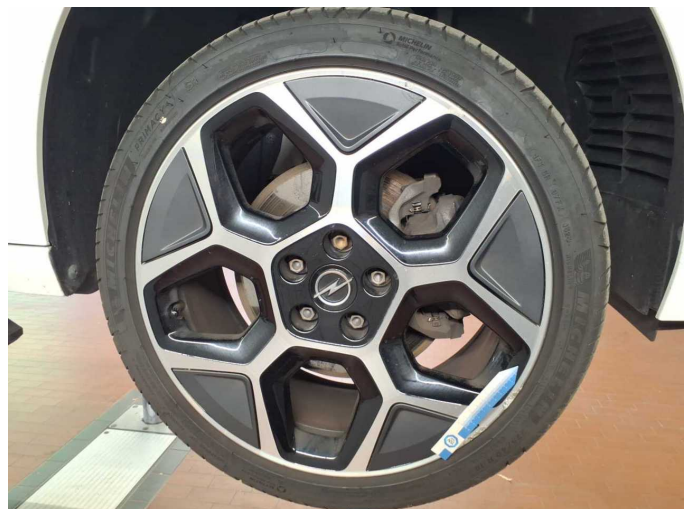
**Damage 5:** Wheel / tyres: Alloy rim - front right side (+Radblende) - Scratched - Replace

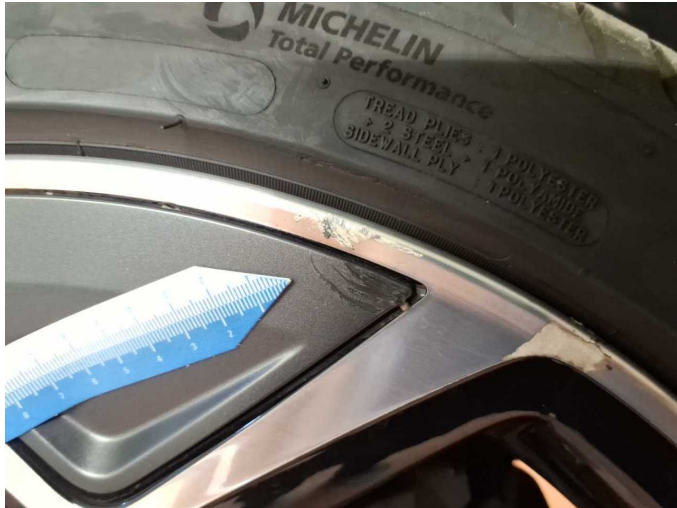
**Damage 5:** Wheel / tyres: Alloy rim - front right side (+Radblende) - Scratched - Replace

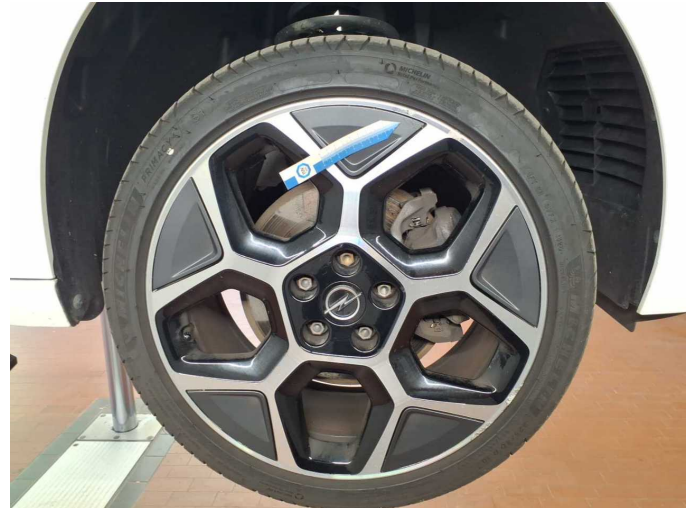
**Damage 5:** Wheel / tyres: Alloy rim - front right side (+Radblende) - Scratched - Replace

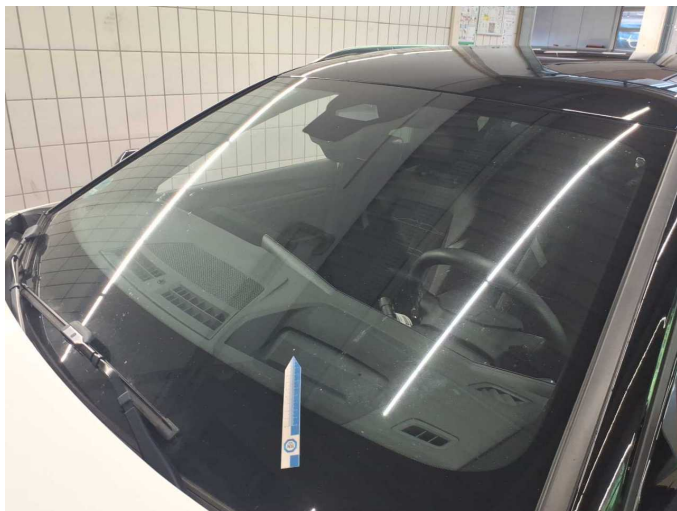
| No. | Component group | Description |
|---|---|---|
| 1 | Vehicle glazing | Windscreen - Stone chips - No deduction |

**Wear and tear 1:** Vehicle glazing: Windscreen - Stone chips - No deduction

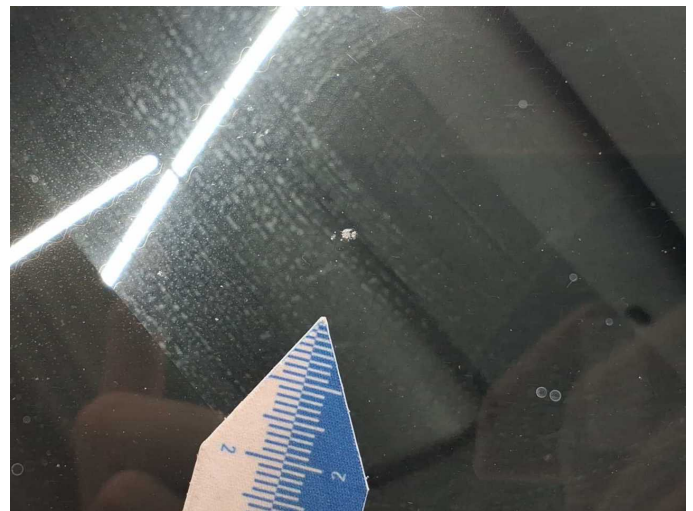
**Wear and tear 1:** Vehicle glazing: Windscreen - Stone chips - No deduction

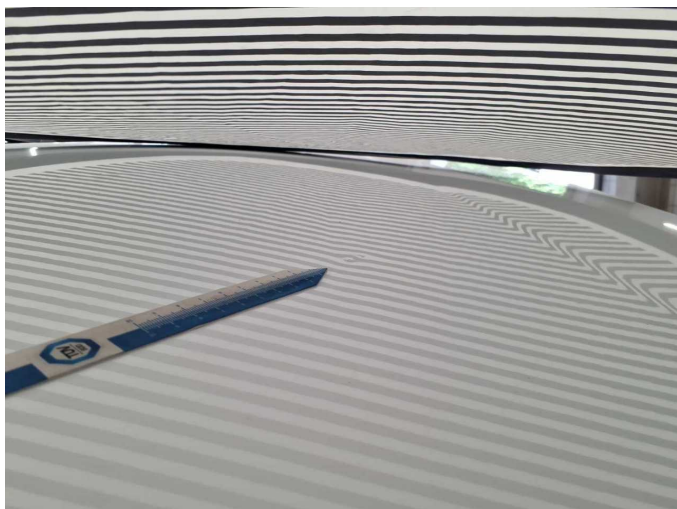
| No. | Component group | Description |
|---|---|---|
| 2 | Bonnet | Bonnet - Dent / paintcoat damage - No deduction |

**Wear and tear 2:** Bonnet: Bonnet - Dent / paintcoat damage - No deduction

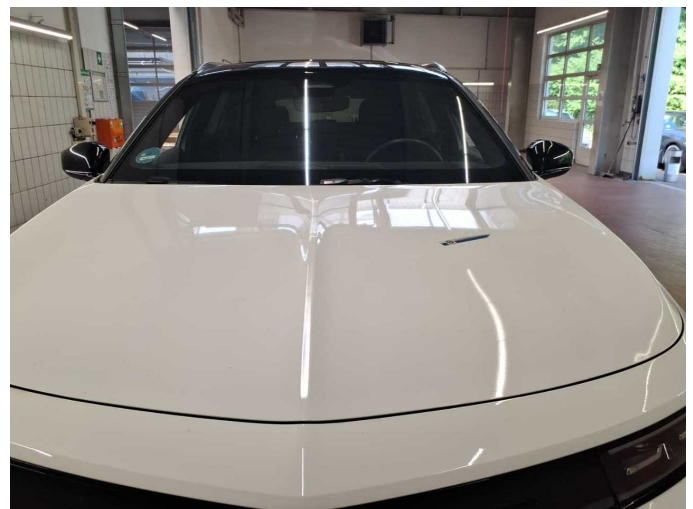
**Wear and tear 2:** Bonnet: Bonnet - Dent / paintcoat damage - No deduction

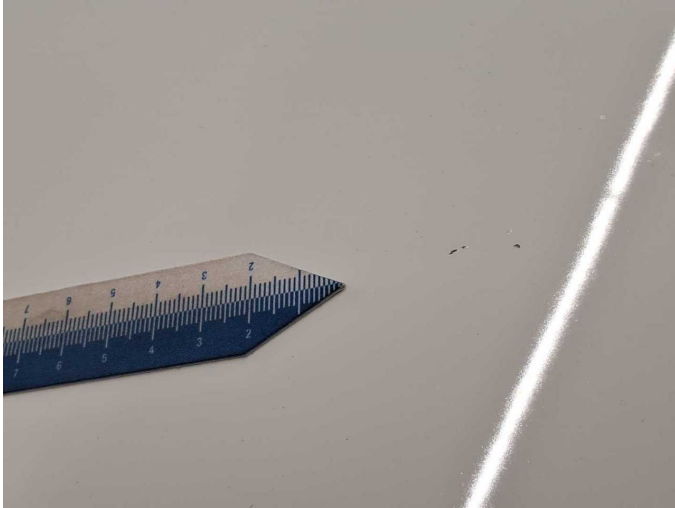
**Wear and tear 2:** Bonnet: Bonnet - Dent / paintcoat damage - No deduction
