Expertise

Protocol number: 47187977  
Order No. / Reference: 26782845  
Inspection date: 18 Aug 2026

Model: Astra 1.5 D Start/Stop Sports Tourer Elegance

VIN: W0VBE8EV5N8042501

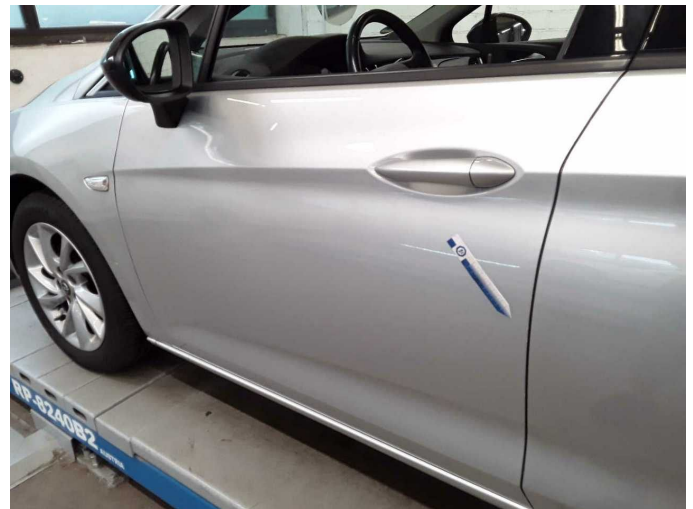
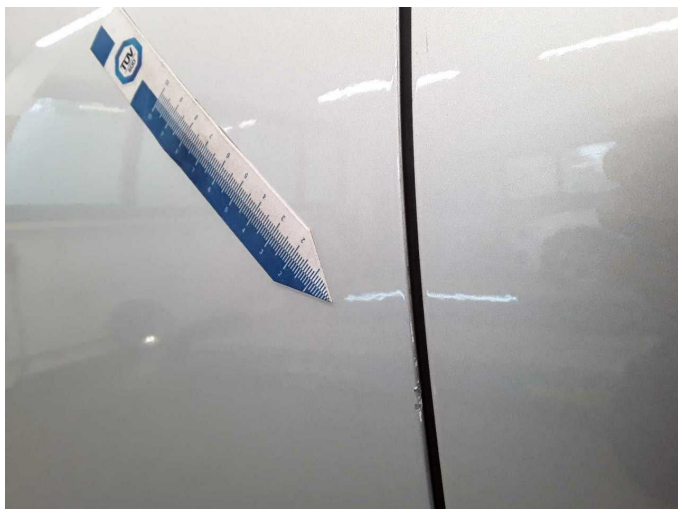
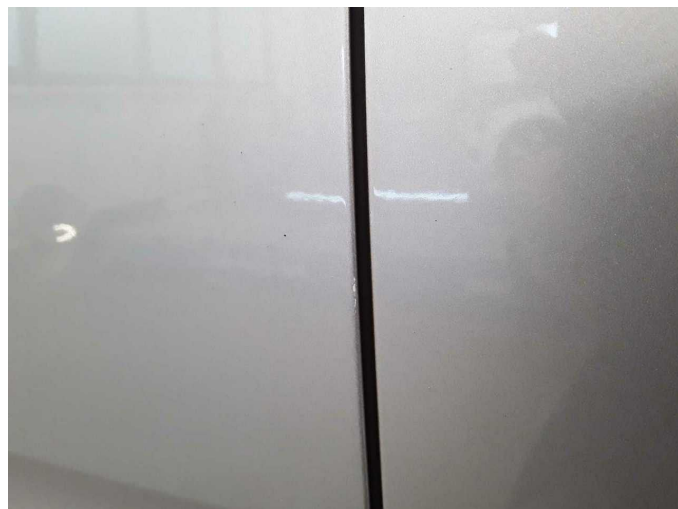
| No. | Component group | Description |
|---|---|---|
| 1 | Door - front left side | Door edge - Scratch(es) - Smart repair |

Damage 1: Door - front left side: Door edge - Scratch(es) - Smart repair

**Damage 1:** Door - front left side: Door edge - Scratch(es) - Smart repair

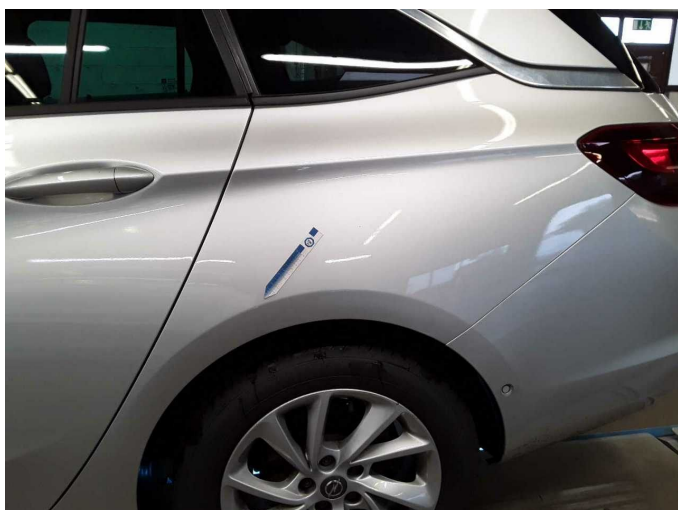
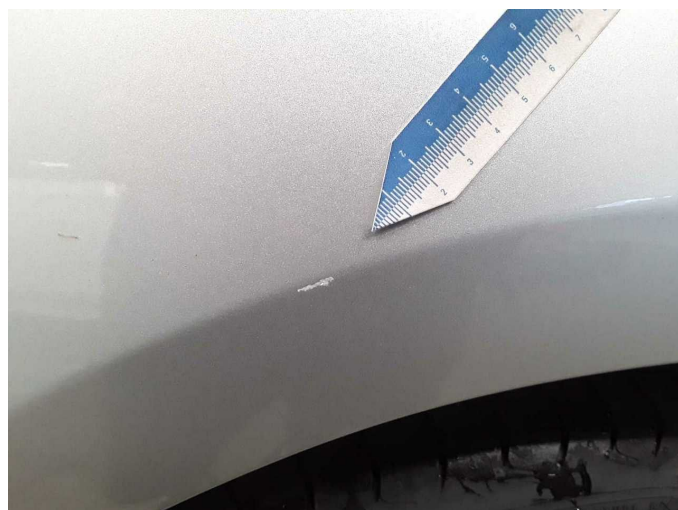
| No. | Component group | Description |
|---|---|---|
| 2 | Side panel - rear left side | Side panel - Scratch(es) - Smart repair |

**Damage 2:** Side panel - rear left side: Side panel - Scratch(es) - Smart repair

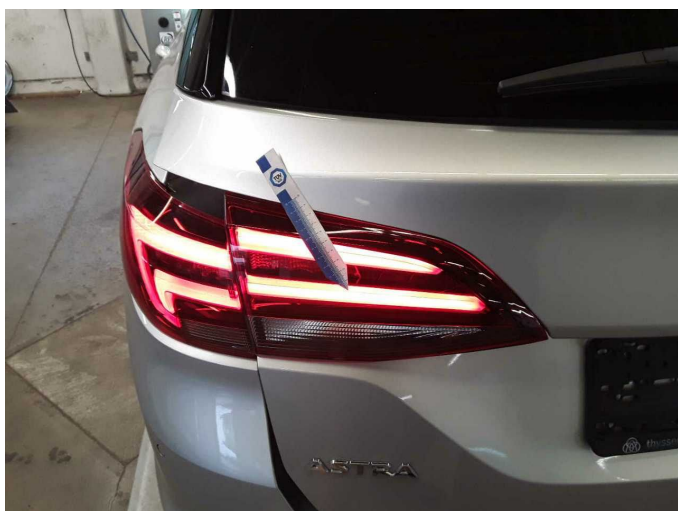
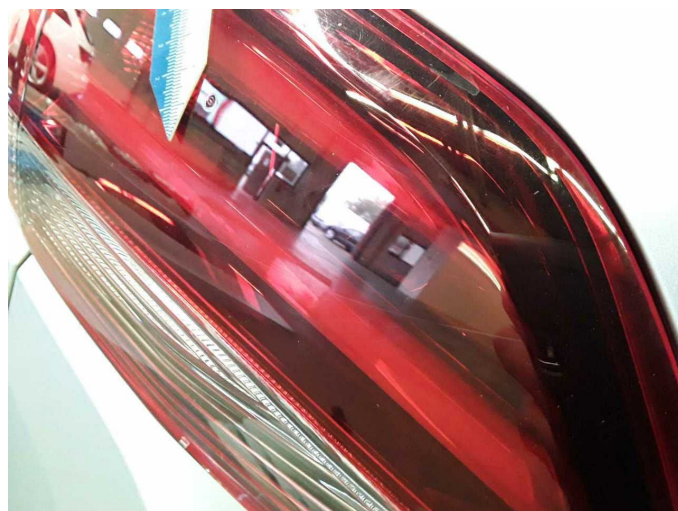
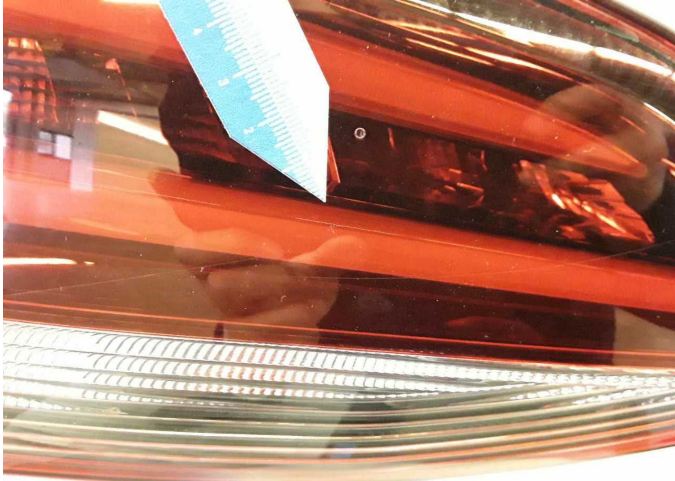
| No. | Component group | Description |
|---|---|---|
| 3 | Tail light | Tail lamp - left side (Leuchte Innen, Verkratzt/Verschürft im Leuchtbereich) - Scratch(es) - Replace |

**Damage 3:** Tail light: Tail lamp - left side (Leuchte Innen, Verkratzt/ Verschürft im Leuchtbereich) - Scratch(es) - Replace

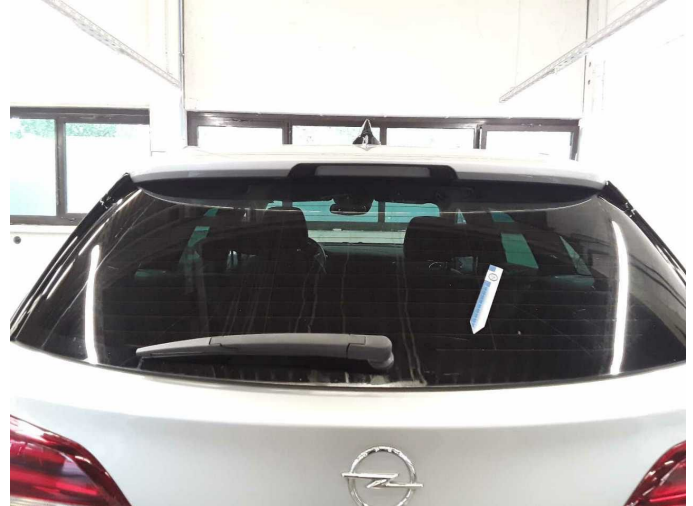
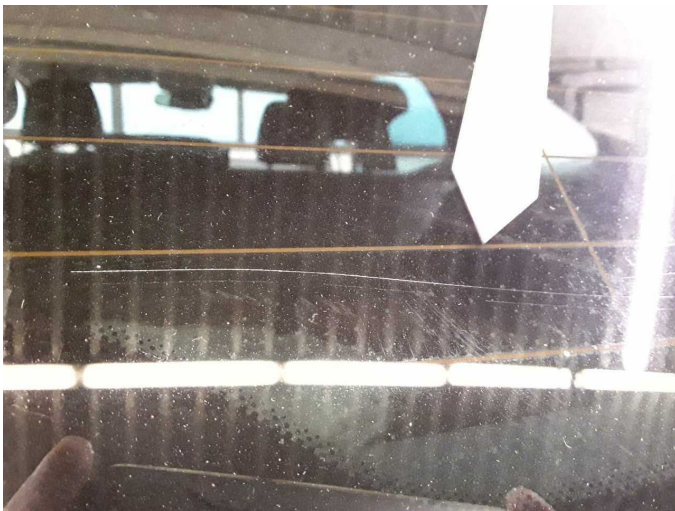
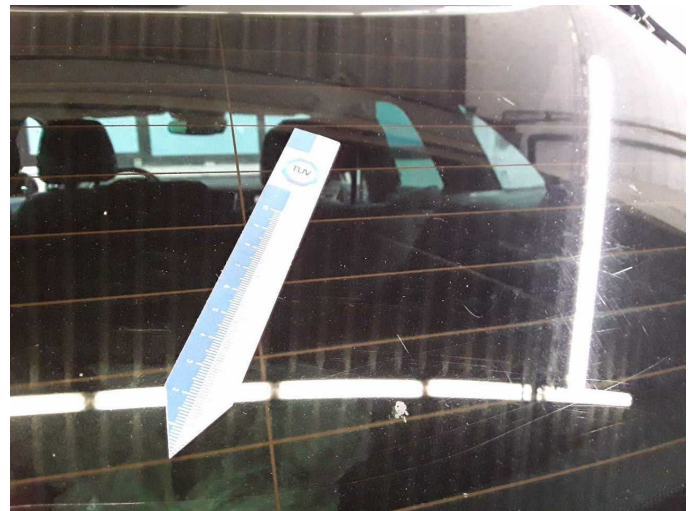
| No. | Component group | Description |
|---|---|---|
| 4 | Vehicle glazing | Rear window (Verkratzt/verschürft im Sichtbereich) - Scratched - Replace |

**Damage 4:** Vehicle glazing: Rear window (Verkratzt/verschürft im Sichtbereich) - Scratched - Replace

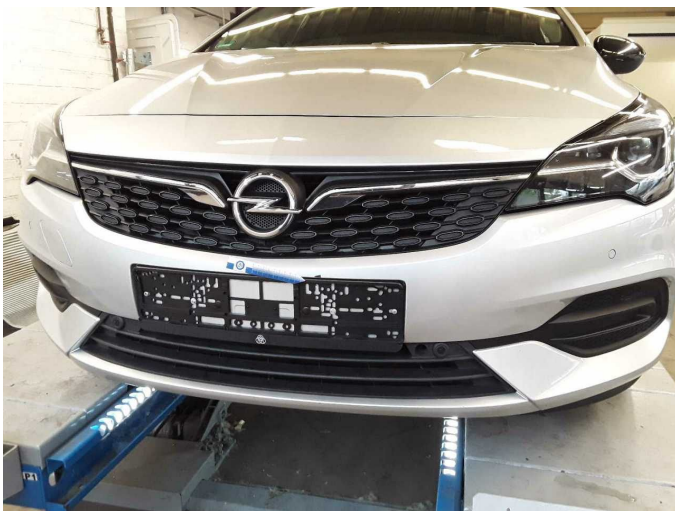
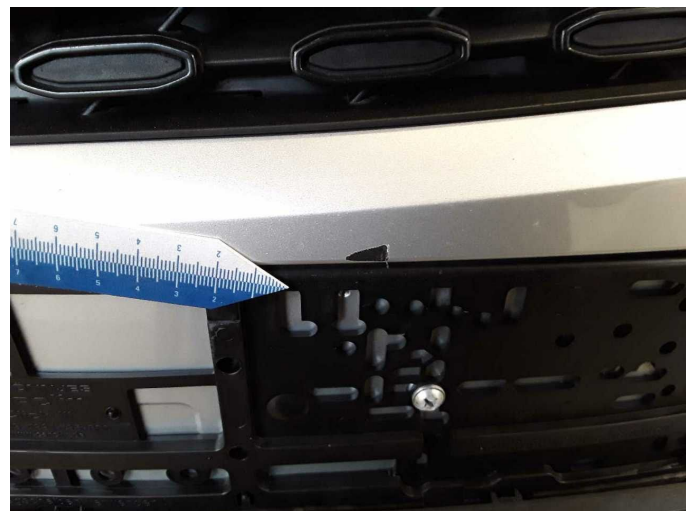
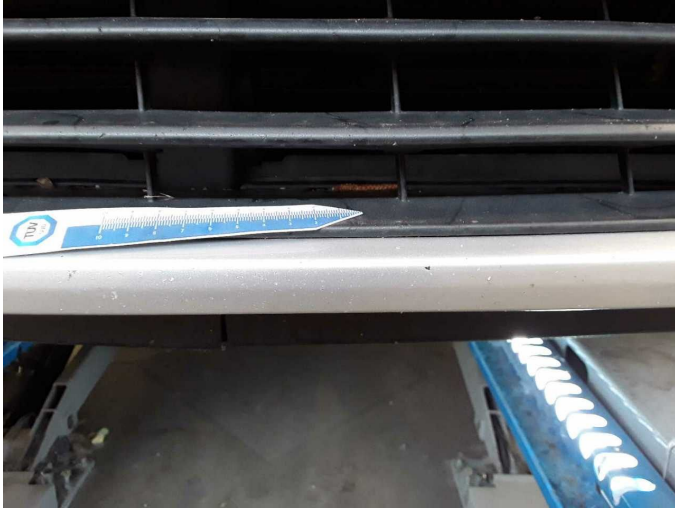
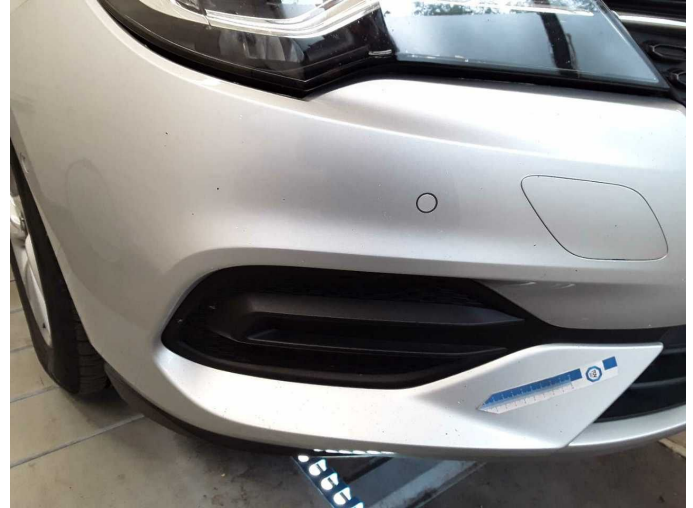
| No. | Component group | Description |
|---|---|---|
| 5 | Front bumper | Front bumper - Scratch(es) - Paint |

**Damage 5:** Front bumper: Front bumper - Scratch(es) - Paint

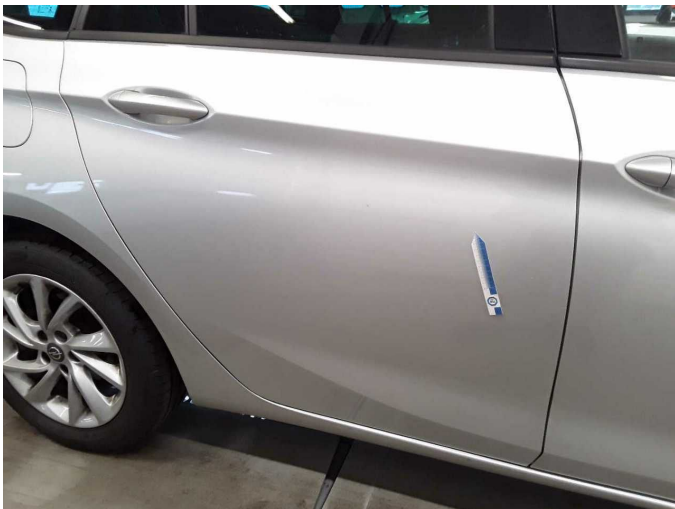
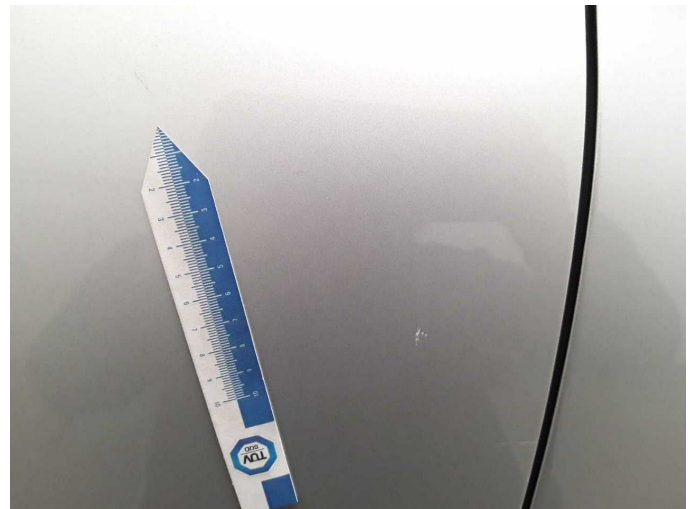
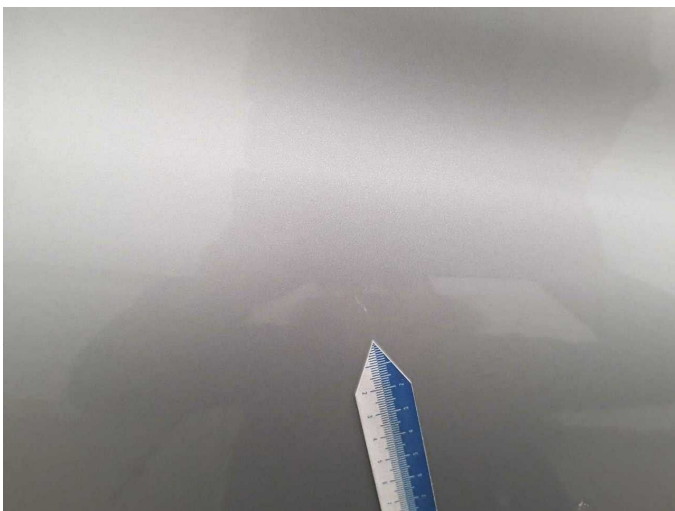
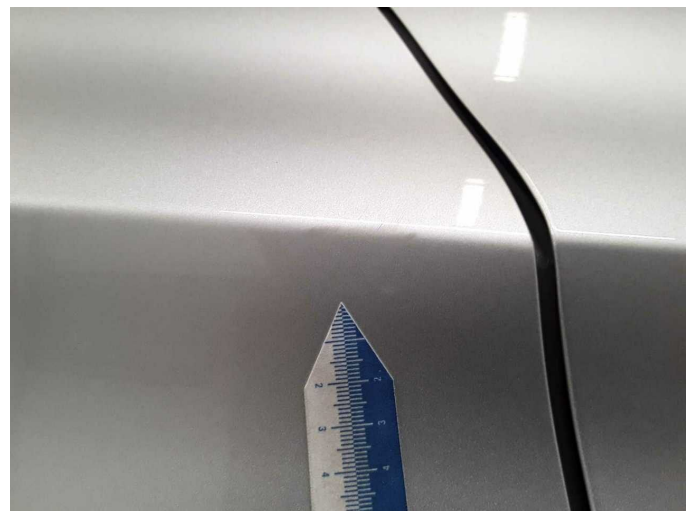
| No. | Component group | Description |
|---|---|---|
| 6 | Door - rear right side | Door - Scratch(es) - Paint |

**Damage 6:** Door - rear right side: Door - Scratch(es) - Paint

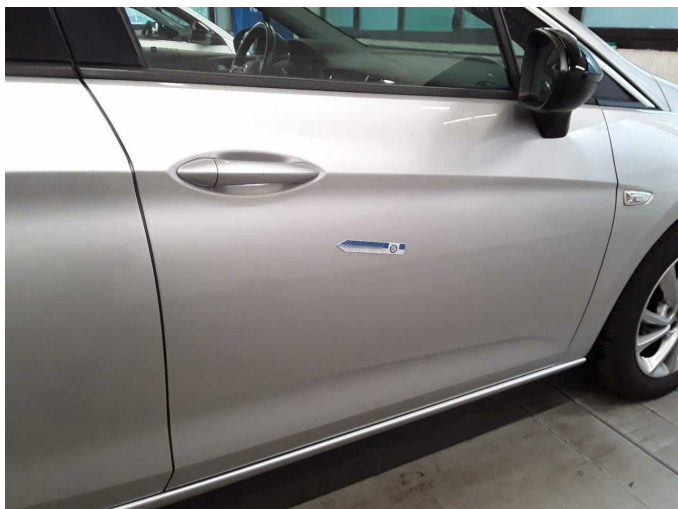
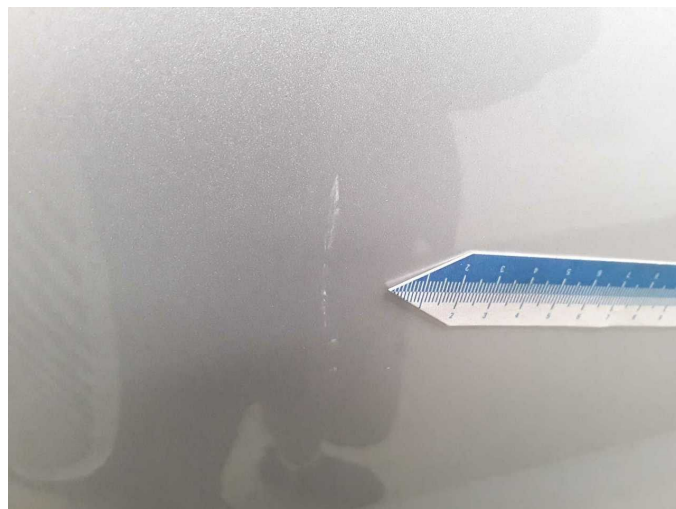
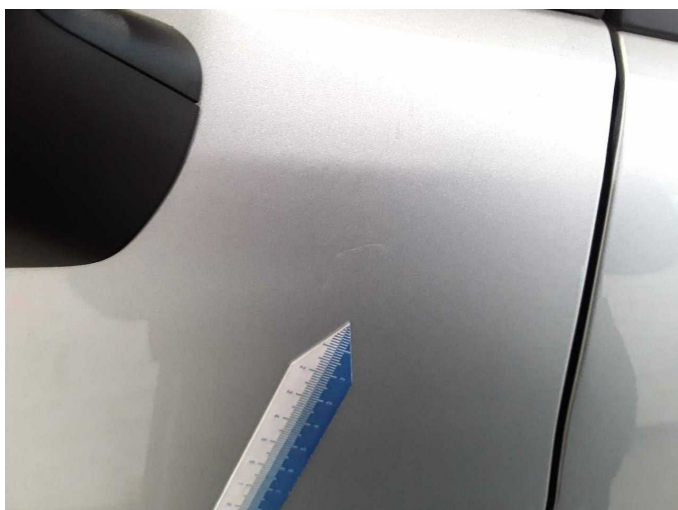
| No. | Component group | Description |
|---|---|---|
| 7 | Door - front right side | Door - Scratch(es) - Paint |

**Damage 7:** Door - front right side: Door - Scratch(es) - Paint

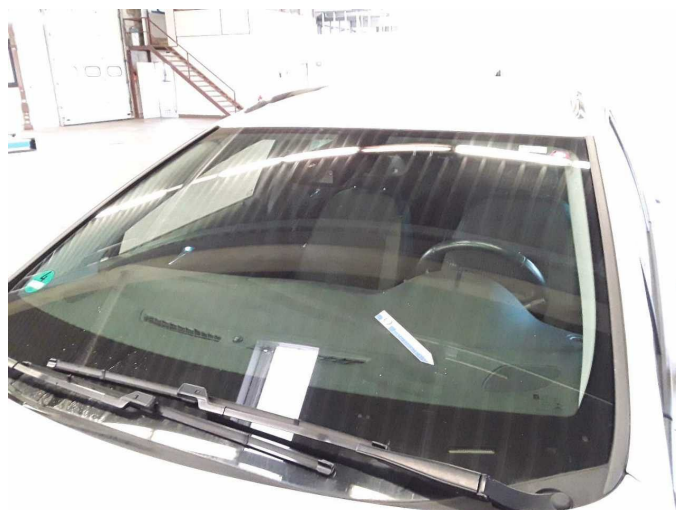
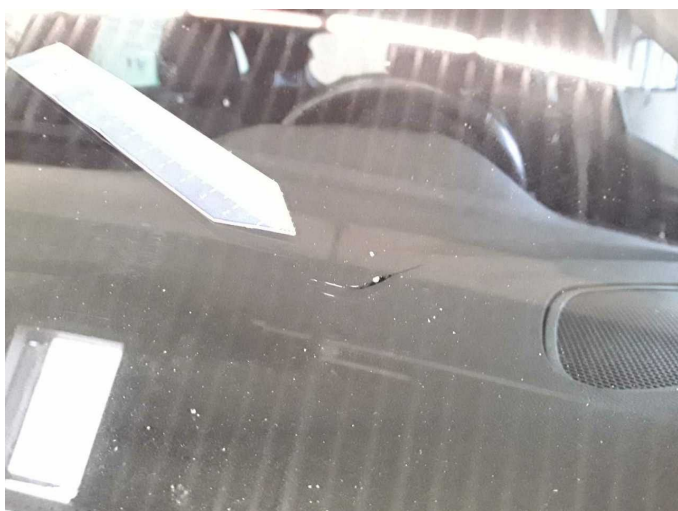
| No. | Component group | Description |
|---|---|---|
| 8 | Vehicle glazing | Windscreen (Mit Rissbildung im Fahrersichtfeld) - Stone chips - Replace |

**Damage 8:** Vehicle glazing: Windscreen (Mit Rissbildung im Fahrersichtfeld) - Stone chips - Replace

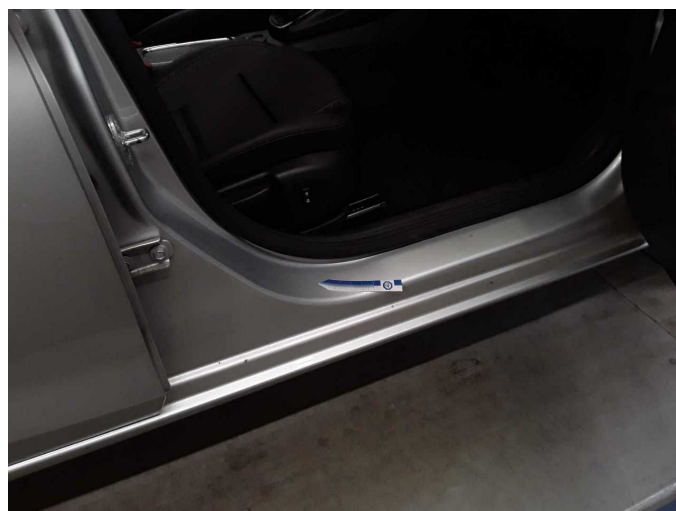
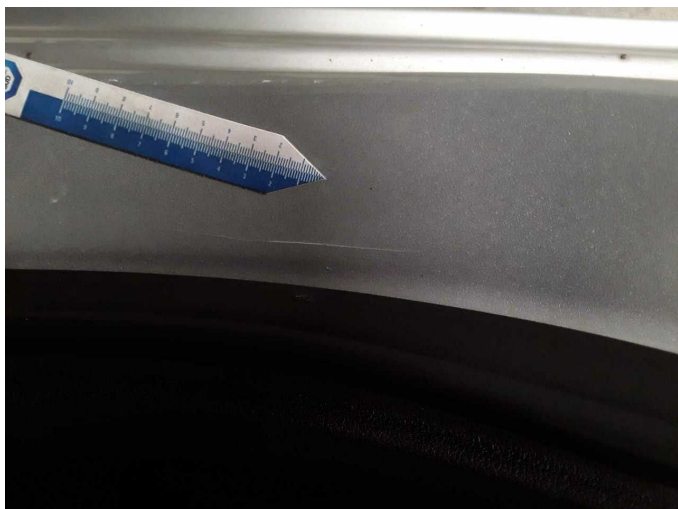
| No. | Component group | Description |
|---|---|---|
| 1 | Sill - right side | Sill - Scratch(es) - No deduction |

**Wear and tear 1:** Sill - right side: Sill - Scratch(es) - No deduction

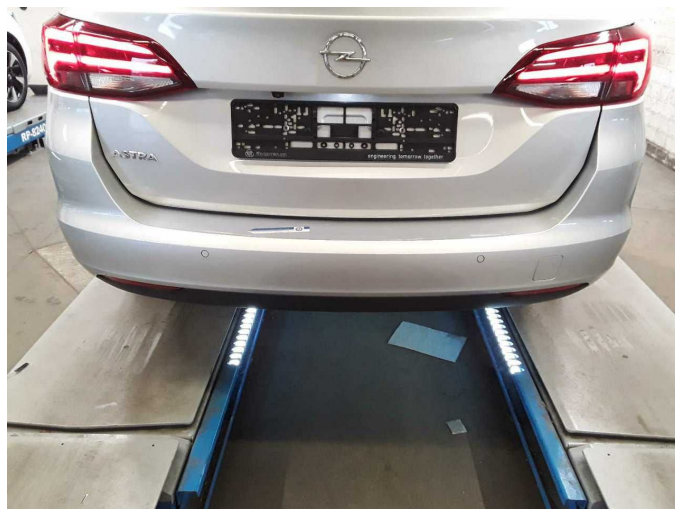
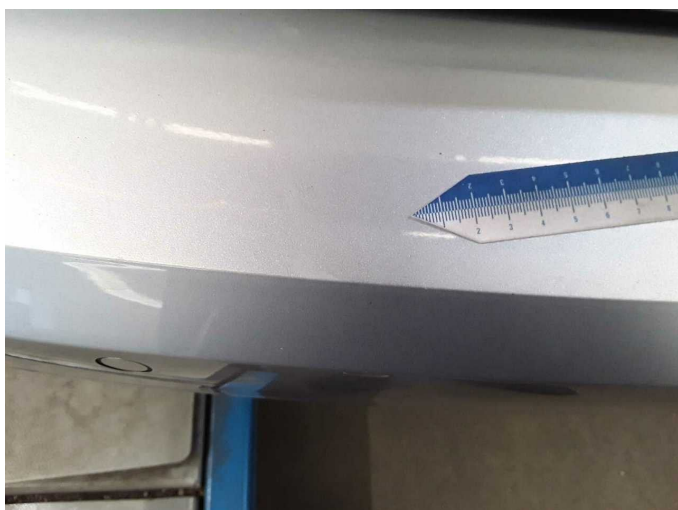
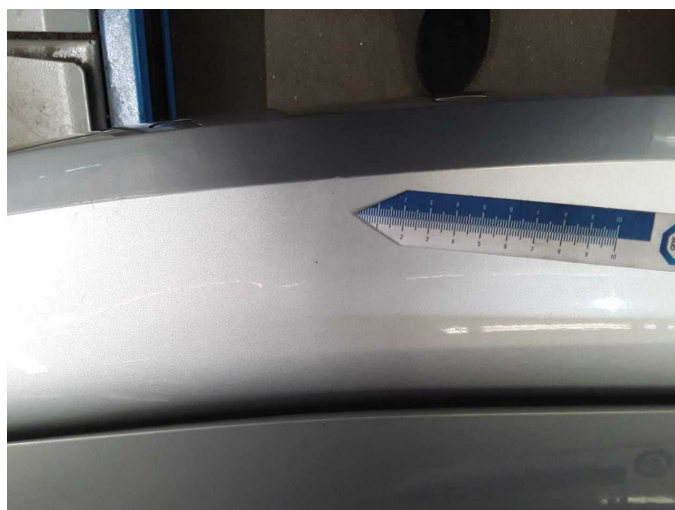
| No. | Component group | Description |
|---|---|---|
| 2 | Rear bumper | Rear bumper - Scratch(es) - No deduction |

**Wear and tear 2:** Rear bumper: Rear bumper - Scratch(es) - No deduction

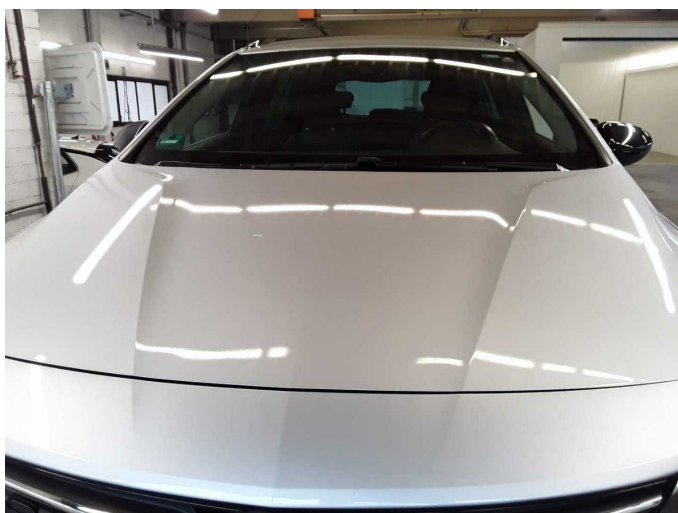
| No. | Component group | Description |
|---|---|---|
| 3 | Bonnet | Bonnet - Stone chips - No deduction |

**Wear and tear 3:** Bonnet: Bonnet - Stone chips - No deduction

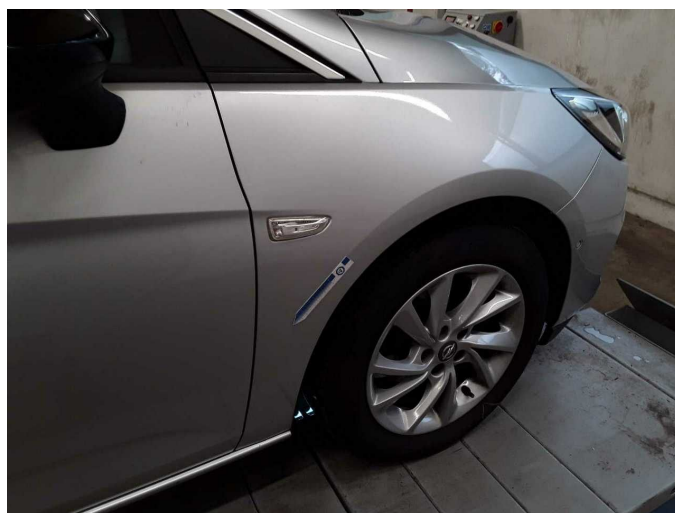
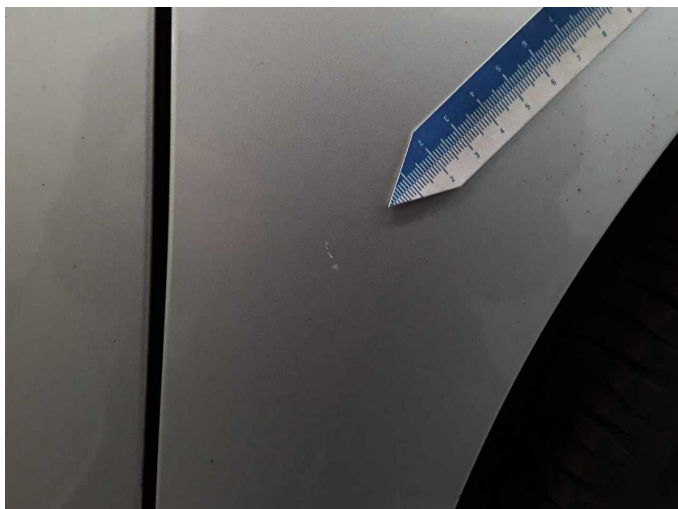
| No. | Component group | Description |
|---|---|---|
| 4 | Mudguard - right side | Mudguard - right side - Scratch(es) - No deduction |

**Wear and tear 4:** Mudguard - right side: Mudguard - right side - Scratch(es) - No deduction

**Wear and tear 4:** Mudguard - right side: Mudguard - right side -  
Scratch(es) - No deduction
