Expertise

Protocol number: 46373607  
Order No. / Reference: 26445539  
Inspection date: 7 Jul 2026

Manufacturer: Ford

Model: S-Max 2.0 EcoBlue Aut. TITANIUM

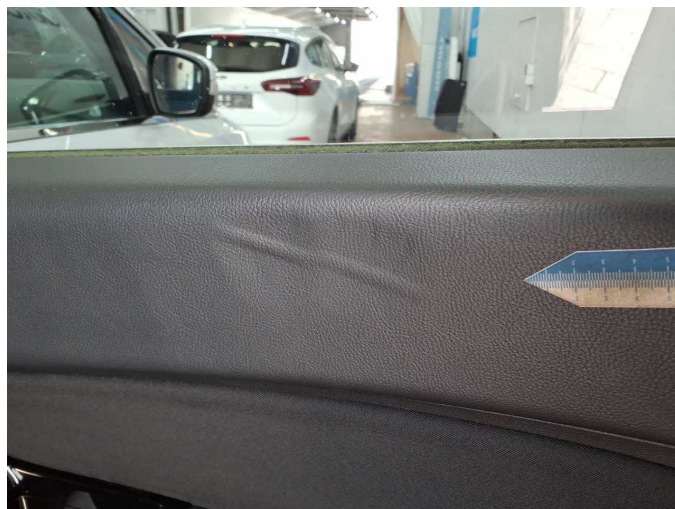
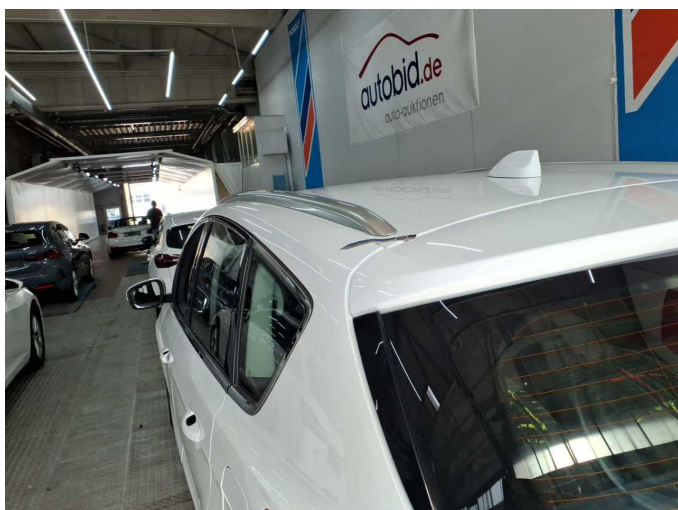
| No. | Component group | Description |
|---|---|---|
| 4 | Trim / covers | Door trim - rear right side - Deformed - Loss in value |

**Damage 4:** Trim / covers: Door trim - rear right side - Deformed - Loss in value

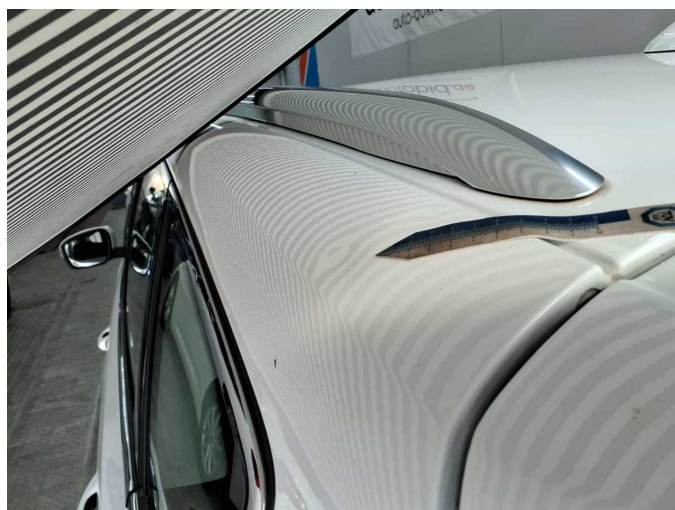
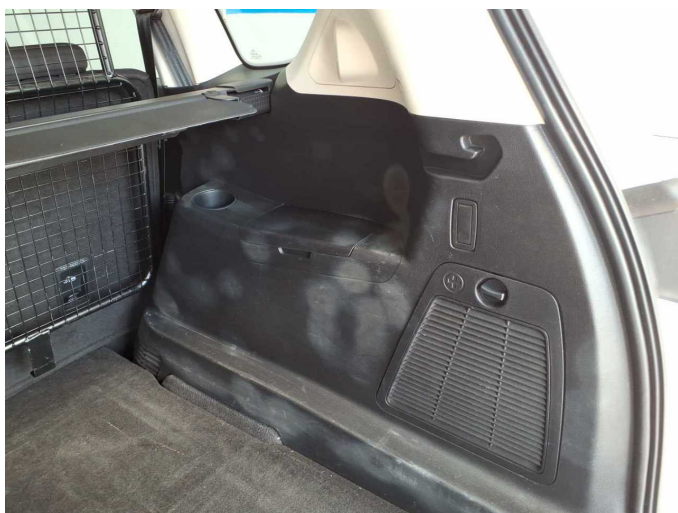
| No. | Component group | Description |
|---|---|---|
| 5 | Roof | Roof rail - left side - dent(s) - Smart repair |

**Damage 5:** Roof: Roof rail - left side - dent(s) - Smart repair

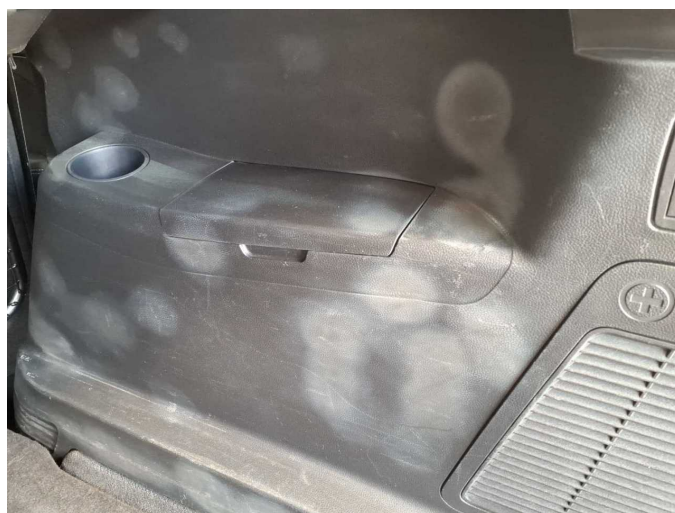
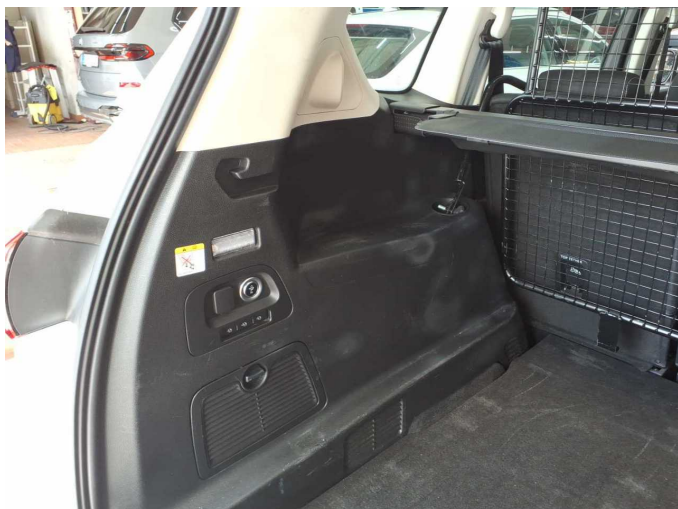
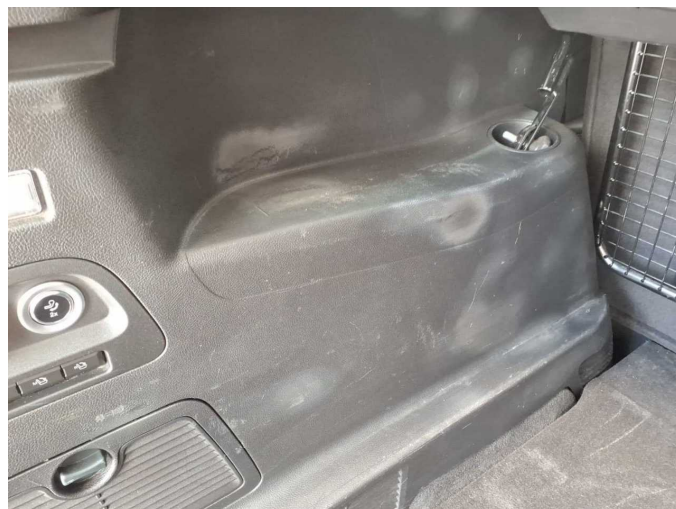
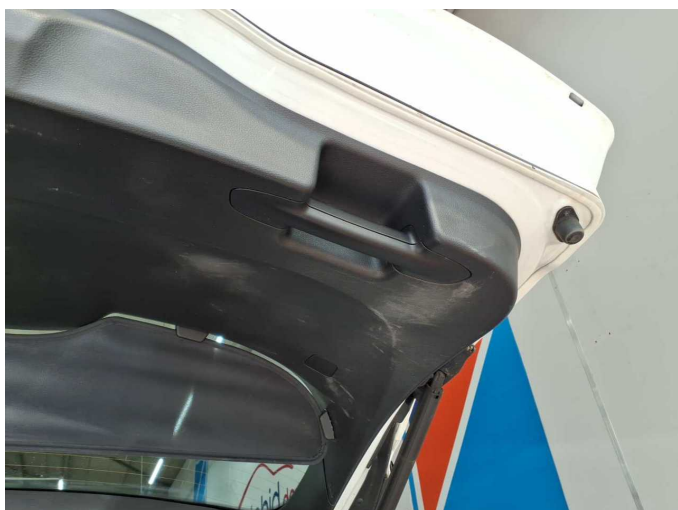
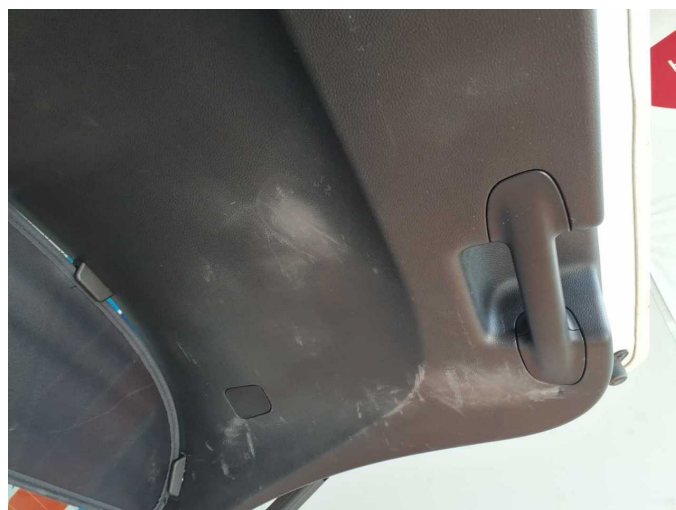
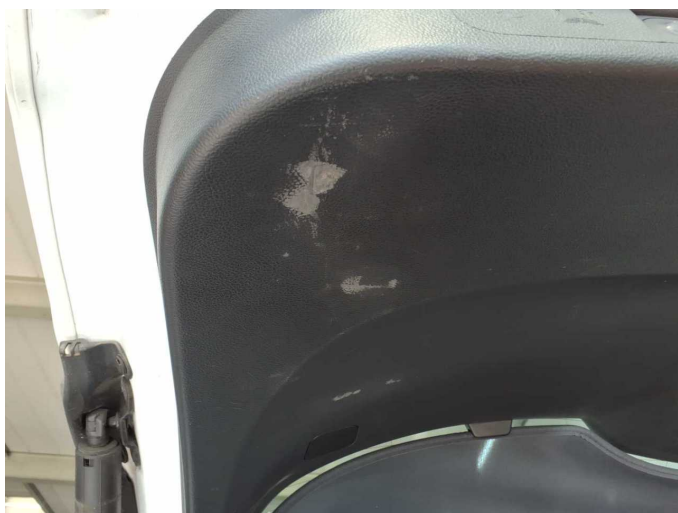
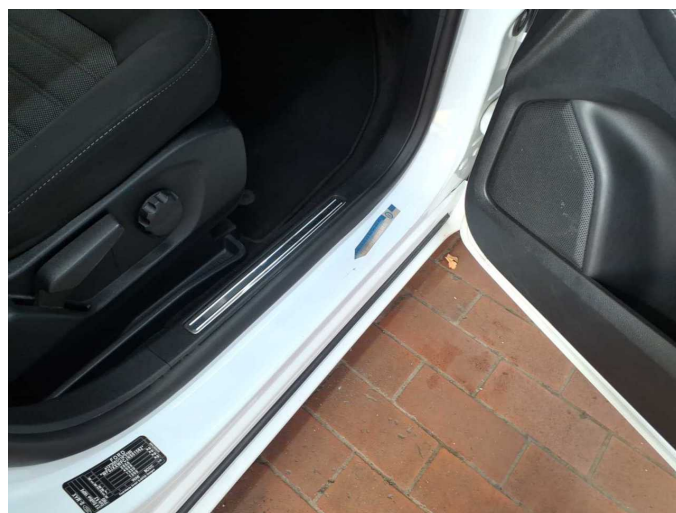
| No. | Component group | Description |
|---|---|---|
| 6 | Interior | Interior (Mit Abfärbungen) - Scratch(es) - Loss in value |

**Damage 6:** Interior: Interior (Mit Abfärbungen) - Scratch(es) - Loss in value

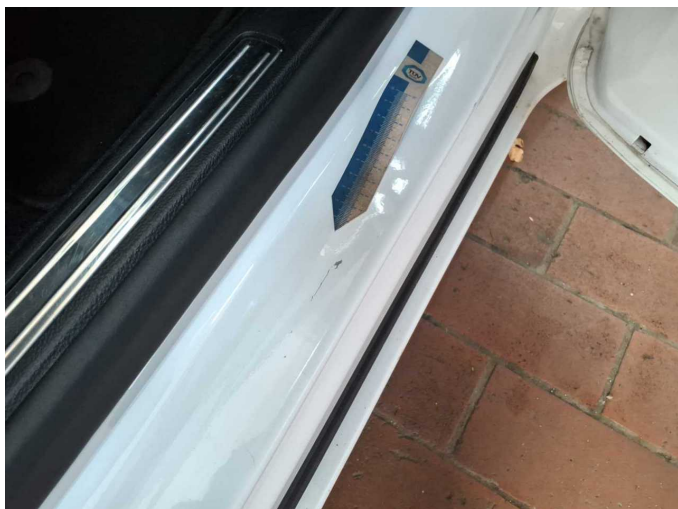
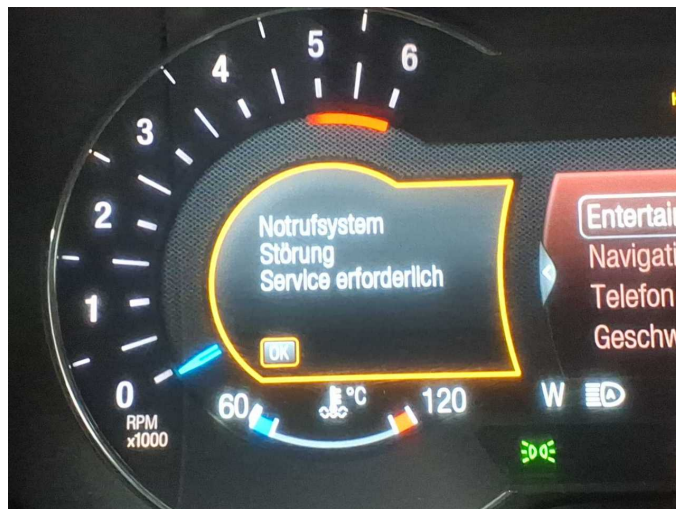
| No. | Component group | Description |
|---|---|---|
| 7 | Sill - right side | Sill - Scratch(es) - Smart repair |

**Damage 7:** Sill - right side: Sill - Scratch(es) - Smart repair

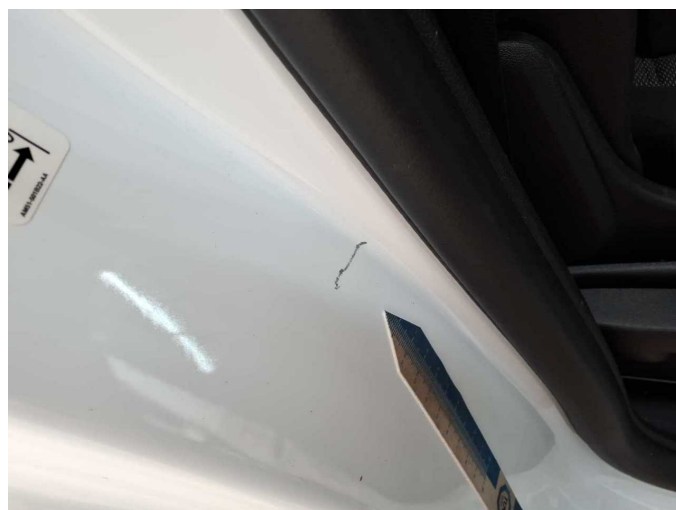
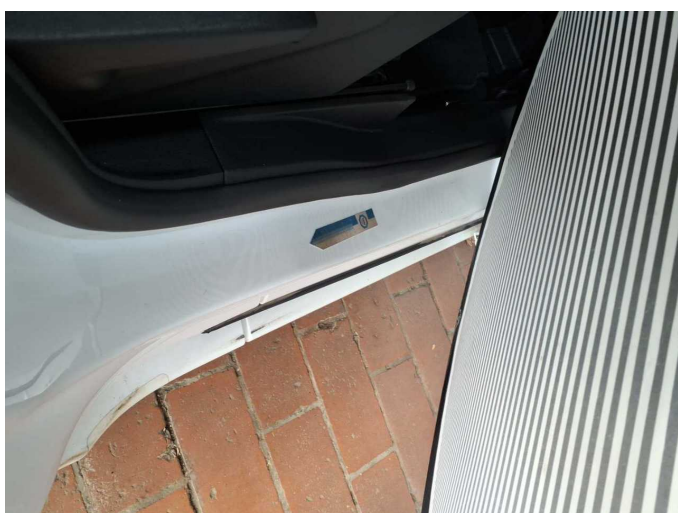
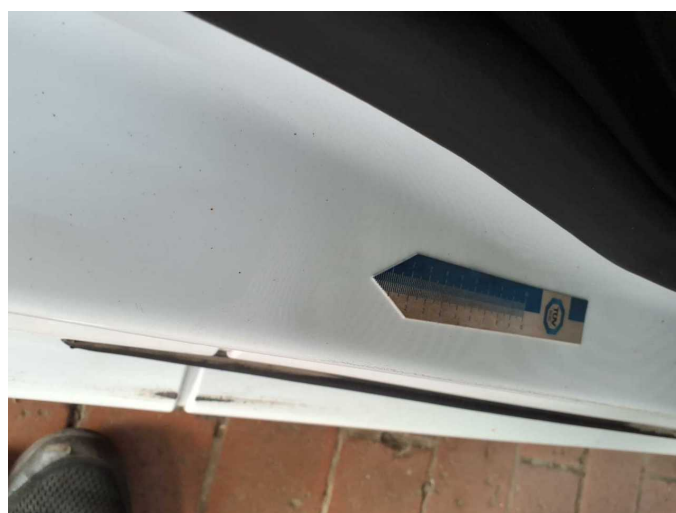
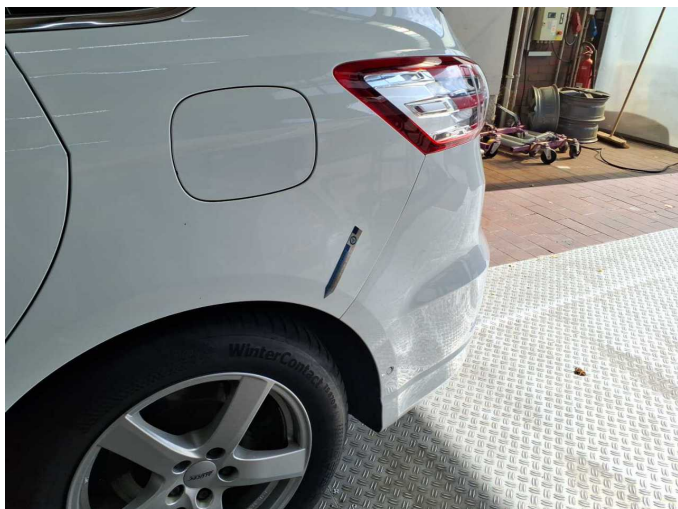
| No. | Component group | Description |
|---|---|---|
| 9 | Side panel - rear right side | Sill (Mit Dellen) - Scratch(es) - Smart repair |

**Damage 9:** Side panel - rear right side: Sill (Mit Dellen) - Scratch(es) - Smart repair

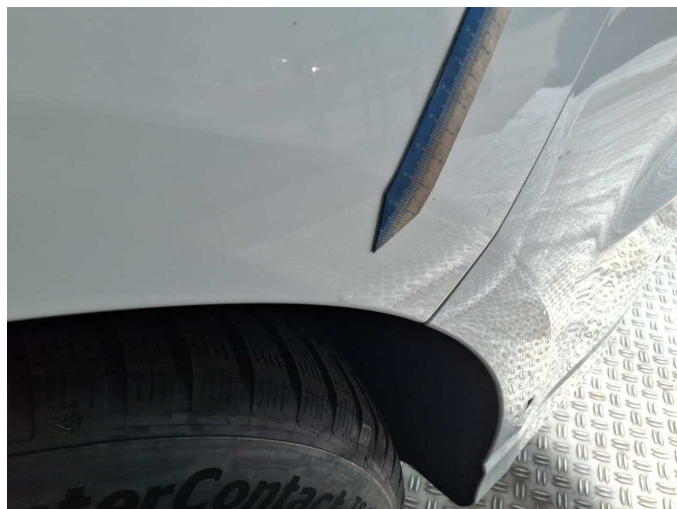
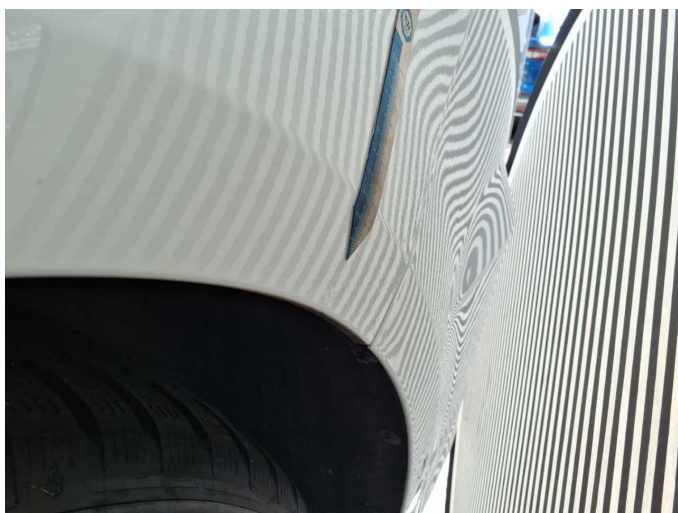
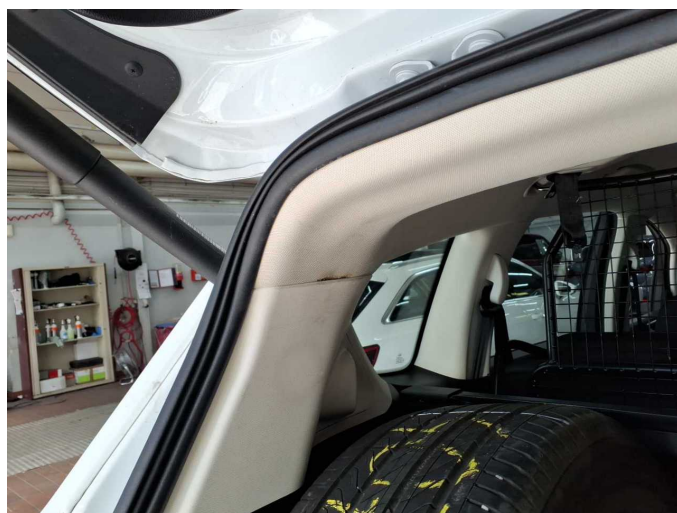
| No. | Component group | Description |
|---|---|---|
| 10 | Side panel - rear left side | Side panel - Corrosion - Smart repair |

**Damage 10:** Side panel - rear left side: Side panel - Corrosion - Smart repair

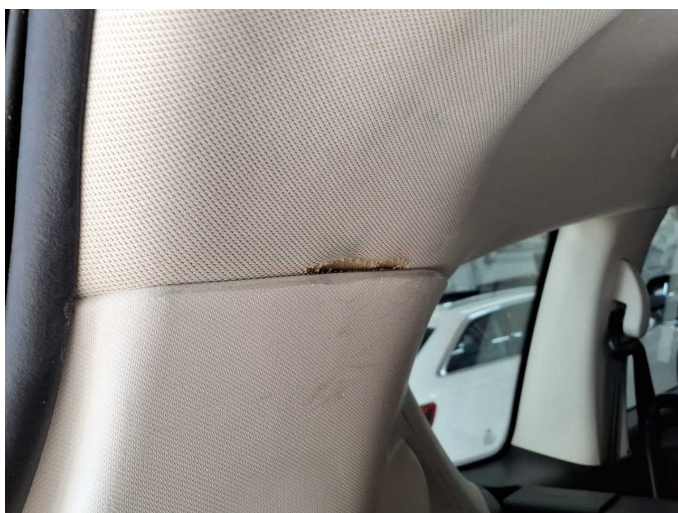
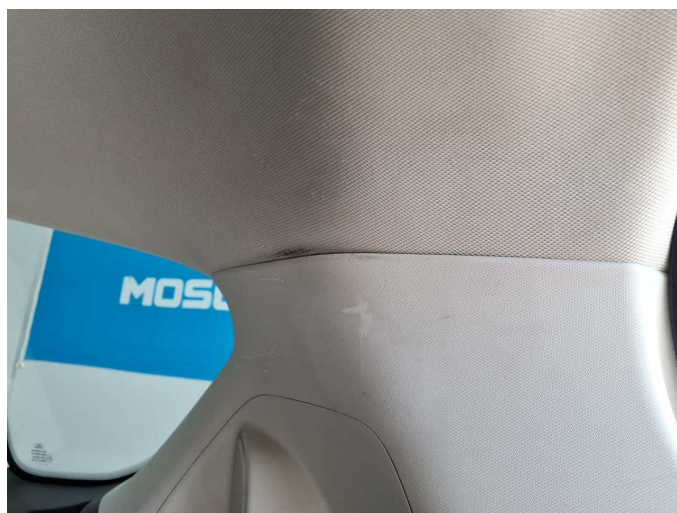
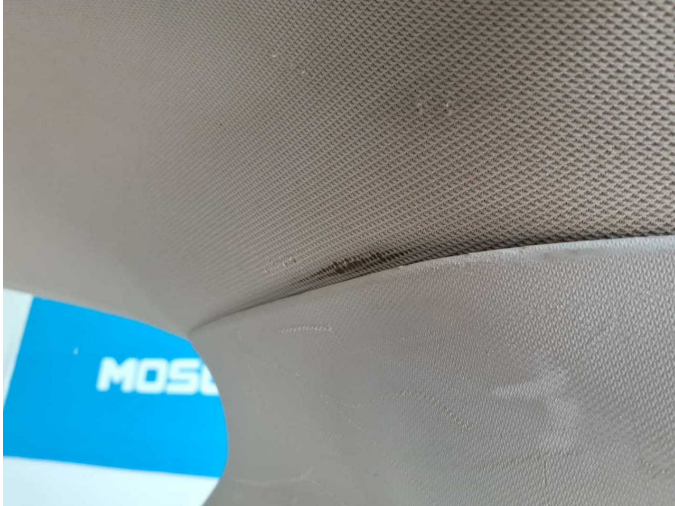
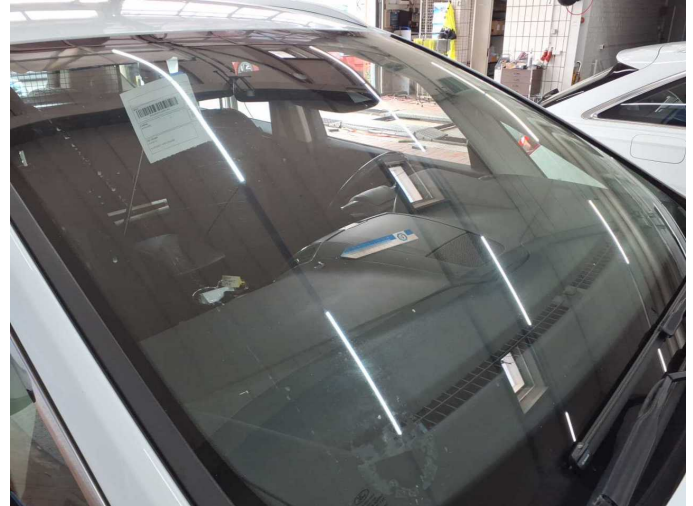
| No. | Component group | Description |
|---|---|---|
| 11 | Trim / covers | Roof lining - Broken / torn - Replace |

**Damage 11:** Trim / covers: Roof lining - Broken / torn - Replace

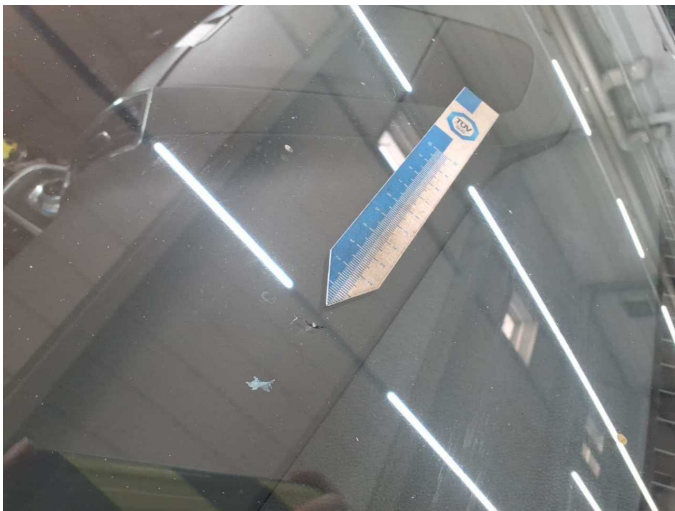
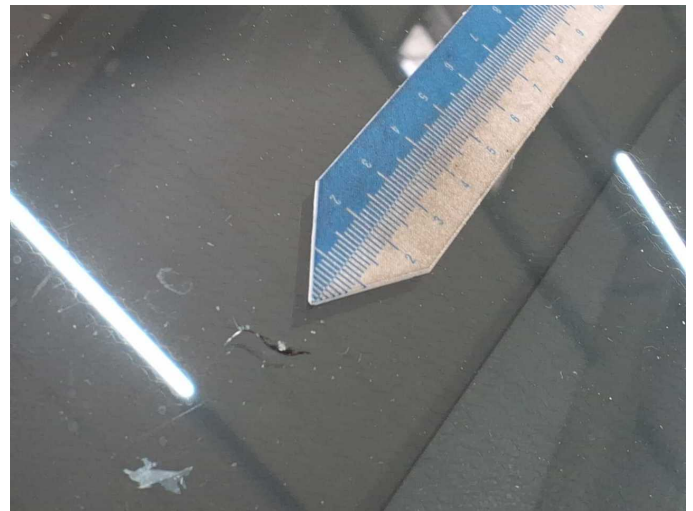
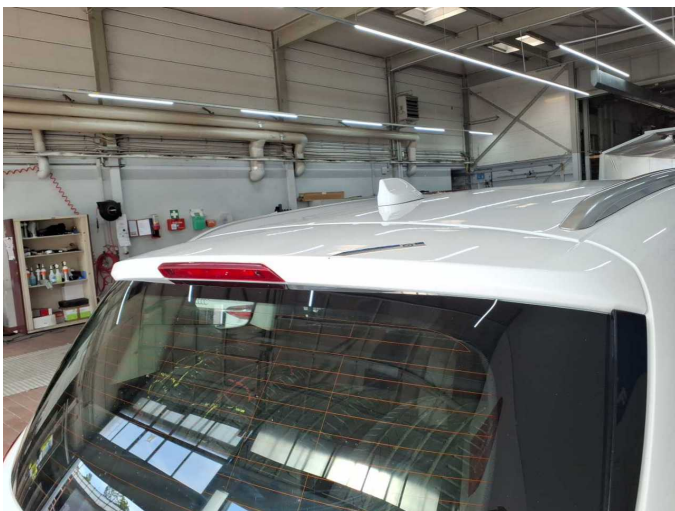
| No. | Component group | Description |
|---|---|---|
| 12 | Vehicle glazing | Windscreen - Stone chips - repair according to calculation |

**Damage 12:** Vehicle glazing: Windscreen - Stone chips - repair according to calculation

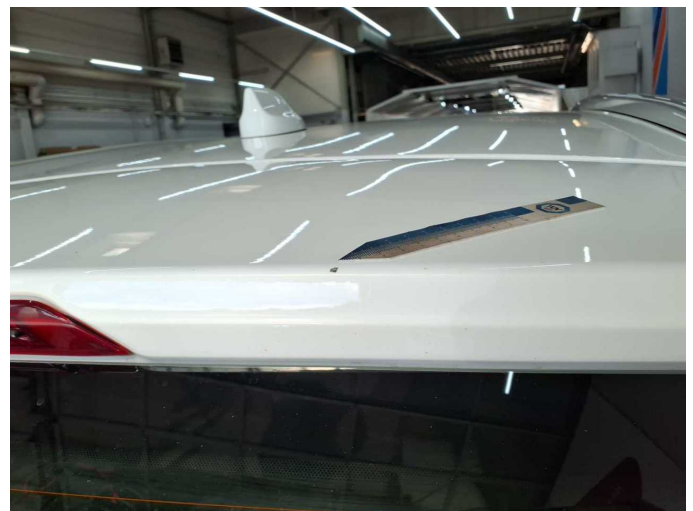
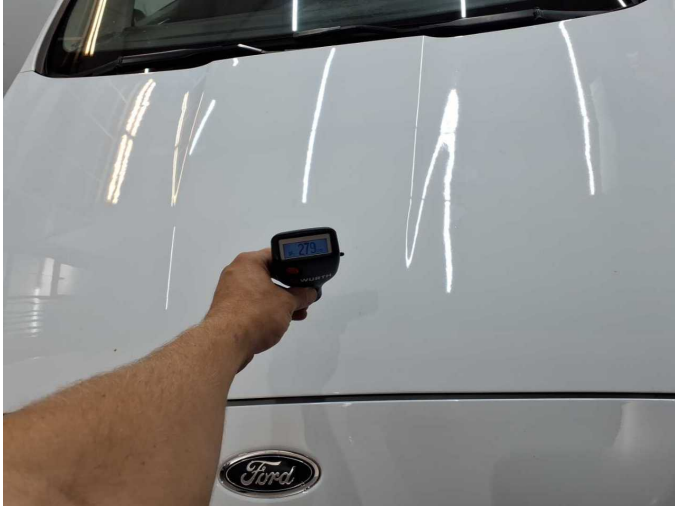
| No. | Component group | Description |
|---|---|---|
| 4 | Boot lid / rear door | Rear spoiler - Scratch(es) - Smart repair |

**Wear and tear 4:** Boot lid / rear door: Rear spoiler - Scratch(es) - Smart repair

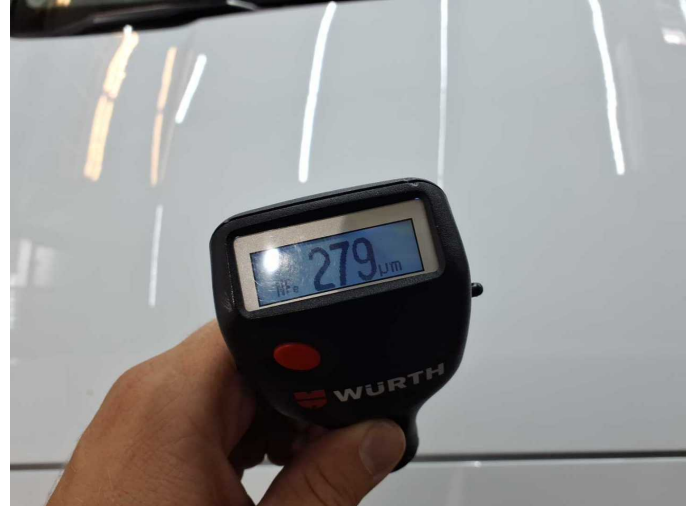
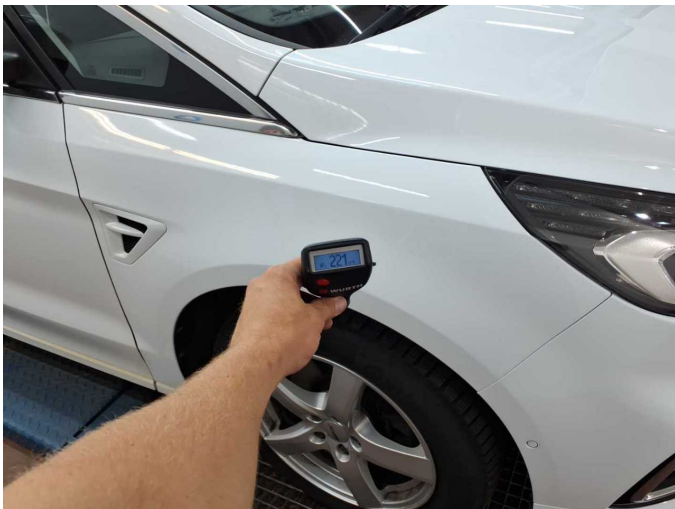
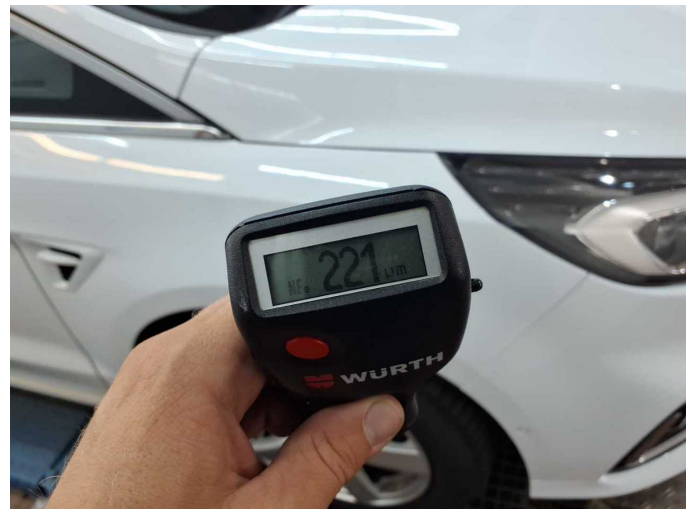
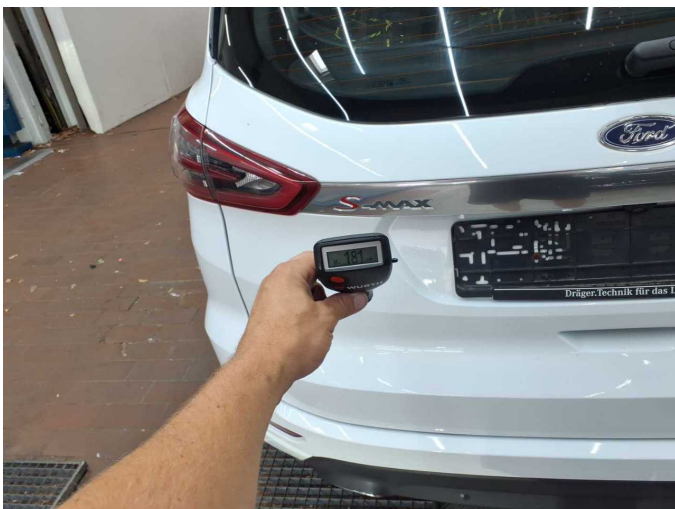
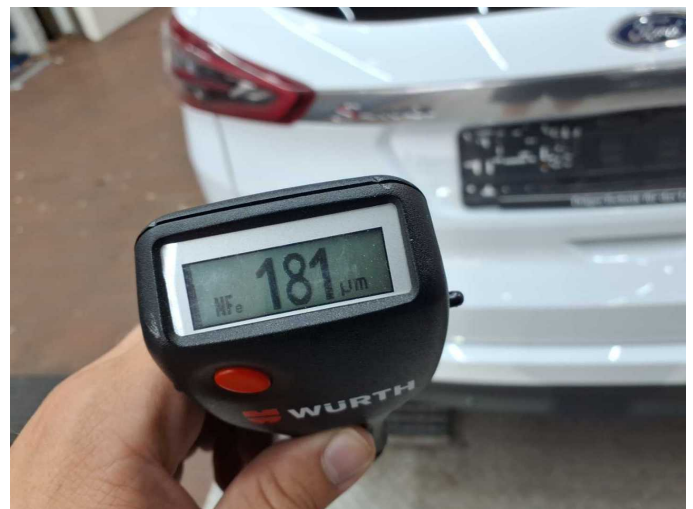
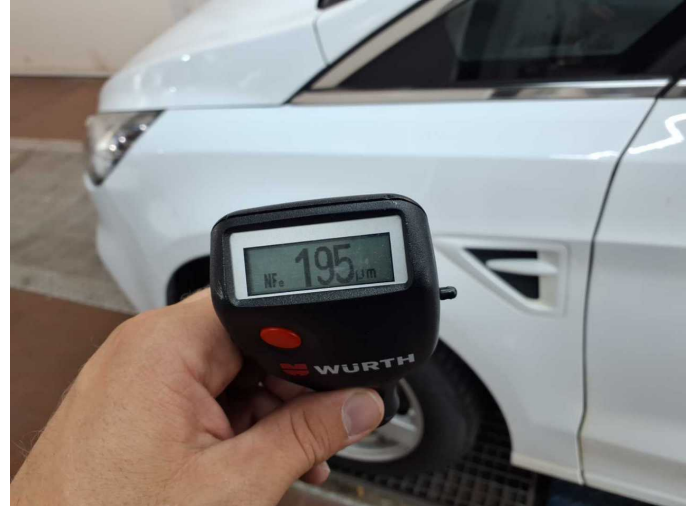
1 Boot lid / rear door, Mudguard - left side, Mudguard - right side, Bonnet, Professionally carried out, Invoice of repair done Non-existent

| Boot lid / rear door | 181 µm | Mudguard - left side | 195 µm |
| Mudguard - right side | 221 µm | Bonnet | 279 µm |

**Repainting 1:** Boot lid / rear door, Mudguard - left side, Mudguard - right side, Bonnet
