Expertise

Protocol number: 46320684
Order No. / Reference: 26503667
Inspection date: 3 Jul 2026

Model: Octavia Combi 2.0 TDI DSG Style

VIN: TMBJJ0NX4PY100671

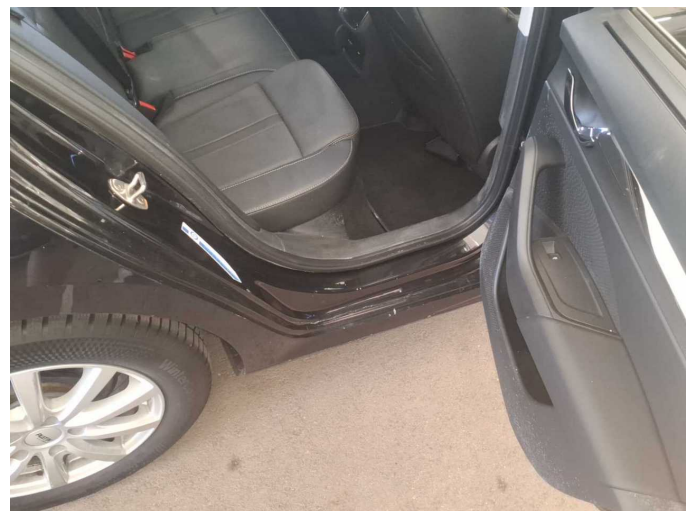
| No. | Component group | Description |
|---|---|--|
| 1 | Side panel - rear right side | Sill - Scratch(es) - Smart repair |

Damage 1: Side panel - rear right side: Sill - Scratch(es) - Smart repair

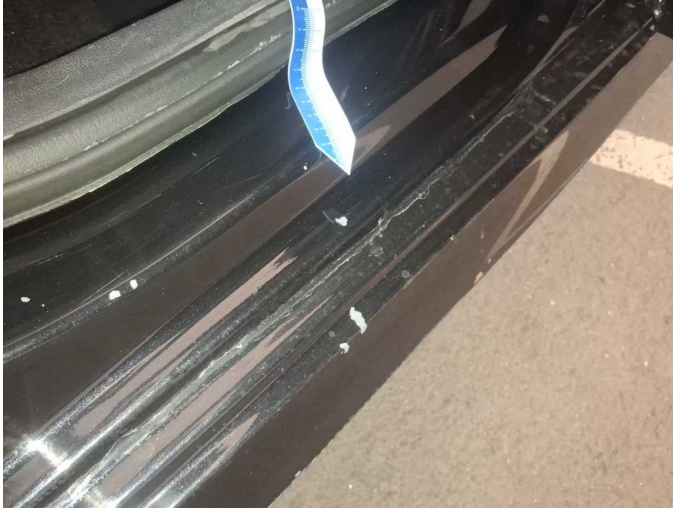
Damage 1: Side panel - rear right side: Sill - Scratch(es) - Smart repair

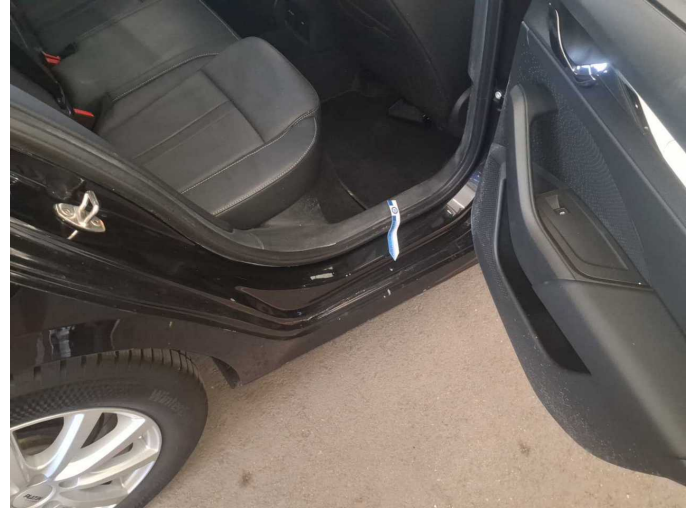
Damage 1: Side panel - rear right side: Sill - Scratch(es) - Smart repair

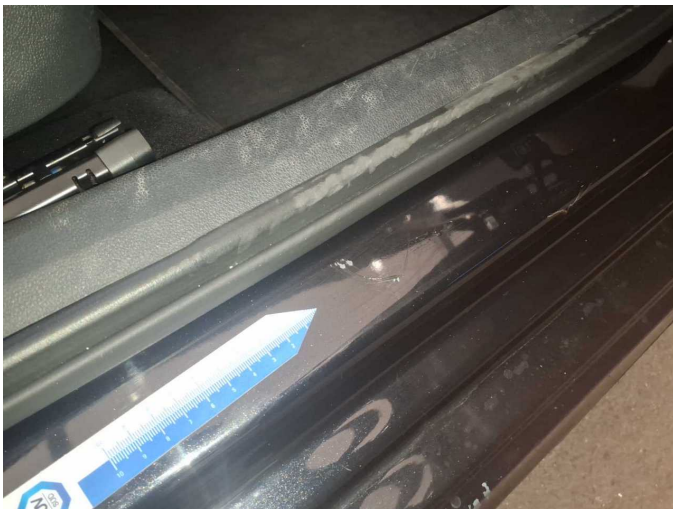
Damage 1: Side panel - rear right side: Sill - Scratch(es) - Smart repair

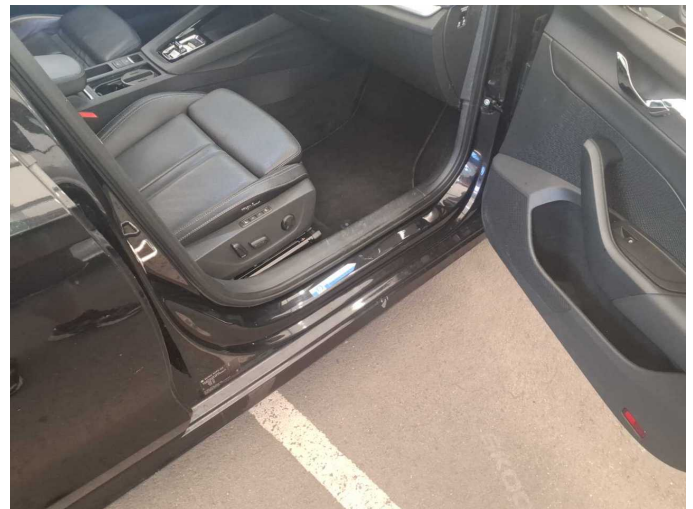
| No. | Component group | Description |
|---|---|--|
| 2 | Sill - right side | Sill - Scratch(es) - Smart repair |

Damage 2: Sill - right side: Sill - Scratch(es) - Smart repair

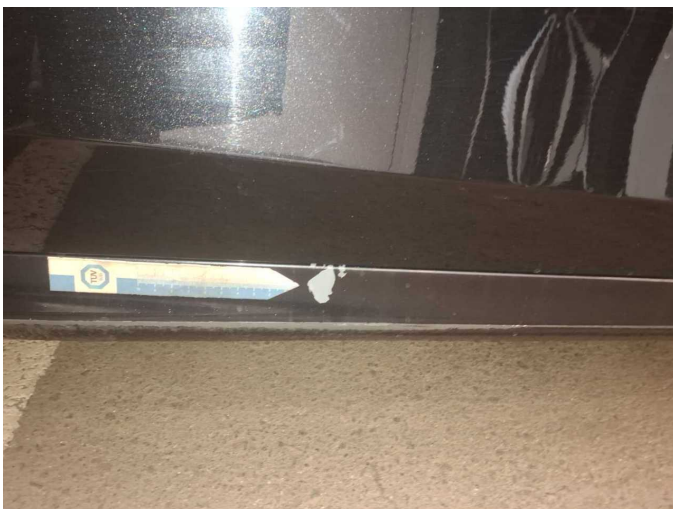
Damage 2: Sill - right side: Sill - Scratch(es) - Smart repair

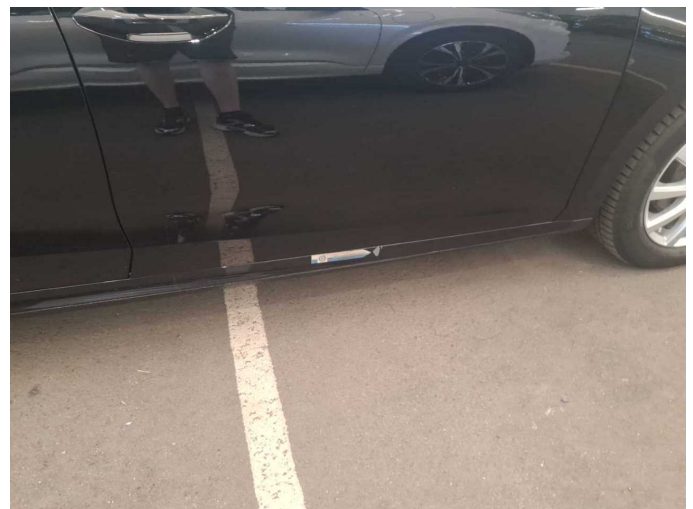
| No. | Component group | Description |
|---|---|--|
| 3 | Sill - right side | Sill - Paint defect - Repair and paint |

Damage 3: Sill - right side: Sill - Paint defect - Repair and paint

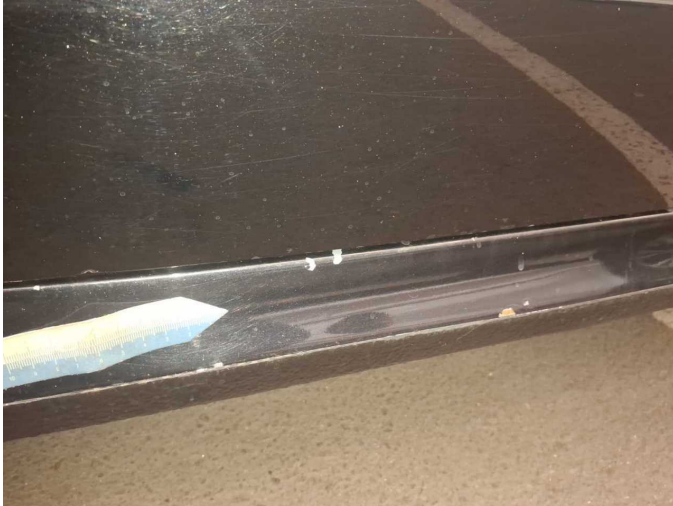
Damage 3: Sill - right side: Sill - Paint defect - Repair and paint

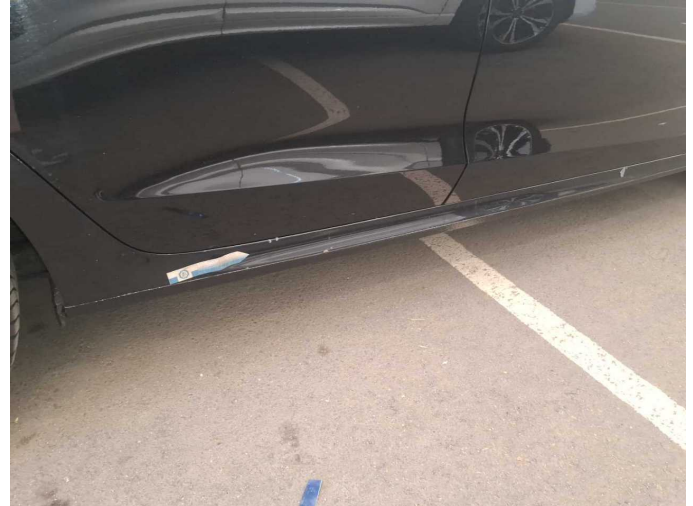
Damage 3: Sill - right side: Sill - Paint defect - Repair and paint

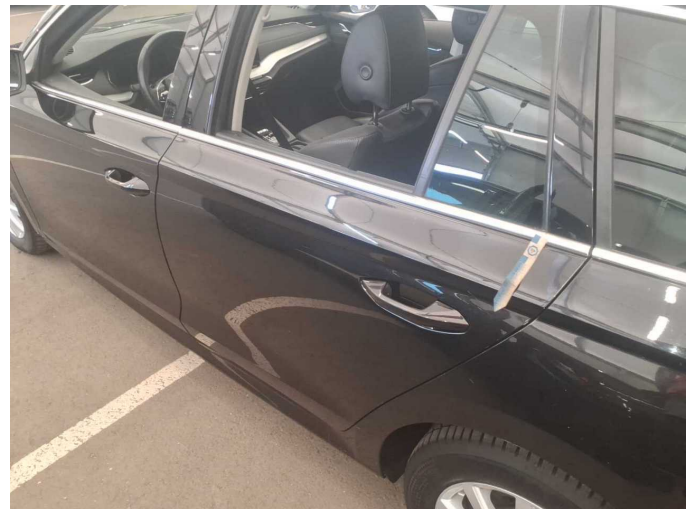
| No. | Component group | Description |
|---|---|--|
| 4 | Door - rear left side | Door - Scratch(es) - Paint |

Damage 4: Door - rear left side: Door - Scratch(es) - Paint

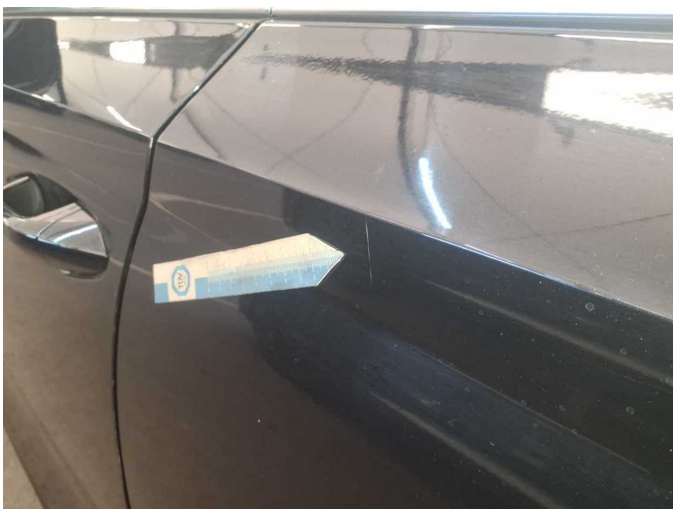
Damage 4: Door - rear left side: Door - Scratch(es) - Paint

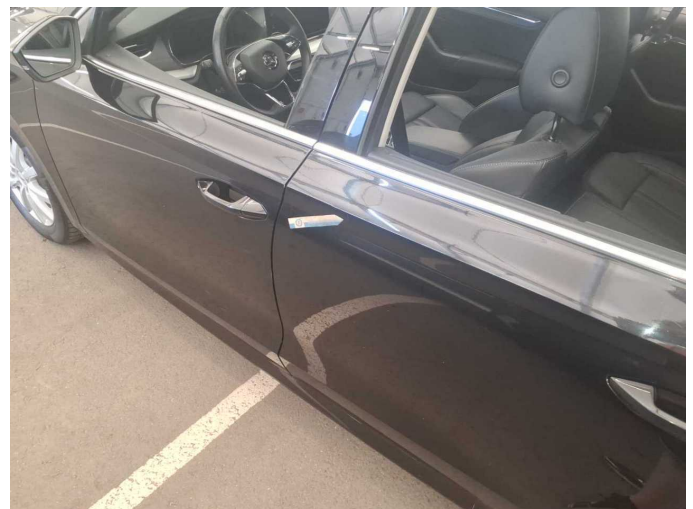
Damage 4: Door - rear left side: Door - Scratch(es) - Paint

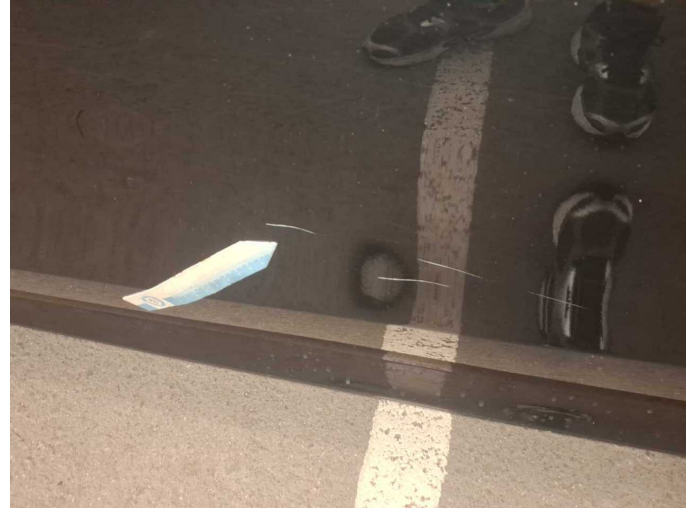
| No. | Component group | Description |
|---|---|--|
| 5 | Door - front left side | Door - Scratch(es) - Paint |

Damage 5: Door - front left side: Door - Scratch(es) - Paint

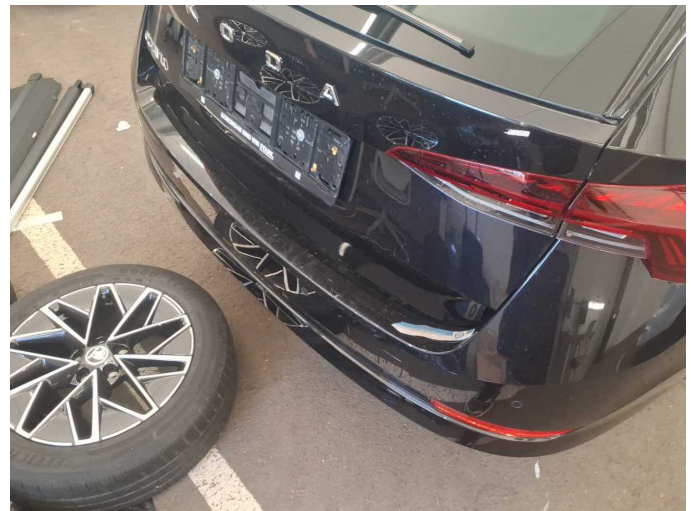
| No. | Component group | Description |
|---|---|--|
| 6 | Rear bumper | Rear bumper - Scratched - Paint |

Damage 6: Rear bumper: Rear bumper - Scratched - Paint

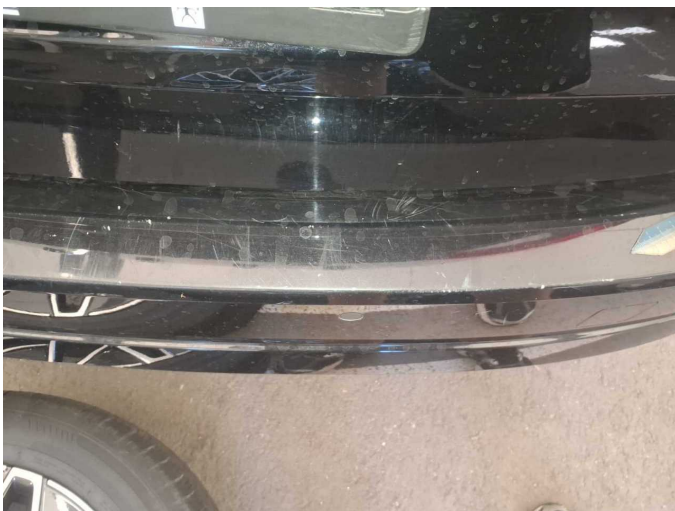
Damage 6: Rear bumper: Rear bumper - Scratched - Paint

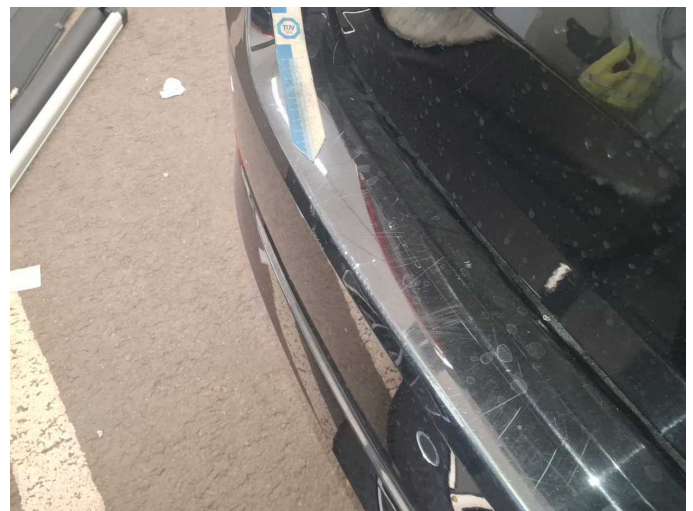
Damage 6: Rear bumper: Rear bumper - Scratched - Paint

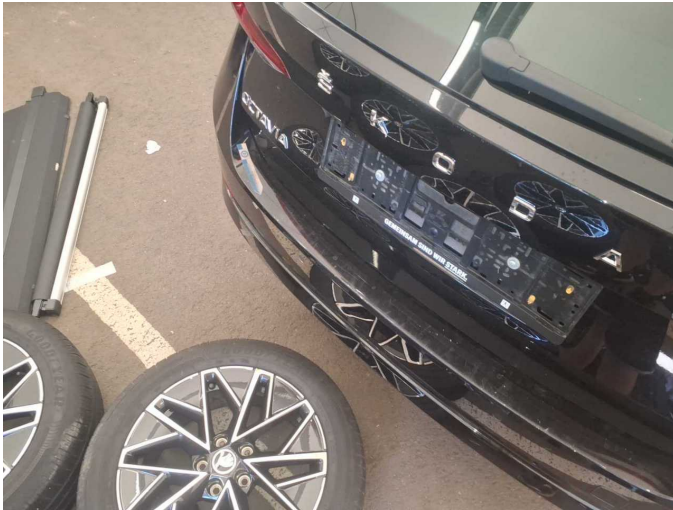
Damage 6: Rear bumper: Rear bumper - Scratched - Paint

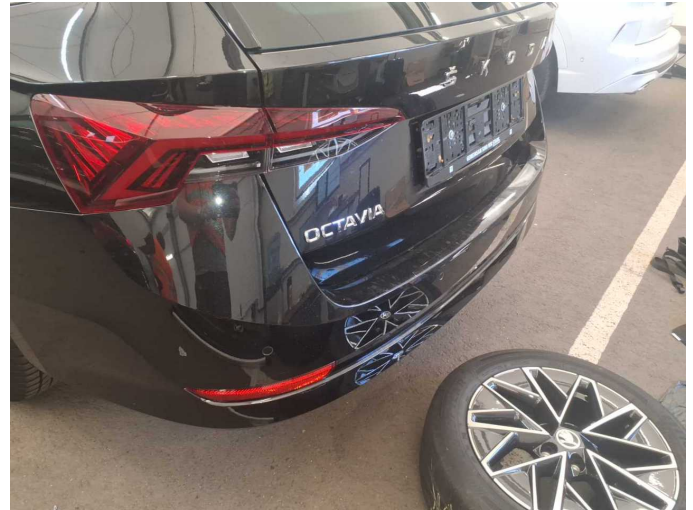
Damage 6: Rear bumper: Rear bumper - Scratched - Paint

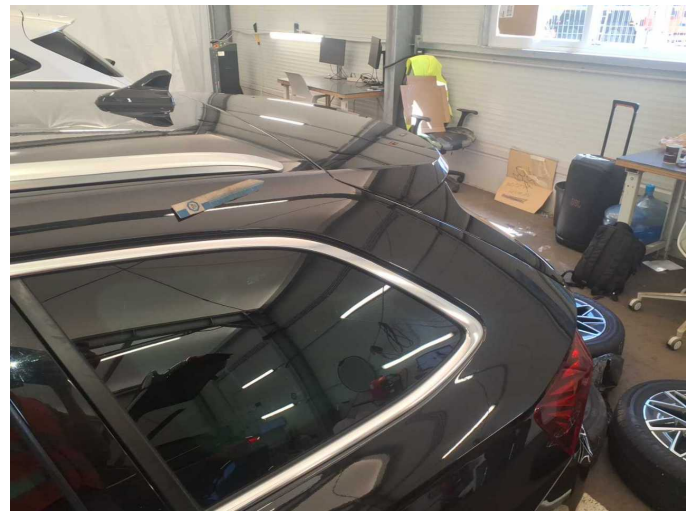
| No. | Component group | Description |
|---|---|--|
| 7 | Side panel - rear left side | Side panel - Scratch(es) - Paint |

Damage 7: Side panel - rear left side: Side panel - Scratch(es) - Paint

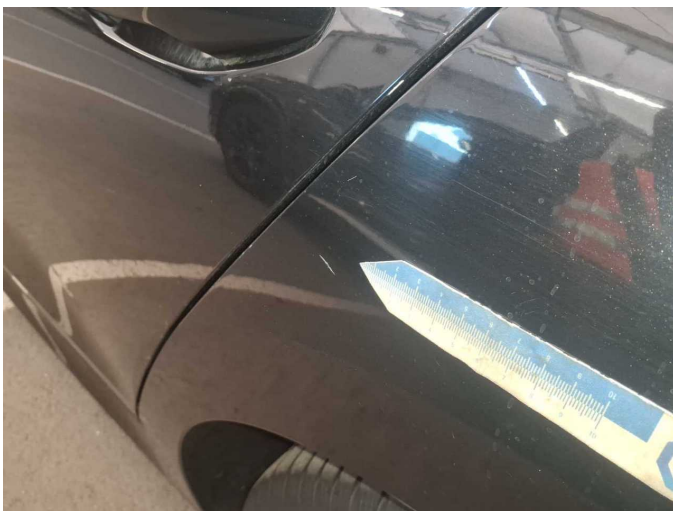
Damage 7: Side panel - rear left side: Side panel - Scratch(es) - Paint

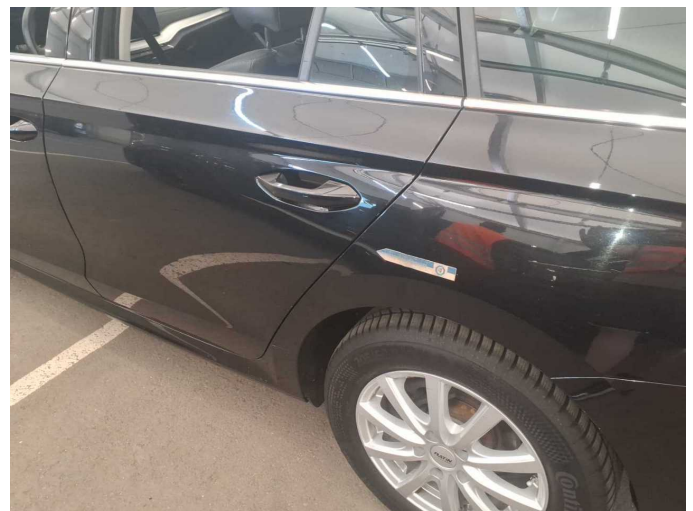
Damage 7: Side panel - rear left side: Side panel - Scratch(es) - Paint

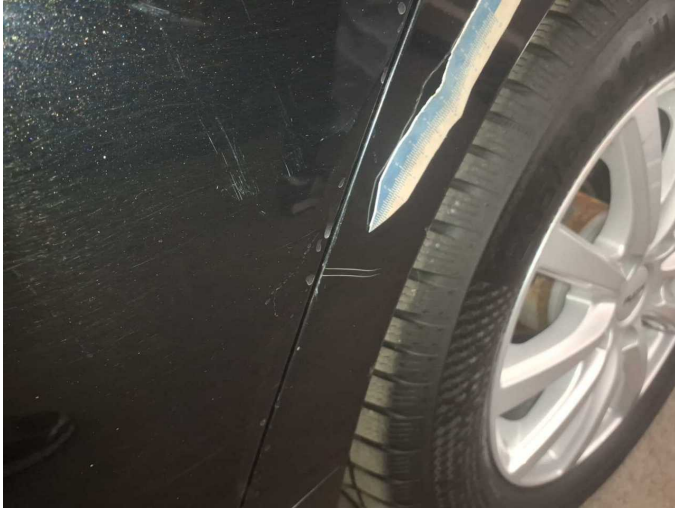
Damage 7: Side panel - rear left side: Side panel - Scratch(es) - Paint

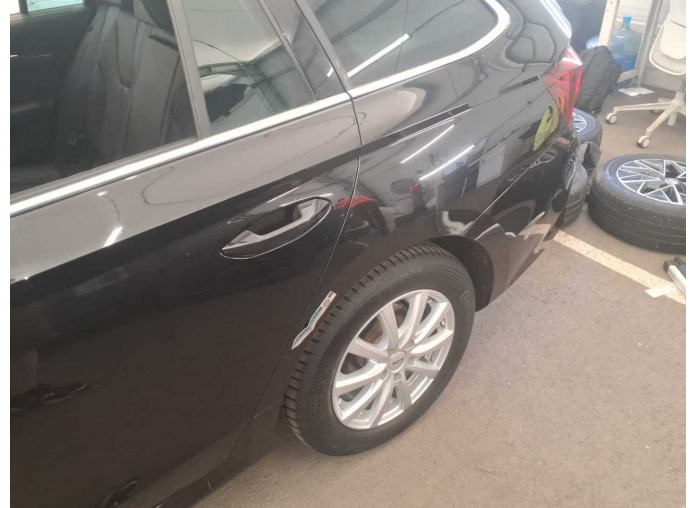
Damage 7: Side panel - rear left side: Side panel - Scratch(es) - Paint

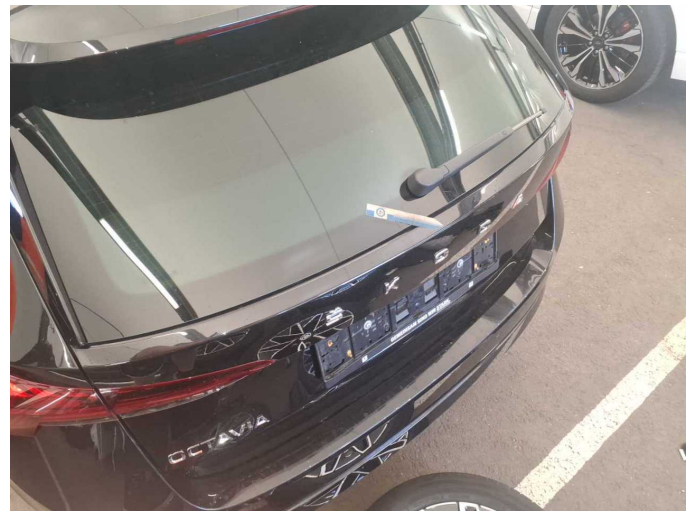
| No. | Component group | Description |
|---|---|--|
| 8 | Boot lid / rear door | Boot lid - Scratch(es) - Paint |

Damage 8: Boot lid / rear door: Boot lid - Scratch(es) - Paint

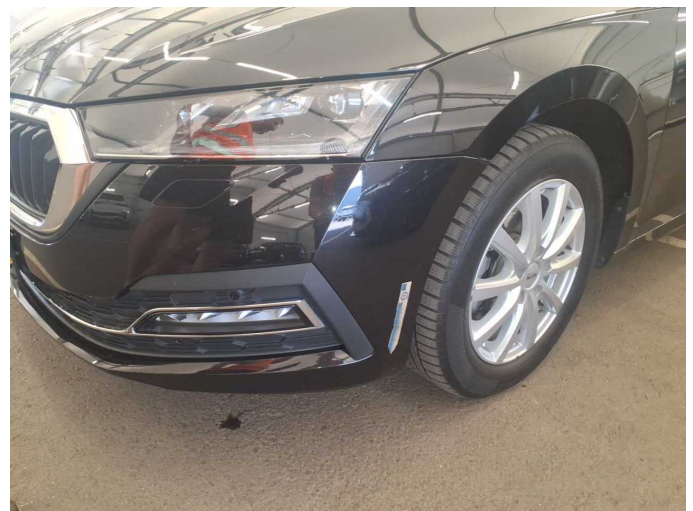
| No. | Component group | Description |
|---|---|--|
| 9 | Front bumper | Front bumper - Scratch(es) - Paint |

Damage 9: Front bumper: Front bumper - Scratch(es) - Paint

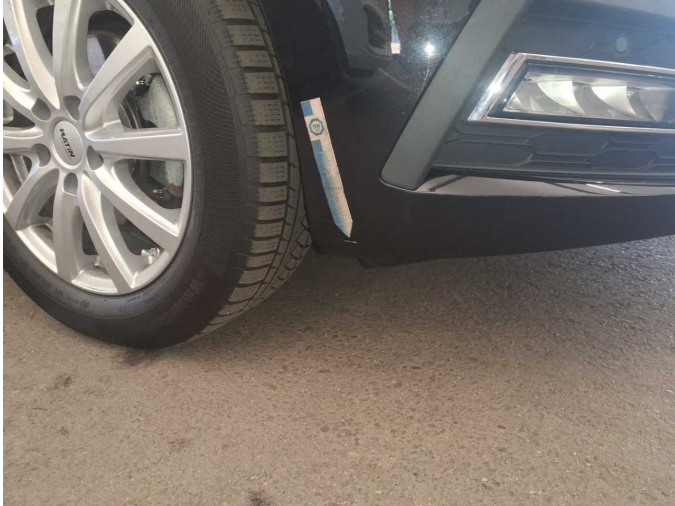
Damage 9: Front bumper: Front bumper - Scratch(es) - Paint

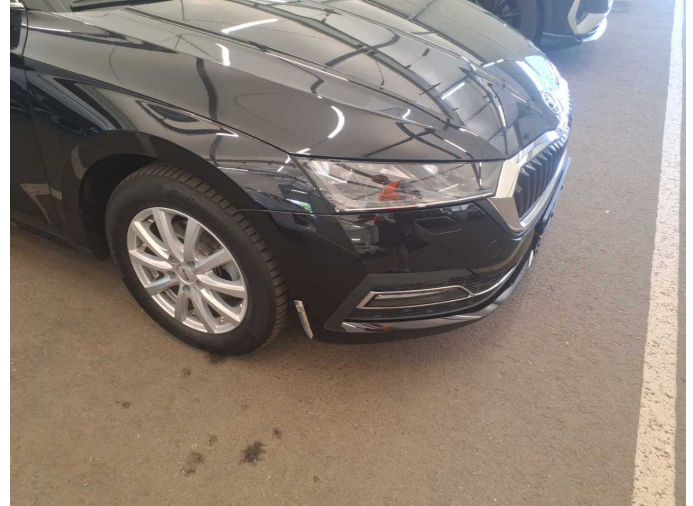
Damage 9: Front bumper: Front bumper - Scratch(es) - Paint

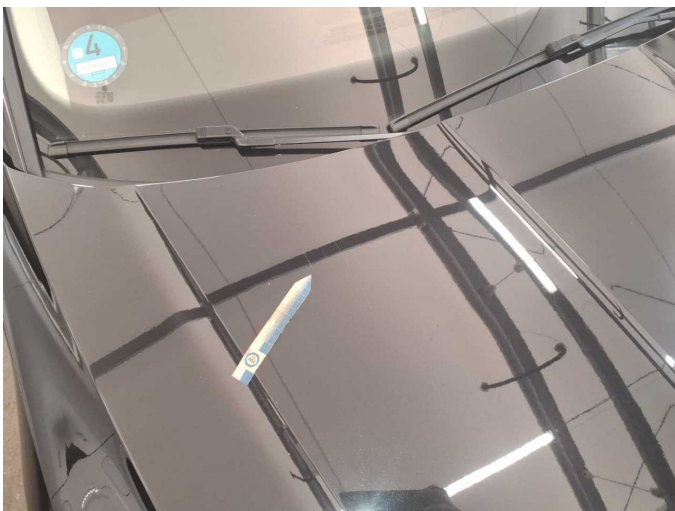
| No. | Component group | Description |
|---|---|---|
| 3 | Bonnet | Bonnet - Scratch(es) - Paint |

Wear and tear 3: Bonnet: Bonnet - Scratch(es) - Paint

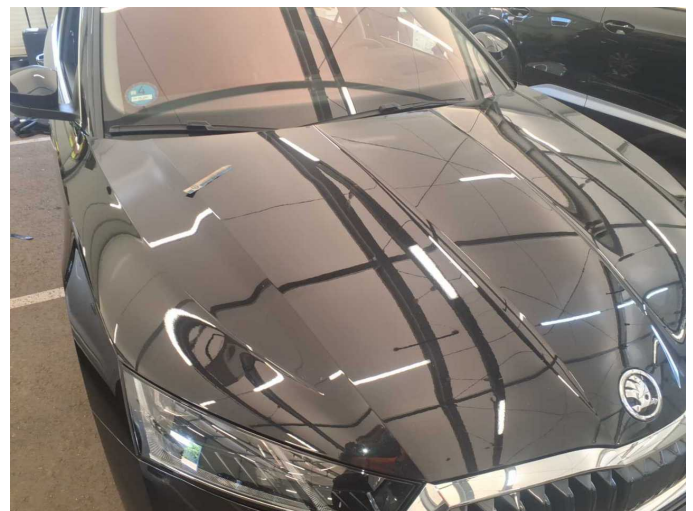
Wear and tear 3: Bonnet: Bonnet - Scratch(es) - Paint

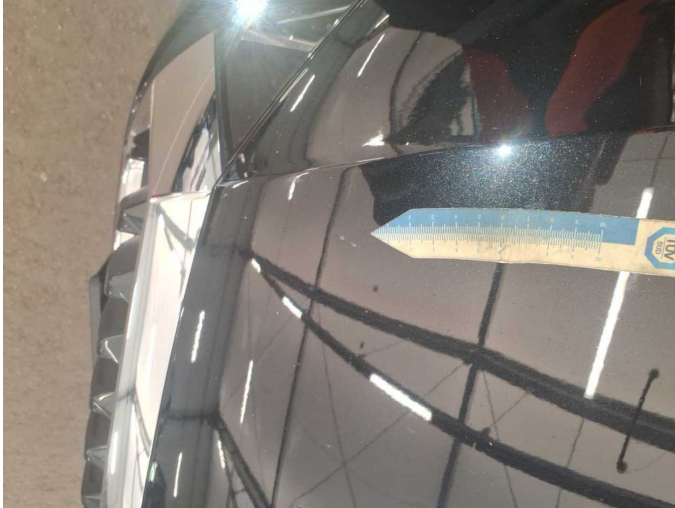
Wear and tear 3: Bonnet: Bonnet - Scratch(es) - Paint

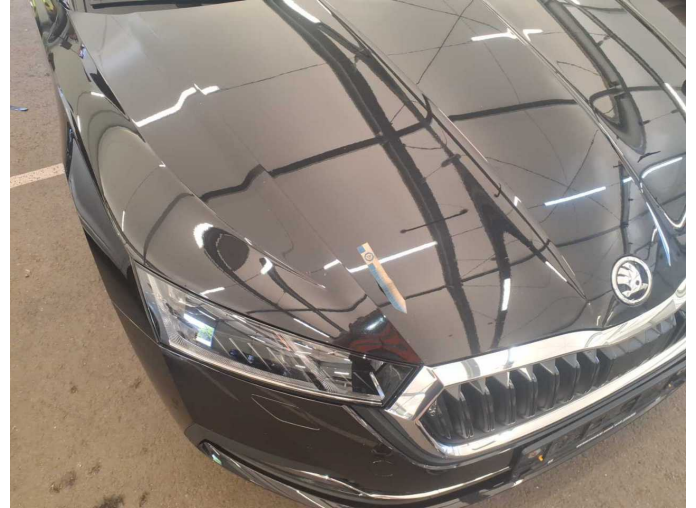
Wear and tear 3: Bonnet: Bonnet - Scratch(es) - Paint

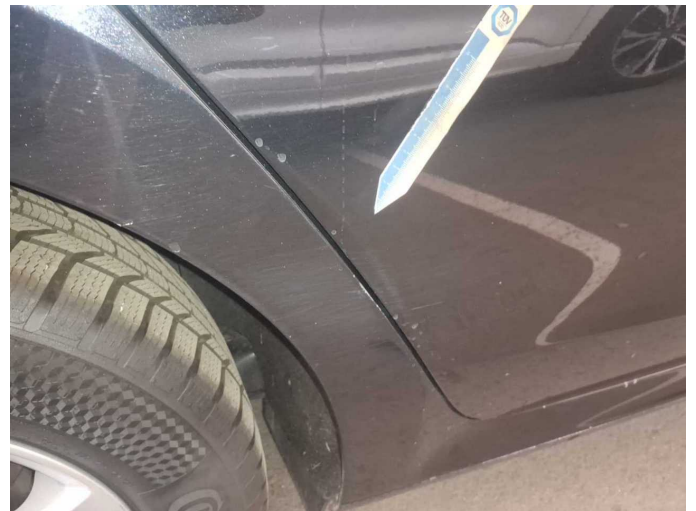
1 Side right

Accident 1: Side right

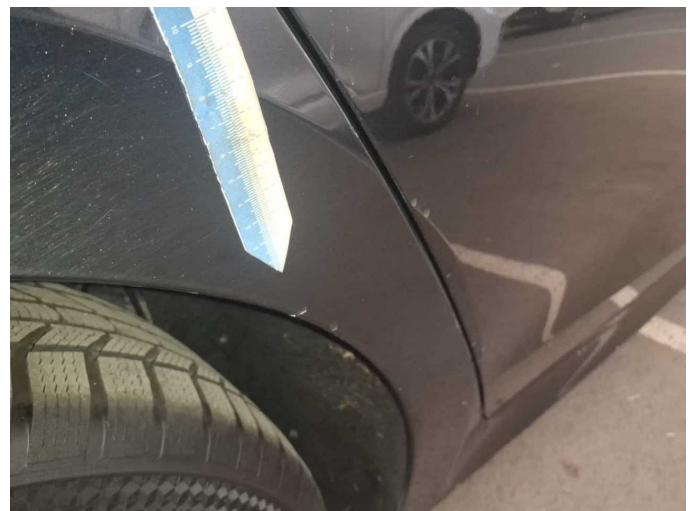
Accident 1: Side right

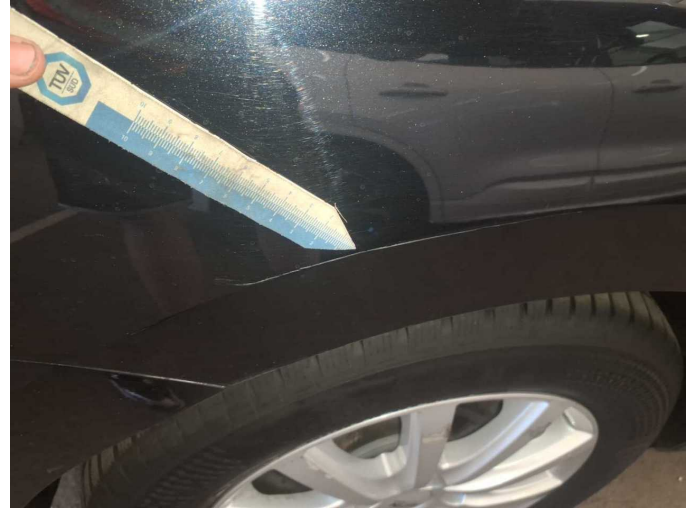
Accident 1: Side right

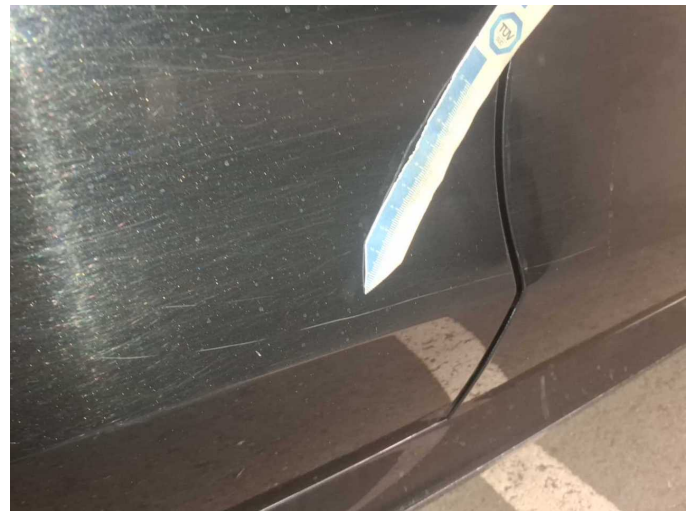
Accident 1: Side right

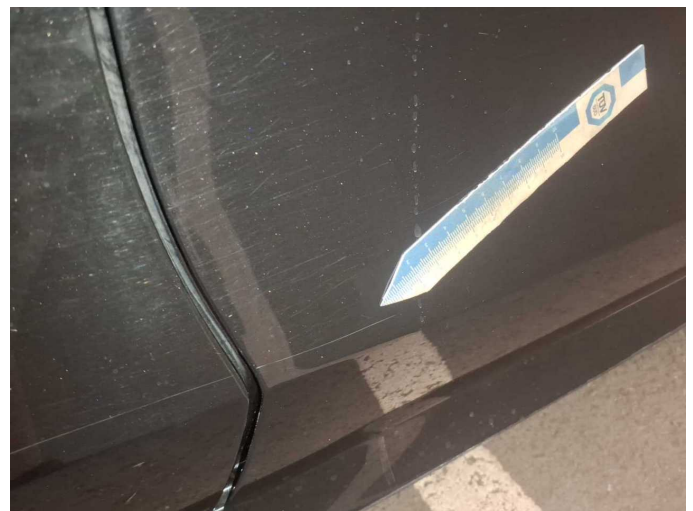
Accident 1: Side right

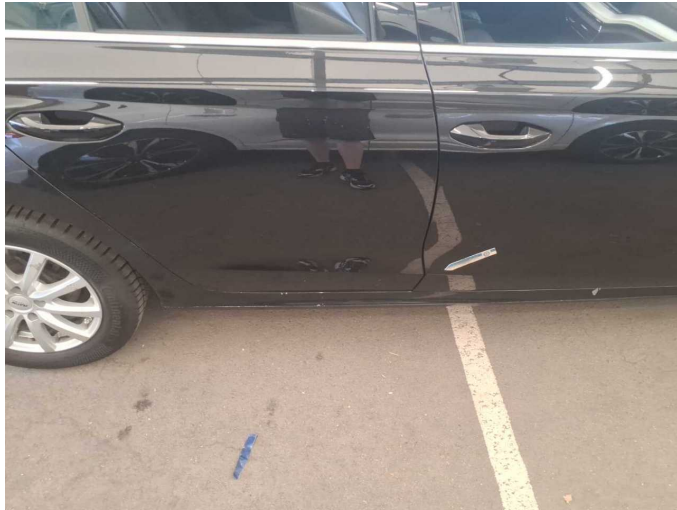
Accident 1: Side right

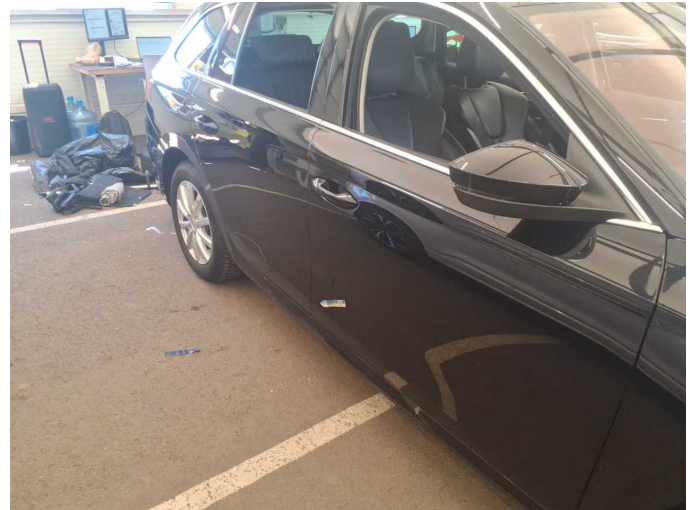
Accident 1: Side right
