## Expertise

Protocol number: 45580978  
Order No. / Reference: 26380199  
Inspection date: 21 May 2026

Manufacturer: Opel

Model: Astra Sports Tourer 1.5 D Automatik Business Elegance

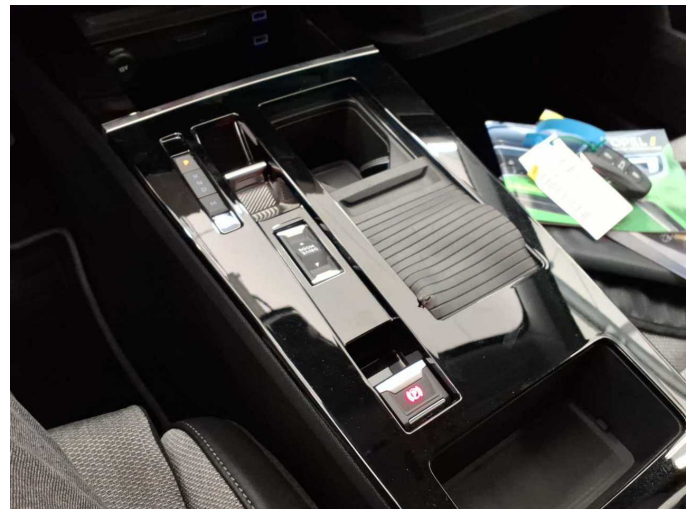
**Damage 1:** Interior: Cup holder - centre (Blende/Rollo beschädigt) - Damaged - Replace

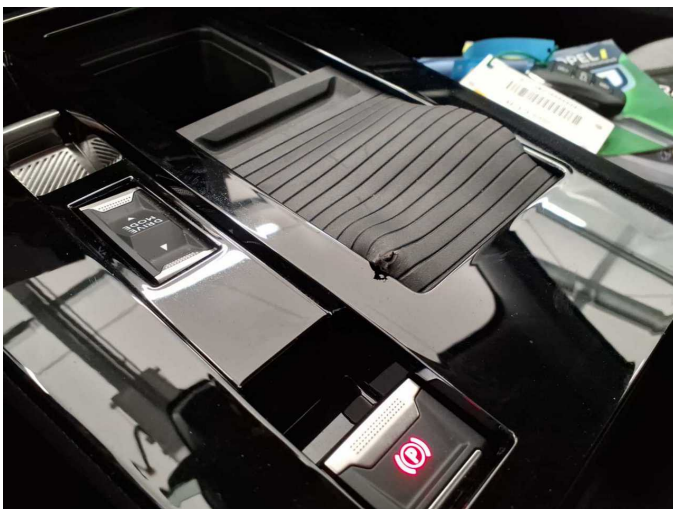
**Damage 1:** Interior: Cup holder - centre (Blende/Rollo beschädigt) - Damaged - Replace

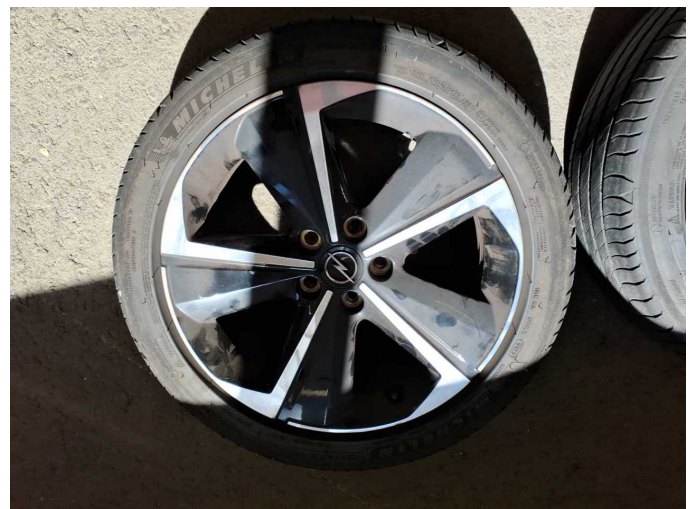
**Damage 3:** 2nd wheel set: 1 alloy rim - Scratch(es) - Loss in value

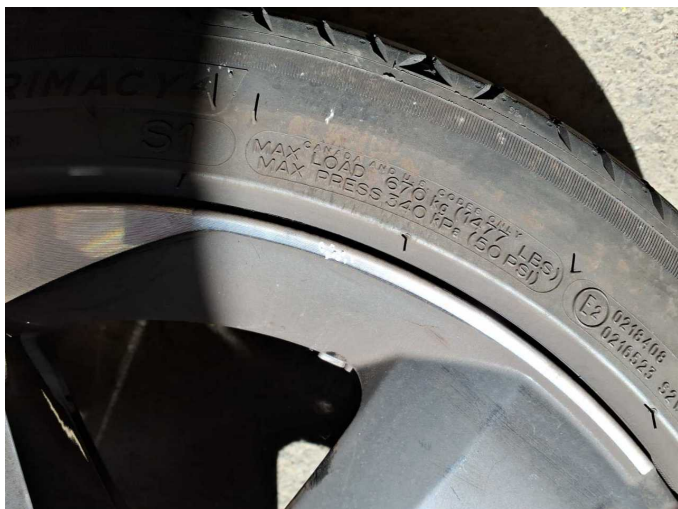
**Damage 3:** 2nd wheel set: 1 alloy rim - Scratch(es) - Loss in value

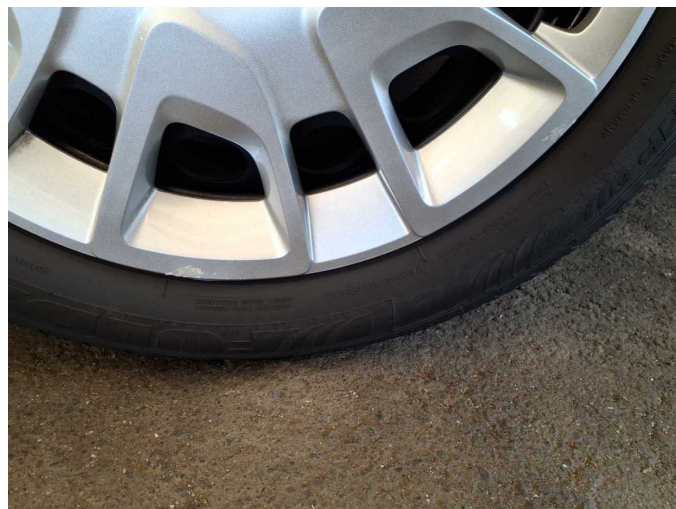
**Wear and tear 1:** Wheel / tyres: Wheel cover - rear left side - Scratched - No deduction
