# MACDAM

## Peugeot 2008 '19

### Damage summary

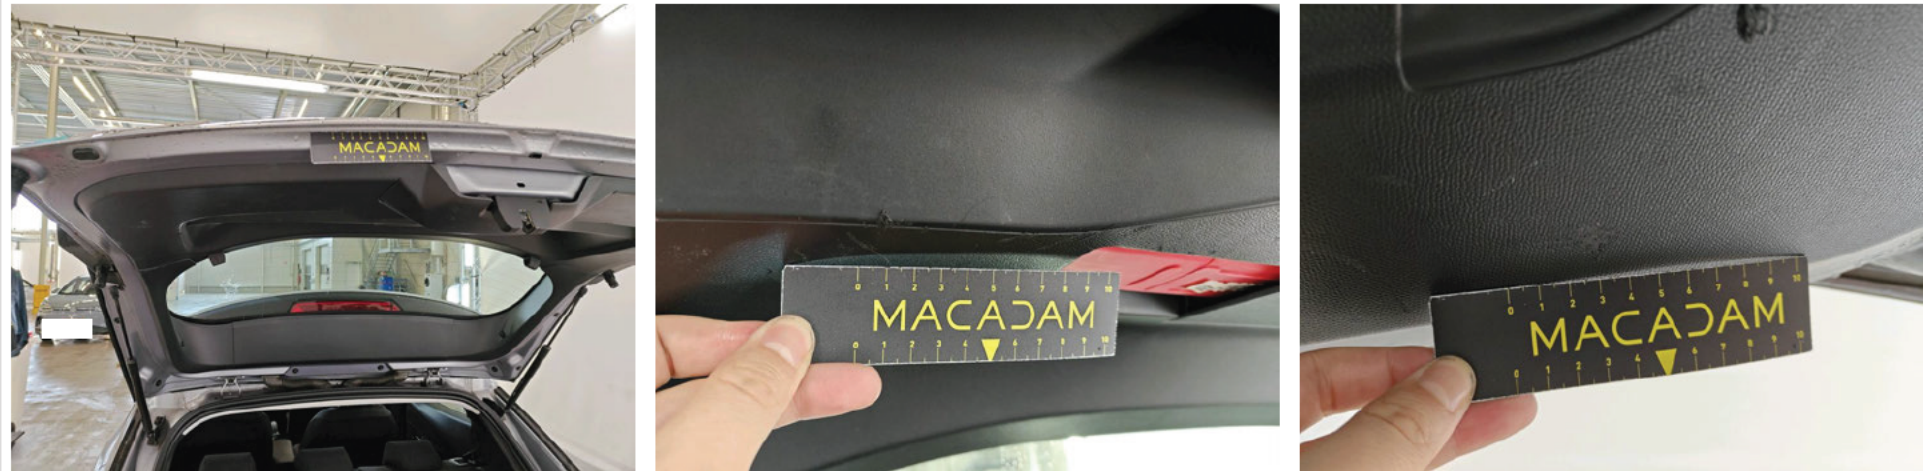
Boot lid covering R

Scratch(es)  
Smart repair  
Rear

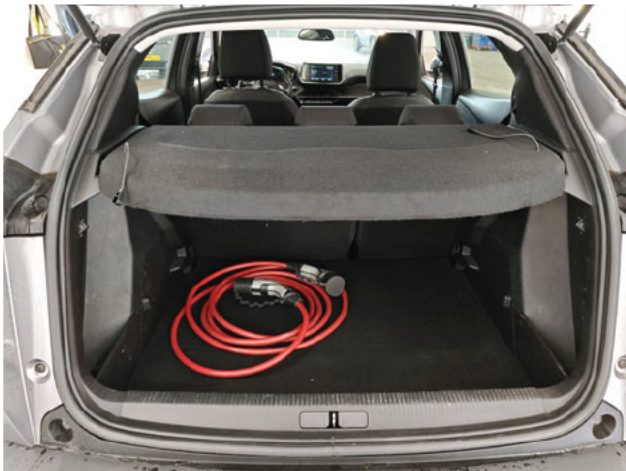
Charging cable (normal)

Missing  
Replace  
Rear

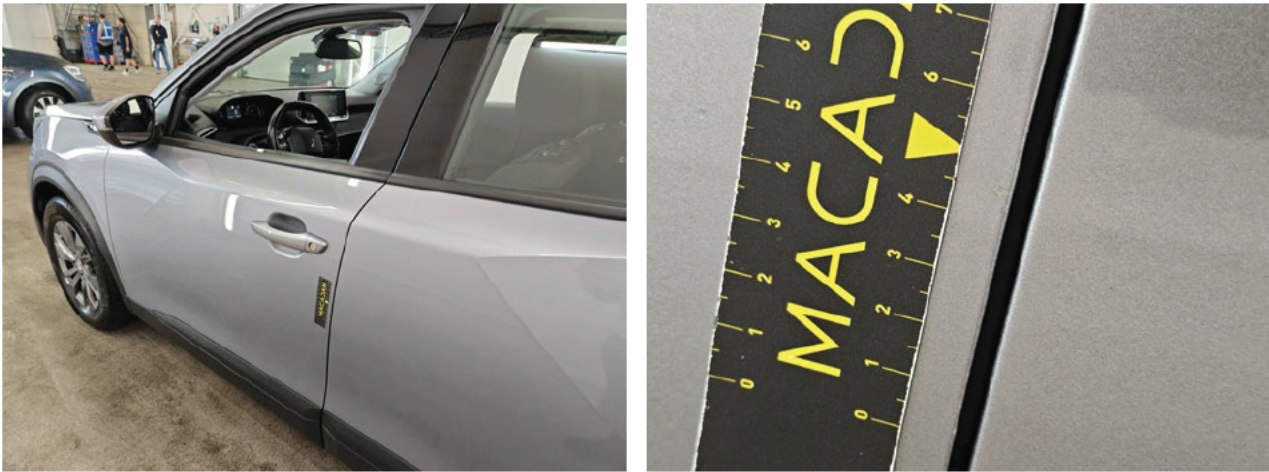
Door FL

Scratch(es)  
Repair and paint (complete)  
Left

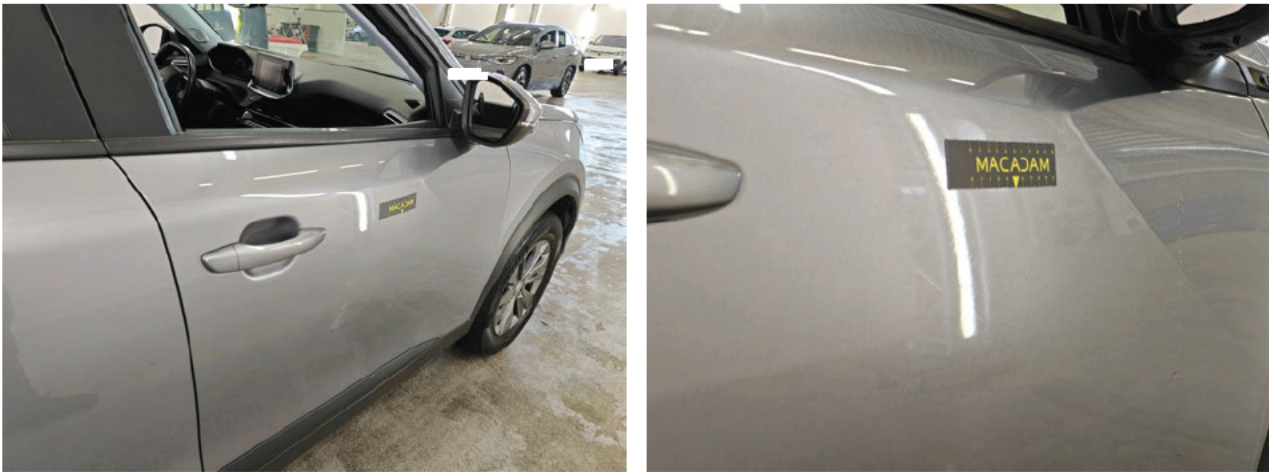
Door FR

Bad repair  
Repair and paint (complete)  
Right

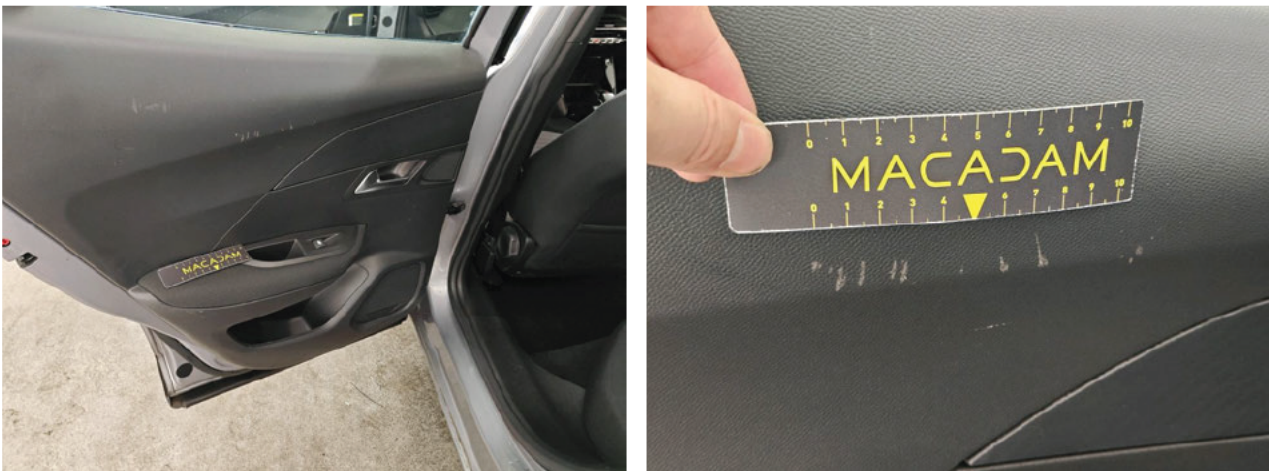
Door panel RL

Scratch(es)  
Smart repair  
Interior

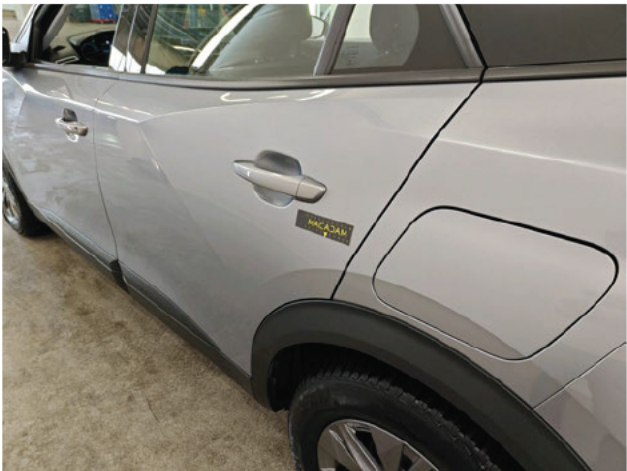
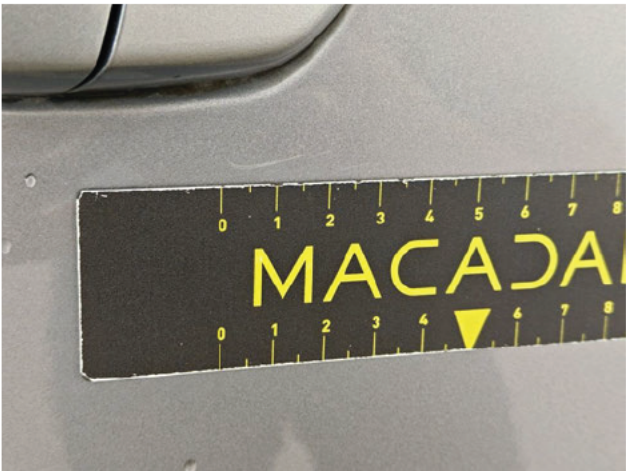
**Door RL**  
Scratch(es)  
Repair and paint (complete)  
Left

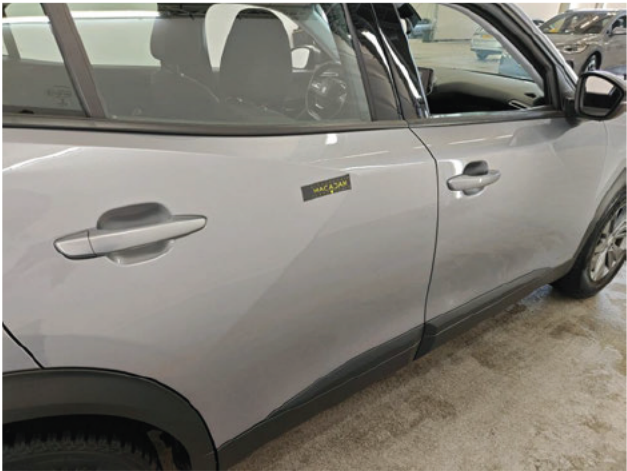
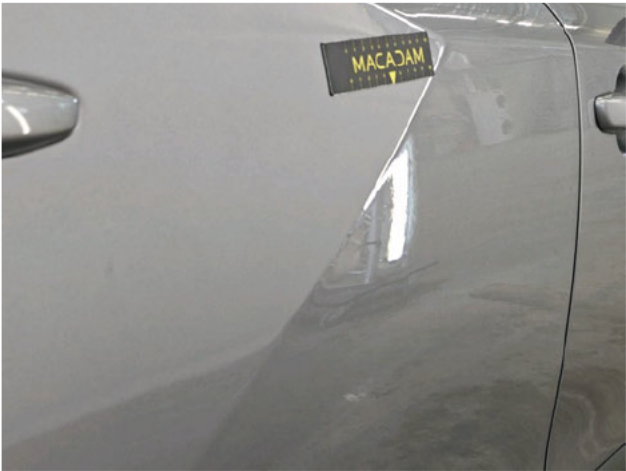
**Door RR**  
Bad repair  
Repair and paint (complete)  
Right

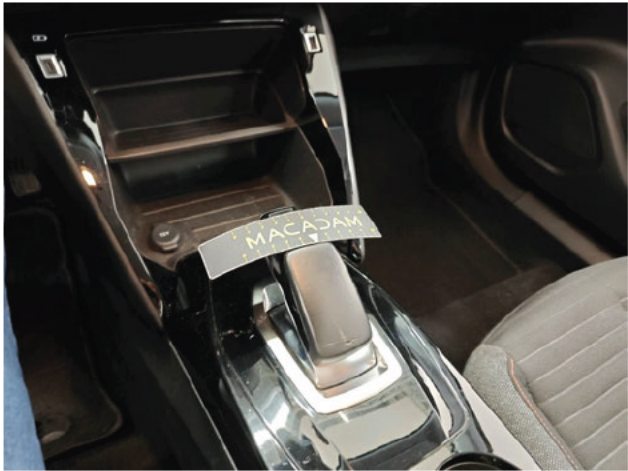
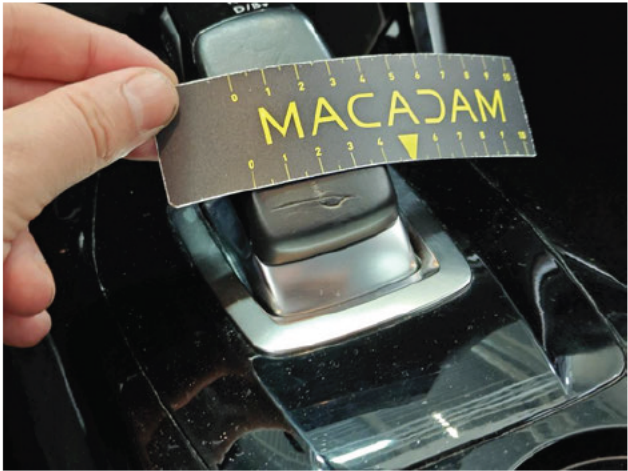
**Gear shift lever knob**  
Scratch(es)  
Smart repair  
Interior

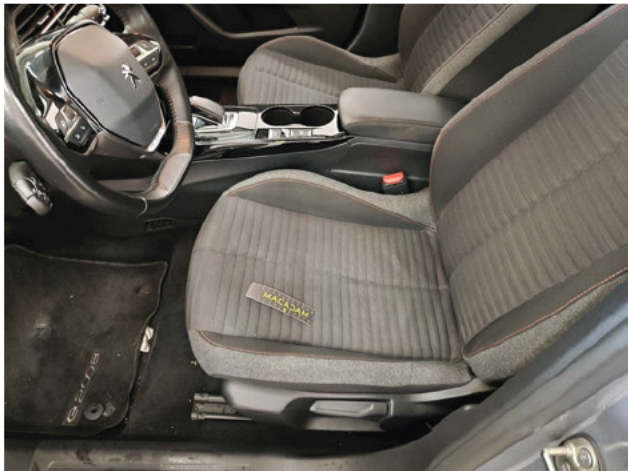
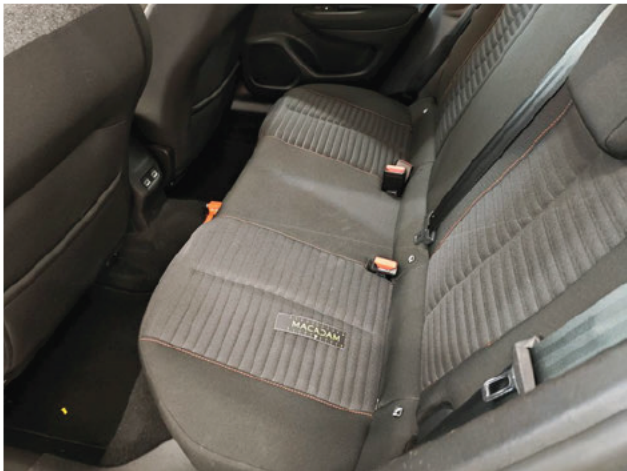
**Interior**  
Stain  
Cleaning  
Interior

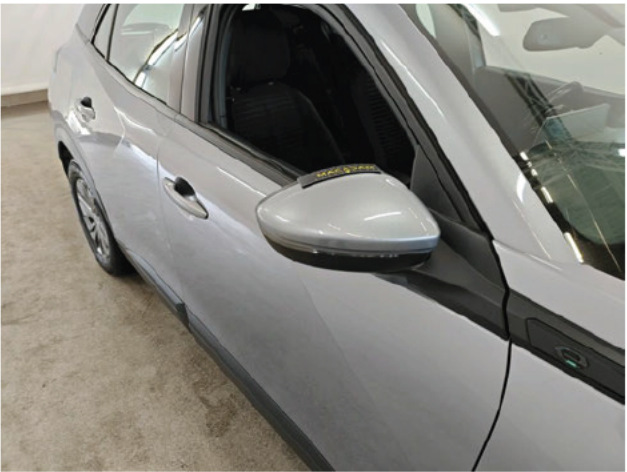
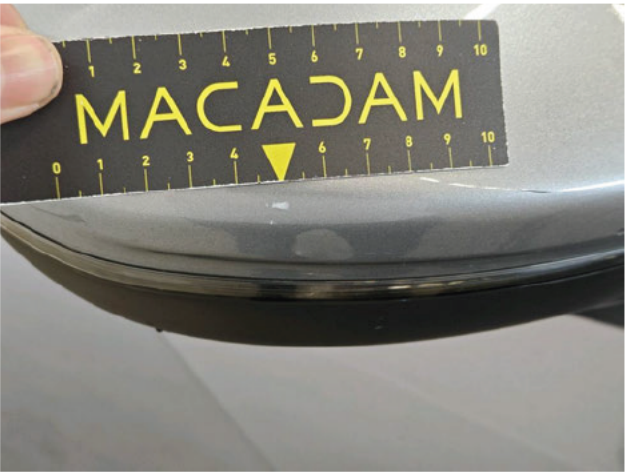
**Outside rear-view mirror housing R**  
Scratch(es)  
Replace and paint  
Right

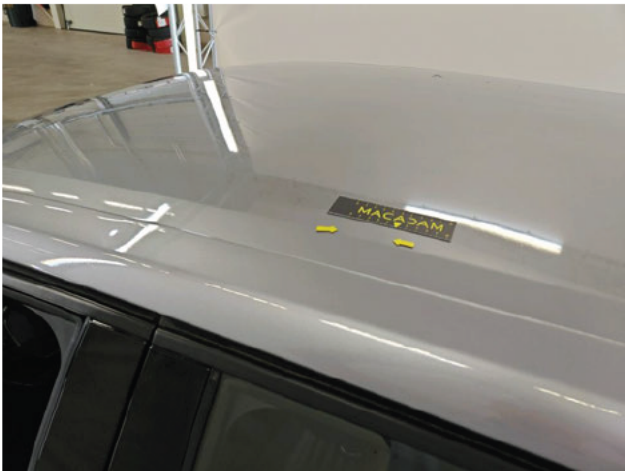
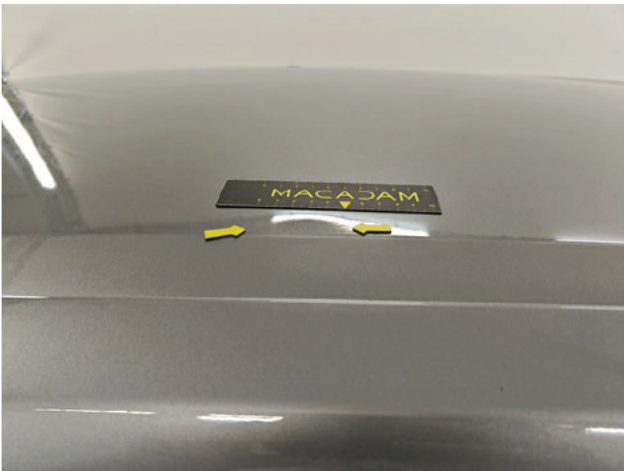
**Roof**  
Dent(s)  
Repair and paint (complete)  
Roof & others

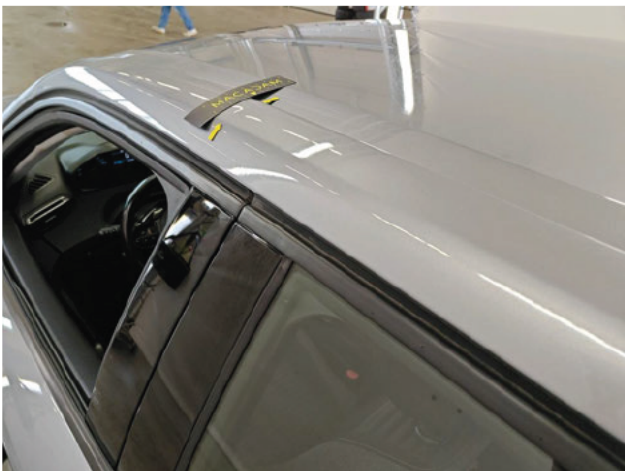
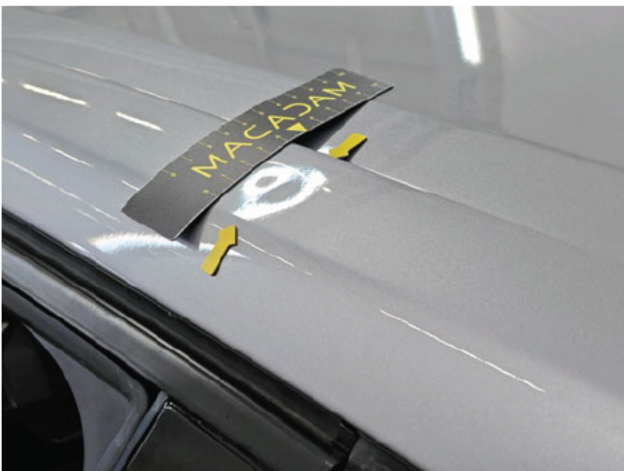
**Roof pillar L**  
Dent(s)  
Repair and paint (complete)  
Left

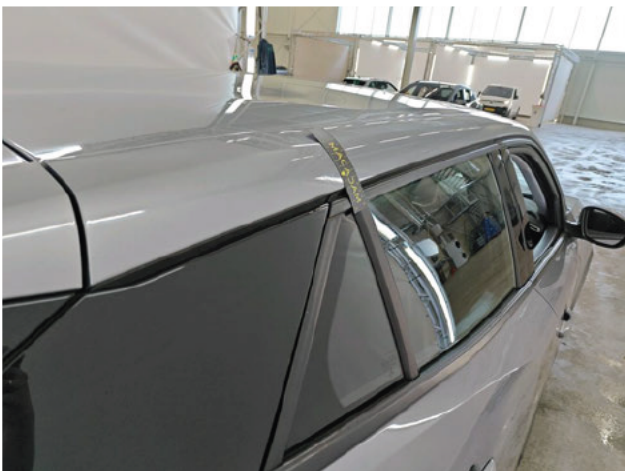
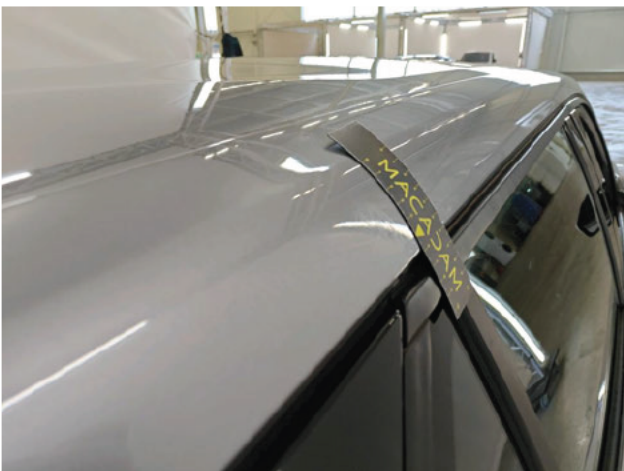
**Roof pillar R**  
Chemical polution  
Repair and paint (complete)  
Right

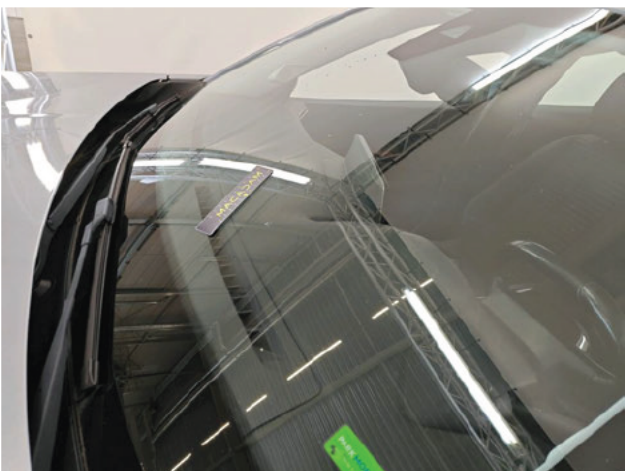
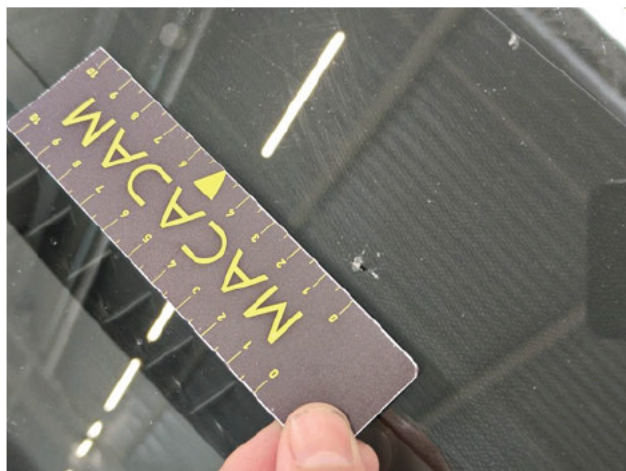
**Windscreen**  
Stone chip(s)  
Windscreen repair  
Front

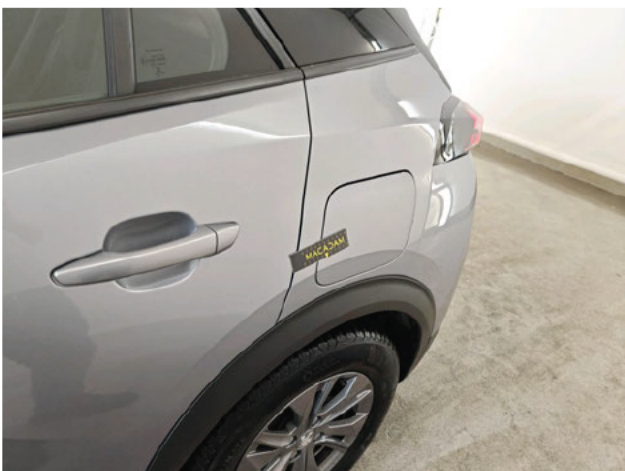
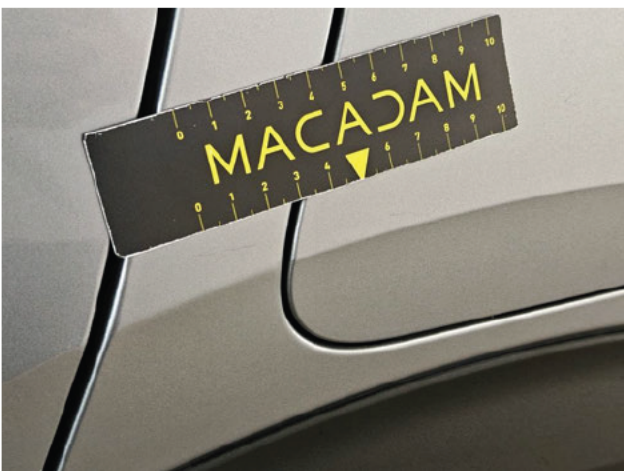
**Wing RL**  
Scratch(es)  
Repair and paint (complete)  
Left

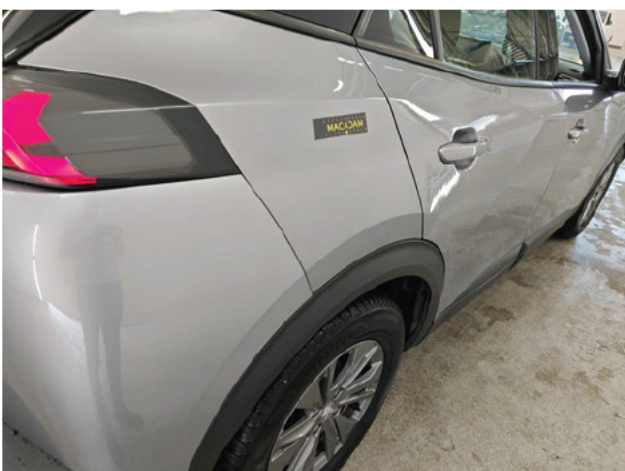
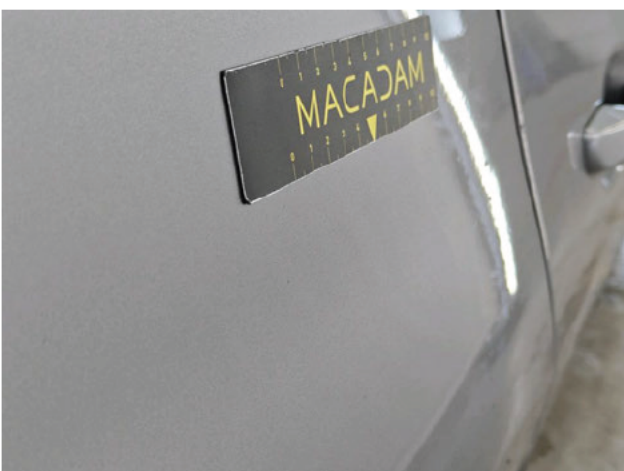
**Wing RR**  
Bad repair  
Repair and paint (complete)  
Right
