Expertise

Protocol number: 46481991  
Order No. / Reference: 26215332  
Inspection date: 10 Jul 2026

Manufacturer: Mercedes-Benz  
VIN: W1VVLBEZ9T4545118

Model: Vito 116 CDI Lang HA Aut. PRO

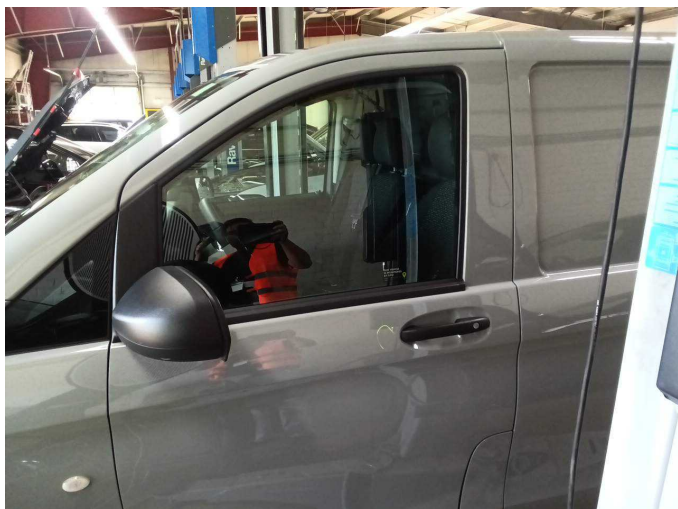
| No. | Component group | Description |
|---|---|---|
| 2 | Door - front left side | Door - dent(s) - Smooth repair work |

**Damage 2:** Door - front left side: Door - dent(s) - Smooth repair work

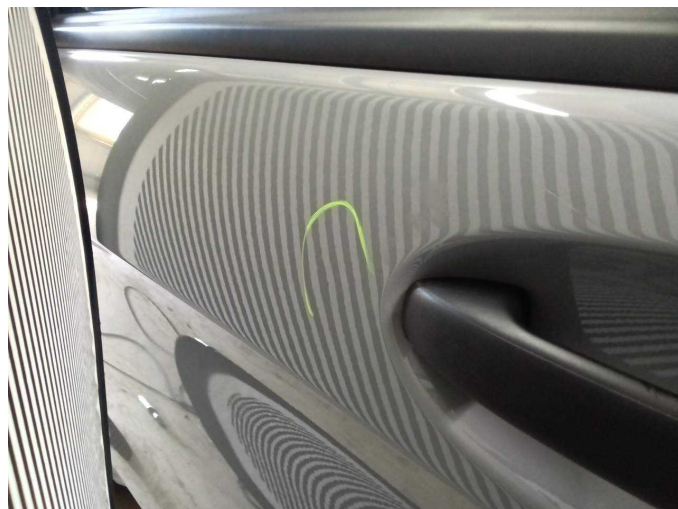
**Damage 2:** Door - front left side: Door - dent(s) - Smooth repair work

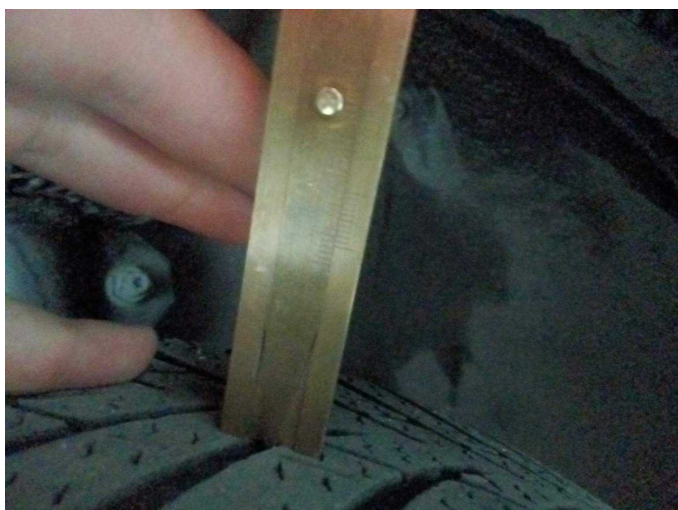
| # | Tyre size | Type of tyre | Manufacturer | Tread depth |
|---|---|---|---|---|
| 1) | 225/55 R17 109H | All-season tyres on Steel rim with wheel cover | Goodyear | 3mm / 3mm |

| No. | Component group | Description |
|---|---|---|
| 3 | Wheel / tyres | Tyre - front - does not meet manufacturer specifications - Replace |

**Damage 3:** Wheel / tyres: Tyre - front - does not meet manufacturer specifications - Replace

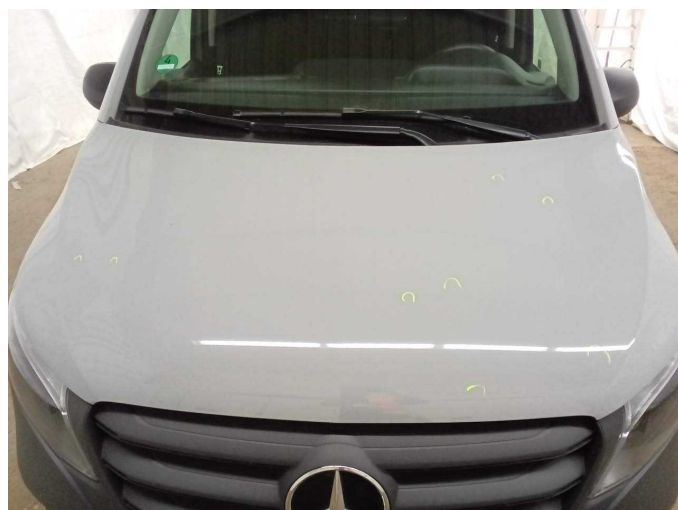
| No. | Component group | Description |
|---|---|---|
| 4 | Bonnet | Bonnet - Stone chips - Paint |

**Damage 4:** Bonnet: Bonnet - Stone chips - Paint

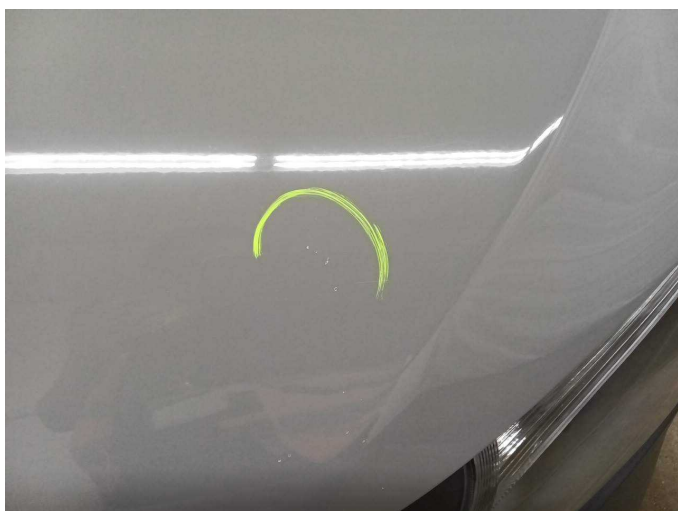
**Damage 4:** Bonnet: Bonnet - Stone chips - Paint

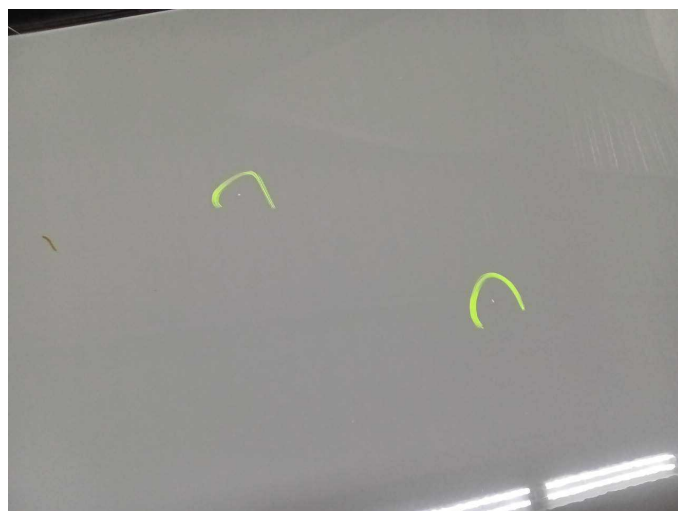
**Damage 4:** Bonnet: Bonnet - Stone chips - Paint

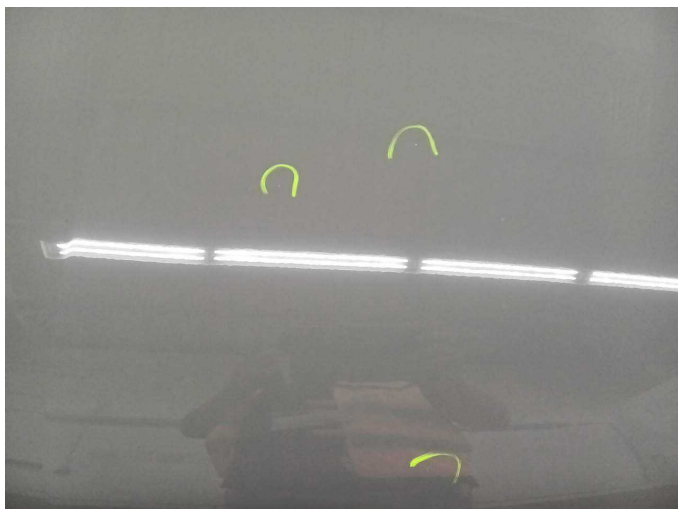
**Damage 4:** Bonnet: Bonnet - Stone chips - Paint

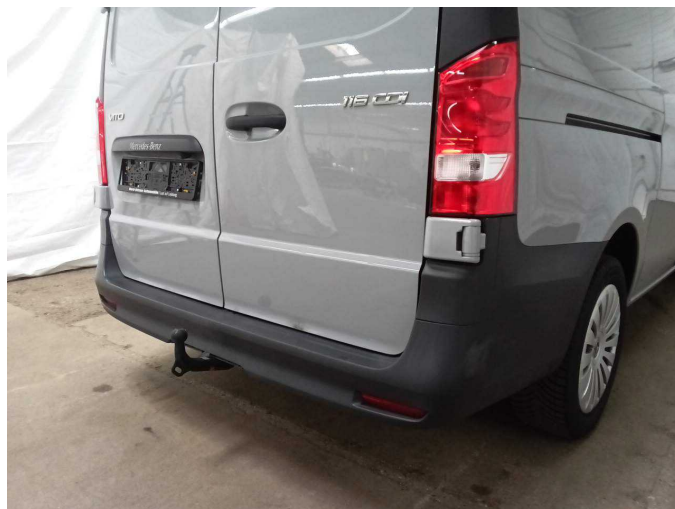
| No. | Component group | Description |
|---|---|---|
| 5 | Rear bumper | Rear bumper - Scratch(es) - Replace |

**Damage 5:** Rear bumper: Rear bumper - Scratch(es) - Replace

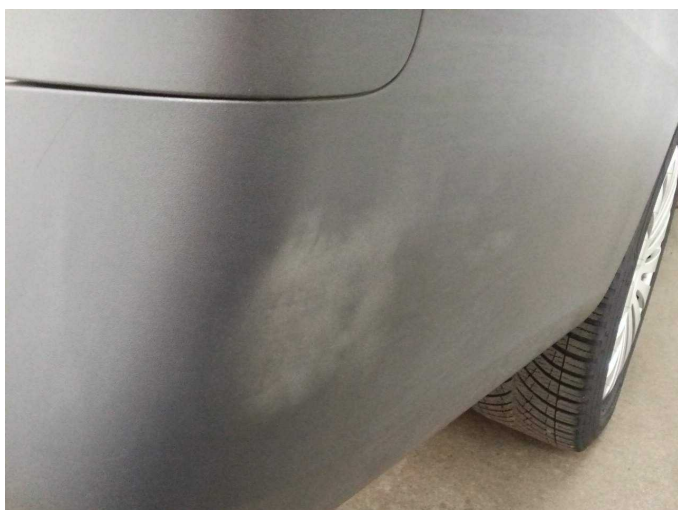
**Damage 5:** Rear bumper: Rear bumper - Scratch(es) - Replace

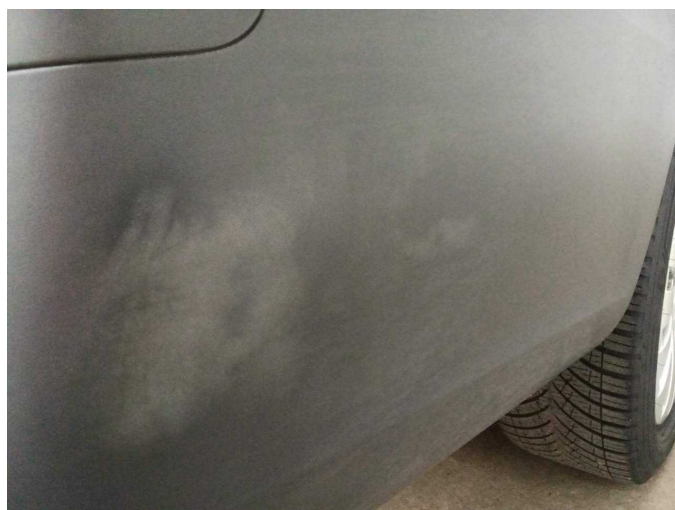
**Damage 5:** Rear bumper: Rear bumper - Scratch(es) - Replace

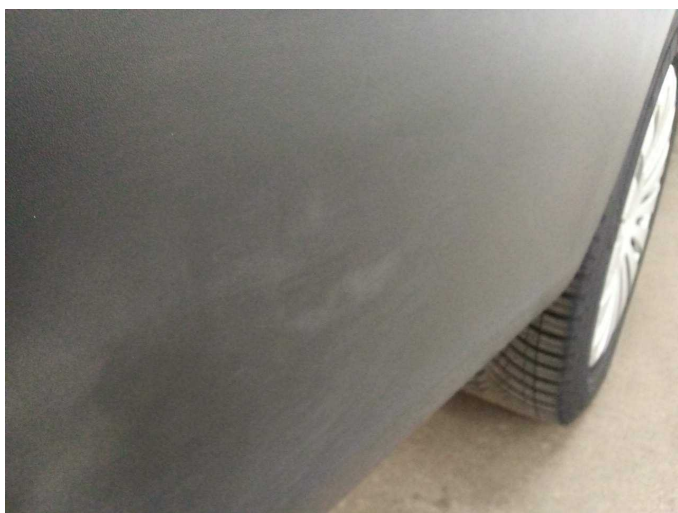
**Damage 5:** Rear bumper: Rear bumper - Scratch(es) - Replace
