Expertise

Protocol number: 46696518  
Order No. / Reference: 26726414  
Inspection date: 24 Jul 2026

Manufacturer: Renault

Model: Megane EV60 220hp optimum charge Paket Techno

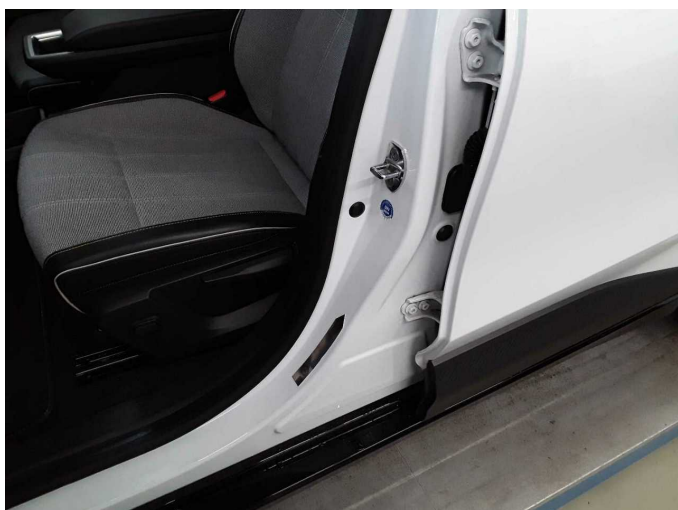
| No. | Component group | Description |
|---|---|---|
| 1 | Body | B-pillar - left side - dent(s) - Smart repair |

**Damage 1:** Body: B-pillar - left side - dent(s) - Smart repair

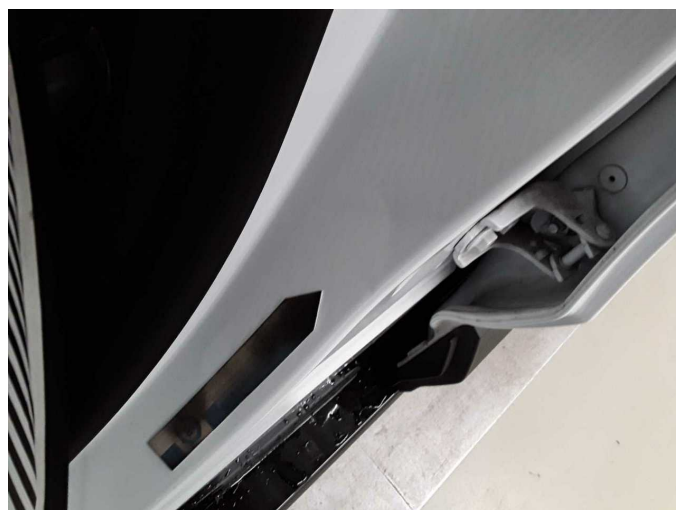
**Damage 1:** Body: B-pillar - left side - dent(s) - Smart repair

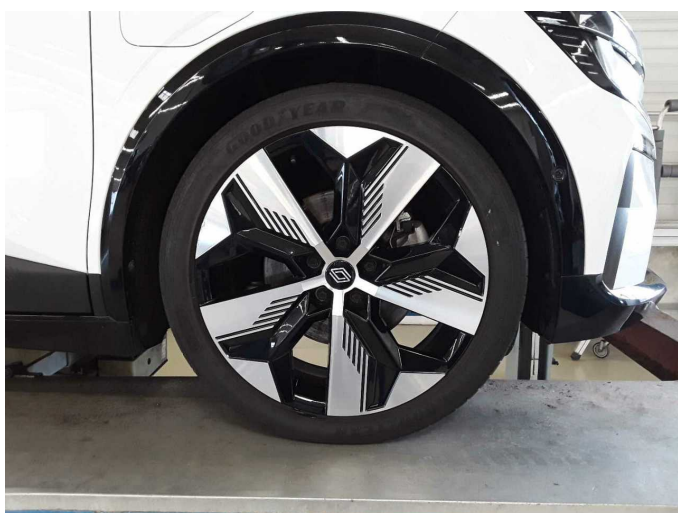
| No. | Component group | Description |
|---|---|---|
| 2 | Wheel / tyres | Alloy rim - front right side - Scratched - Loss in value |

**Damage 2:** Wheel / tyres: Alloy rim - front right side - Scratched - Loss in value

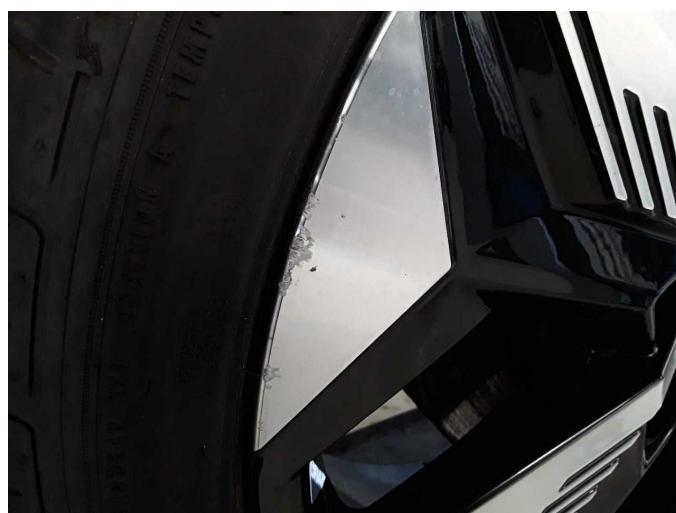
**Damage 2:** Wheel / tyres: Alloy rim - front right side - Scratched - Loss in value

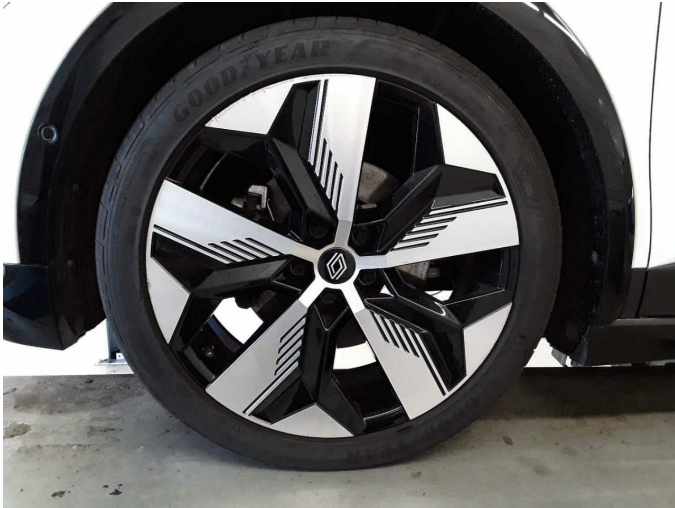
| No. | Component group | Description |
|---|---|---|
| 3 | Wheel / tyres | Alloy rim - front left side (Materialabtrag) - Scratched - Replace |

**Damage 3:** Wheel / tyres: Alloy rim - front left side (Materialabtrag) - Scratched - Replace

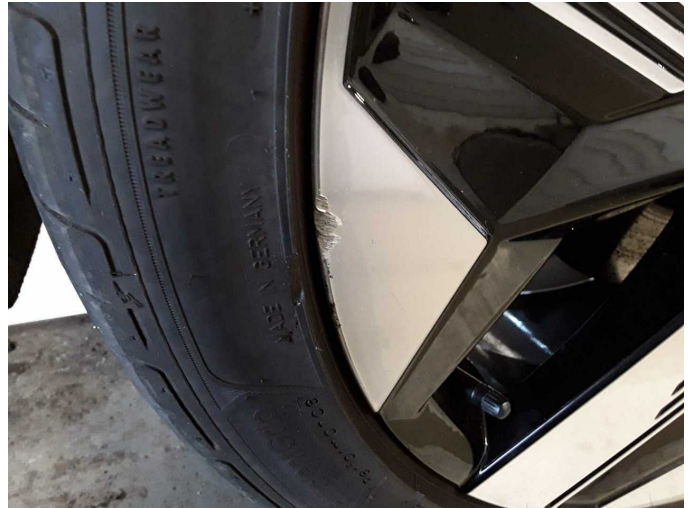
**Damage 3:** Wheel / tyres: Alloy rim - front left side (Materialabtrag) - Scratched - Replace

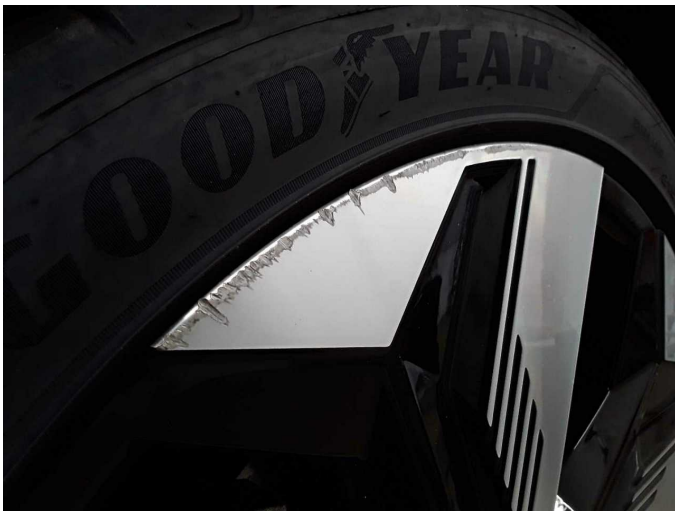
**Damage 3:** Wheel / tyres: Alloy rim - front left side (Materialabtrag) - Scratched - Replace

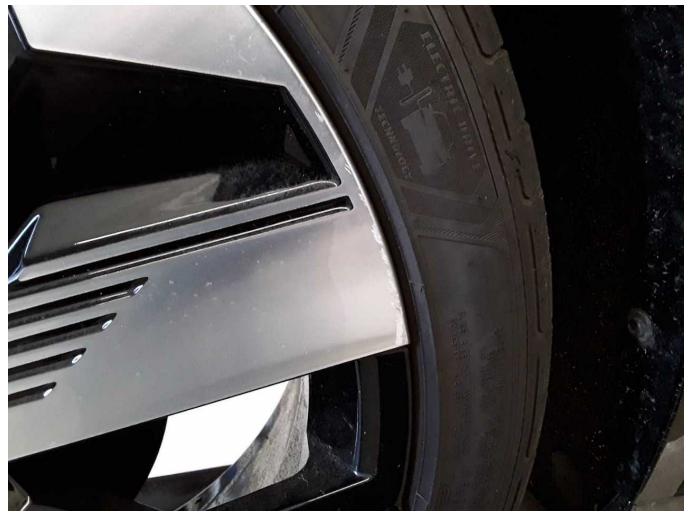
**Damage 3:** Wheel / tyres: Alloy rim - front left side (Materialabtrag) - Scratched - Replace

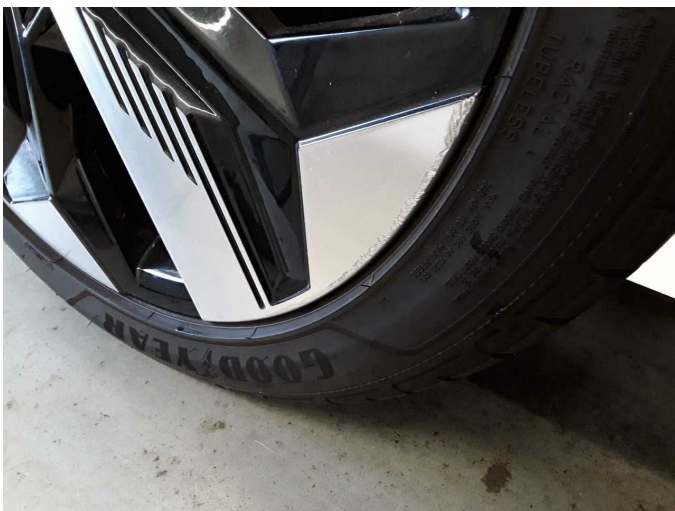
**Damage 3:** Wheel / tyres: Alloy rim - front left side (Materialabtrag) - Scratched - Replace
