Expertise

Protocol number: 46885855  
Order No. / Reference: 26816672  
Inspection date: 4 Aug 2026

Manufacturer: Opel

Model: Insignia Sports Tourer 2.0 Diesel 4x4 Aut. Ultimate

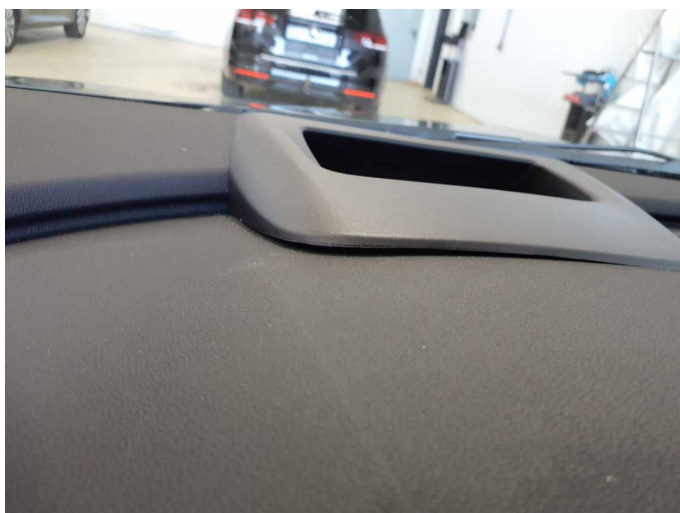
| No. | Component group | Description |
|---|---|---|
| 1 | Trim / covers | Trim / covers - Malposition - Repair |

**Damage 1:** Trim / covers: Trim / covers - Malposition - Repair

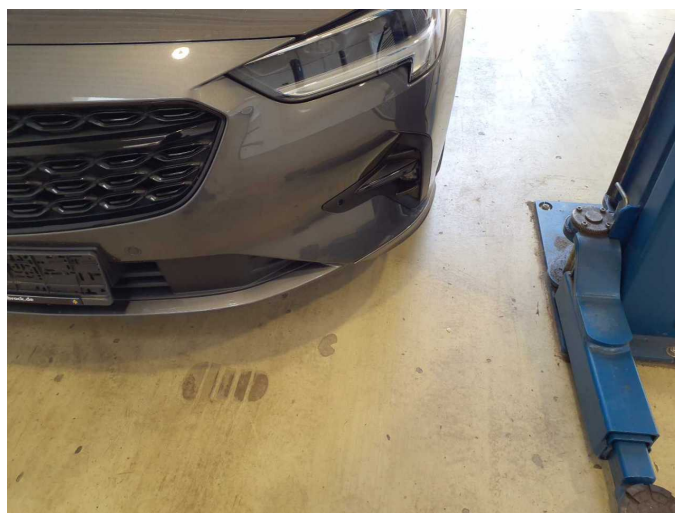
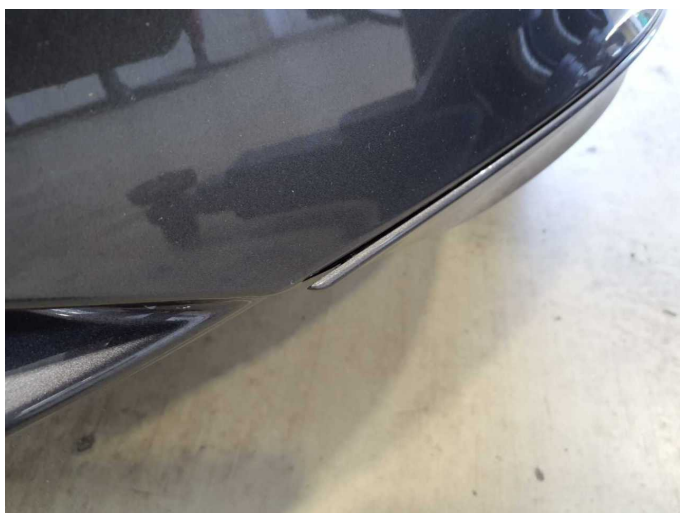
| No. | Component group | Description |
|---|---|---|
| 2 | Trim / covers | Trim / covers - Loose - Repair |

**Damage 2:** Trim / covers: Trim / covers - Loose - Repair

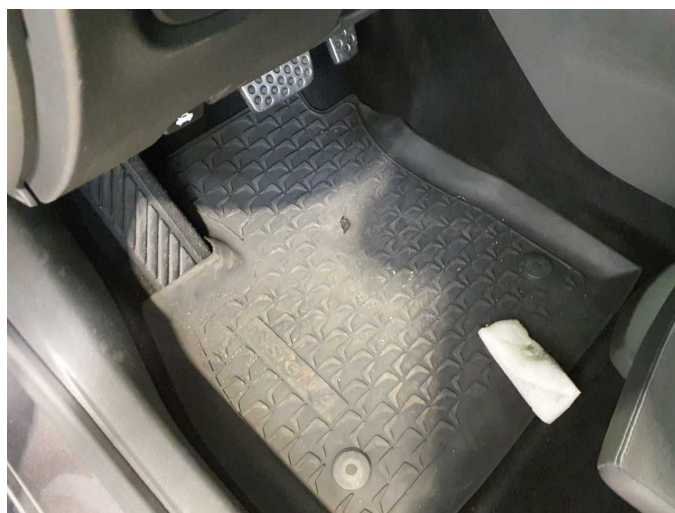
| No. | Component group | Description |
|---|---|---|
| 3 | Trim / covers | Floor mats - Broken / torn - Replace |

**Damage 3:** Trim / covers: Floor mats - Broken / torn - Replace

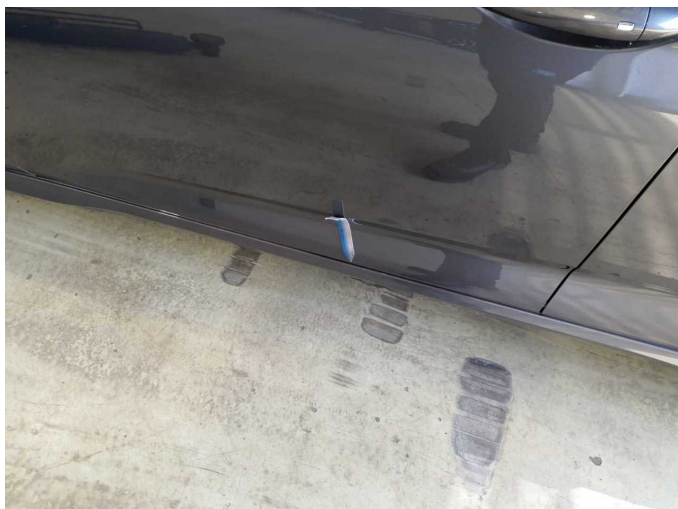
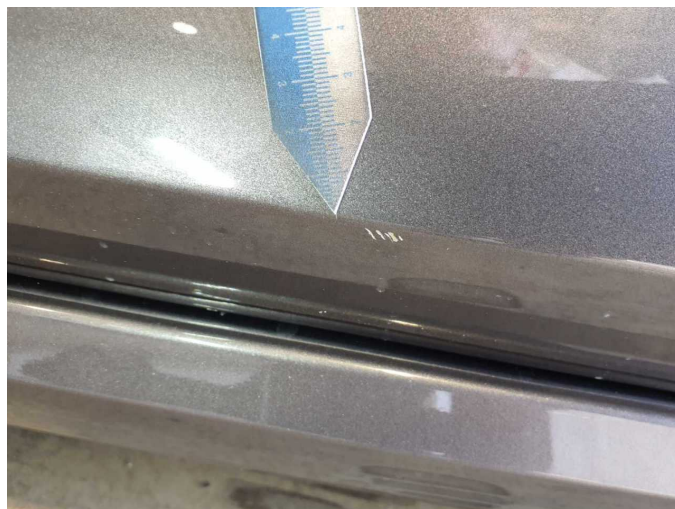
| No. | Component group | Description |
|---|---|---|
| 5 | Door - front left side | Door - Scratch(es) - Smart repair |

**Damage 5:** Door - front left side: Door - Scratch(es) - Smart repair

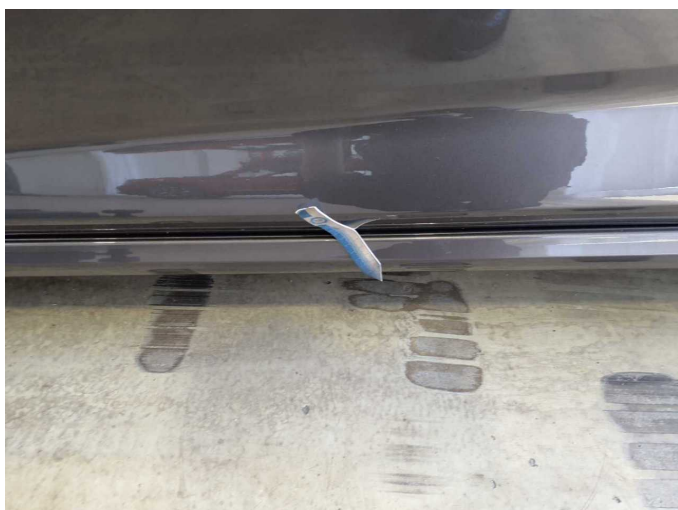
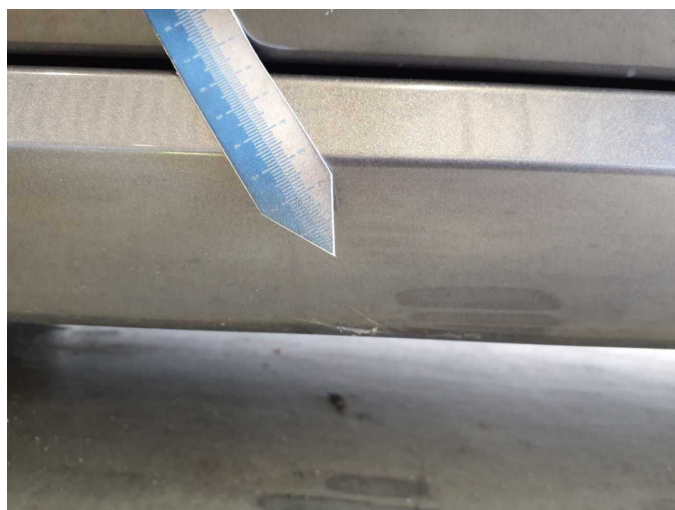
| No. | Component group | Description |
|---|---|---|
| 6 | Sill - left side | Trim - Scratch(es) - Smart repair |

**Damage 6:** Sill - left side: Trim - Scratch(es) - Smart repair

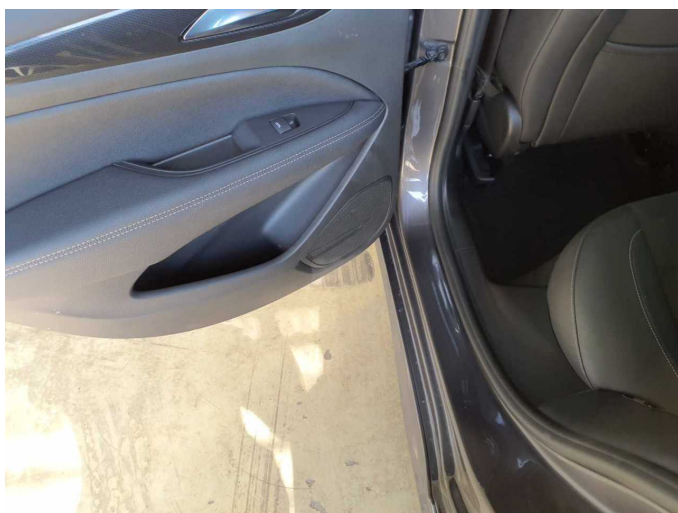
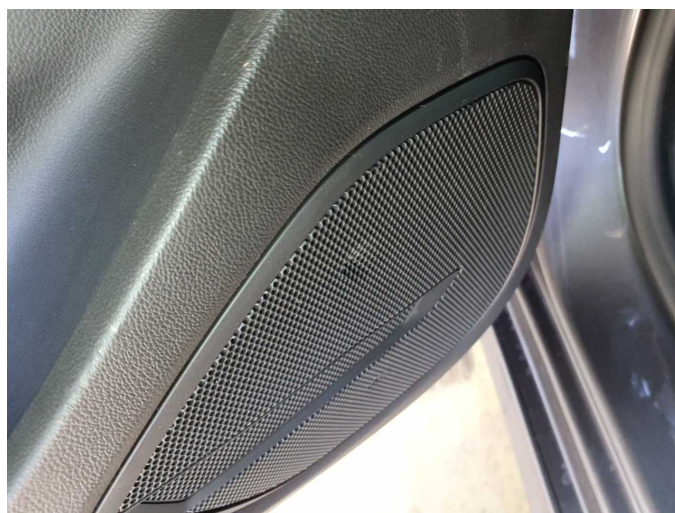
| No. | Component group | Description |
|---|---|---|
| 7 | Trim / covers | Door trim - rear right side - dent(s) - Loss in value |

**Damage 7:** Trim / covers: Door trim - rear right side - dent(s) - Loss in value

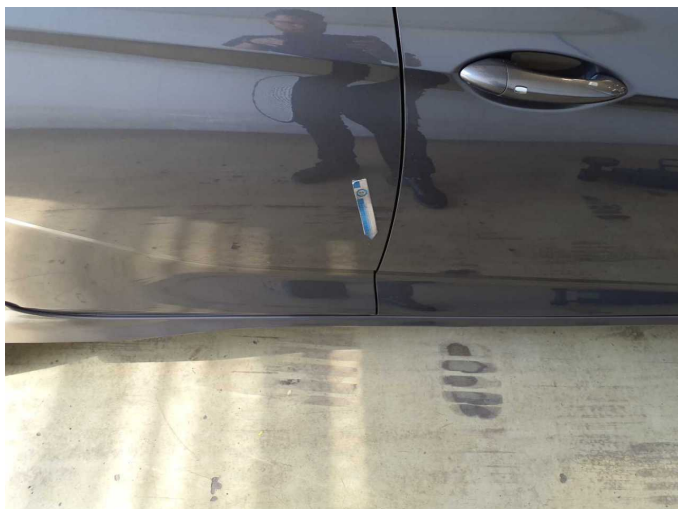
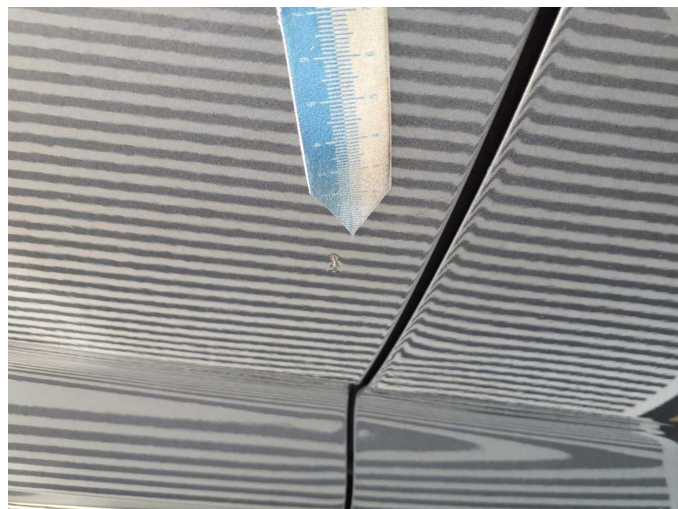
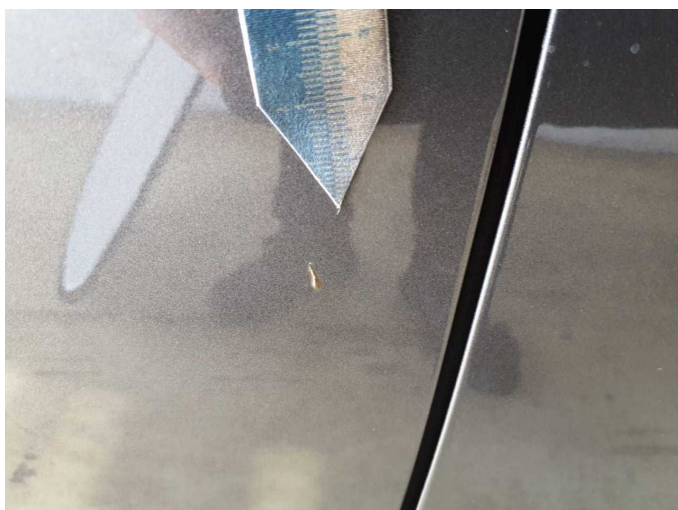
| No. | Component group | Description |
|---|---|---|
| 8 | Door - rear right side | Door - Corrosion - Repair and paint |

**Damage 8:** Door - rear right side: Door - Corrosion - Repair and paint

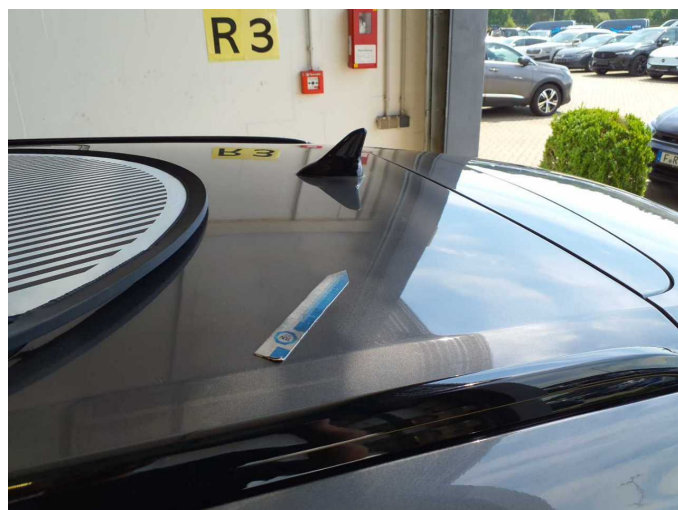
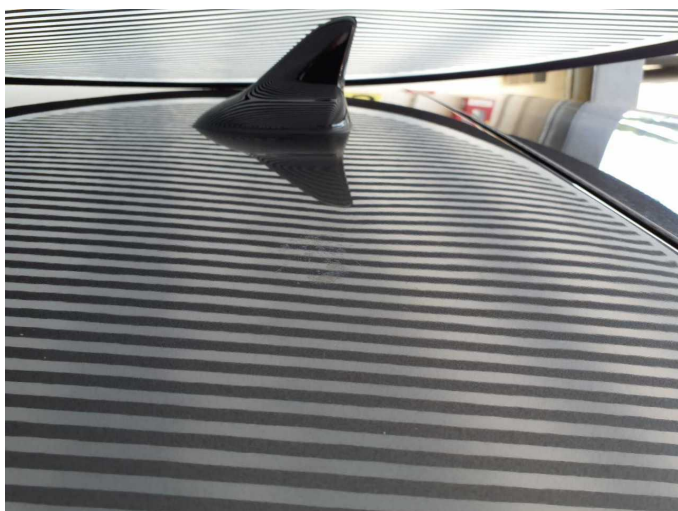
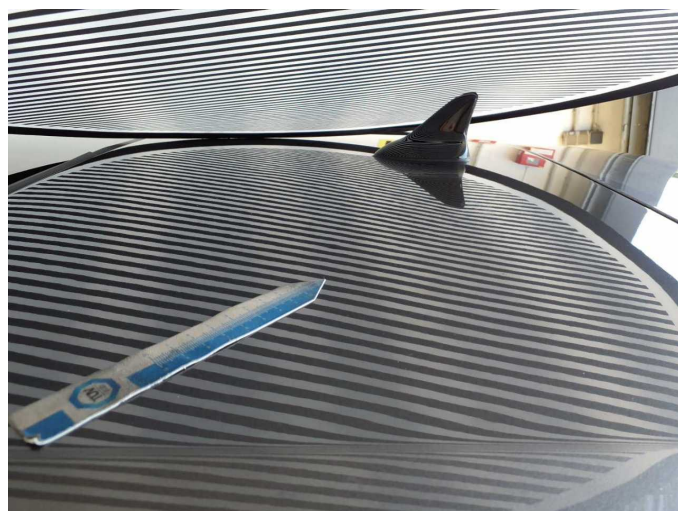
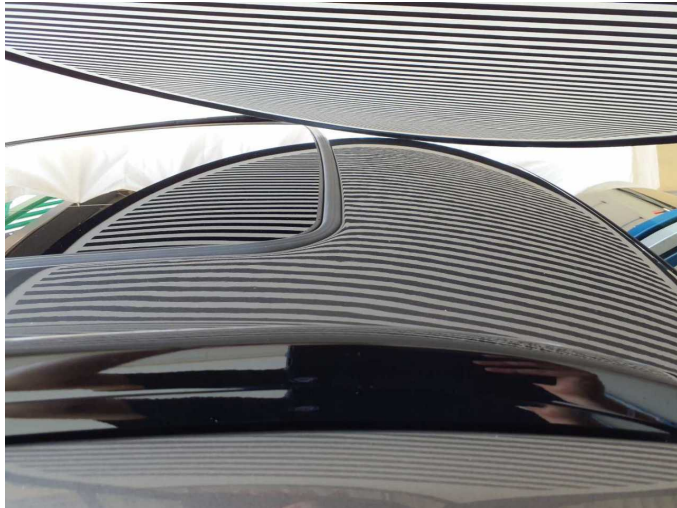
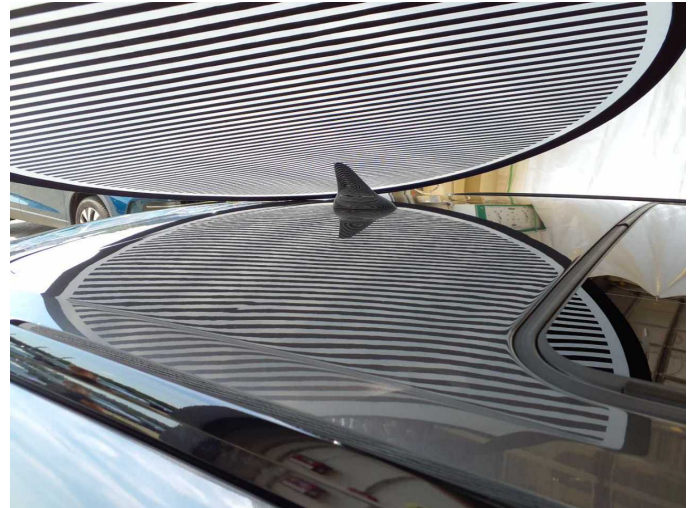
| No. | Component group | Description |
|---|---|---|
| 9 | Roof | Roof (Anätzung) - Paint defect - Repair and paint |

**Damage 9:** Roof: Roof (Anätzung) - Paint defect - Repair and paint

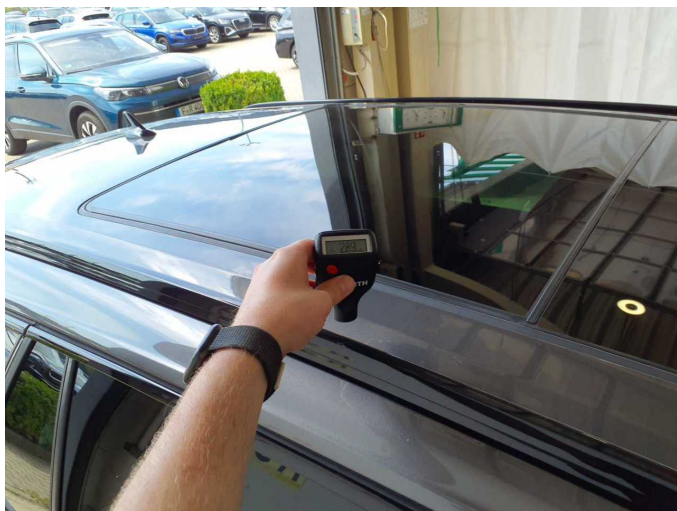
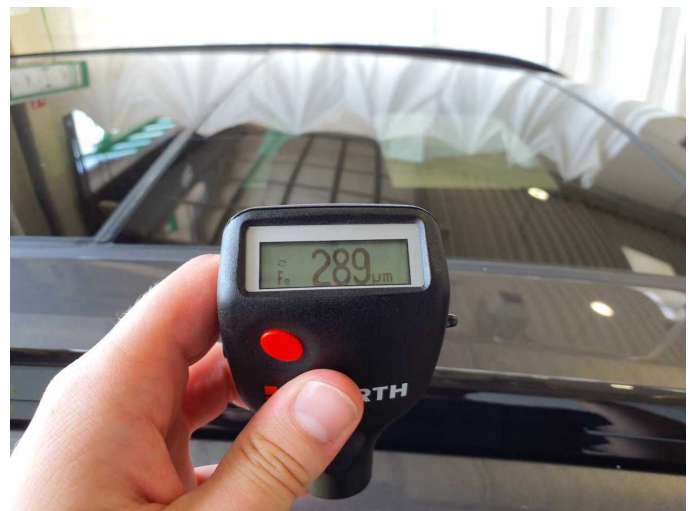
1 Roof, Professionally carried out, Invoice of repair done Non-existent

Roof 289 µm

**Repainting 1:** Roof
