Expertise

Protocol number: 46865961  
Order No. / Reference: 26622594  
Inspection date: 17 Jul 2026

Manufacturer: Opel

Model: Grandland 1.5 D Automatik Elegance

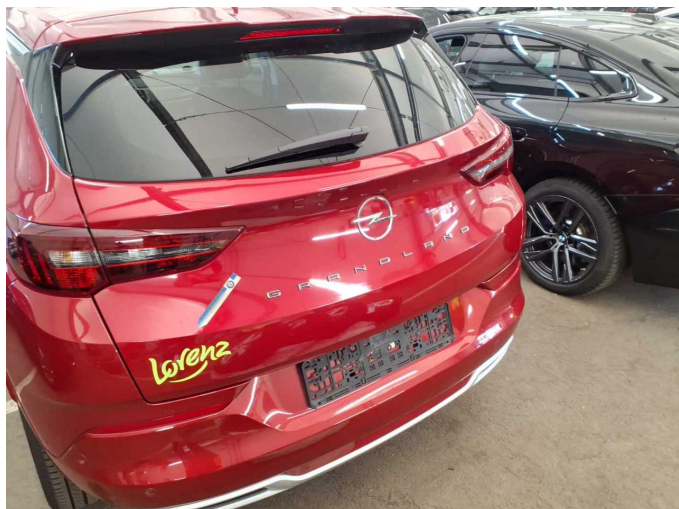
| No. | Component group | Description |
|---|---|---|
| 1 | Boot lid / rear door | Boot lid - Glued / labelled - De-glue / neutralise |

**Damage 1:** Boot lid / rear door: Boot lid - Glued / labelled - De-glue / neutralise

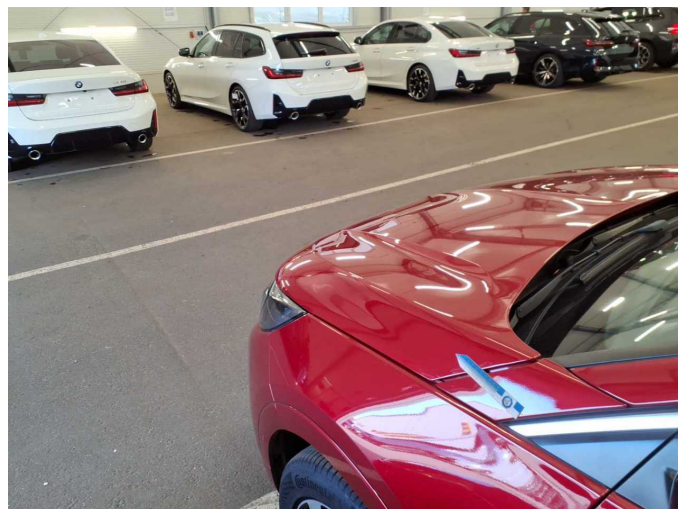
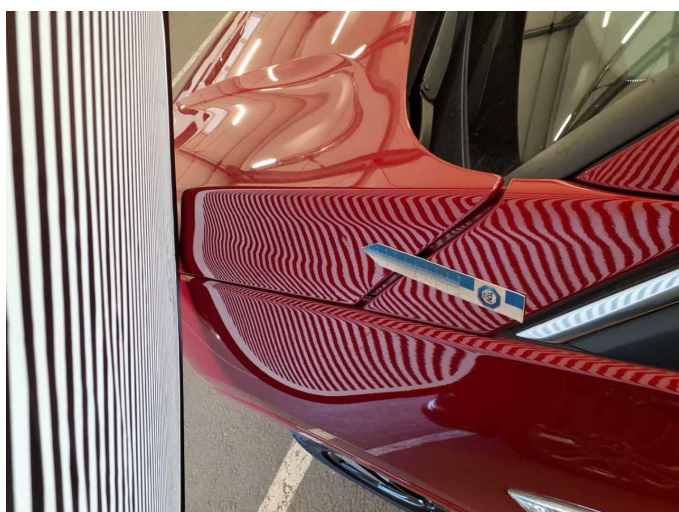
| No. | Component group | Description |
|---|---|---|
| 2 | Bonnet | Bonnet - dent(s) - Smooth repair work |

**Damage 2:** Bonnet: Bonnet - dent(s) - Smooth repair work

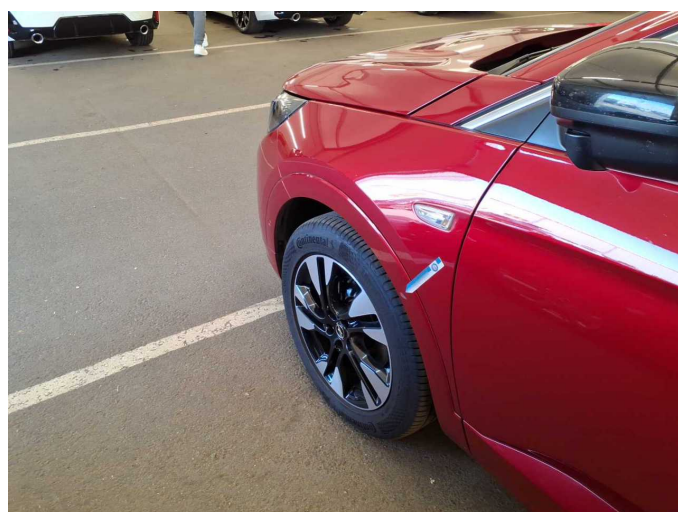
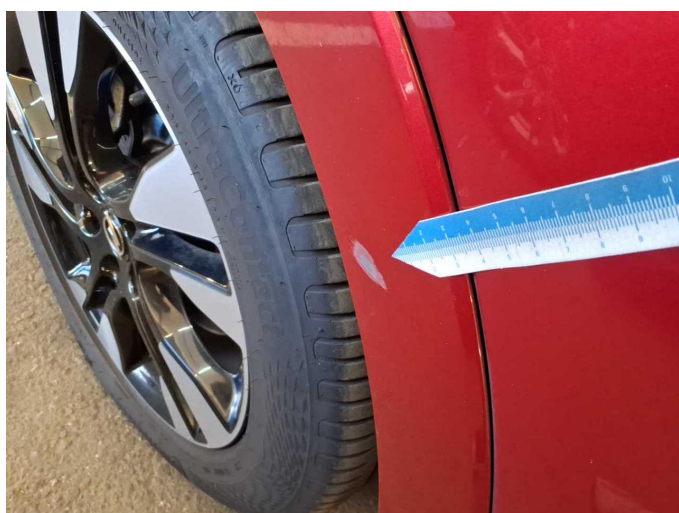
| No. | Component group | Description |
|---|---|---|
| 3 | Mudguard - left side | Wheel well extension - Scratched - Smart repair |

**Damage 3:** Mudguard - left side: Wheel well extension - Scratched - Smart repair

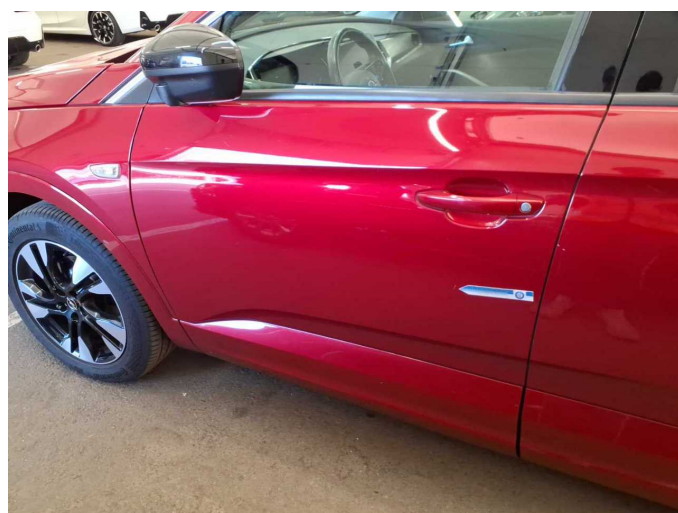
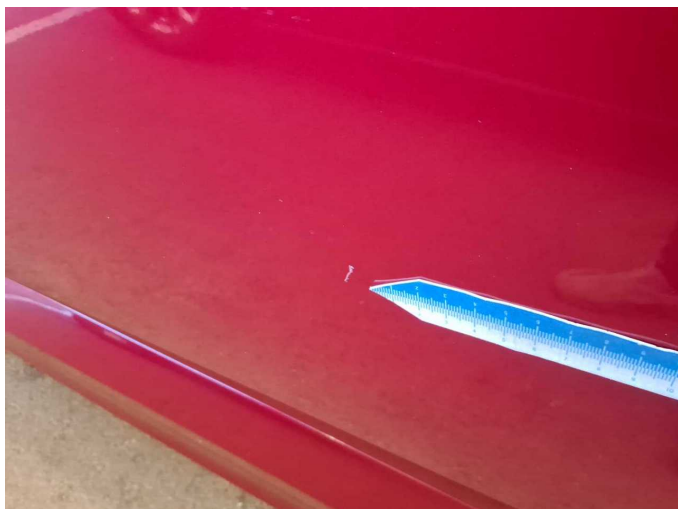
| No. | Component group | Description |
|---|---|---|
| 4 | Door - front left side | Door - Scratch(es) - Smart repair |

**Damage 4:** Door - front left side: Door - Scratch(es) - Smart repair

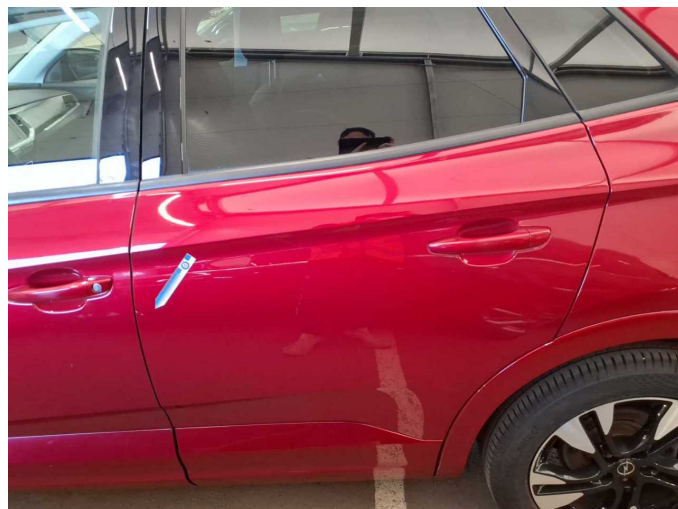
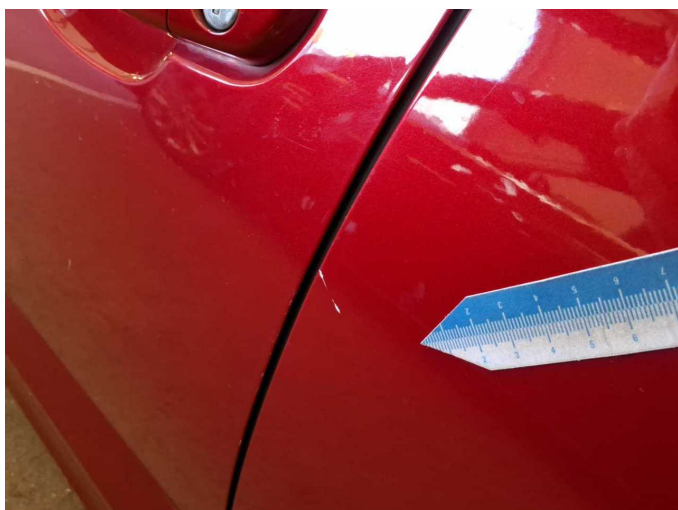
| No. | Component group | Description |
|---|---|---|
| 5 | Door - rear left side | Door - Scratch(es) - Smart repair |

**Damage 5:** Door - rear left side: Door - Scratch(es) - Smart repair

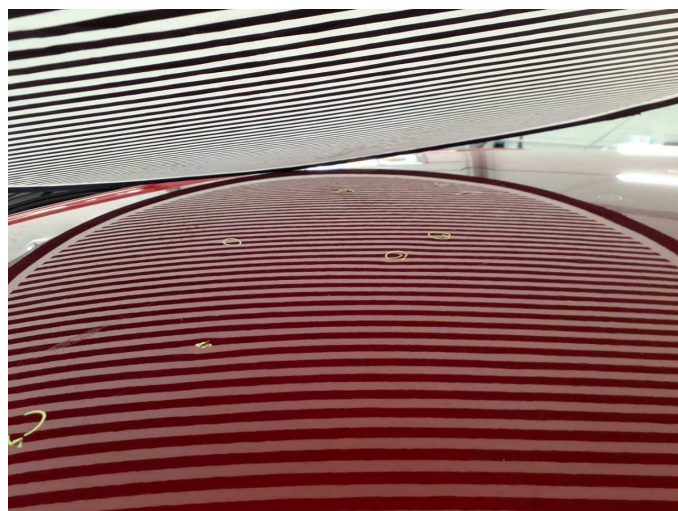
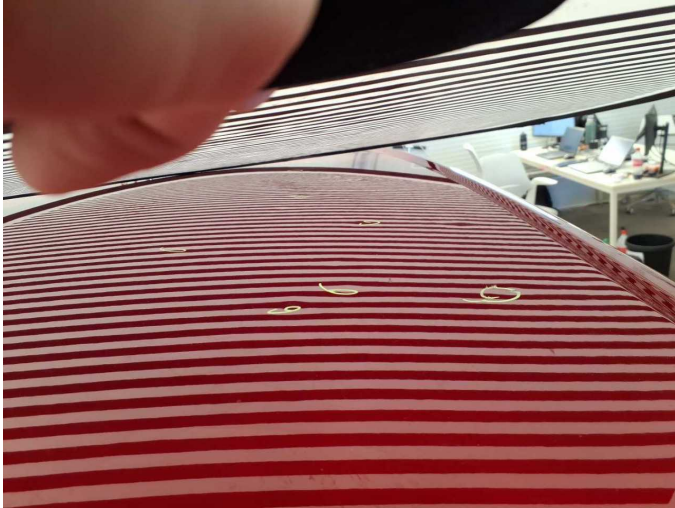
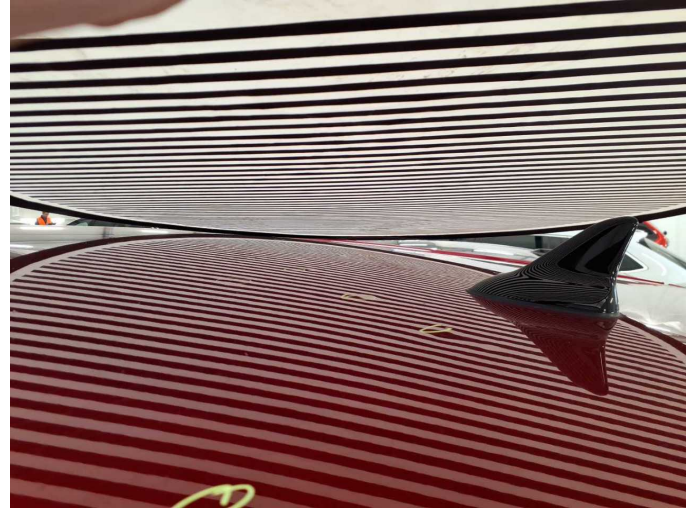
| No. | Component group | Description |
|---|---|---|
| 7 | Roof | Roof (30 Dellen auf dem dach mit 2cm Durchmesser) - Damage by hail - Repair |

**Damage 7:** Roof: Roof (30 Dellen auf dem dach mit 2cm Durchmesser) - Damage by hail - Repair

**Damage 7:** Roof: Roof (30 Dellen auf dem dach mit 2cm Durchmesser) -  
Damage by hail - Repair
