Expertise

Protocol number: 44657566
Order number / reference: 26109586
Inspection date: 16 Mar 2026

Model: Insignia Sports Tourer 2.0 Diesel Aut. Ultimate

VIN: W0VZS8GP6N1044823

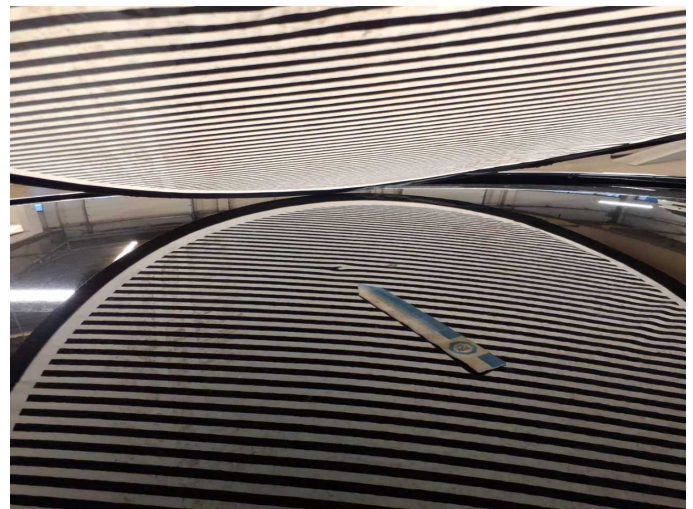
Damage 2: Roof: Roof - dent(s) - Smooth repair work

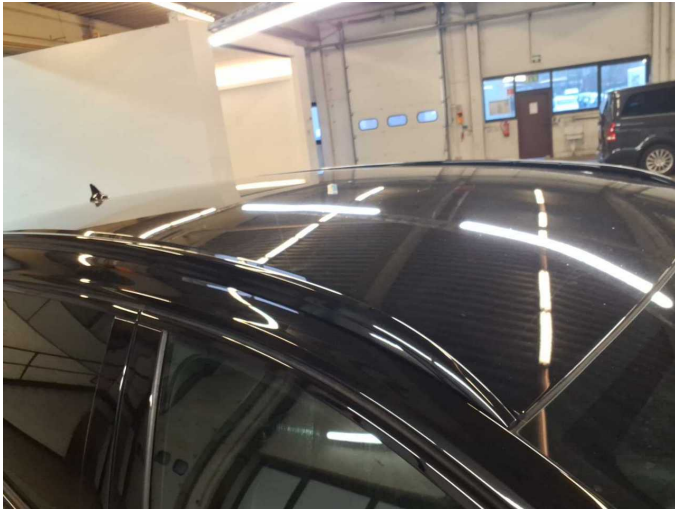
Damage 2: Roof: Roof - dent(s) - Smooth repair work

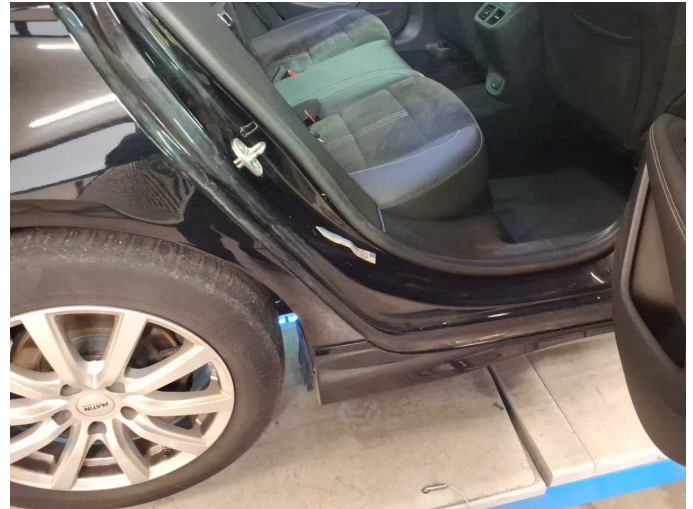
Damage 3: Side panel - rear right side: Sill - Dent / paintcoat damage - Smart repair

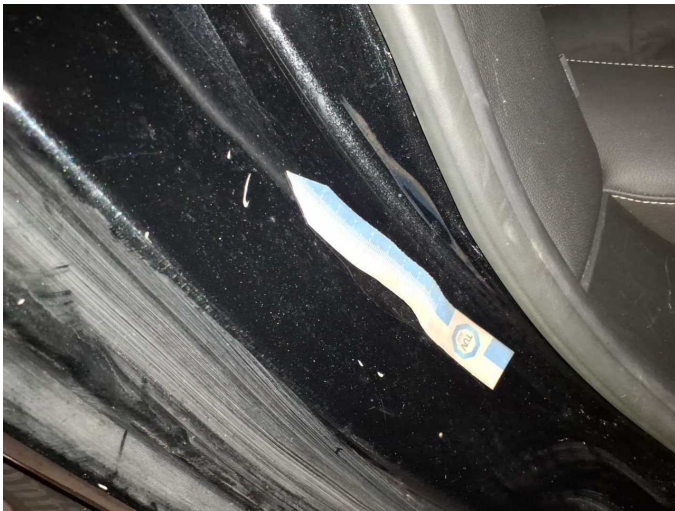
Damage 3: Side panel - rear right side: Sill - Dent / paintcoat damage - Smart repair

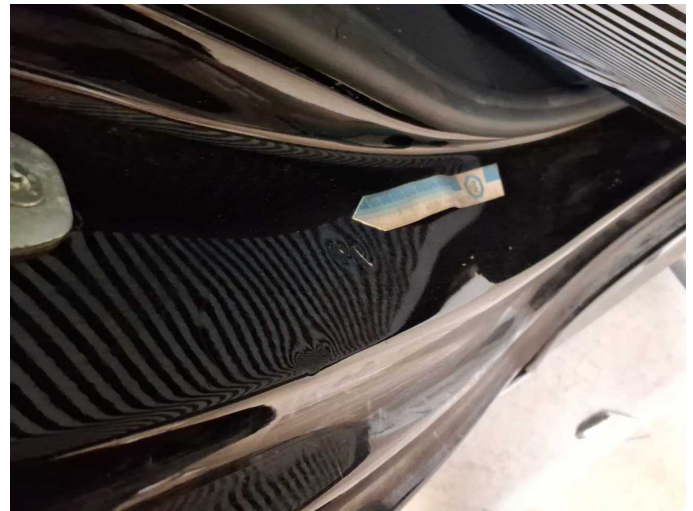
Damage 3: Side panel - rear right side: Sill - Dent / paintcoat damage - Smart repair

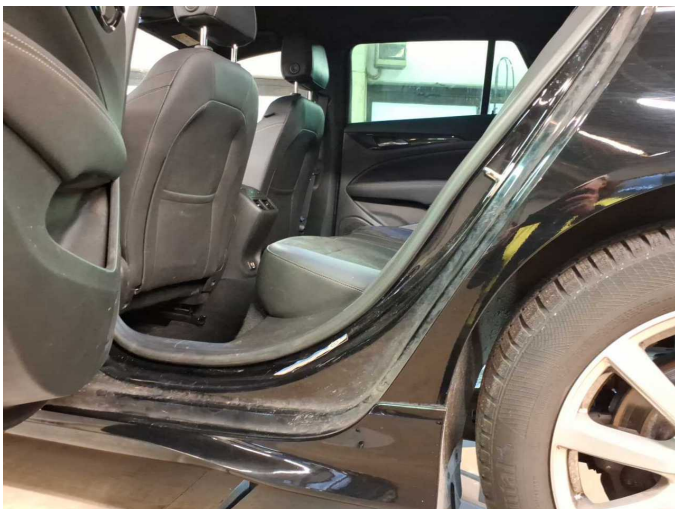
Damage 4: Side panel - rear left side: Sill - Scratched - Smart repair

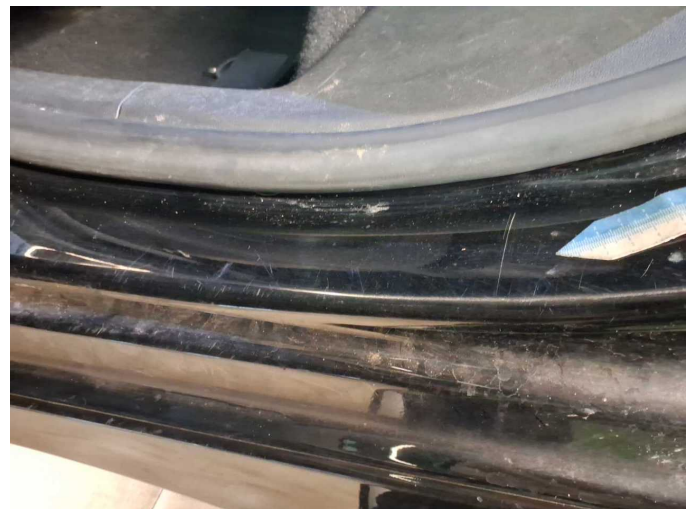
Damage 4: Side panel - rear left side: Sill - Scratched - Smart repair

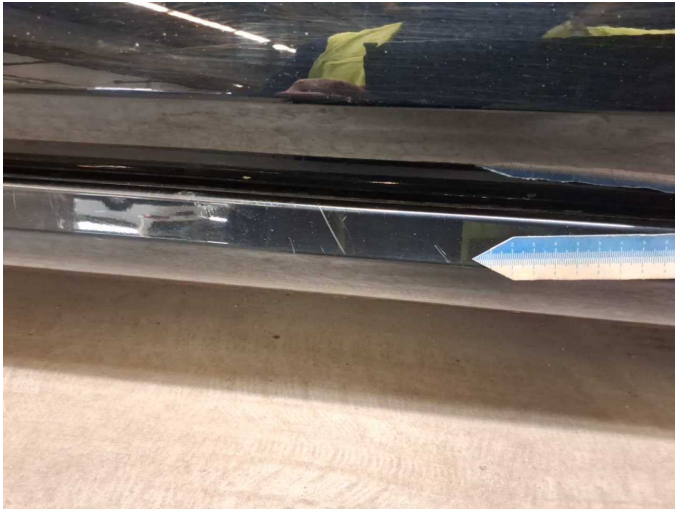
Damage 5: Sill - left side: Trim - Scratched - Smart repair

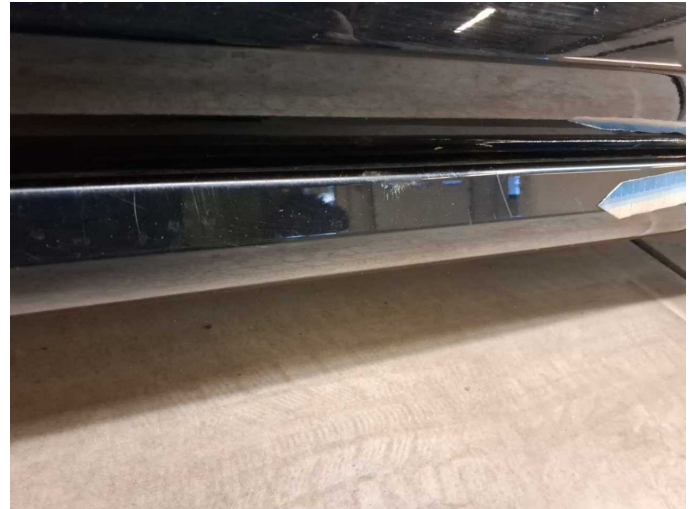
Damage 5: Sill - left side: Trim - Scratched - Smart repair

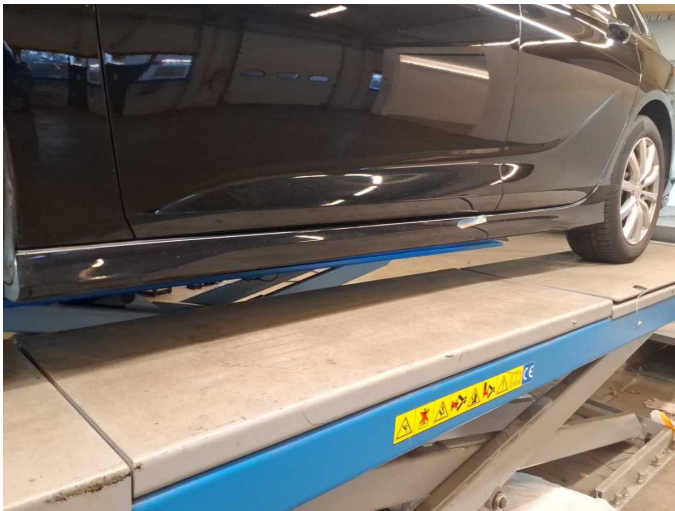
Damage 5: Sill - left side: Trim - Scratched - Smart repair

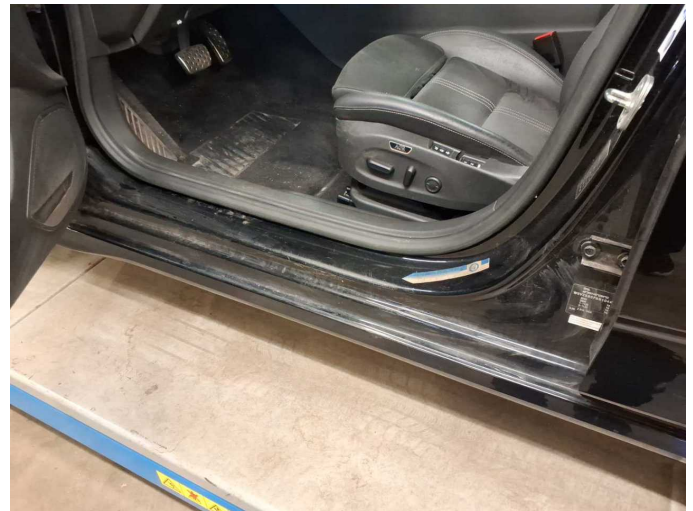
Damage 6: Sill - left side: Sill - Scratched - Smart repair

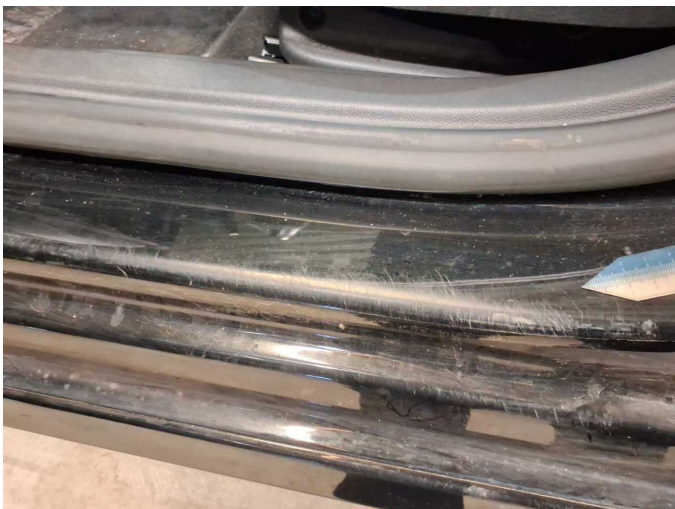
Damage 6: Sill - left side: Sill - Scratched - Smart repair

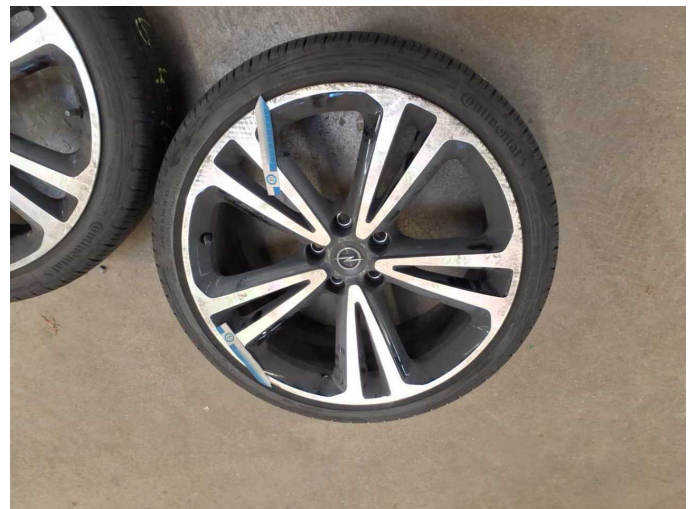
Damage 8: 2nd wheel set: 3 tyres (245 35 r 20 Sommer) - Broken / torn - Replace

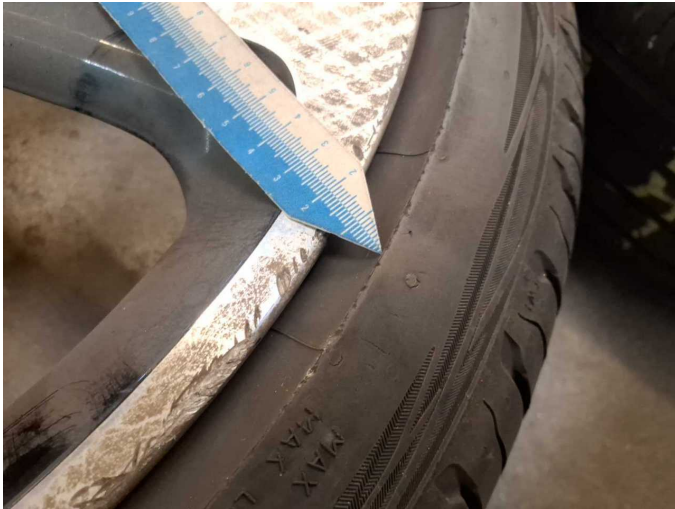
Damage 8: 2nd wheel set: 3 tyres (245 35 r 20 Sommer) - Broken / torn - Replace

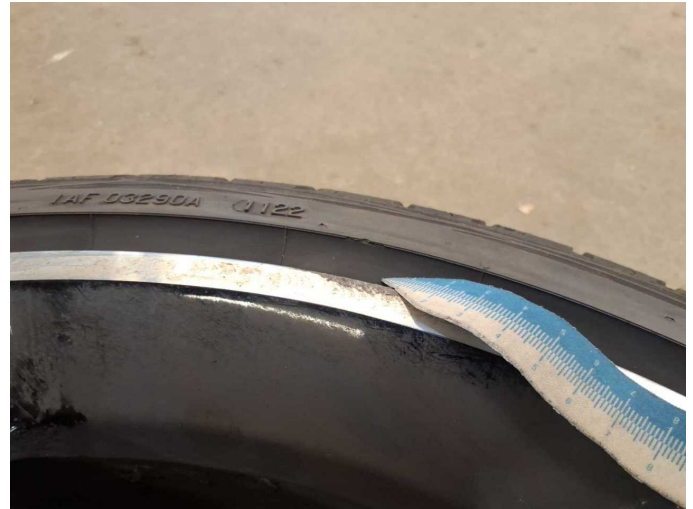
Damage 8: 2nd wheel set: 3 tyres (245 35 r 20 Sommer) - Broken / torn - Replace

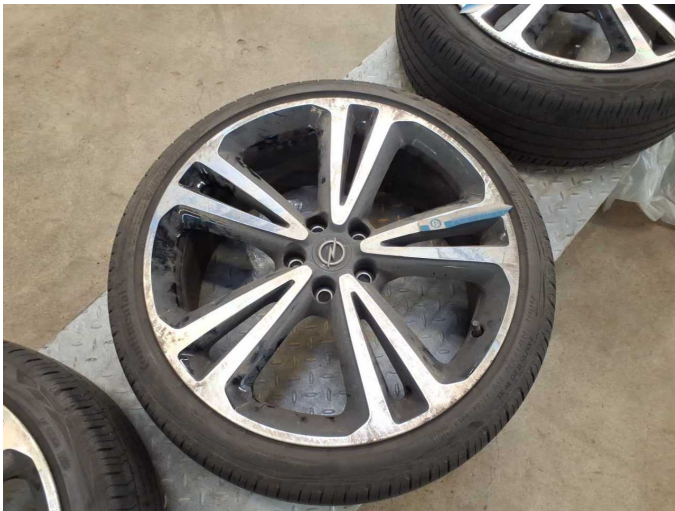
Damage 8: 2nd wheel set: 3 tyres (245 35 r 20 Sommer) - Broken / torn - Replace

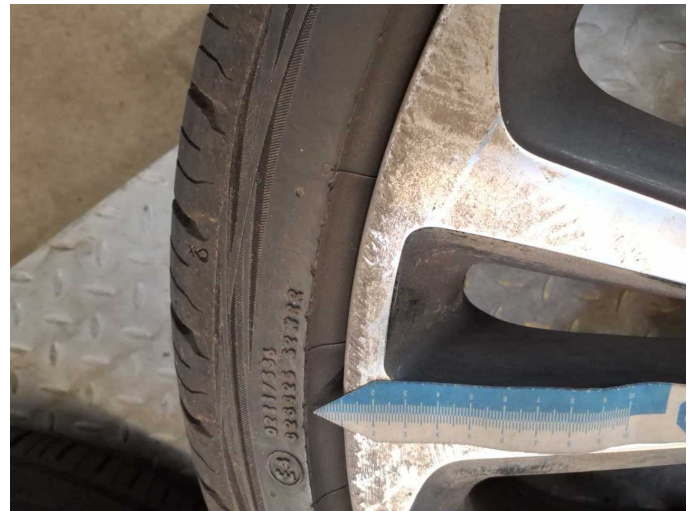
Damage 8: 2nd wheel set: 3 tyres (245 35 r 20 Sommer) - Broken / torn - Replace

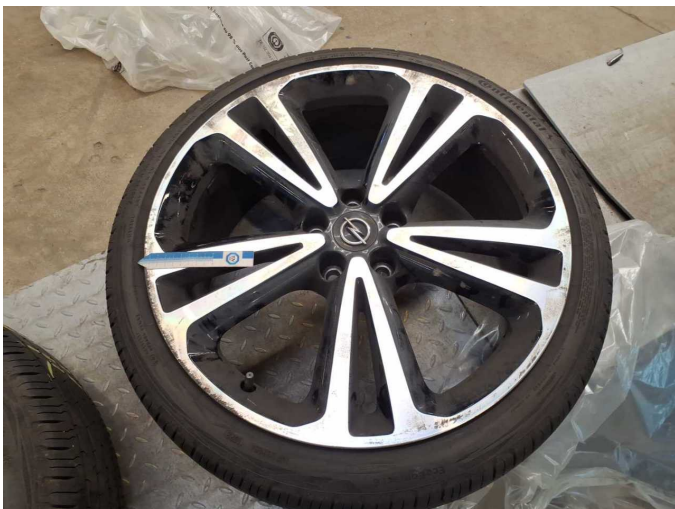
Damage 8: 2nd wheel set: 3 tyres (245 35 r 20 Sommer) - Broken / torn - Replace

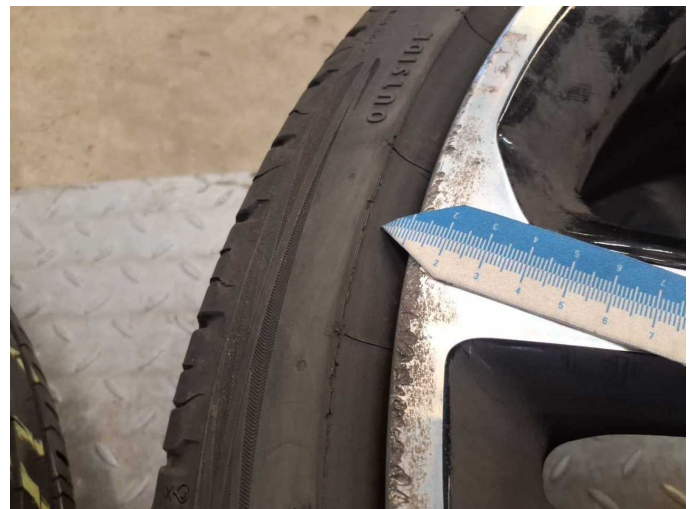
Damage 8: 2nd wheel set: 3 tyres (245 35 r 20 Sommer) - Broken / torn - Replace

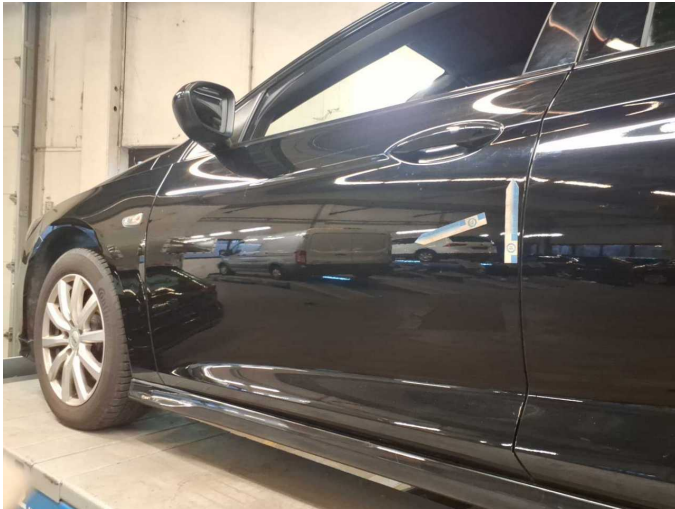
Damage 9: Door - front left side: Door - Scratched - Paint

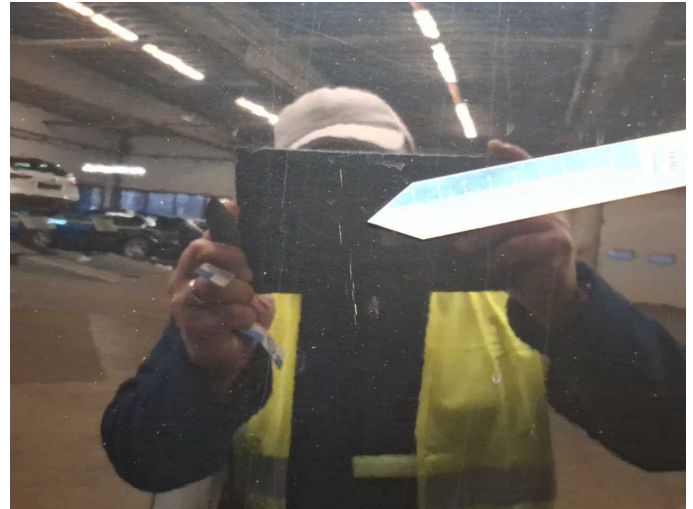
Damage 9: Door - front left side: Door - Scratched - Paint

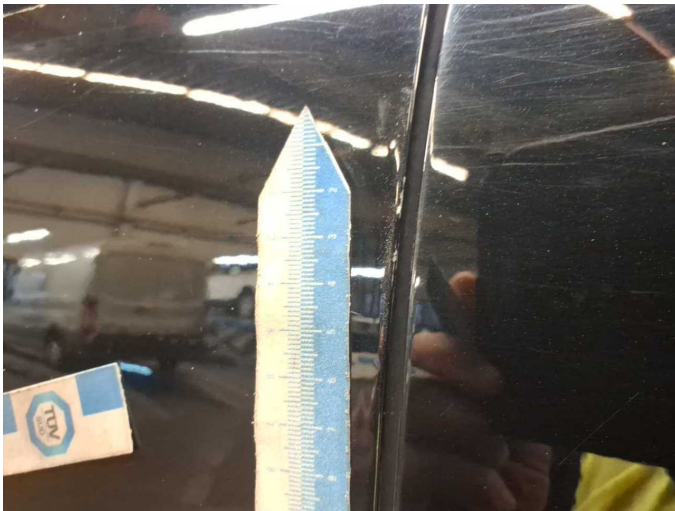
Damage 9: Door - front left side: Door - Scratched - Paint

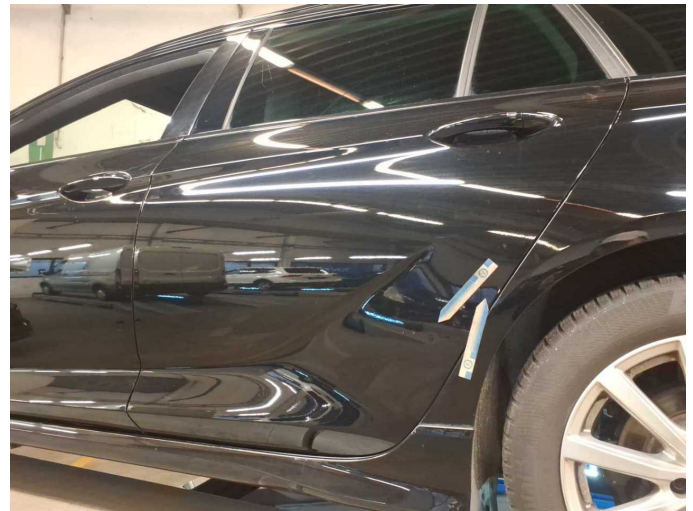
Damage 10: Door - rear left side: Door - Dent / paintcoat damage - Repair and paint

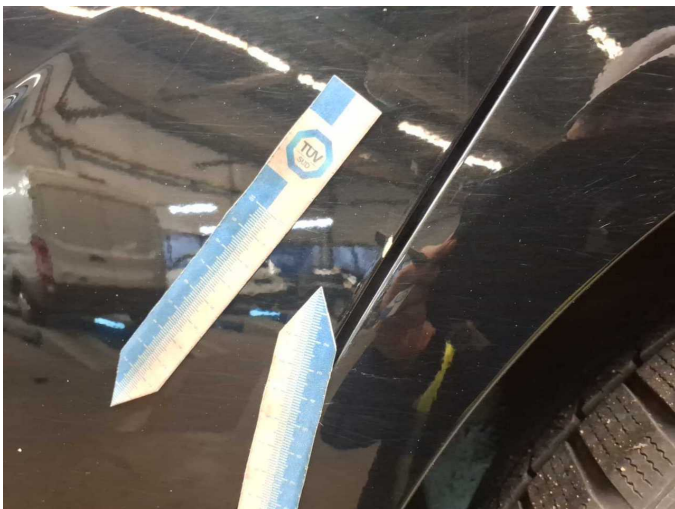
Damage 10: Door - rear left side: Door - Dent / paintcoat damage - Repair and paint

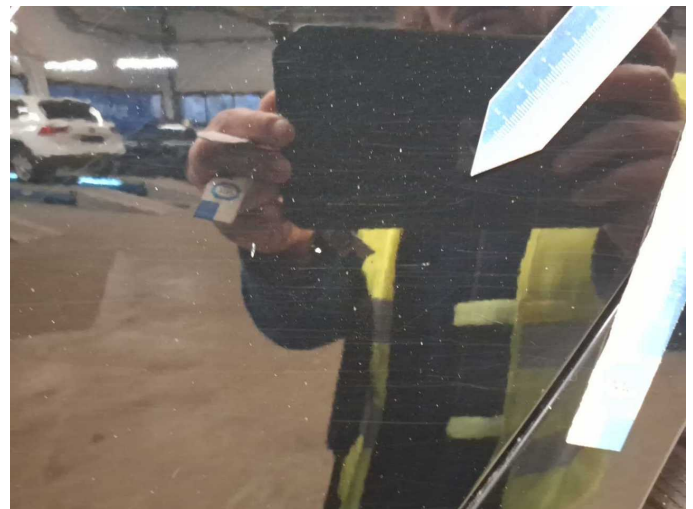
Damage 10: Door - rear left side: Door - Dent / paintcoat damage - Repair and paint

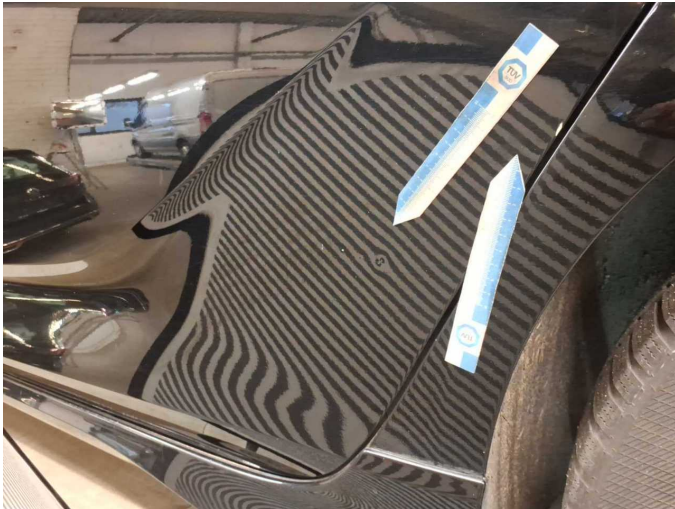
Damage 10: Door - rear left side: Door - Dent / paintcoat damage - Repair and paint

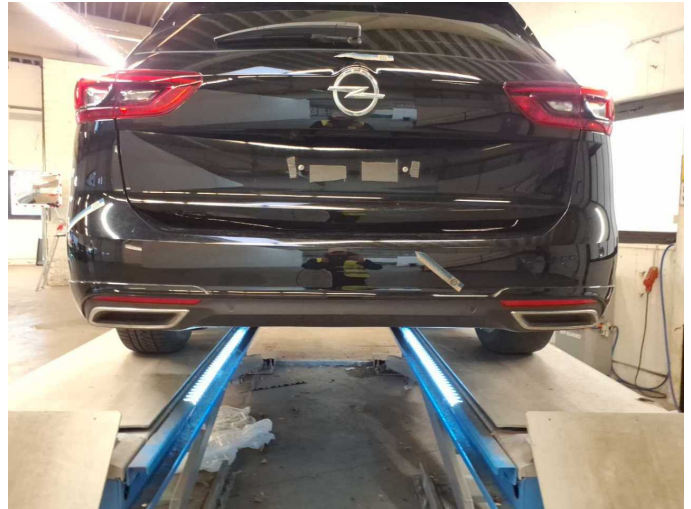
Damage 11: Rear bumper: Rear bumper - Scratched - Paint

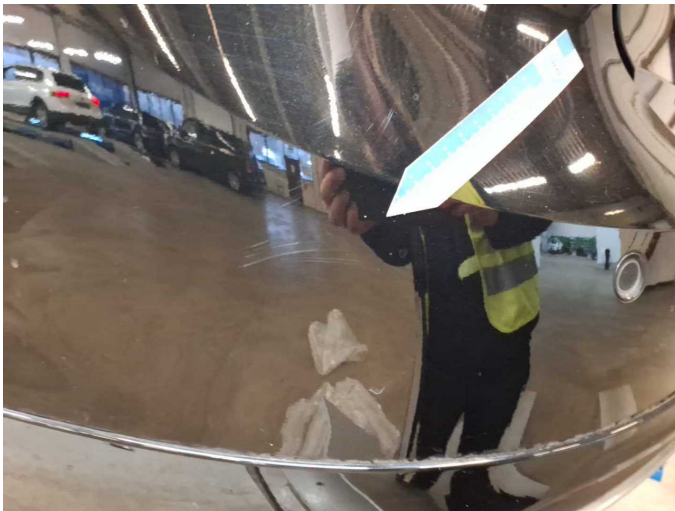
Damage 11: Rear bumper: Rear bumper - Scratched - Paint

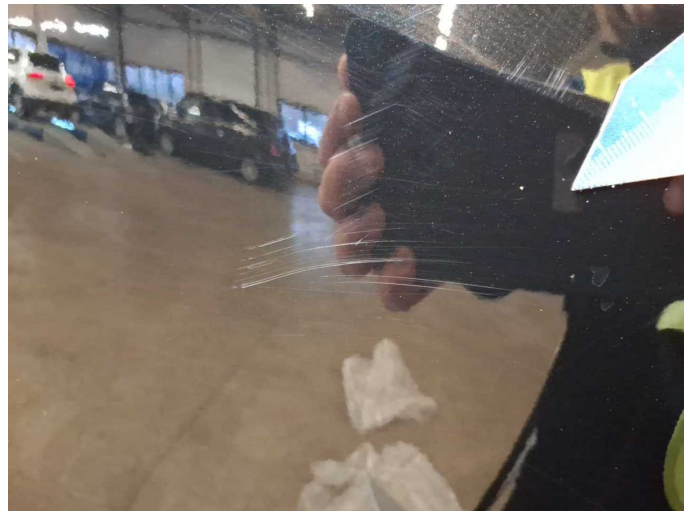
Damage 11: Rear bumper: Rear bumper - Scratched - Paint

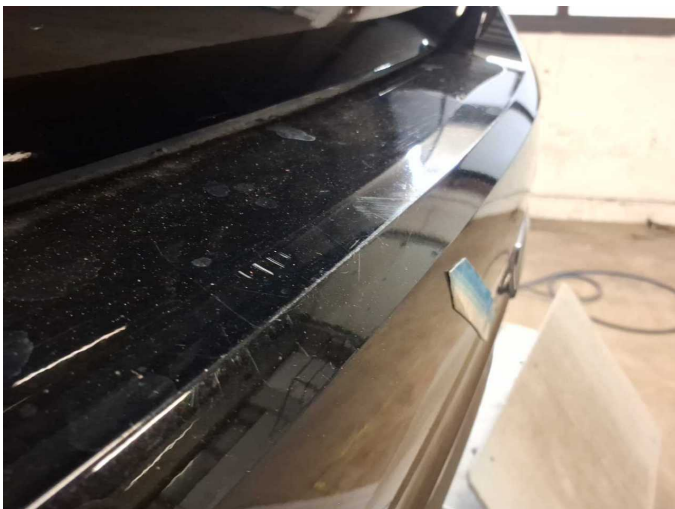
Damage 11: Rear bumper: Rear bumper - Scratched - Paint

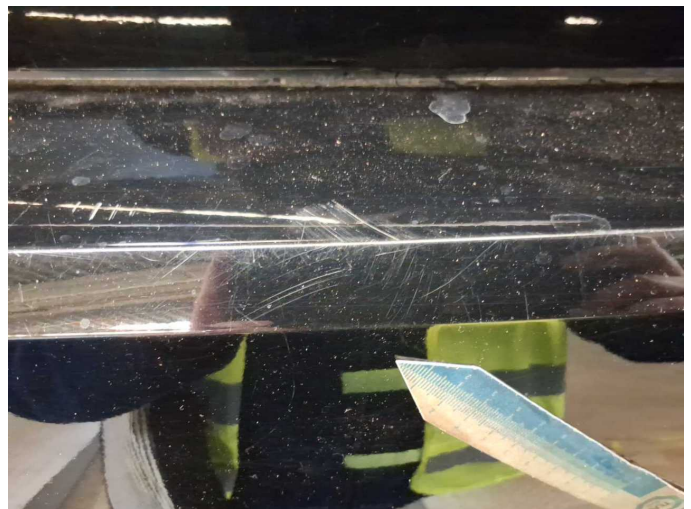
Damage 11: Rear bumper: Rear bumper - Scratched - Paint

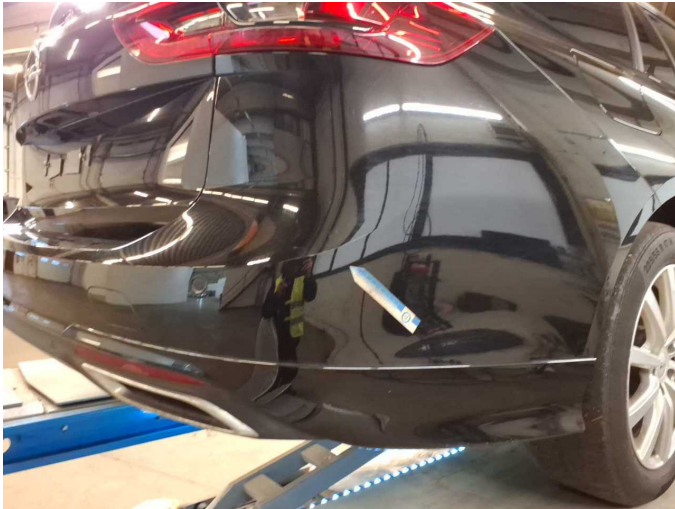
Damage 11: Rear bumper: Rear bumper - Scratched - Paint

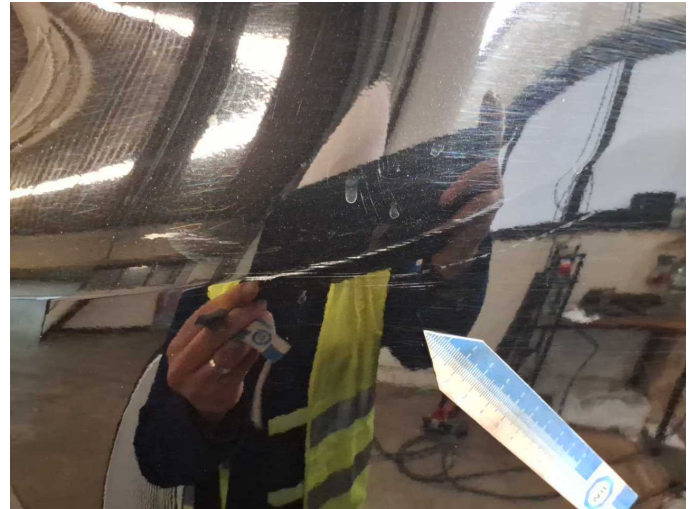
Damage 11: Rear bumper: Rear bumper - Scratched - Paint

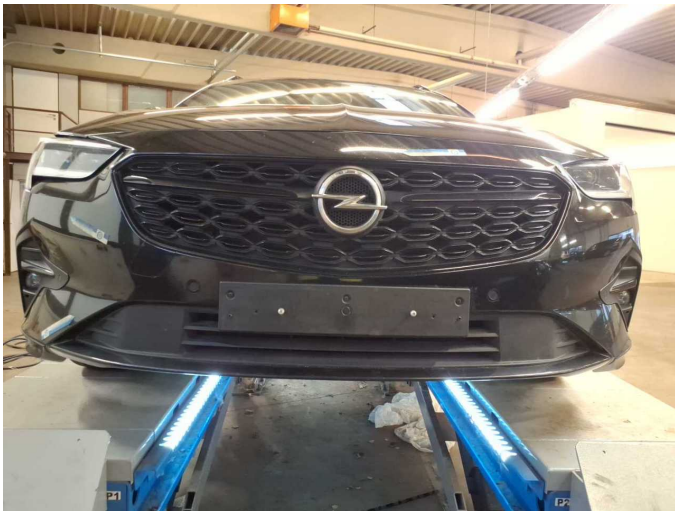
Damage 12: Front bumper: Front bumper - Stone chips - Paint

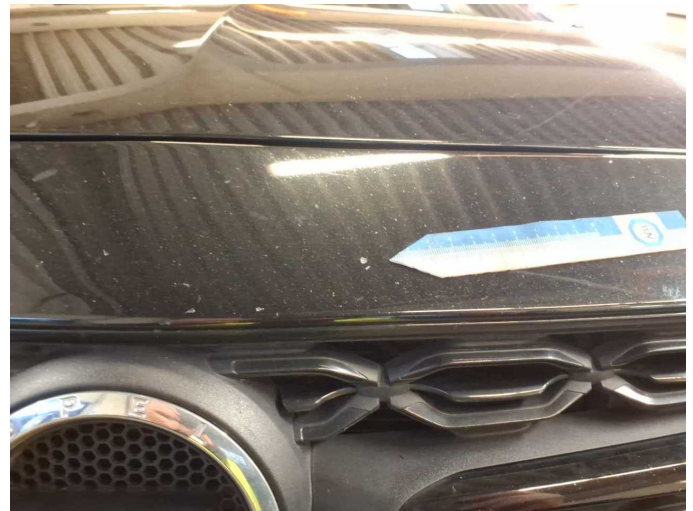
Damage 12: Front bumper: Front bumper - Stone chips - Paint

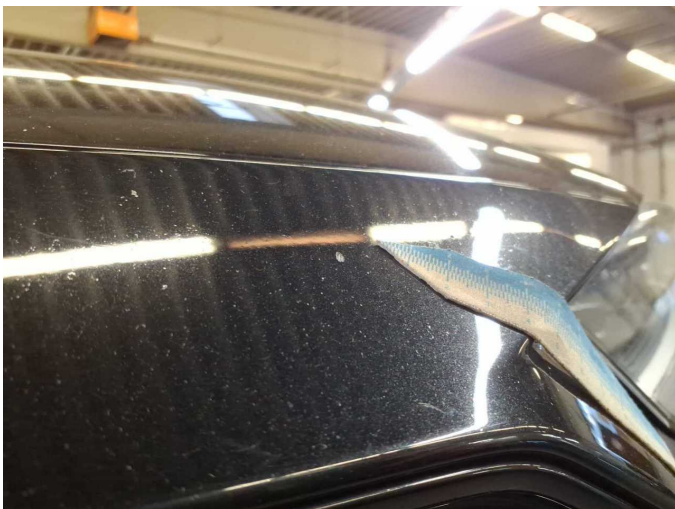
Damage 12: Front bumper: Front bumper - Stone chips - Paint

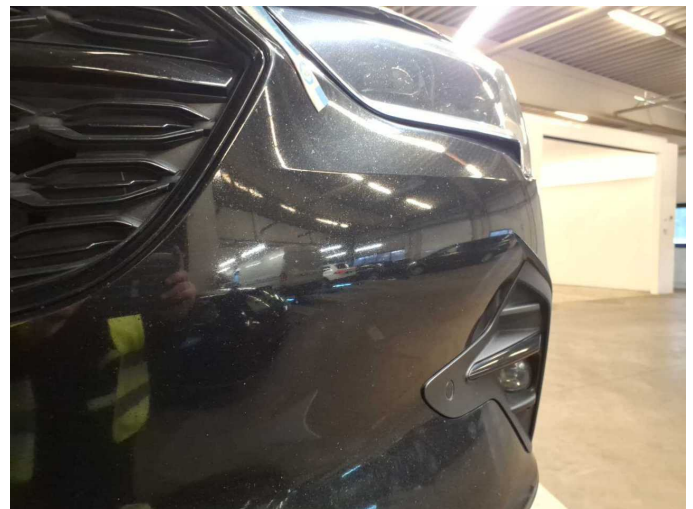
Damage 12: Front bumper: Front bumper - Stone chips - Paint

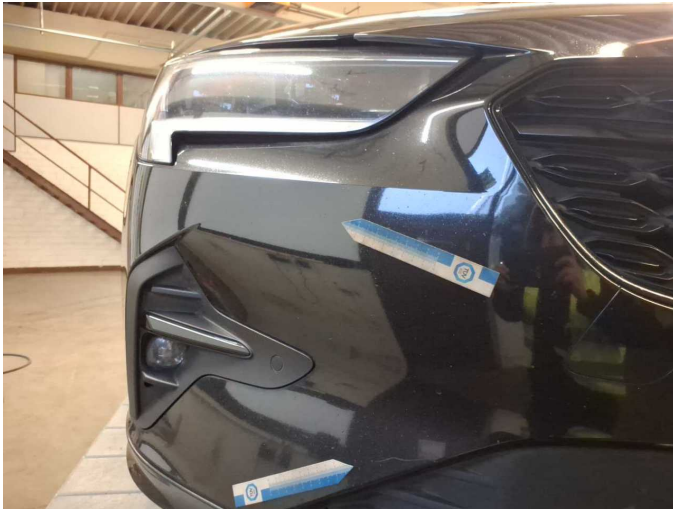
Damage 12: Front bumper: Front bumper - Stone chips - Paint

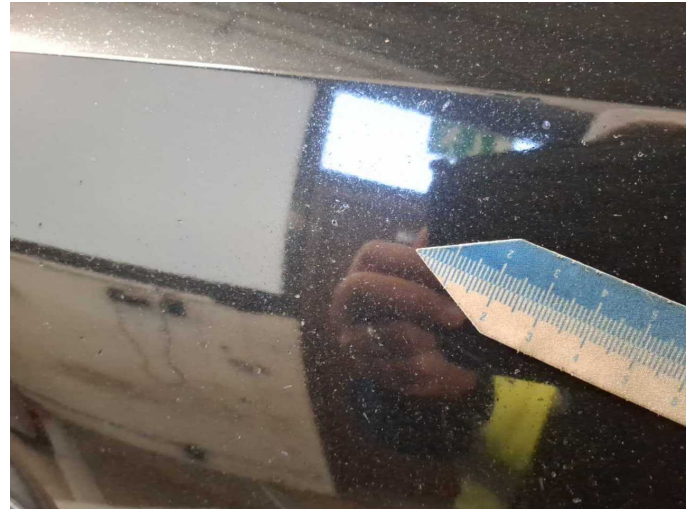
Damage 12: Front bumper: Front bumper - Stone chips - Paint

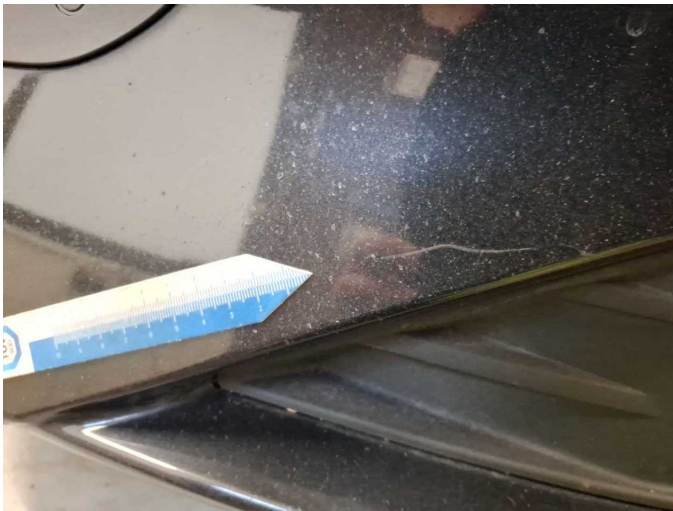
Damage 12: Front bumper: Front bumper - Stone chips - Paint

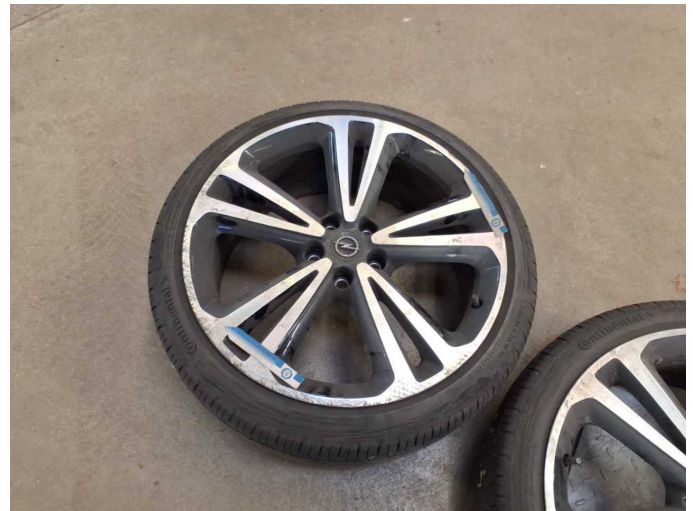
Damage 13: 2nd wheel set: 3 alloy rims (Materialabtrag) - Scratched - repair according to calculation

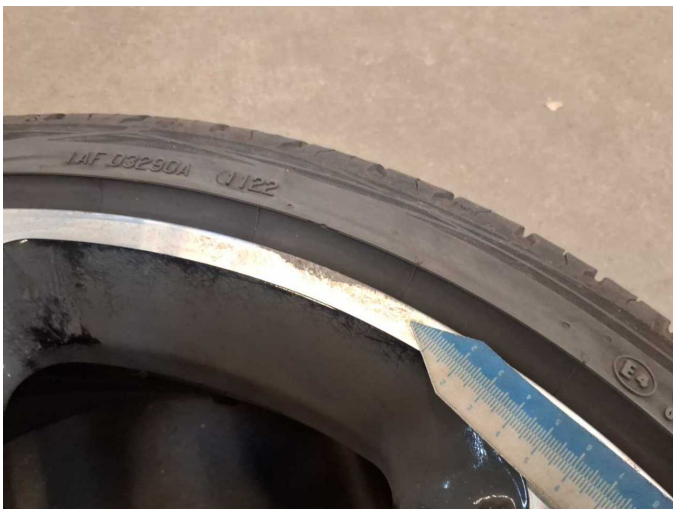
Damage 13: 2nd wheel set: 3 alloy rims (Materialabtrag) - Scratched - repair according to calculation

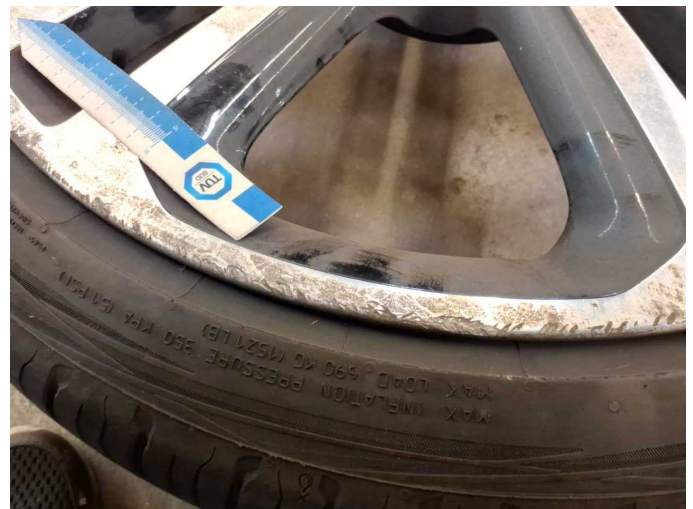
Damage 13: 2nd wheel set: 3 alloy rims (Materialabtrag) - Scratched - repair according to calculation

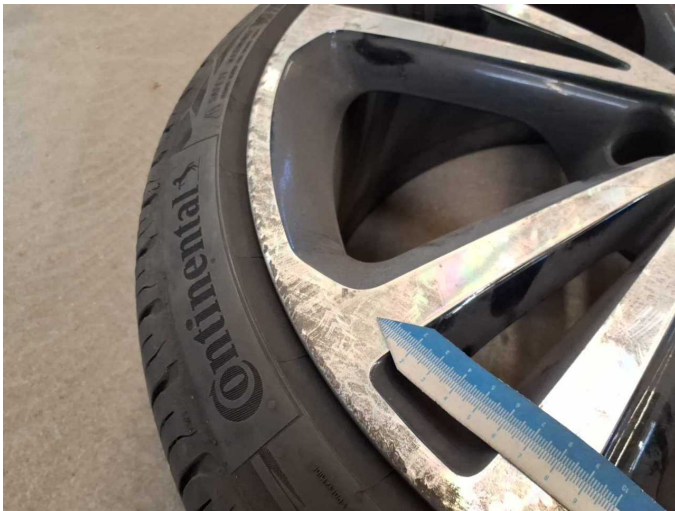
Damage 13: 2nd wheel set: 3 alloy rims (Materialabtrag) - Scratched - repair according to calculation

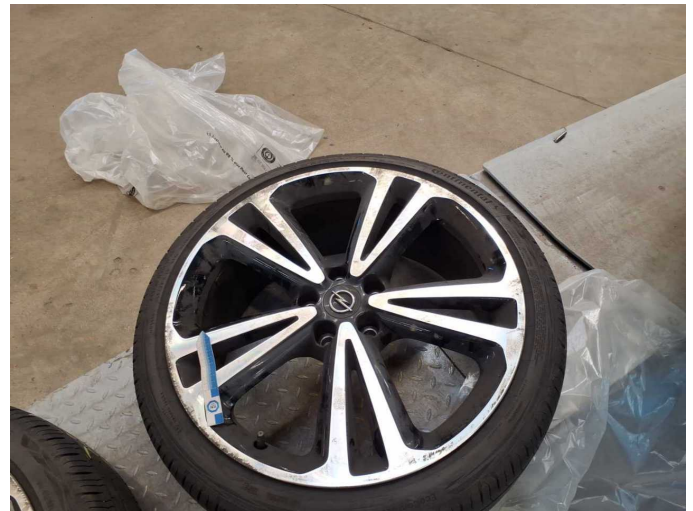
Damage 13: 2nd wheel set: 3 alloy rims (Materialabtrag) - Scratched - repair according to calculation

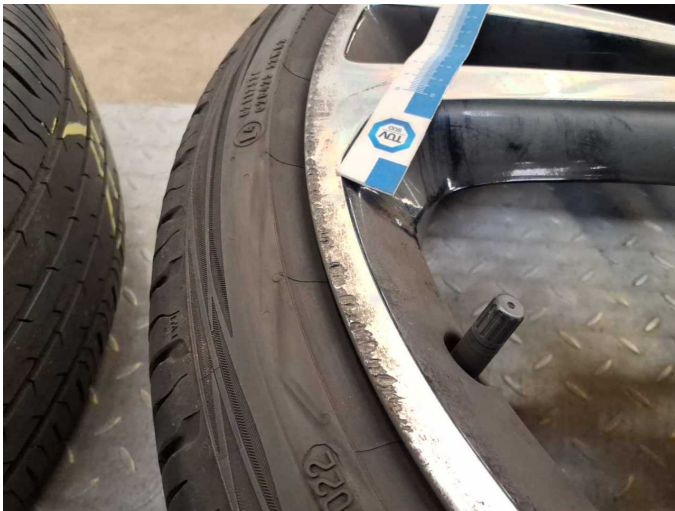
Damage 13: 2nd wheel set: 3 alloy rims (Materialabtrag) - Scratched - repair according to calculation

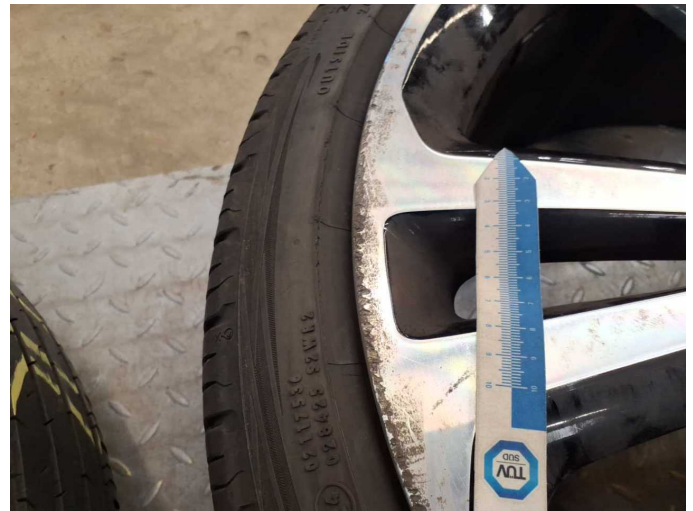
Damage 13: 2nd wheel set: 3 alloy rims (Materialabtrag) - Scratched - repair according to calculation

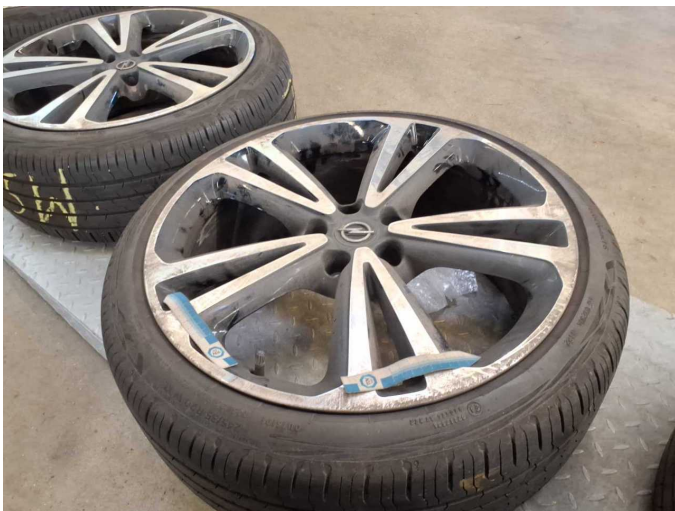
Damage 13: 2nd wheel set: 3 alloy rims (Materialabtrag) - Scratched - repair according to calculation

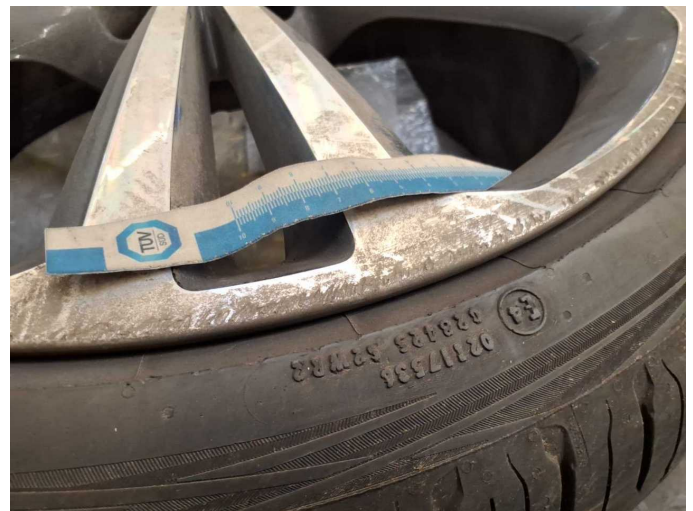
Damage 13: 2nd wheel set: 3 alloy rims (Materialabtrag) - Scratched - repair according to calculation

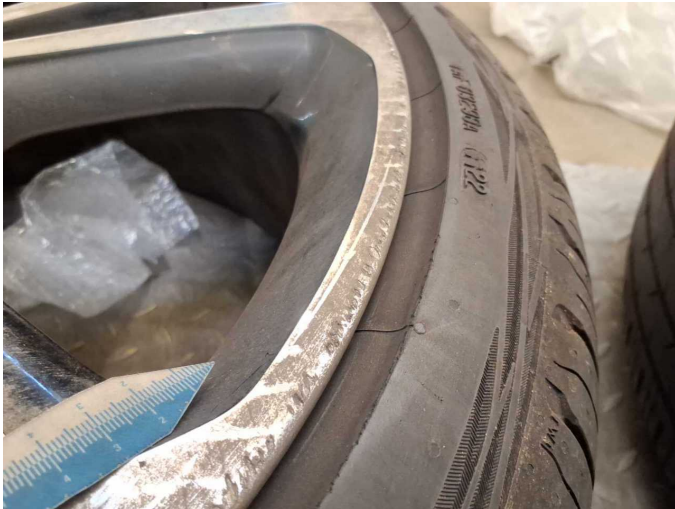
Damage 13: 2nd wheel set: 3 alloy rims (Materialabtrag) - Scratched - repair according to calculation

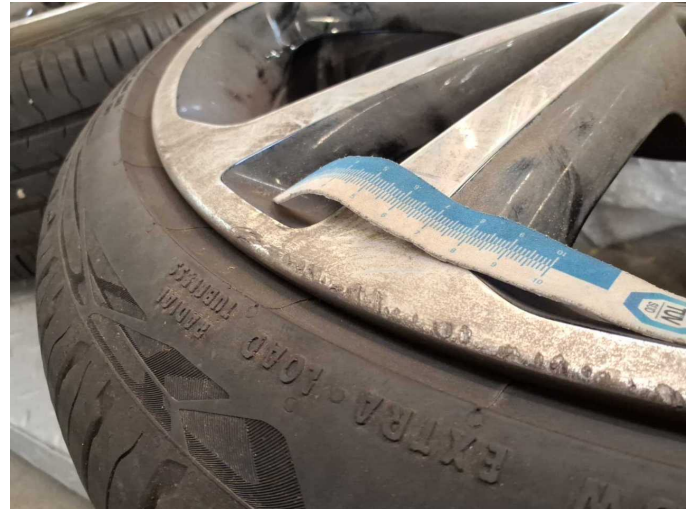
Damage 13: 2nd wheel set: 3 alloy rims (Materialabtrag) - Scratched - repair according to calculation

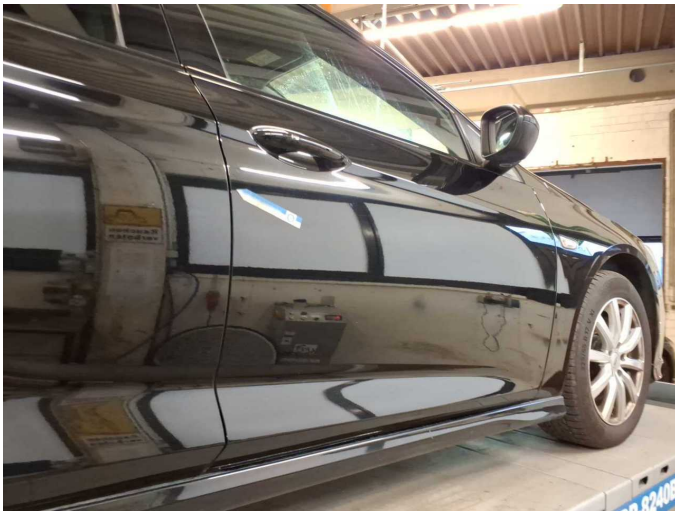
Wear and tear 1: Door - front right side: Door edge - Scratched - No deduction

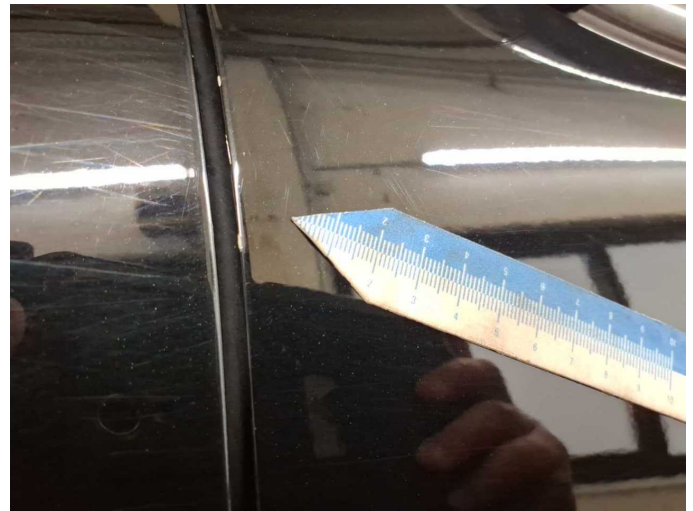
Wear and tear 1: Door - front right side: Door edge - Scratched - No deduction

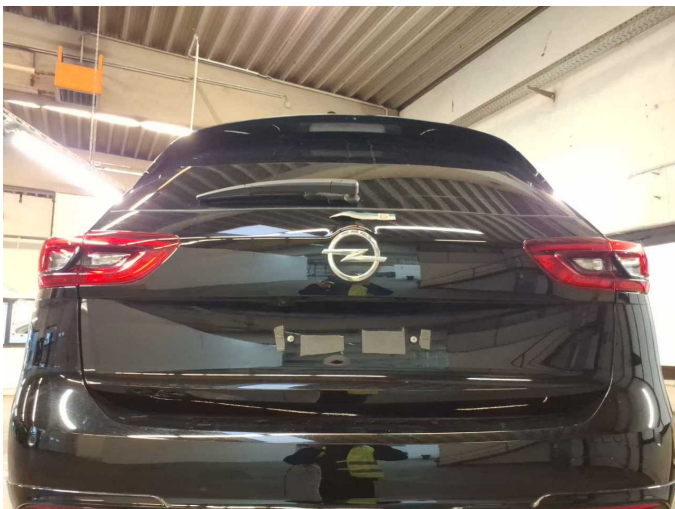
Wear and tear 2: Boot lid / rear door: Boot lid - dent(s) - Smooth repair work

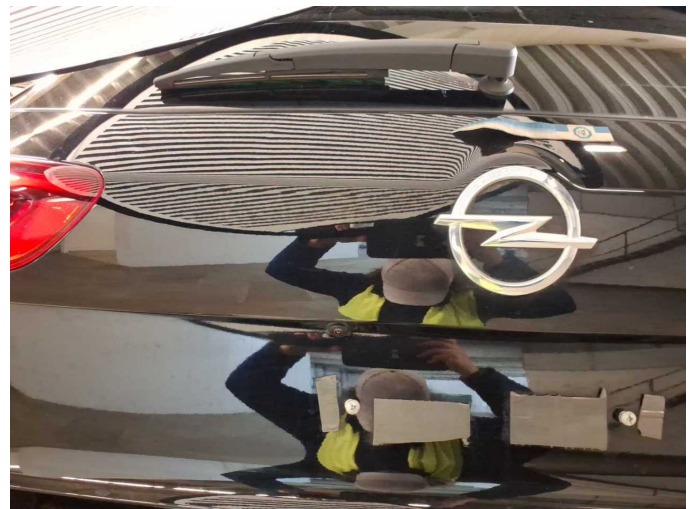
Wear and tear 2: Boot lid / rear door: Boot lid - dent(s) - Smooth repair work
