Expertise

Protocol number: 45941219
 Order No. / Reference: 26499938
 Inspection date: 15 Jun 2026

Model: 317 CDI Sprinter Kompakt HA 9G-TRONIC

VIN: W1V9076311P517600

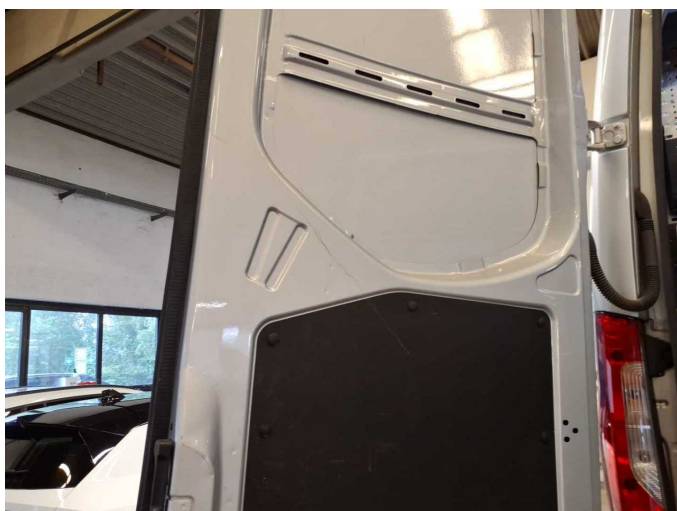
Damage 2: Boot lid / rear door: Rear door - left side - Scratch(es) - Smart repair

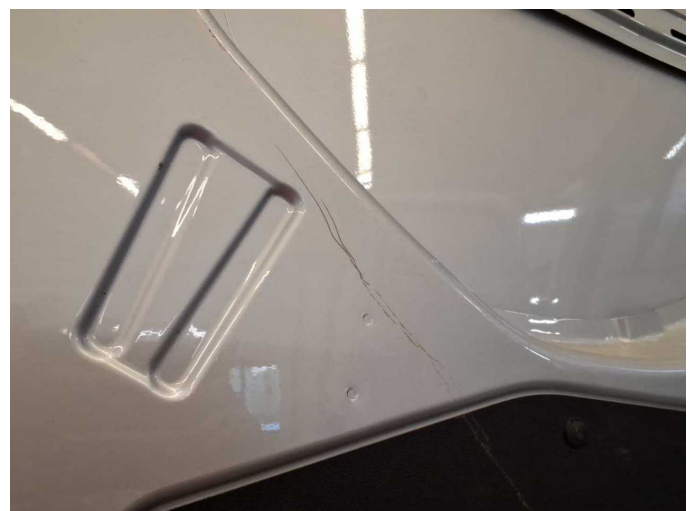
Damage 2: Boot lid / rear door: Rear door - left side - Scratch(es) - Smart repair

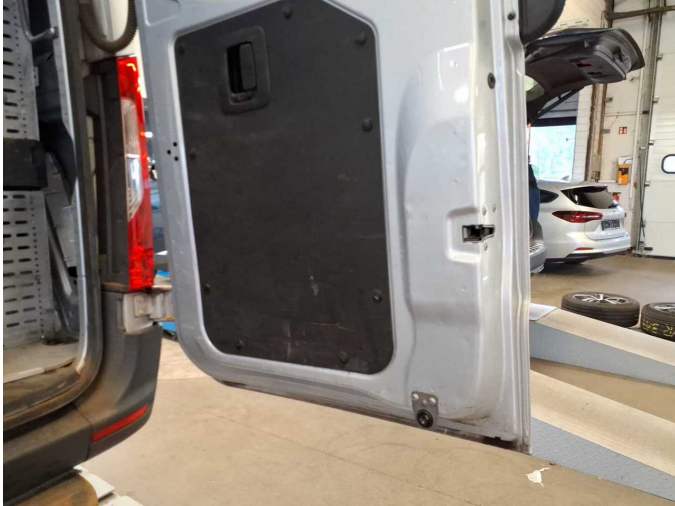
Damage 3: Boot lid / rear door: Rear door - right side (Verkleidung innen)
- Broken / torn - Replace

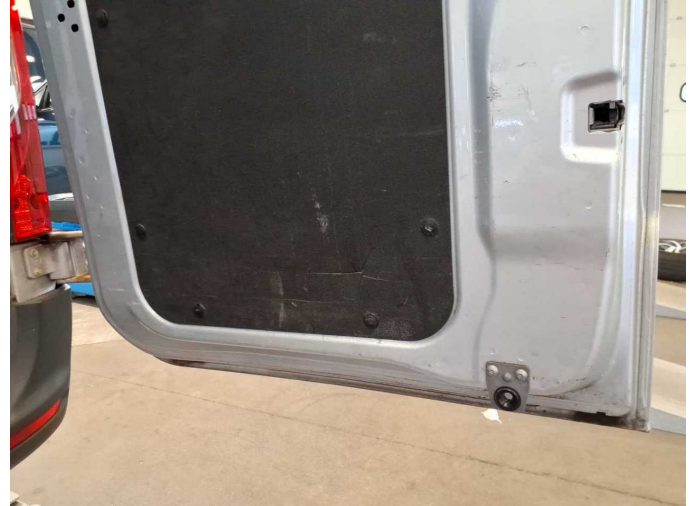
Damage 3: Boot lid / rear door: Rear door - right side (Verkleidung innen)
- Broken / torn - Replace

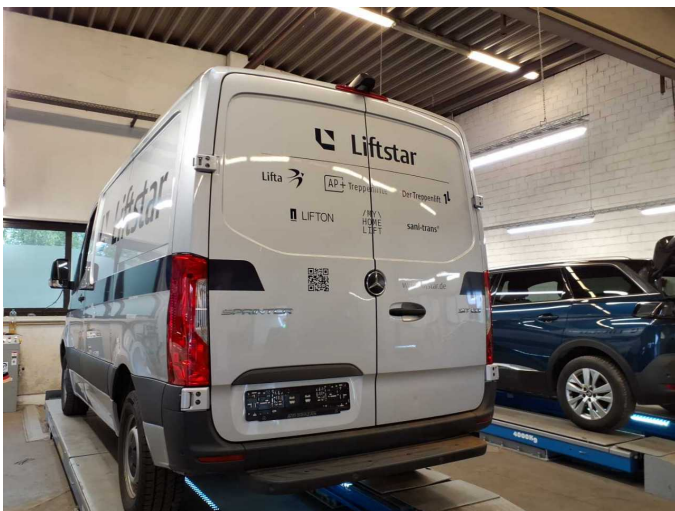
Damage 4: Body: Body - Glued / labelled - De-glug / neutralise

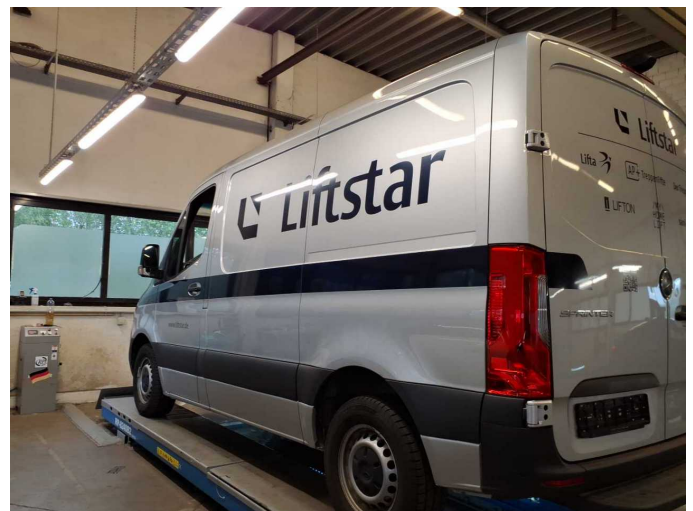
Damage 4: Body: Body - Glued / labelled - De-glug / neutralise

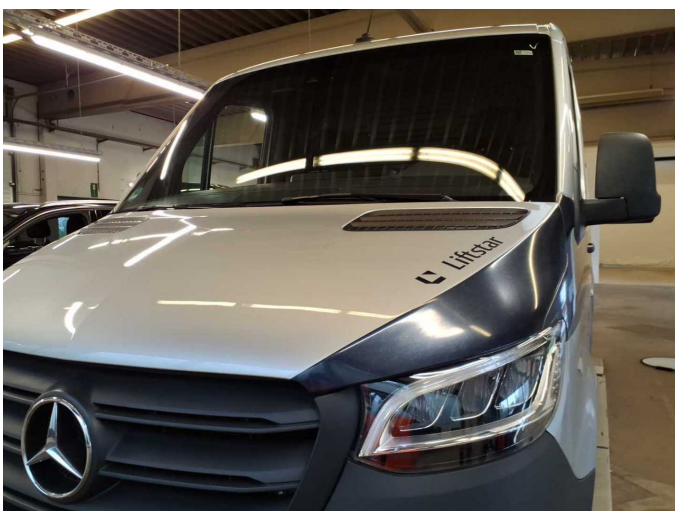
Damage 4: Body: Body - Glued / labelled - De-glug / neutralise

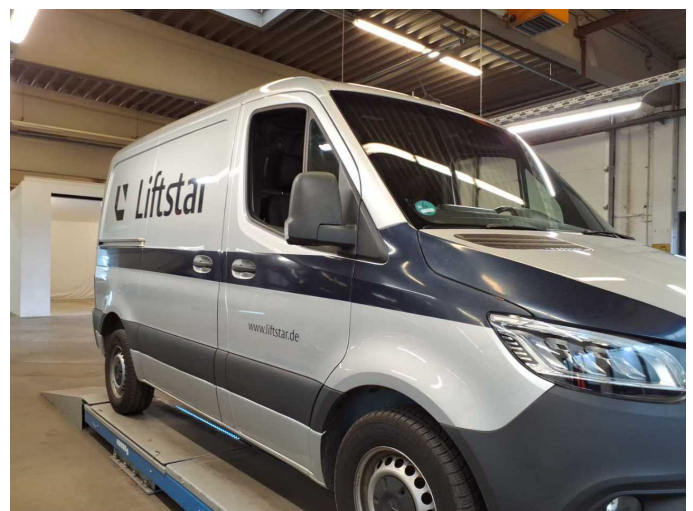
Damage 4: Body: Body - Glued / labelled - De-glug / neutralise

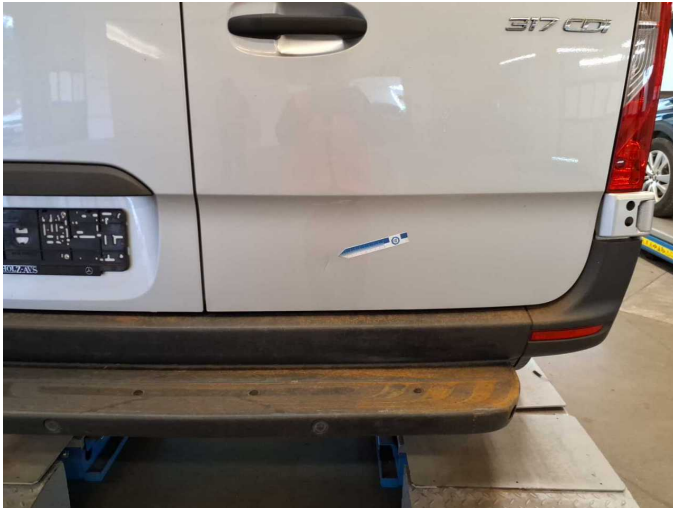
Damage 5: Boot lid / rear door: Rear door - right side - Dent / paintcoat damage - Repair and paint

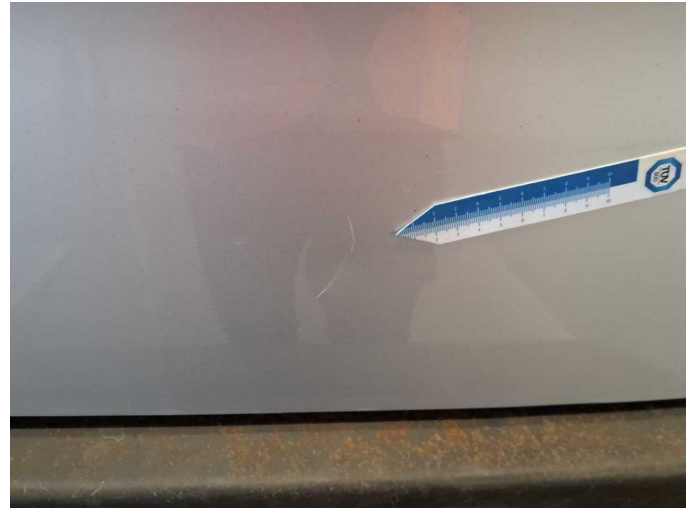
Damage 5: Boot lid / rear door: Rear door - right side - Dent / paintcoat damage - Repair and paint

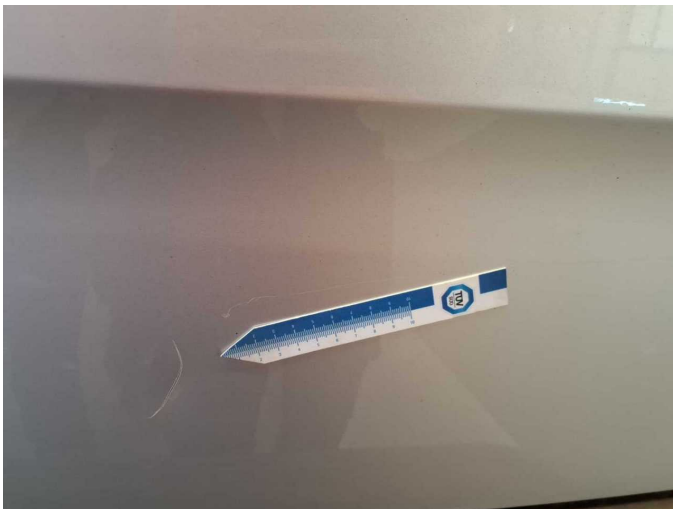
Damage 5: Boot lid / rear door: Rear door - right side - Dent / paintcoat damage - Repair and paint

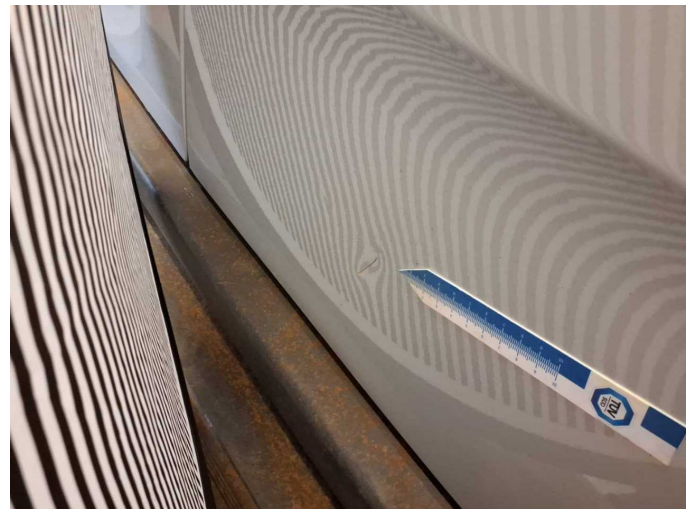
Damage 5: Boot lid / rear door: Rear door - right side - Dent / paintcoat damage - Repair and paint
