Expertise

Protocol number: 45982891
Order No. / Reference: 26494513
Inspection date: 11 Jun 2026

Manufacturer: Ford

Model: S-Max 2.5 Duratec FHEV TITANIUM

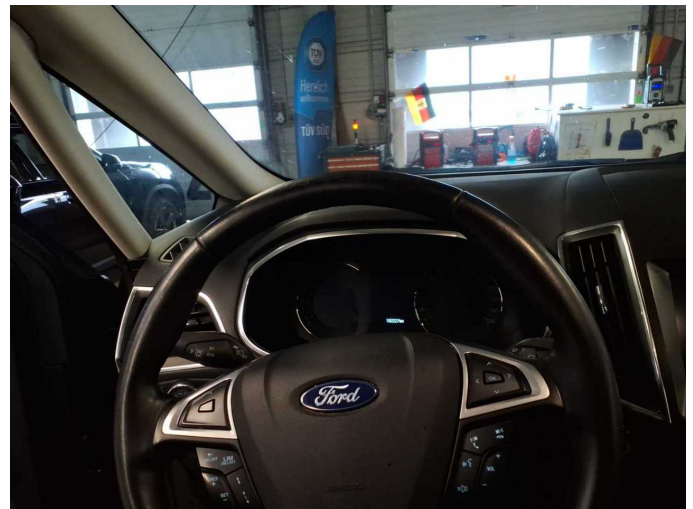
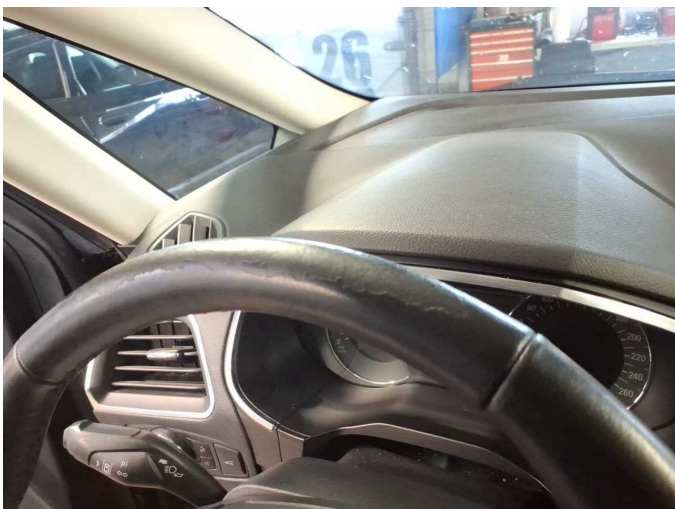
Damage 2: Steering system: Steering wheel - Abrasion - Smart repair

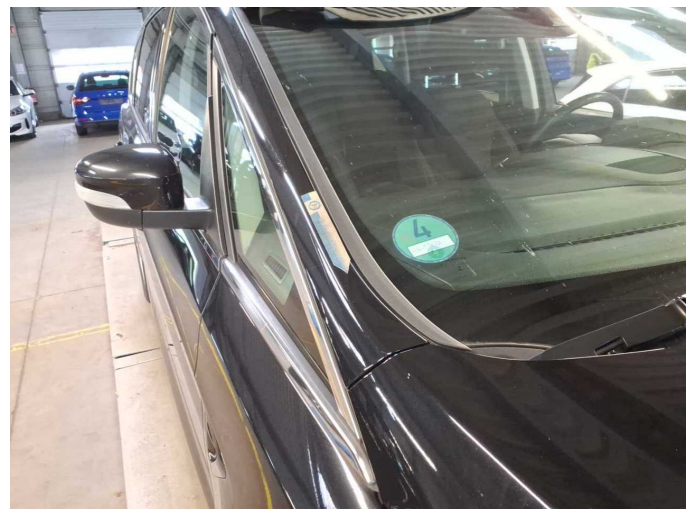
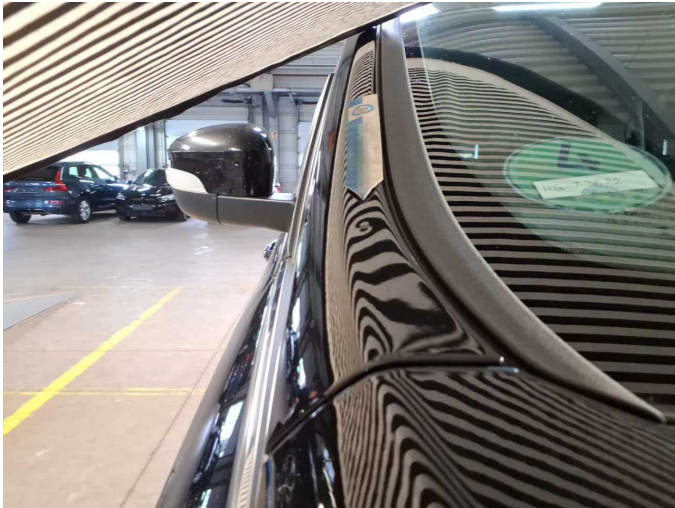
Damage 3: Body: A-pillar - right side - dent(s) - Smooth repair work

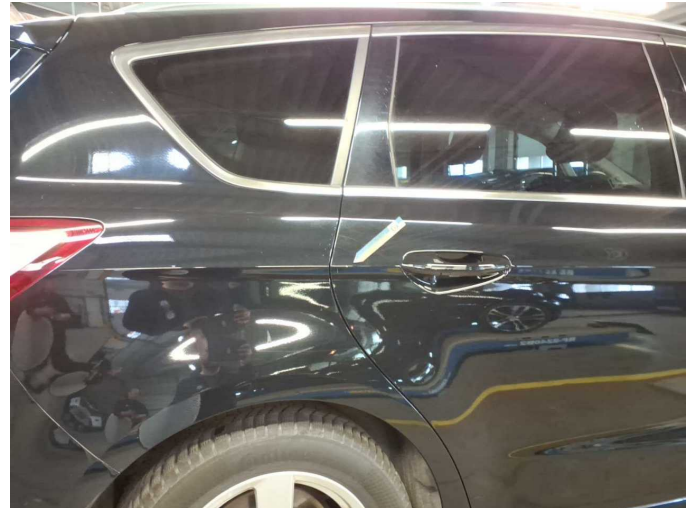
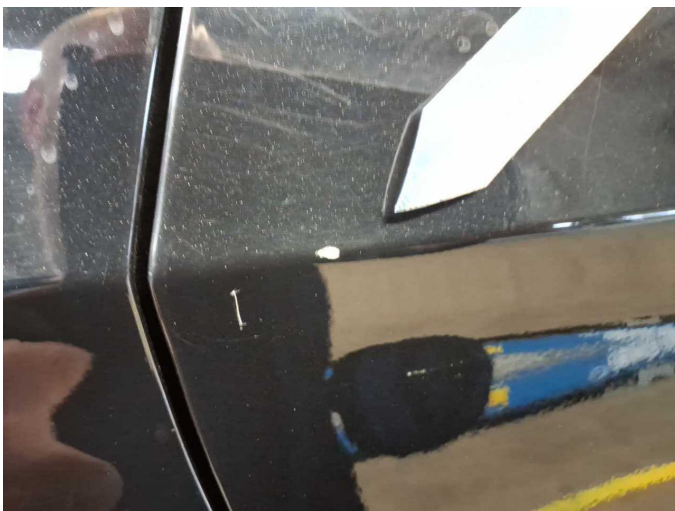
Damage 4: Door - rear right side: Door - Scratch(es) - Smart repair

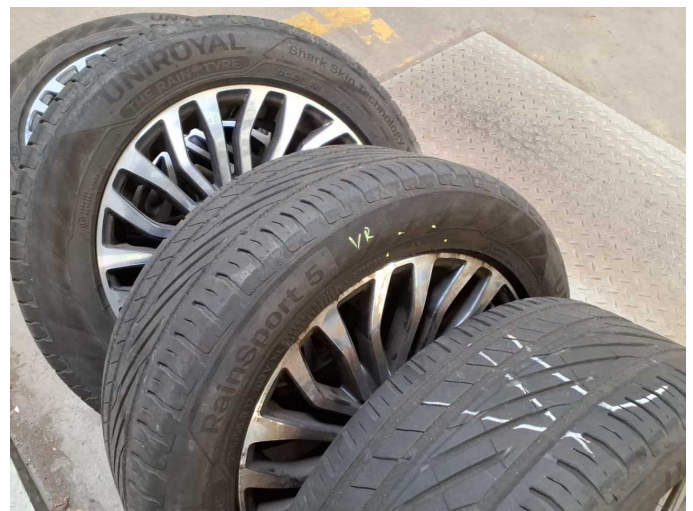
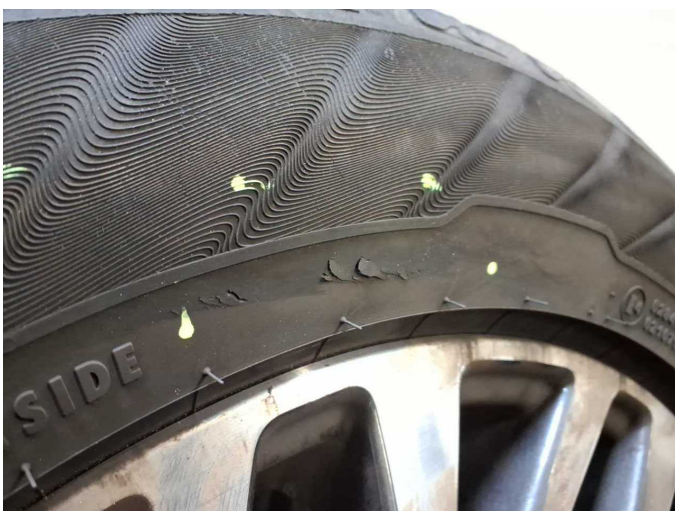
Damage 5: 2nd wheel set: 1 tyre (Flanke) - Damaged - Replace

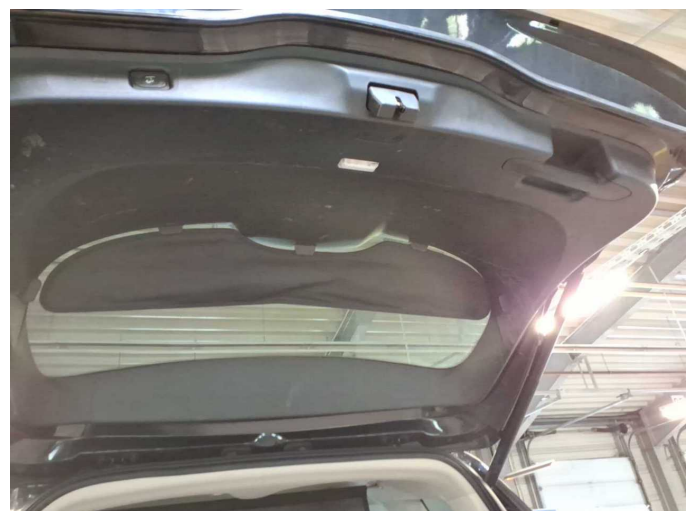
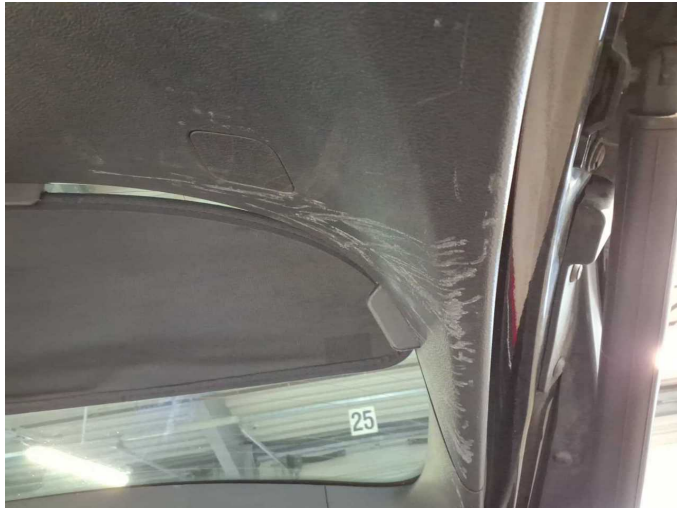
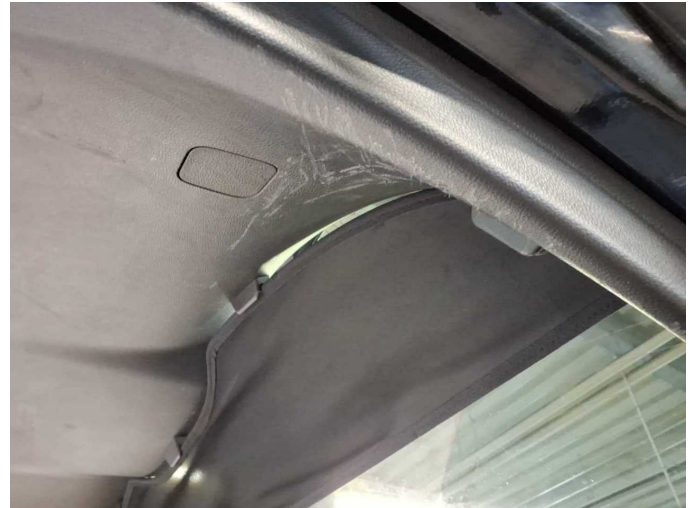
Damage 6: Trim / covers: Boot lid - interior trim - Scratched - Replace
