Expertise

Protocol number: 46346892  
Order No. / Reference: 26638320  
Inspection date: 2 Jul 2026

Manufacturer: Volkswagen

Model: Tiguan Allspace 2.0 TDI SCR DSG Life

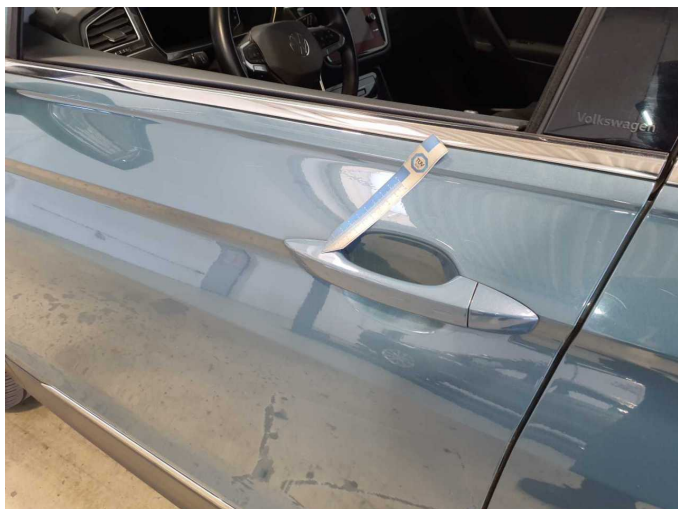
| No. | Component group | Description |
|---|---|---|
| 2 | Door - front left side | Door handle - outside - Scratch(es) - Smart repair |

**Damage 2:** Door - front left side: Door handle - outside - Scratch(es) - Smart repair

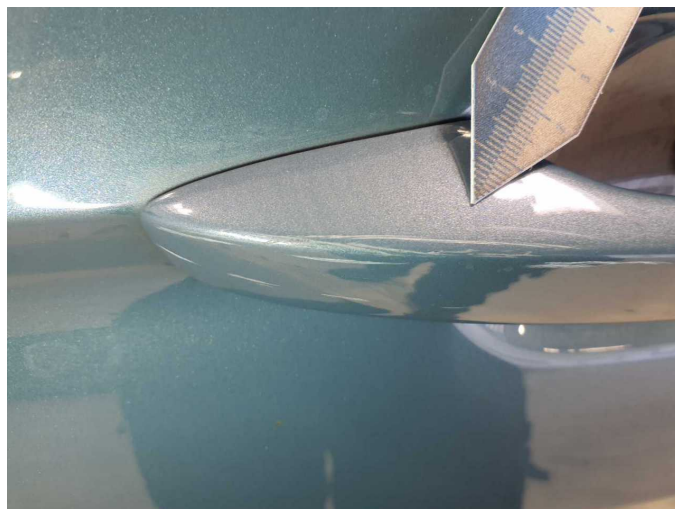
**Damage 2:** Door - front left side: Door handle - outside - Scratch(es) - Smart repair

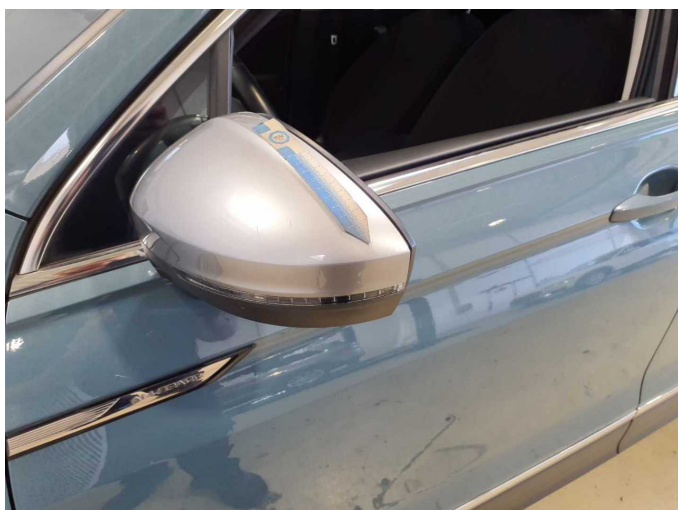
| No. | Component group | Description |
|---|---|---|
| 3 | Wing mirror - left side | Cap - Scratch(es) - Smart repair |

**Damage 3:** Wing mirror - left side: Cap - Scratch(es) - Smart repair

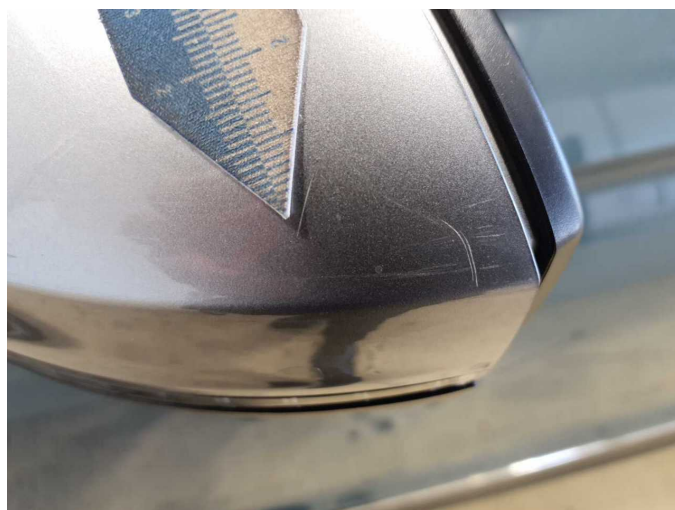
**Damage 3:** Wing mirror - left side: Cap - Scratch(es) - Smart repair

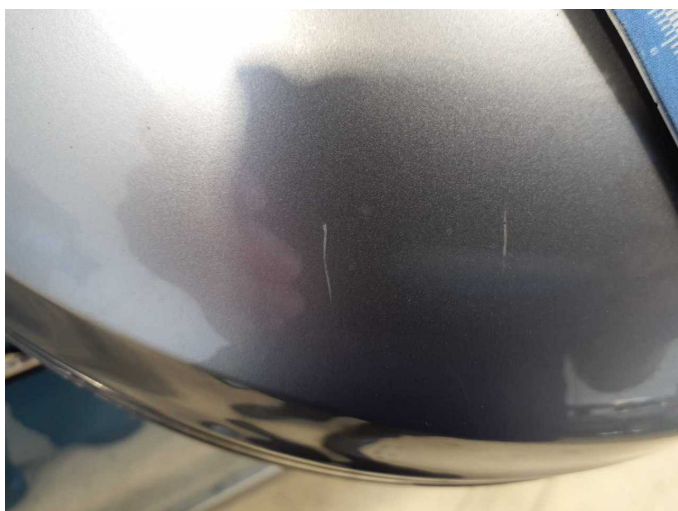
**Damage 3:** Wing mirror - left side: Cap - Scratch(es) - Smart repair

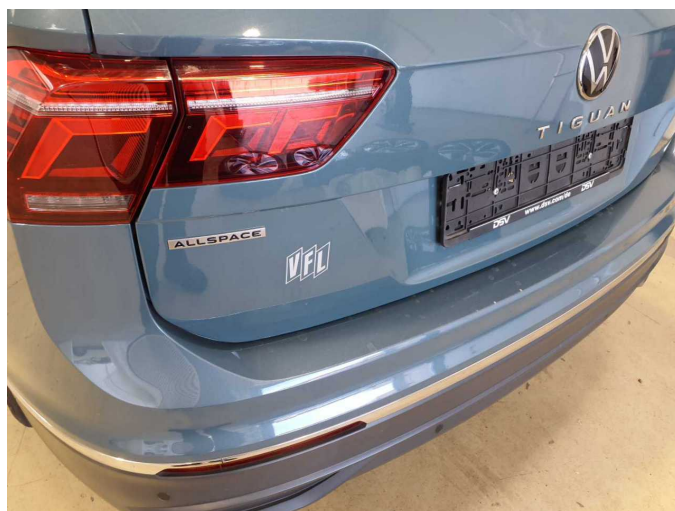
| No. | Component group | Description |
|---|---|---|
| 4 | Boot lid / rear door | Boot lid - Glued / labelled - De-glue / neutralise |

**Damage 4:** Boot lid / rear door: Boot lid - Glued / labelled - De-glue / neutralise

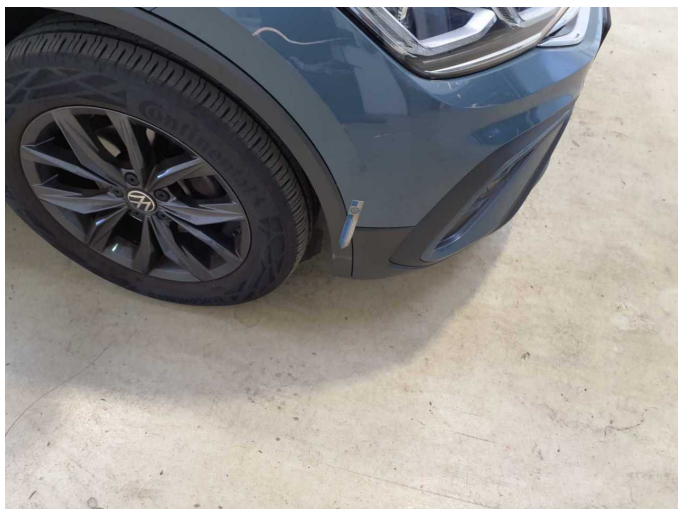
| No. | Component group | Description |
|---|---|---|
| 5 | Mudguard - right side | Wheel well extension - Scratch(es) - Smart repair |

**Damage 5:** Mudguard - right side: Wheel well extension - Scratch(es) - Smart repair

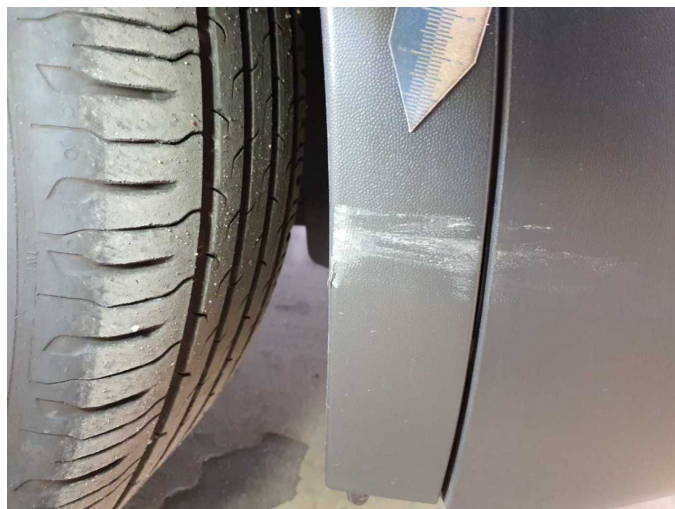
**Damage 5:** Mudguard - right side: Wheel well extension - Scratch(es) - Smart repair

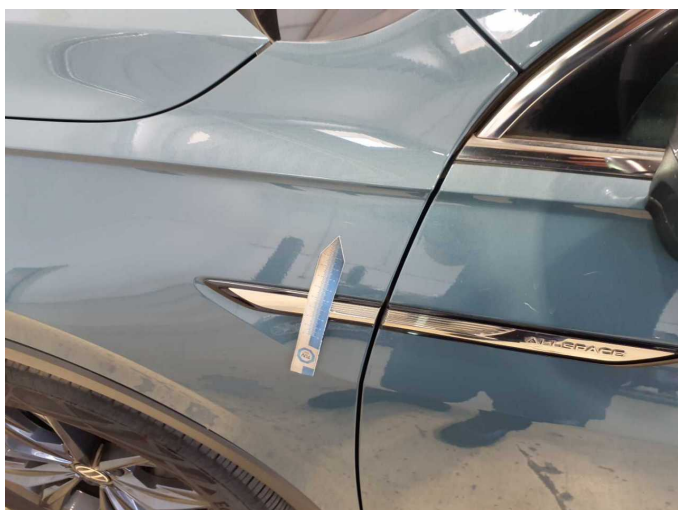
| No. | Component group | Description |
|---|---|---|
| 6 | Mudguard - left side | Mudguard - left side - Scratch(es) - Smart repair |

**Damage 6:** Mudguard - left side: Mudguard - left side - Scratch(es) - Smart repair

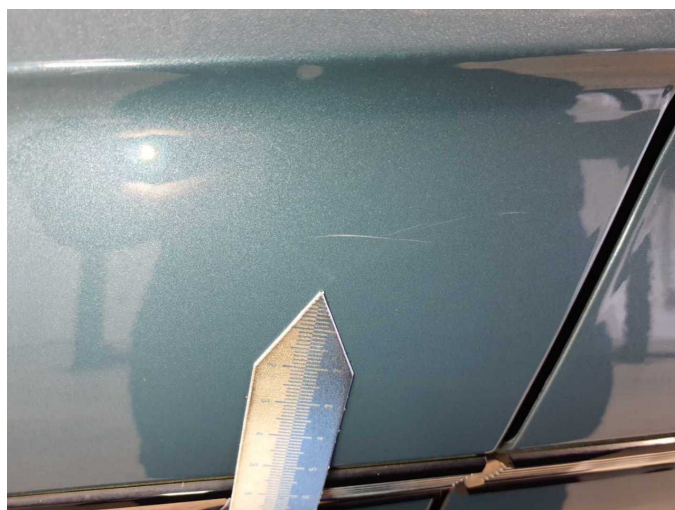
**Damage 6:** Mudguard - left side: Mudguard - left side - Scratch(es) - Smart repair

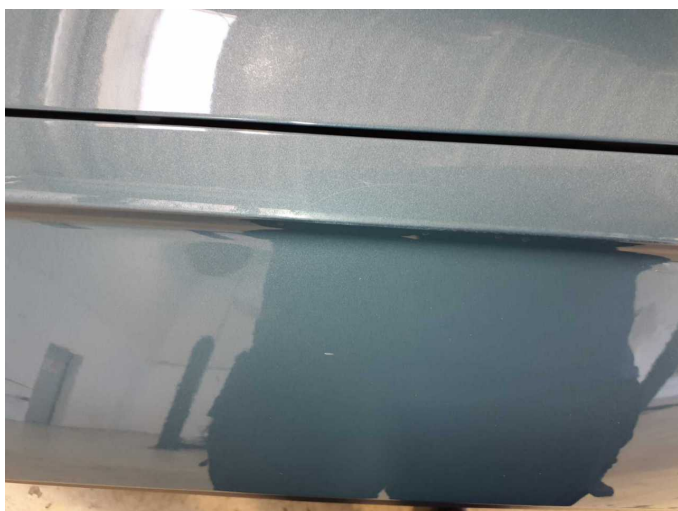
**Damage 6:** Mudguard - left side: Mudguard - left side - Scratch(es) - Smart repair

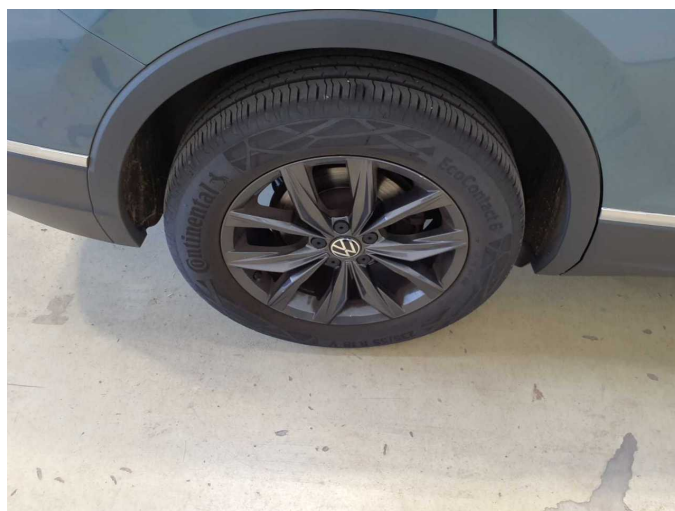
| No. | Component group | Description |
|---|---|---|
| 7 | Wheel / tyres | Tyre - rear right side (nicht fahrbereit) - Broken / torn - Replace |

**Damage 7:** Wheel / tyres: Tyre - rear right side (nicht fahrbereit) - Broken / torn - Replace

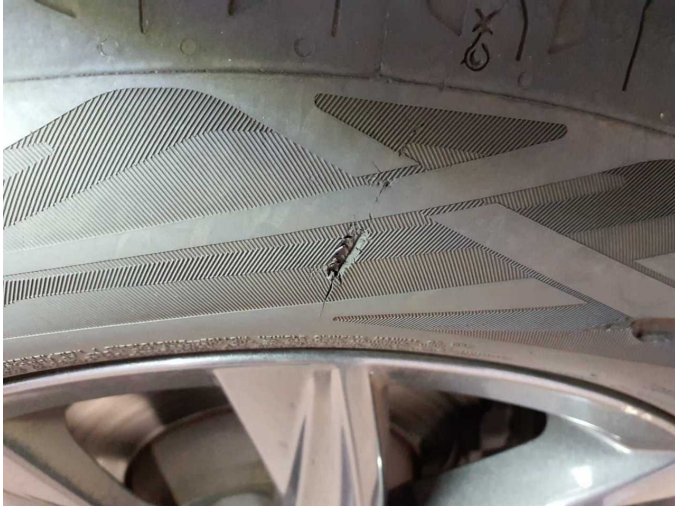
**Damage 7:** Wheel / tyres: Tyre - rear right side (nicht fahrbereit) - Broken / torn - Replace

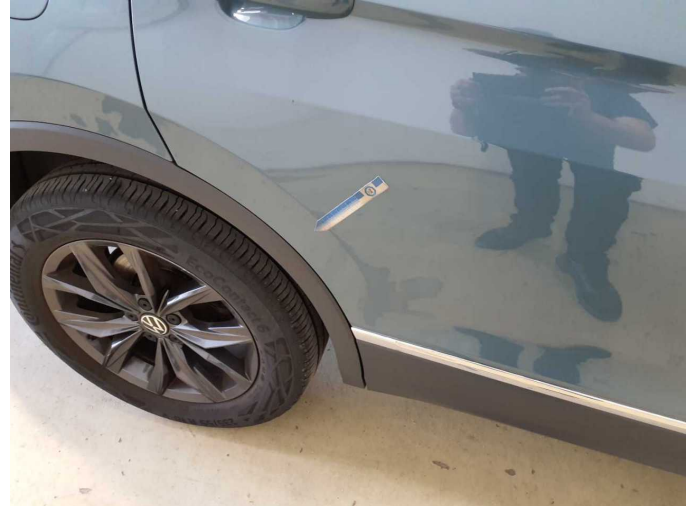
| No. | Component group | Description |
|---|---|---|
| 8 | Door - rear right side | Door (Einschlüsse und Spachtel rissig) - dent(s) - Smart repair |

| No. | Repainting |
|---|---|
| 5 | Door - rear right side, Unprofessionally carried out, Invoice of repair done Non-existent |

| Side panel - rear right side | 213 µm | Door - rear right side | 946 µm |

**Damage 8:** Door - rear right side: Door (Einschlüsse und Spachtel rissig) - dent(s) - Smart repair

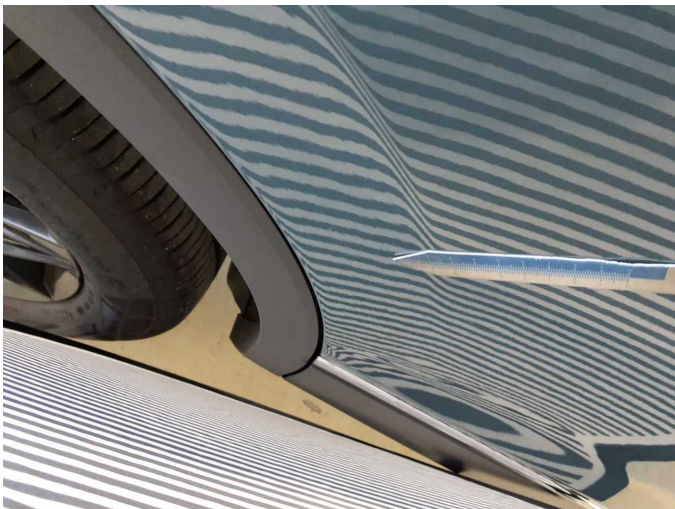
**Damage 8:** Door - rear right side: Door (Einschlüsse und Spachtel rissig) - dent(s) - Smart repair

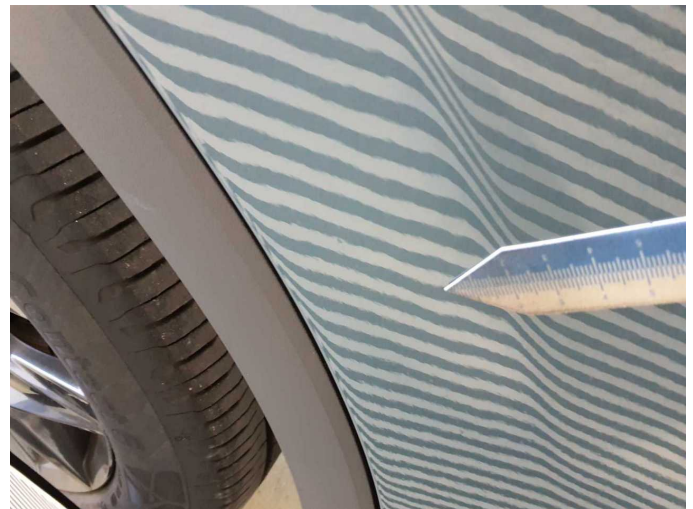
**Damage 8:** Door - rear right side: Door (Einschlüsse und Spachtel rissig) - dent(s) - Smart repair

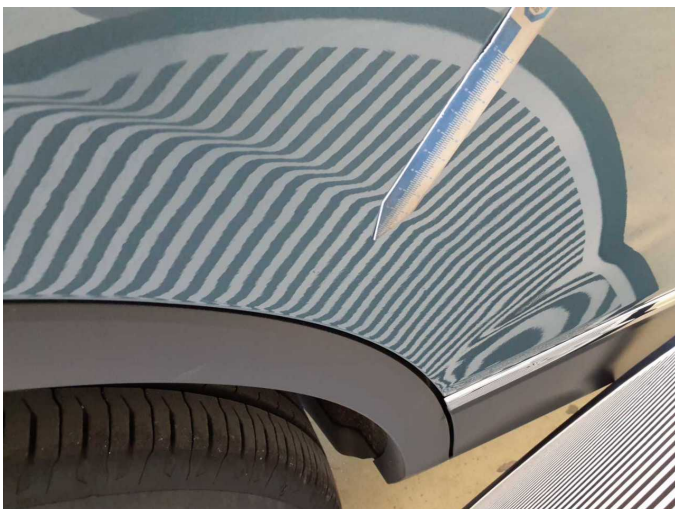
**Damage 8:** Door - rear right side: Door (Einschlüsse und Spachtel rissig) - dent(s) - Smart repair

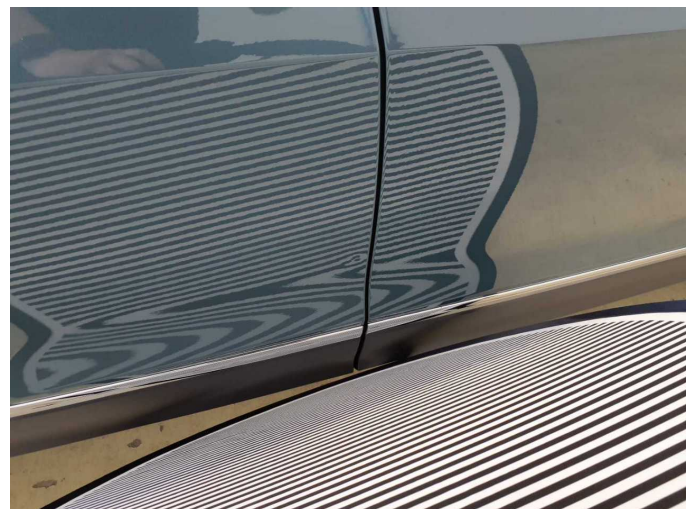
**Damage 8:** Door - rear right side: Door (Einschlüsse und Spachtel rissig) - dent(s) - Smart repair

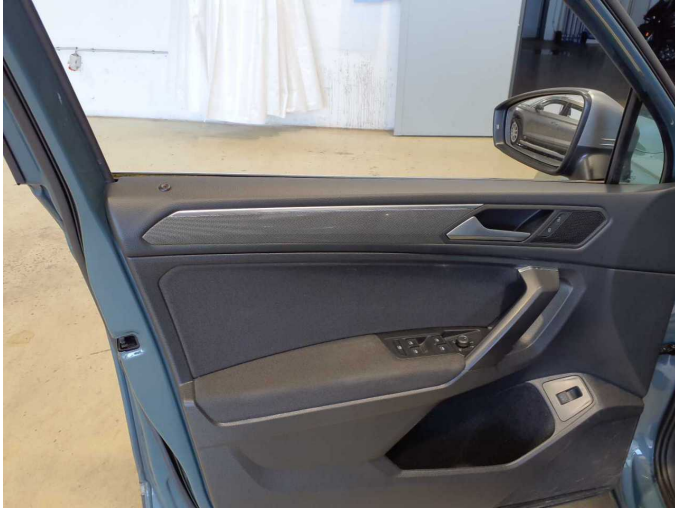
| No. | Component group | Description |
|---|---|---|
| 9 | Trim / covers | Door trim - front left side (Kratzer) - Differs from the original configuration - Replace |

**Damage 9:** Trim / covers: Door trim - front left side (Kratzer) - Differs from the original configuration - Replace

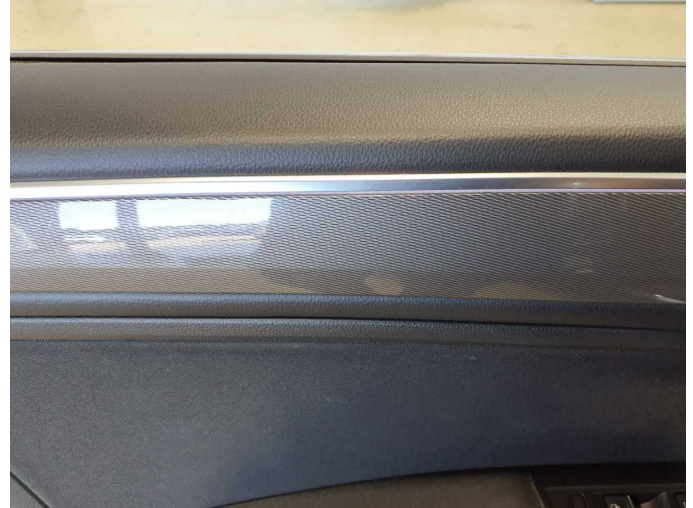
**Damage 9:** Trim / covers: Door trim - front left side (Kratzer) - Differs from the original configuration - Replace

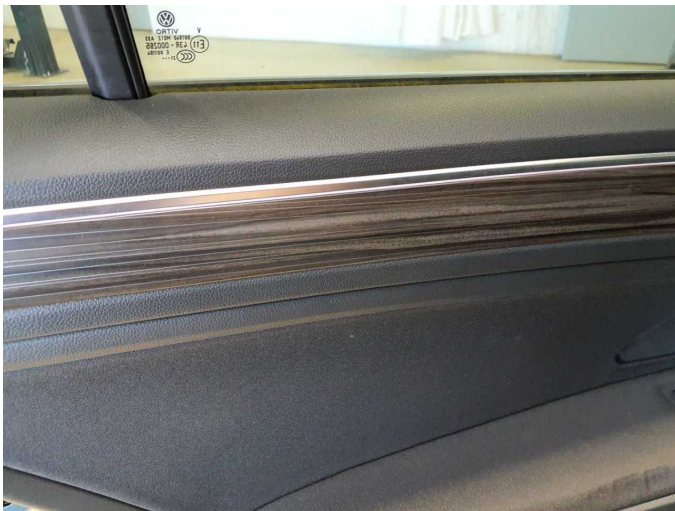
**Damage 9:** Trim / covers: Door trim - front left side (Kratzer) - Differs from the original configuration - Replace

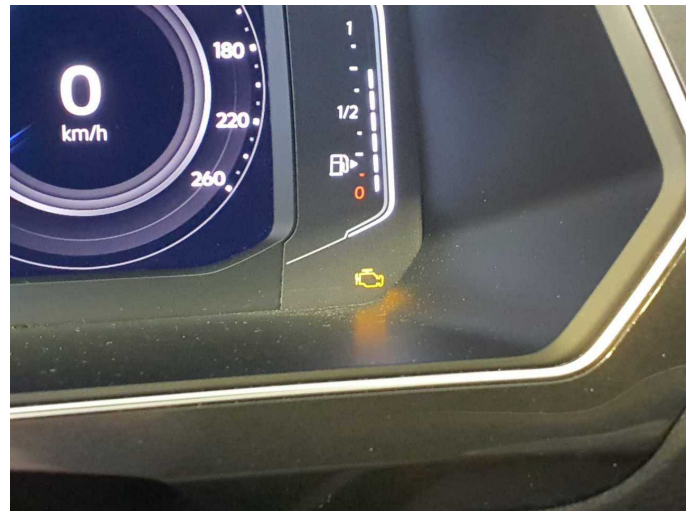
| No. | Component group | Description |
|---|---|---|
| 10 | Engine | Engine (Motorkonntrolle leuchtet, nicht fahrbereit) - Specify findings - Perform diagnosis |

**Damage 10:** Engine: Engine (Motorkontrolle leuchtet, nicht fahrbereit) - Specify findings - Perform diagnosis

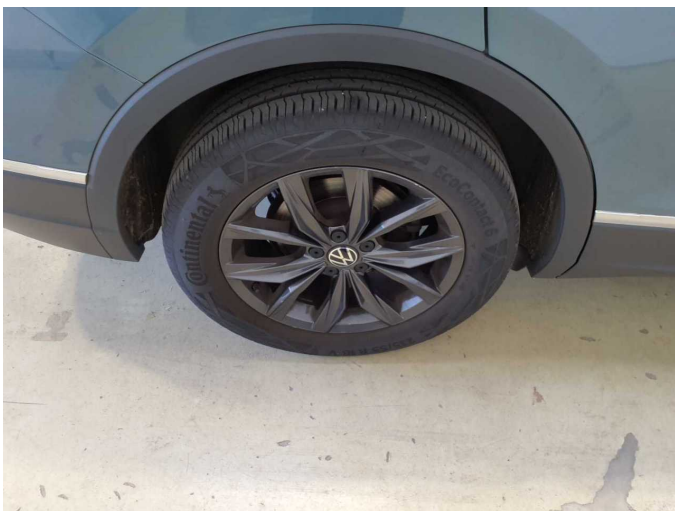
| No. | Component group | Description |
|---|---|---|
| 11 | Wheel / tyres | Alloy rim - rear right side - Scratch(es) - Loss in value |

**Damage 11:** Wheel / tyres: Alloy rim - rear right side - Scratch(es) - Loss in value

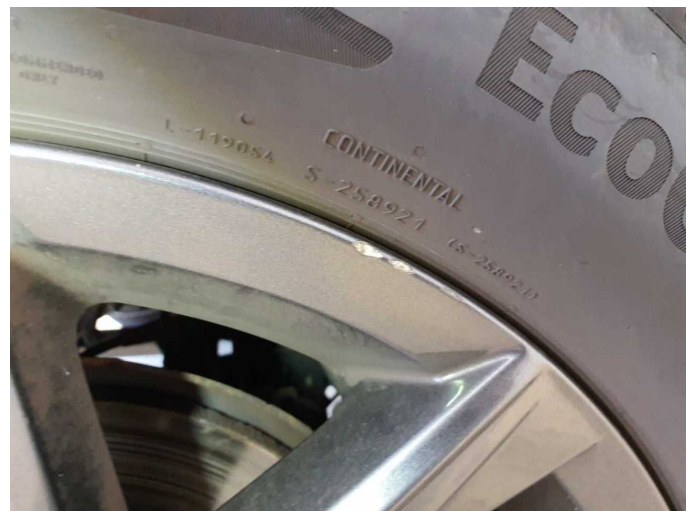
**Damage 11:** Wheel / tyres: Alloy rim - rear right side - Scratch(es) - Loss in value

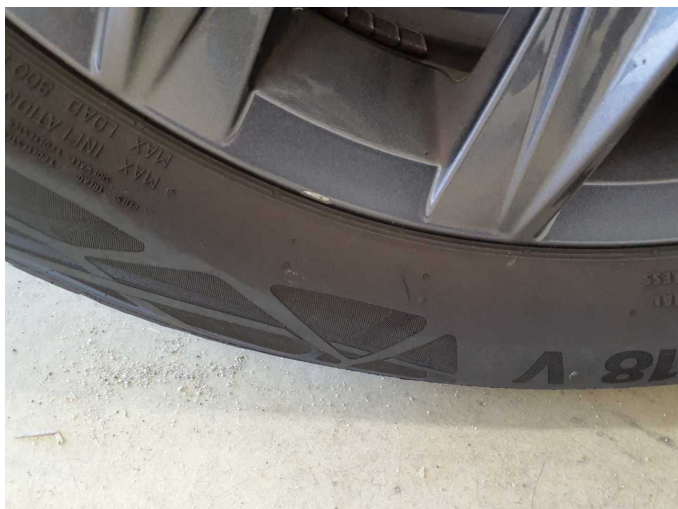
**Damage 11:** Wheel / tyres: Alloy rim - rear right side - Scratch(es) - Loss in value

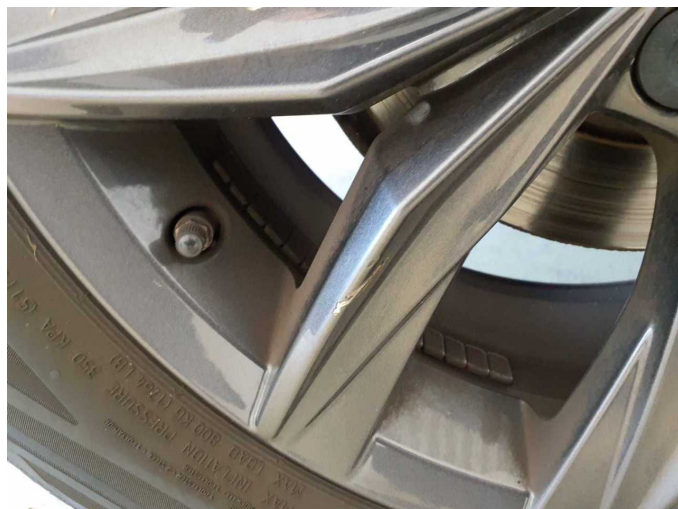
**Damage 11:** Wheel / tyres: Alloy rim - rear right side - Scratch(es) - Loss in value

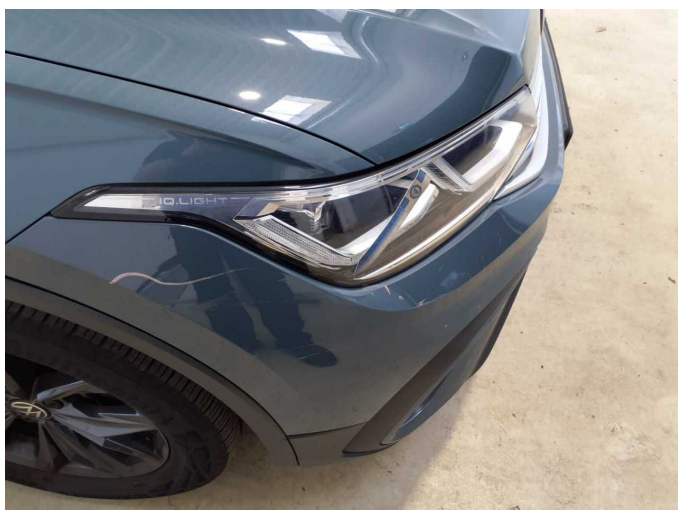
| No. | Component group | Description |
|---|---|---|
| 12 | Headlight | Headlight - right side (nicht im Lichtschein) - Scratch(es) - Loss in value |

**Damage 12:** Headlight: Headlight - right side (nicht im Lichtschein) - Scratch(es) - Loss in value

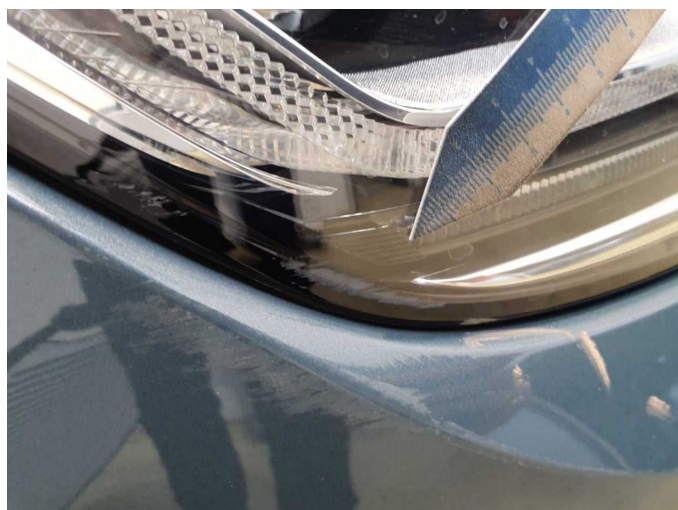
**Damage 12:** Headlight: Headlight - right side (nicht im Lichtschein) - Scratch(es) - Loss in value

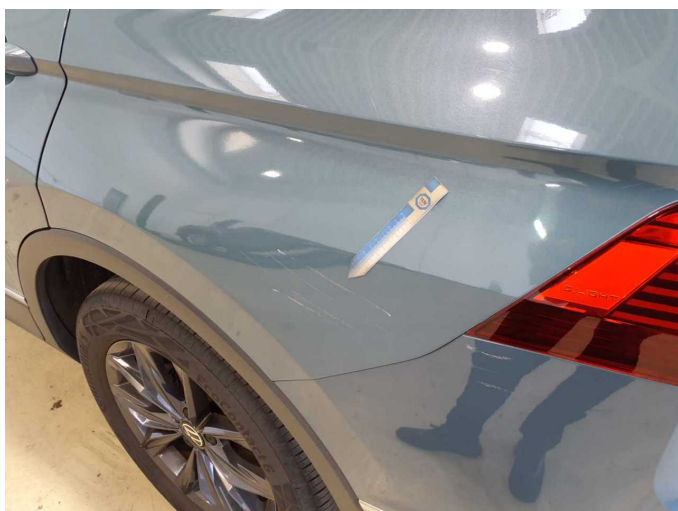
| No. | Component group | Description |
|---|---|---|
| 13 | Side panel - rear left side | Side panel - Scratch(es) - Paint |

**Damage 13:** Side panel - rear left side: Side panel - Scratch(es) - Paint

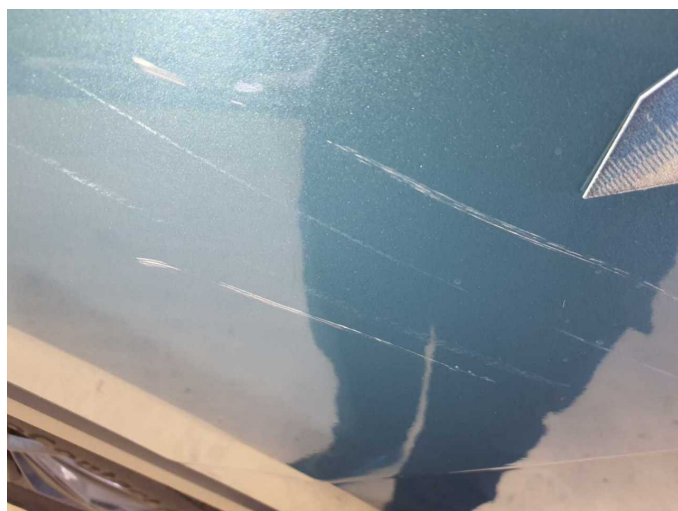
**Damage 13:** Side panel - rear left side: Side panel - Scratch(es) - Paint

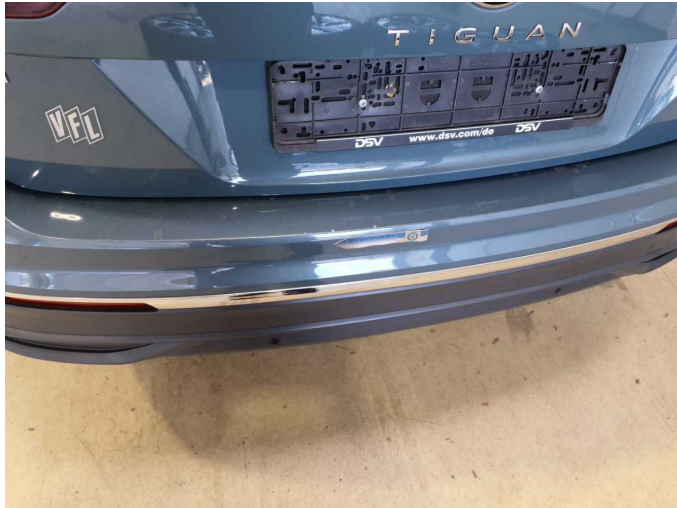
| No. | Component group | Description |
|---|---|---|
| 14 | Rear bumper | Rear bumper - Scratch(es) - Paint |

**Damage 14:** Rear bumper: Rear bumper - Scratch(es) - Paint

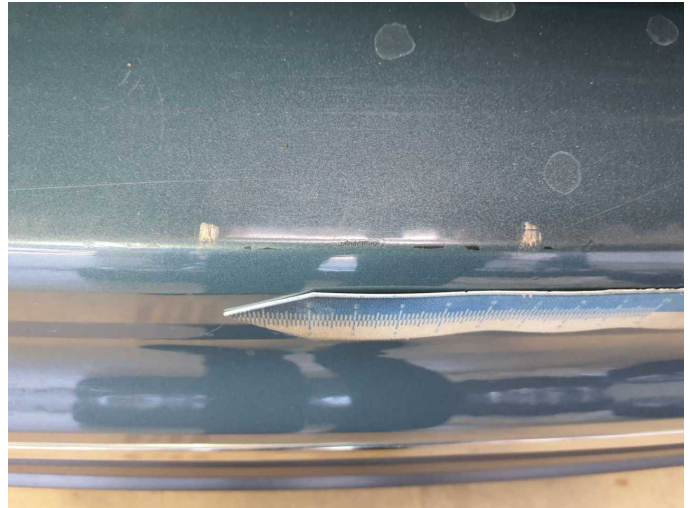
**Damage 14:** Rear bumper: Rear bumper - Scratch(es) - Paint

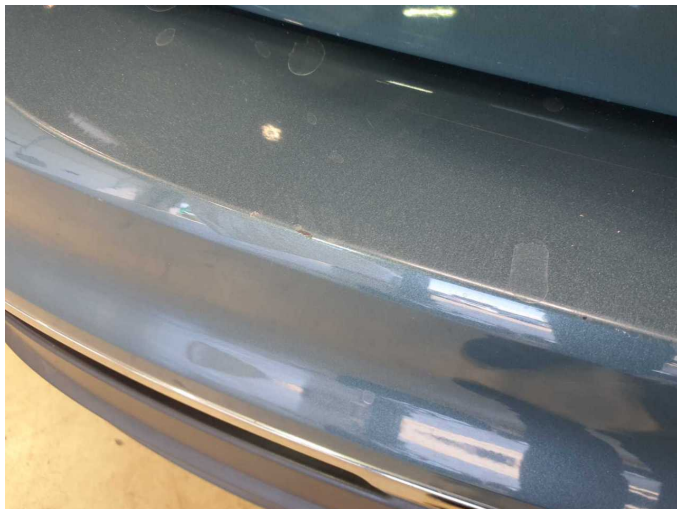
**Damage 14:** Rear bumper: Rear bumper - Scratch(es) - Paint

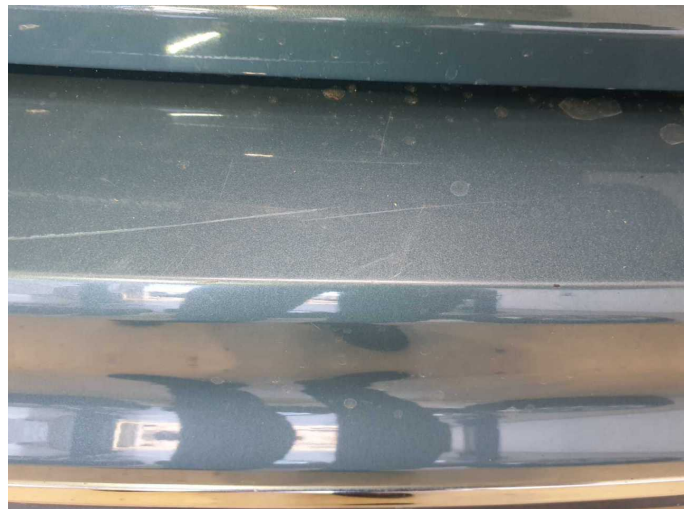
**Damage 14:** Rear bumper: Rear bumper - Scratch(es) - Paint

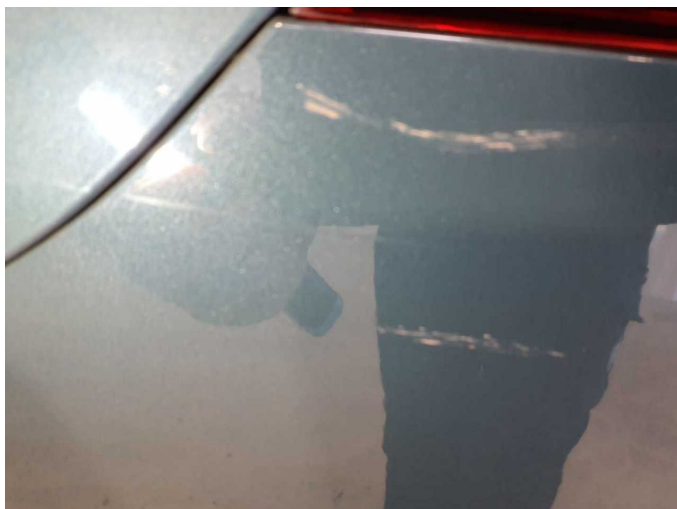
**Damage 14:** Rear bumper: Rear bumper - Scratch(es) - Paint

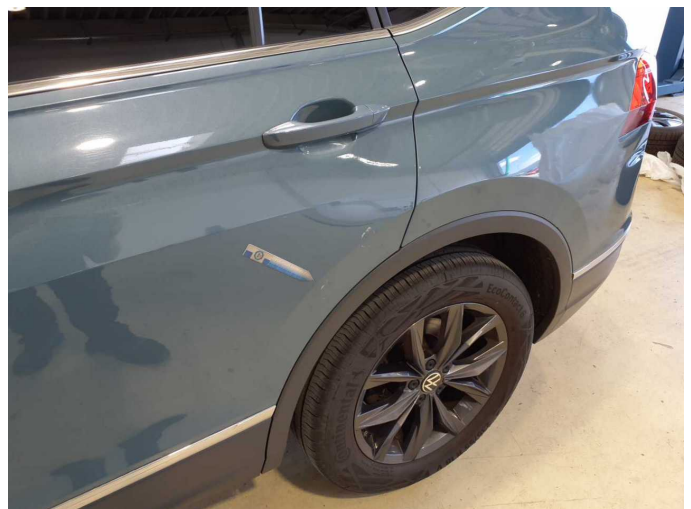
| No. | Component group | Description |
|---|---|---|
| 15 | Door - rear left side | Door - Dent / paintcoat damage - Repair and paint |

**Damage 15:** Door - rear left side: Door - Dent / paintcoat damage - Repair and paint

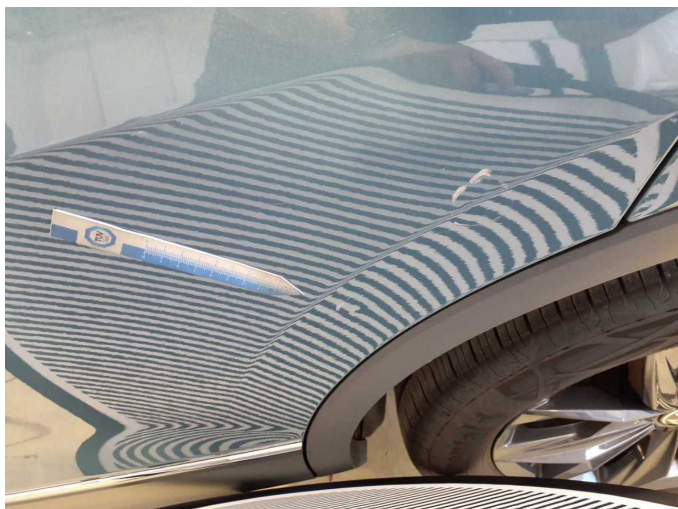
**Damage 15:** Door - rear left side: Door - Dent / paintcoat damage - Repair and paint

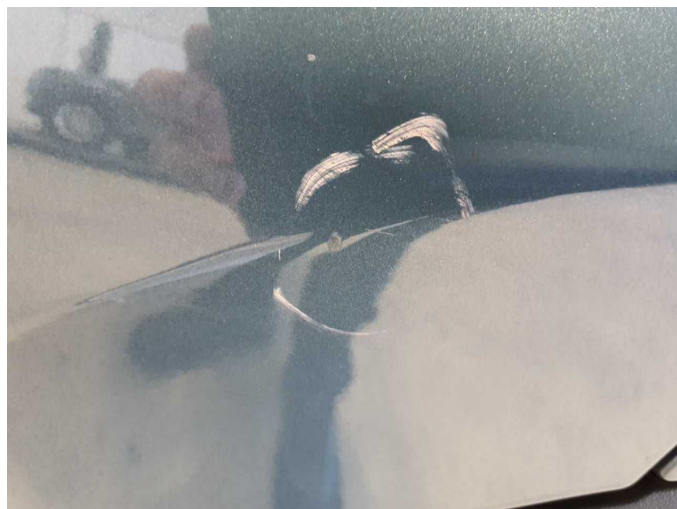
**Damage 15:** Door - rear left side: Door - Dent / paintcoat damage - Repair and paint

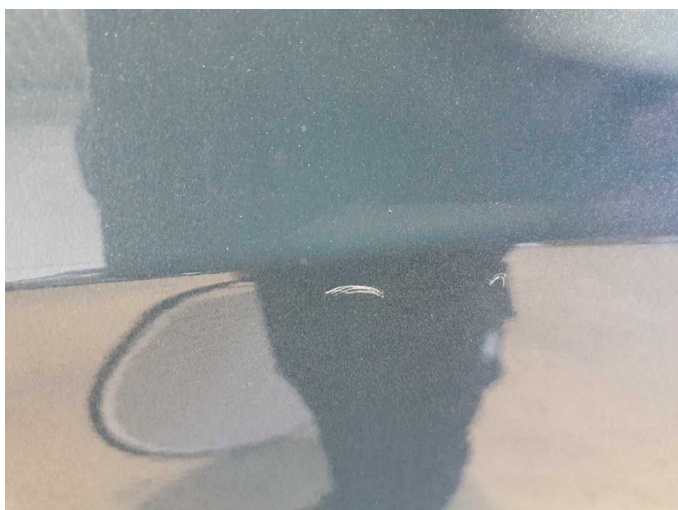
**Damage 15:** Door - rear left side: Door - Dent / paintcoat damage - Repair and paint

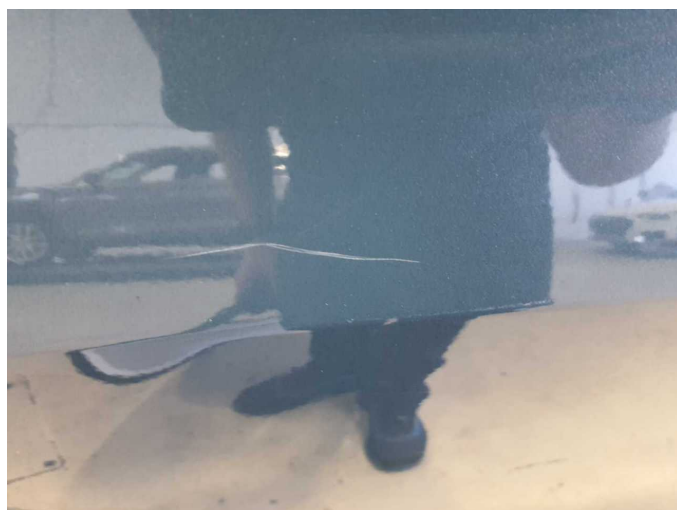
**Damage 15:** Door - rear left side: Door - Dent / paintcoat damage - Repair and paint

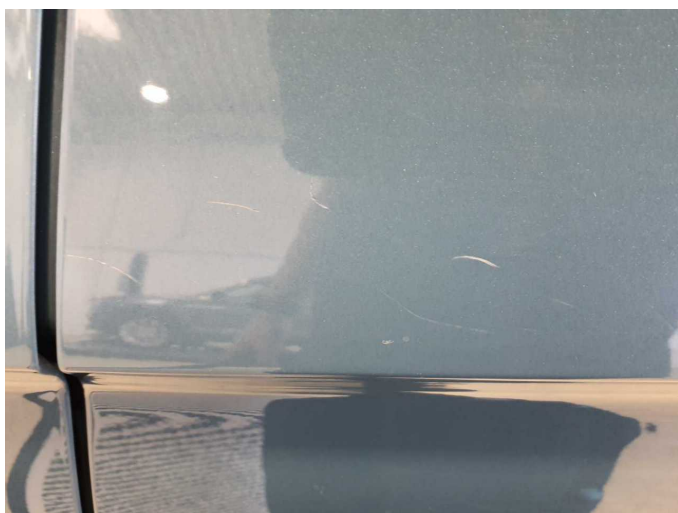
**Damage 15:** Door - rear left side: Door - Dent / paintcoat damage - Repair and paint

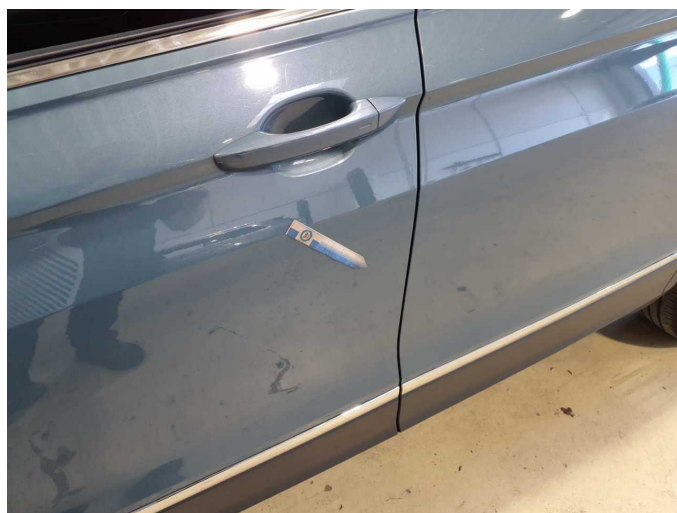
| No. | Component group | Description |
|---|---|---|
| 16 | Door - front left side | Door - Dent / paintcoat damage - Repair and paint |

**Damage 16:** Door - front left side: Door - Dent / paintcoat damage - Repair and paint

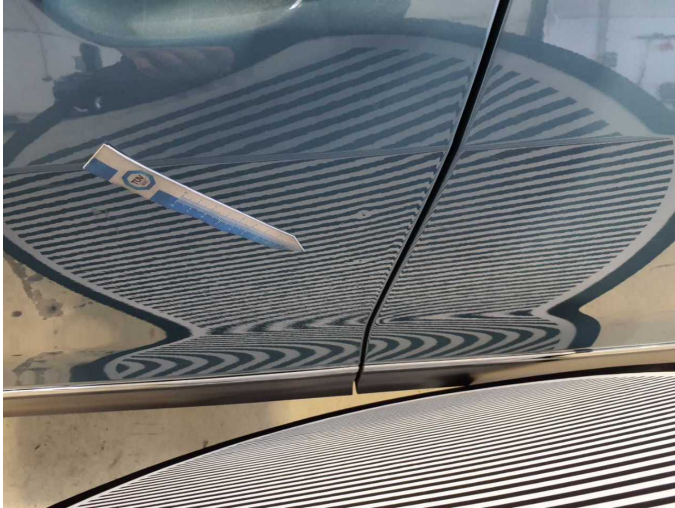
**Damage 16:** Door - front left side: Door - Dent / paintcoat damage - Repair and paint

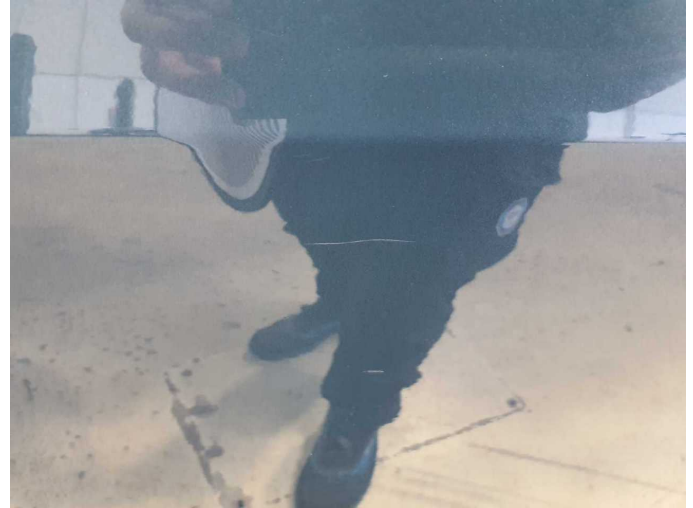
**Damage 16:** Door - front left side: Door - Dent / paintcoat damage - Repair and paint

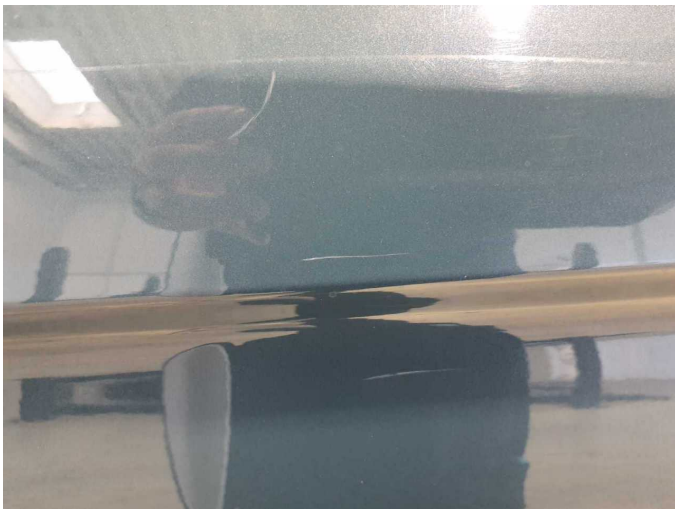
**Damage 16:** Door - front left side: Door - Dent / paintcoat damage - Repair and paint

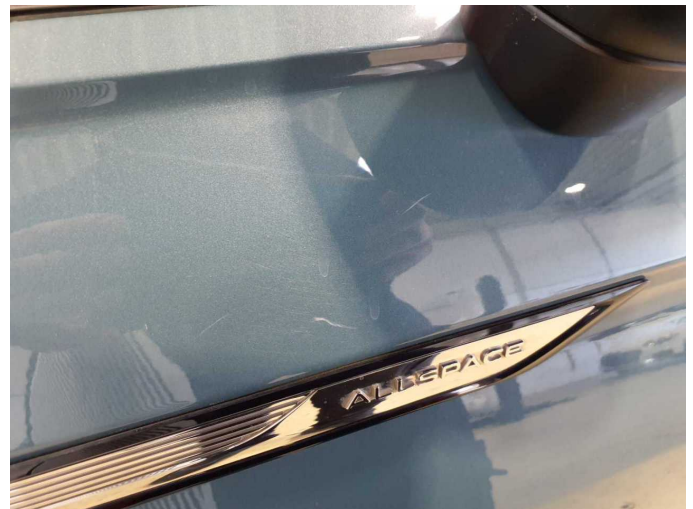
**Damage 16:** Door - front left side: Door - Dent / paintcoat damage - Repair and paint

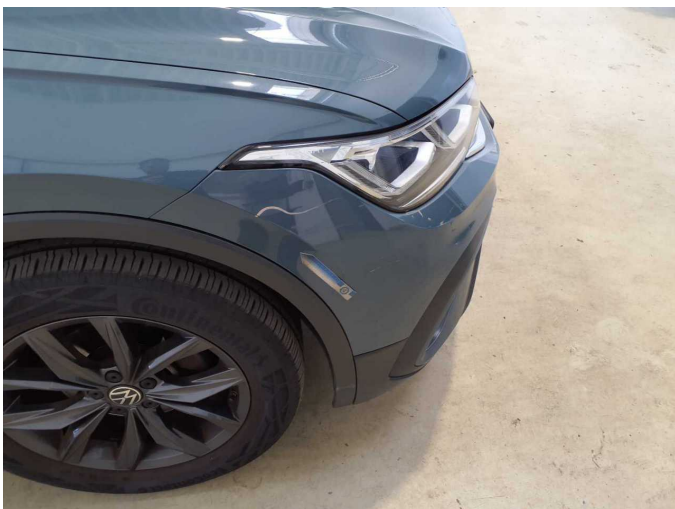
| No. | Component group | Description |
|---|---|---|
| 17 | Front bumper | Front bumper - Dent / paintcoat damage - Repair and paint |

**Damage 17:** Front bumper: Front bumper - Dent / paintcoat damage - Repair and paint

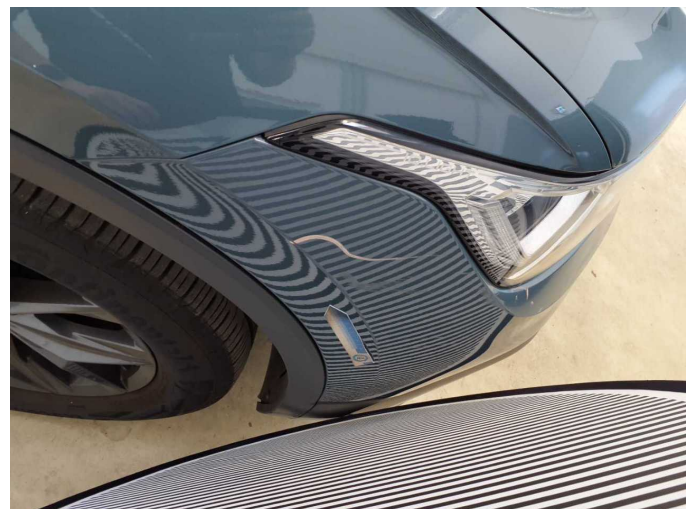
**Damage 17:** Front bumper: Front bumper - Dent / paintcoat damage - Repair and paint

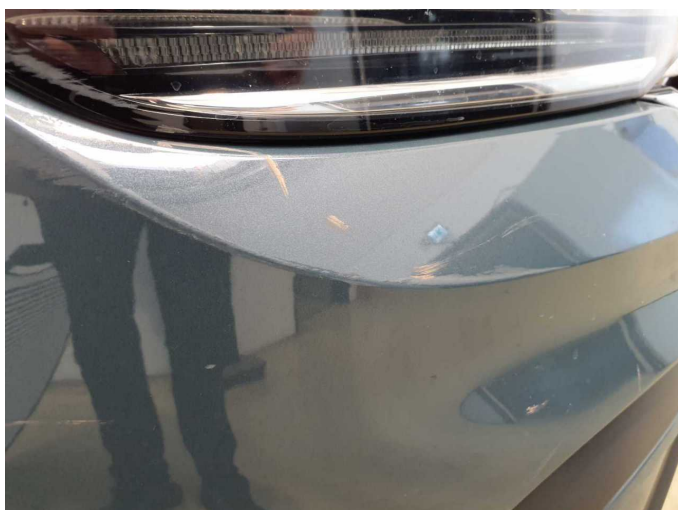
**Damage 17:** Front bumper: Front bumper - Dent / paintcoat damage - Repair and paint

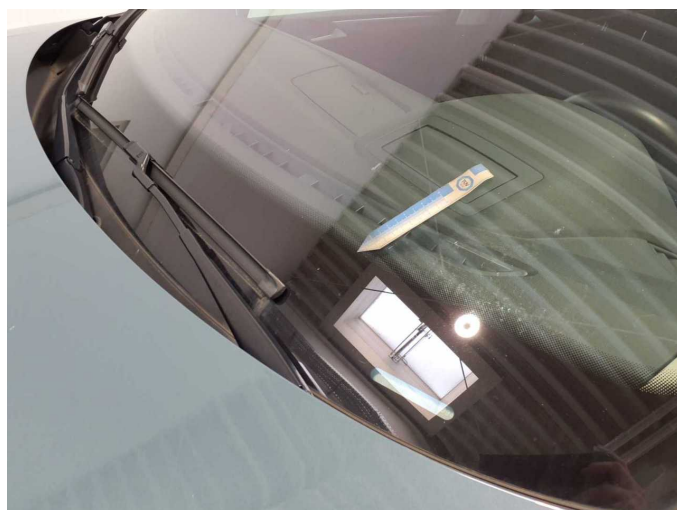
| No. | Component group | Description |
|---|---|---|
| 18 | Vehicle glazing | Windscreen - Broken / torn - repair according to calculation |

**Damage 18:** Vehicle glazing: Windscreen - Broken / torn - repair according to calculation

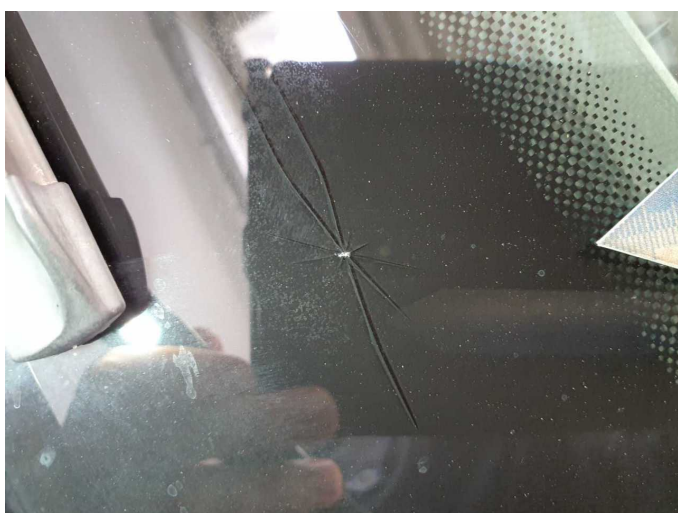
**Damage 18:** Vehicle glazing: Windscreen - Broken / torn - repair according to calculation

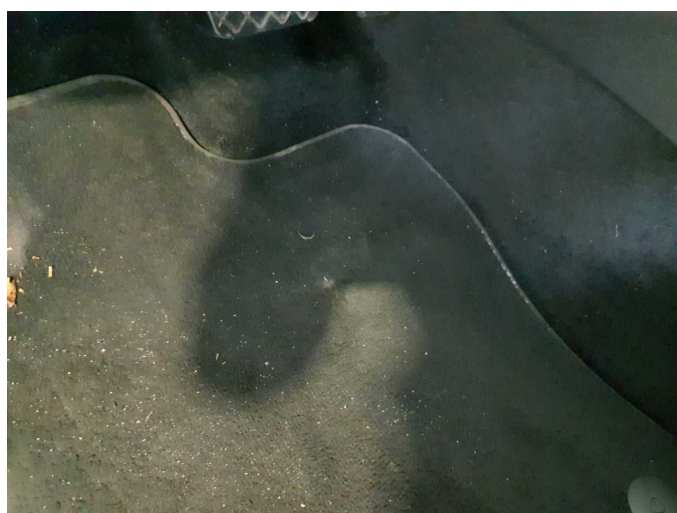
| No. | Component group | Description |
|---|---|---|
| 4 | Trim / covers | Floor mats - Broken / torn - No deduction |

**Wear and tear 4:** Trim / covers: Floor mats - Broken / torn - No deduction

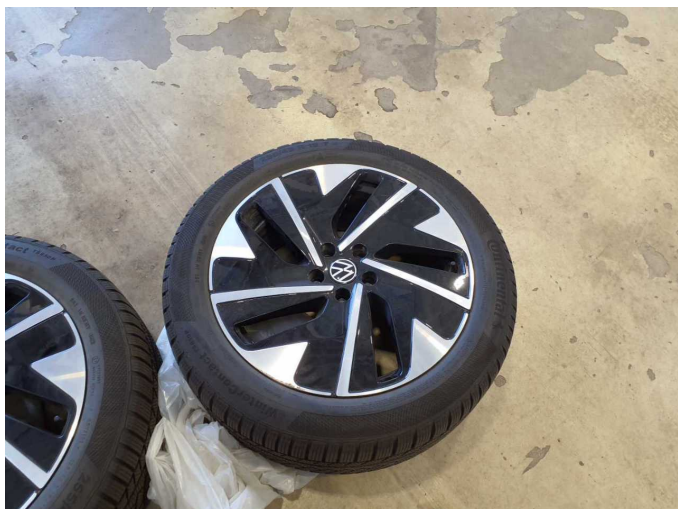
| No. | Component group | Description |
|---|---|---|
| 5 | 2nd wheel set | 1 alloy rim - Scratch(es) - No deduction |

**Wear and tear 5:** 2nd wheel set: 1 alloy rim - Scratch(es) - No deduction

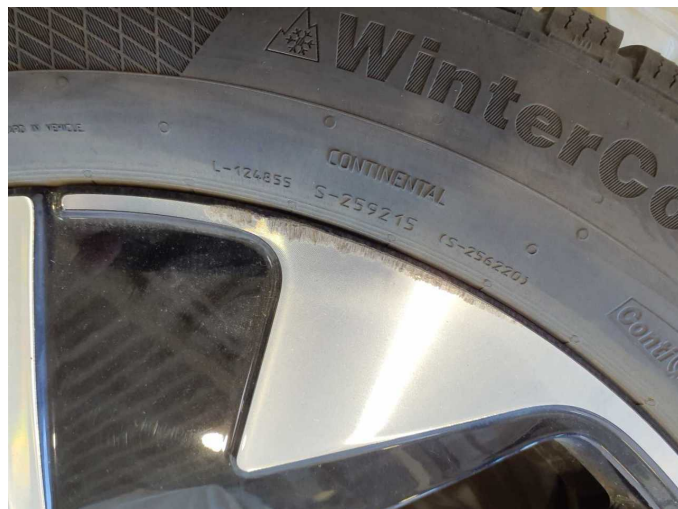
**Wear and tear 5:** 2nd wheel set: 1 alloy rim - Scratch(es) - No deduction

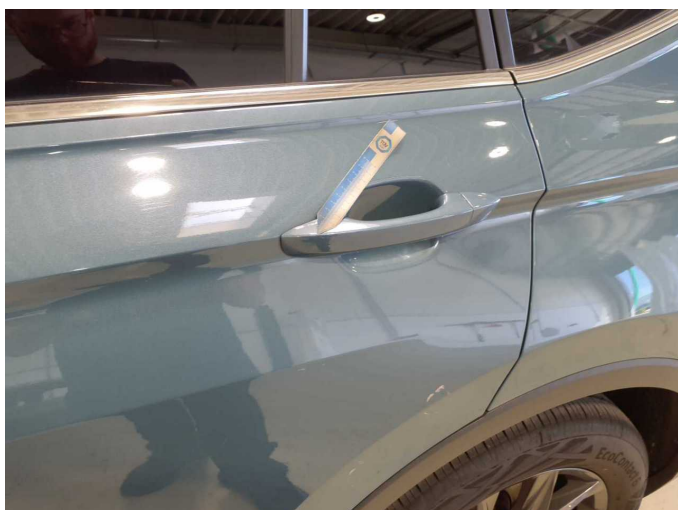
| No. | Component group | Description |
|---|---|---|
| 6 | Door - rear left side | Door handle - outside - Scratch(es) - Smart repair |

**Wear and tear 6:** Door - rear left side: Door handle - outside - Scratch(es) - Smart repair

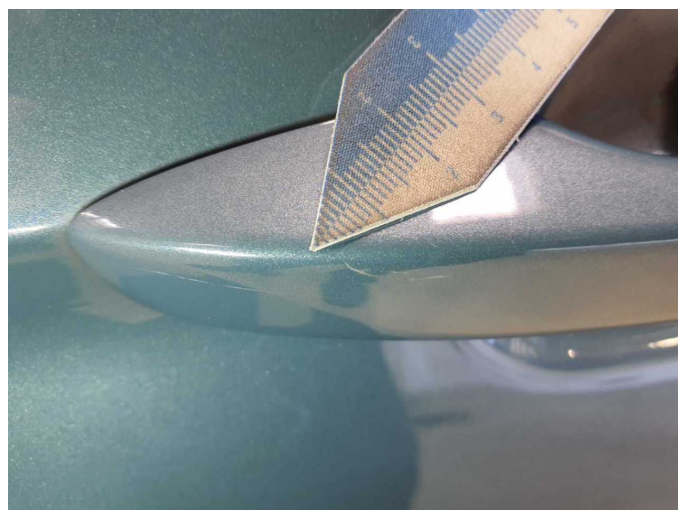
**Wear and tear 6:** Door - rear left side: Door handle - outside - Scratch(es) - Smart repair
