Expertise

Protocol number: 46042714
Order No. / Reference: 25932288
Inspection date: 16 Jun 2026

Model: Vito 116 CDI Tourer Lang Aut. SELECT

VIN: W1VVLFEZ1T4546416

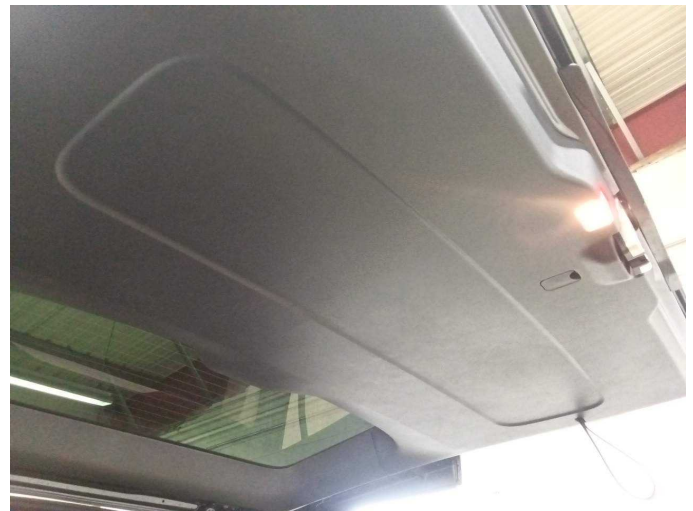
Damage 2: Trim / covers: Boot lid - interior trim - Scratched - Loss in value

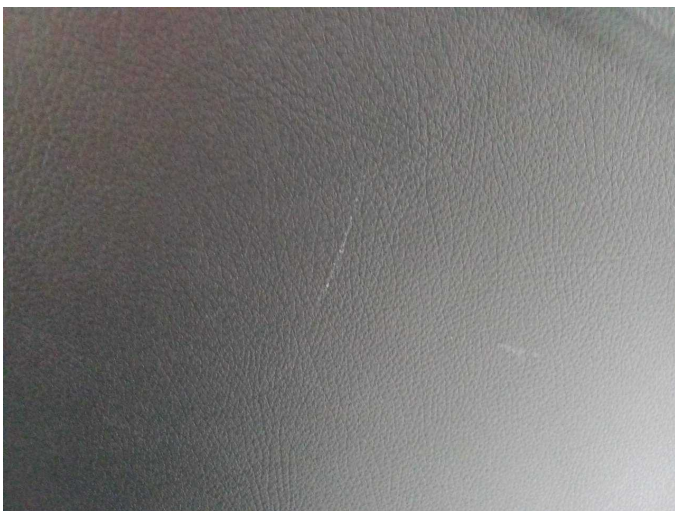
Damage 2: Trim / covers: Boot lid - interior trim - Scratched - Loss in value

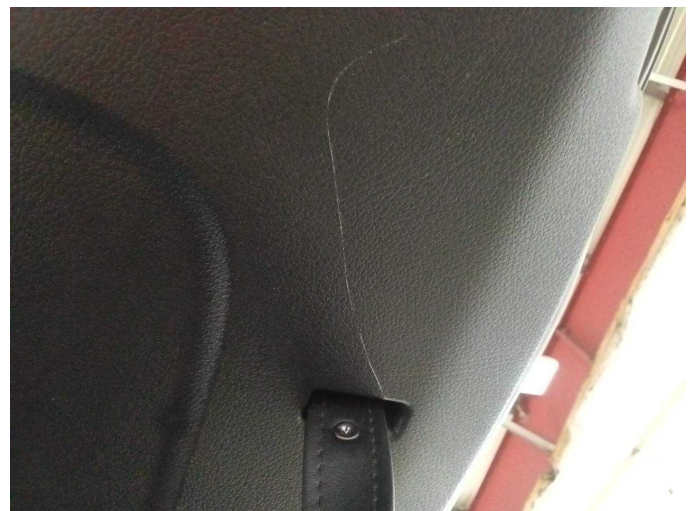
Damage 2: Trim / covers: Boot lid - interior trim - Scratched - Loss in value

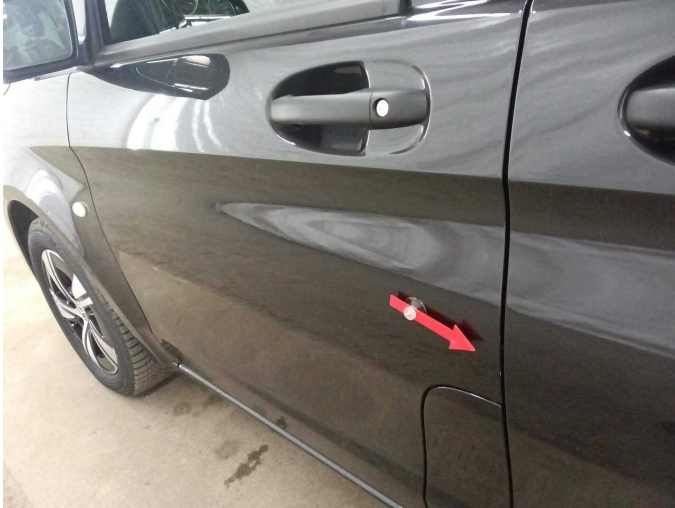
Damage 3: Door - front left side: Door edge - Scratch(es) - Smart repair

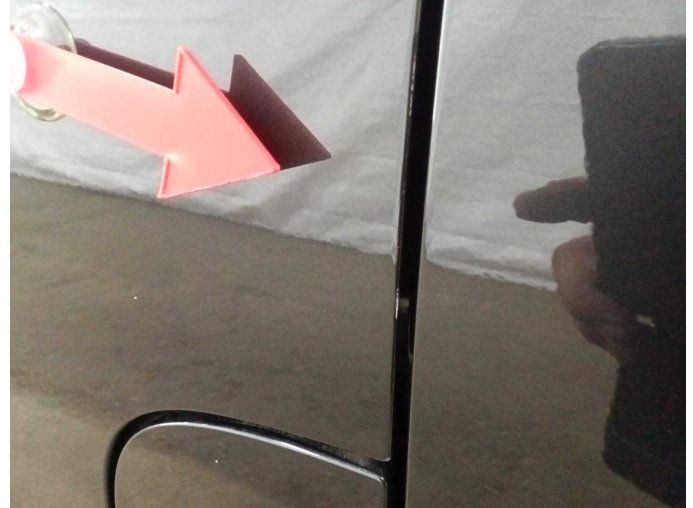
Damage 3: Door - front left side: Door edge - Scratch(es) - Smart repair

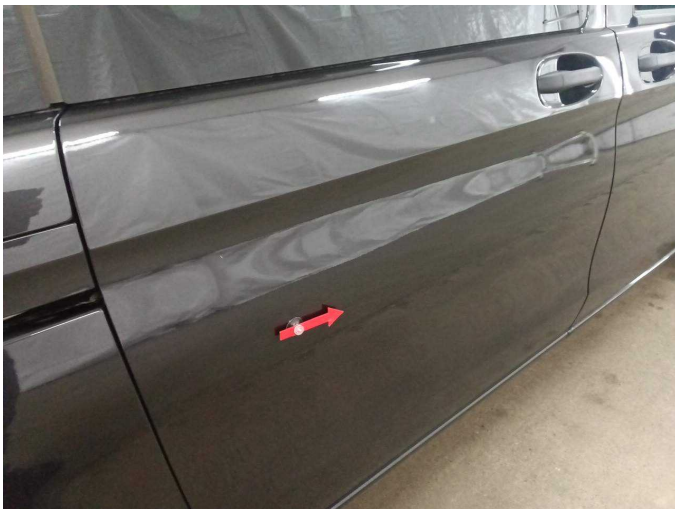
Damage 4: Sliding door, right: Sliding door - dent(s) - Smooth repair work

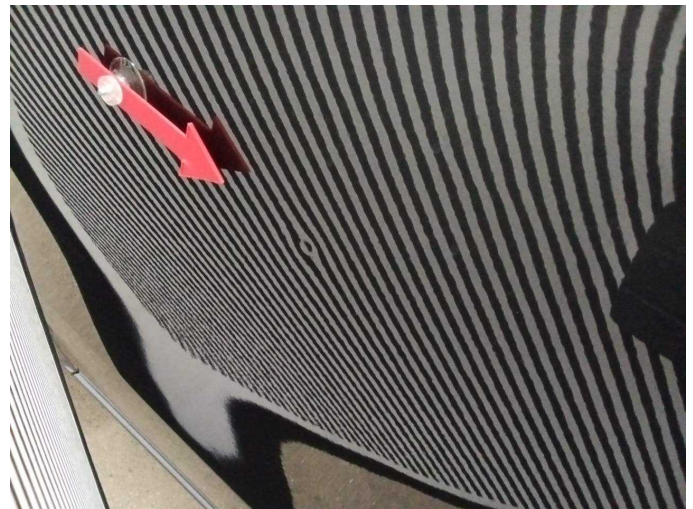
Damage 4: Sliding door, right: Sliding door - dent(s) - Smooth repair work

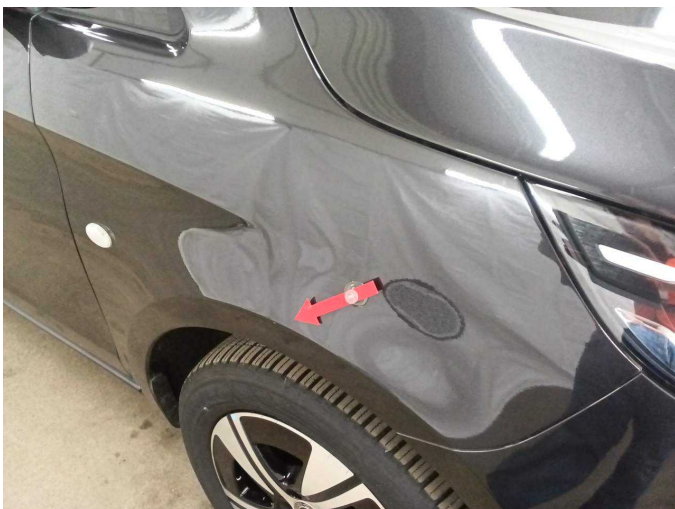
Damage 5: Mudguard - right side: Mudguard - right side - Scratch(es) - Smart repair

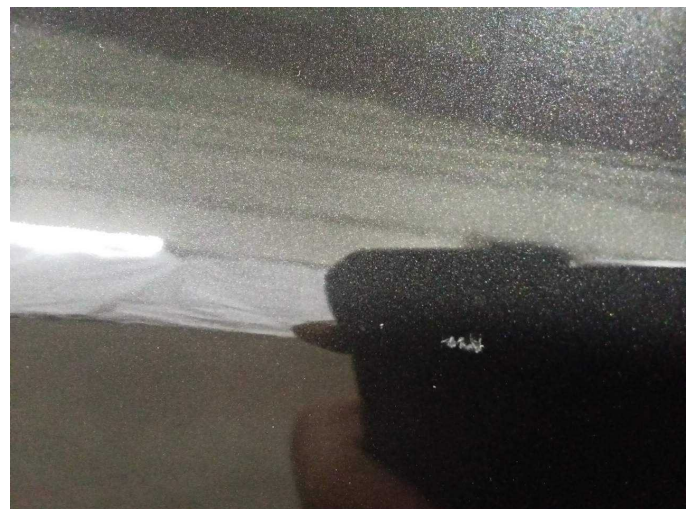
Damage 5: Mudguard - right side: Mudguard - right side - Scratch(es) - Smart repair

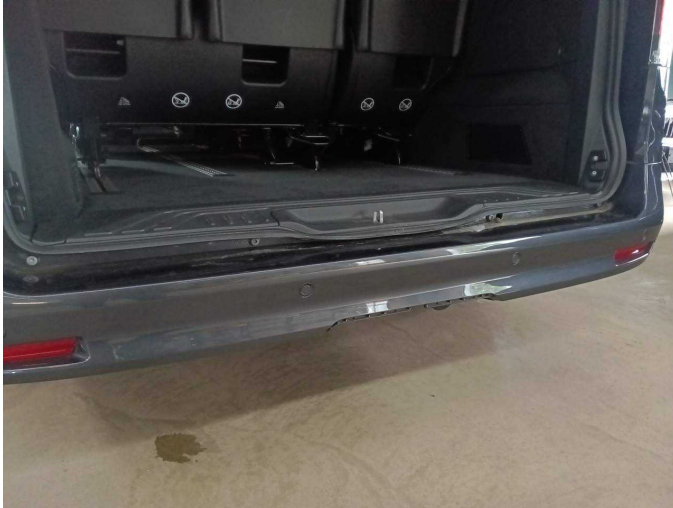
Damage 6: Rear of vehicle: Trailer hitch (Anhängerabdeckung fehlt) - Missing - Perform

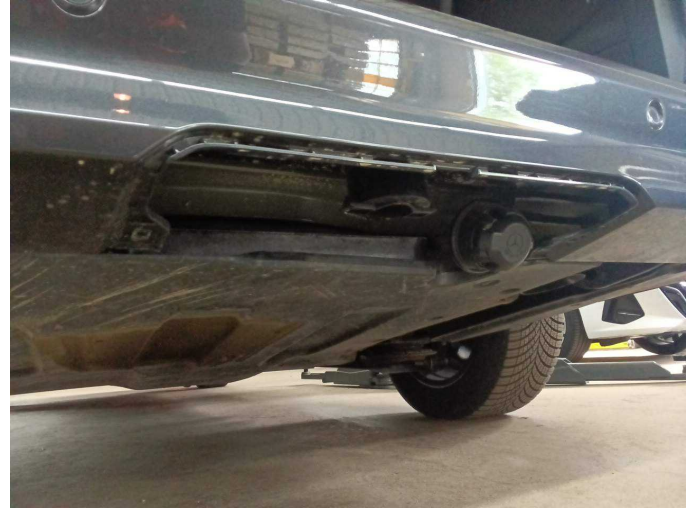
Damage 6: Rear of vehicle: Trailer hitch (Anhängerabdeckung fehlt) - Missing - Perform

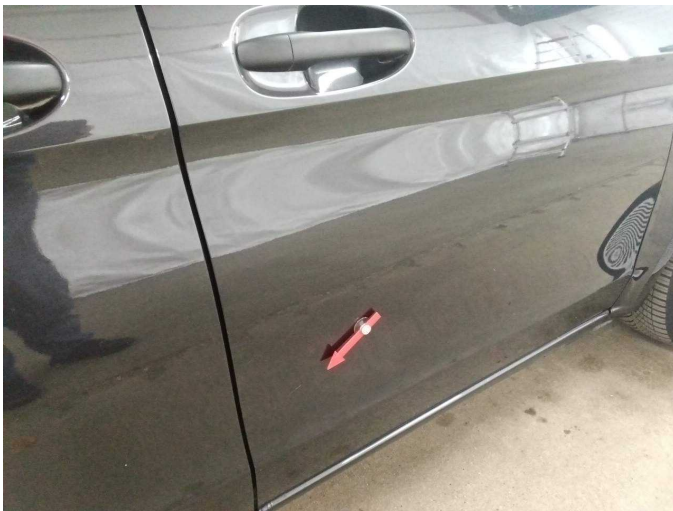
Damage 7: Door - front right side: Door - Scratch(es) - Paint

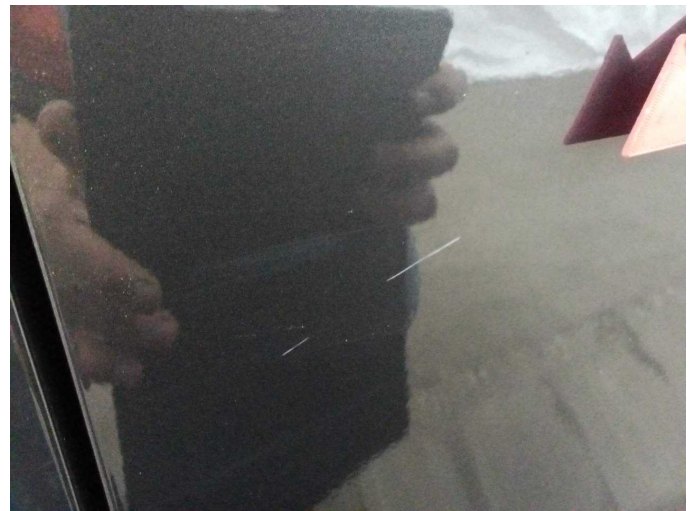
Damage 7: Door - front right side: Door - Scratch(es) - Paint
