Expertise

Protocol number: 46657645  
Order No. / Reference: 26578258  
Inspection date: 23 Jul 2026

Manufacturer: Skoda  
VIN: TMBJR9NP8P7049713

Model: Superb Combi 2.0 TDI DSG L&K

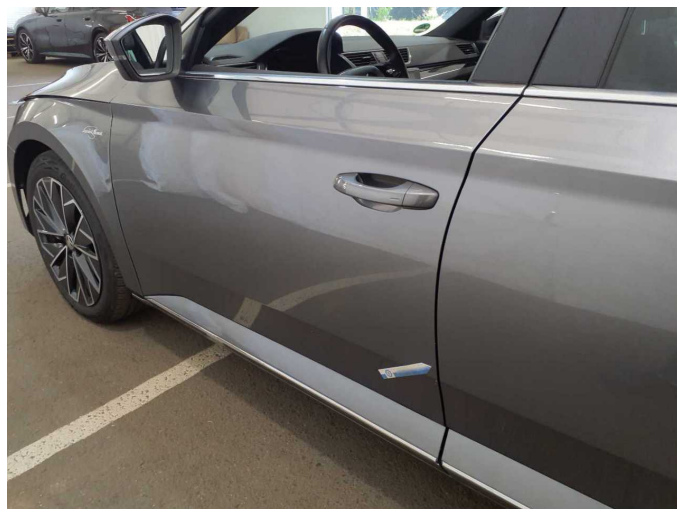
| No. | Component group | Description |
|---|---|---|
| 1 | Door - front left side | Door edge - Scratch(es) - Smart repair |

**Damage 1:** Door - front left side: Door edge - Scratch(es) - Smart repair

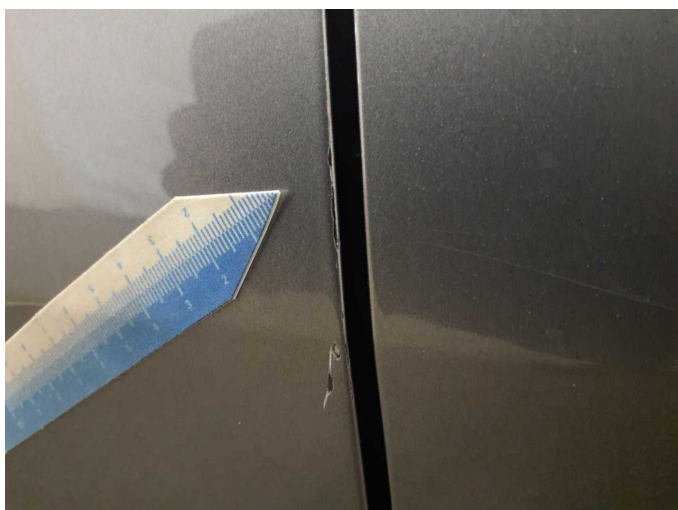
**Damage 1:** Door - front left side: Door edge - Scratch(es) - Smart repair

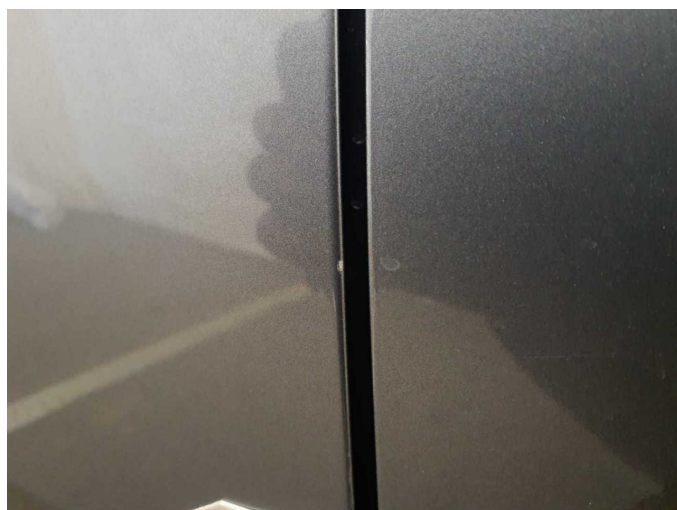
**Damage 1:** Door - front left side: Door edge - Scratch(es) - Smart repair

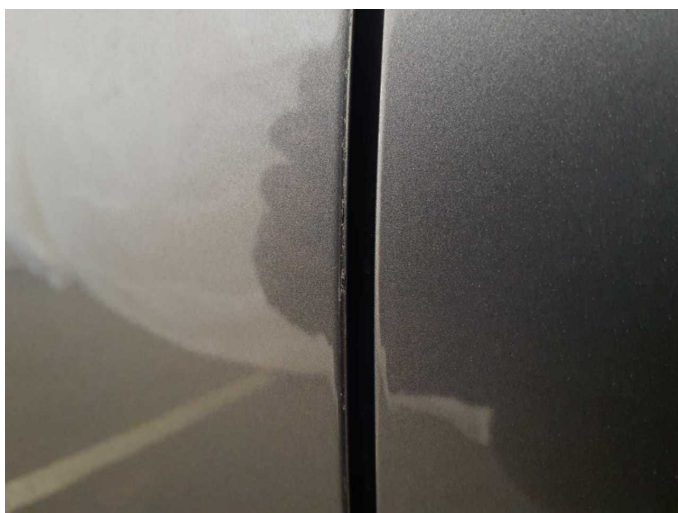
**Damage 1:** Door - front left side: Door edge - Scratch(es) - Smart repair

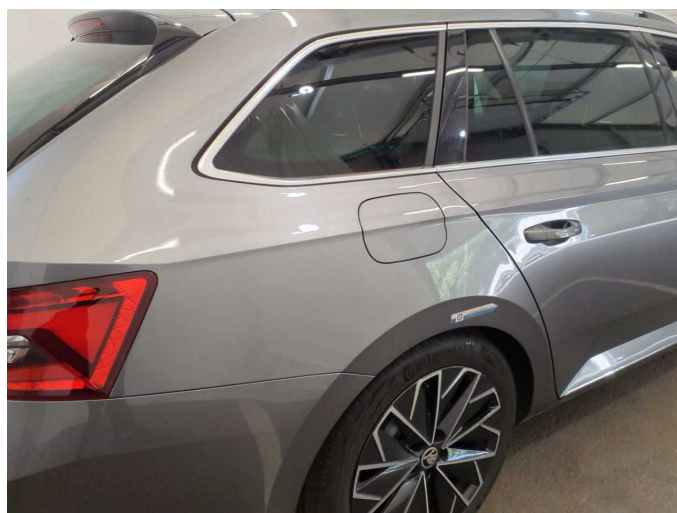
| No. | Component group | Description |
|---|---|---|
| 2 | Side panel - rear right side | Side panel - dent(s) - Smart repair |

**Damage 2:** Side panel - rear right side: Side panel - dent(s) - Smart repair

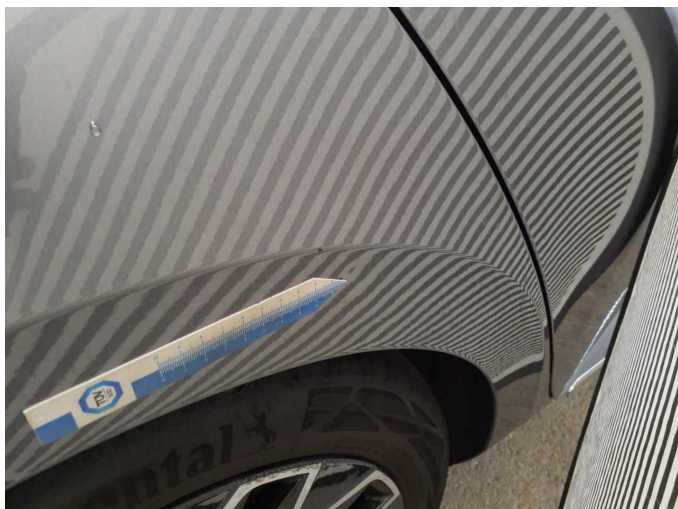
**Damage 2:** Side panel - rear right side: Side panel - dent(s) - Smart repair

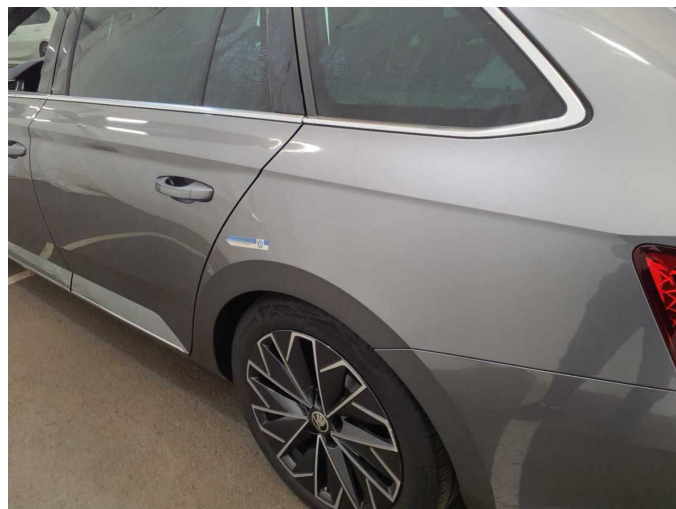
| No. | Component group | Description |
|---|---|---|
| 3 | Side panel - rear left side | Side panel - dent(s) - Smart repair |

**Damage 3:** Side panel - rear left side: Side panel - dent(s) - Smart repair

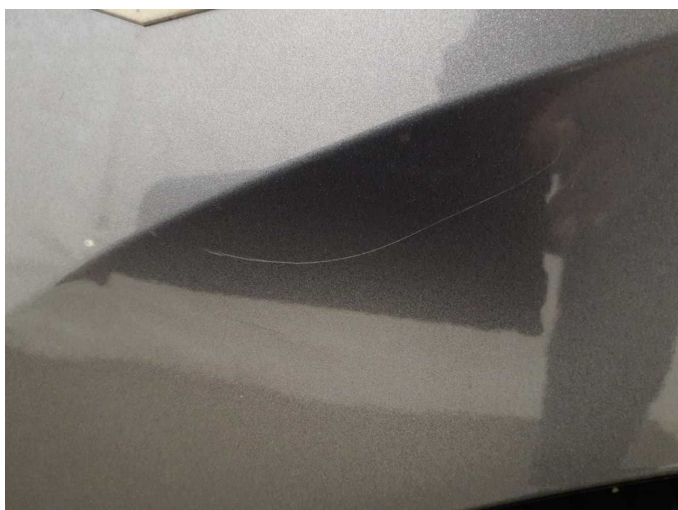
**Damage 3:** Side panel - rear left side: Side panel - dent(s) - Smart repair

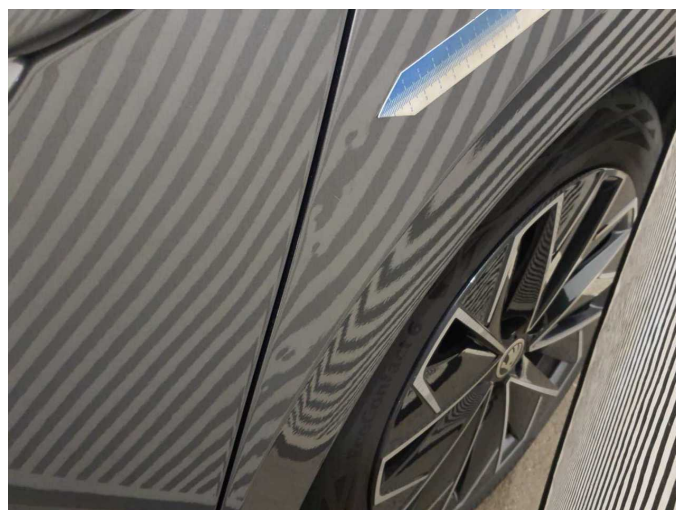
**Damage 3:** Side panel - rear left side: Side panel - dent(s) - Smart repair

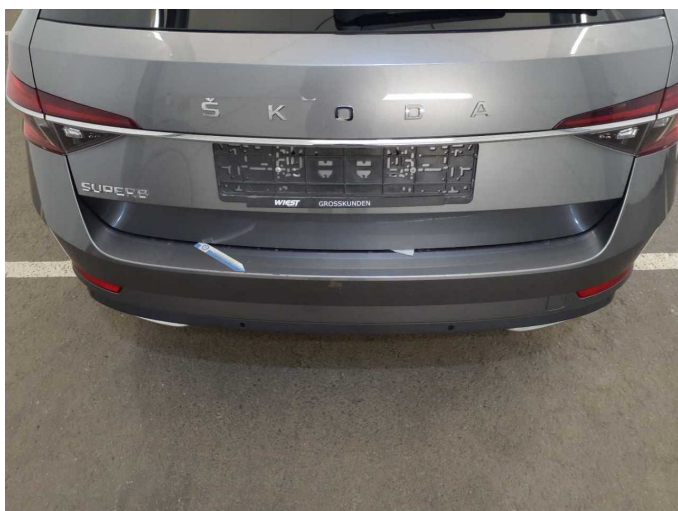
| No. | Component group | Description |
|---|---|---|
| 4 | Rear bumper | Rear bumper - Scratch(es) - Smart repair |

**Damage 4:** Rear bumper: Rear bumper - Scratch(es) - Smart repair

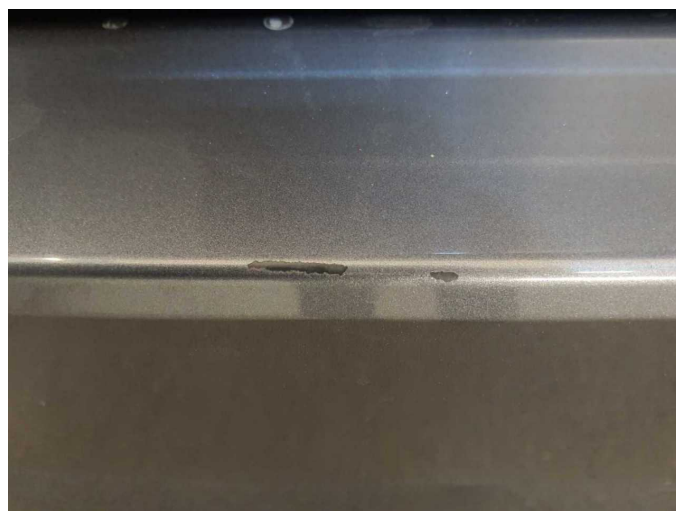
**Damage 4:** Rear bumper: Rear bumper - Scratch(es) - Smart repair

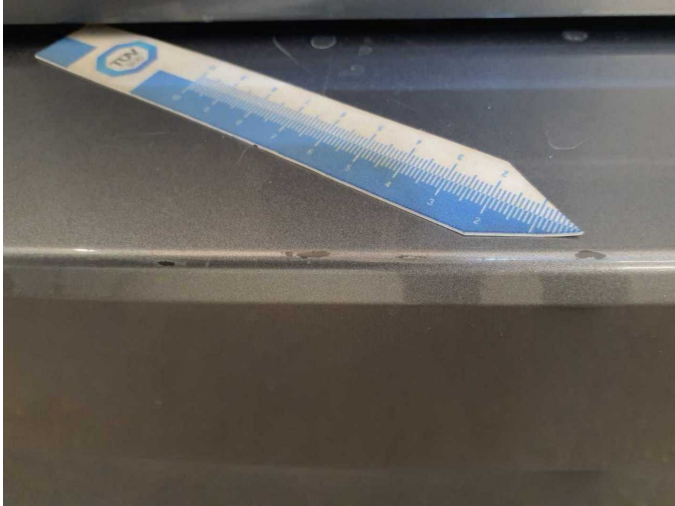
**Damage 4:** Rear bumper: Rear bumper - Scratch(es) - Smart repair

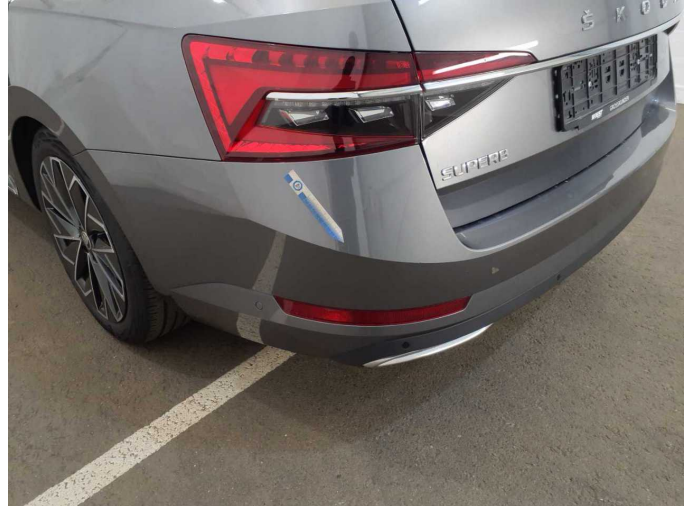
**Damage 4:** Rear bumper: Rear bumper - Scratch(es) - Smart repair

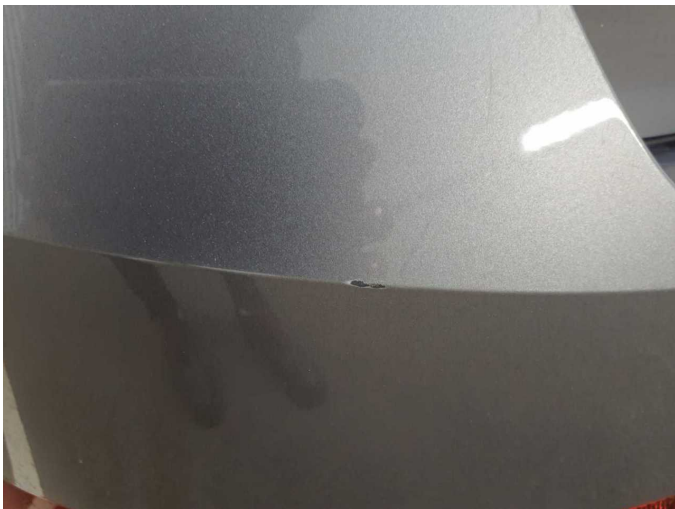
**Damage 4:** Rear bumper: Rear bumper - Scratch(es) - Smart repair

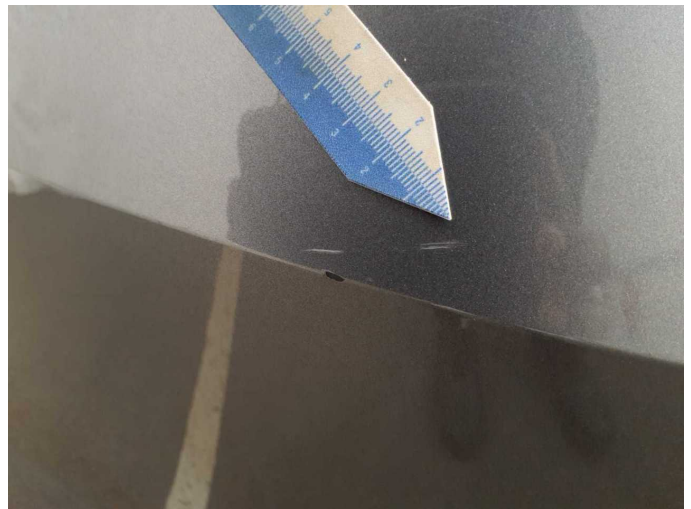
**Damage 4:** Rear bumper: Rear bumper - Scratch(es) - Smart repair

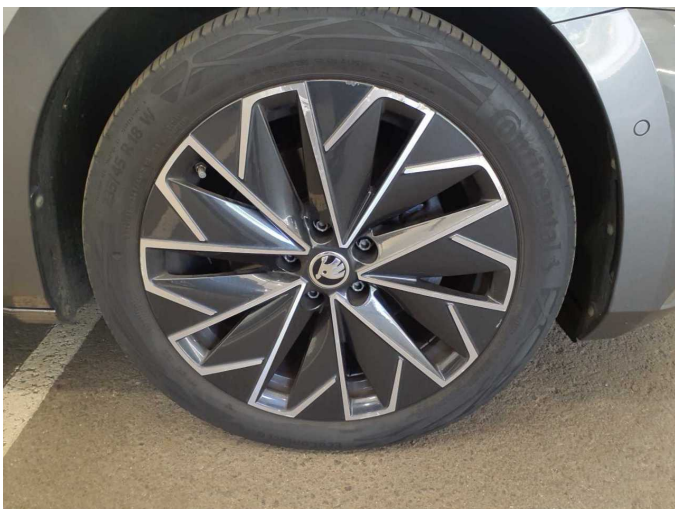
| No. | Component group | Description |
|---|---|---|
| 5 | Wheel / tyres | Tyre - front right side - Broken / torn - Replace |

**Damage 5:** Wheel / tyres: Tyre - front right side - Broken / torn - Replace

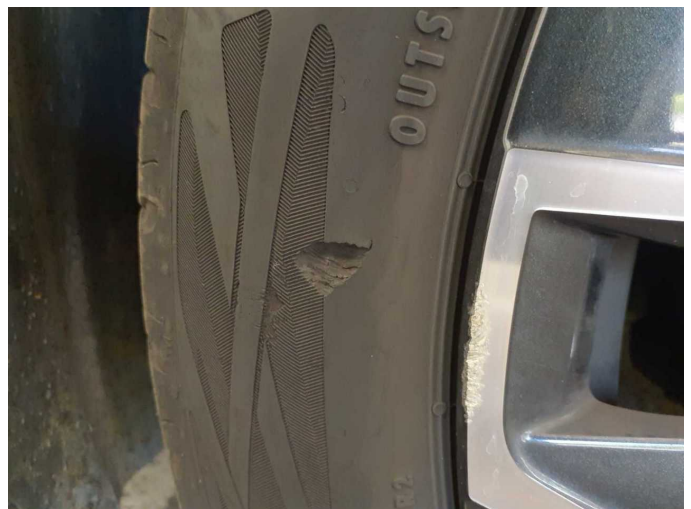
**Damage 5:** Wheel / tyres: Tyre - front right side - Broken / torn - Replace

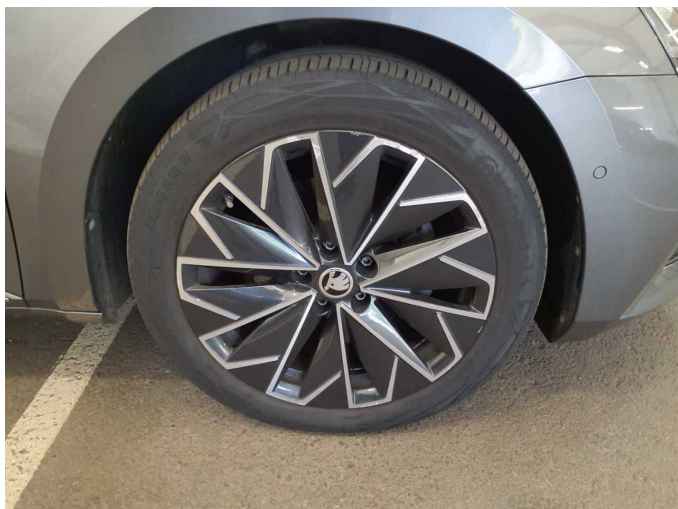
| No. | Component group | Description |
|---|---|---|
| 7 | Wheel / tyres | Alloy rim - front right side - Scratched - Replace |

**Damage 7:** Wheel / tyres: Alloy rim - front right side - Scratched - Replace

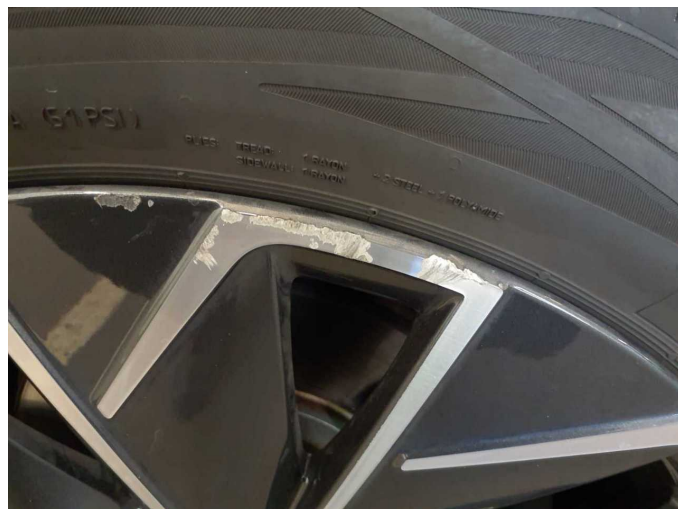
**Damage 7:** Wheel / tyres: Alloy rim - front right side - Scratched - Replace

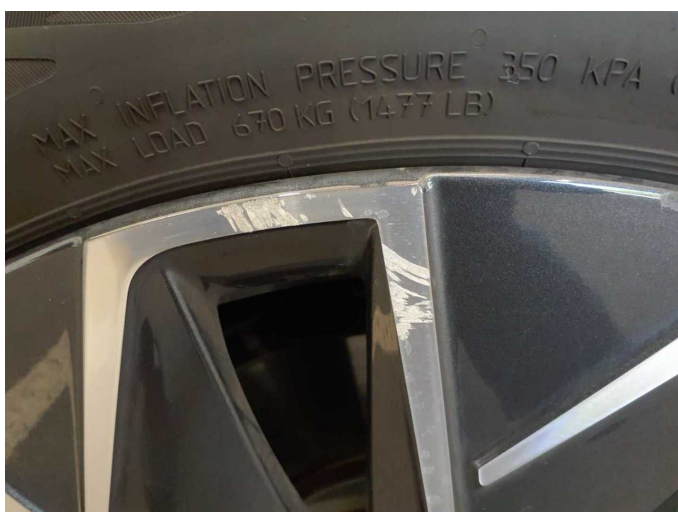
**Damage 7:** Wheel / tyres: Alloy rim - front right side - Scratched - Replace

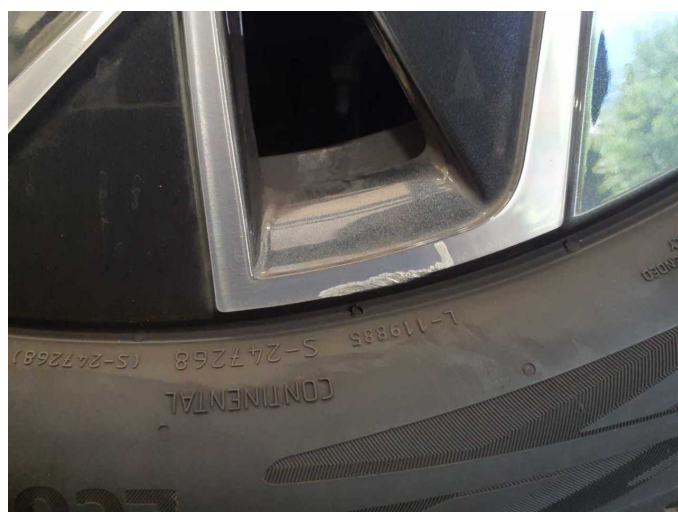
**Damage 7:** Wheel / tyres: Alloy rim - front right side - Scratched - Replace

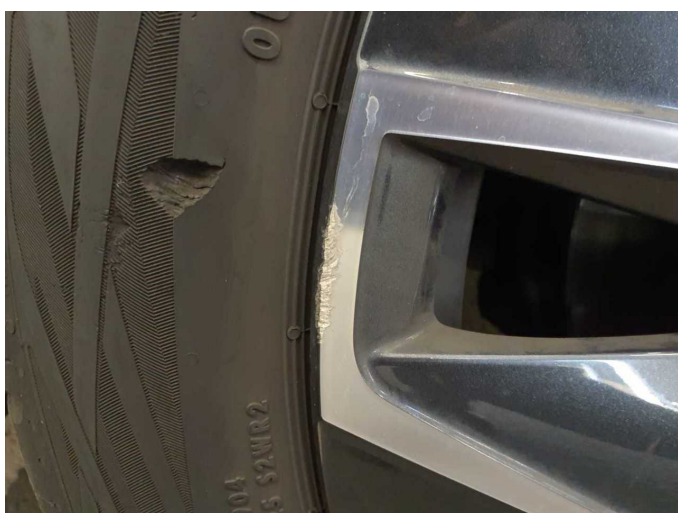
**Damage 7:** Wheel / tyres: Alloy rim - front right side - Scratched - Replace

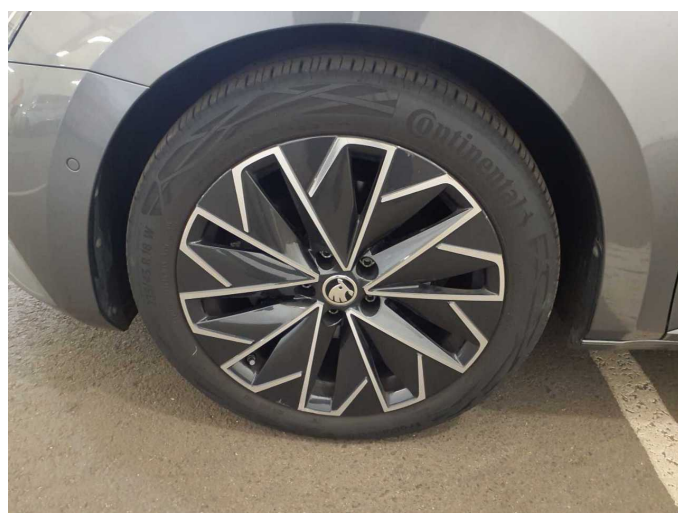
| No. | Component group | Description |
|---|---|---|
| 8 | Wheel / tyres | Alloy rim - front left side - Scratched - Replace |

**Damage 8:** Wheel / tyres: Alloy rim - front left side - Scratched - Replace

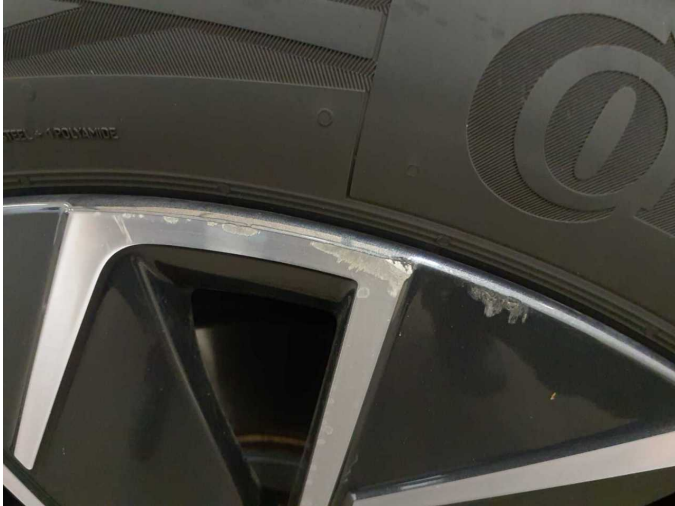
**Damage 8:** Wheel / tyres: Alloy rim - front left side - Scratched - Replace

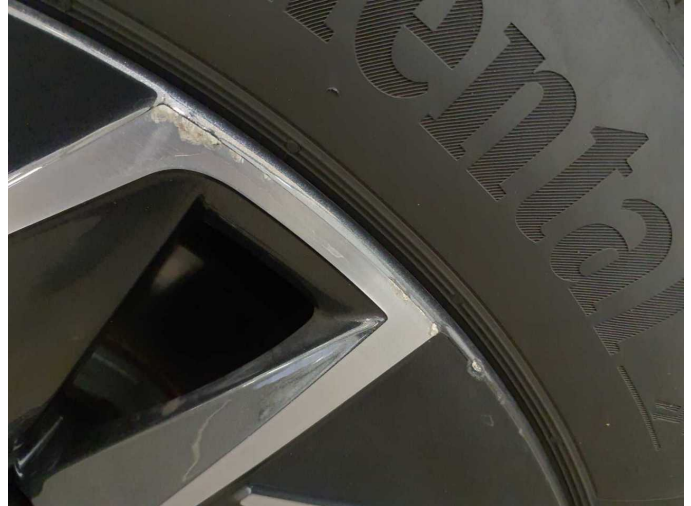
**Damage 8:** Wheel / tyres: Alloy rim - front left side - Scratched - Replace

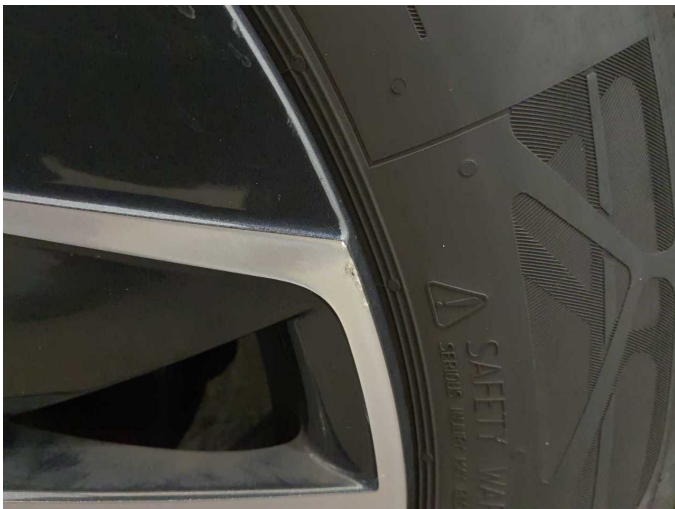
**Damage 8:** Wheel / tyres: Alloy rim - front left side - Scratched - Replace

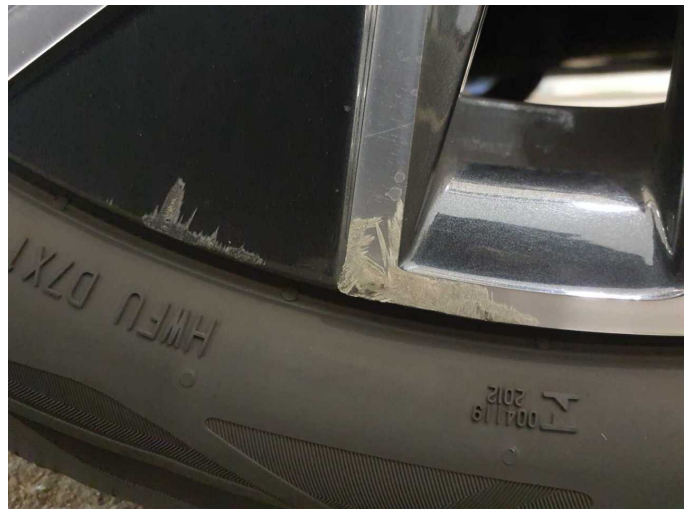
**Damage 8:** Wheel / tyres: Alloy rim - front left side - Scratched - Replace

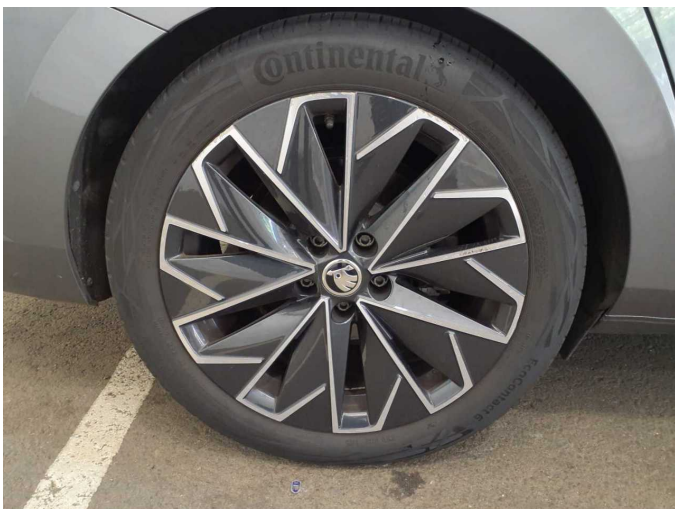
| No. | Component group | Description |
|---|---|---|
| 9 | Wheel / tyres | Alloy rim - rear right side - Scratched - Replace |

**Damage 9:** Wheel / tyres: Alloy rim - rear right side - Scratched - Replace

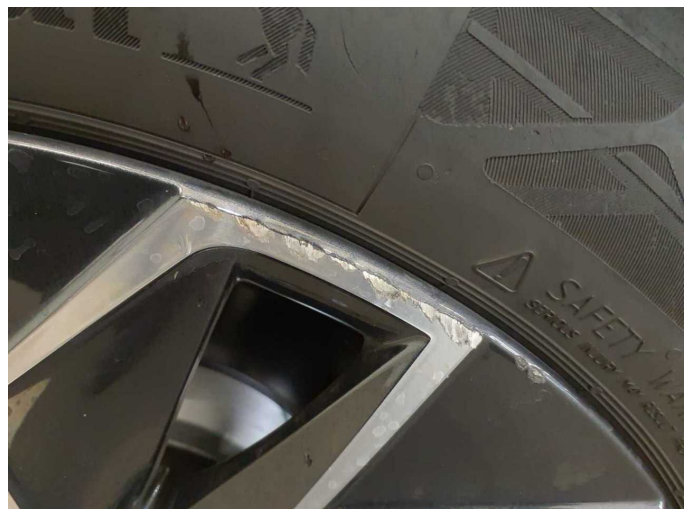
**Damage 9:** Wheel / tyres: Alloy rim - rear right side - Scratched - Replace

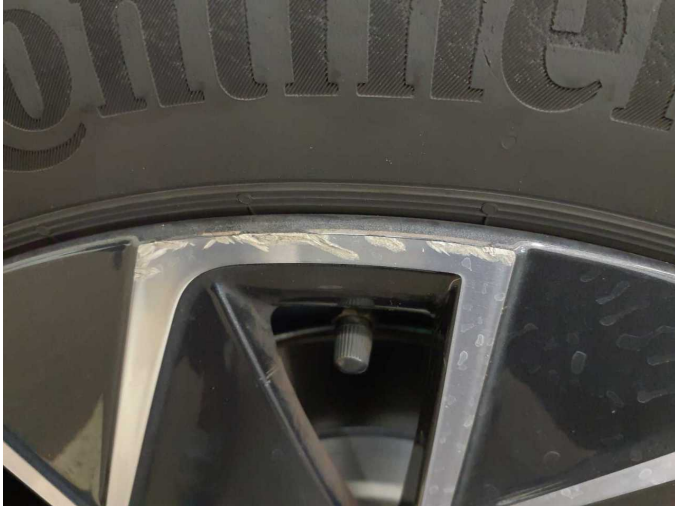
**Damage 9:** Wheel / tyres: Alloy rim - rear right side - Scratched - Replace

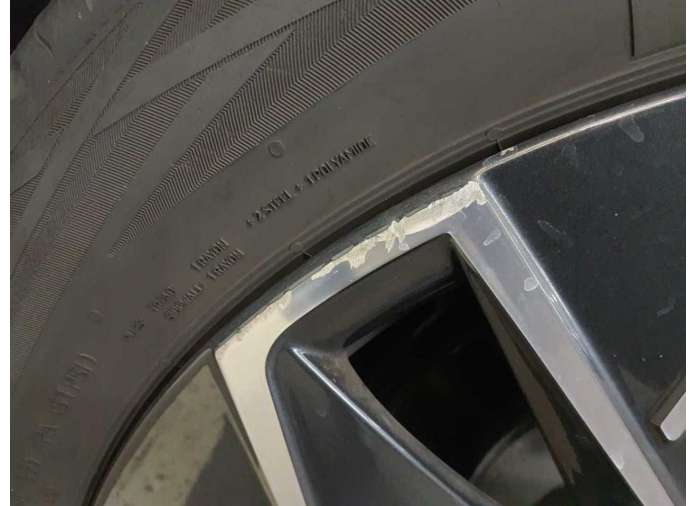
**Damage 9:** Wheel / tyres: Alloy rim - rear right side - Scratched - Replace

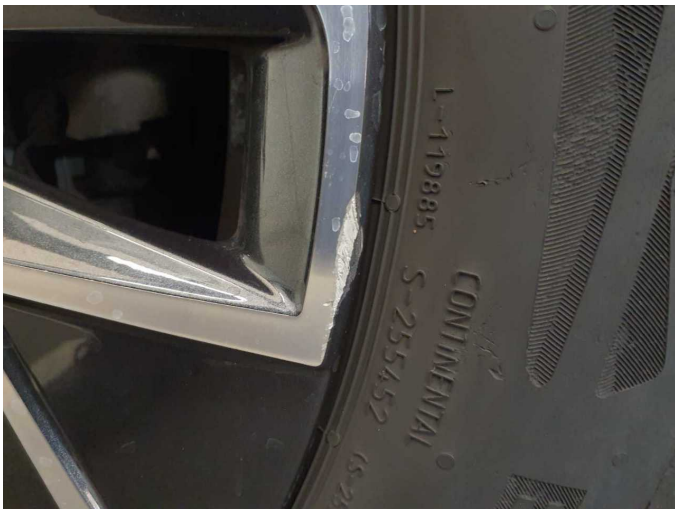
**Damage 9:** Wheel / tyres: Alloy rim - rear right side - Scratched - Replace

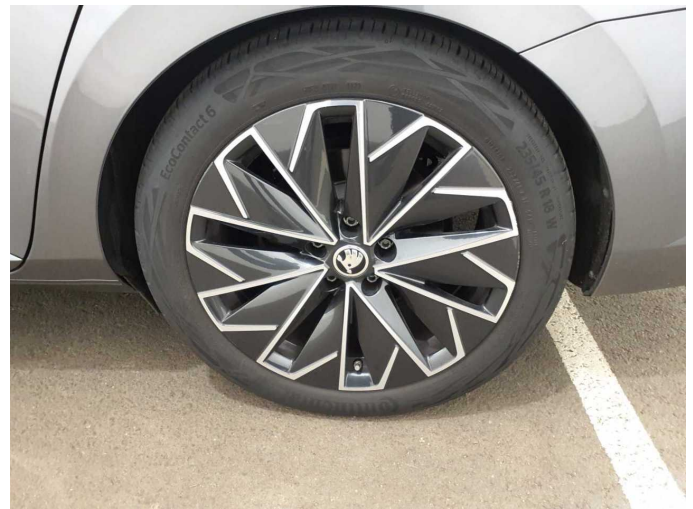
| No. | Component group | Description |
|---|---|---|
| 10 | Wheel / tyres | Alloy rim - rear left side - Scratched - Replace |

**Damage 10:** Wheel / tyres: Alloy rim - rear left side - Scratched - Replace

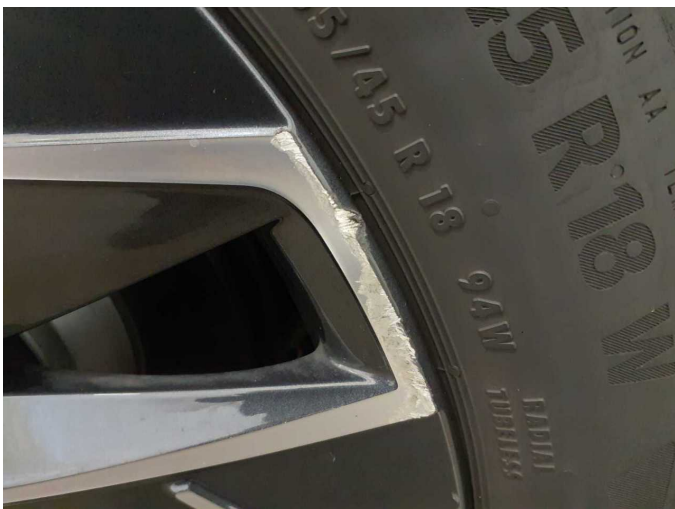
**Damage 10:** Wheel / tyres: Alloy rim - rear left side - Scratched - Replace

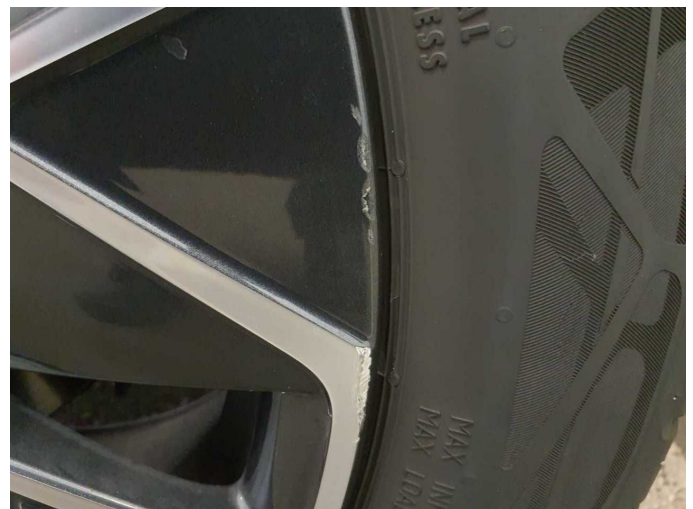
**Damage 10:** Wheel / tyres: Alloy rim - rear left side - Scratched - Replace

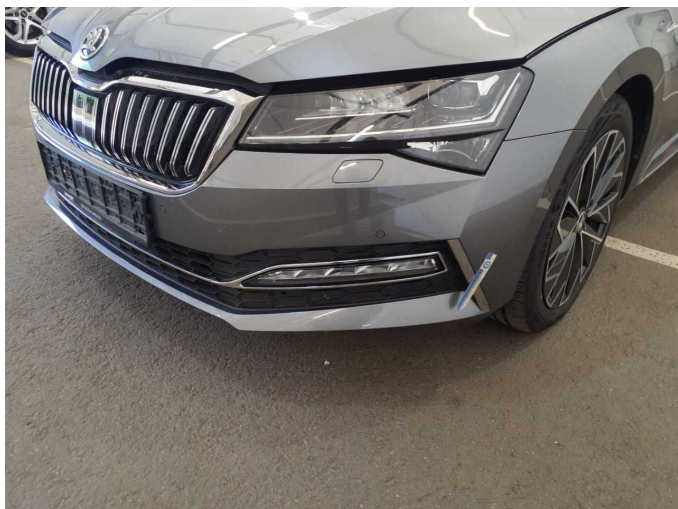
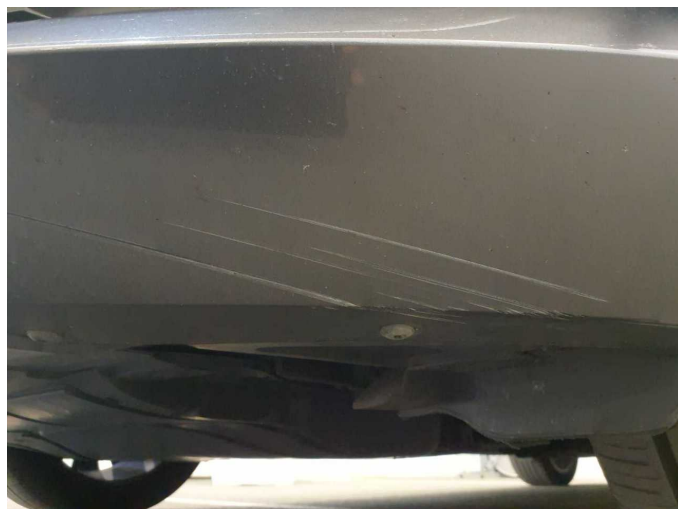
| No. | Component group | Description |
|---|---|---|
| 11 | Front bumper | Front bumper - Scratch(es) - Repair and paint |

**Damage 11:** Front bumper: Front bumper - Scratch(es) - Repair and paint

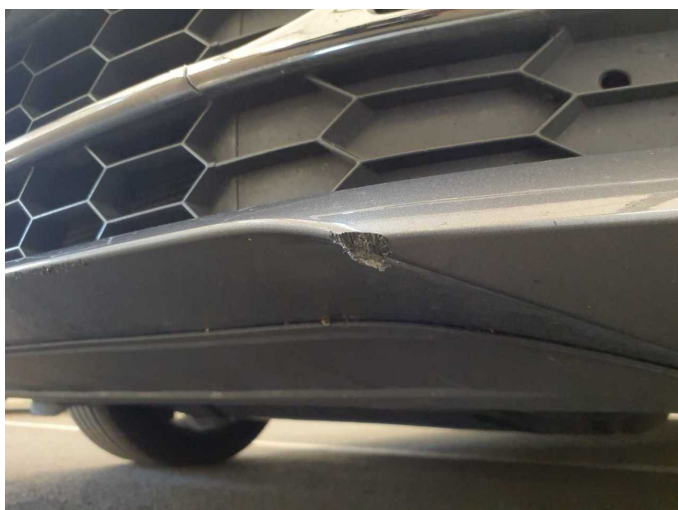
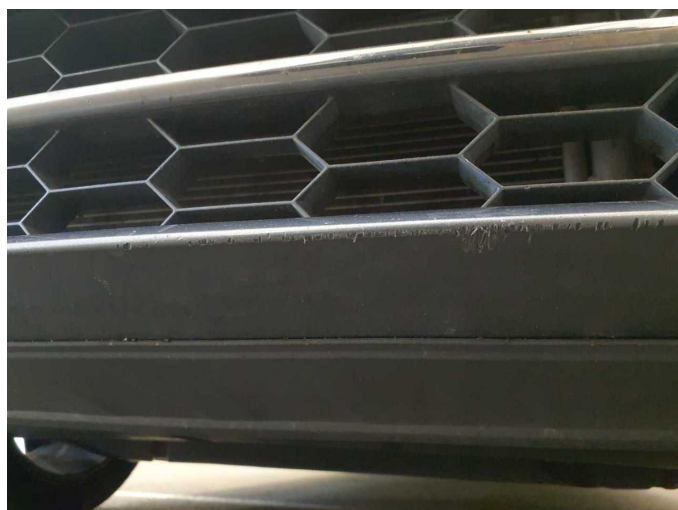
**Damage 11:** Front bumper: Front bumper - Scratch(es) - Repair and paint
