Expertise

Protocol number: 46255379  
Order No. / Reference: 26512727  
Inspection date: 30 Jun 2026

Manufacturer: Skoda  
VIN: TMBJF9NU8P5057045

Model: Karoq 2.0 TDI SCR Style

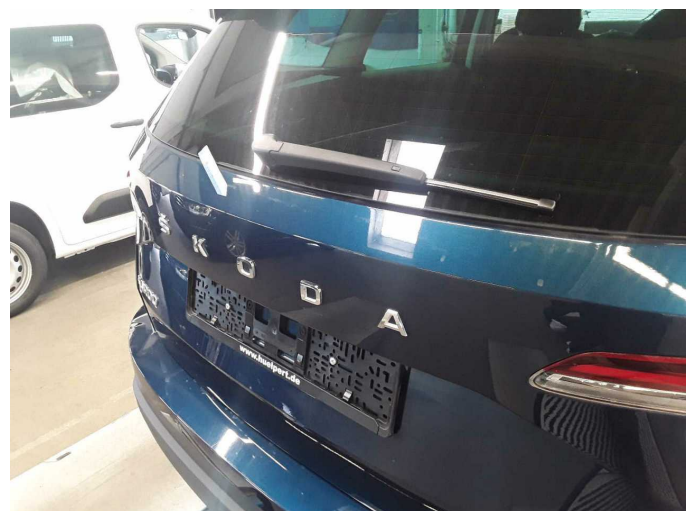
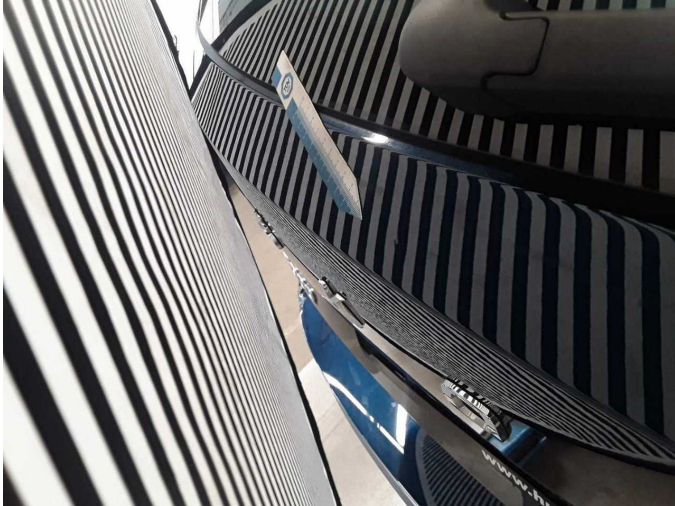
| No. | Component group | Description |
|---|---|---|
| 1 | Boot lid / rear door | Boot lid - Dent / paintcoat damage - Smart repair |

**Damage 1:** Boot lid / rear door: Boot lid - Dent / paintcoat damage - Smart repair

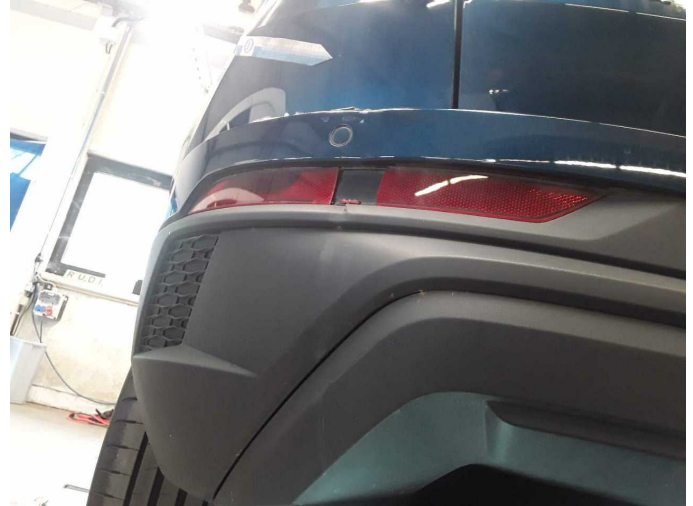
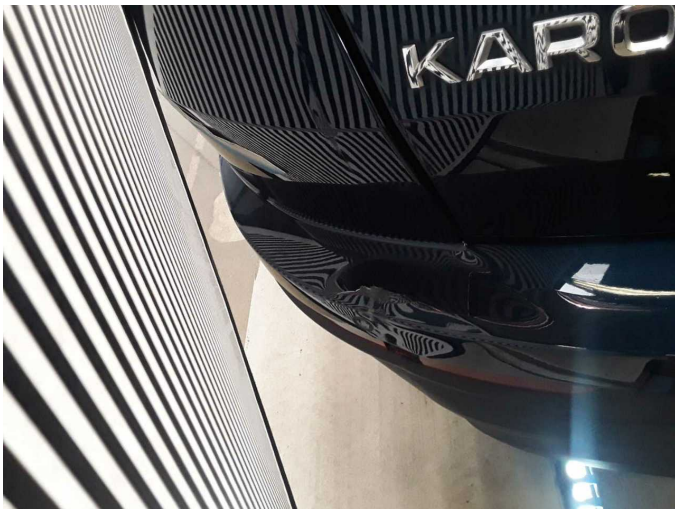
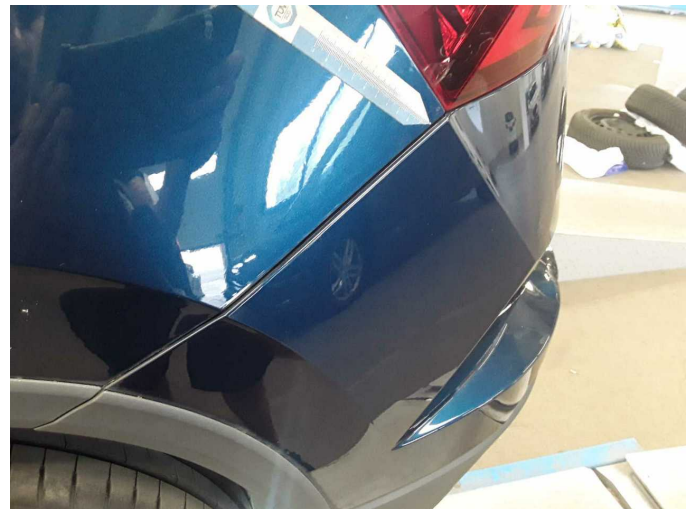
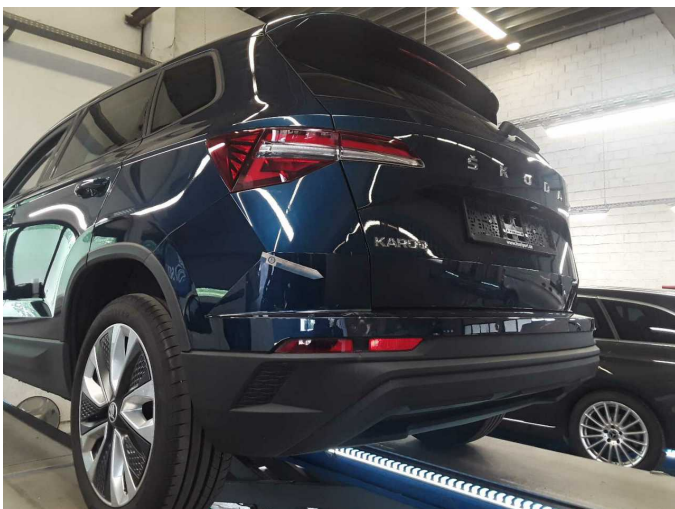
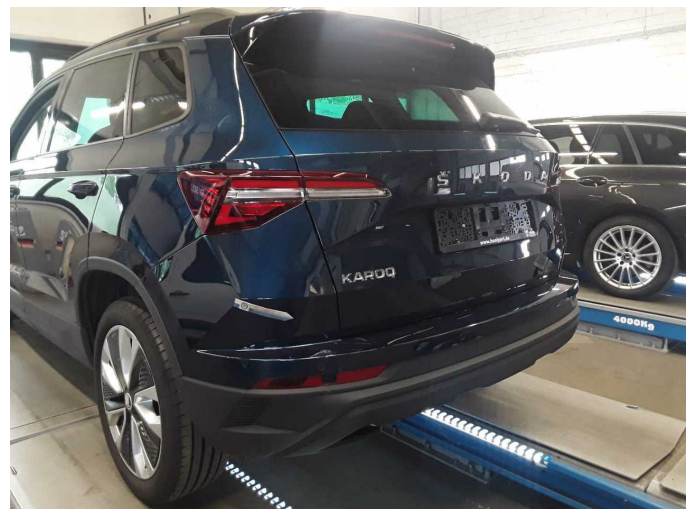
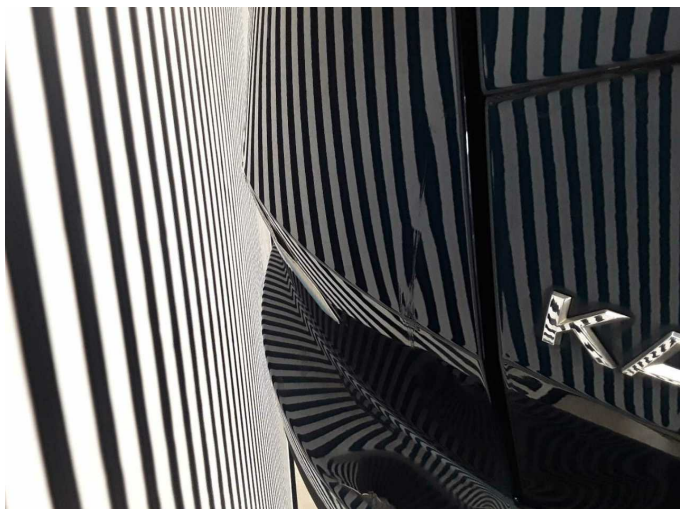
| No. | Component group | Description |
|---|---|---|
| 2 | Rear bumper | Rear bumper (+Reflektor+Spoiler) - Damaged - repair according to calculation |

Die beigefügte Reparaturkostenkalkulation wurde nach bestem Wissen und Gewissen unter eingeschränkten Besichtigungsbedingung im demontagefreien Zustand erstellt. Es können aufgrund verdeckter Beschädigung, Mehrkosten und somit Abweichung der für die Stoßstange ausgewiesenen Reparaturkosten nicht ausgeschlossen werden.

**Damage 2:** Rear bumper: Rear bumper (+Reflektor+Spoiler) - Damaged - repair according to calculation

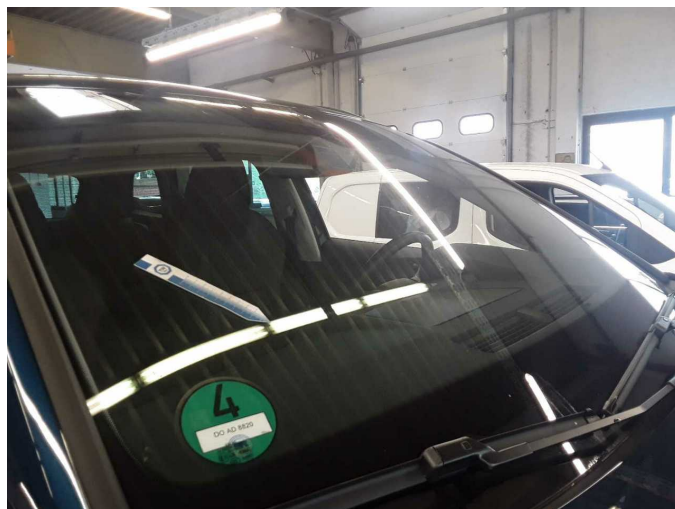
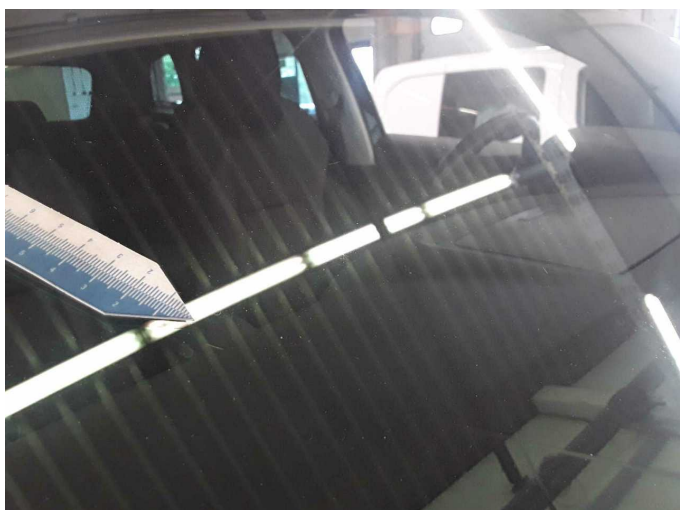
| No. | Component group | Description |
|---|---|---|
| 1 | Vehicle glazing | Windscreen - Stone chips - No deduction |

**Wear and tear 1:** Vehicle glazing: Windscreen - Stone chips - No deduction

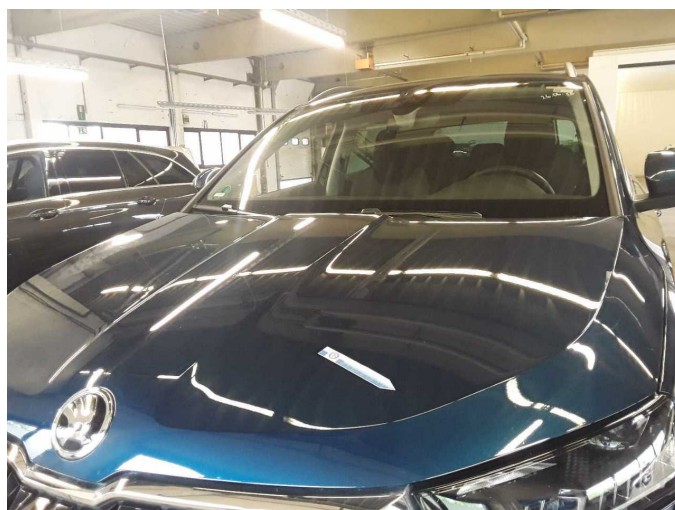
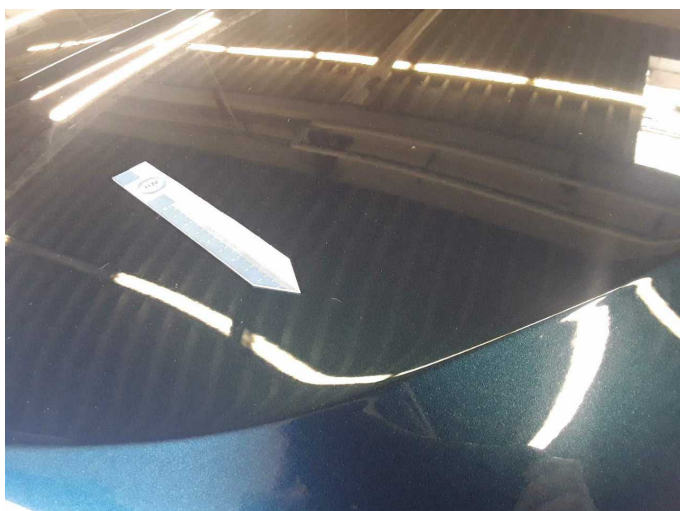
| No. | Component group | Description |
|---|---|---|
| 2 | Bonnet | Bonnet - Stone chips - No deduction |

**Wear and tear 2:** Bonnet: Bonnet - Stone chips - No deduction

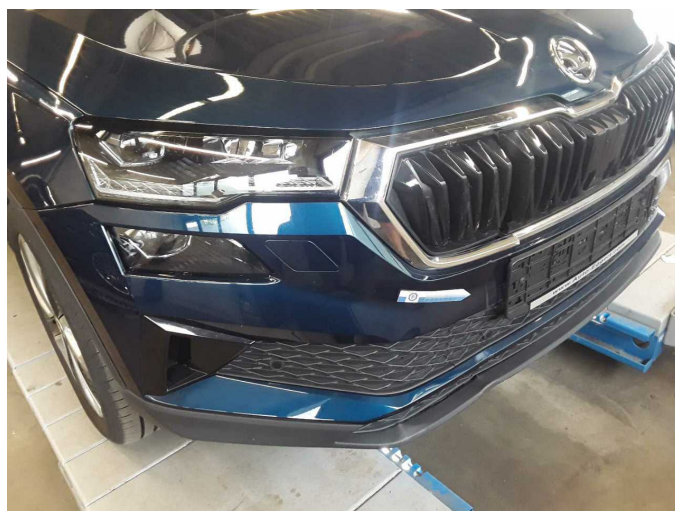
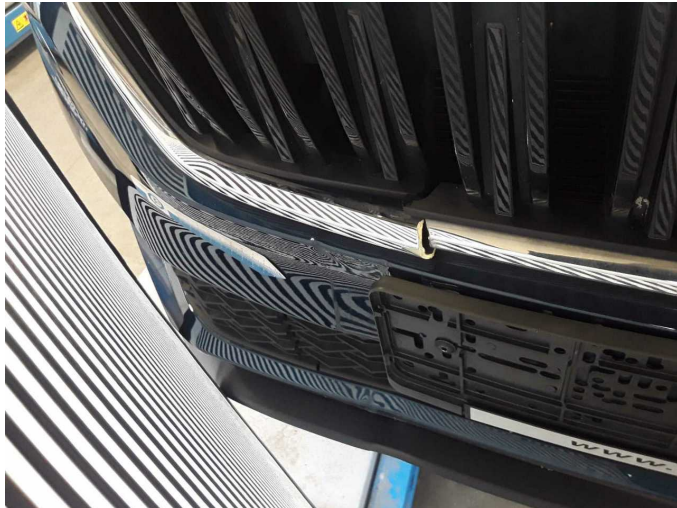
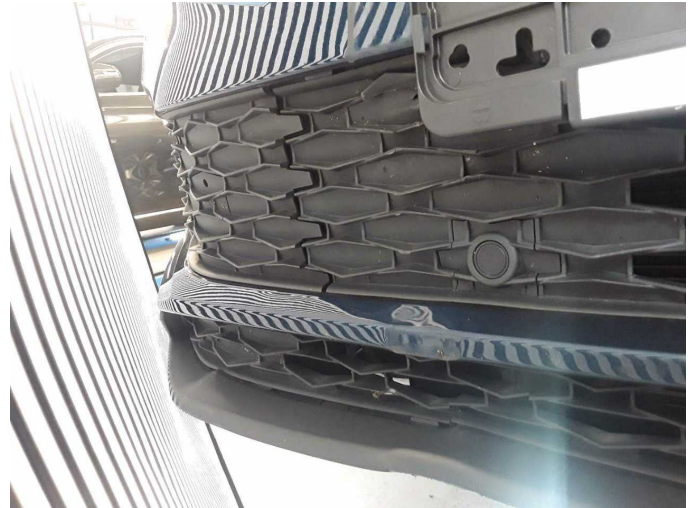
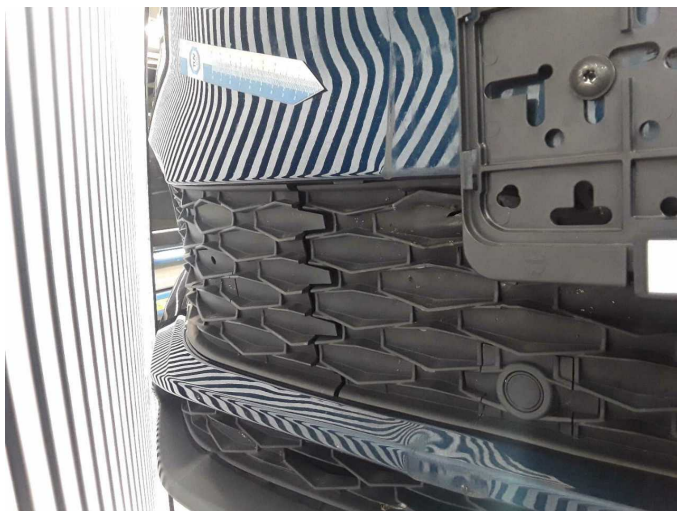
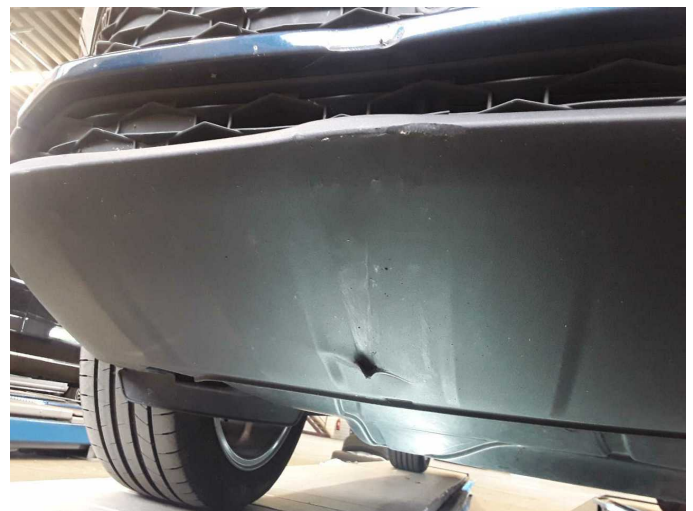
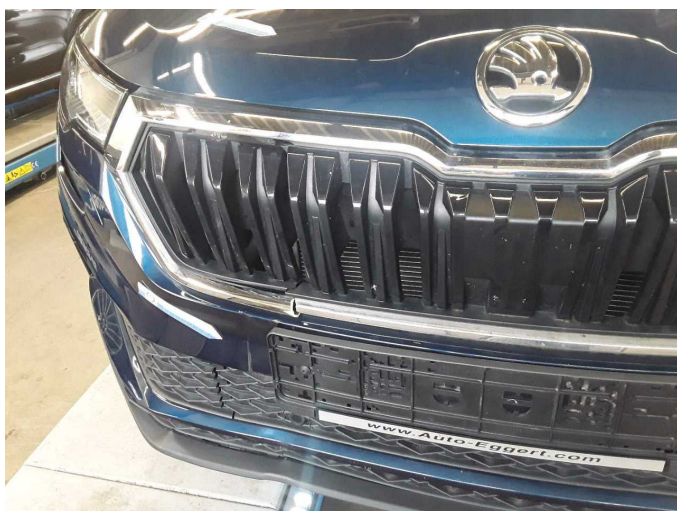
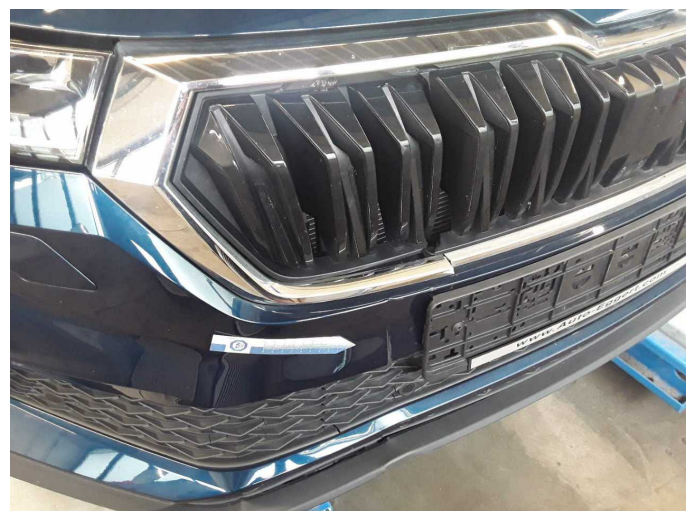
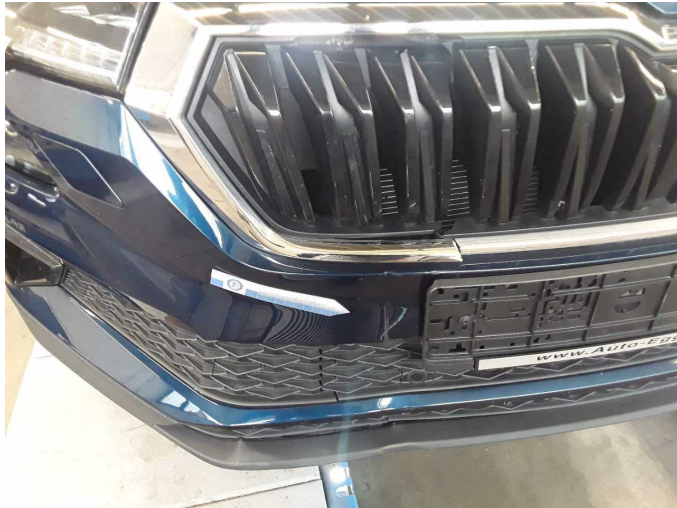
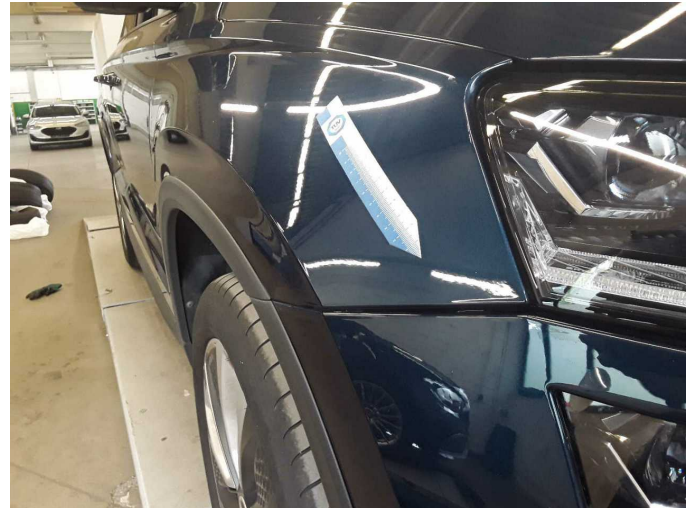
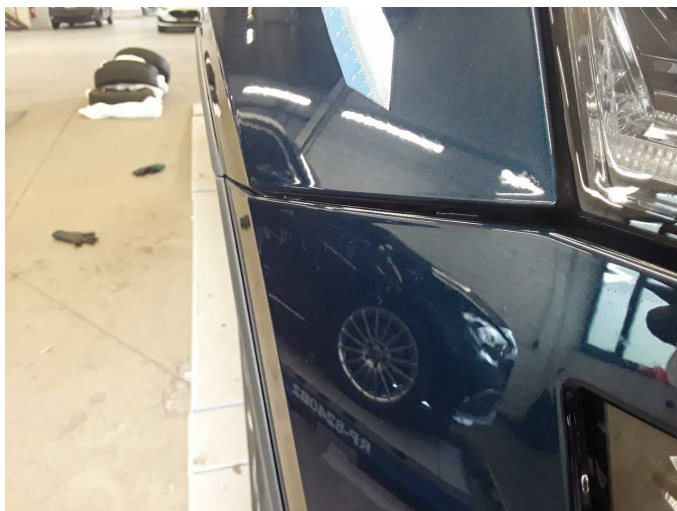
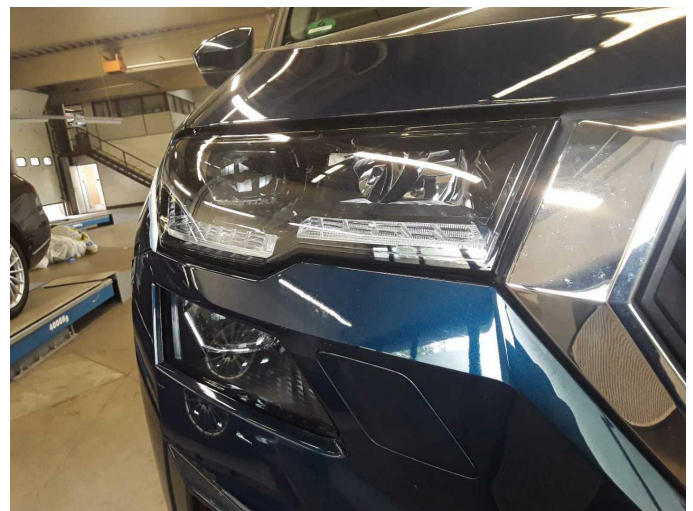
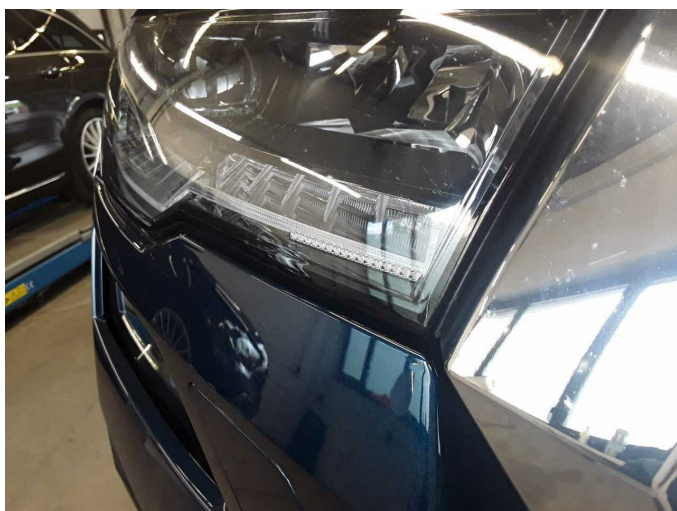
| No. | Accident |
|---|---|
| 1 | Front, Underbody |

Die beigefügte Reparaturkostenkalkulation wurde nach bestem Wissen und Gewissen unter eingeschränkten Besichtigungsbedingung im demontagefreien Zustand erstellt. Es können aufgrund verdeckter Beschädigung erhebliche Mehrkosten und somit Abweichung der für den Unfall ausgewiesenen Reparaturkosten nicht ausgeschlossen werden.

**Accident 1:** Front, Underbody

**Accident 1: Front, Underbody**
