Expertise

Protocol number: 46683343  
Order No. / Reference: 26694837  
Inspection date: 23 Jul 2026

Manufacturer: Opel

Model: Combo Cargo 1.5 D Selection

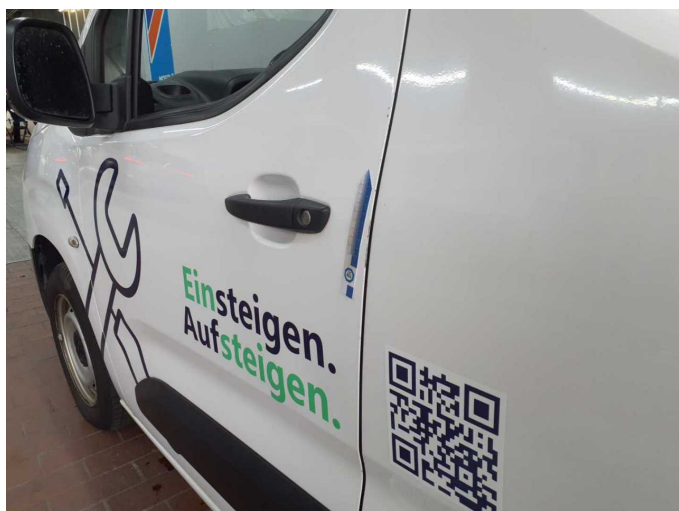
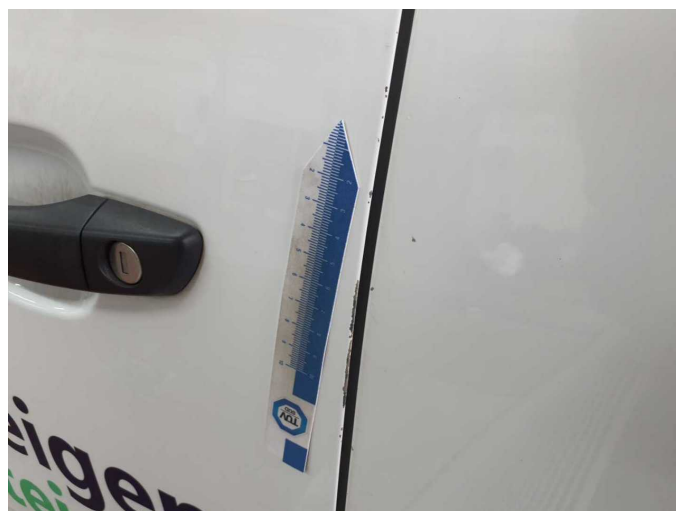
| No. | Component group | Description |
|---|---|---|
| 1 | Door - front left side | Door edge - Scratch(es) - Smart repair |

**Damage 1:** Door - front left side: Door edge - Scratch(es) - Smart repair

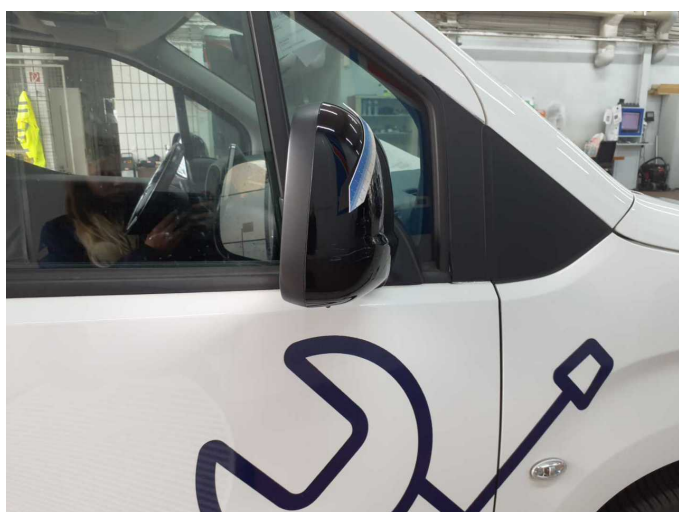
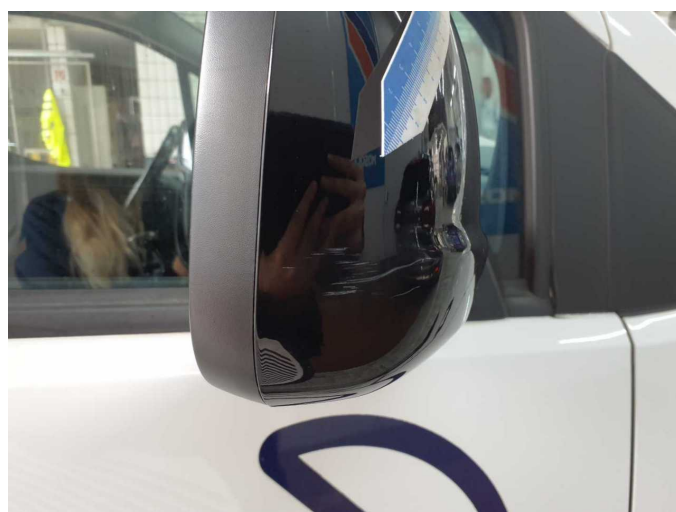
| No. | Component group | Description |
|---|---|---|
| 2 | Wing mirror - right side | Cap - Scratch(es) - Smart repair |

**Damage 2:** Wing mirror - right side: Cap - Scratch(es) - Smart repair

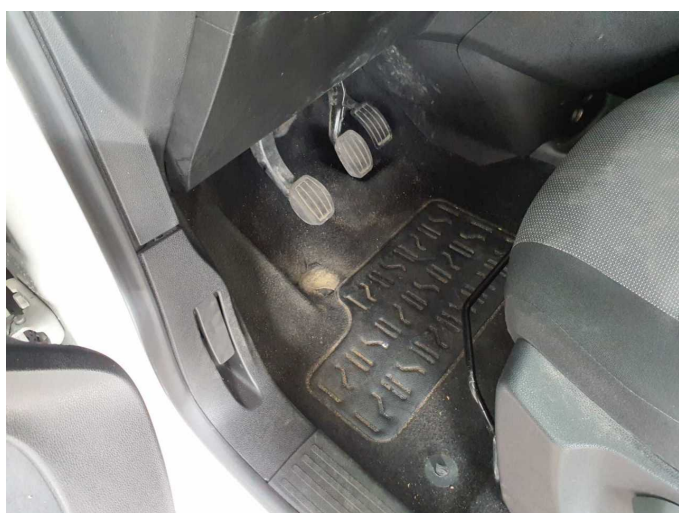
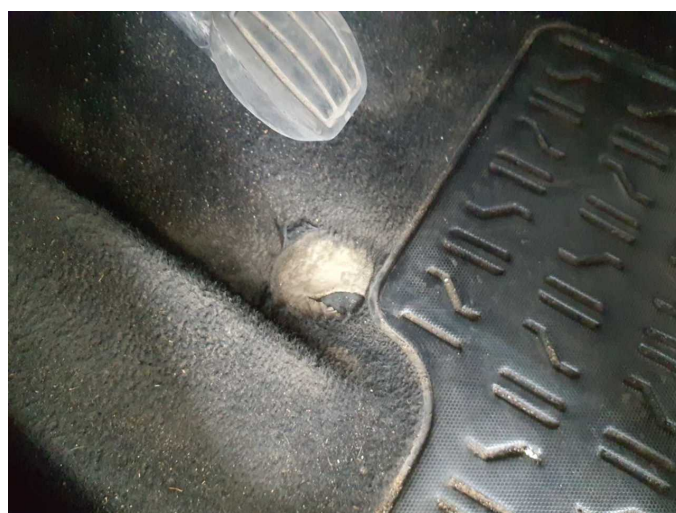
| No. | Component group | Description |
|---|---|---|
| 3 | Trim / covers | Carpet - front left side - Holes - Loss in value |

**Damage 3:** Trim / covers: Carpet - front left side - Holes - Loss in value

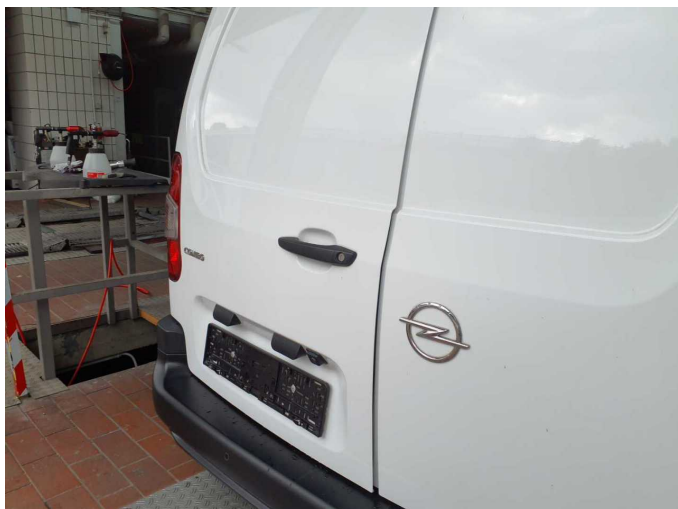
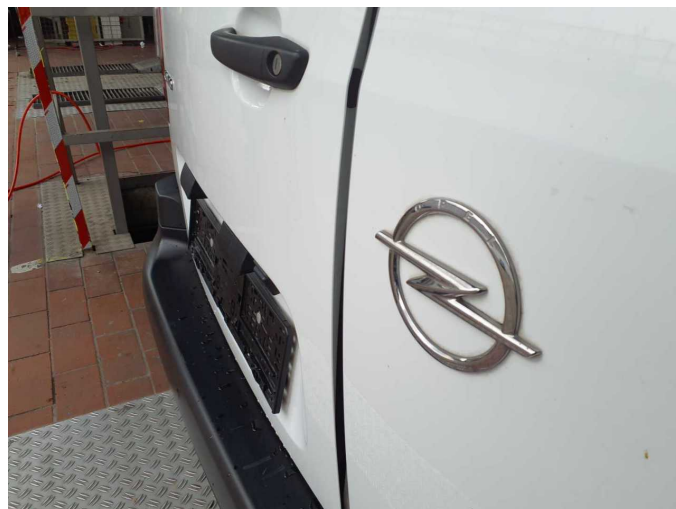
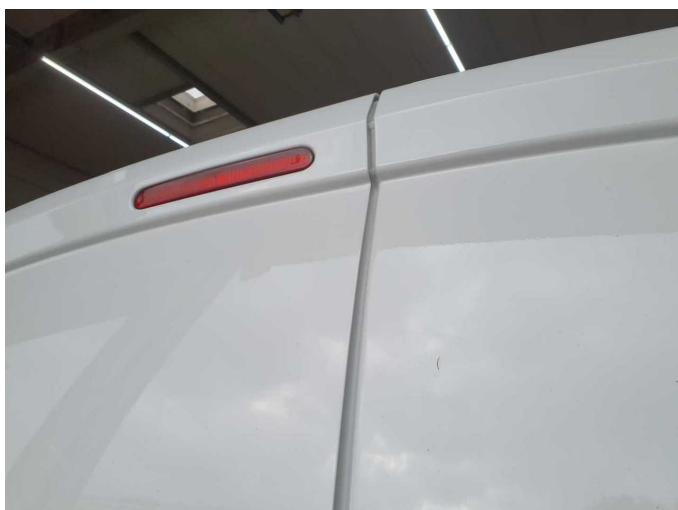
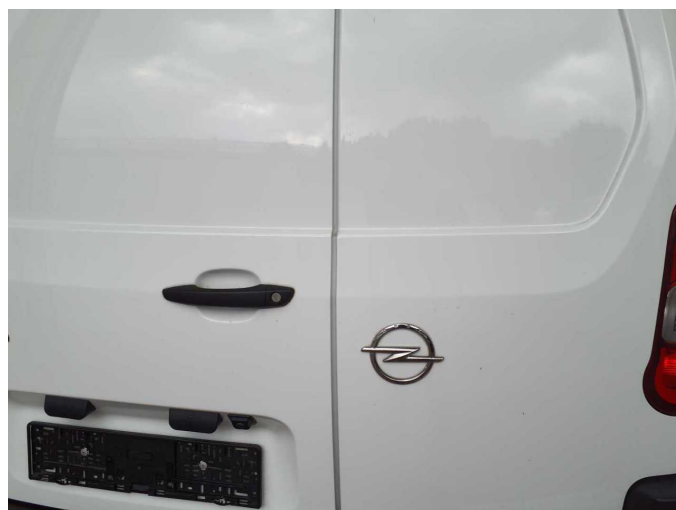
| No. | Component group | Description |
|---|---|---|
| 4 | Door - rear left side | Door - Malposition - Un- / install |

**Damage 4:** Door - rear left side: Door - Malposition - Un- / install

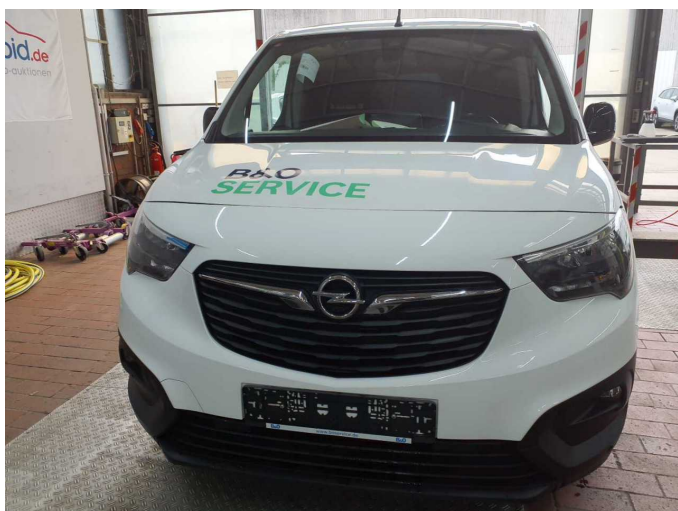
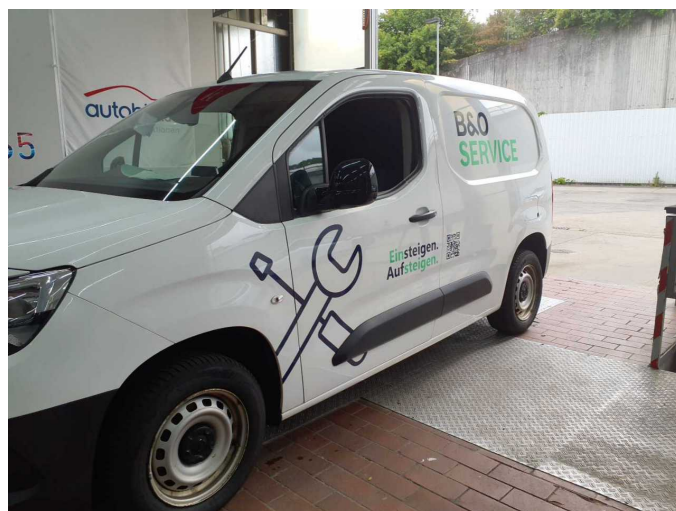
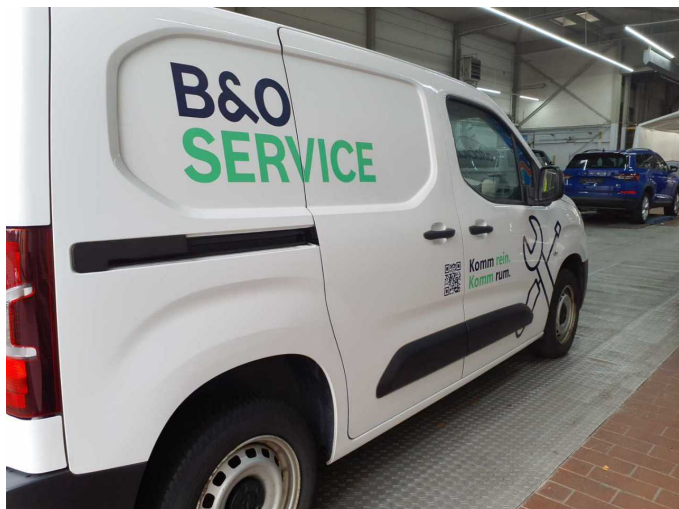
| No. | Component group | Description |
|---|---|---|
| 5 | Body | Body - Glued / labelled - De-glue / neutralise |

**Damage 5:** Body: Body - Glued / labelled - De-glue / neutralise

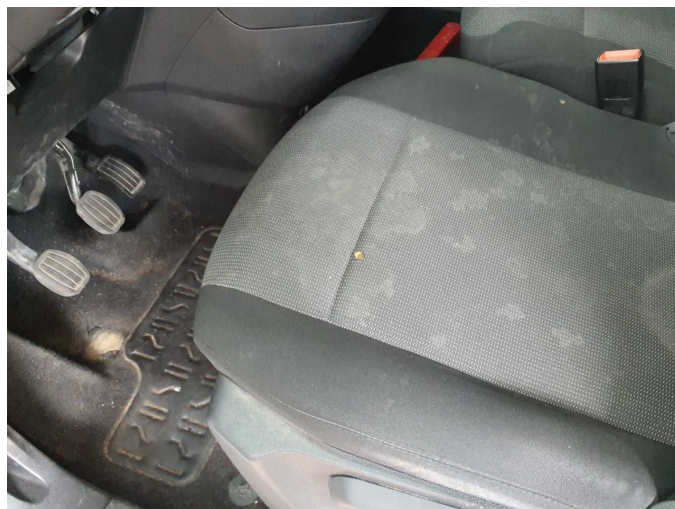
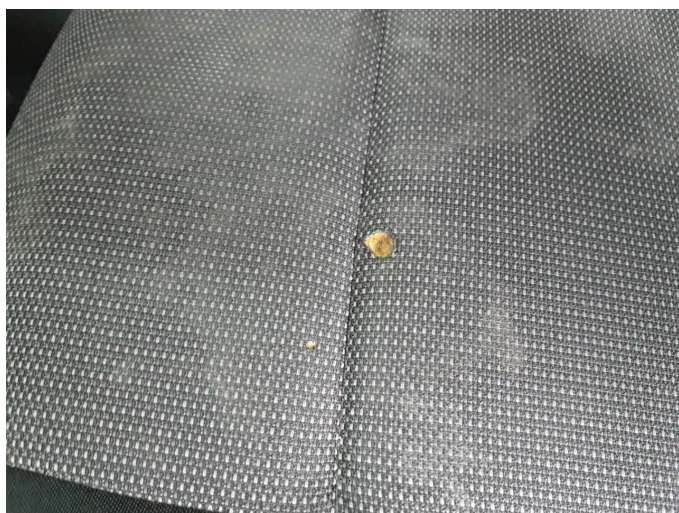
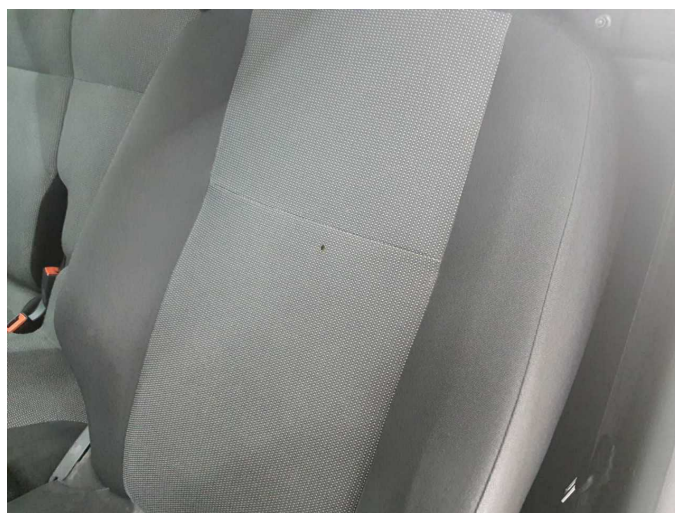
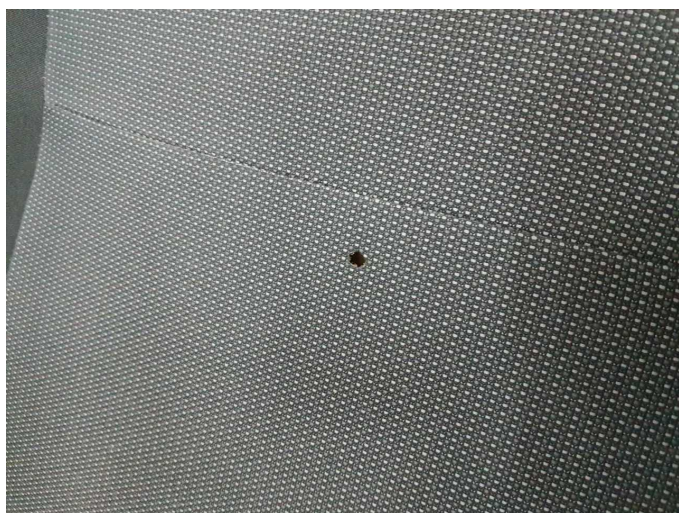
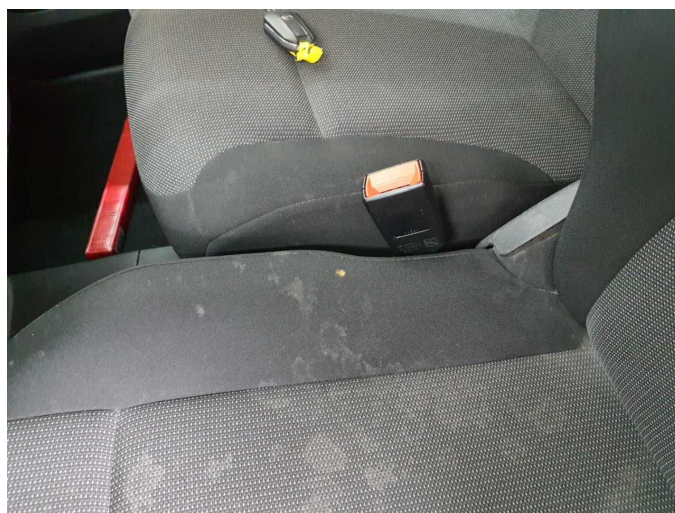
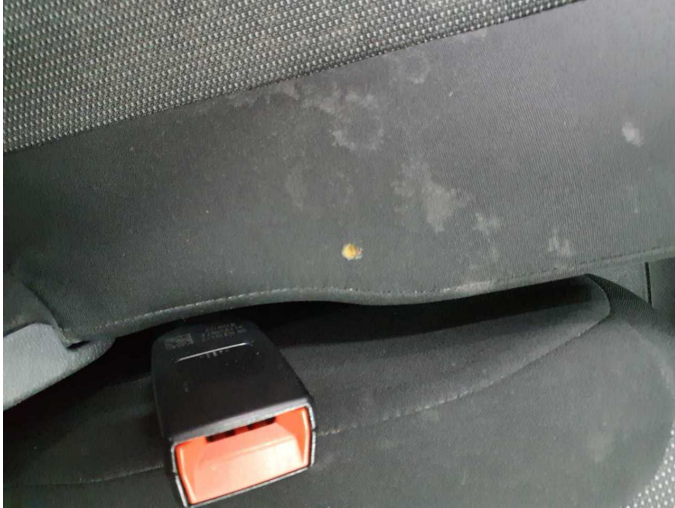
| No. | Component group | Description |
|---|---|---|
| 6 | Seat - front | Seat cover - left side - Holes - Replace |

**Damage 6:** Seat - front: Seat cover - left side - Holes - Replace

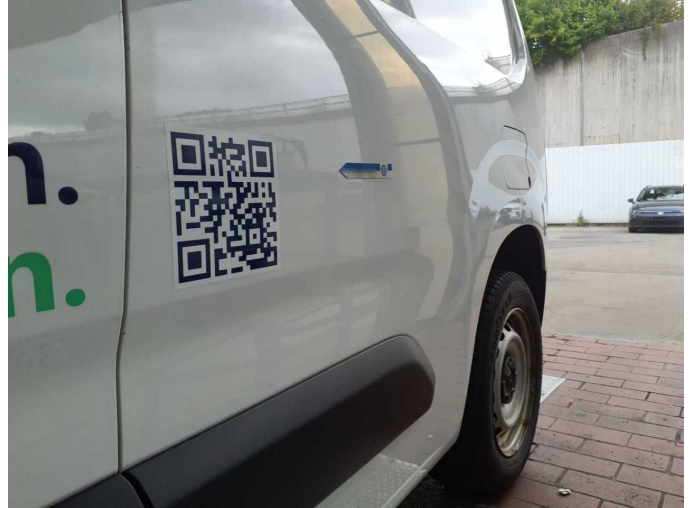
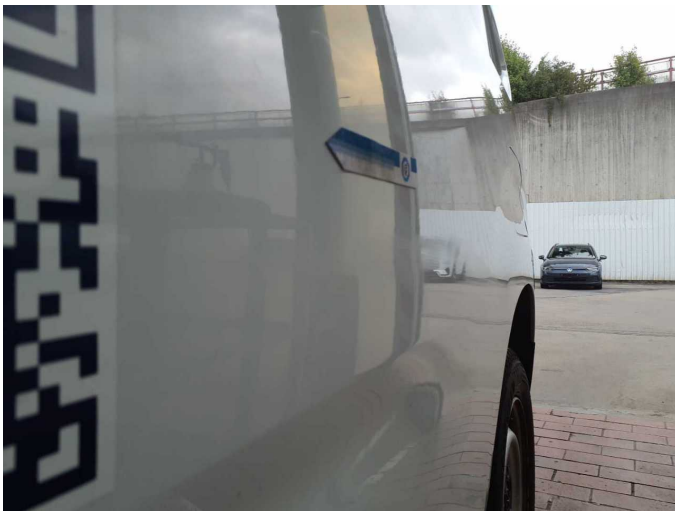
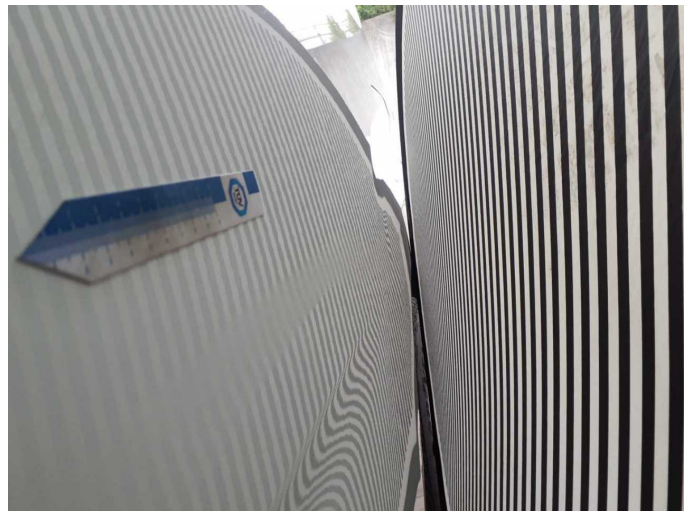
| No. | Component group | Description |
|---|---|---|
| 7 | Side panel - rear left side | Side panel - Dent / paintcoat damage - Paint |

**Damage 7:** Side panel - rear left side: Side panel - Dent / paintcoat damage - Paint

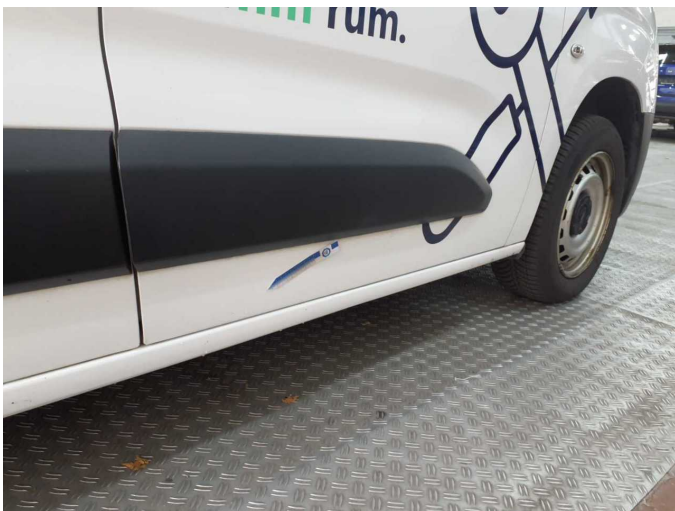
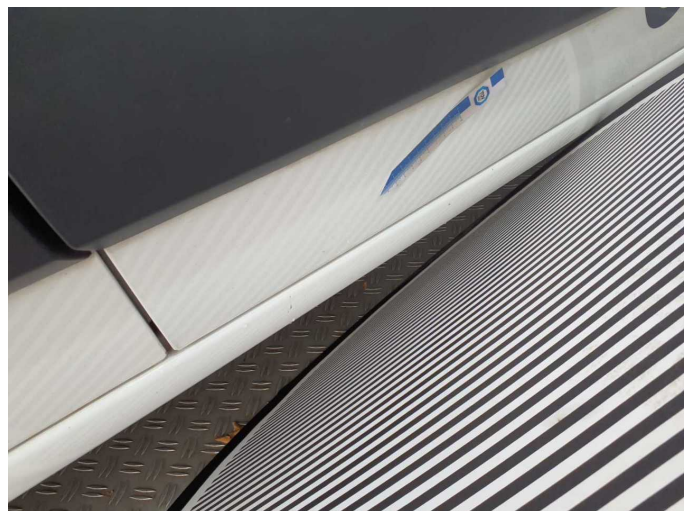
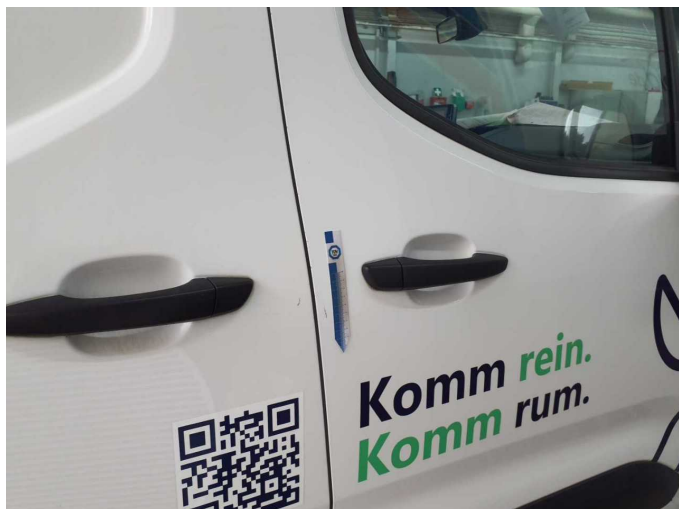
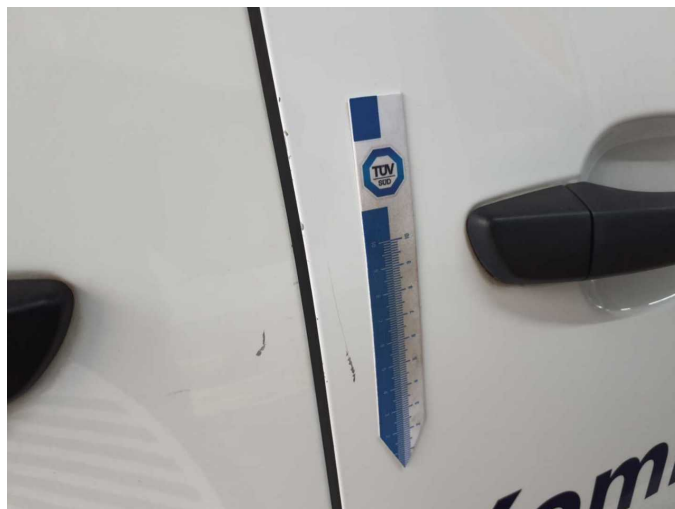
| No. | Component group | Description |
|---|---|---|
| 5 | Door - front right side | Door - Dent / paintcoat damage - No deduction |

**Wear and tear 5:** Door - front right side: Door - Dent / paintcoat damage - No deduction

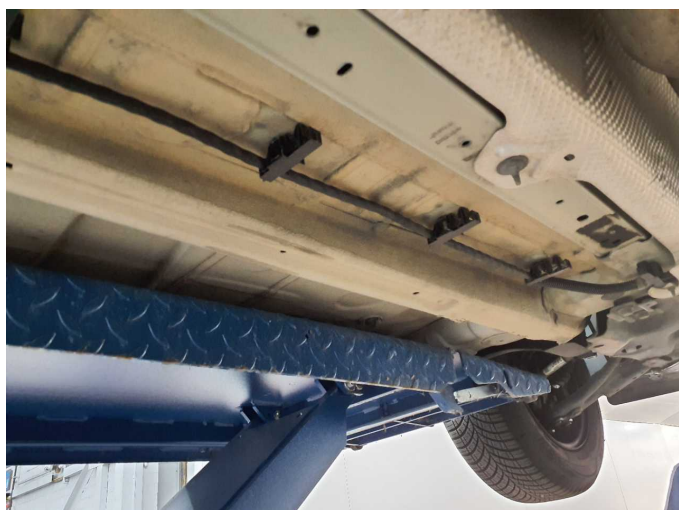
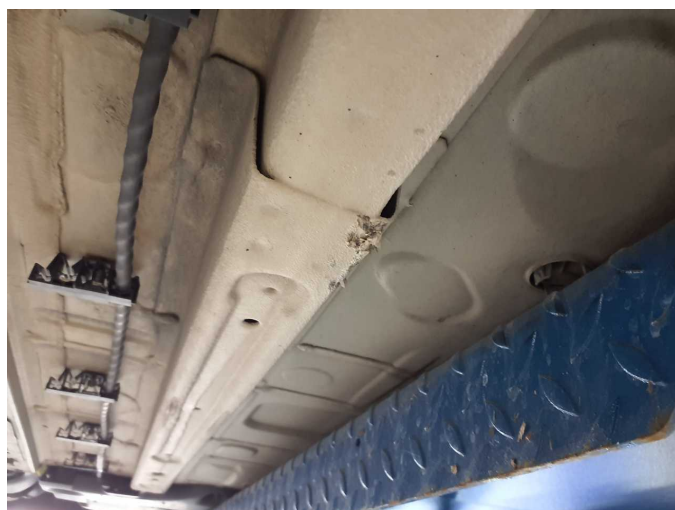
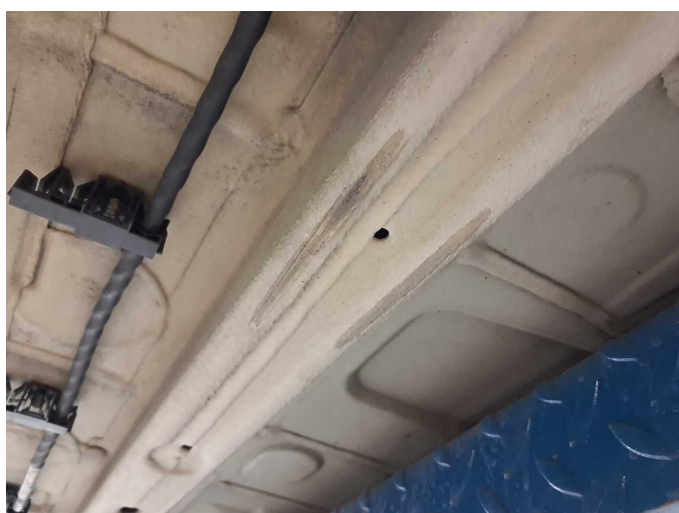
| No. | Component group | Description |
|---|---|---|
| 9 | Body | Underbody - Scratch(es) - No deduction |

**Wear and tear 9:** Body: Underbody - Scratch(es) - No deduction

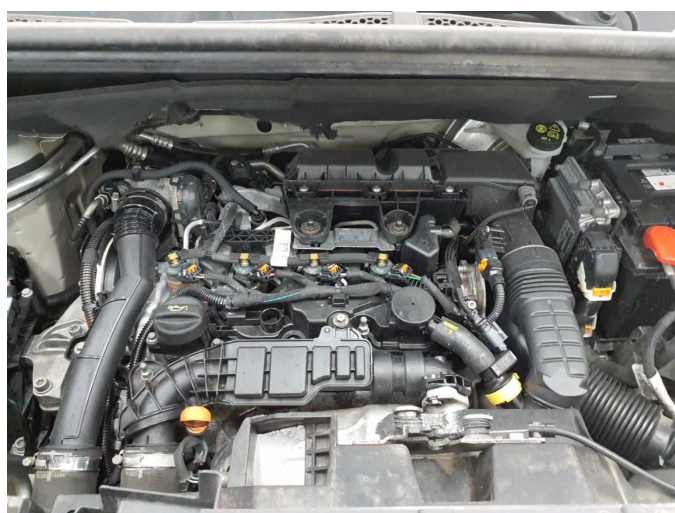
Engine - Engine cover

**Missing part 1:** Engine: Engine cover - Missing - Replace
