Expertise

Protocol number: 46125695  
Order No. / Reference: 26475521  
Inspection date: 18 Jun 2026

Manufacturer: Ford

Model: Transit Connect 230 L2 Autm. Trend Kasten

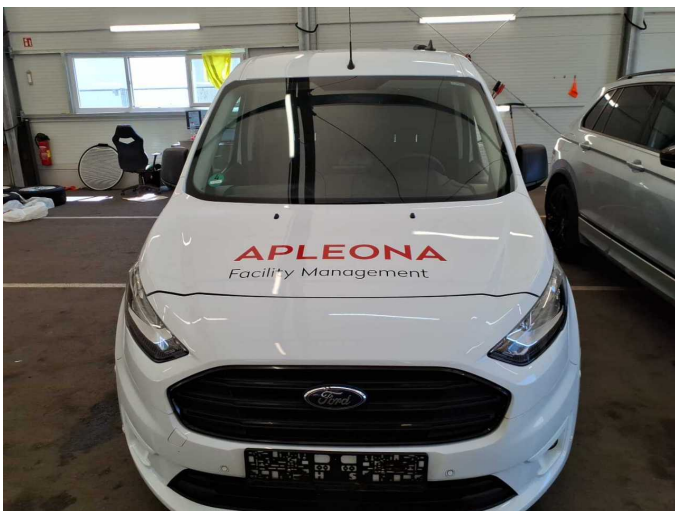
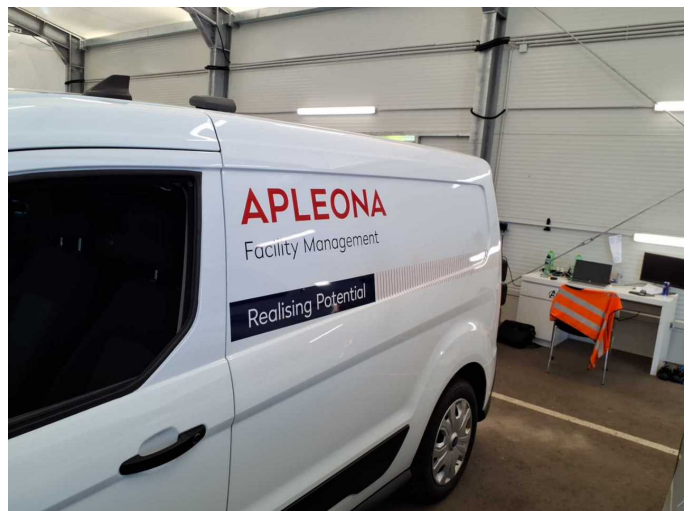
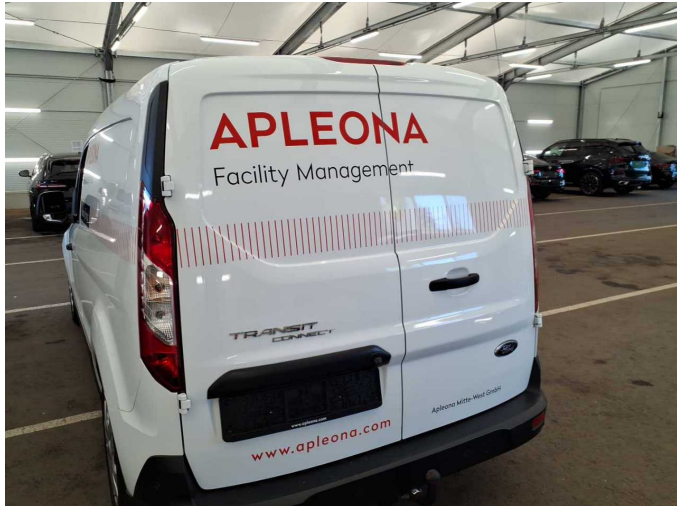
| No. | Component group | Description |
|---|---|---|
| 1 | Body | Body - Glued / labelled - De-glue / neutralise |

Damage 1: Body: Body - Glued / labelled - De-glue / neutralise

**Damage 1:** Body: Body - Glued / labelled - De-glue / neutralise

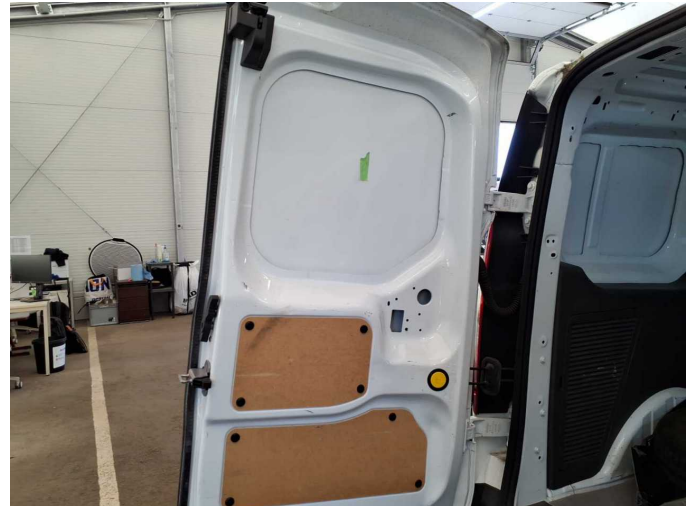
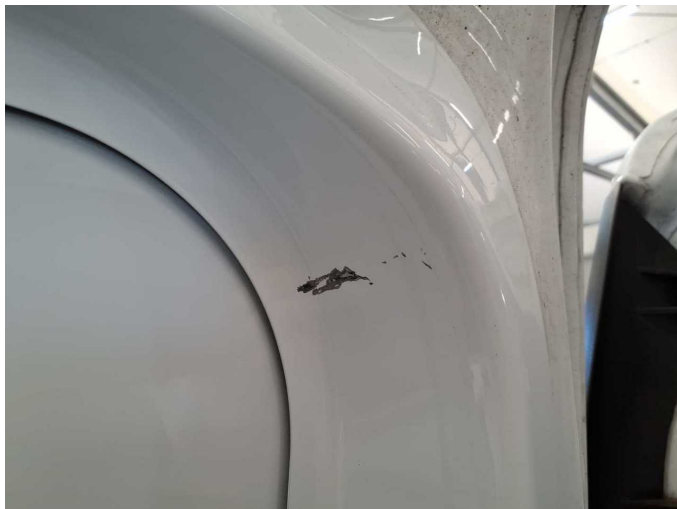
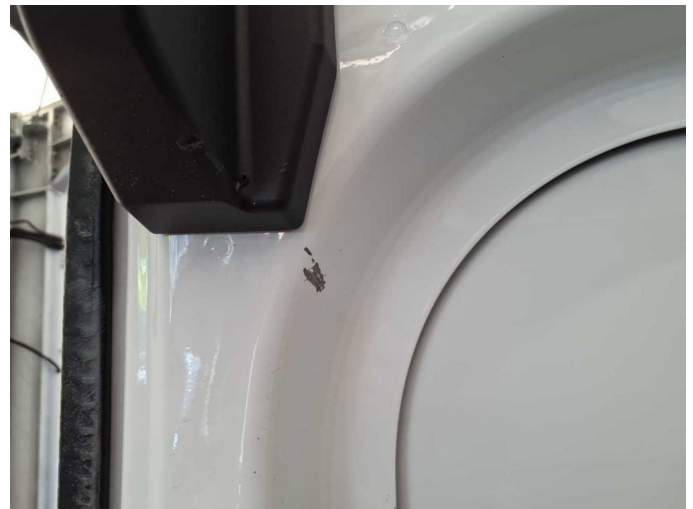
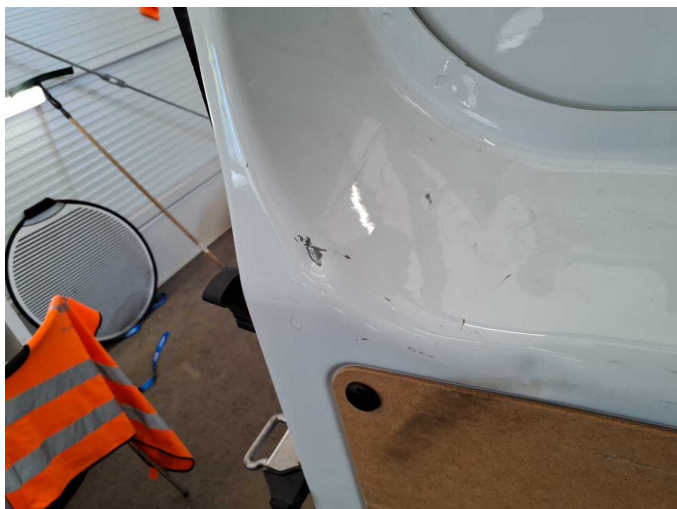
| No. | Component group | Description |
|---|---|---|
| 2 | Boot lid / rear door | Rear door - left side (Innen) - Scratch(es) - Paint |

**Damage 2:** Boot lid / rear door: Rear door - left side (Innen) - Scratch(es) - Paint

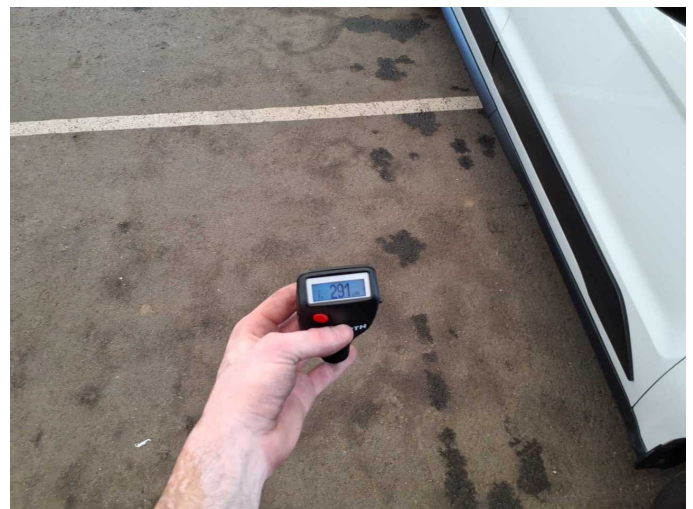
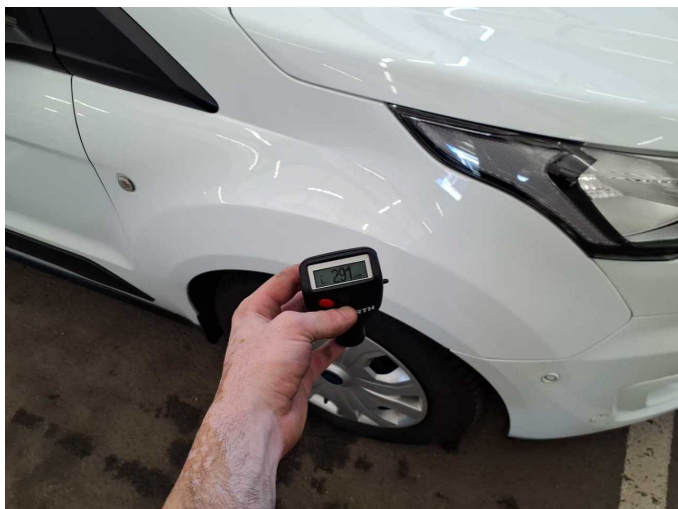
| No. | Repainting |
|---|---|
| 1 | Mudguard - right side |

| Mudguard - right side | 291 µm | Side panel - rear right side | 330 µm |

**Repainting 1:** Mudguard - right side

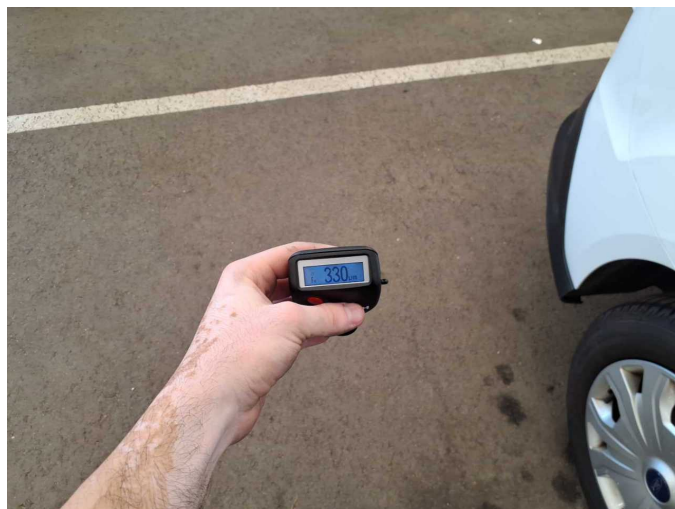
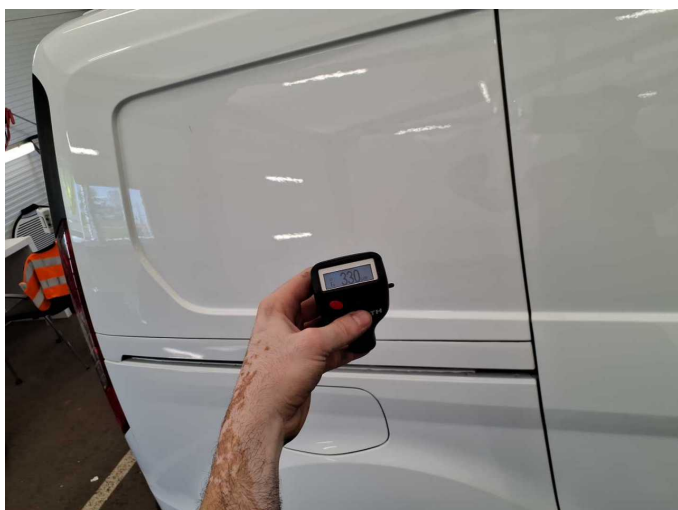
| No. | Repainting |
|---|---|
| 2 | Side panel - rear right side |

**Repainting 2:** Side panel - rear right side

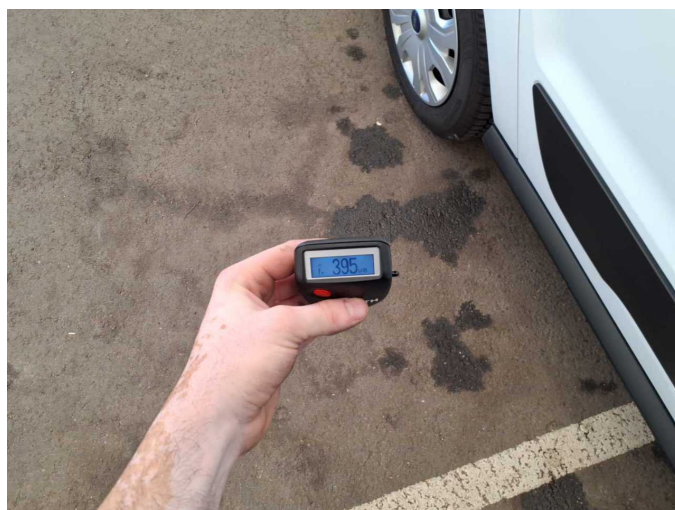
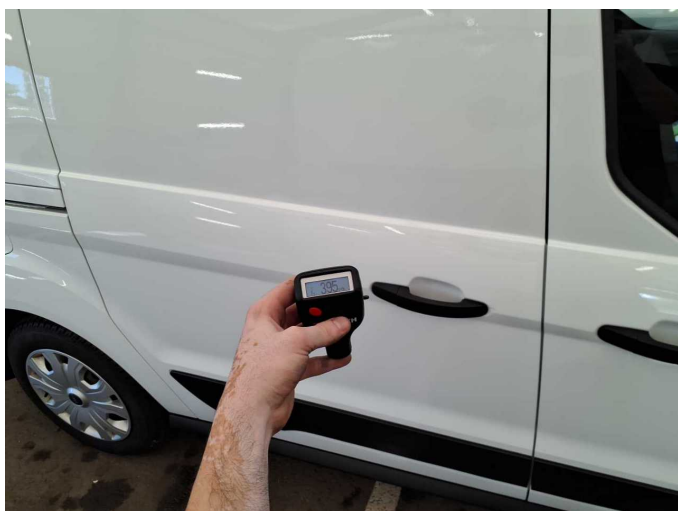
| No. | Repainting |
|---|---|
| 3 | Door - rear right side |

| Door - rear right side | 395 µm | Door - front right side | 193 µm |

**Repainting 3:** Door - rear right side

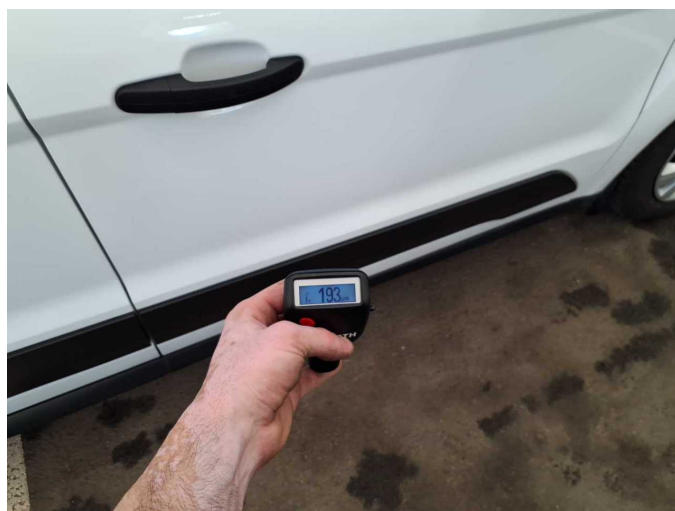
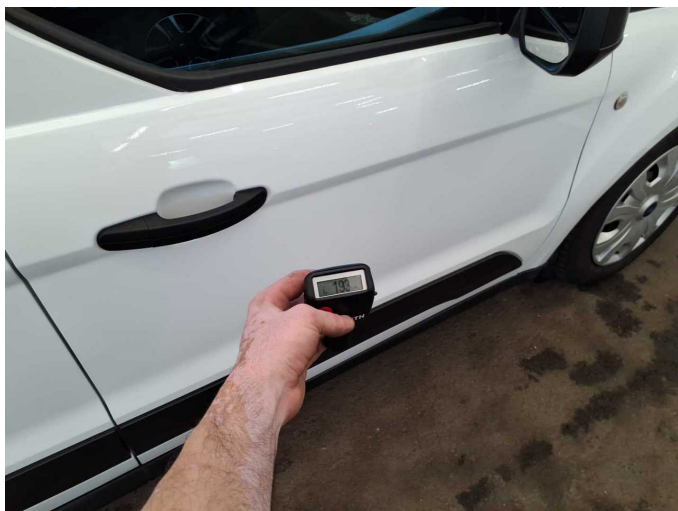
| No. | Repainting |
|---|---|
| 4 | Door - front right side |

**Repainting 4:** Door - front right side
