Expertise

Protocol number: 46466139  
Order No. / Reference: 26521300  
Inspection date: 10 Jul 2026

Manufacturer: Mercedes-Benz

Model: EQE 300 Electric Art

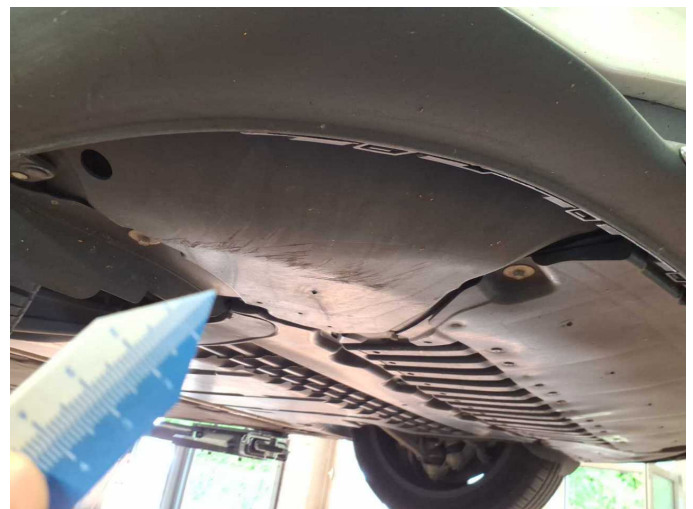
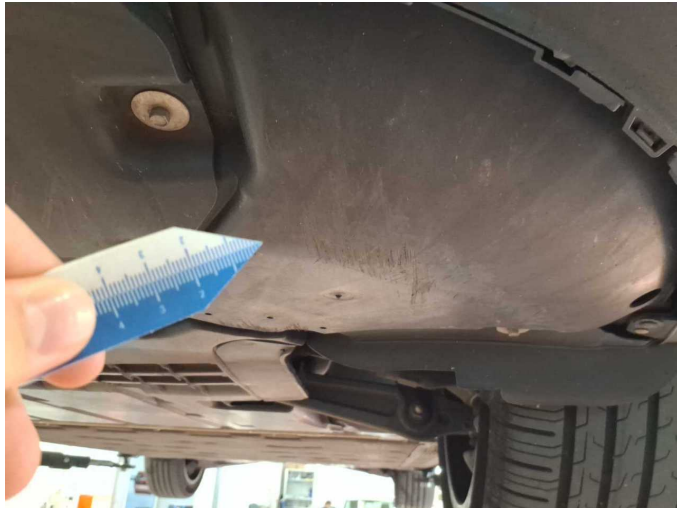
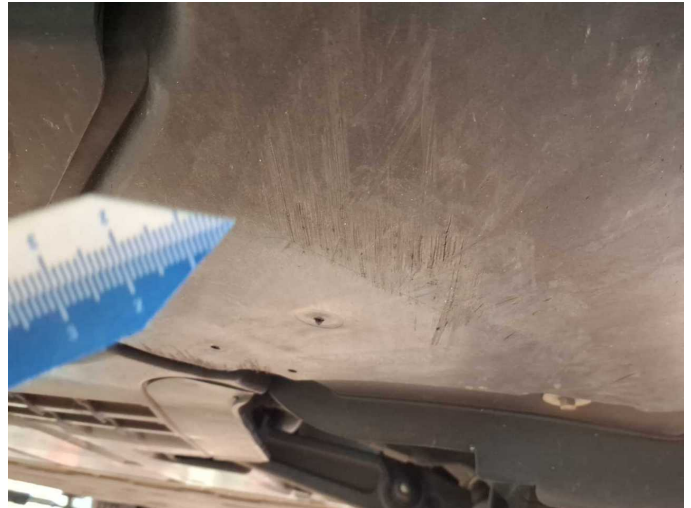
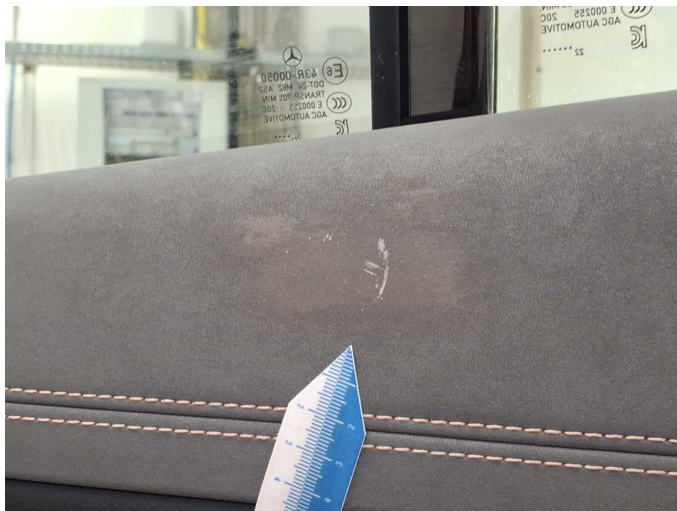
| No. | Component group | Description |
|---|---|---|
| 1 | Body | Underbody panelling (Links und Rechts) - Scratched - Replace |

**Damage 1:** Body: Underbody panelling (Links und Rechts) - Scratched - Replace

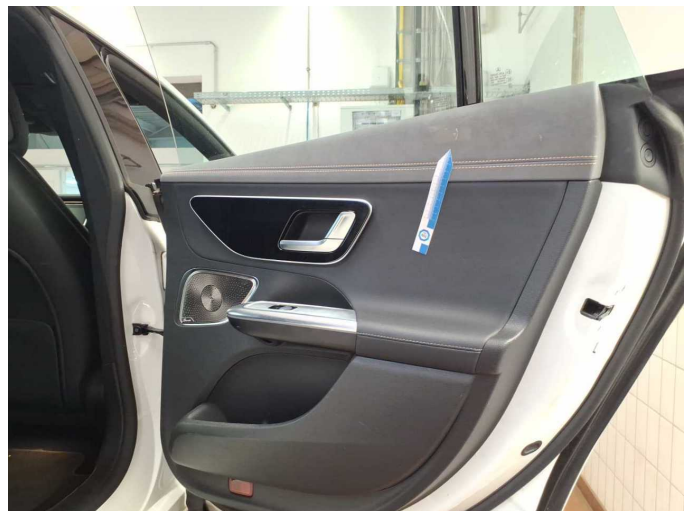
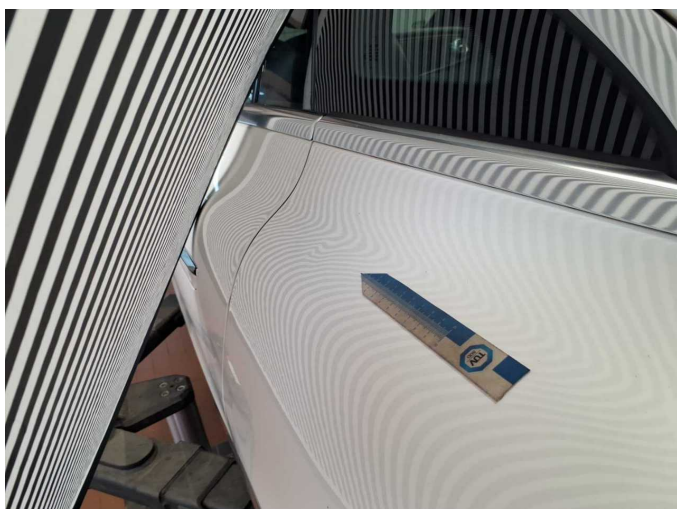
| No. | Component group | Description |
|---|---|---|
| 2 | Trim / covers | Door trim - rear right side - Soiled - Clean |

**Damage 2:** Trim / covers: Door trim - rear right side - Soiled - Clean

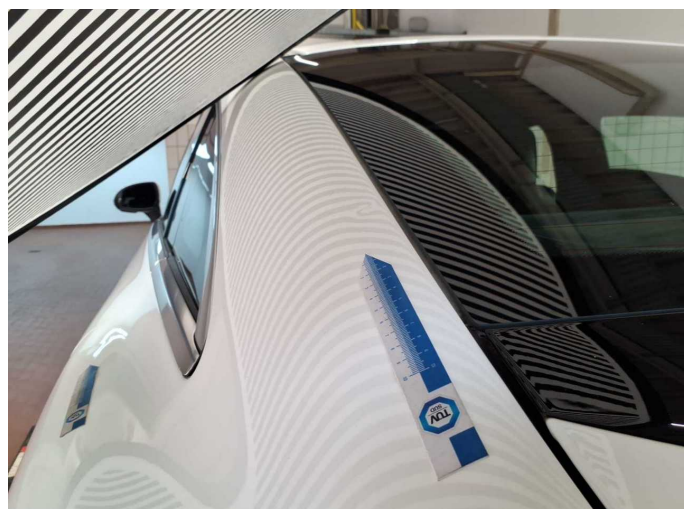
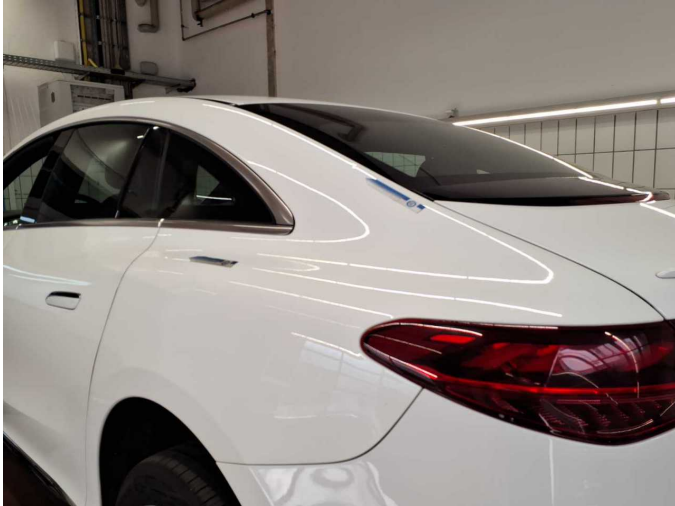
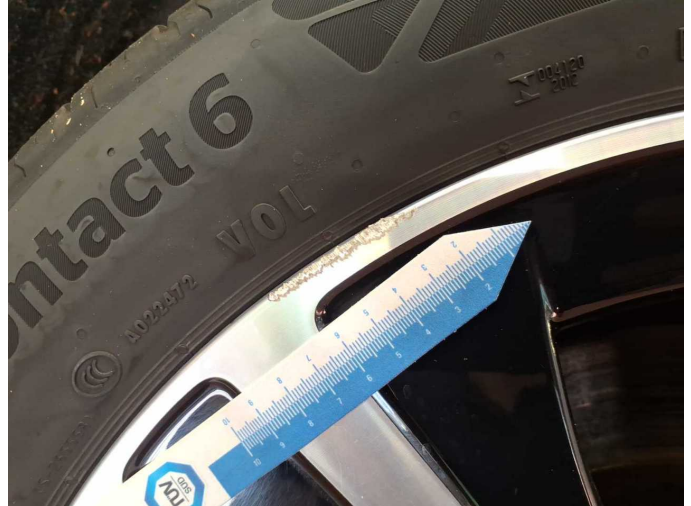
| No. | Component group | Description |
|---|---|---|
| 3 | Side panel - rear left side | Side panel - dent(s) - Smooth repair work |

**Damage 3:** Side panel - rear left side: Side panel - dent(s) - Smooth repair work

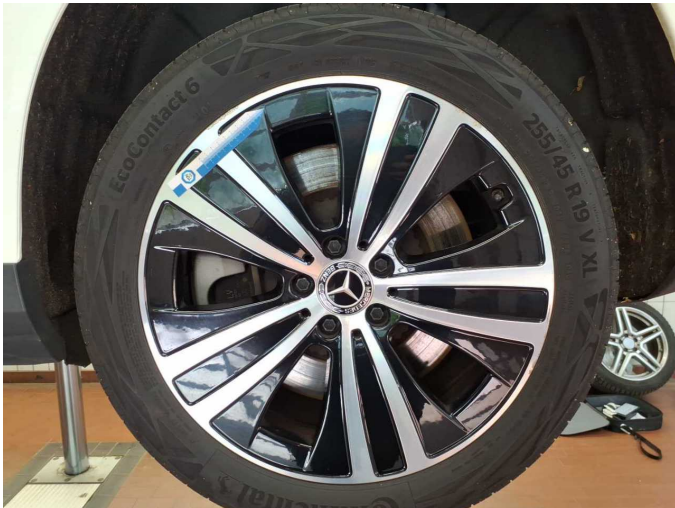
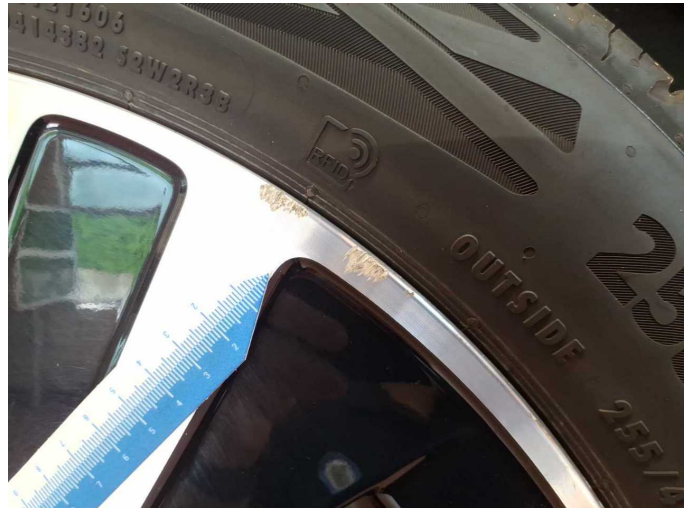
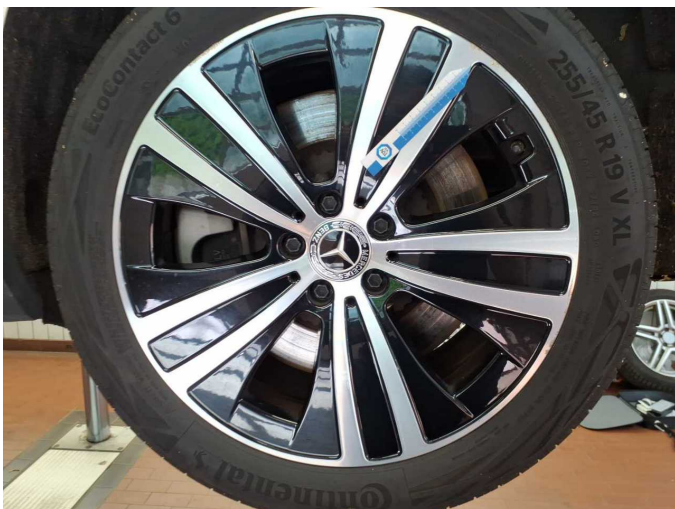
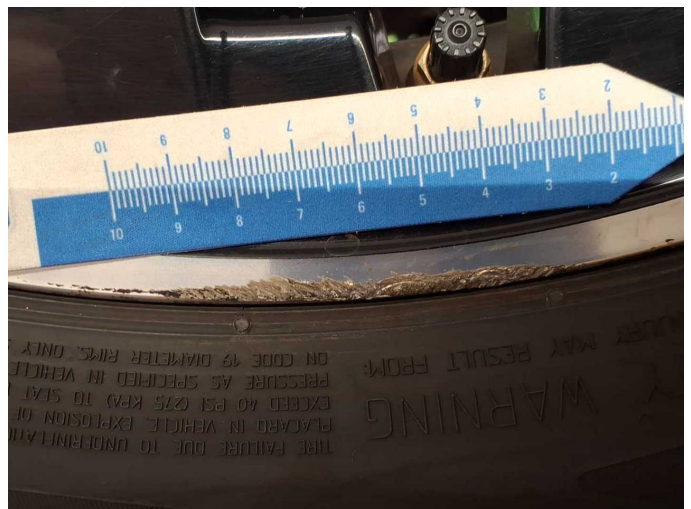
| No. | Component group | Description |
|---|---|---|
| 4 | Wheel / tyres | Alloy rim - rear left side - Scratch(es) - Loss in value |

**Damage 4:** Wheel / tyres: Alloy rim - rear left side - Scratch(es) - Loss in value

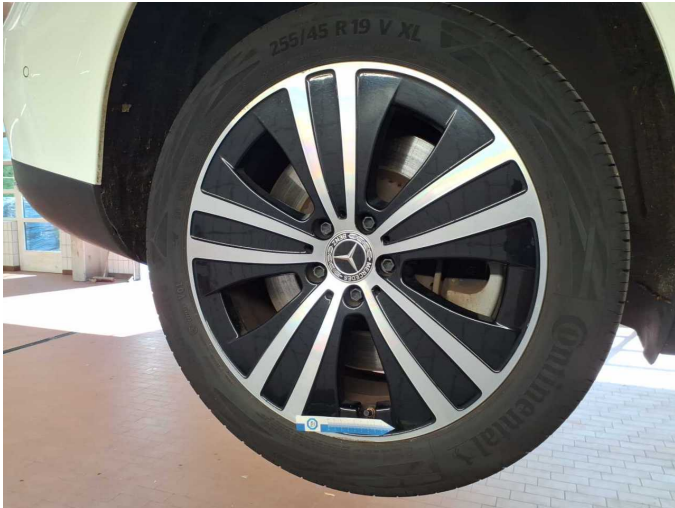
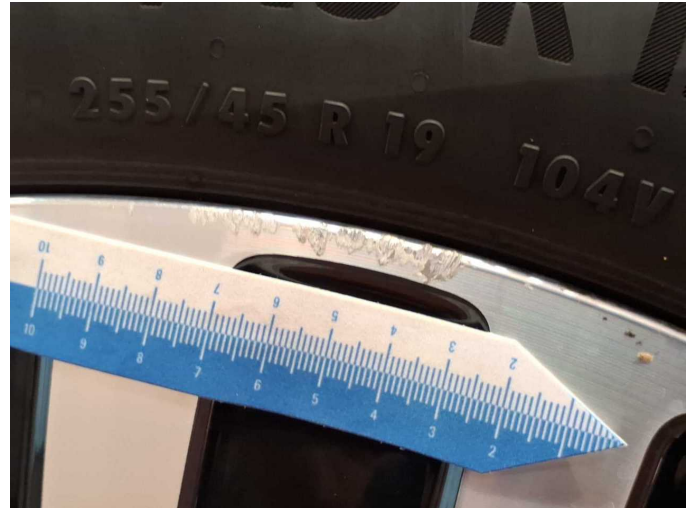
| No. | Component group | Description |
|---|---|---|
| 5 | Wheel / tyres | Alloy rim - rear right side - Scratch(es) - Loss in value |

**Damage 5:** Wheel / tyres: Alloy rim - rear right side - Scratch(es) - Loss in value

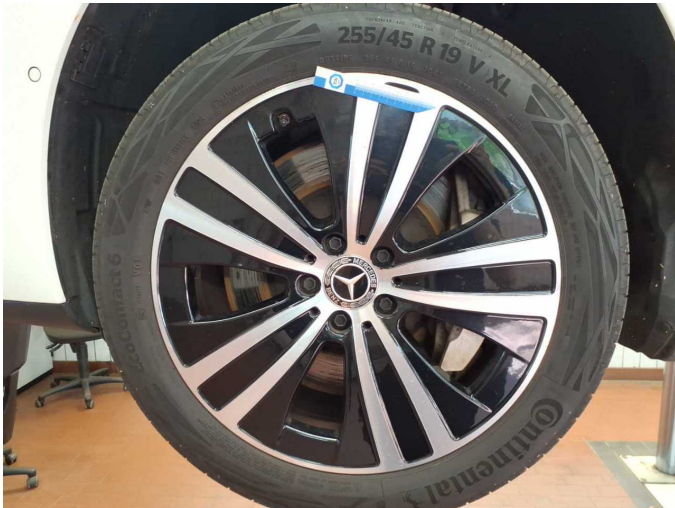
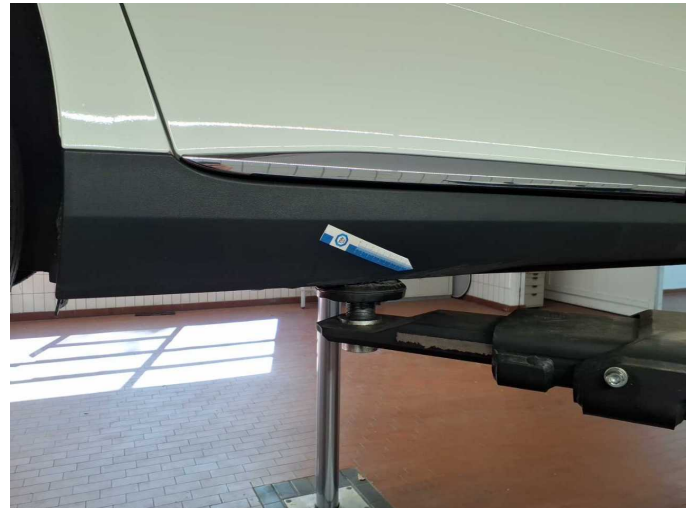
| No. | Component group | Description |
|---|---|---|
| 6 | Wheel / tyres | Alloy rim - front left side - Scratch(es) - Loss in value |

**Damage 6:** Wheel / tyres: Alloy rim - front left side - Scratch(es) - Loss in value

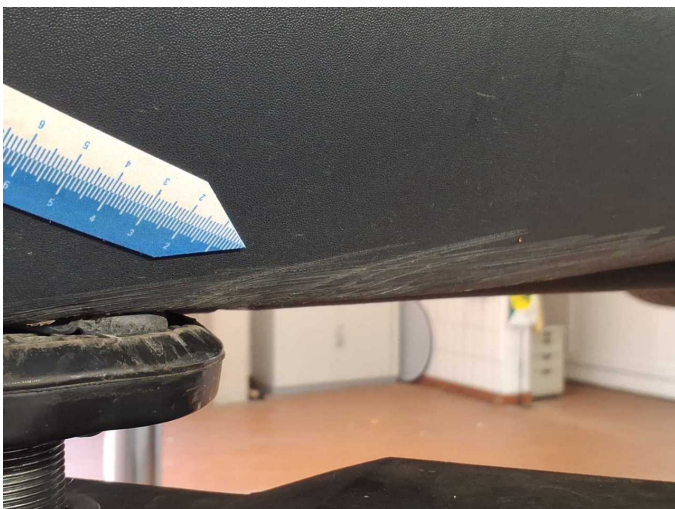
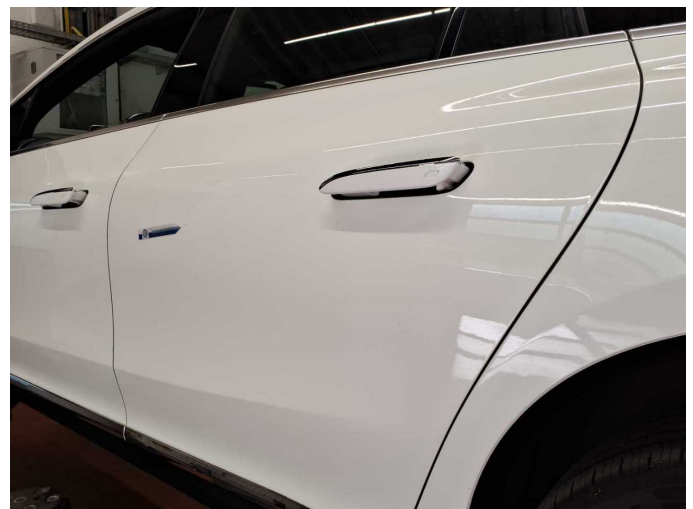
| No. | Component group | Description |
|---|---|---|
| 7 | Sill - right side | Trim - Scratch(es) - Replace |

**Damage 7:** Sill - right side: Trim - Scratch(es) - Replace

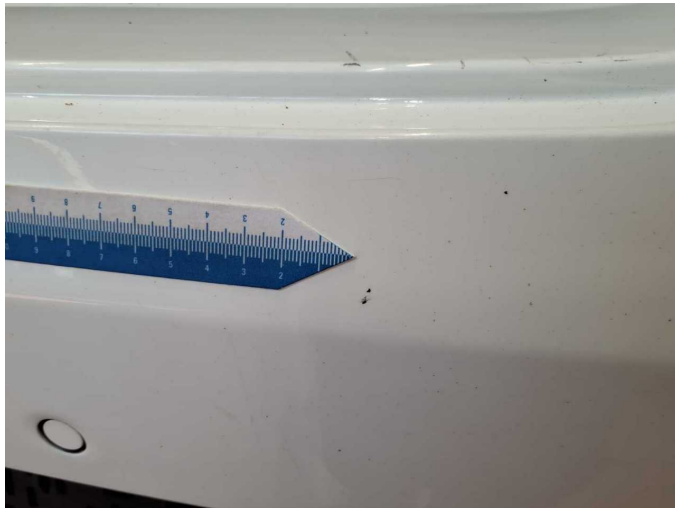
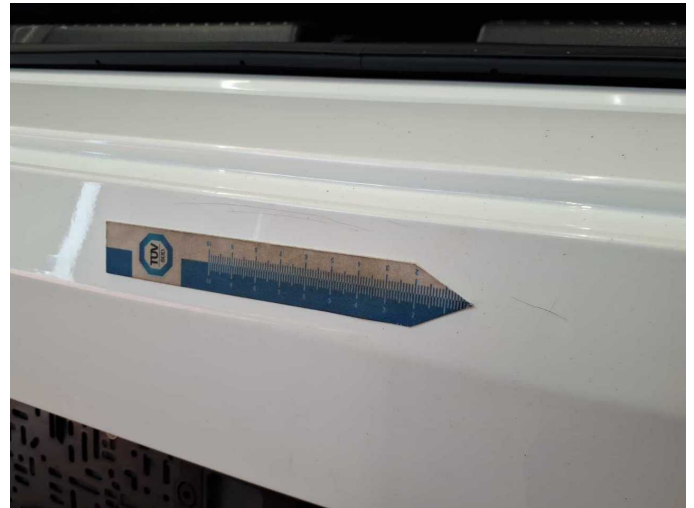
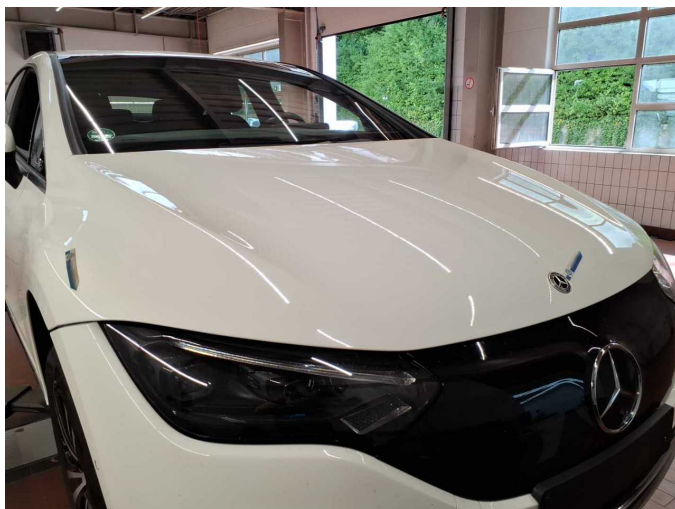
| No. | Component group | Description |
|---|---|---|
| 9 | Rear bumper | Rear bumper - Scratch(es) - Paint |

**Damage 9:** Rear bumper: Rear bumper - Scratch(es) - Paint

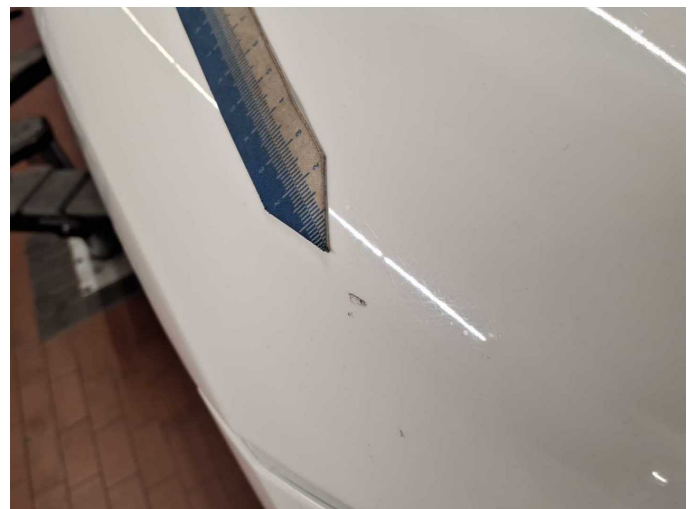
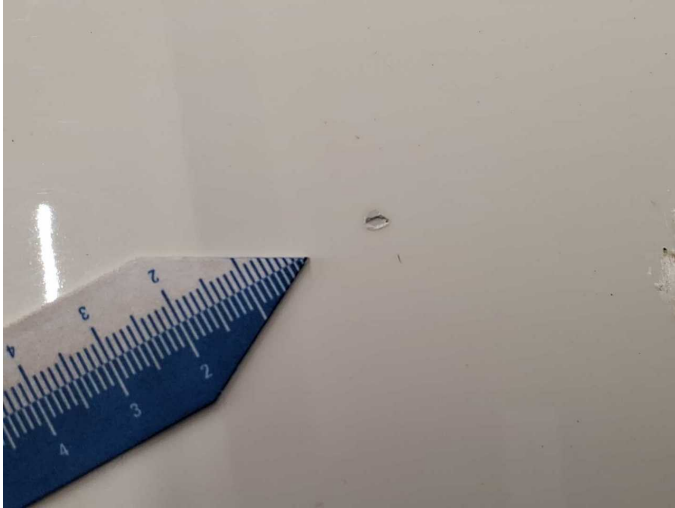
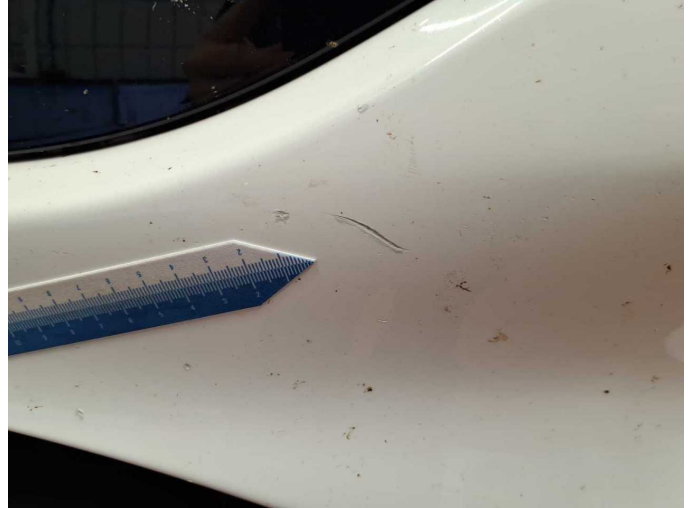
| No. | Component group | Description |
|---|---|---|
| 10 | Bonnet | Bonnet - Stone chips - Paint |

**Damage 10:** Bonnet: Bonnet - Stone chips - Paint

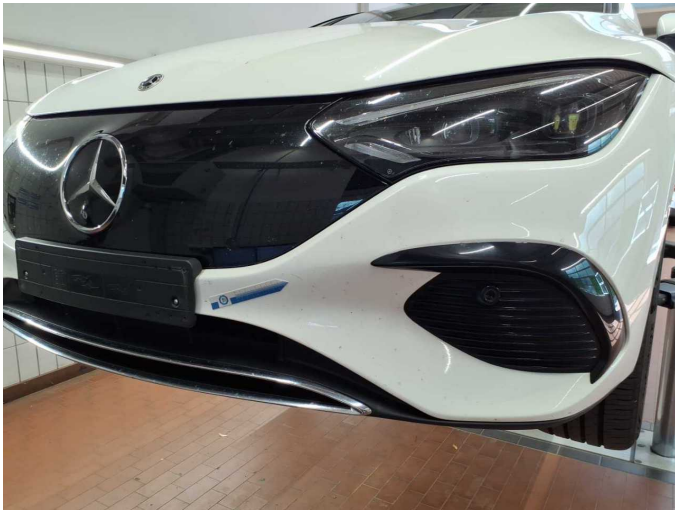
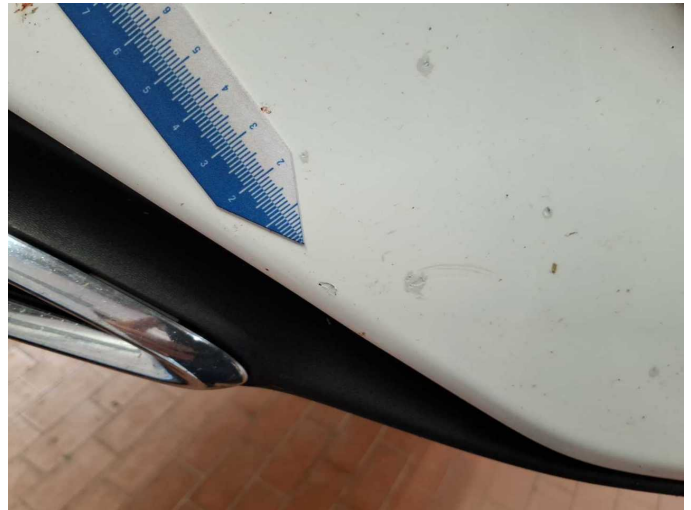
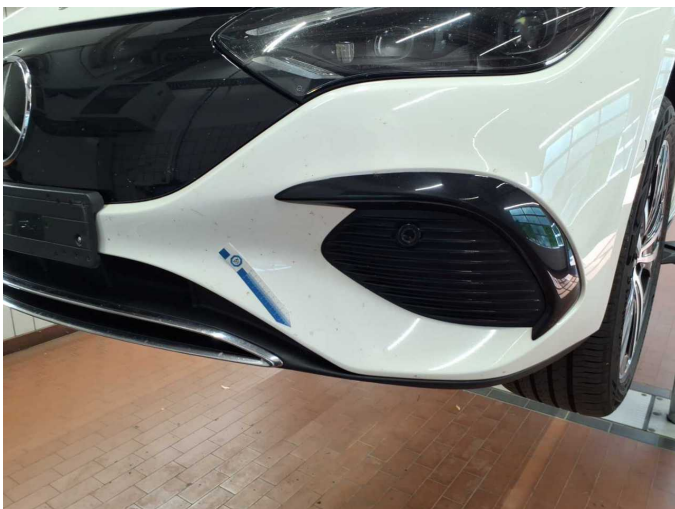
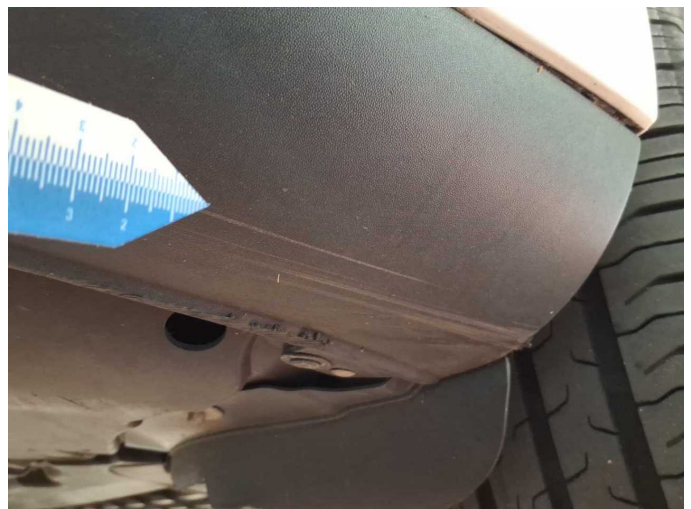
| No. | Component group | Description |
|---|---|---|
| 11 | Front bumper | Front bumper - Stone chips - Paint |

**Damage 11:** Front bumper: Front bumper - Stone chips - Paint

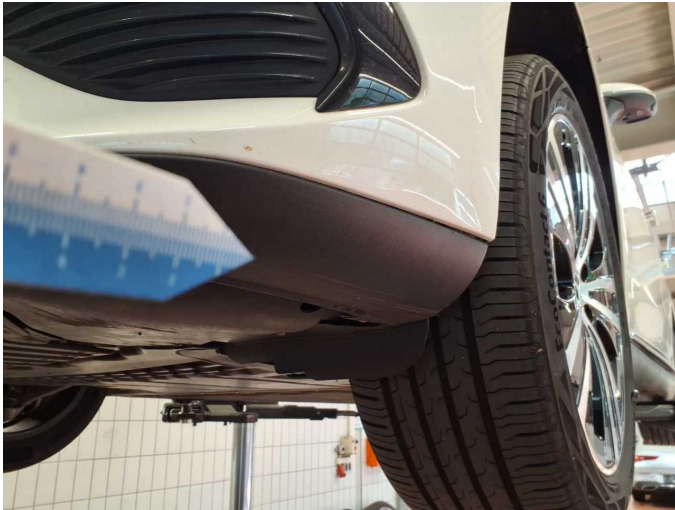
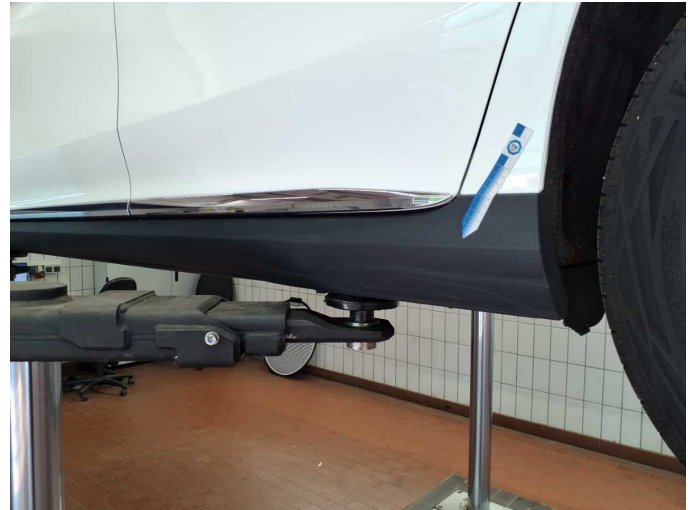
| No. | Component group | Description |
|---|---|---|
| 1 | Front bumper | Spoiler - Scratch(es) - No deduction |

**Wear and tear 1:** Front bumper: Spoiler - Scratch(es) - No deduction

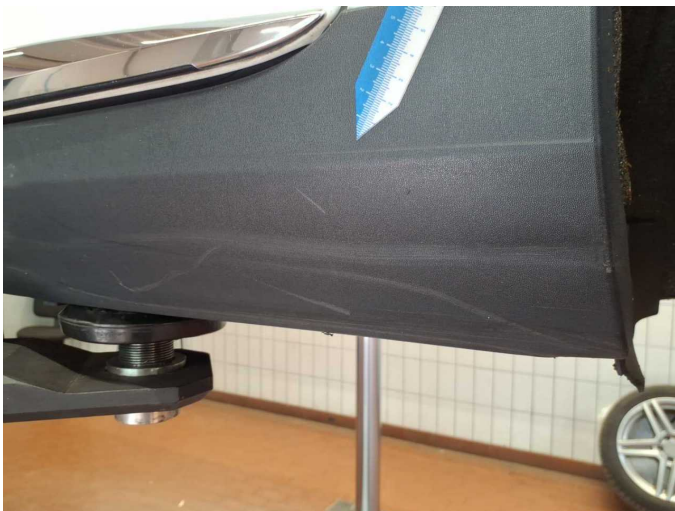
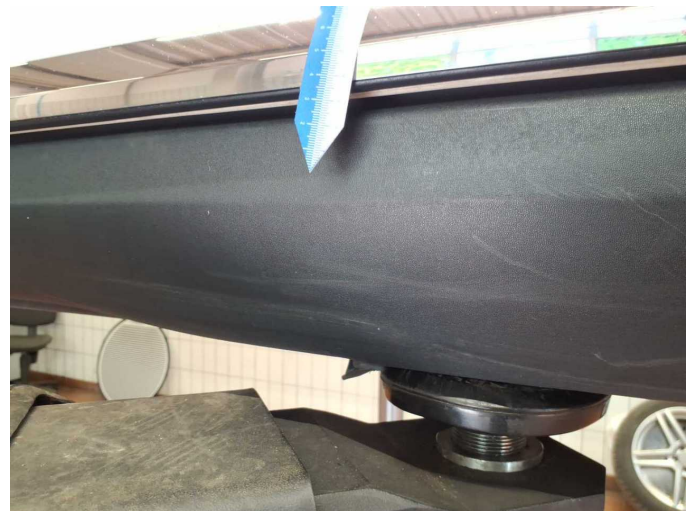
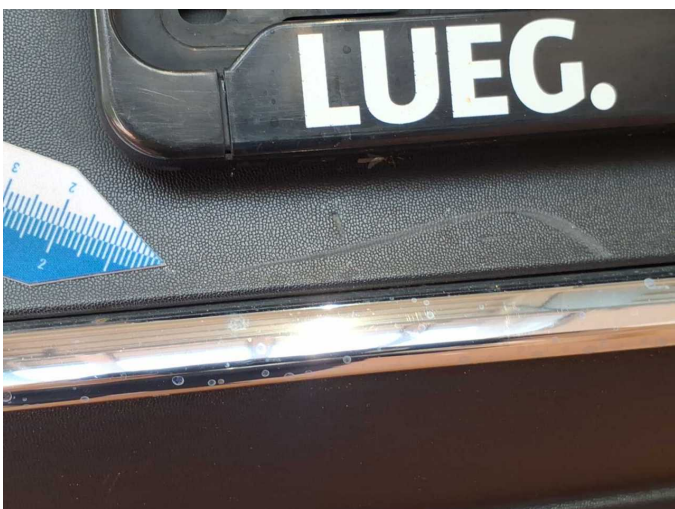
| No. | Component group | Description |
|---|---|---|
| 2 | Sill - left side | Trim - Scratch(es) - No deduction |

**Wear and tear 2:** Sill - left side: Trim - Scratch(es) - No deduction

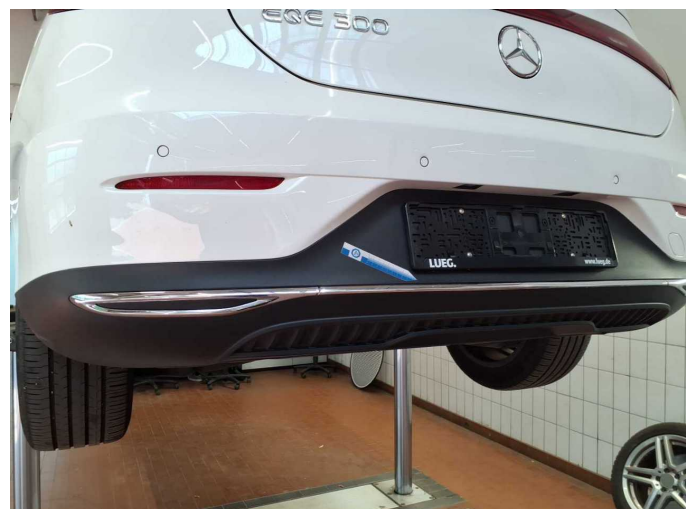
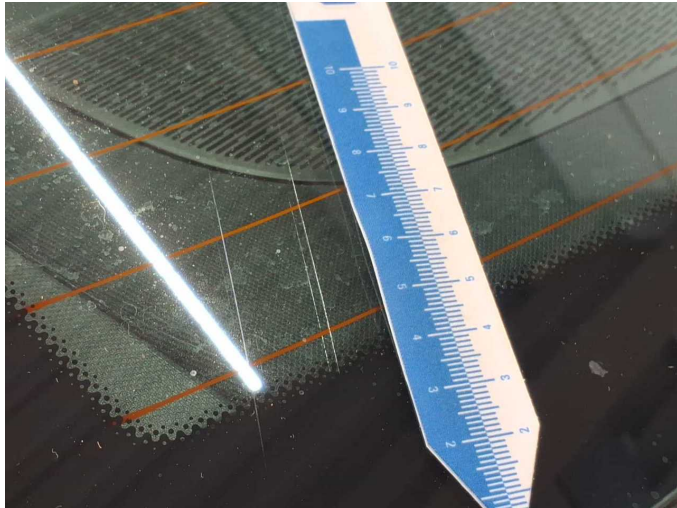
| No. | Component group | Description |
|---|---|---|
| 3 | Rear bumper | Spoiler - Scratch(es) - No deduction |

**Wear and tear 3:** Rear bumper: Spoiler - Scratch(es) - No deduction

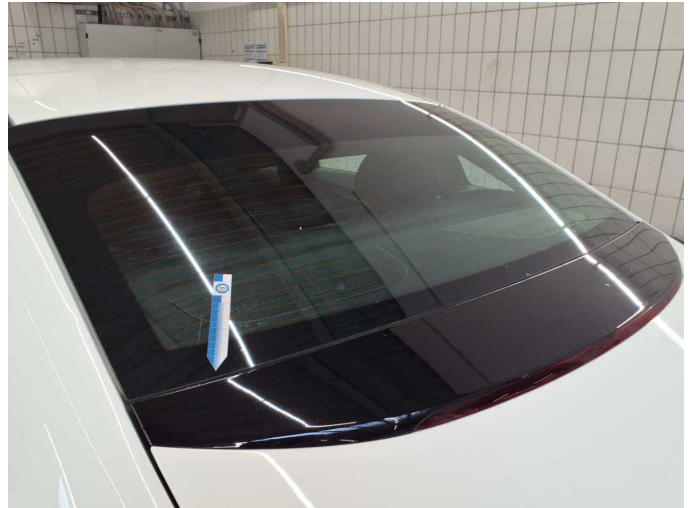
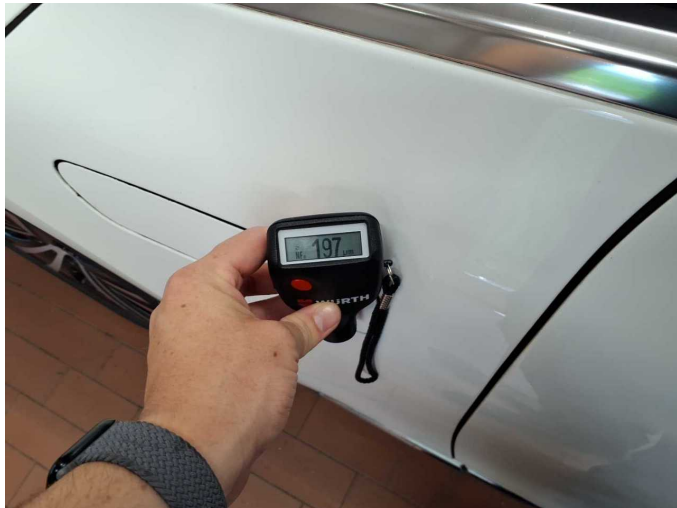
| No. | Component group | Description |
|---|---|---|
| 4 | Vehicle glazing | Rear window - Scratch(es) - No deduction |

**Wear and tear 4:** Vehicle glazing: Rear window - Scratch(es) - No deduction
