Expertise

Protocol number: 45914975  
Order No. / Reference: 26437548  
Inspection date: 11 Jun 2026

| Manufacturer: Opel | Model: Astra 1.5 D Start/Stop Sports Tourer Automatik Business Edition |
| VIN: W0VBD8EVXN8038401 | |

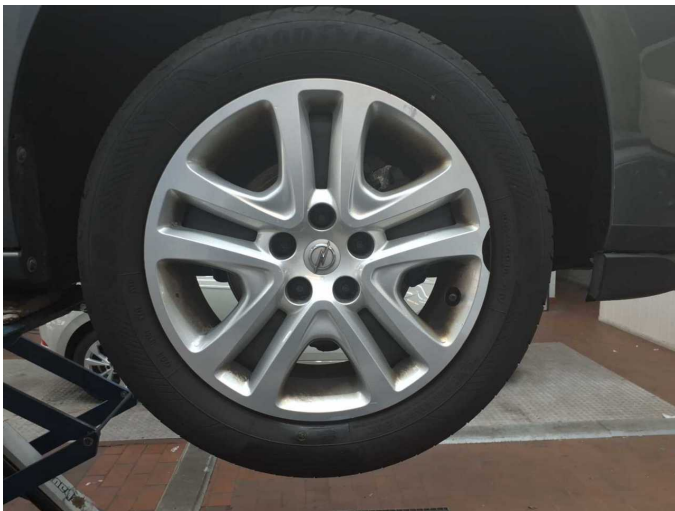
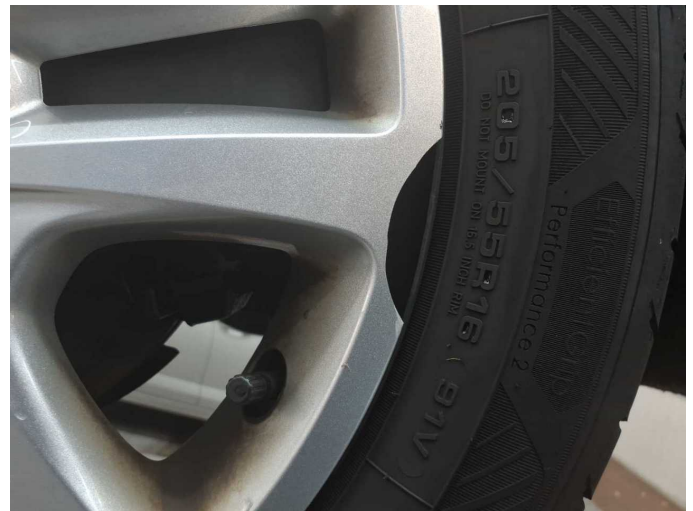
| No. | Component group | Description |
|---|---|---|
| 1 | Wheel / tyres | Wheel cover - front right side - Broken / torn - Replace |

**Damage 1:** Wheel / tyres: Wheel cover - front right side - Broken / torn - Replace

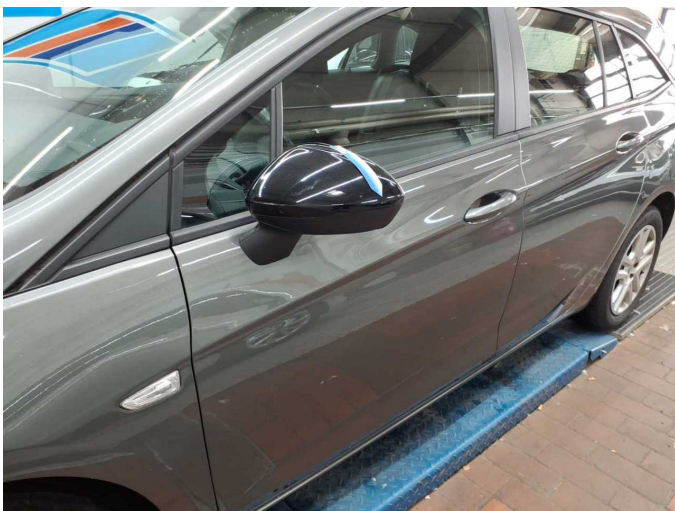
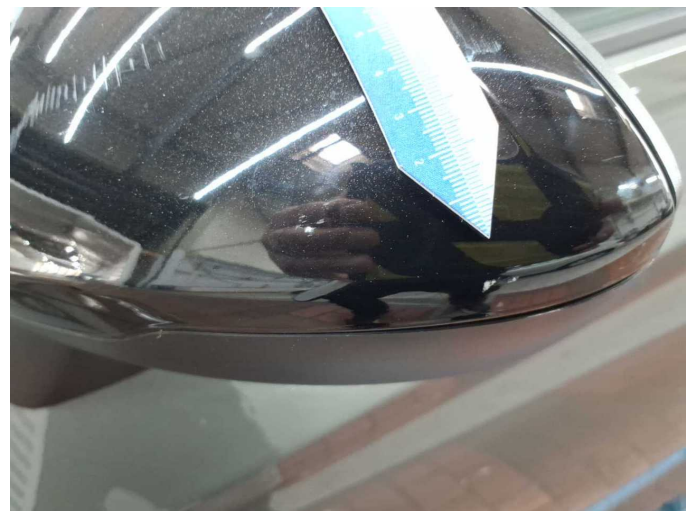
| No. | Component group | Description |
|---|---|---|
| 2 | Wing mirror - left side | Cap - Scratch(es) - Smart repair |

**Damage 2:** Wing mirror - left side: Cap - Scratch(es) - Smart repair

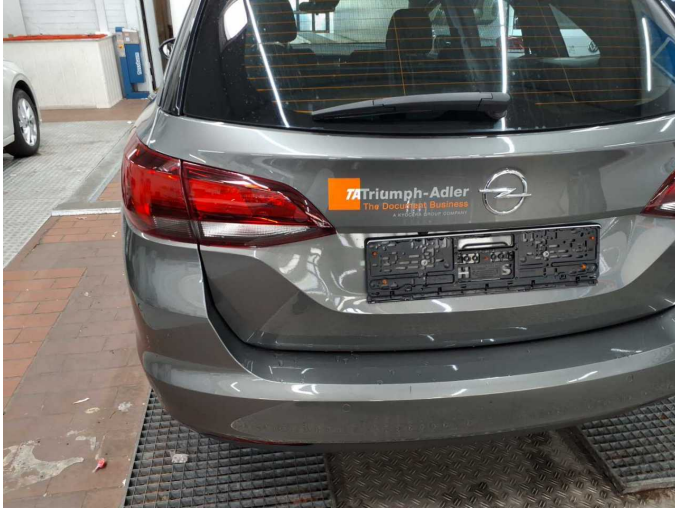
| No. | Component group | Description |
|---|---|---|
| 3 | Body | Body - Glued / labelled - De-glue / neutralise |

**Damage 3:** Body - Body - Glued / labelled - De-glue / neutralise

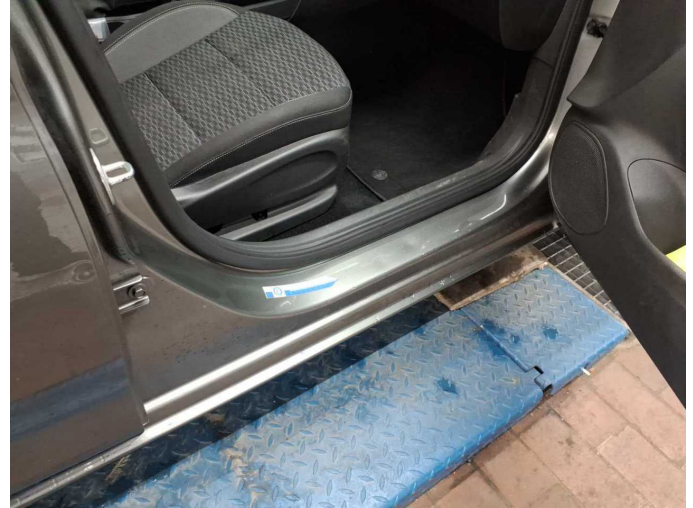
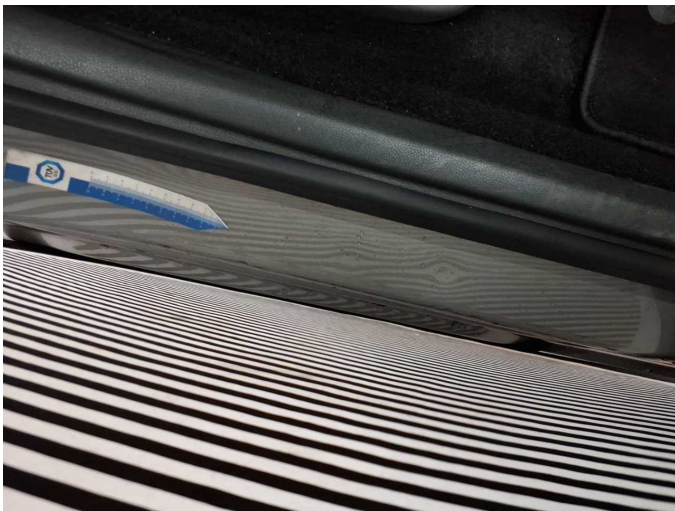
| No. | Component group | Description |
|---|---|---|
| 4 | Sill - right side | Sill - dent(s) - Smooth repair work |

**Damage 4:** Sill - right side: Sill - dent(s) - Smooth repair work

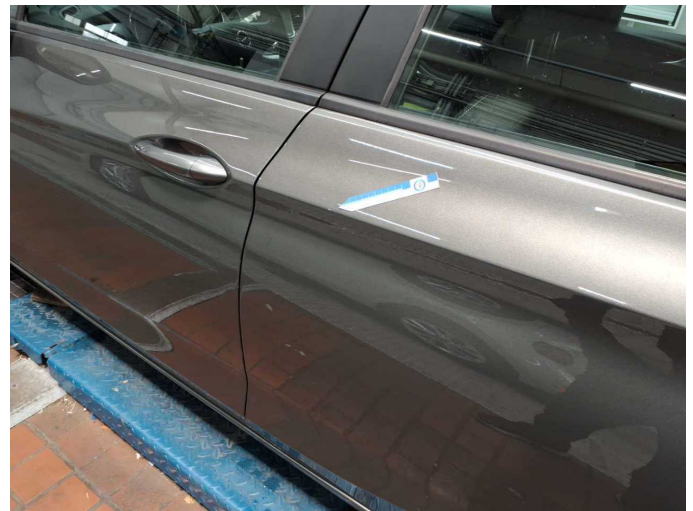
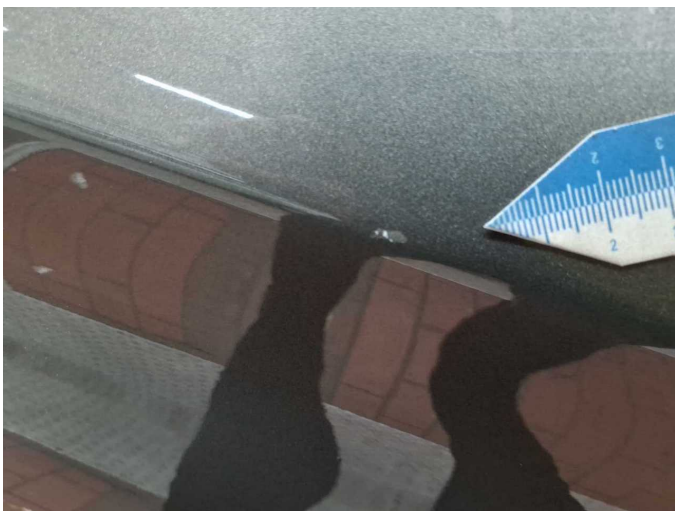
| No. | Component group | Description |
|---|---|---|
| 5 | Door - rear left side | Door - Scratch(es) - Smart repair |

**Damage 5:** Door - rear left side: Door - Scratch(es) - Smart repair

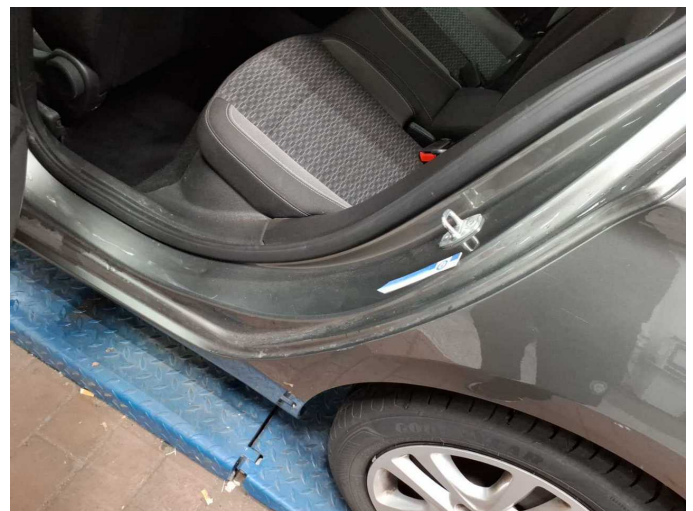
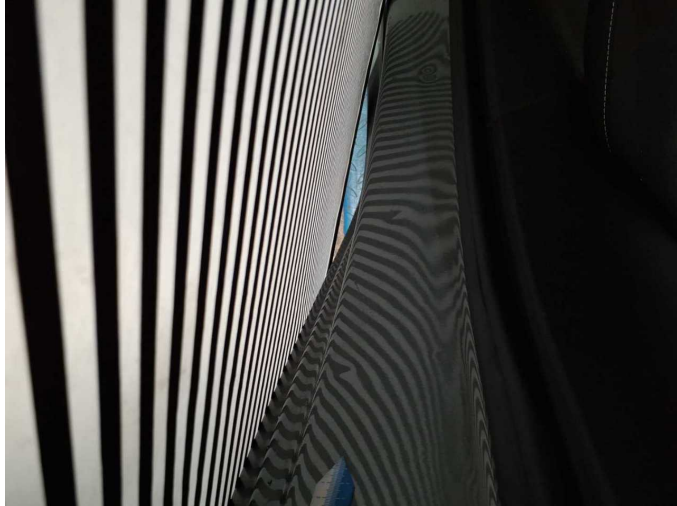
| No. | Component group | Description |
|---|---|---|
| 6 | Side panel - rear left side | Sill - dent(s) - Smooth repair work |

**Damage 6:** Side panel - rear left side: Sill - dent(s) - Smooth repair work

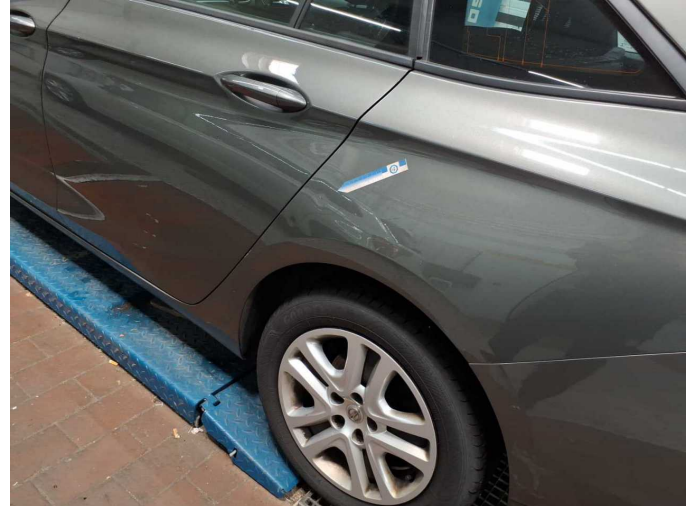
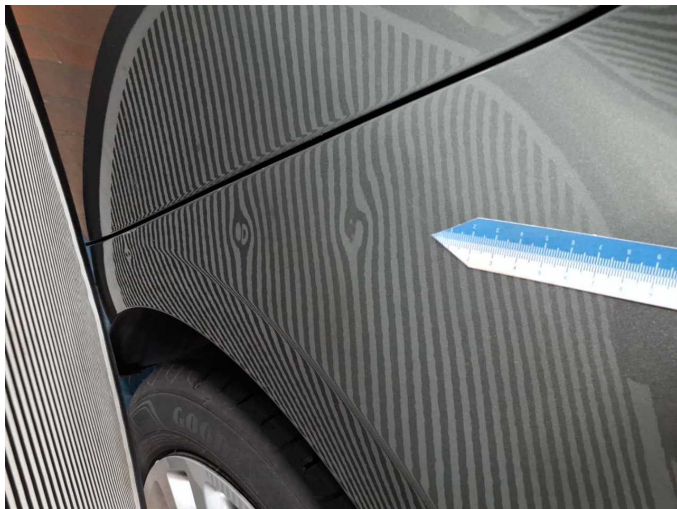
| No. | Component group | Description |
|---|---|---|
| 7 | Side panel - rear left side | Side panel - dent(s) - Smooth repair work |

**Damage 7:** Side panel - rear left side: Side panel - dent(s) - Smooth repair work

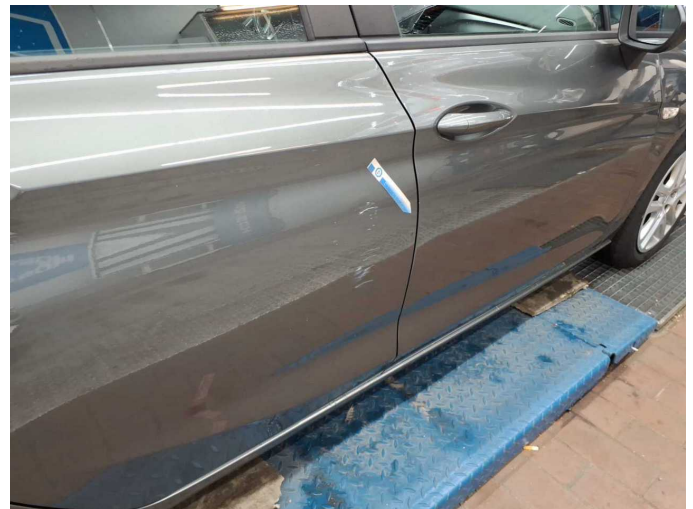
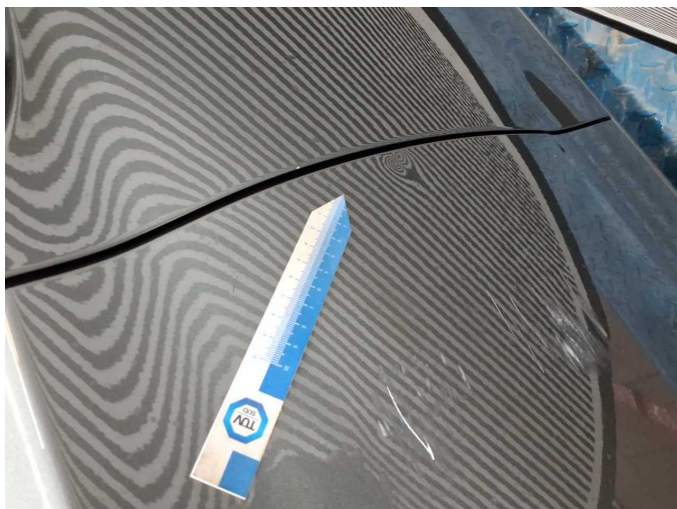
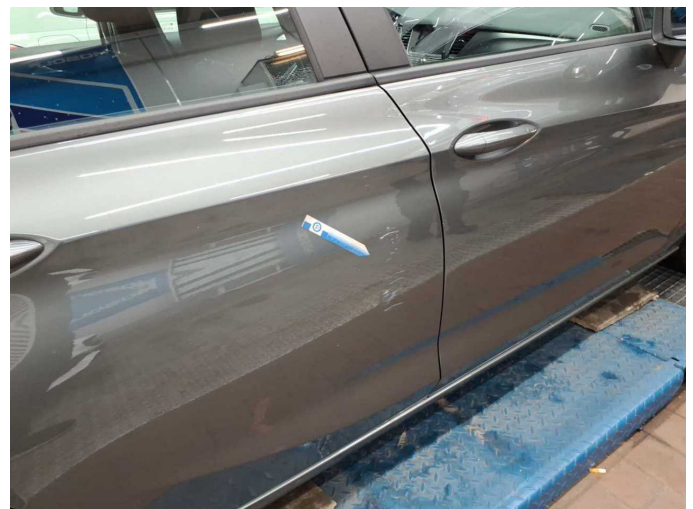
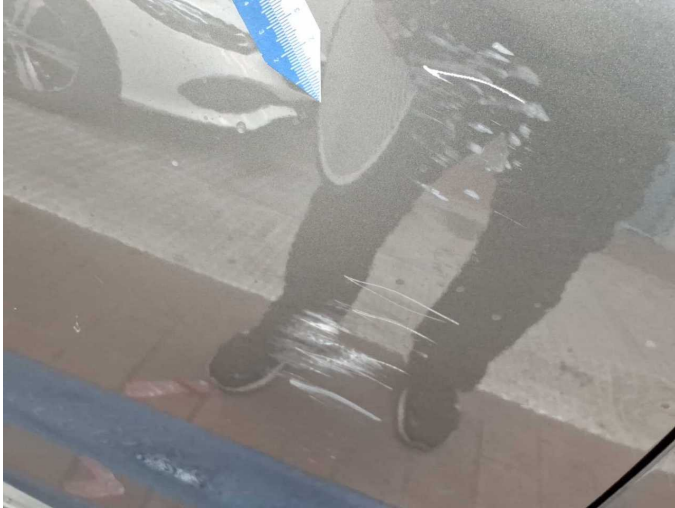
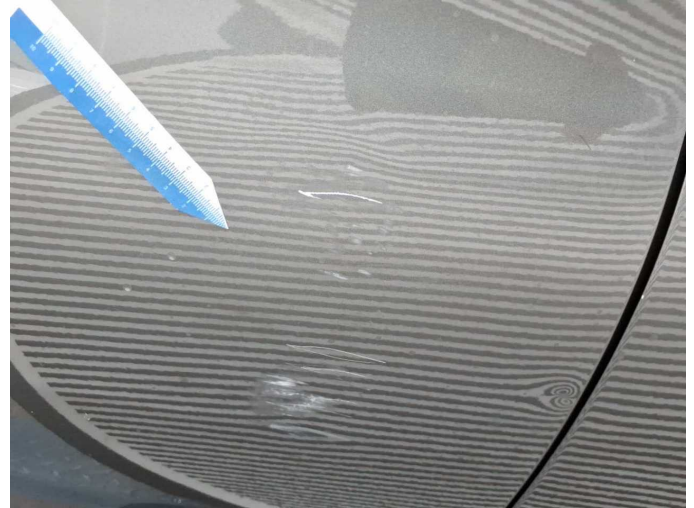
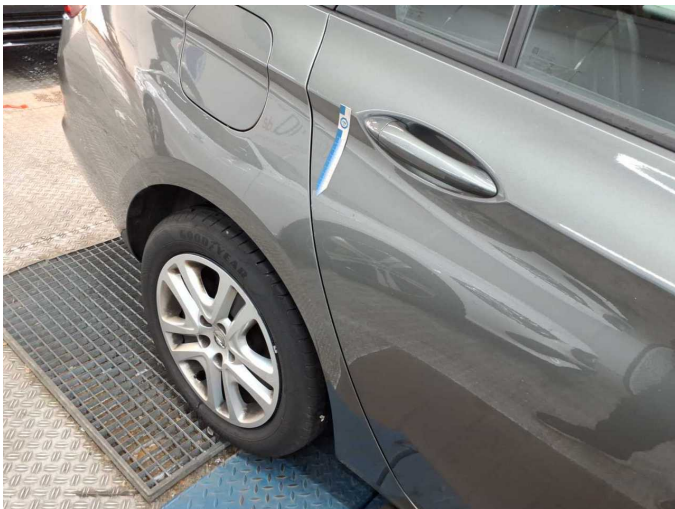
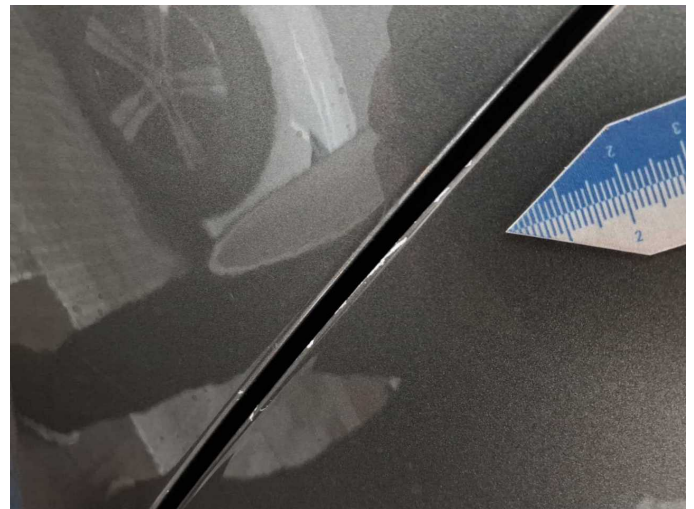
| No. | Component group | Description |
|---|---|---|
| 8 | Door - rear right side | Door - Dent / paintcoat damage - Paint |

**Damage 8:** Door - rear right side: Door - Dent / paintcoat damage - Paint

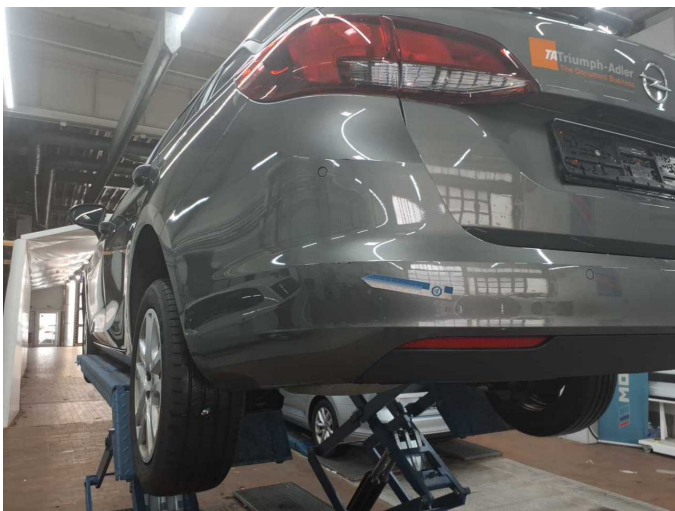
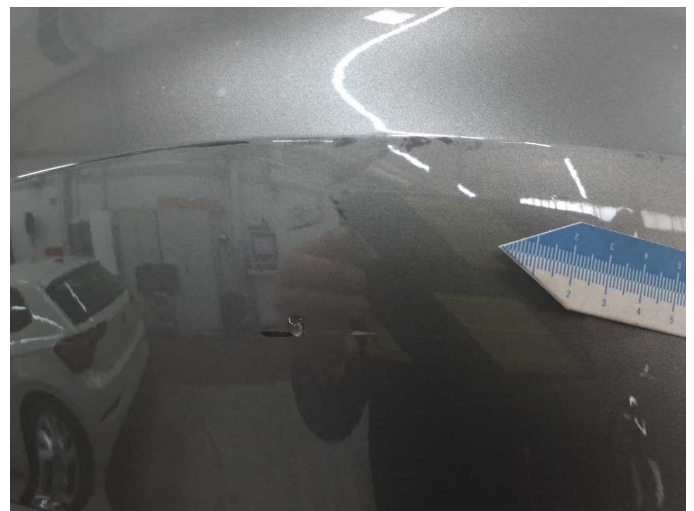
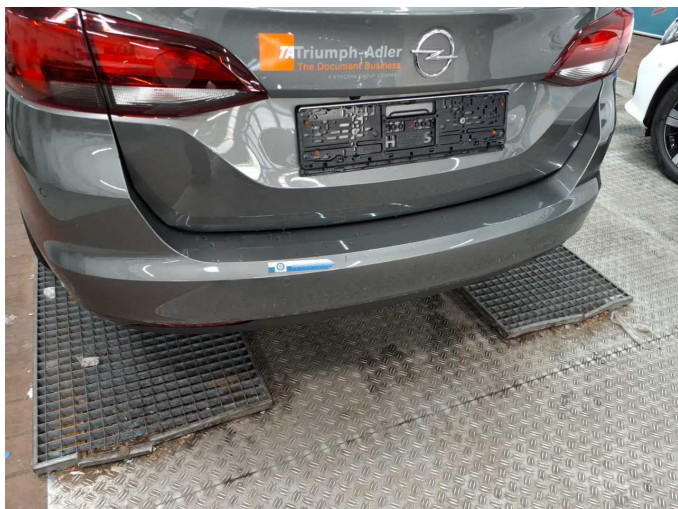
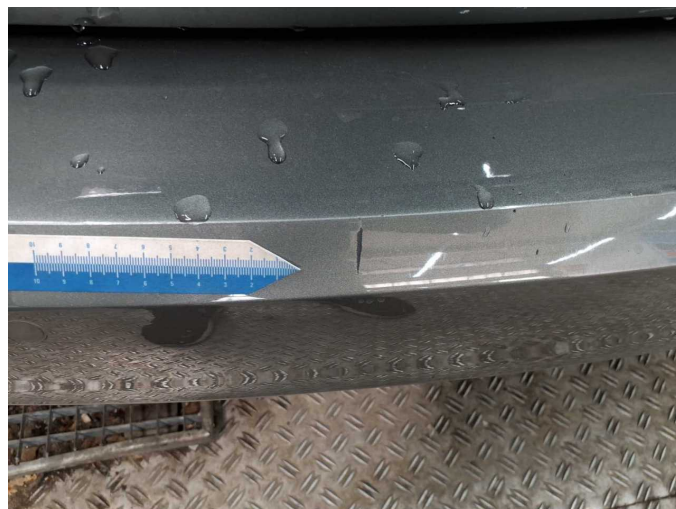
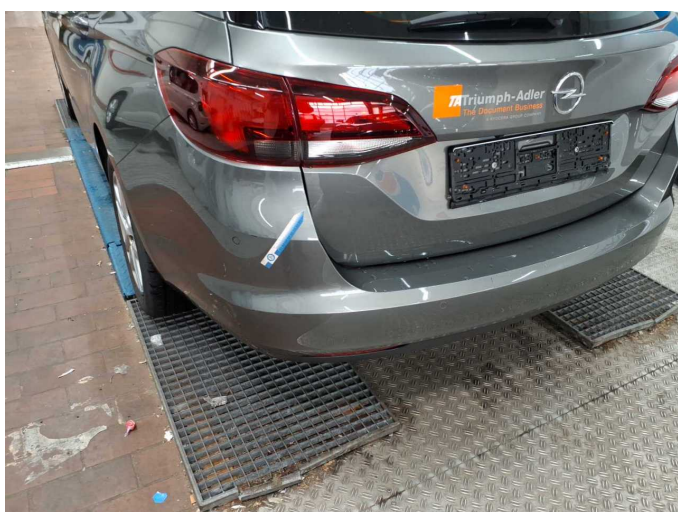
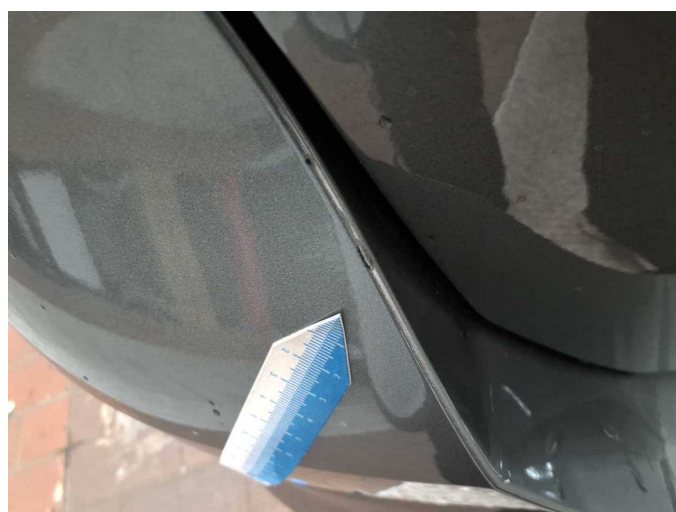
| No. | Component group | Description |
|---|---|---|
| 9 | Rear bumper | Rear bumper - Scratch(es) - Paint |

**Damage 9:** Rear bumper: Rear bumper - Scratch(es) - Paint

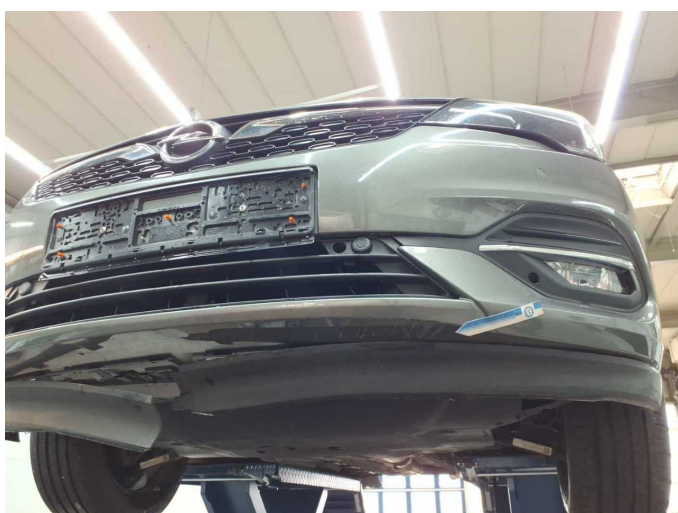
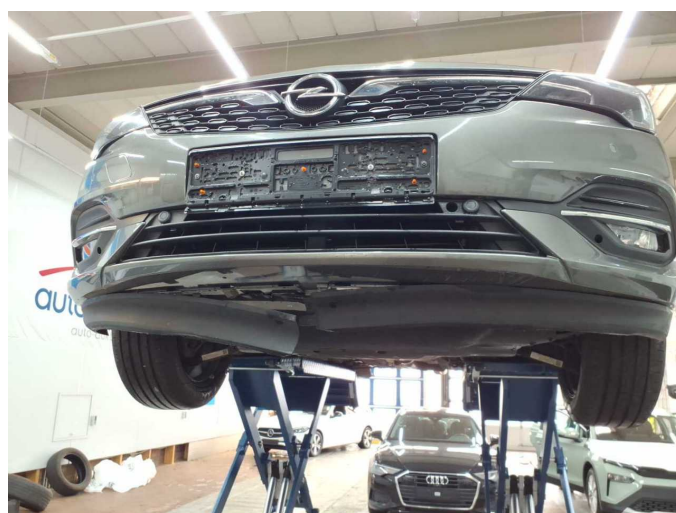
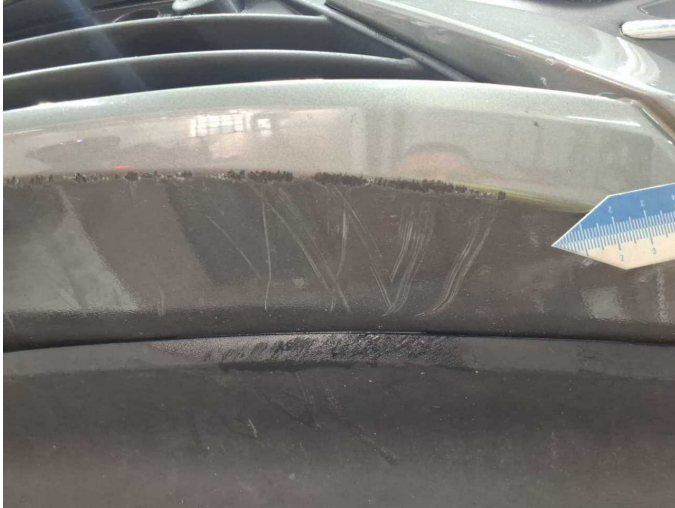
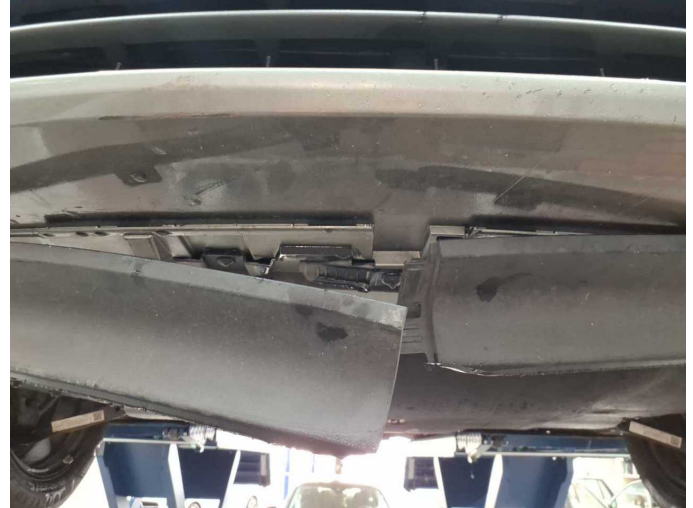
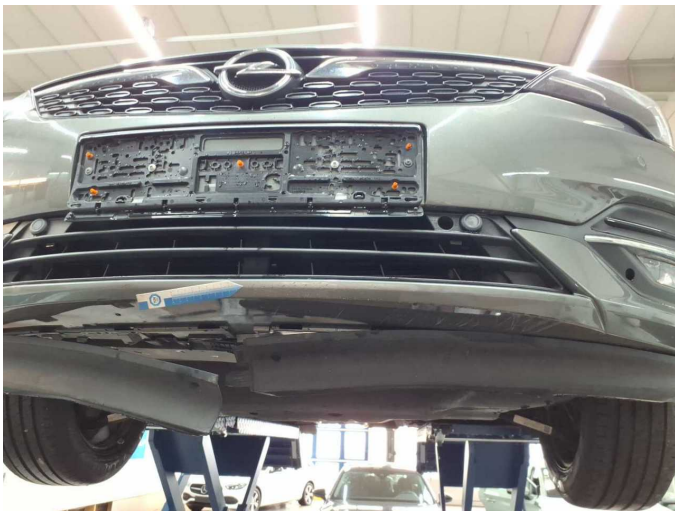
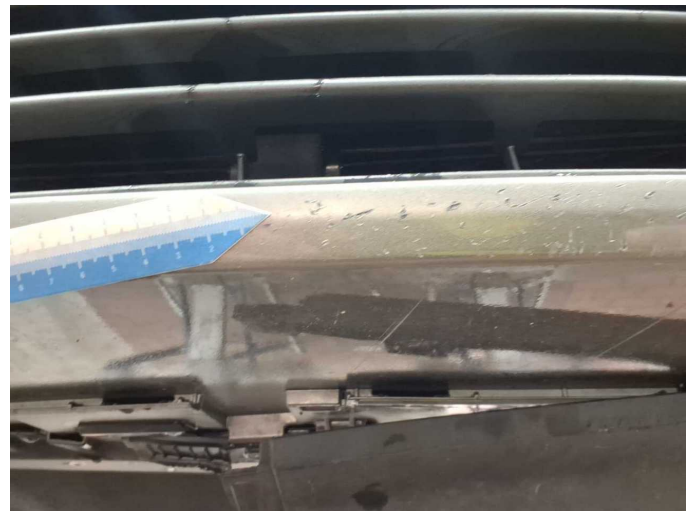
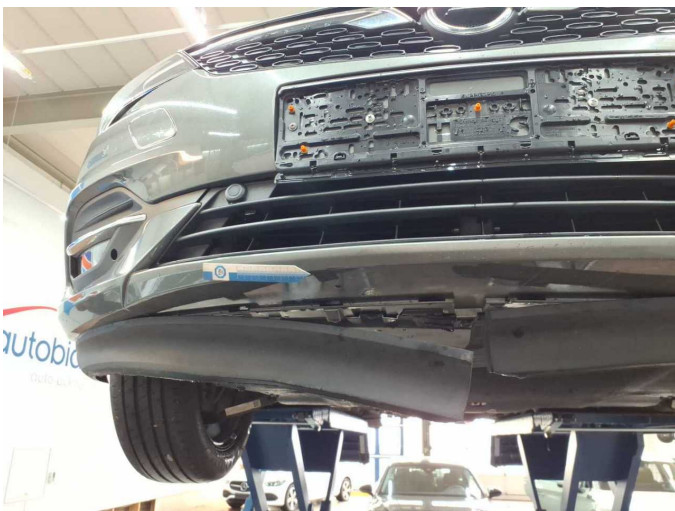
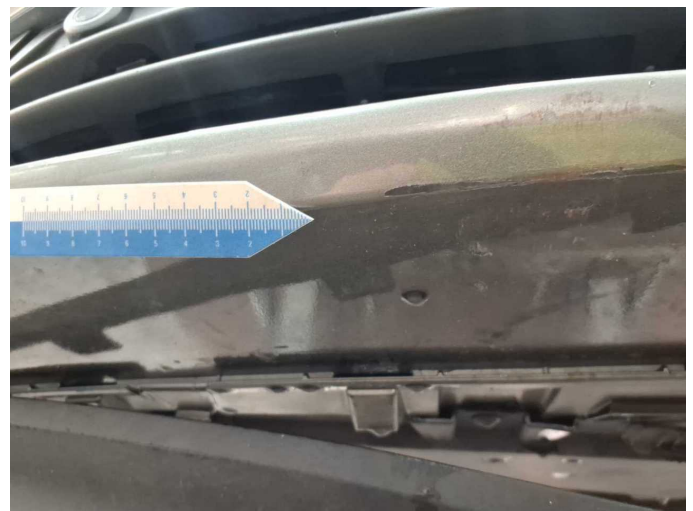
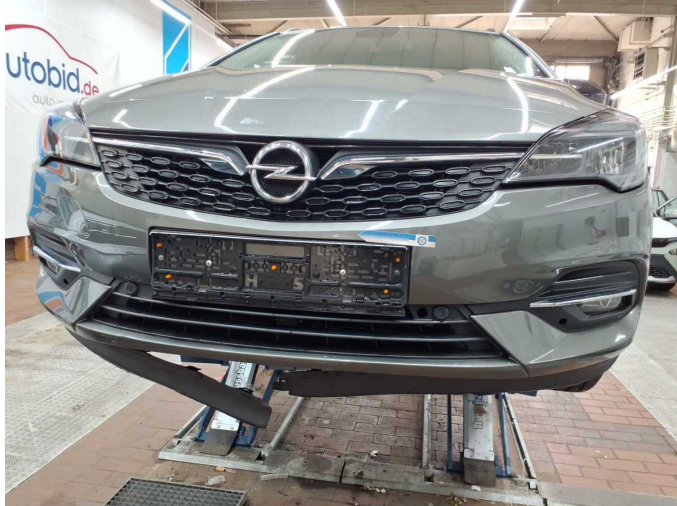
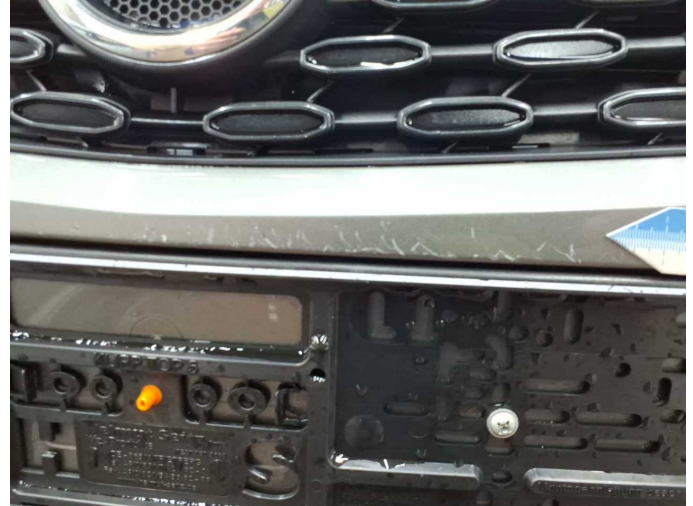
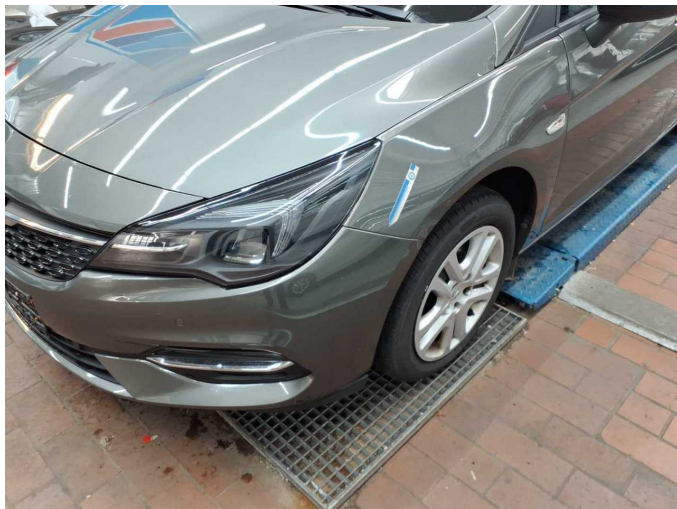
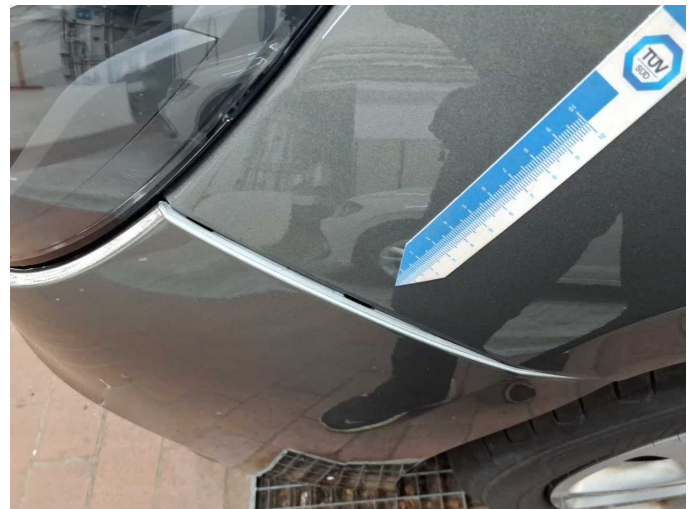
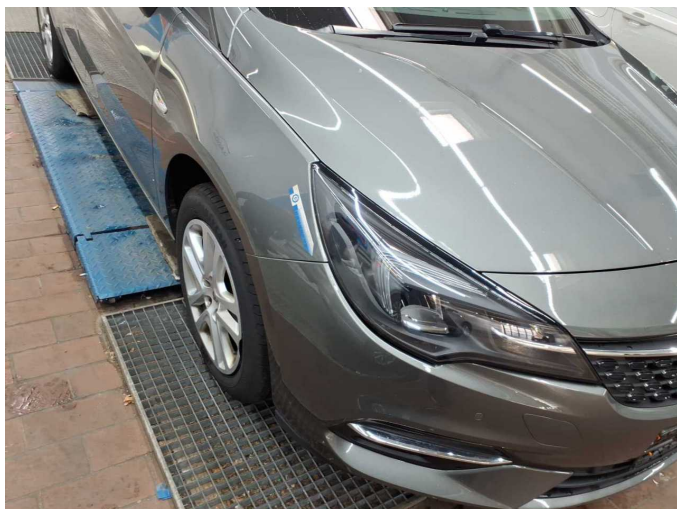
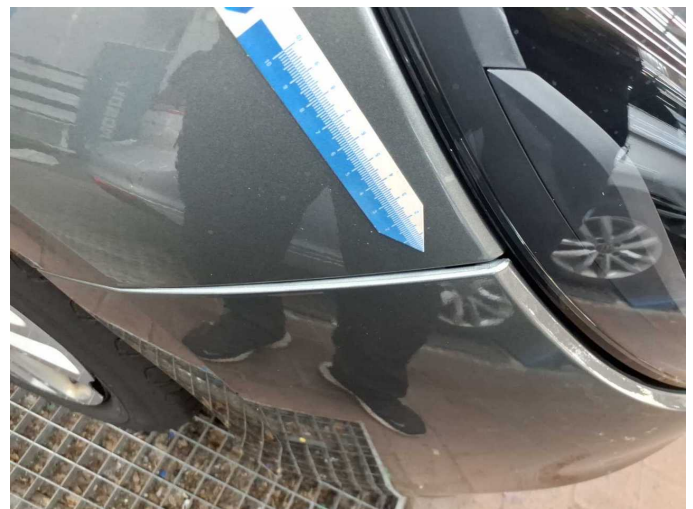
| No. | Component group | Description |
|---|---|---|
| 10 | Front bumper | Front bumper (Halter + Spoiler (L/R) + Aufpralldämpfer erneuert) - Scratched - Paint |

**Damage 10:** Front bumper: Front bumper (Halter + Spoiler (L/R) + Aufpralldämpfer erneuert) - Scratched - Paint

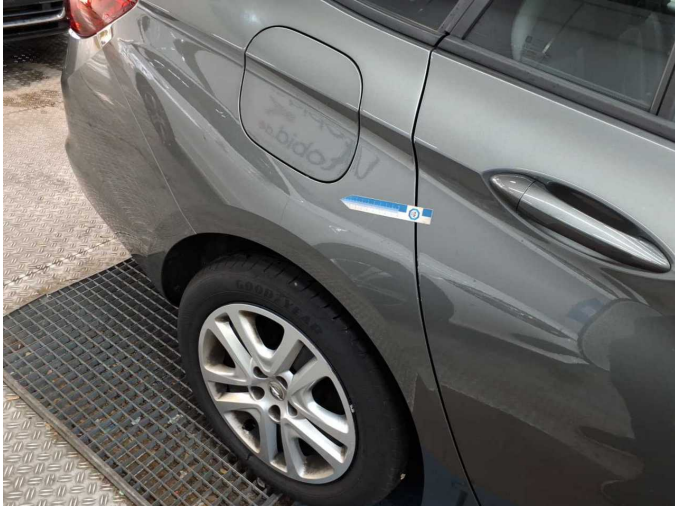
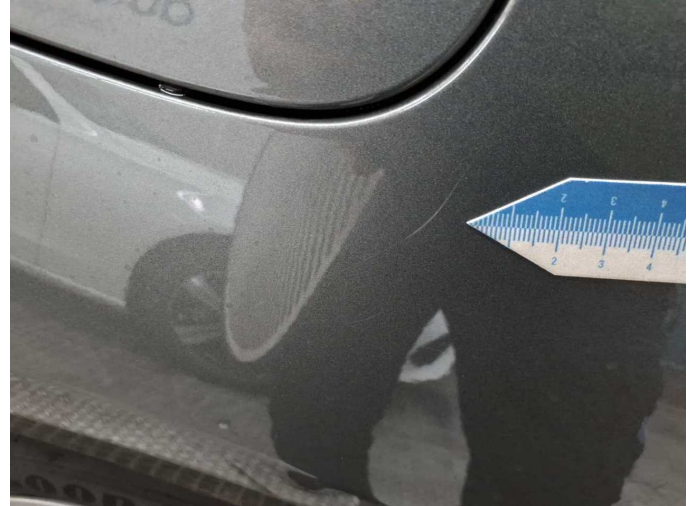
| No. | Component group | Description |
|---|---|---|
| 5 | Side panel - rear right side | Side panel - Scratch(es) - No deduction |

**Wear and tear 5:** Side panel - rear right side: Side panel - Scratch(es) - No deduction

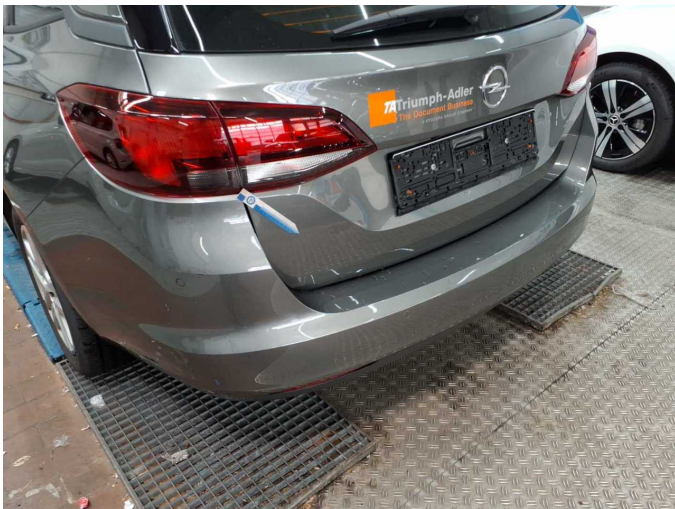
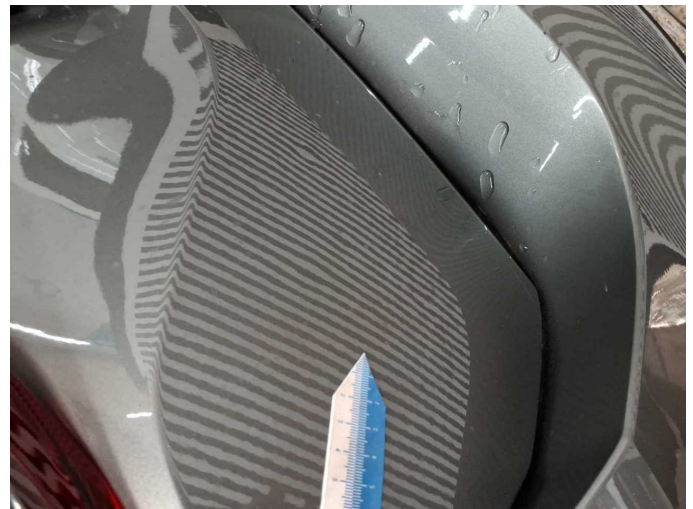
| No. | Component group | Description |
|---|---|---|
| 6 | Boot lid / rear door | Boot lid - dent(s) - Smooth repair work |

**Wear and tear 6:** Boot lid / rear door: Boot lid - dent(s) - Smooth repair work

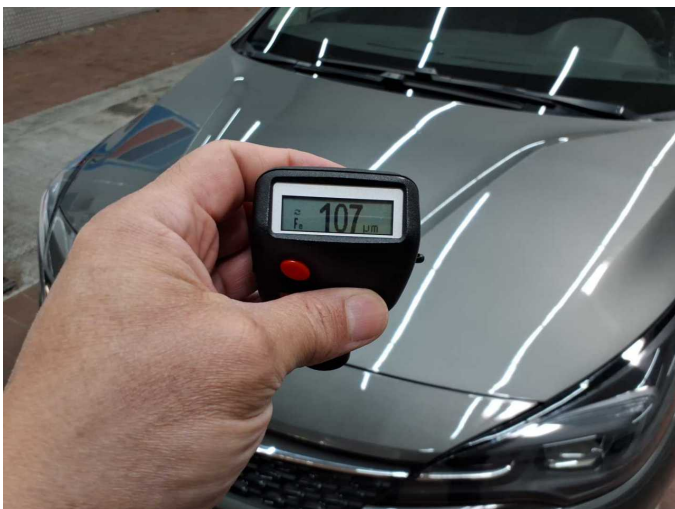
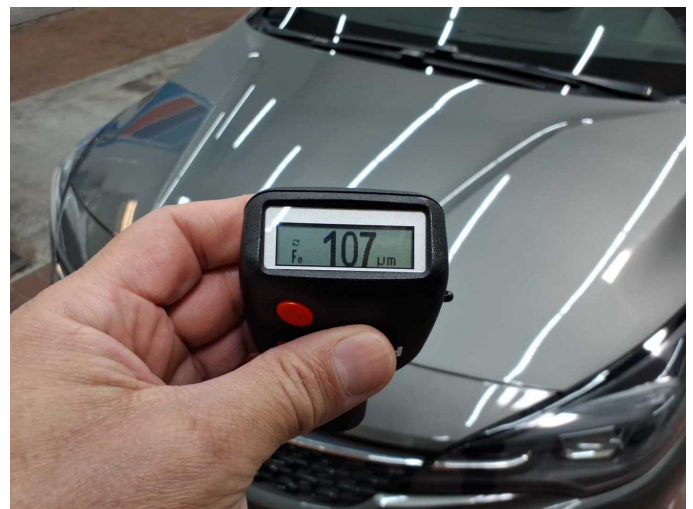
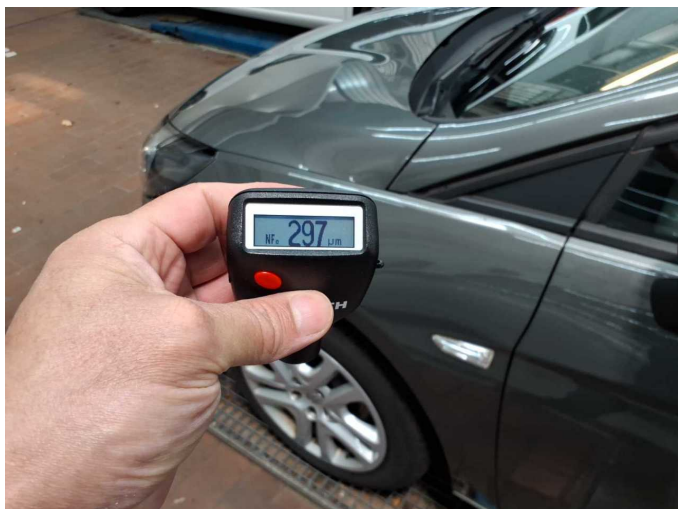
| No. | Repainting |
|---|---|
| 1 | Mudguard - left side, Bonnet, Professionally carried out |

| Mudguard - left side | 297 µm | Bonnet | 107 µm |

**Repainting 1:** Mudguard - left side, Bonnet
