Expertise

Protocol number: 46385496
Order No. / Reference: 26539196
Inspection date: 7 Jul 2026

Model: Transit Custom 320 L2H1 LKW VA MH Trend

VIN: WF0ZXXTTGZPS39571

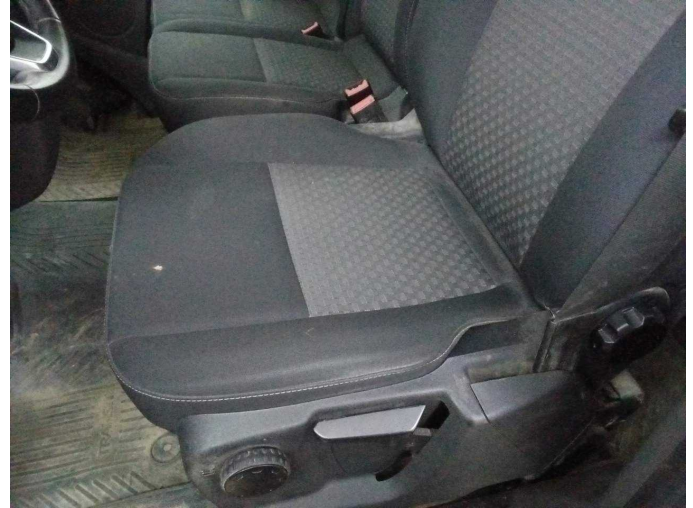
Damage 1: Seat - front: Seat cover - left side - Clean

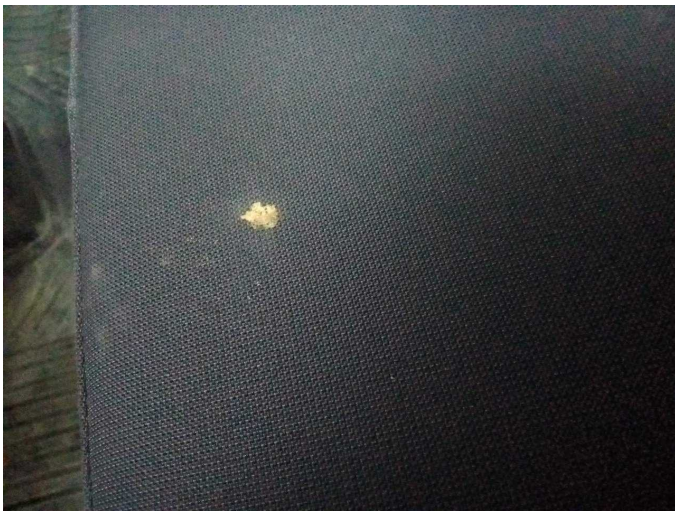
Damage 1: Seat - front: Seat cover - left side - Clean

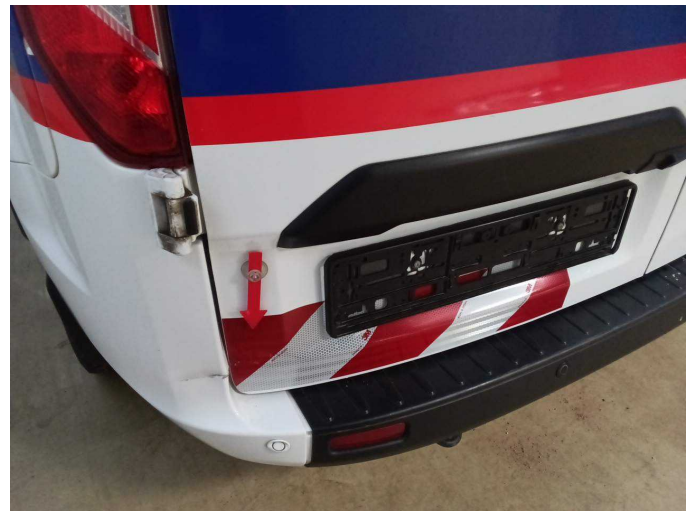
Damage 2: Boot lid / rear door: Boot lid - Scratch(es) - Smart repair

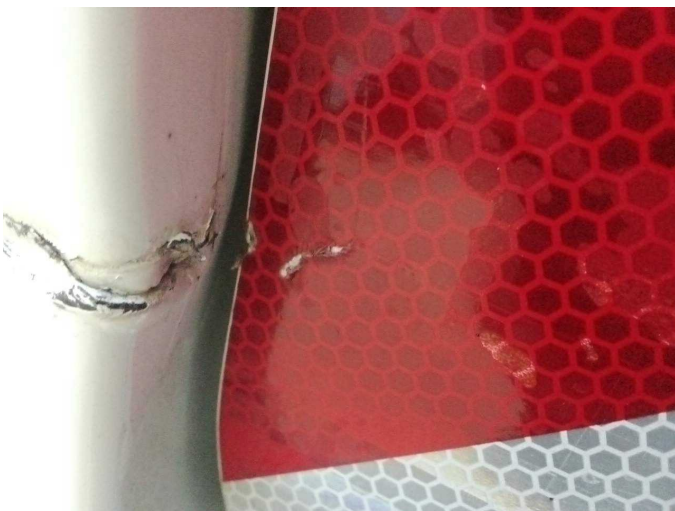
Damage 2: Boot lid / rear door: Boot lid - Scratch(es) - Smart repair

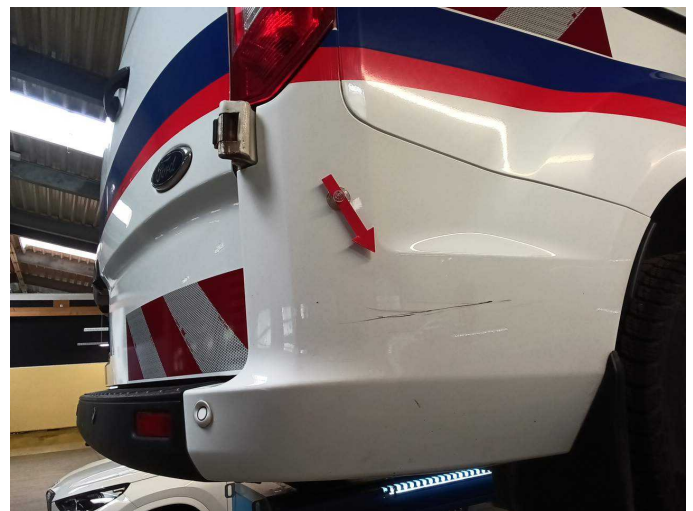
Damage 3: Rear bumper: Bumper - rear right side - Scratched - Paint

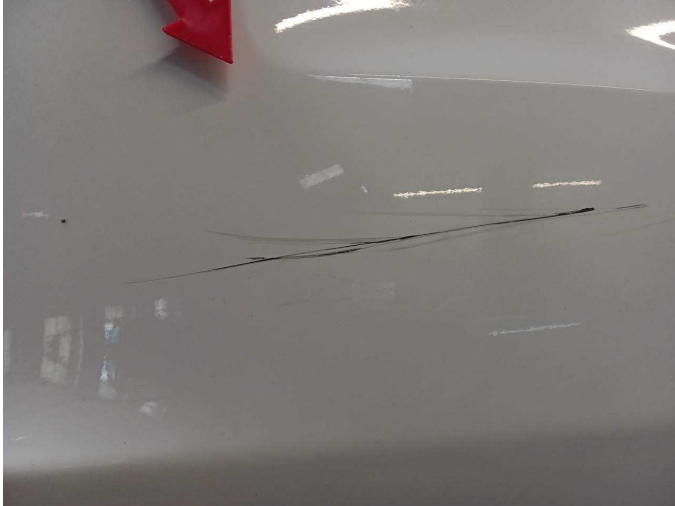
Damage 3: Rear bumper: Bumper - rear right side - Scratched - Paint

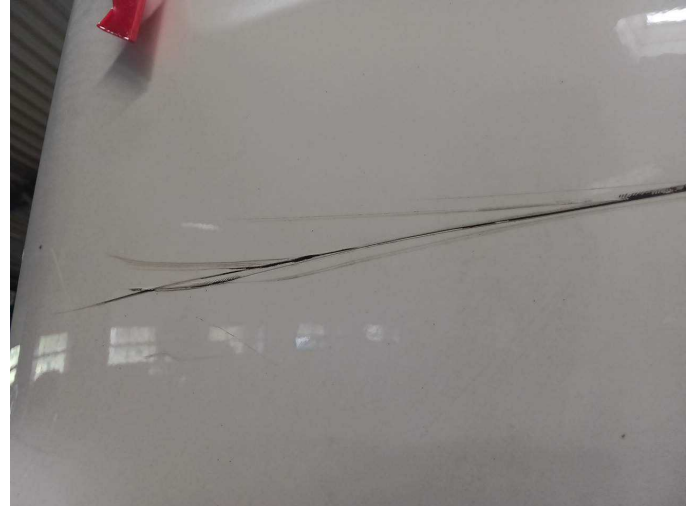
Damage 3: Rear bumper: Bumper - rear right side - Scratched - Paint

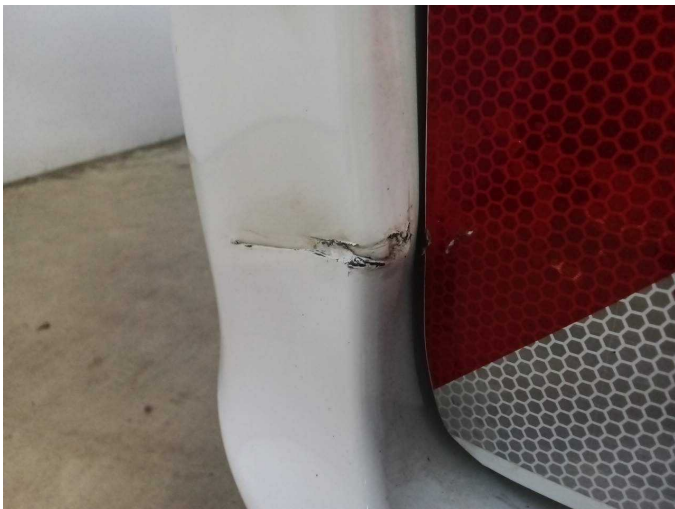
Damage 4: Rear bumper: Bumper - rear left side - Scratched - Repair and paint

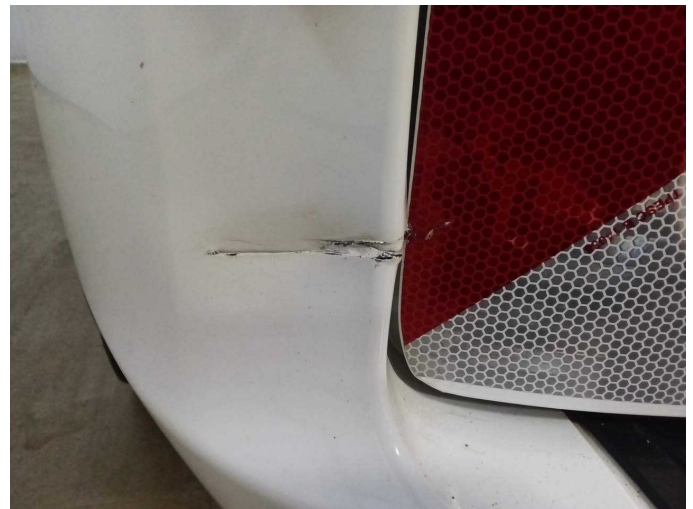
Damage 4: Rear bumper: Bumper - rear left side - Scratched - Repair and paint

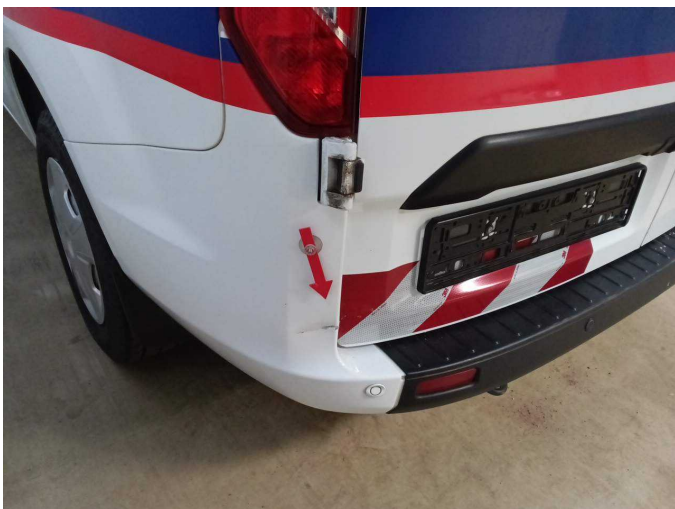
Damage 4: Rear bumper: Bumper - rear left side - Scratched - Repair and paint

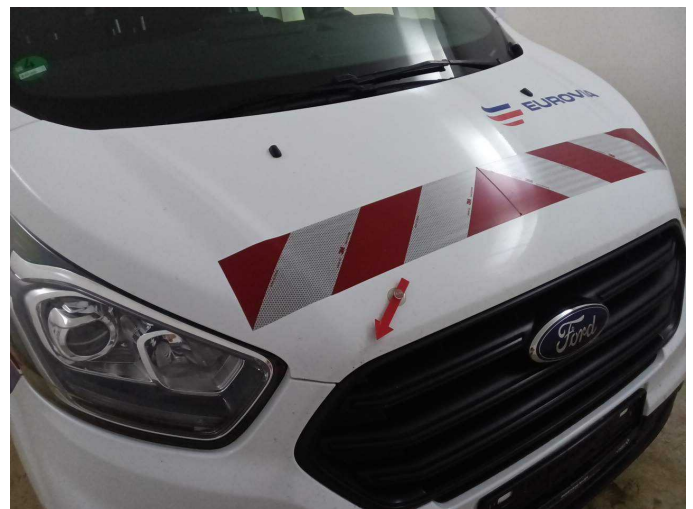
Wear and tear 1: Bonnet: Bonnet - Stone chips - No deduction

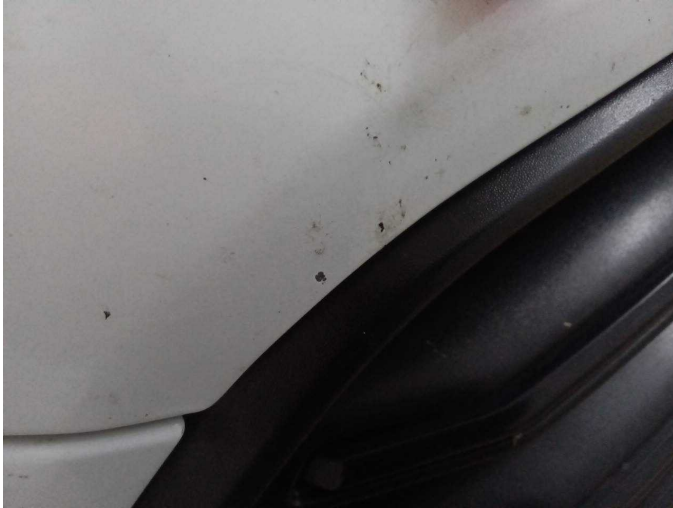
Wear and tear 1: Bonnet: Bonnet - Stone chips - No deduction

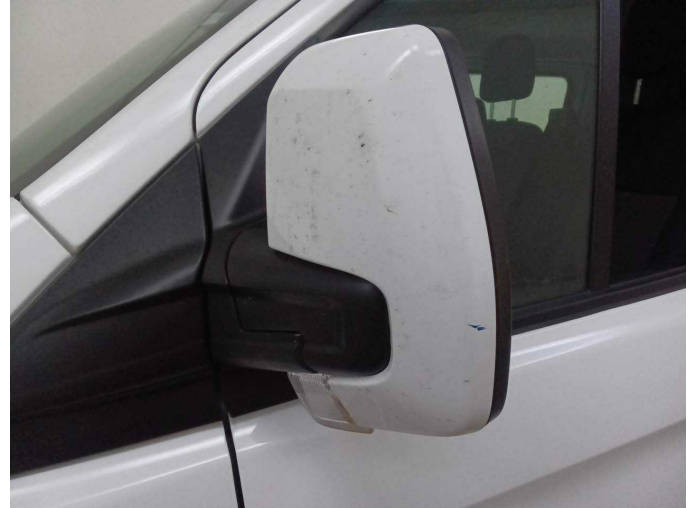
Wear and tear 2: Wing mirror - left side: Mirror housing - Scratch(es) - No deduction

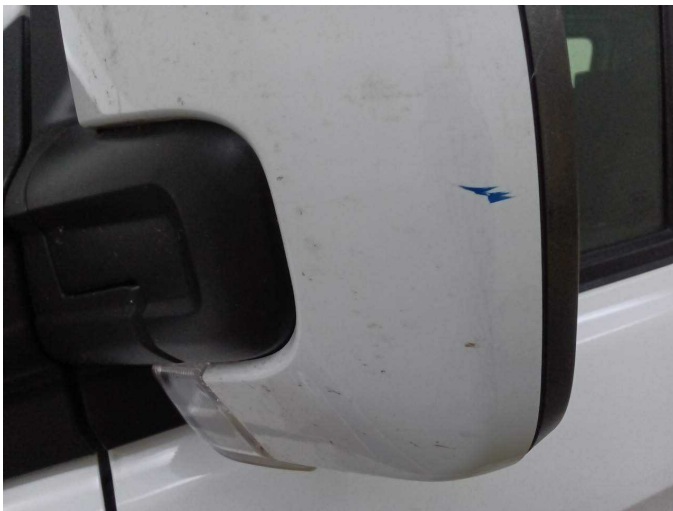
Wear and tear 2: Wing mirror - left side: Mirror housing - Scratch(es) - No deduction

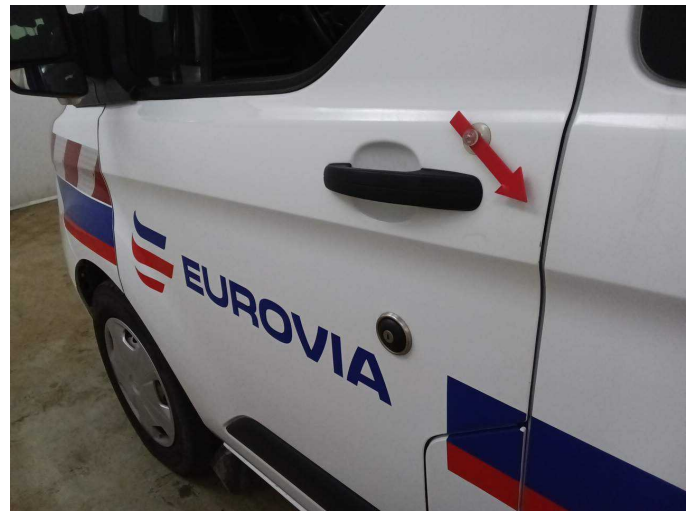
Wear and tear 3: Door - front left side: Door edge - Scratch(es) - No deduction

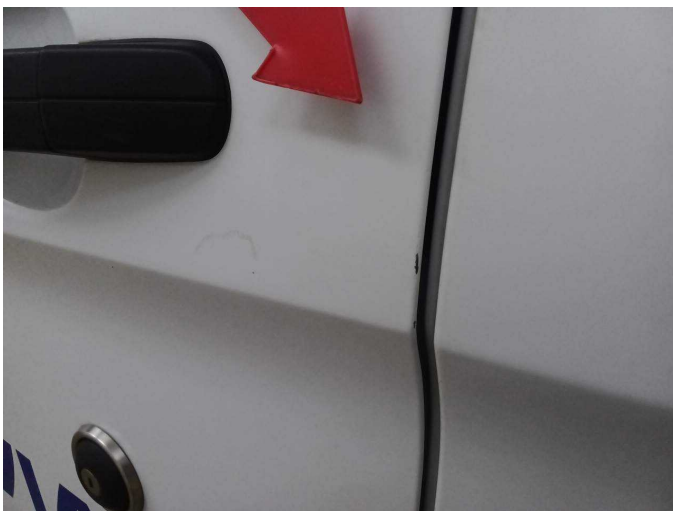
Wear and tear 3: Door - front left side: Door edge - Scratch(es) - No deduction

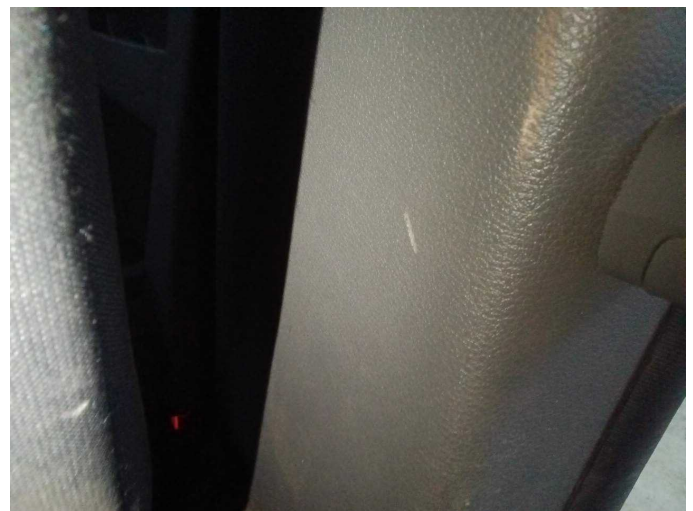
Wear and tear 4: Trim / covers: B-pillar - trim - interior, right side - Scratch(es) - No deduction

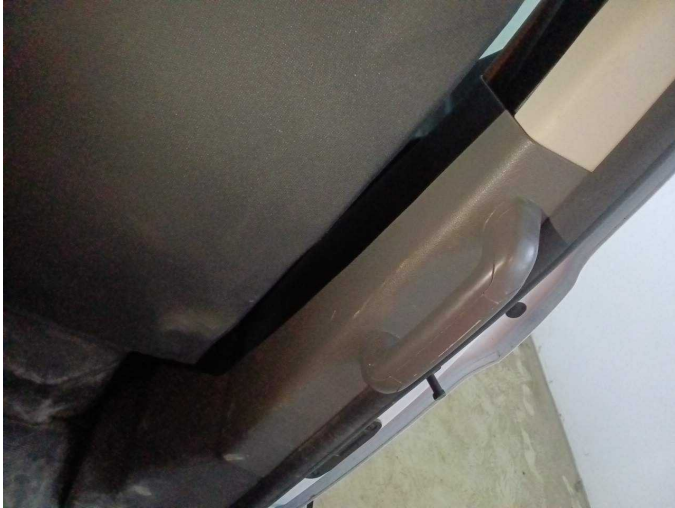
Wear and tear 4: Trim / covers: B-pillar - trim - interior, right side - Scratch(es) - No deduction

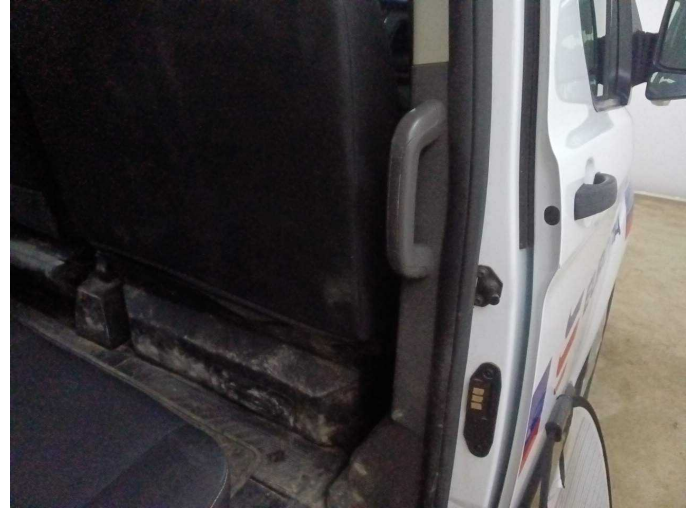
Wear and tear 4: Trim / covers: B-pillar - trim - interior, right side - Scratch(es) - No deduction

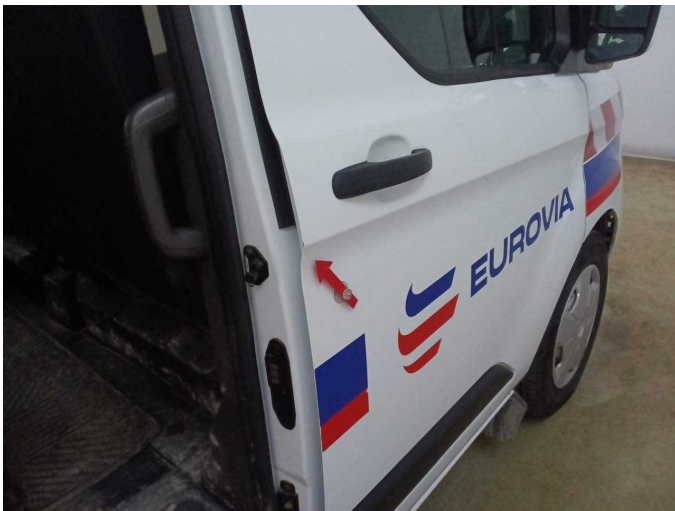
Wear and tear 5: Door - front right side: Door edge - Scratch(es) - No deduction

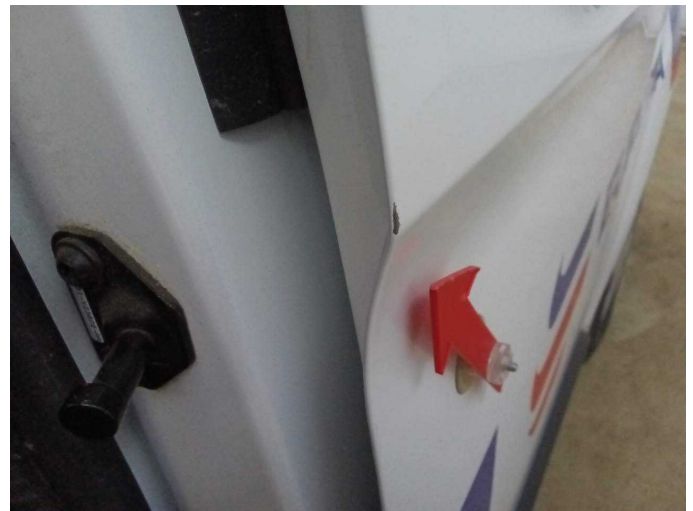
Wear and tear 5: Door - front right side: Door edge - Scratch(es) - No deduction
