» Overview

VIN: WVVZZZ3C6RE035004

Vehicle category:	Passenger Car
Vehicle type:	EstateCar
Make:	Volkswagen
Model:	Passat
Manufacturers and type code:	0603 / BQS
Date of first registration:	05.03.2024
Mileage:	104,140 km
Proof of mileage:	ReadOff
Exterior colour:	Deep Black Perleffekt
Roof colour:	Deep Black Perleffekt
Propulsion:	Front
Fuel:	Diesel
Engine size (cc):	2,000 ccm
Performance:	110 kW (150 PS)
Length:	
Height:	
Width:	
Permitted total weight:	
Wheelbase:	
Number of powered axles:	2
Cylinders:	4
Euronorm:	Euro 6
Number of doors:	4
Number of seats:	5
Gearbox:	Automatic 7-speed
Upholstery type:	Lining fabrics
Interior colour:	Titanschwarz/Titanschwarz/Titanschwarz
Number of keys:	1

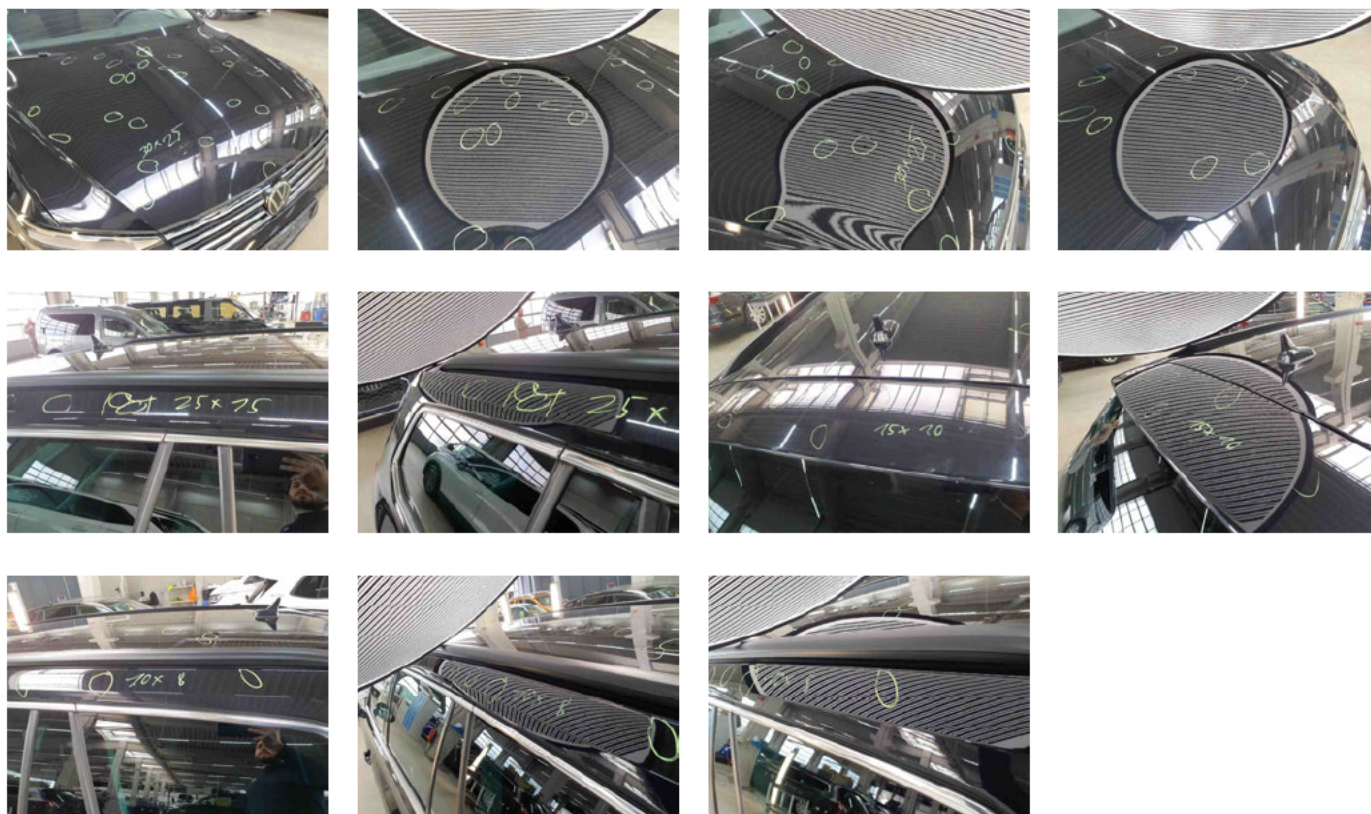
1 - Bonnet - Hail damage - Paintless dent repair (hail)	Repaircosts:	€ 1,160.00
	Net cost:	€ 1,160.00
Fixed Price		€ 1,160.00

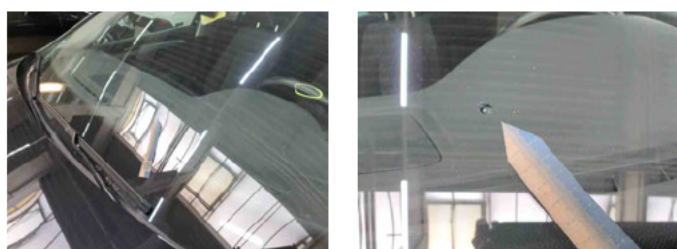
2 - Windscreen - Broken - Replace	Repaircosts:	€ 950.00
	Net cost:	€ 950.00
Parts Price		€ 950.00

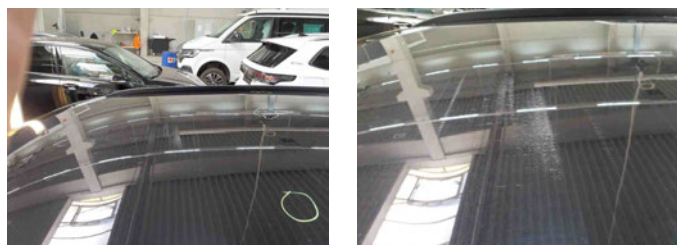
3 - Roof - Abrasion - Paint		Repaircosts:	€ 726.00
		Net cost:	€ 457.38
Paint material			€ 210.00
Paint work	43 WU		€ 516.00

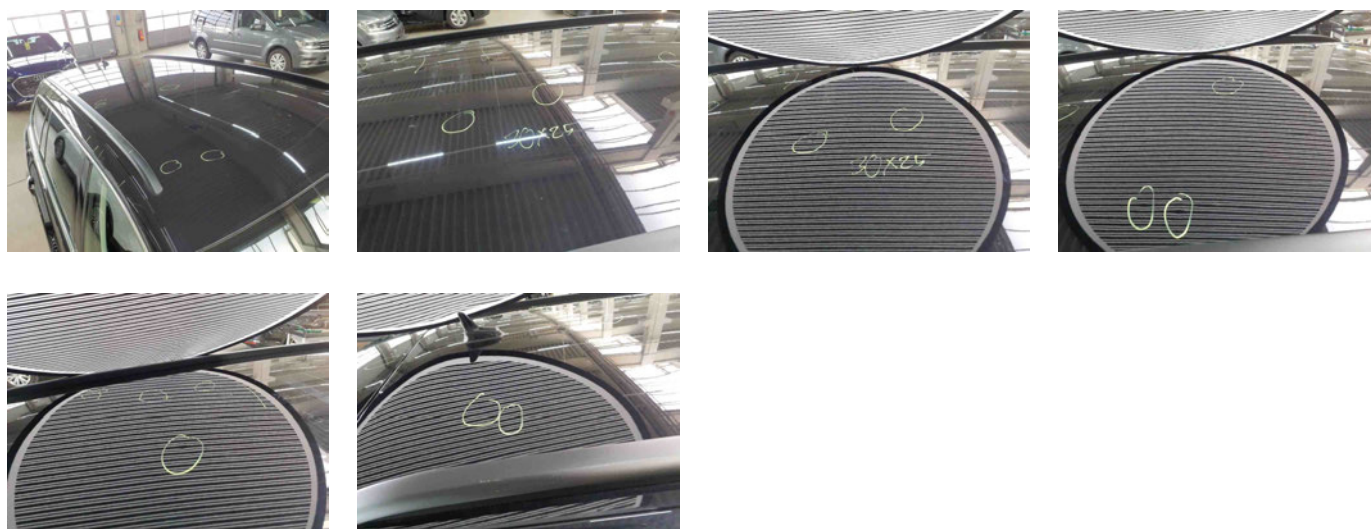
4 - Roof - Hail damage - Paintless dent repair (hail)		Repaircosts:	€ 680.00
		Net cost:	€ 680.00
Fixed Price			€ 680.00

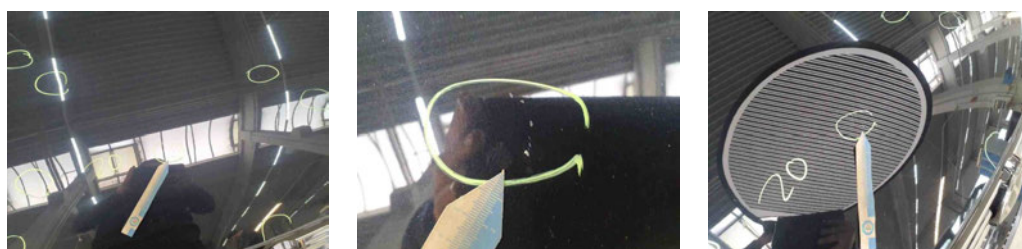
5 - Bonnet - Dent(s) and scratch(es) - Repair and paint (complete)		Repaircosts:	€ 507.50
		Net cost:	€ 319.73
Paint material			€ 147.50
Paint work	30 WU		€ 360.00

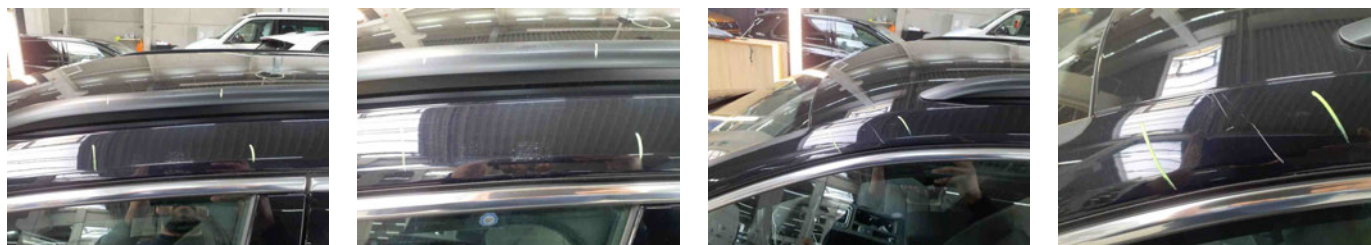
12 - Roof pillar L - Scratch(es) - Repair and paint (complete)		Repaircosts:	€ 239.50
		Net cost:	€ 150.89
Paint material			€ 47.50
Paint work	16 WU		€ 192.00

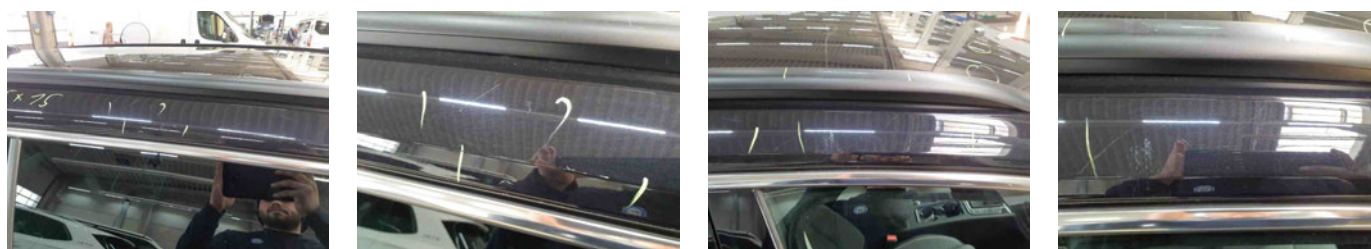
13 - Roof pillar R - Scratch(es) - Paint		Repaircosts:	€ 239.50
		Net cost:	€ 150.89
Paint material			€ 47.50
Paint work	16 WU		€ 192.00

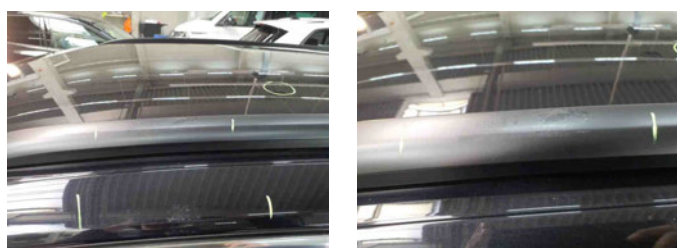
14 - Roof rail L - Abrasion - Repair and paint (complete)		Repaircosts:	€ 198.75
		Net cost:	€ 125.21
Paint material			€ 18.75
Paint work	15 WU		€ 180.00

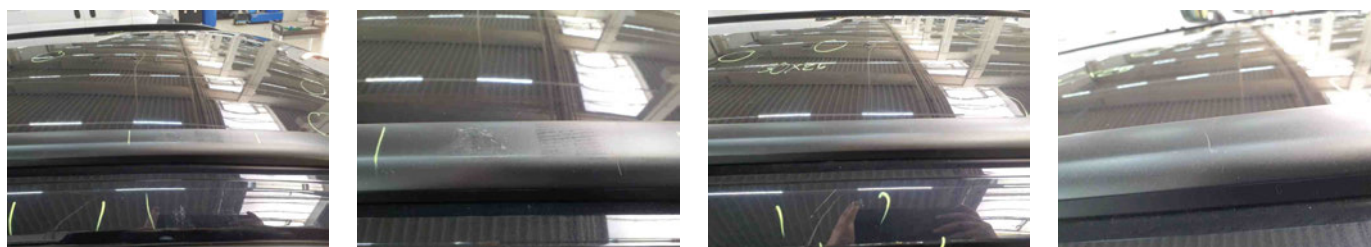
15 - Roof rail R - Abrasion - Repair and paint (complete)		Repaircosts:	€ 198.75
		Net cost:	€ 125.21
Paint material			€ 18.75
Paint work	15 WU		€ 180.00
