Expertise

Protocol number: 45831245
Order No. / Reference: 26466629
Inspection date: 8 Jun 2026

Model: T-Roc 2.0 TDI SCR Life

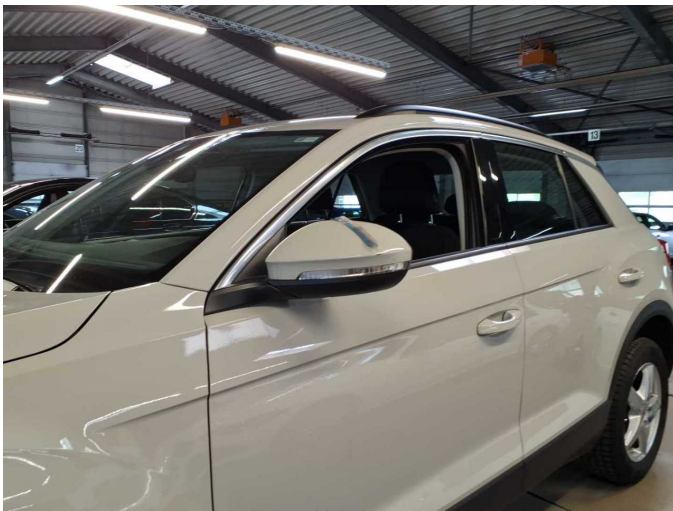
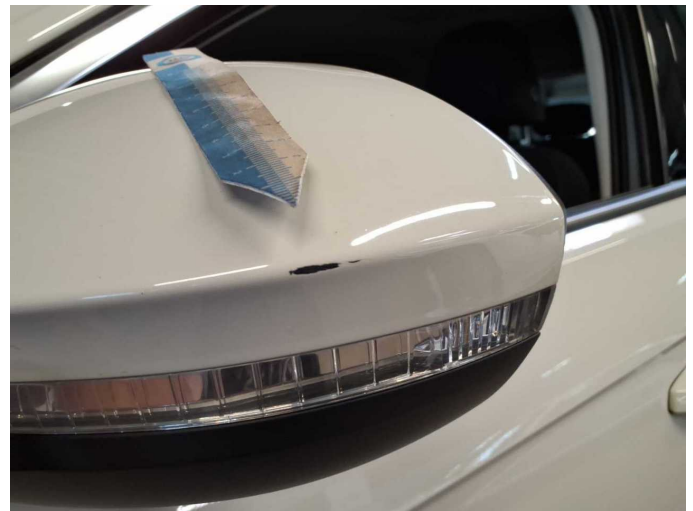
Damage 1: Wing mirror - left side: Cap - Scratch(es) - Smart repair

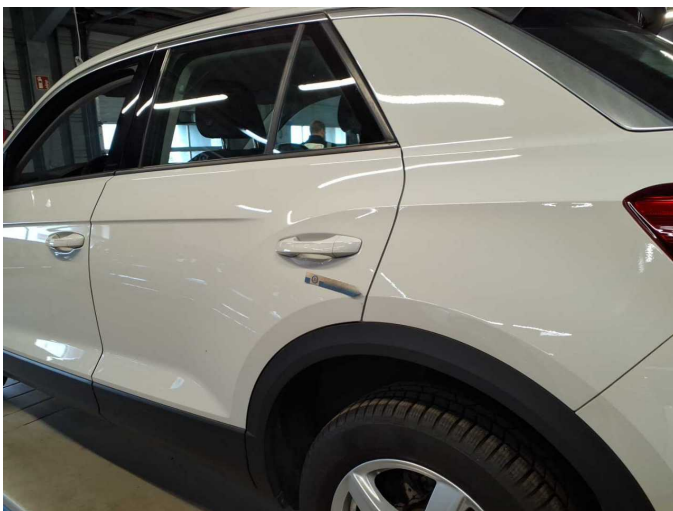
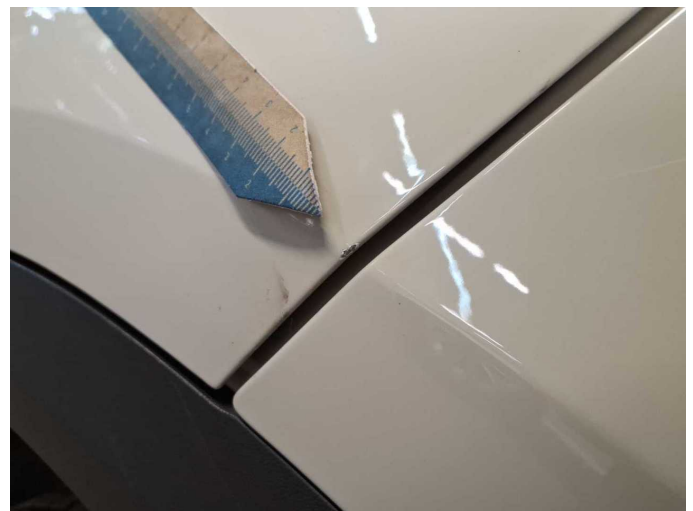
Damage 2: Door - rear left side: Door edge - Scratch(es) - Smart repair

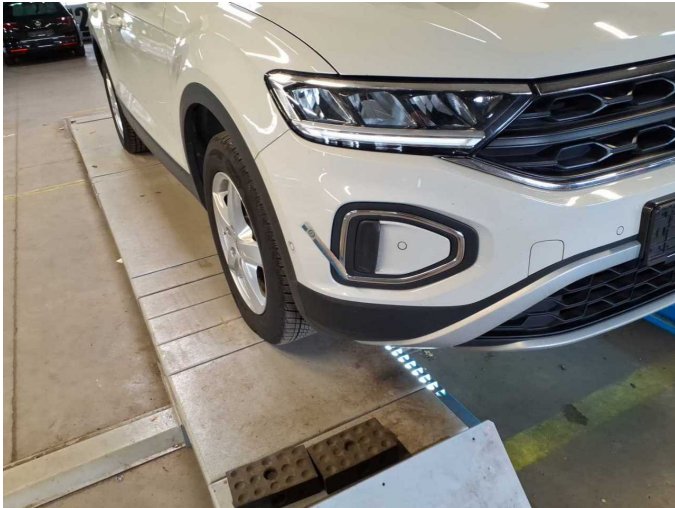
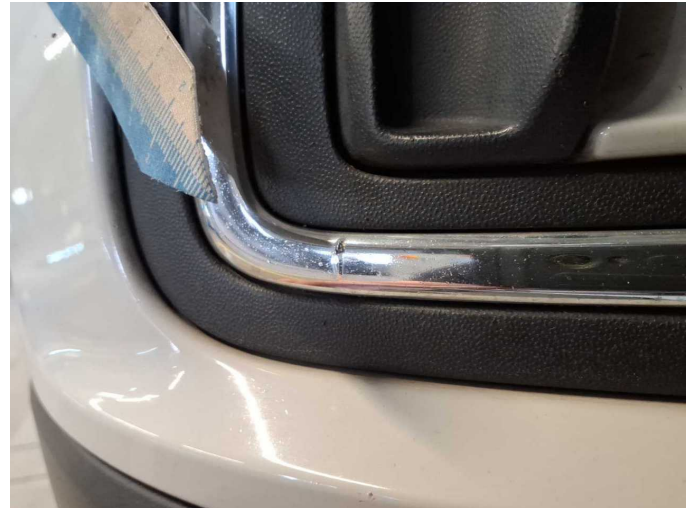
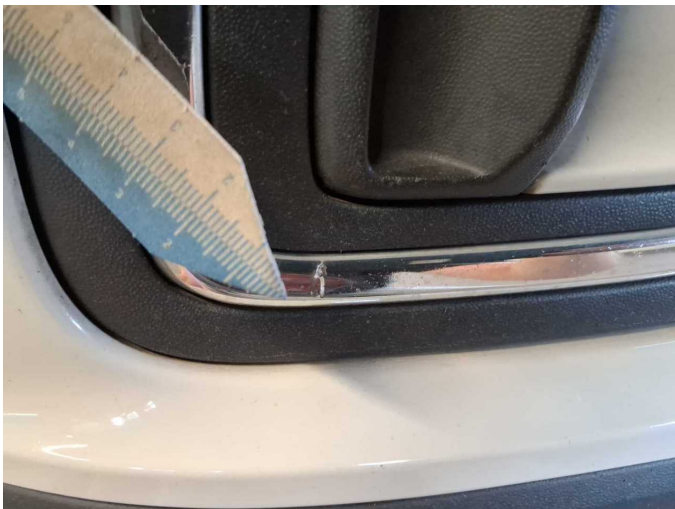
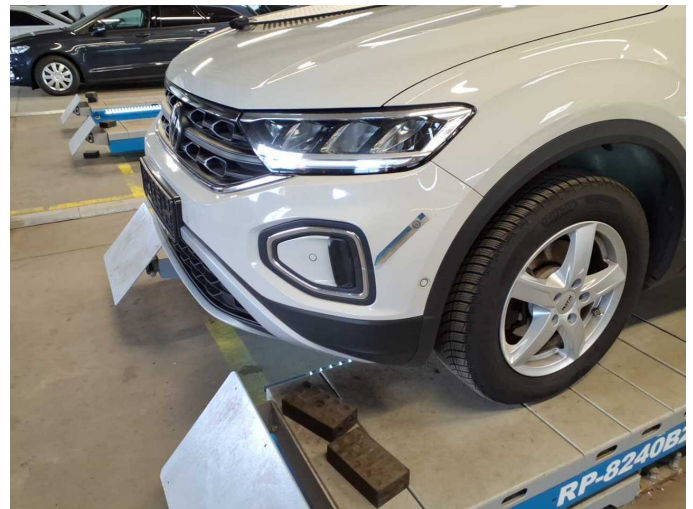
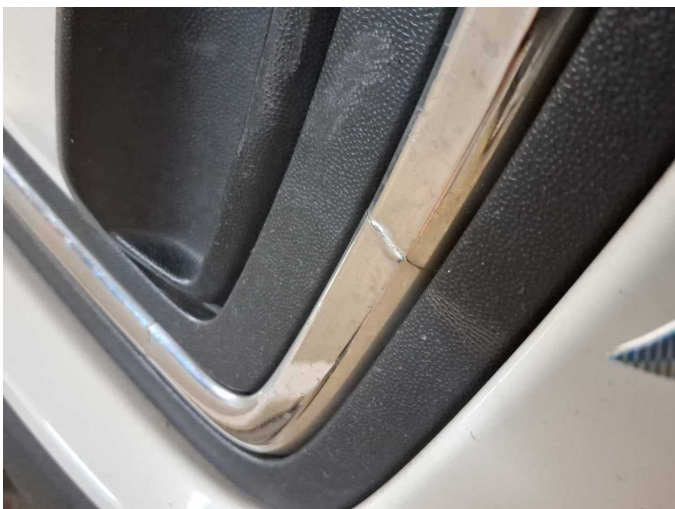
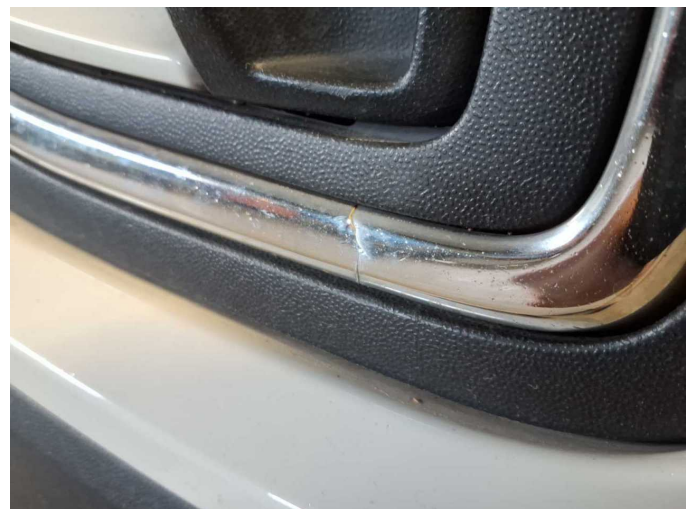
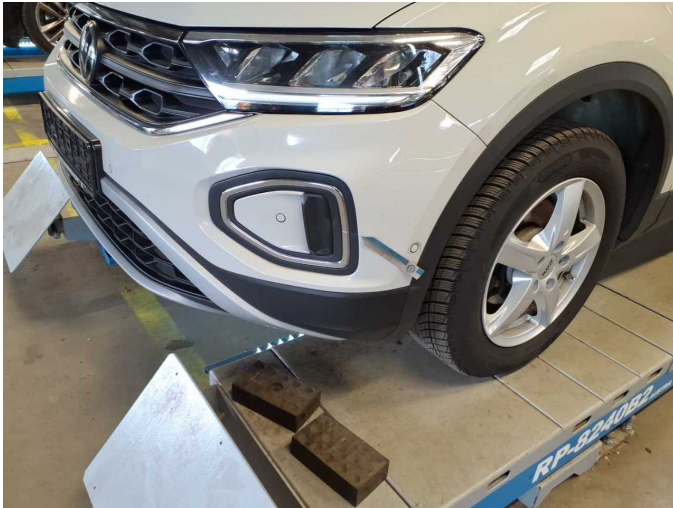
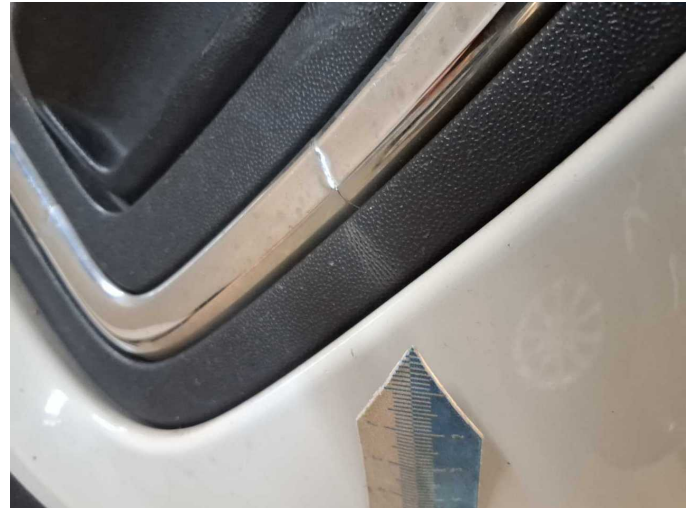
Damage 3: Front bumper: Air-inlet grille (links, rechts, + Kunststoffeinsatz) - Broken / torn - Replace

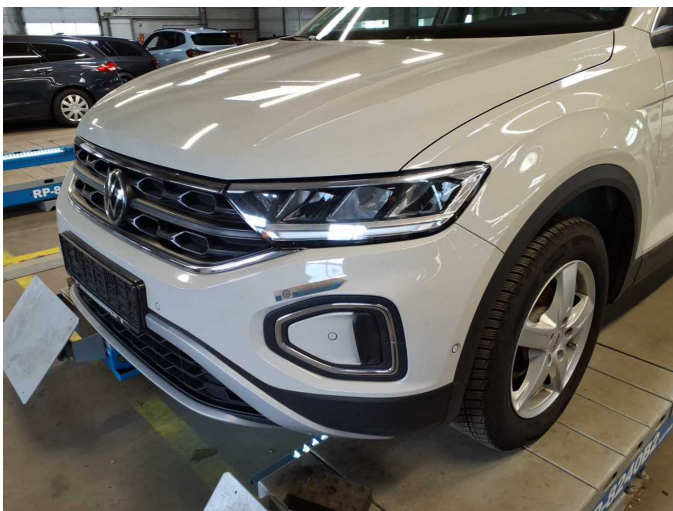
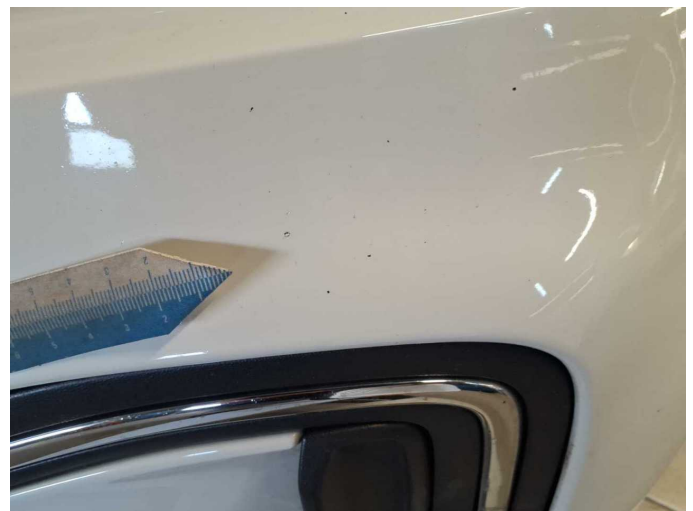
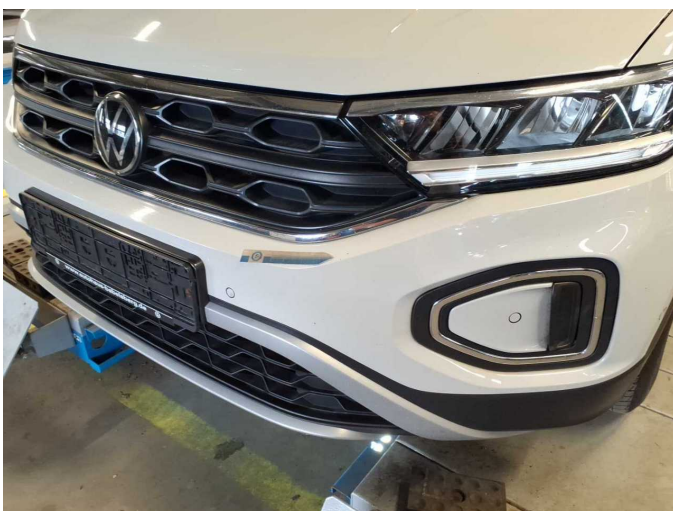
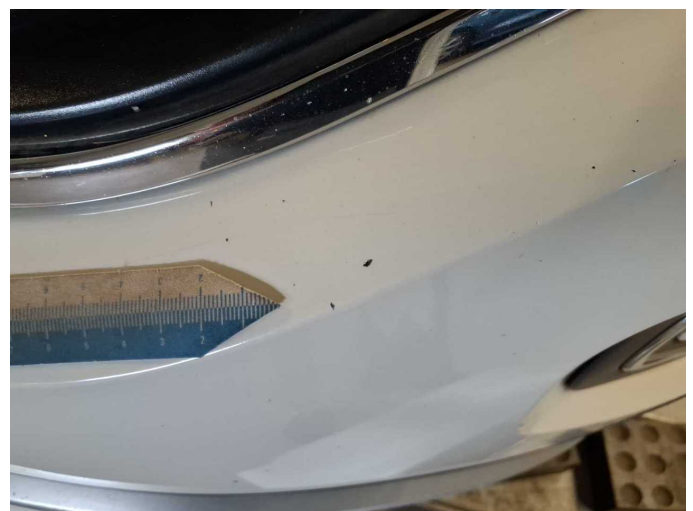
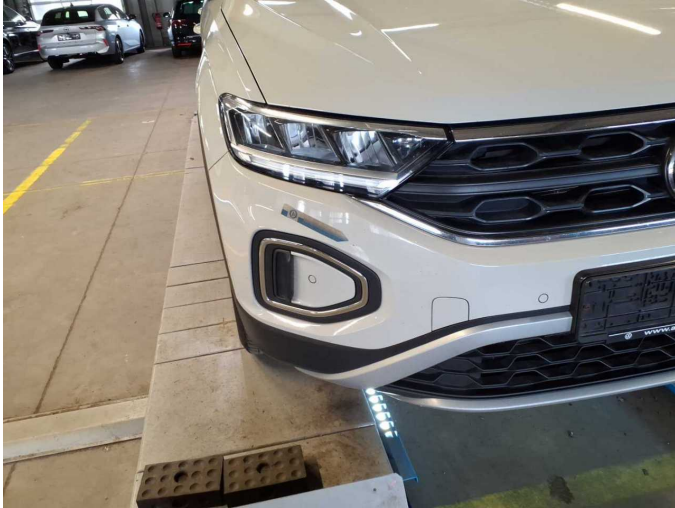
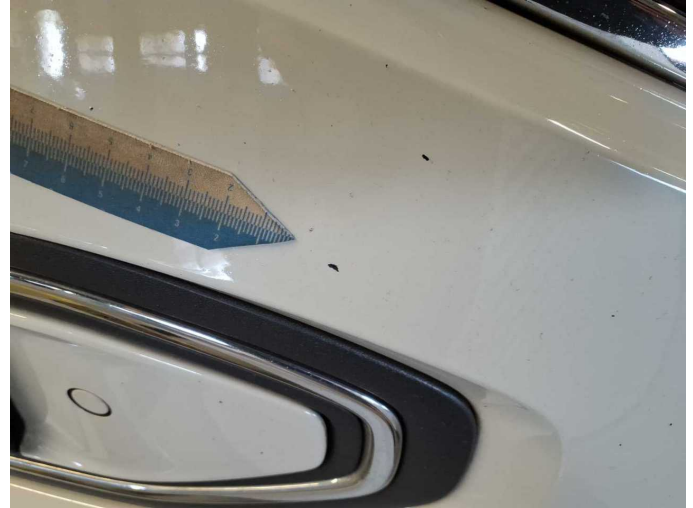
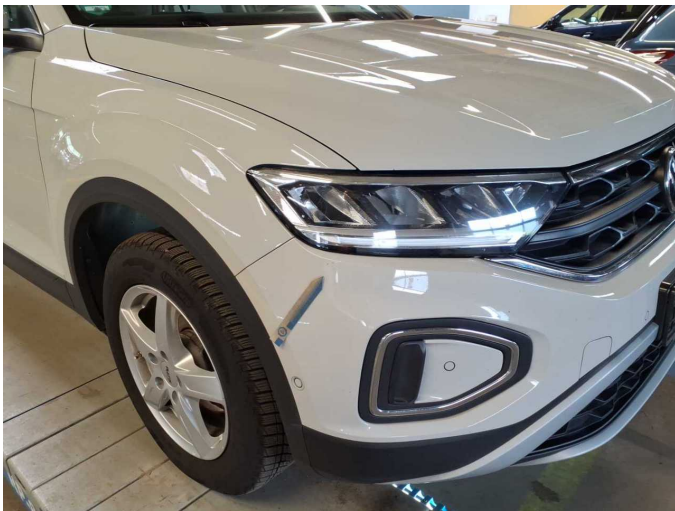
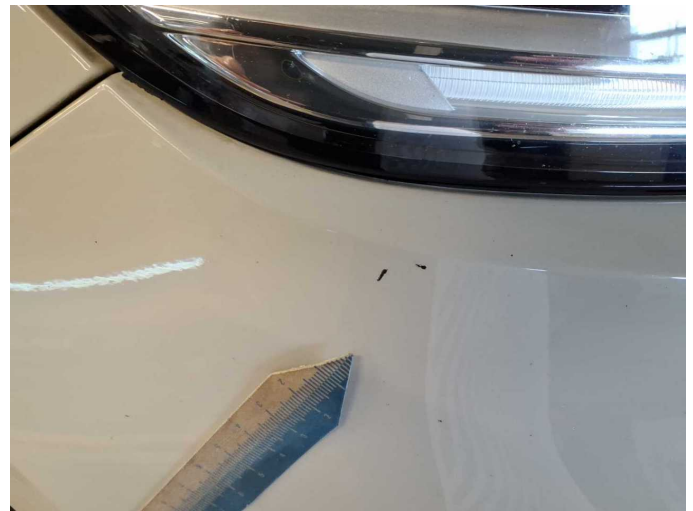
Damage 4: Front bumper: Front bumper - Stone chips - Paint
