Expertise

Protocol number: 46903819  
Order No. / Reference: 26833275  
Inspection date: 4 Aug 2026

Manufacturer: Mercedes-Benz

Model: V 220 d lang 9G-TRONIC Edition

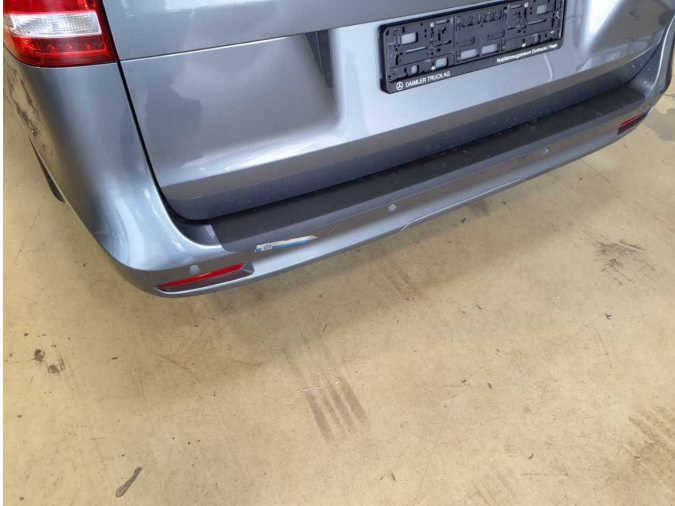
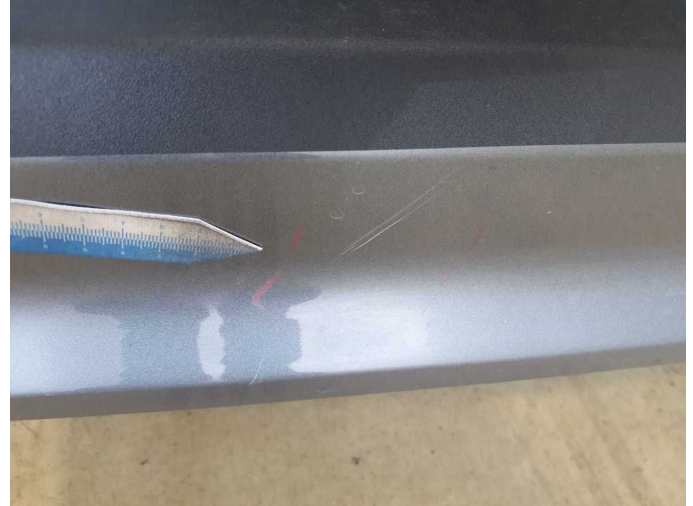
| No. | Component group | Description |
|---|---|---|
| 1 | Rear bumper | Rear bumper - Scratch(es) - Loss in value |

**Damage 1:** Rear bumper: Rear bumper - Scratch(es) - Loss in value

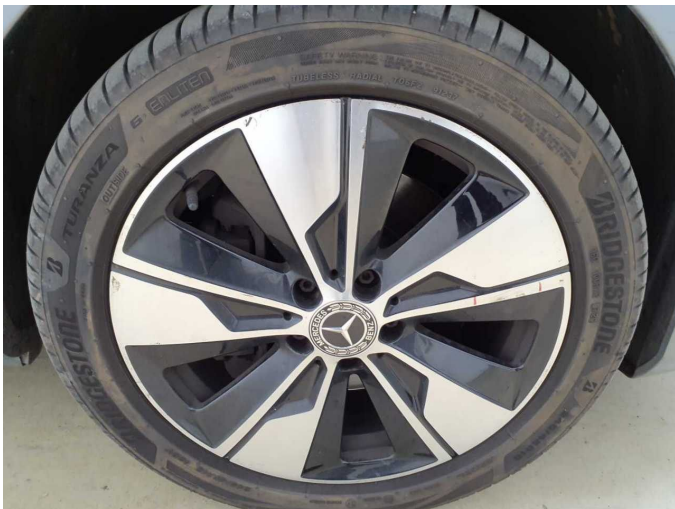
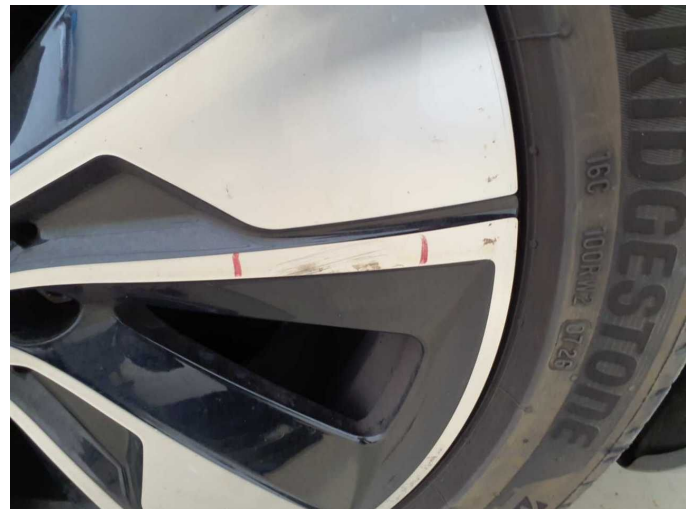
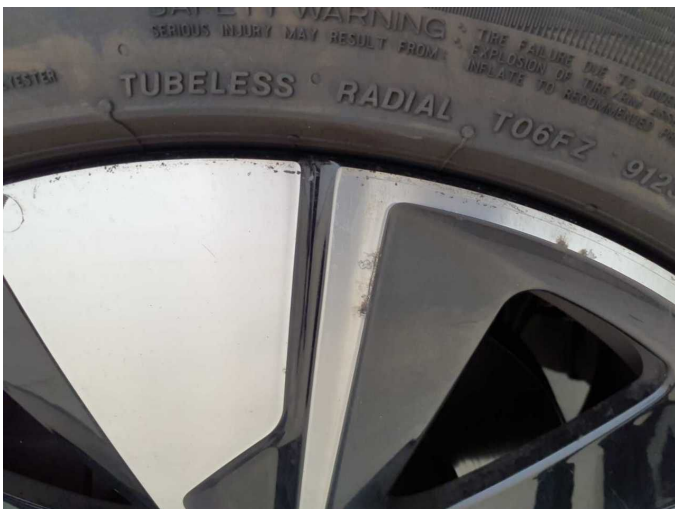
| No. | Component group | Description |
|---|---|---|
| 2 | Wheel / tyres | Alloy rim - front right side - Scratch(es) - Loss in value |

**Damage 2:** Wheel / tyres: Alloy rim - front right side - Scratch(es) - Loss in value

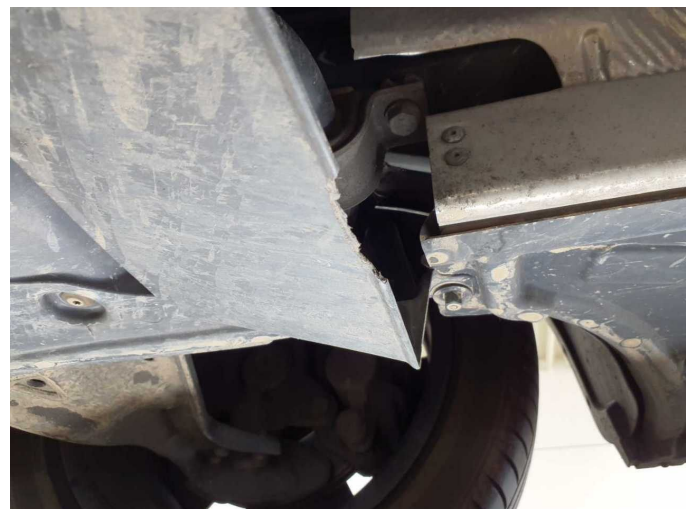
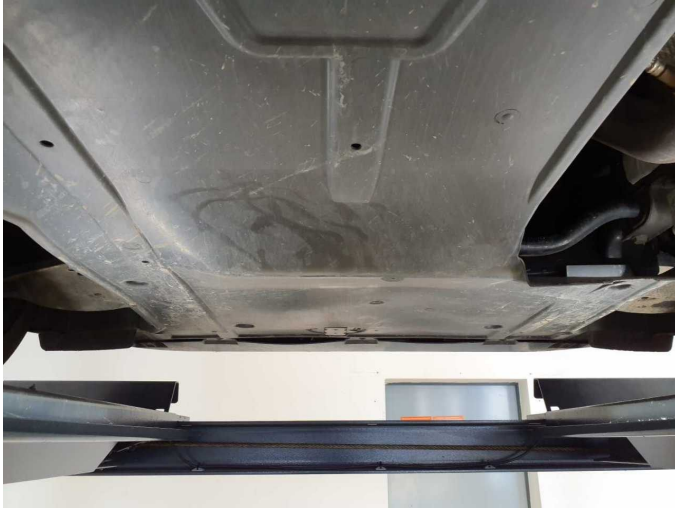
| No. | Component group | Description |
|---|---|---|
| 3 | Body | Underbody panelling - Broken / torn - Replace |

**Damage 3:** Body: Underbody panelling - Broken / torn - Replace

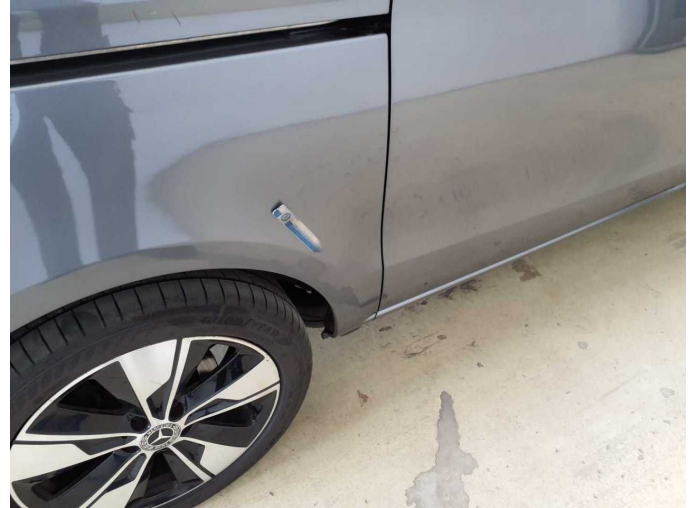
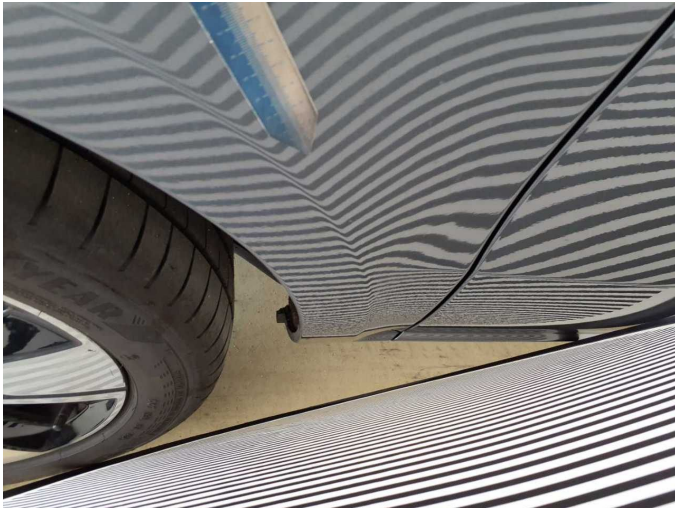
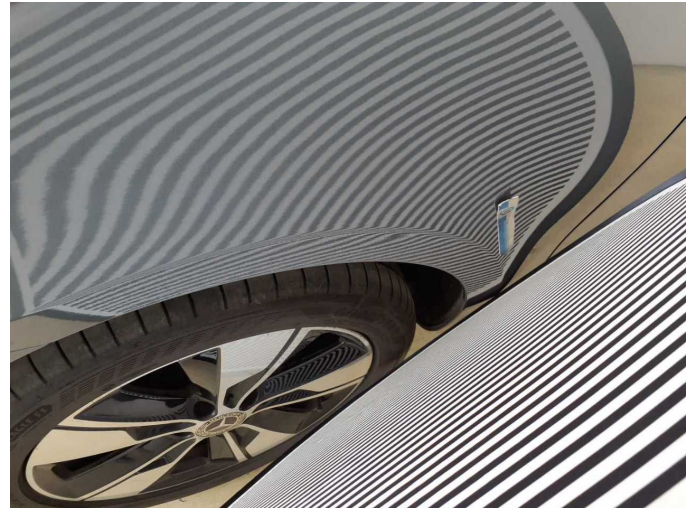
| No. | Component group | Description |
|---|---|---|
| 4 | Side panel - rear right side | Side panel (Einschlüsse-Mehrkosten möglich) - Unprofessionally repaired - Conditioning |

**Damage 4:** Side panel - rear right side: Side panel (Einschlüsse-Mehrkosten möglich) - Unprofessionally repaired - Conditioning

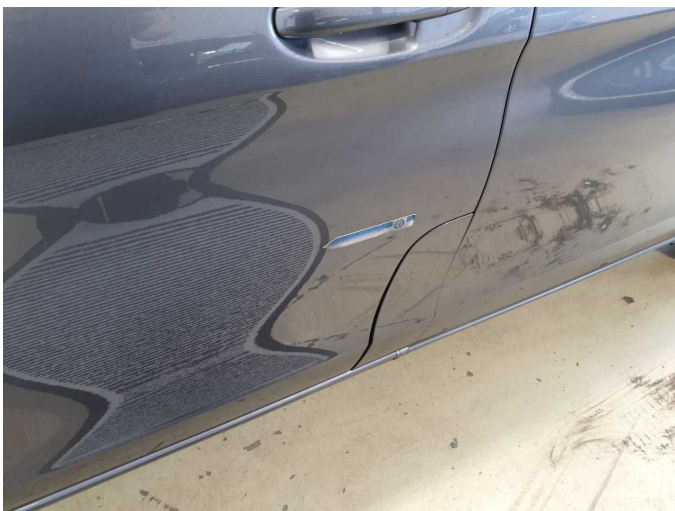
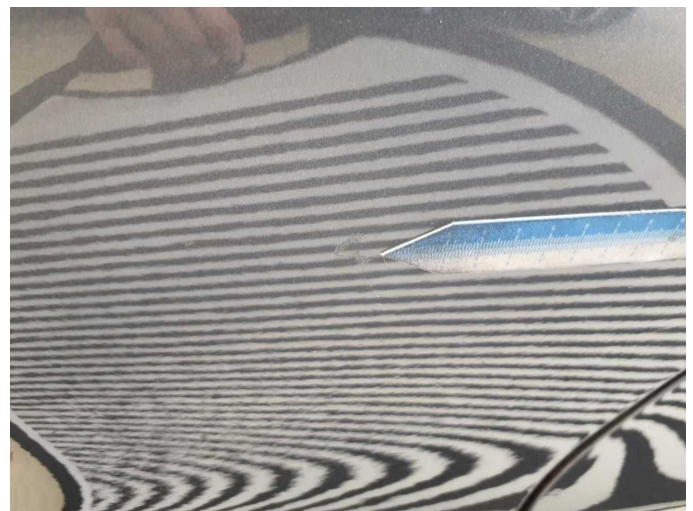
| No. | Component group | Description |
|---|---|---|
| 5 | Door - front left side | Door (Lack Druckstelle) - Unprofessionally repaired - Smart repair |

| No. | Repainting |
|---|---|
| 4 | Door - front left side, Unprofessionally carried out, Invoice of repair done Non-existent |

| Side panel - rear left side | 627 µm | Door - front left side | 779 µm |

**Damage 5:** Door - front left side: Door (Lack Druckstelle) - Unprofessionally repaired - Smart repair

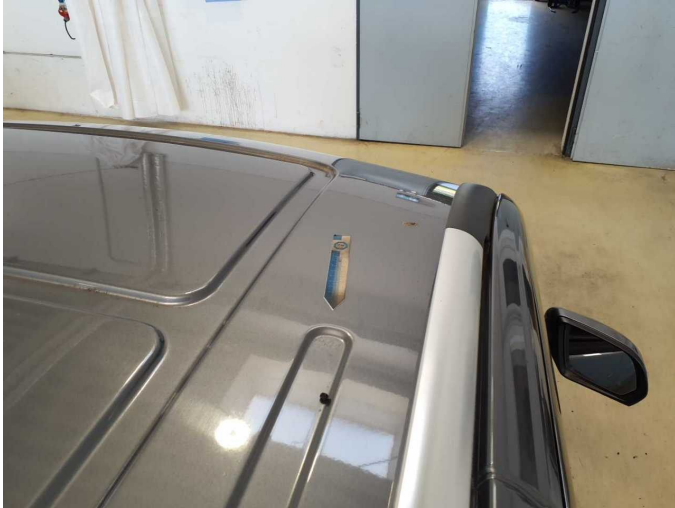
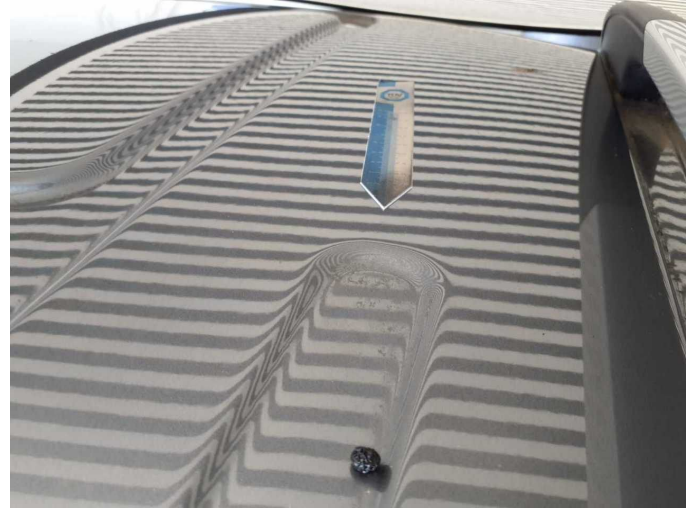
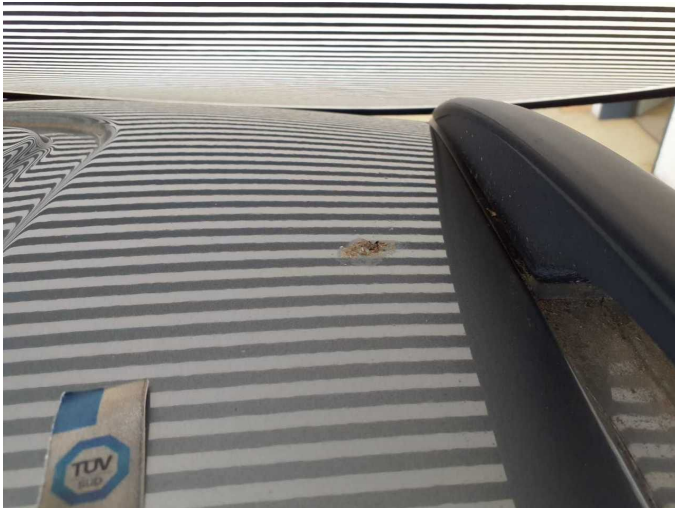
| No. | Component group | Description |
|---|---|---|
| 6 | Roof | Roof (Anätzung-Mehrkosten möglich) - Paint defect - Conditioning |

**Damage 6:** Roof: Roof (Anätzung-Mehrkosten möglich) - Paint defect - Conditioning

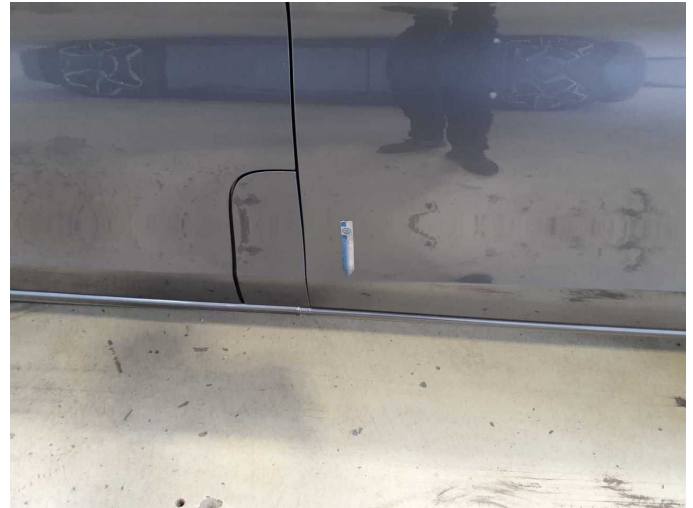
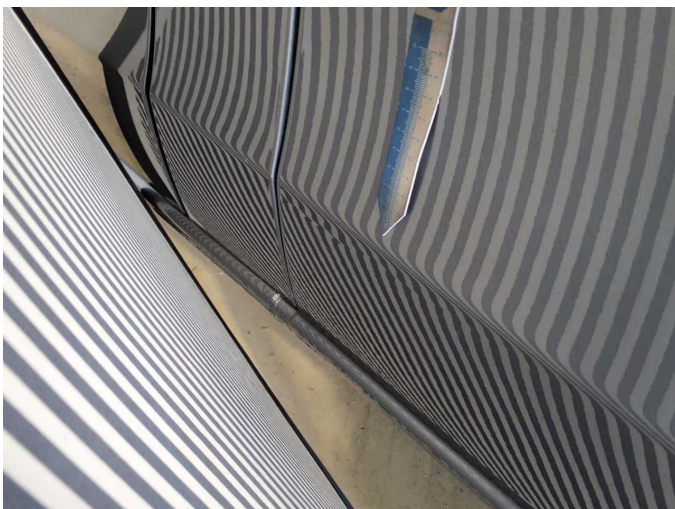
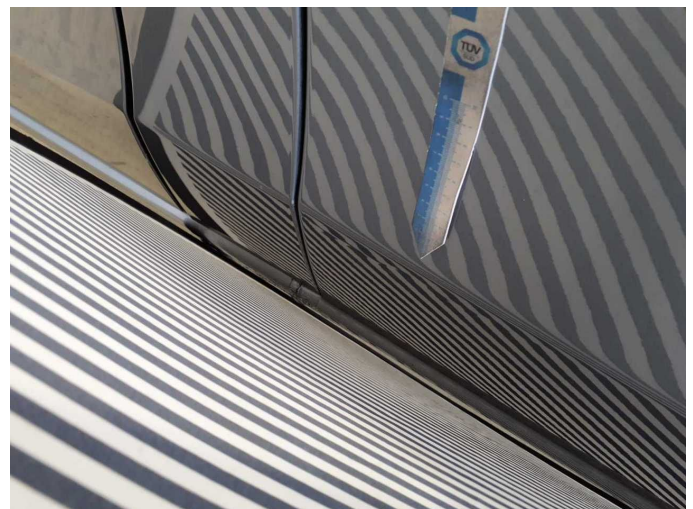
| No. | Component group | Description |
|---|---|---|
| 7 | Side panel - rear left side | Side panel (Läufer-Mehrkosten möglich) - Unprofessionally repaired - Conditioning |

**Damage 7:** Side panel - rear left side: Side panel (Läufer-Mehrkosten möglich) - Unprofessionally repaired - Conditioning

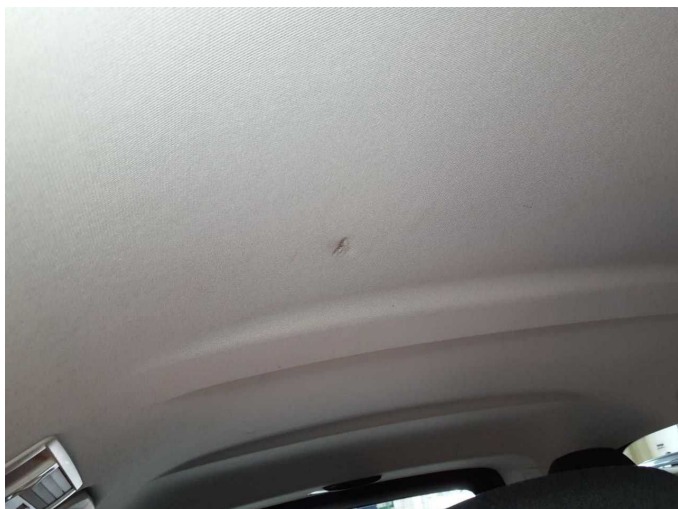
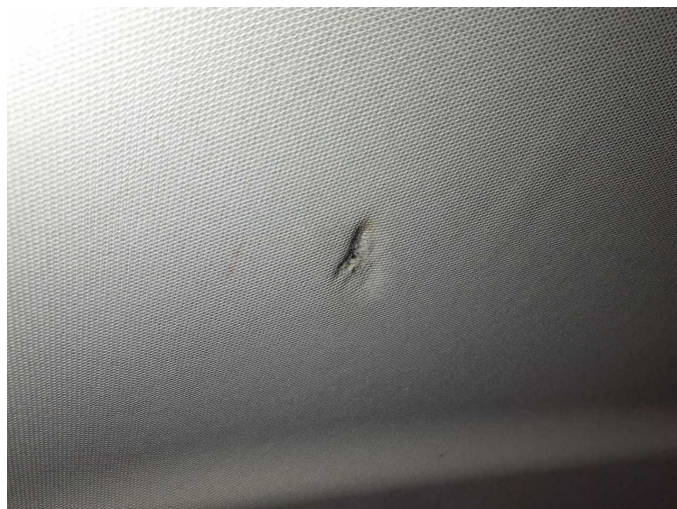
| No. | Component group | Description |
|---|---|---|
| 8 | Trim / covers | Roof lining - Broken / torn - Replace |

**Damage 8:** Trim / covers: Roof lining - Broken / torn - Replace

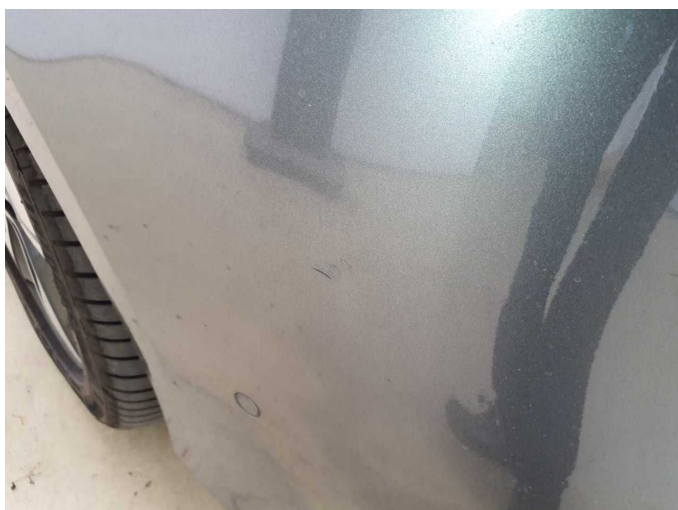
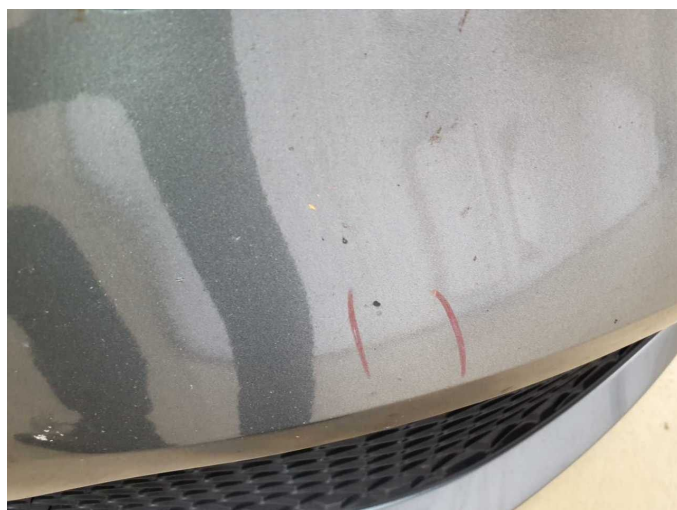
| No. | Component group | Description |
|---|---|---|
| 3 | Front bumper | Front bumper - Scratch(es) - No deduction |

**Wear and tear 3:** Front bumper: Front bumper - Scratch(es) - No deduction

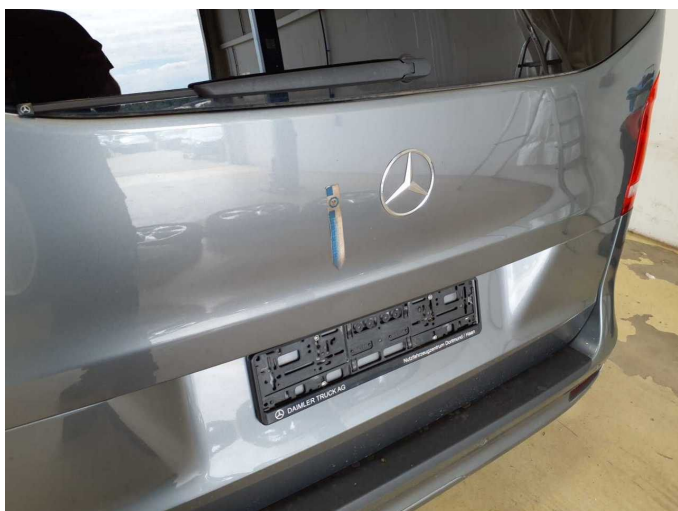
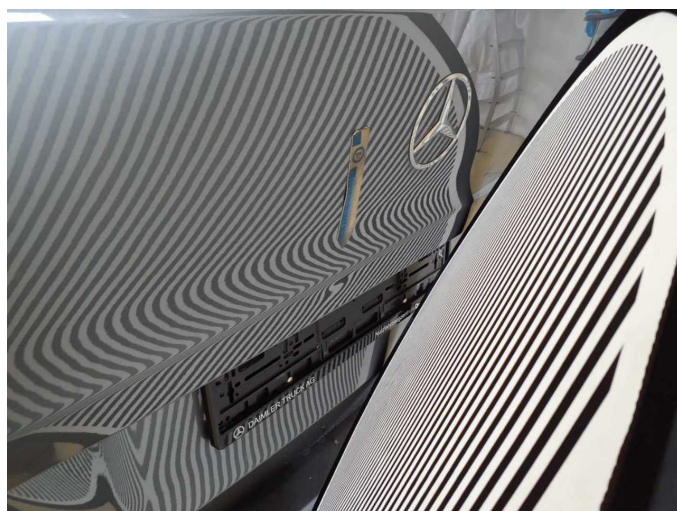
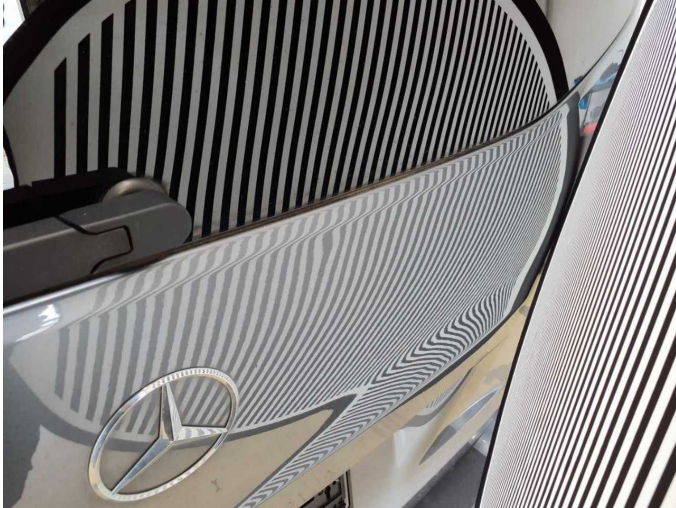
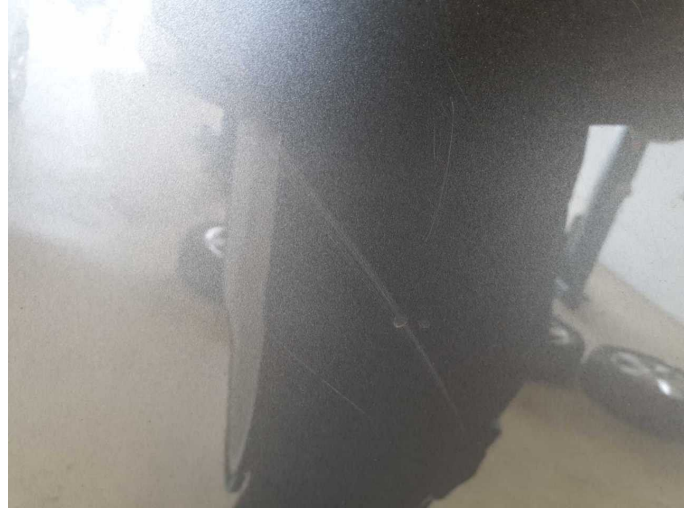
| No. | Component group | Description |
|---|---|---|
| 8 | Boot lid / rear door | Boot lid - Dent / paintcoat damage - No deduction |

**Wear and tear 8:** Boot lid / rear door: Boot lid - Dent / paintcoat damage - No deduction

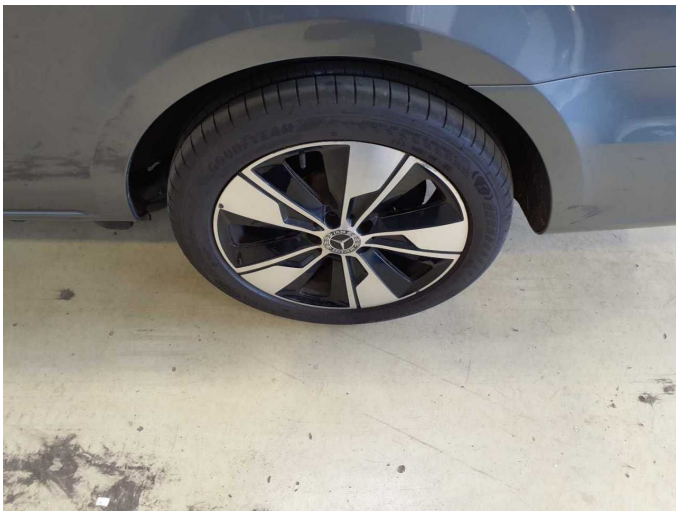
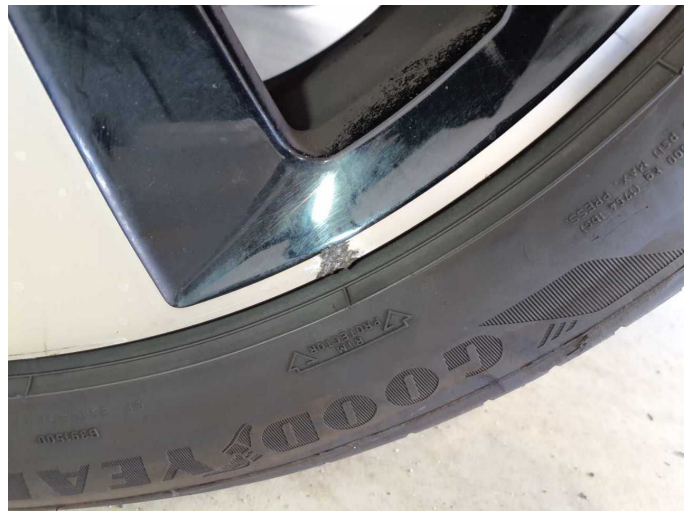
| No. | Component group | Description |
|---|---|---|
| 9 | Wheel / tyres | Alloy rim - rear left side - Scratch(es) - No deduction |

**Wear and tear 9:** Wheel / tyres: Alloy rim - rear left side - Scratch(es) - No deduction

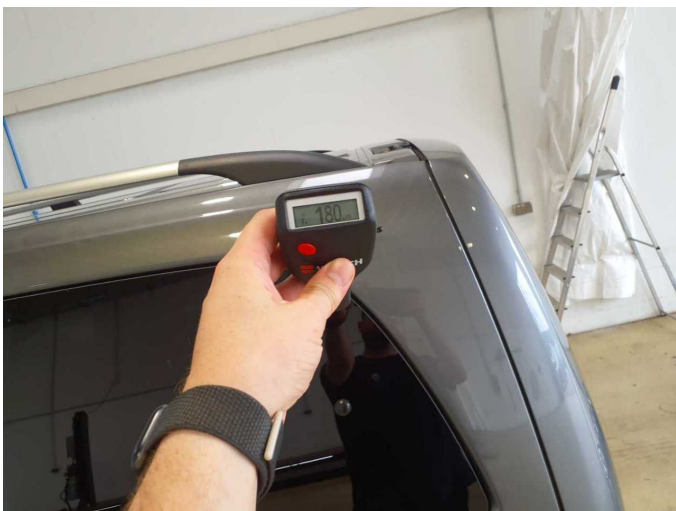
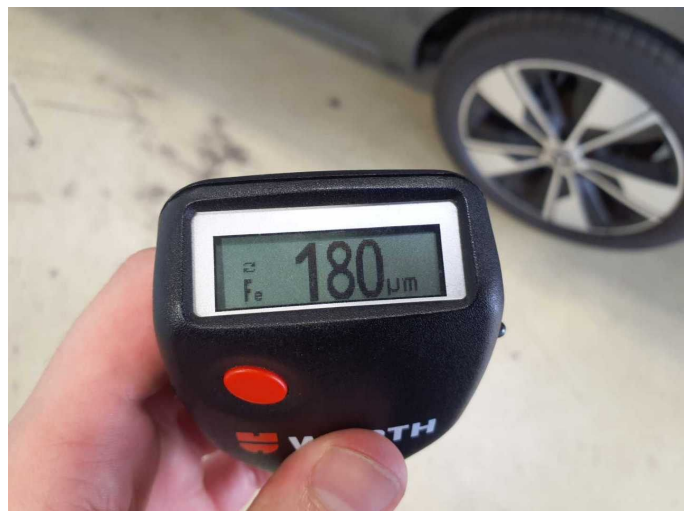
| No. | Repainting |
|---|---|
| 1 | Roof rail - left side, Professionally carried out, Invoice of repair done Non-existent |

| Roof rail - left side | 180 µm | Bonnet | 248 µm |

**Repainting 1:** Roof rail - left side

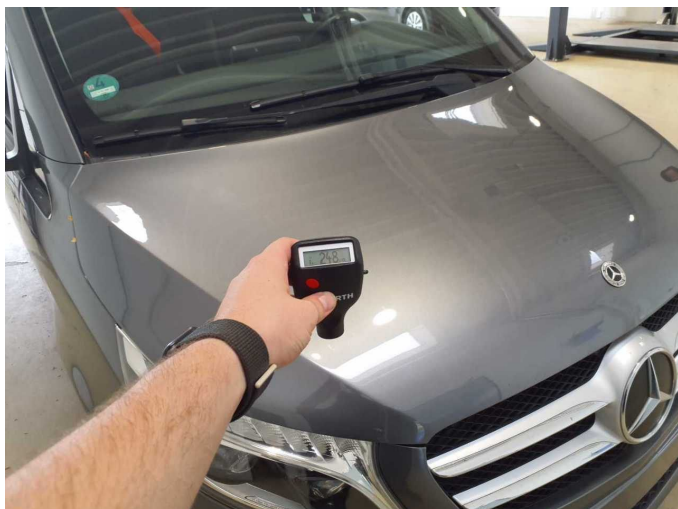
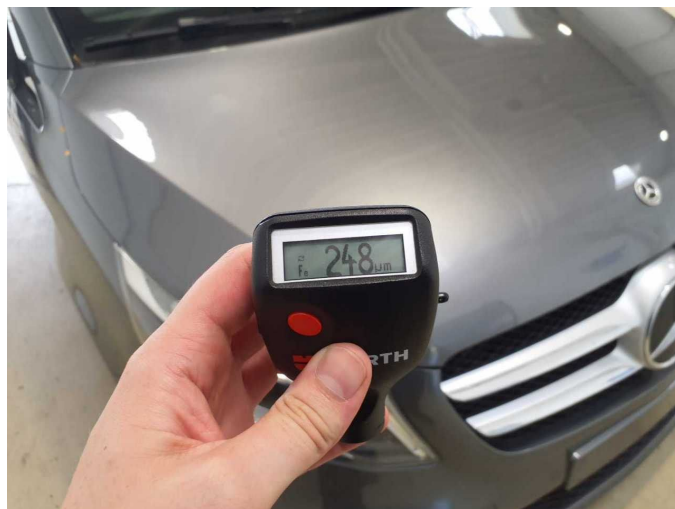
| No. | Repainting |
|---|---|
| 2 | Bonnet, Professionally carried out, Invoice of repair done Non-existent |

**Repainting 2: Bonnet**

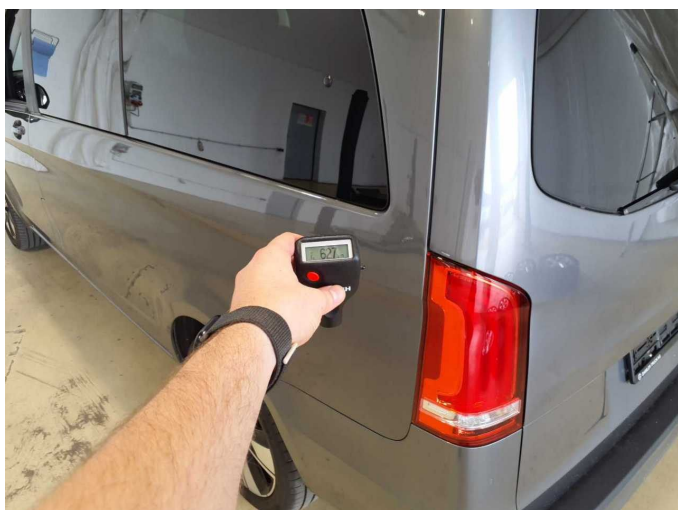
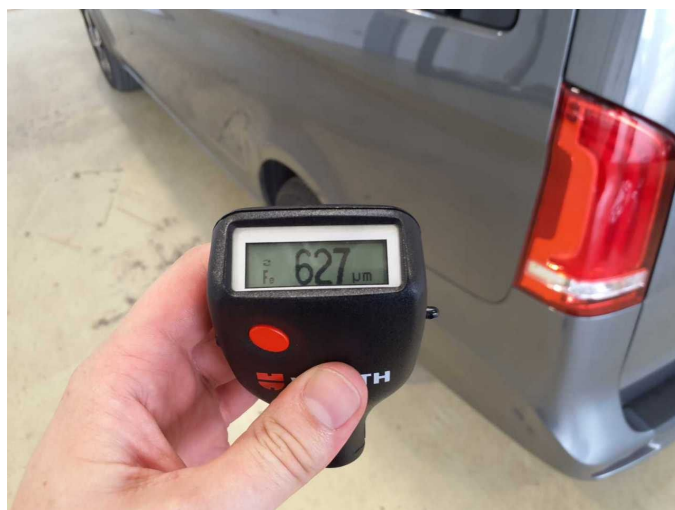
| No. | Repainting |
|---|---|
| 3 | Side panel - rear left side, Unprofessionally carried out, Invoice of repair done Non-existent |

**Repainting 3: Side panel - rear left side**

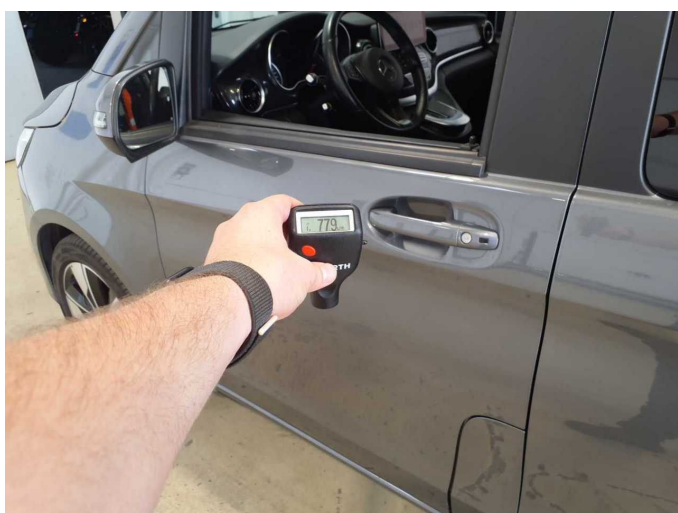
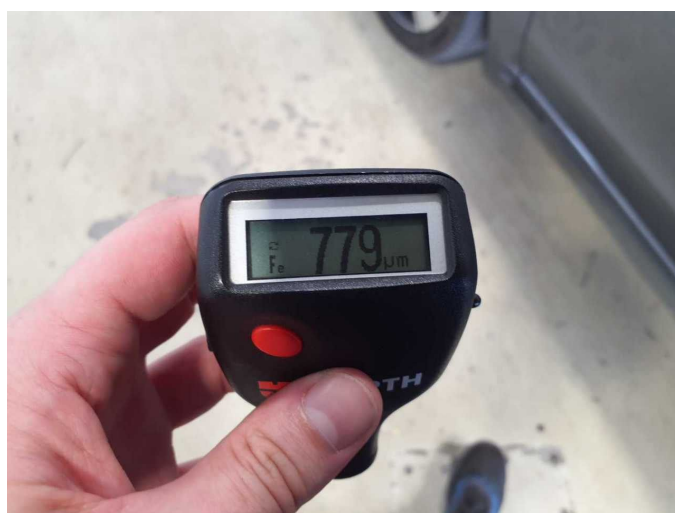
**Repainting 4: Door - front left side**
