Expertise

Protocol number: 43488009
Order number / reference: 25764302
Inspection date: 21 Jan 2026

Model: Kodiaq 2.0 TDI DSG Tour

VIN: TMBJJ9NS3P8024174

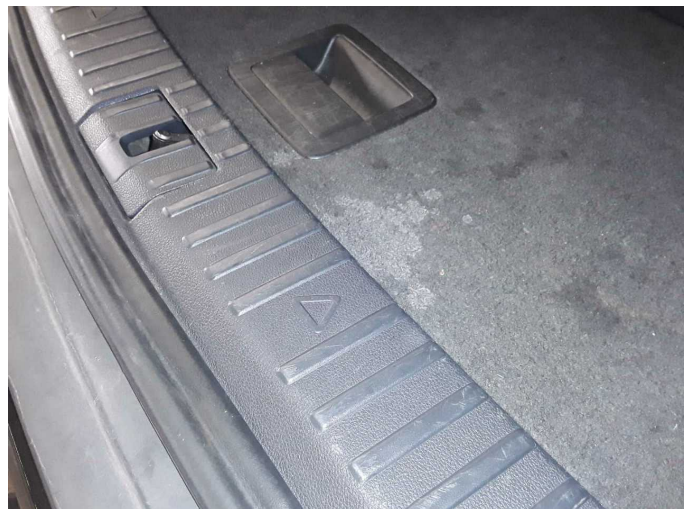
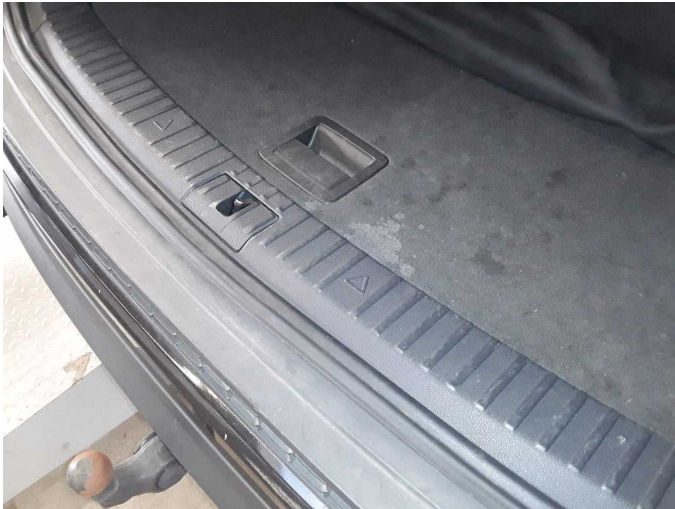
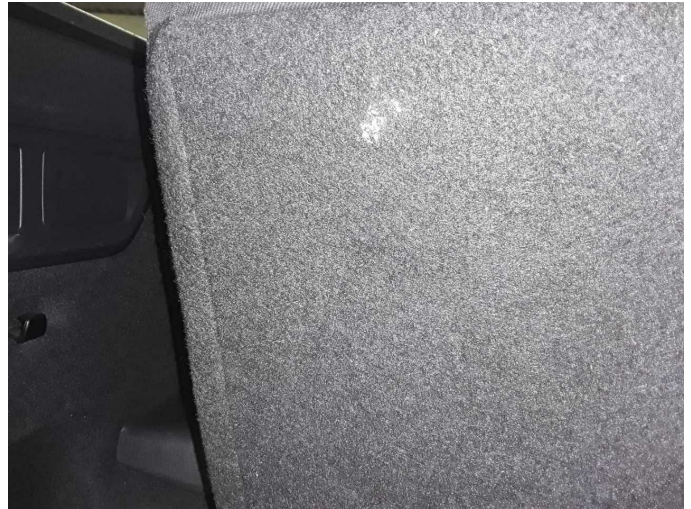
Damage 1: Interior: Cargo area floor - Soiled - Conditioning

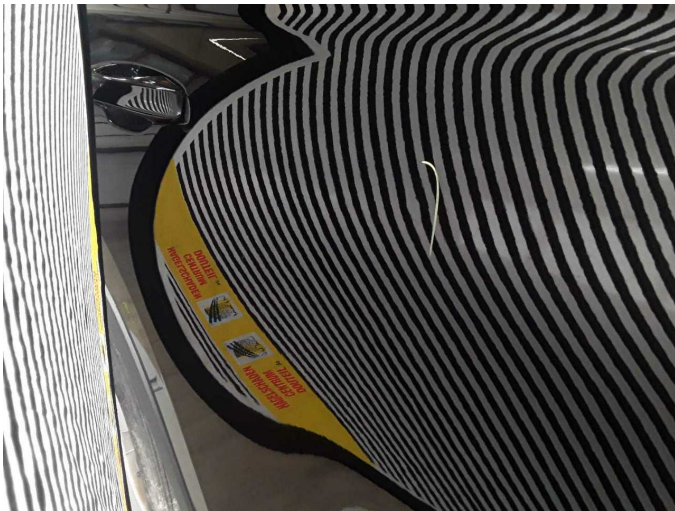
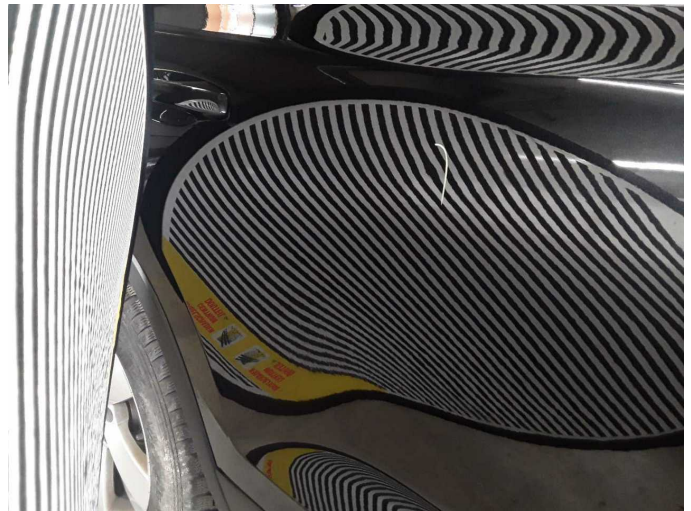
Damage 2: Door - rear right side: Door - dent(s) - Smooth repair work

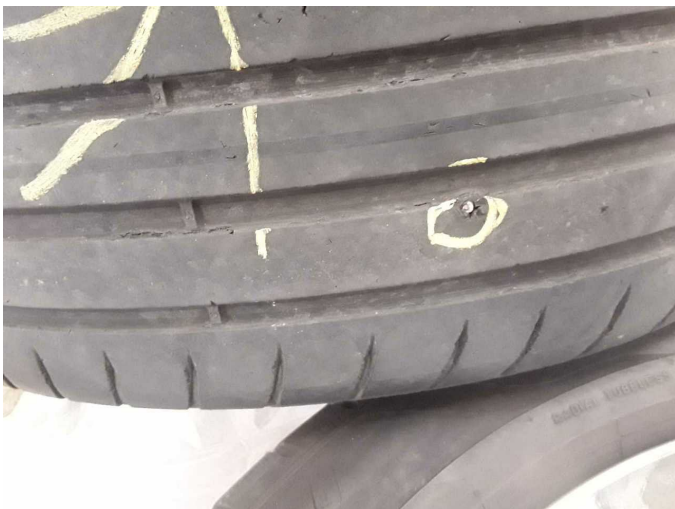
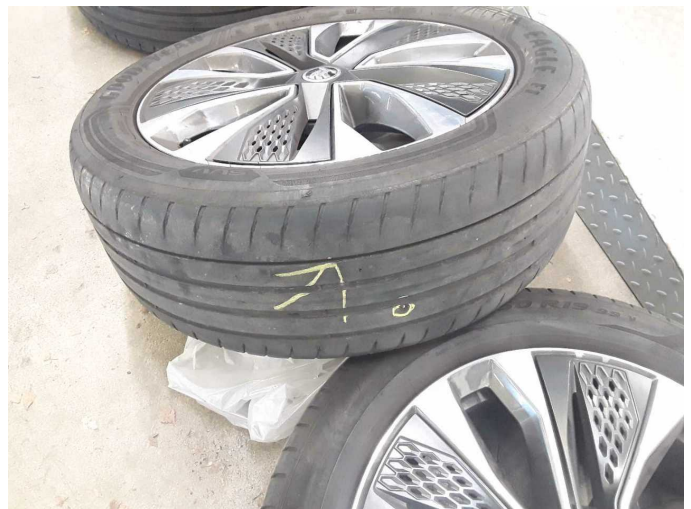
Damage 3: 2nd wheel set: 1 tyre - Damaged - Replace

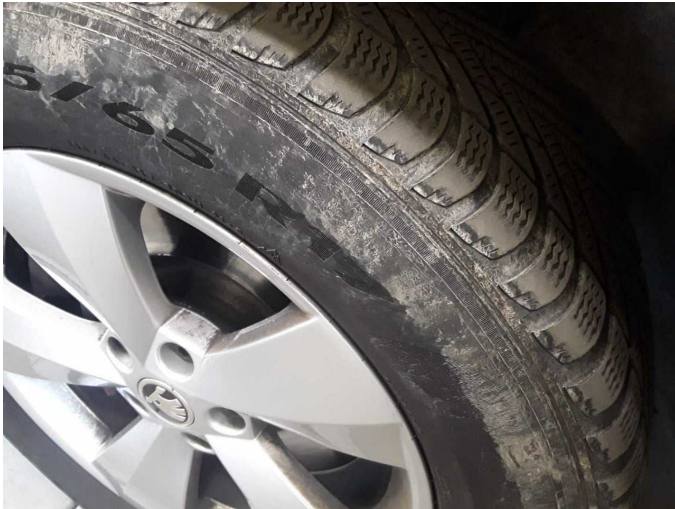
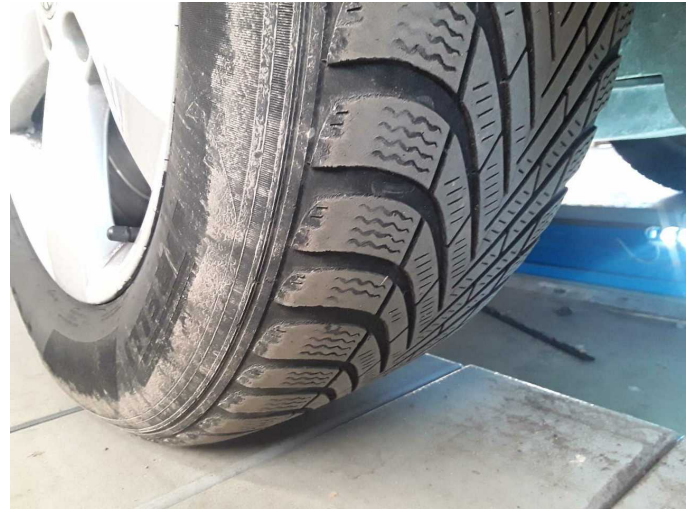
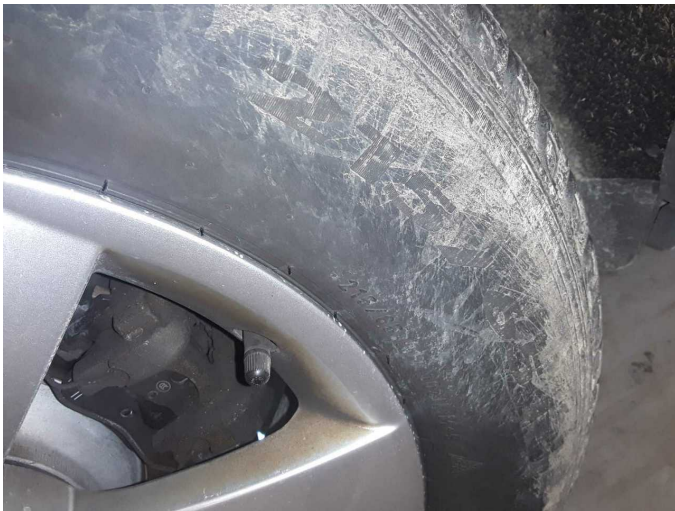
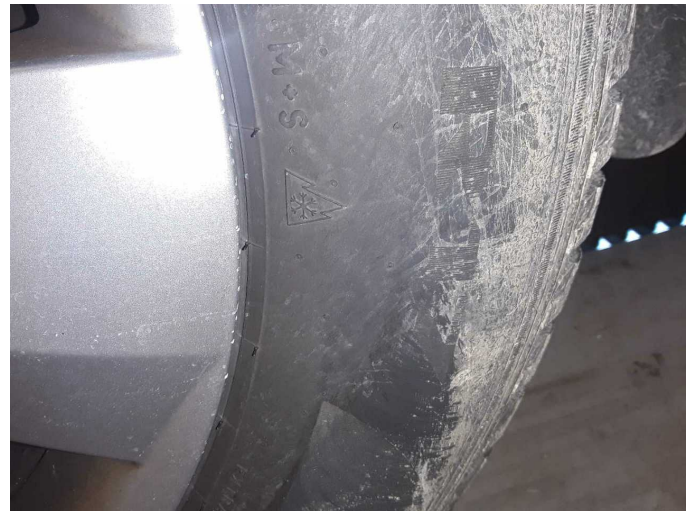
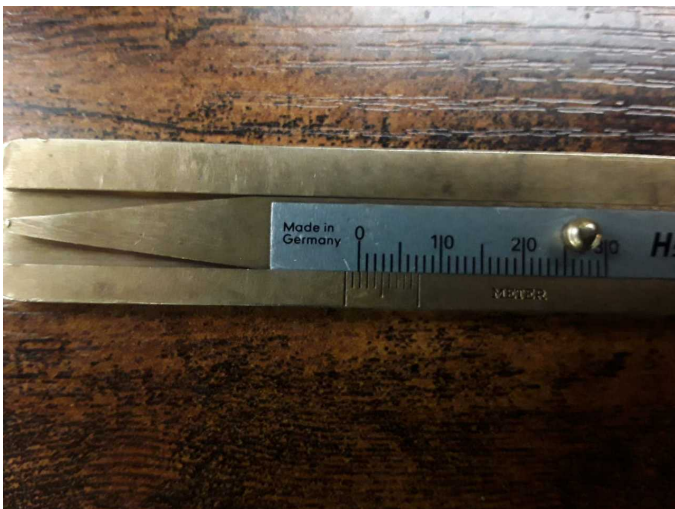
Damage 4: Wheel / tyres: Tyre - front (2x) - Does not meet the leasing specifications - Replace

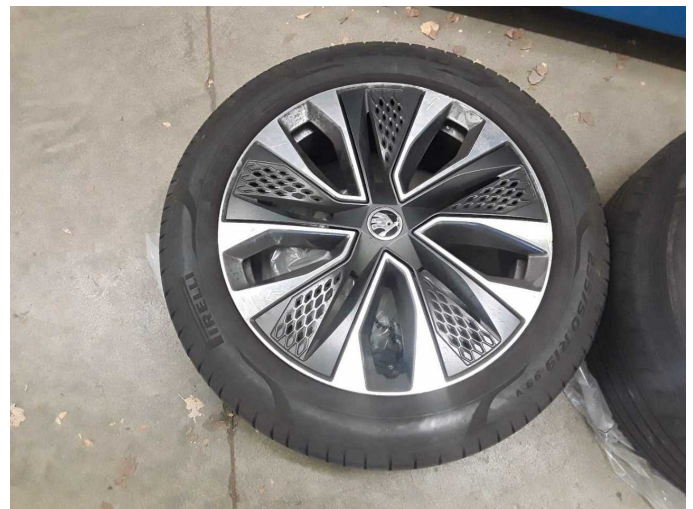
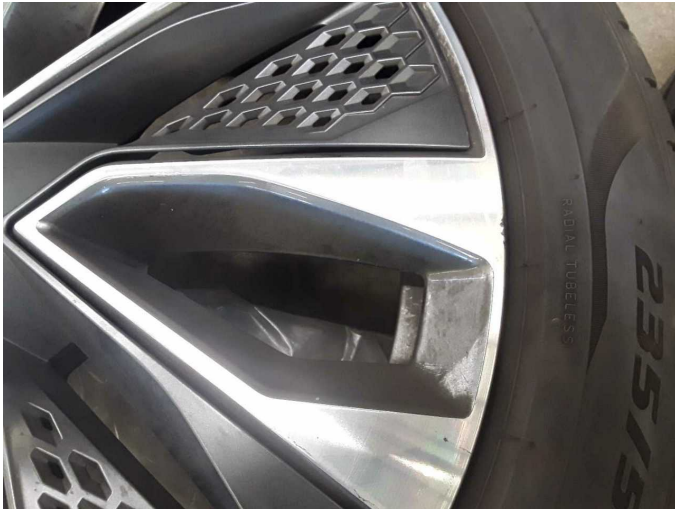
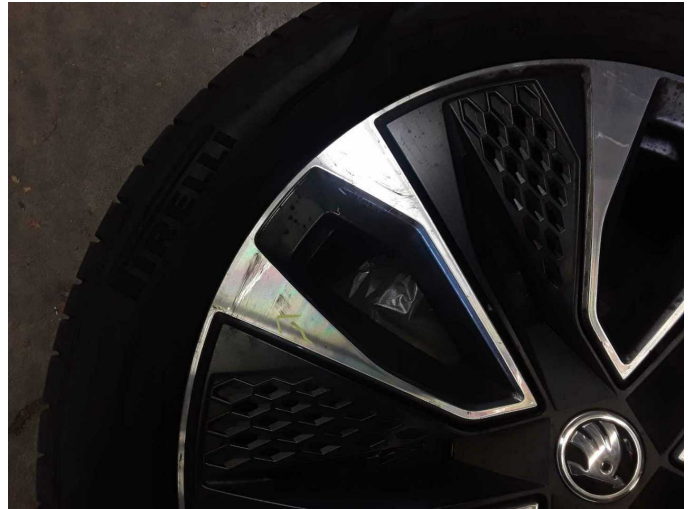
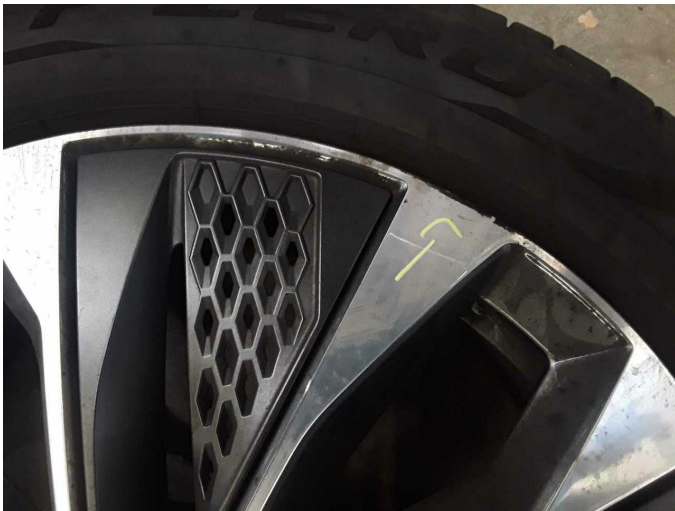
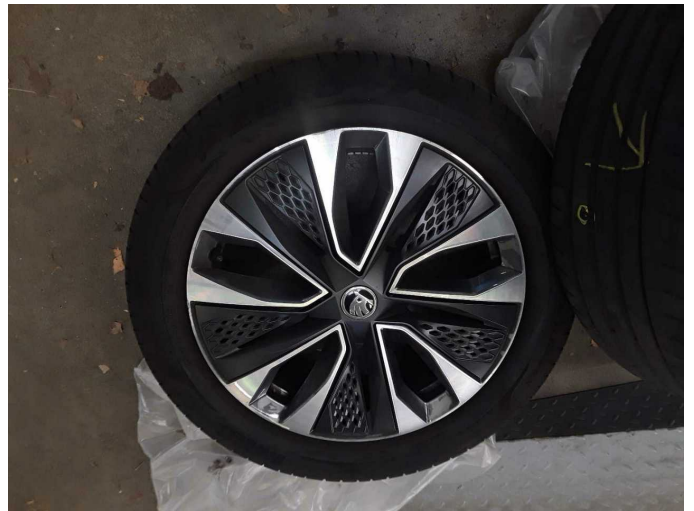
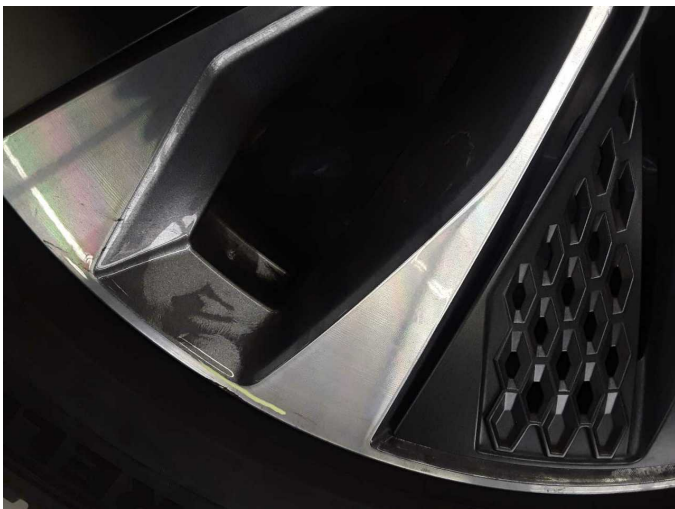
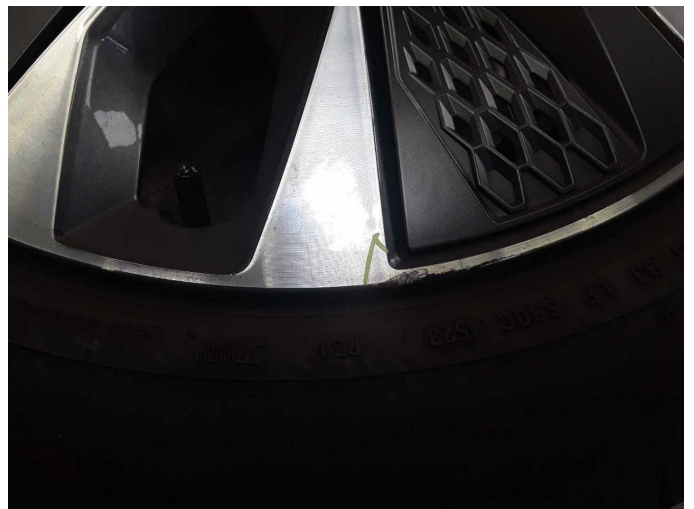
Damage 5: 2nd wheel set: 2 alloy rims (2x) - Scratch(es) - Loss in value

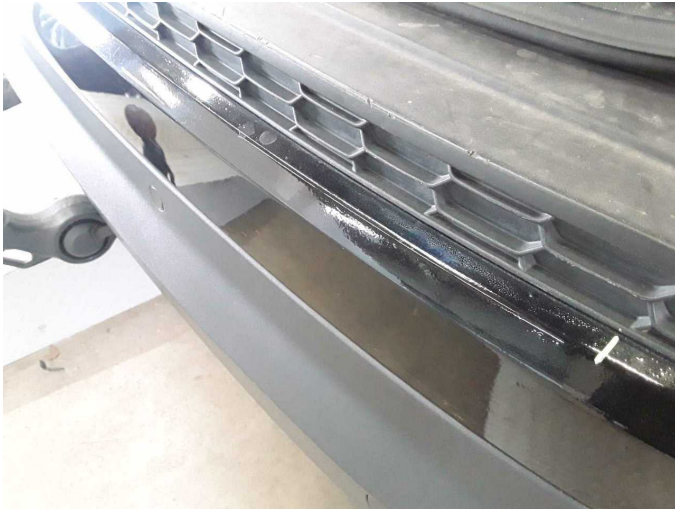
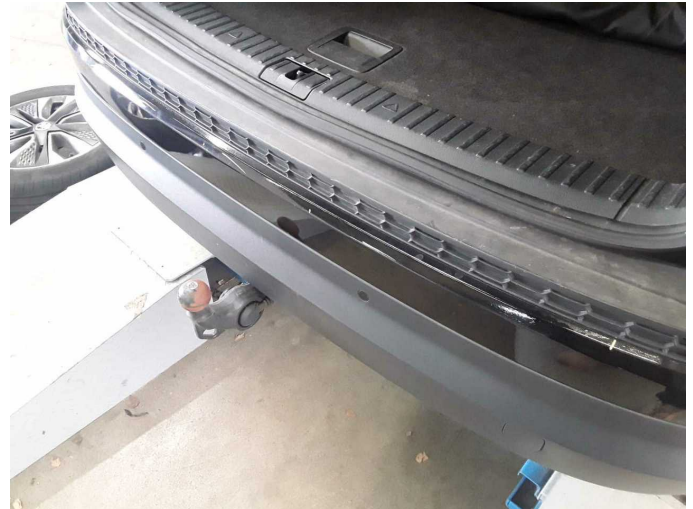
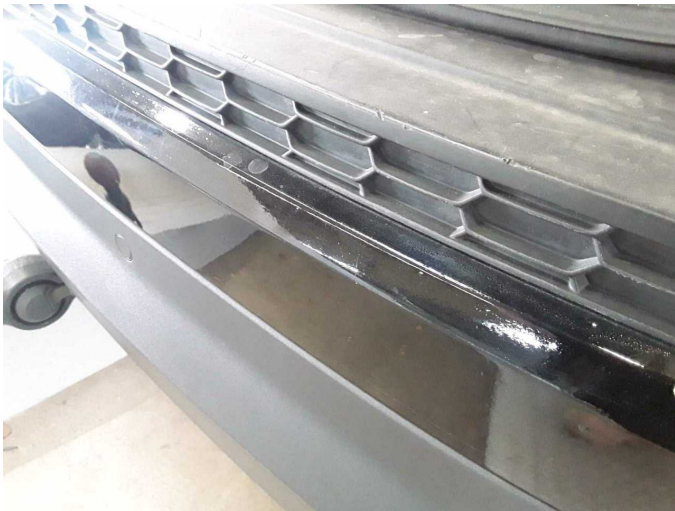
No.	Repainting
1	Mudguard - left side, Door - rear right side, Door - front right side, Professionally carried out, Invoice of repair done Non-existent
2	Bumper rear, Unprofessionally carried out

Damage 6: Rear bumper: Rear bumper - Unprofessionally repaired - Paint

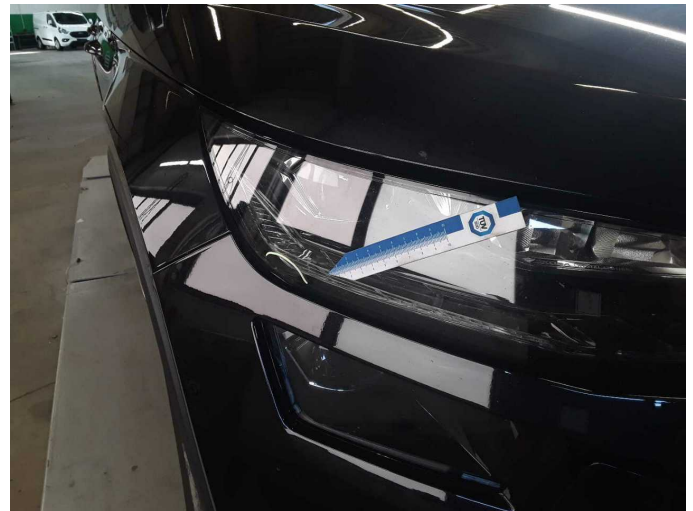
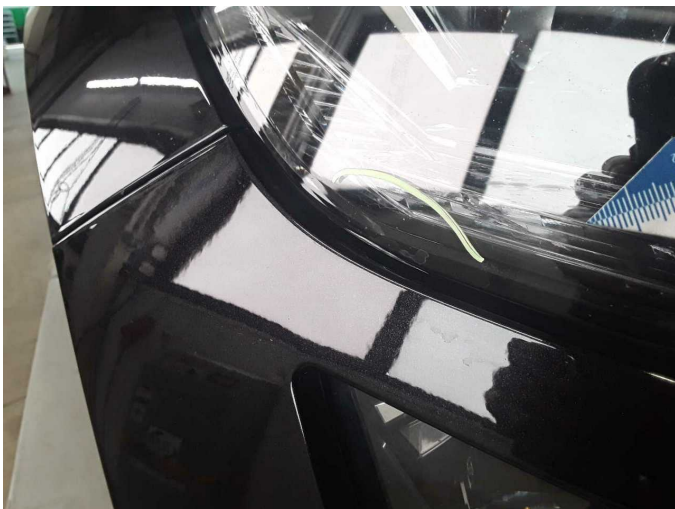
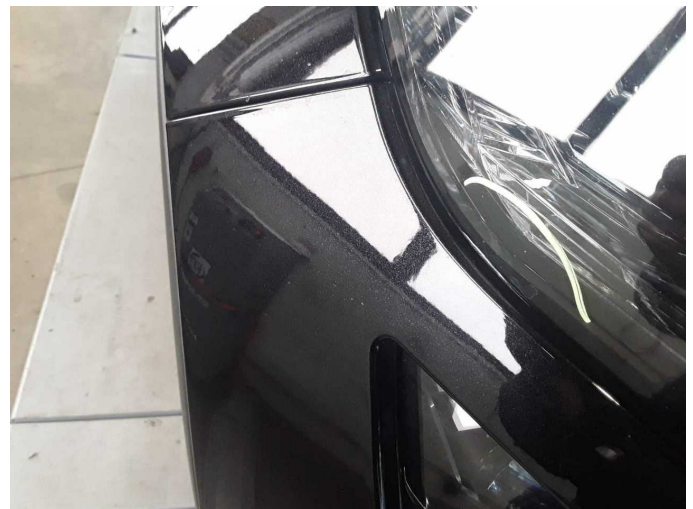
Damage 7: Headlight: Headlight - right side (nicht im Lichtkegel) - Scratch(es) - Replace

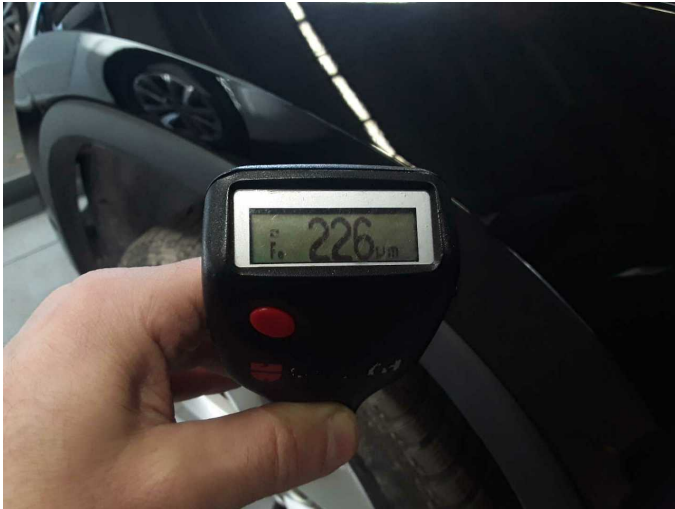
Mudguard - left side: 226 µm

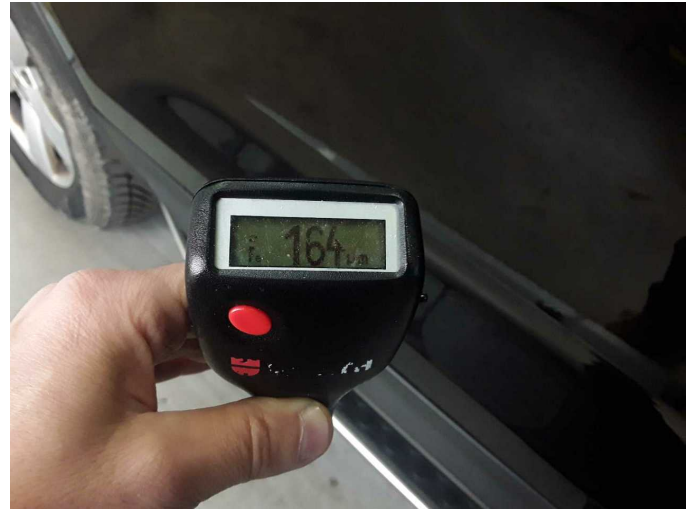
Door - rear right side: 164 µm

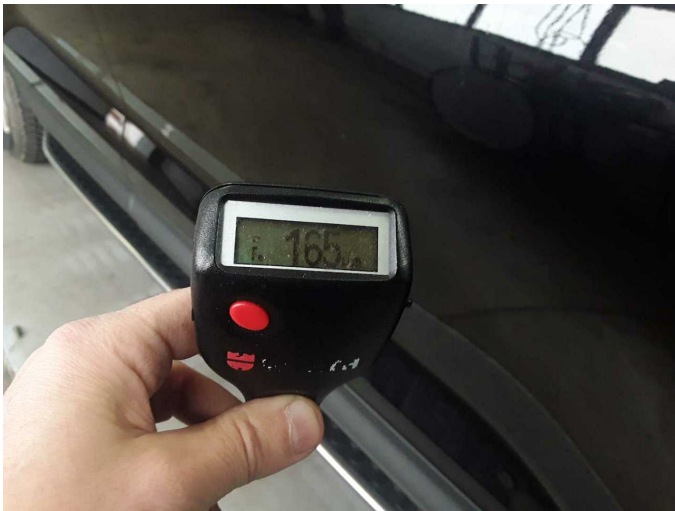
Door - front right side: 165 µm
